# Snow Study Summary Report

Observations of Snow Load Effects on Four School Buildings in New England

October 2016

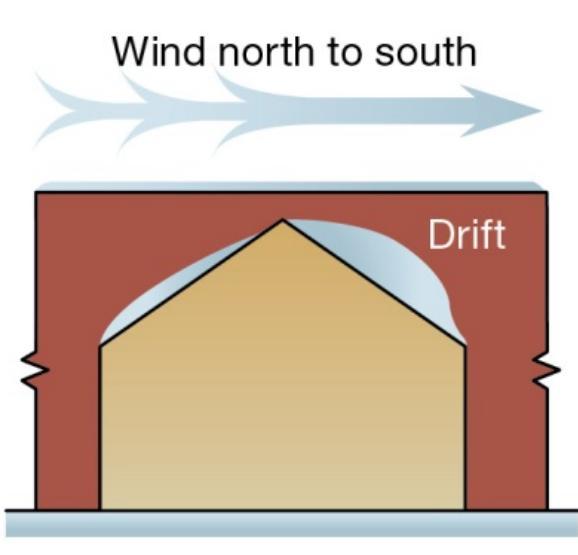
Figure 1 shows an aerial view of Mitchell Elementary School. The area where the roof collapsed is on the south side of the central wing gable roof (the ridge line is nominally east-west). In addition, there is an upper-level roof to the right (nominally east) of the damaged area. Since the wind directions were from the north and west, the roof was subject to over-the-ridge gable roof drifts due to the north wind, and windward roof step drifts due to the west wind (see Figures 2 and 3). Unfortunately, there is no current guidance on how to combine the over-the-ridge drifts with windward or leeward roof step drifts when both types of drifts occupy the same roof area.

Figure 2: Cross section looking east through the drift area (not to scale)

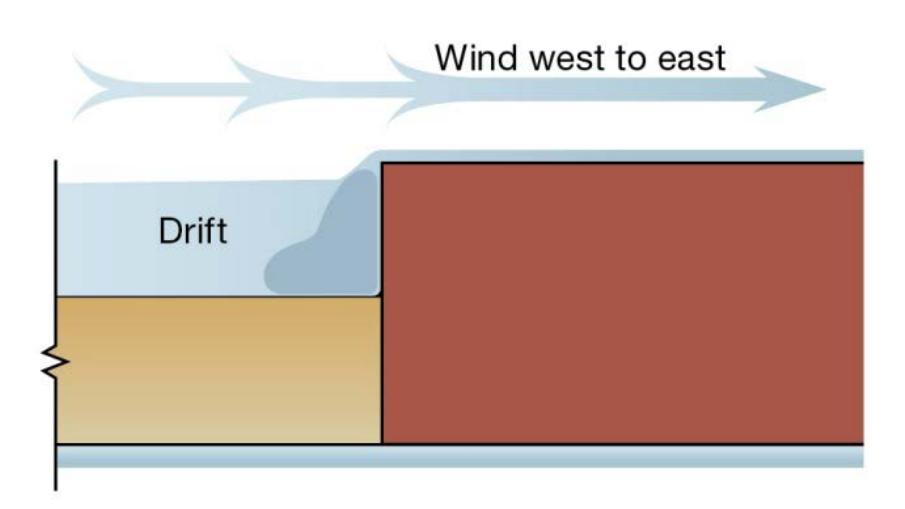
Figure 3: Cross section looking north toward the drift area (not to scale)

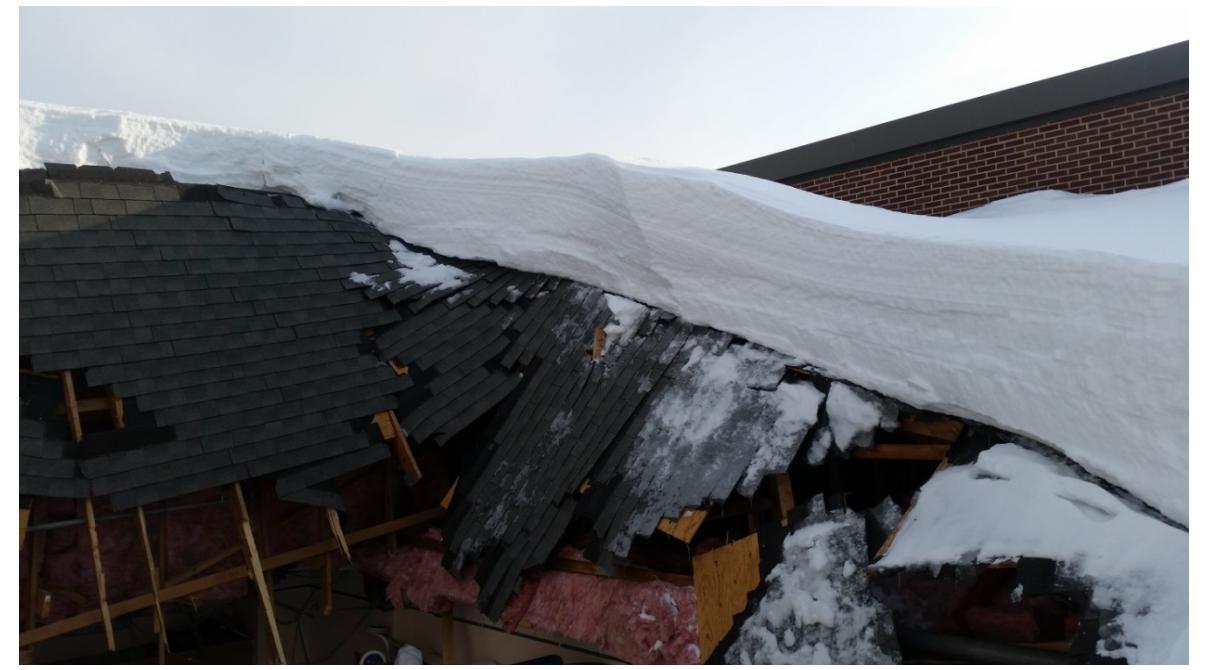
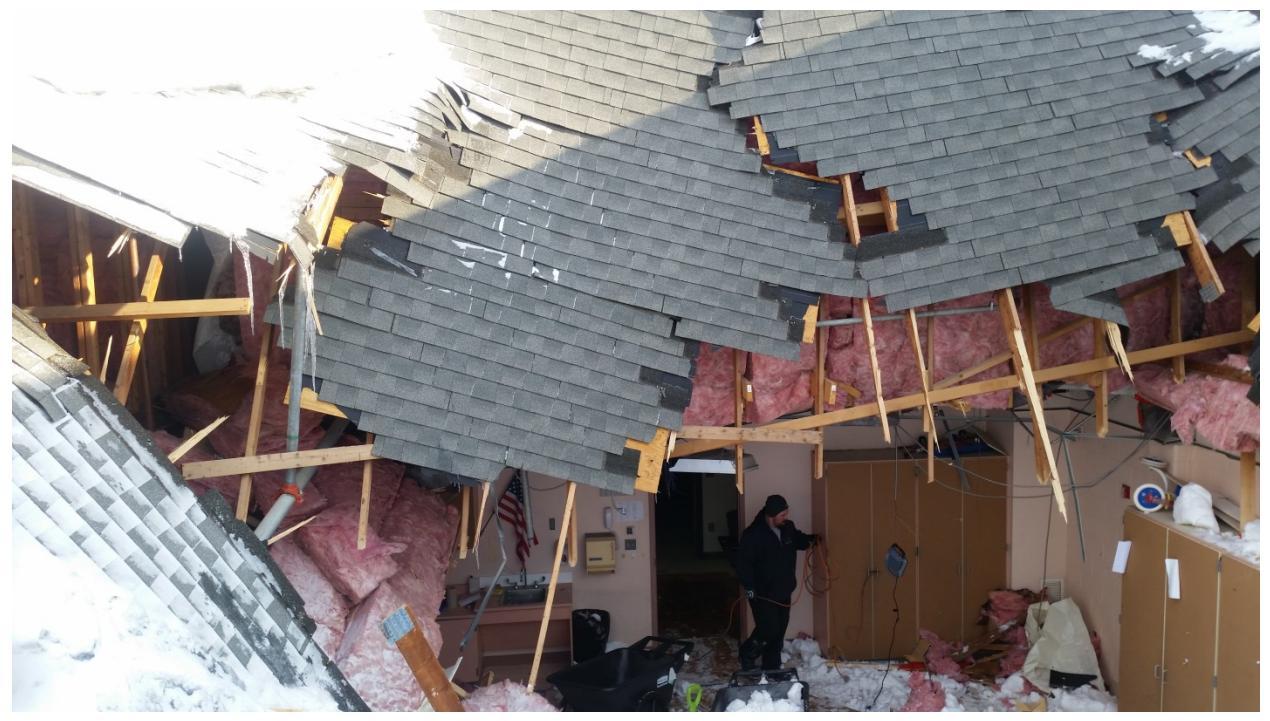
On Thursday, February 19, 2015, the roof above Classroom 218 collapsed due to snow loading. Fortunately, Massachusetts schools were on winter vacation that week, so the area was unoccupied. Classroom 218 is located on the southeastern end of the central wing indicated by the outline in Figure 1. As noted above, the roof failure appeared to have been triggered by loading from snow drifts that formed in a roof valley on the leeward side of the building's medium-sloped gable roof. The roof was demolished shortly after failure, but the collapsed roof prior to demolition is shown in Figures 4 and 5.

Figure 4: Collapsed roof prior to demolition/removal, looking east (Photo courtesy of RebuildEx)

Figure 5: Collapsed roof prior to demolition/removal, looking north (Photo courtesy of RebuildEx)

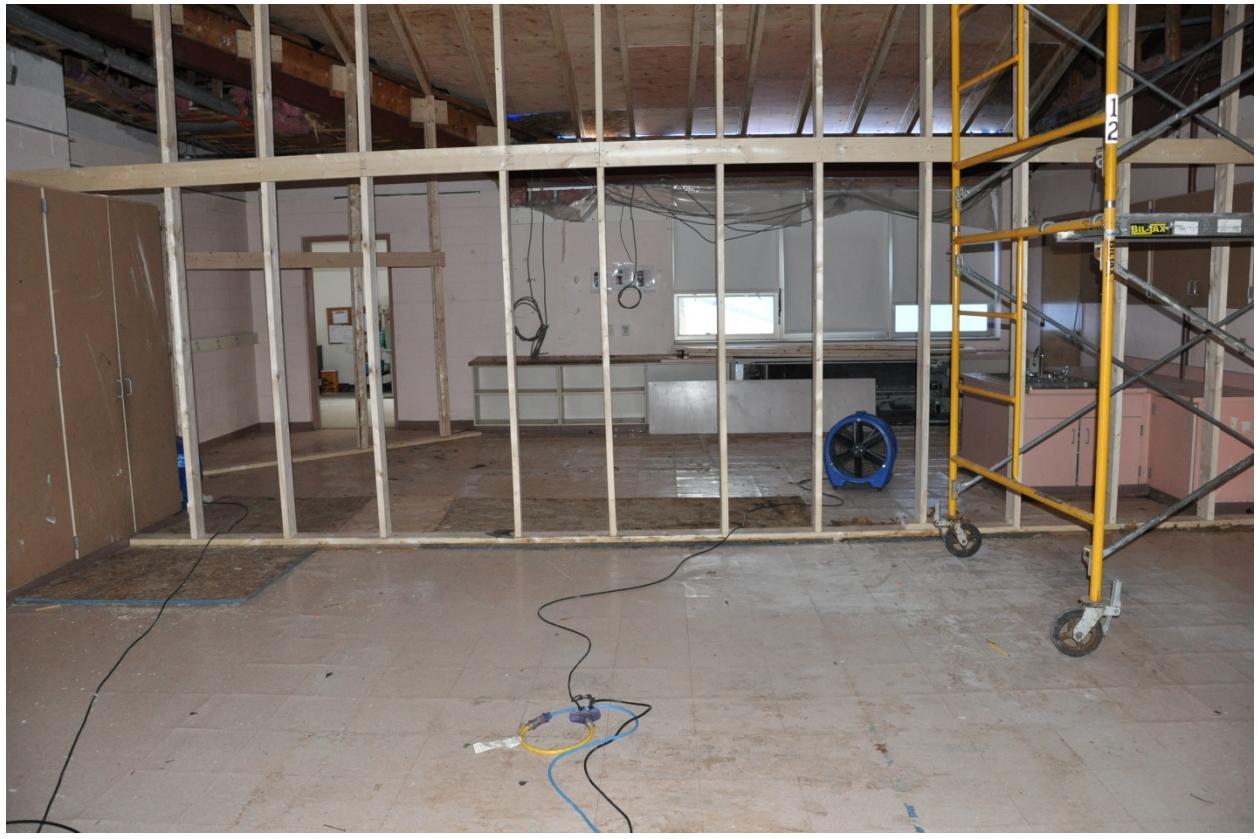
By the time the assessment team arrived, the collapsed roof and ceiling above Classroom 218 had been removed and temporarily replaced with shored wood I-joist rafters, as shown in Figure 6. The steel valley beam (specified in the construction plans as W21x50) and valley supports remained in place. Based on discussions with local officials, a cursory plan review, and observations of surrounding areas, the assessment team learned that the removed roof structure consisted of wood truss members that spanned 28 feet from a steel support beam extending eastwest (specified in the construction plans as W18x40) to the exterior classroom wall. A combination of dimensional lumber rafters (which remained in place) and wood trusses (which were removed) spanned the steel support beam and valley. According to the roof framing plan above Classroom 218, shown in Figure 7, all roof members in the area were specified at 24 inches on center spacing.

Figure 6: Classroom space beneath collapsed roof area, looking south. Note temporary I-joist rafters installed with shoring.

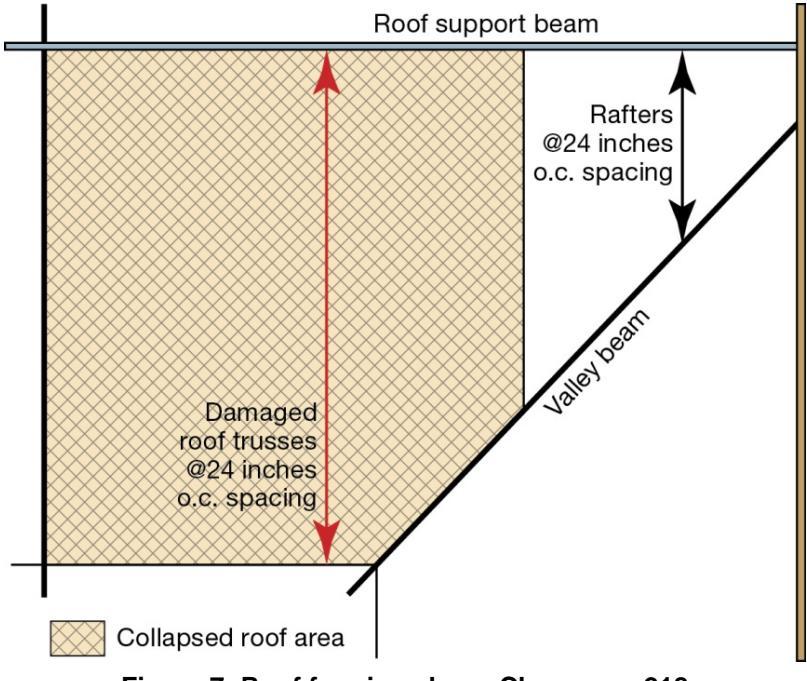
Figure 7: Roof framing above Classroom 218

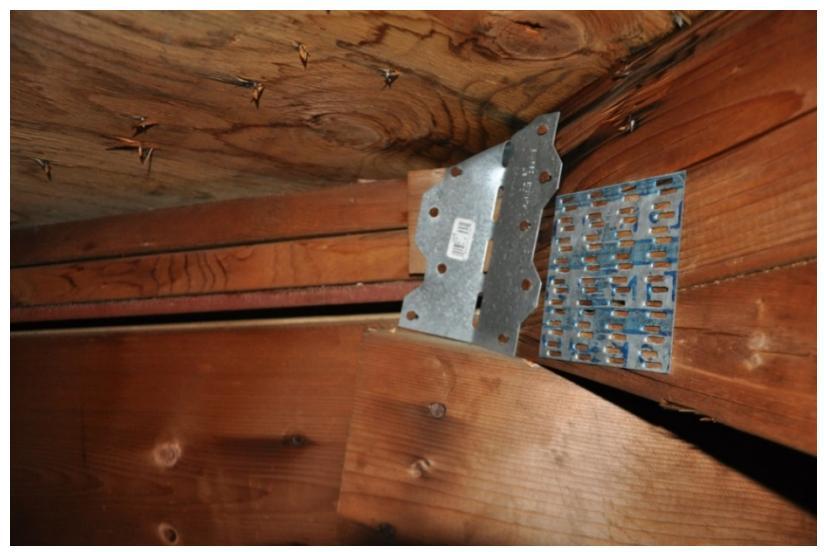
The type of valley attachment of rafters and roof trusses that remained intact varied. While all trusses on the opposing side of the valley were supported vertically by approximately 12-inchlong 2x12 blocks nailed into the valley beam's 2x12 web nail plate, some attachments were enhanced by skewable metal connectors (see Figure 8) that were nailed into the valley's double top flange nail plate. The damaged (removed) trusses appeared to have been toe-nailed into, and supported atop, similar 2x12 blocks that remained in place, but it is unknown whether the removed trusses were attached to the valley web nail plate with metal connectors. Likewise, skewed rafter hangers were present for some 2x12 rafters on the opposing side of the valley, but not found on the rafter-to-valley connection above Classroom 218, as shown in Figures 9 and 10.

Figure 8: Roof truss supported by 2x12 bearing block and attached to valley beam nail plates with skewable metal connector

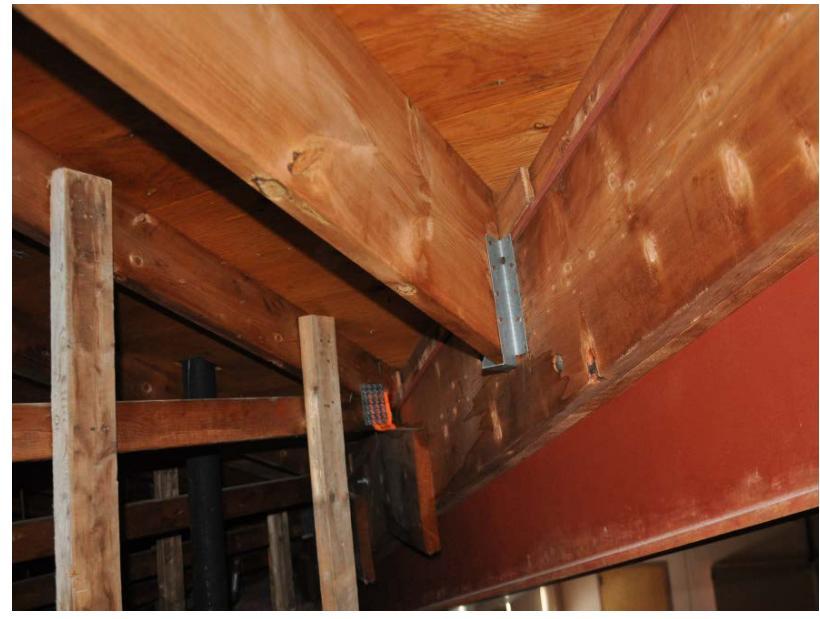
Figure 9: Undamaged 2x12 rafter attached to opposing side of valley beam with skewed metal hanger

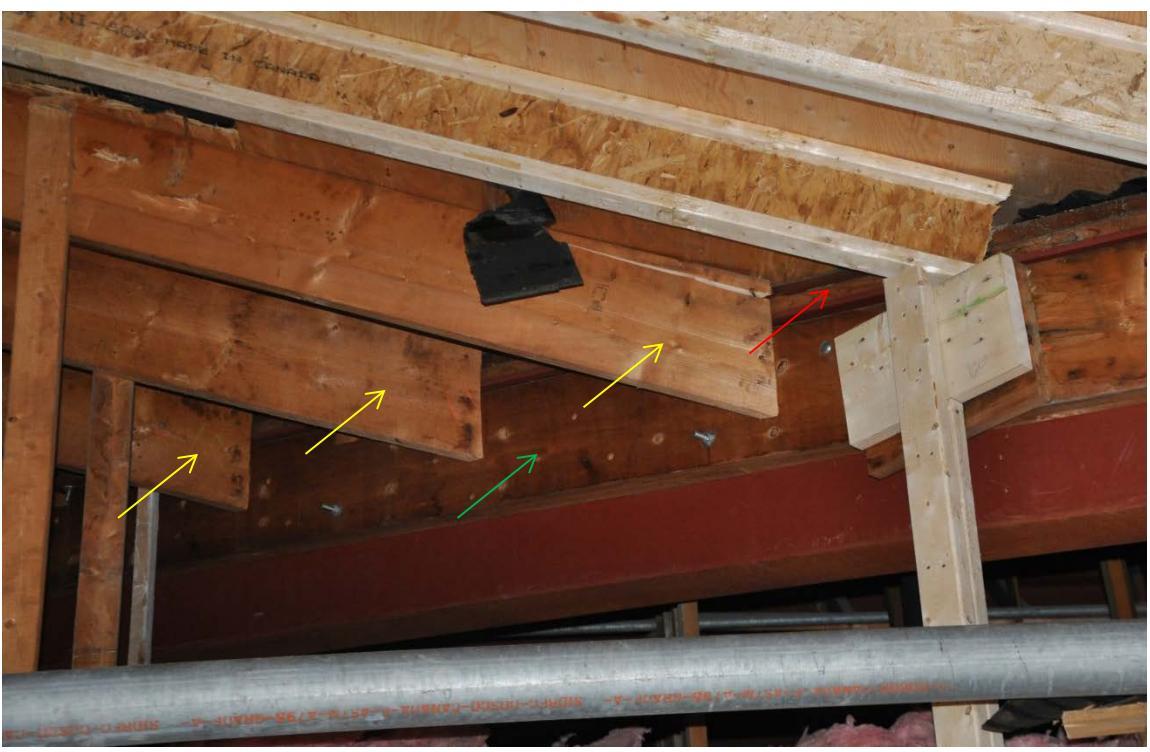
Figure 10: Undamaged 2x12 rafters (yellow arrows) above Classroom 218 toe-nailed to valley beam nail plates (green arrow is web nail plate and red arrow is flange nail plate)

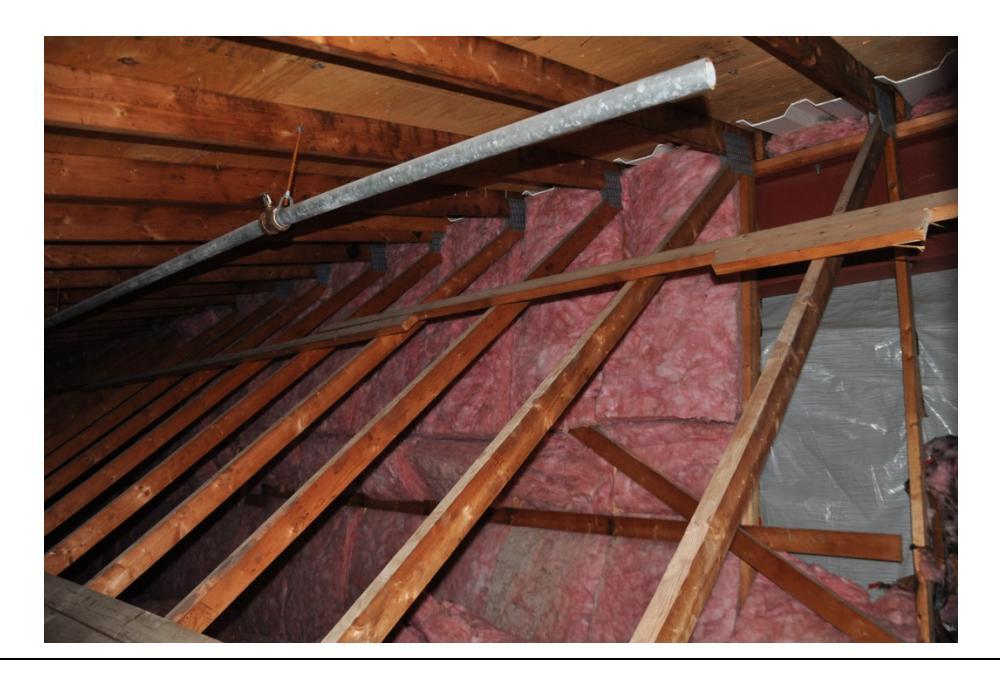
Roof trusses adjacent to the collapsed area with the same truss types and spans were observed to have two rows of web bracing, as shown in Figures 11 and 12. In some cases the braces were installed closer to the truss chords, as opposed to closer to the center of the web as shown in Figure 11. Intermittent cross bracing or X bracing of truss web braces, which provides lateral restraint, was not observed near Classroom 218, as shown in Figure 12.

Figure 11: Roof truss web bracing installed close to the truss chords

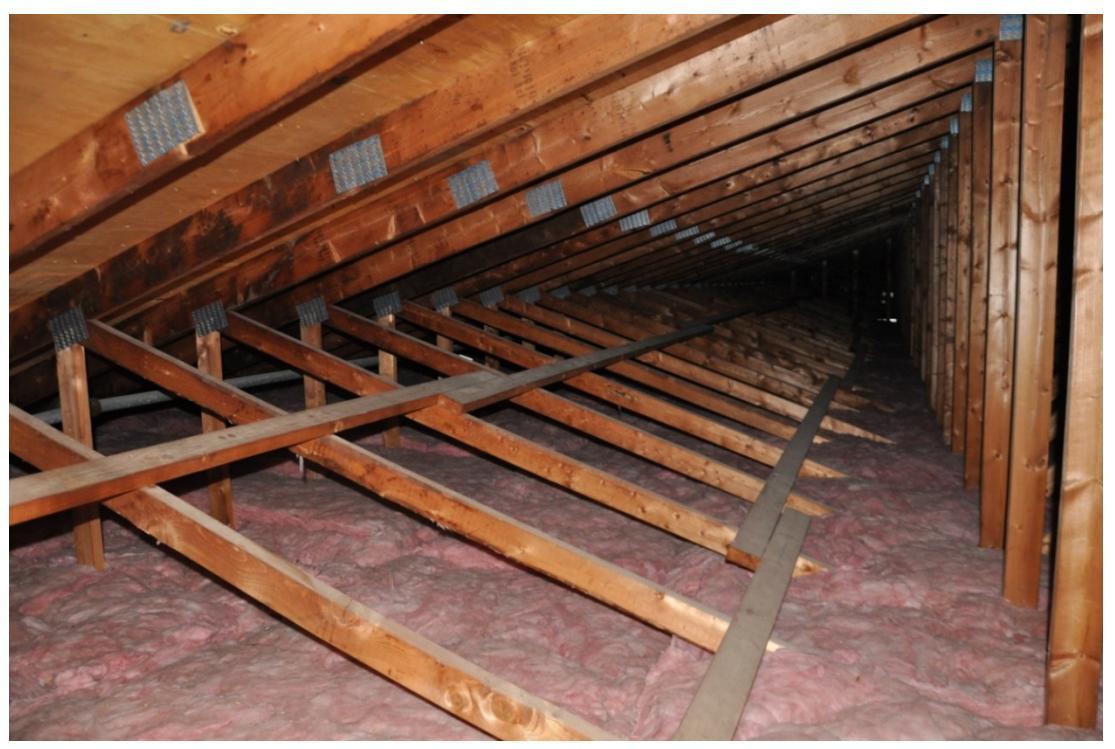
Figure 12: Roof truss web bracing installed closer to the center of the web

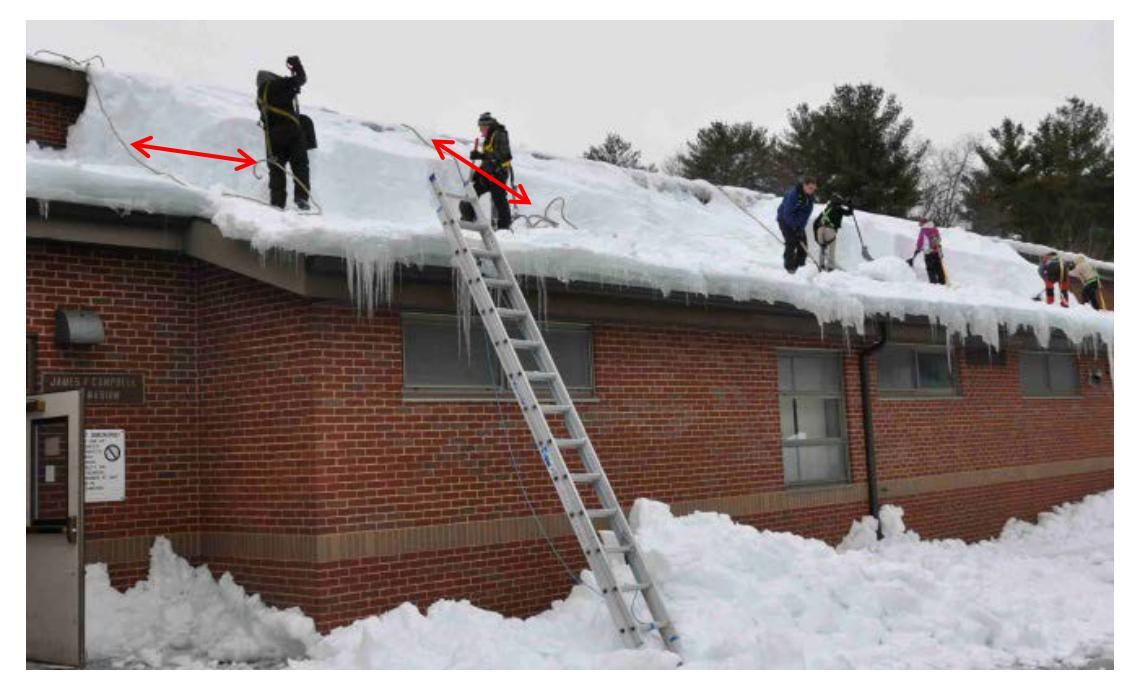
Snow removal operations were in progress during the assessment team's site visit, as shown in Figure 13. According to school officials, snow removal was performed by a roofing contractor and commenced across the school district shortly before the roof collapsed. Snow was to be removed from all roof areas.

# Figure 13: Snow removal commenced on this section of roof after the roof collapsed (red arrows indicate safety harnesses)

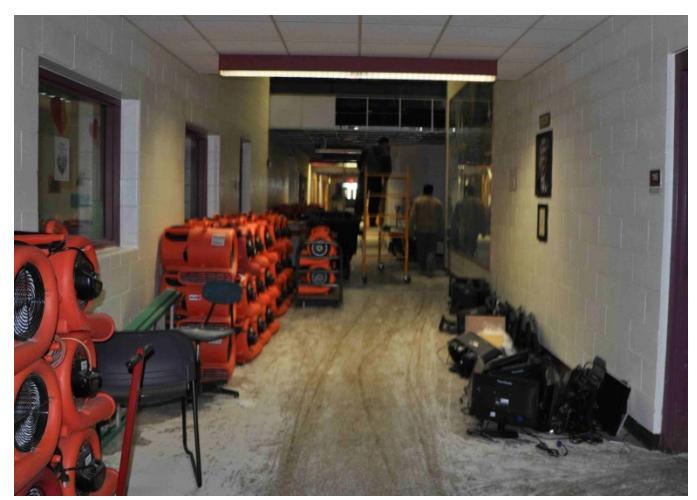
As a result of significant water damage (see Figure 14) due to frozen and ruptured water pipes direct and indirect consequences of the actual roof collapse—the school was closed indefinitely. Students and teachers were reassigned to neighboring schools until repairs could be completed at Mitchell Elementary.

Figure 14: Water-damaged computers and drying equipment

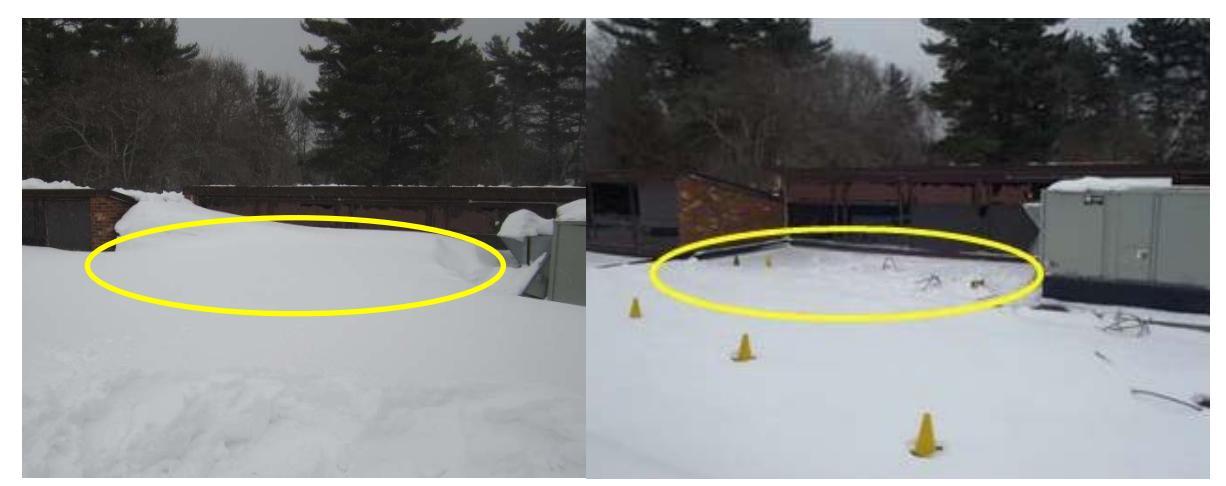
Figure 16: View (looking northeast) of the damaged roof area (yellow circle) before snow removal (left image) and after (right image) (photos courtesy of school official)

On Thursday, February 19, 2015, a section of roof above the school library failed under snow loads. Fortunately, Massachusetts schools were on vacation that week, so the area was unoccupied. The school library is near the convergence of the three wings, as indicated by the red outline in Figure 15. As noted above, the damage appeared to have been triggered by loading from drifts that formed on a section of flat roof that abutted a clerestory roof. Figure 16 shows the damaged area before and after snow removal.

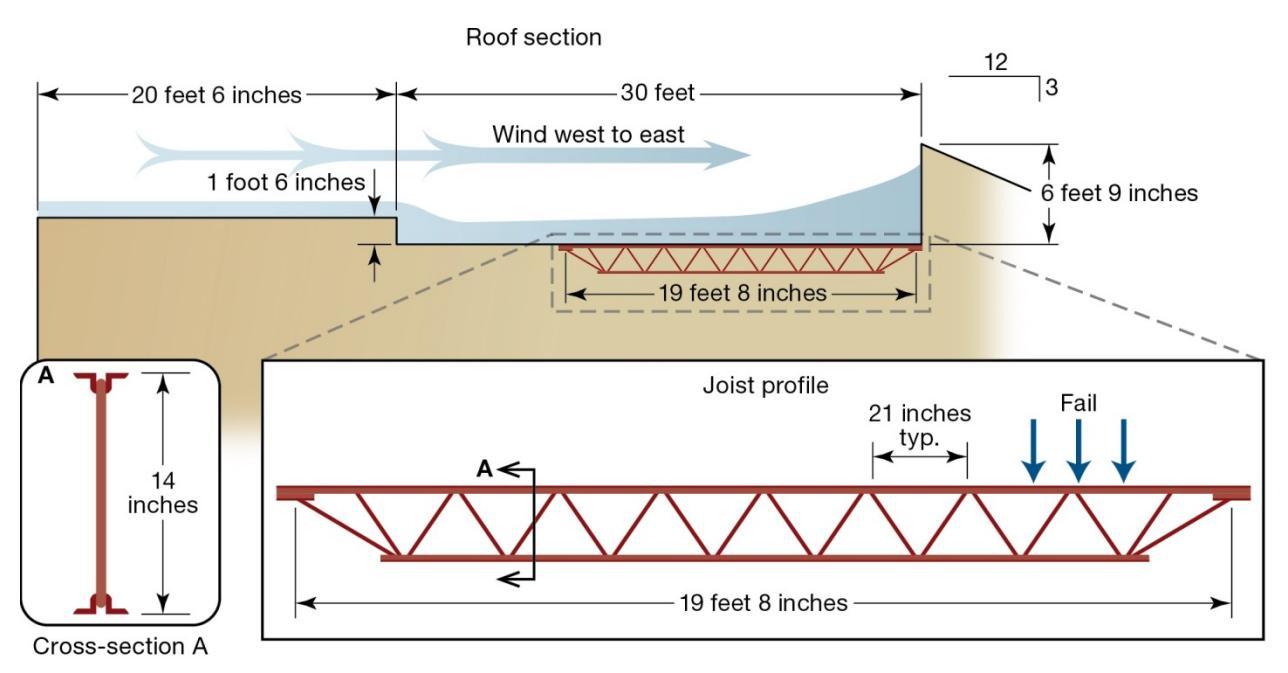
By the time the assessment team arrived, the suspended ceiling above the library had been removed below the snow-damaged area, allowing them to observe damaged open web steel joists that support the roof deck. The 14-inch-deep joists (which the construction plans specified as "H5 series") were spaced at 6 feet on center and simply spanned at 19 feet 8 inches in the nominal east-west direction. As illustrated in Figure 17, joist failure from overloading occurred over the eastern portion of the span nearest the clerestory support, where drifting was deepest due to windward (from the west wind) roof step. Likewise, deformed joists were all located at the northern end of the flat roof adjacent to the clerestory, where drifting was deepest due to leeward (from the north wind) roof step.

Figure 17: Damaged steel joists shown in roof cross section, joist profile, and joist cross section (looking north)

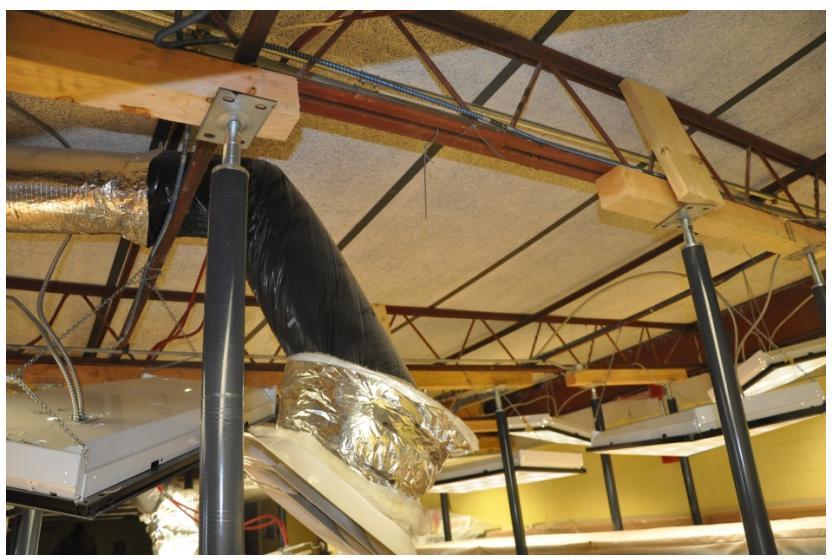
The damaged joists had been temporarily shored along the bottom flanges with a series of 4x4 blocks supported by adjustable steel pipe columns, as shown in Figure 18. As shown in Figure 19, both the joist flanges (top and bottom) and web chords were badly deformed at the end of the span, where snow drift loading is greatest. One joist web had completely separated from the end of the bottom flange at the same clerestory end support (see Figure 20).

Figure 18: Damaged steel joists with temporary shoring

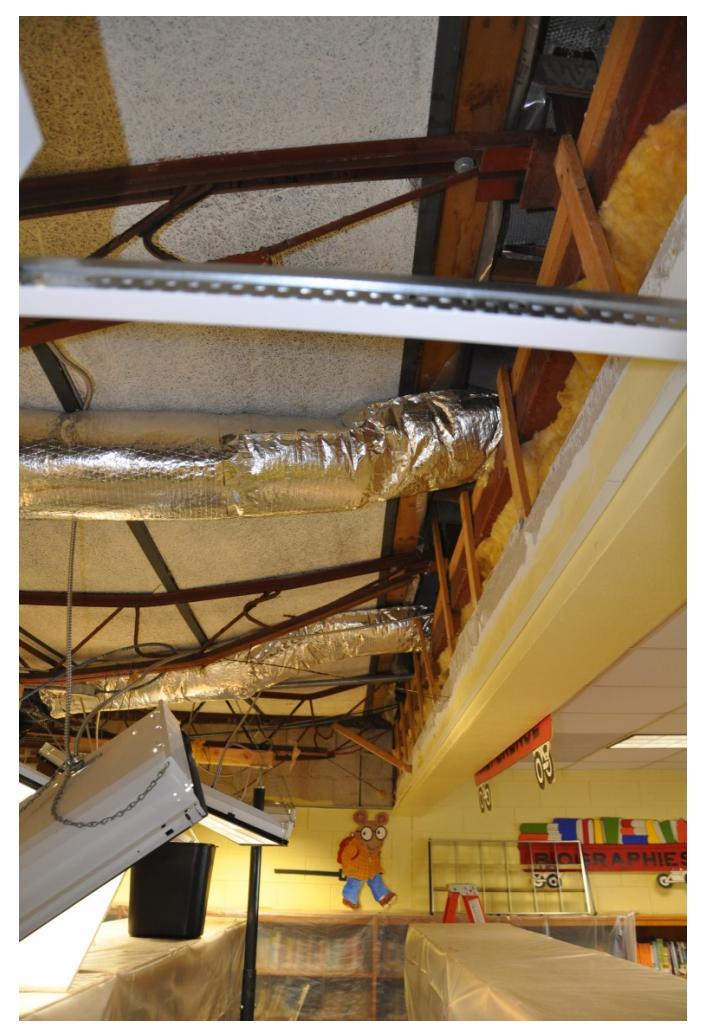
Figure 19: Damaged steel joists with deflected flanges and webs at clerestory beam (looking north)

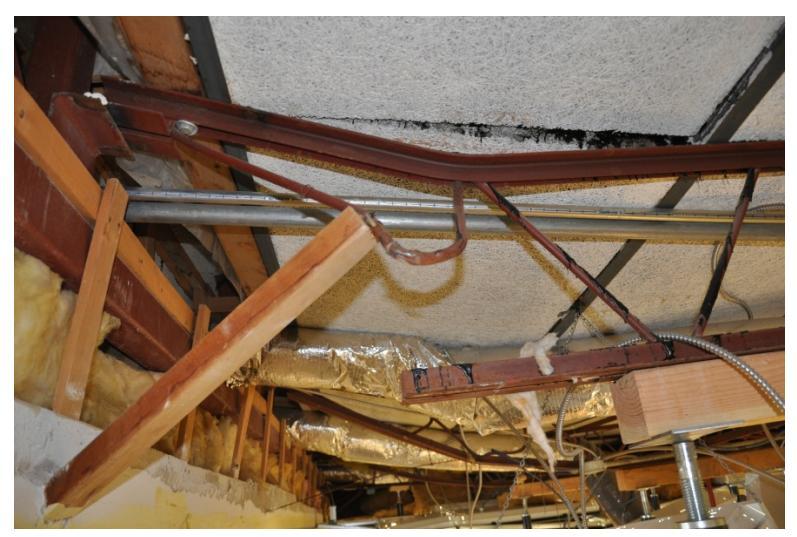
Figure 20: Damaged steel joist with joist web separated from bottom flange (looking south)

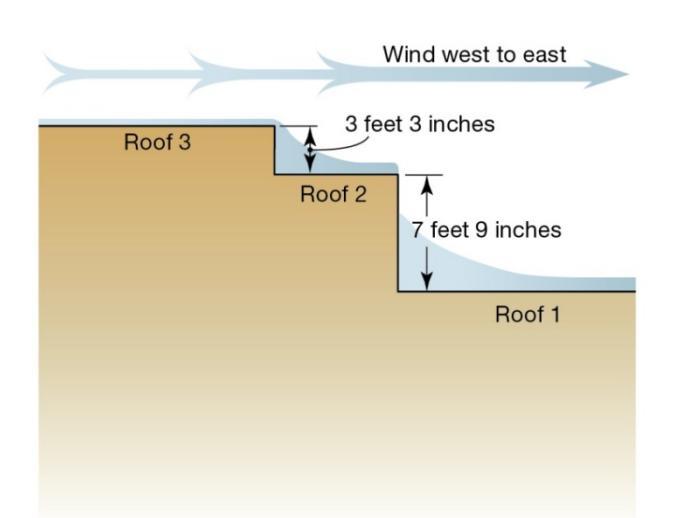
Figure 21 shows an aerial view of Milford High School. The damaged roof area is indicated by the red oval. It is a flat roof area with skylights. There are two higher roofs to the west of the damaged area; hence, the adjacent lower roof area is subject to leeward snow drifts due to wind from the west, as shown in Figure 22.

#### Figure 22: Cross section of the damaged (Roof 1) drift area (looking north; not to scale)

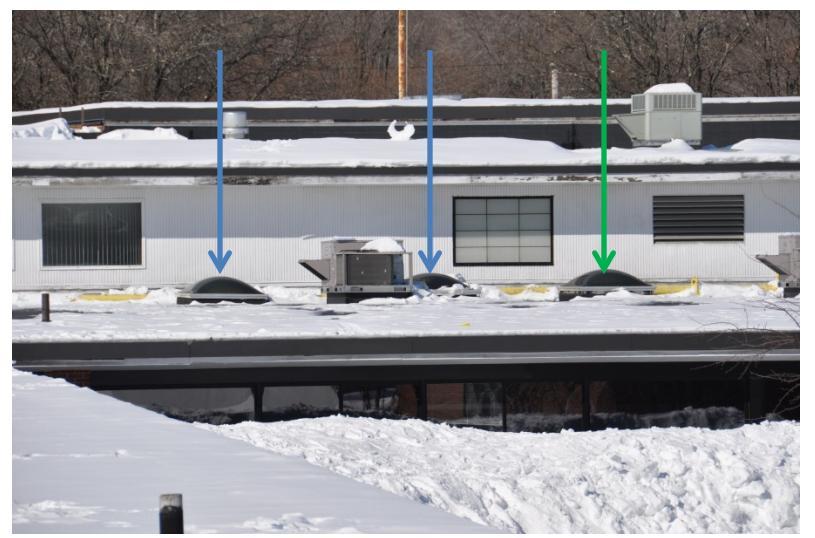
On Friday morning, February 20, 2015, school staff noticed ceiling deflection around the skylights above Classrooms 204 and 205. After consulting with the Director of Facilities and Grounds, the decision was made to close school for the day because of safety concerns related to the damaged roof area near the skylights. The following week was scheduled as winter vacation for New Hampshire schools, which gave staff enough time to complete structural repairs before classes resumed. As noted above, the roof damage appeared to have been triggered by loading from snow drifts that formed above the lower flat roof section adjacent to the higher stepped roofs (see Figure 23).

Figure 23: Lower roof area (looking west) with snow removed in foreground (blue arrows indicate skylights above Classroom 204, green arrow identifies adjacent skylight above Classroom 205)

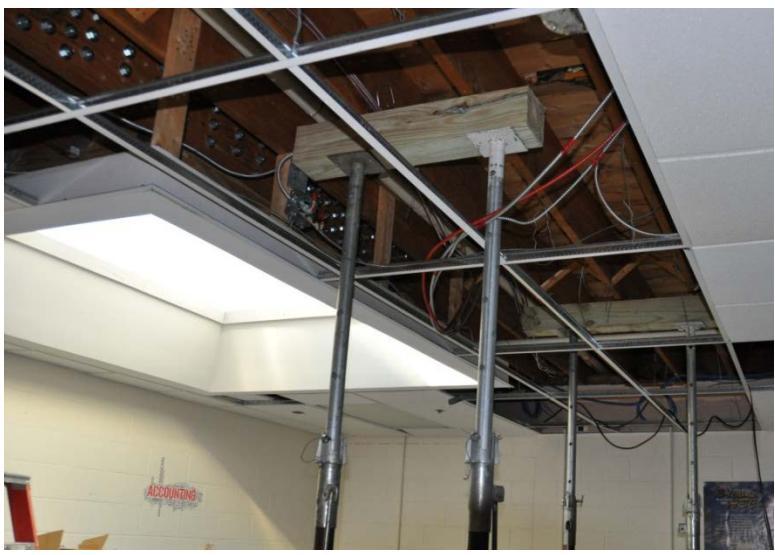
By the time assessment team arrived, the suspended ceiling had been removed in the area of the skylight above Classrooms 204 and 205, revealing damaged framing members temporarily shored with 4x4 blocks or shims. In some areas, the blocks were supported at each end by adjustable steel pipe columns (see Figure 24), and in others by 4x4 wood posts.

Figure 24: Shoring around Classroom 205 skylight

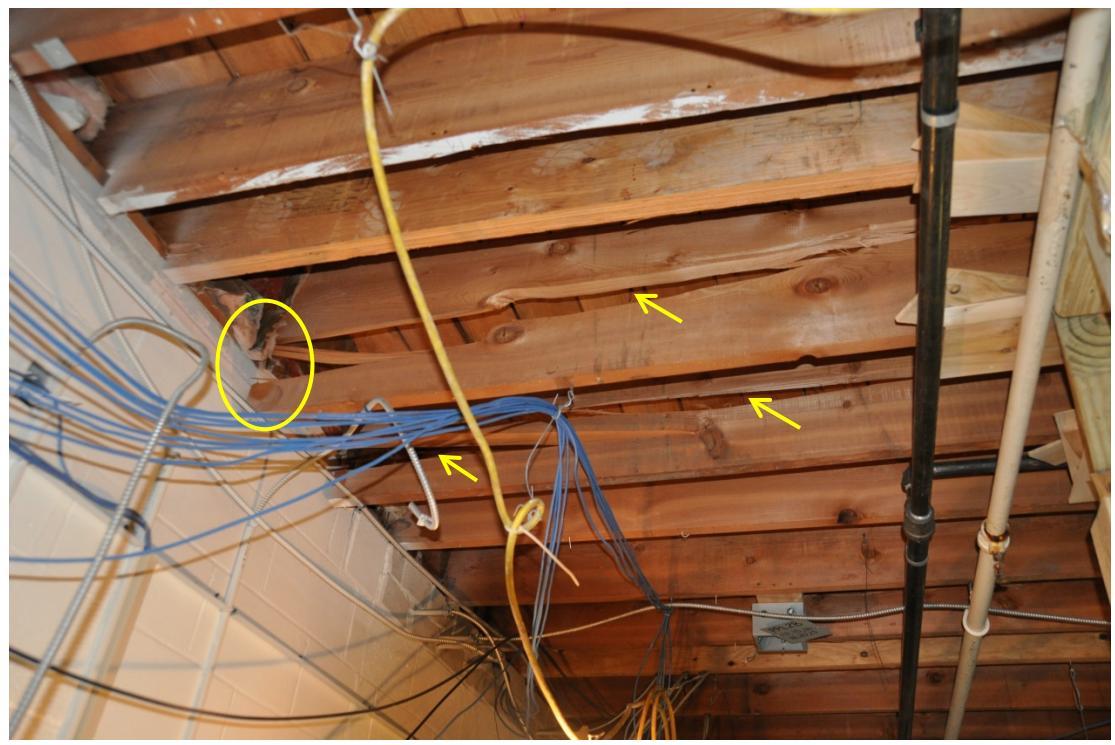
The assessment team observed that the flat roof and suspended ceiling above Classrooms 204 and 205 were supported by 2x14 wood joists spaced 16 inches on center. The members spanned approximately 25 feet from the corridor wall to the opposite (rear) classroom wall, which extended upward to support the higher flat roof. Several 2x14 joists had split horizontally, most notably on either side of the skylight nearest the Classroom 204 egress door. The largest splits started where notches, approximately 3 inches deep, had been cut into the base of the joists to facilitate bearing at the rear classroom wall (see Figure 25). In addition to the joist sections being weakened by notch cuts, snow drift depths increased toward the rear classroom wall, generating greater support reactions (and shear stresses) from framing members than at the corridor wall support. Other joists in Classroom 205 had smaller horizontal splits that originated at nails used to attach cross bracing (see Figure 26).

Figure 25: Split joists at rear wall support around Classroom 204 skylight (arrows indicate horizontal splits and circles show notches at end bearing)

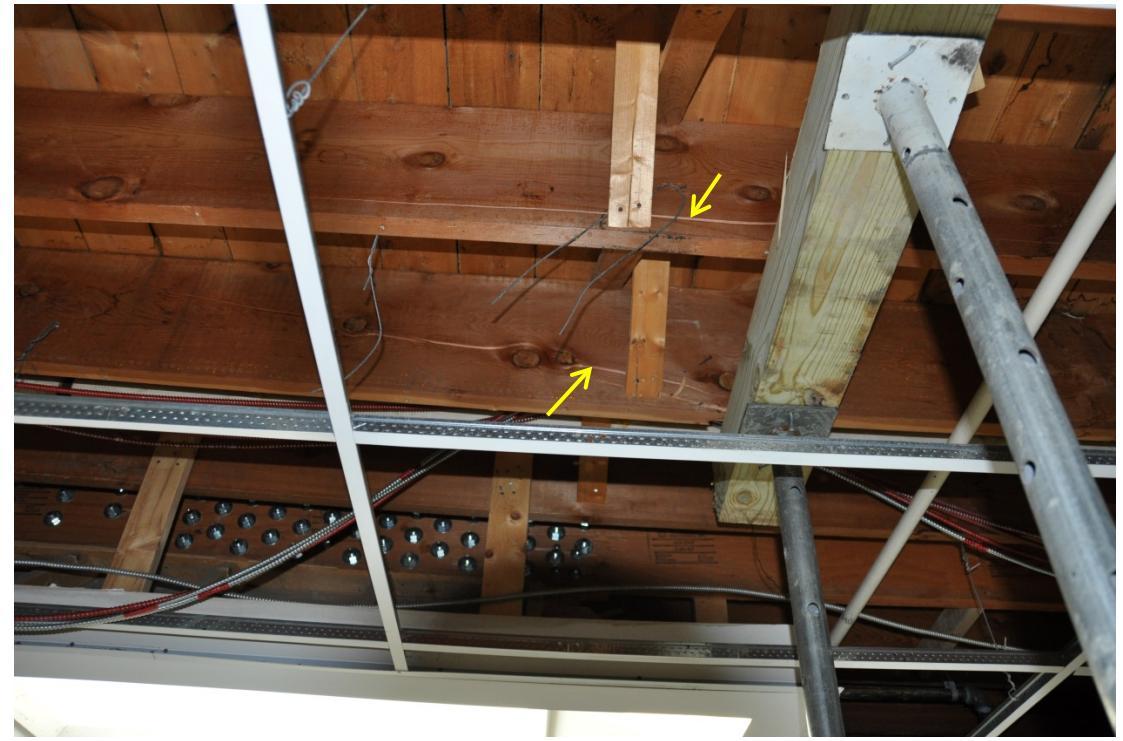
Figure 26: Split joists at nailed cross bracing around Classroom 205 skylight (arrows indicate splits)

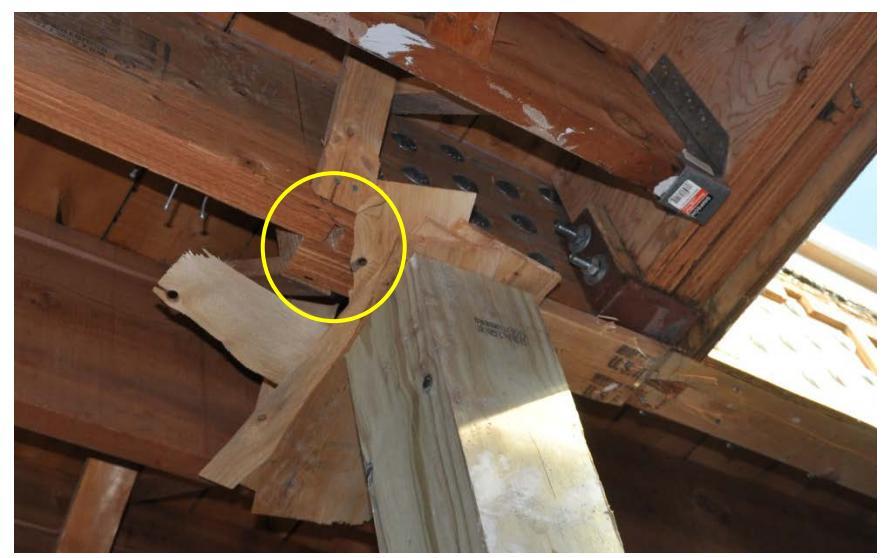
Single 1.75x14 laminated veneer lumber (LVL) members that were installed to frame the skylight openings also showed signs of distress and were temporarily shored, as shown in Figure 27. Unlike the large horizontal splits at notched joists, the LVL member splits occurred away from the end supports and originated at the bottom surface, indicating strain in flexure.

Figure 27: Split LVL member at Classroom 204 skylight (circle indicates split)

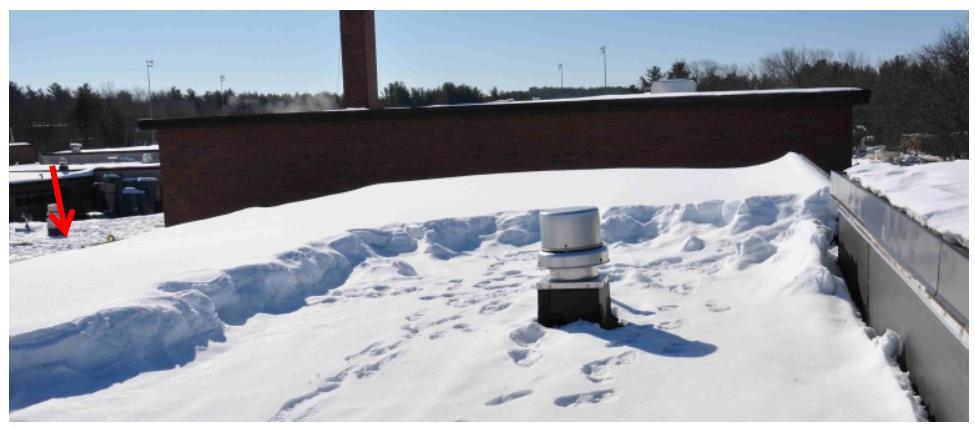
After school staff noted the deflected skylights, a roofing contractor was retained to remove snow drifts from the roofs (see Figures 28 and 29), and from around rooftop heating, ventilation, and air conditioning (HVAC) units (Figure 30) and fans. This work was also undertaken at all of the other schools in the district.

Figure 28: View of the upper roof adjacent to the skylights after removal of the drift. The red arrow indicates the lower roof in the area of the deflected skylights.

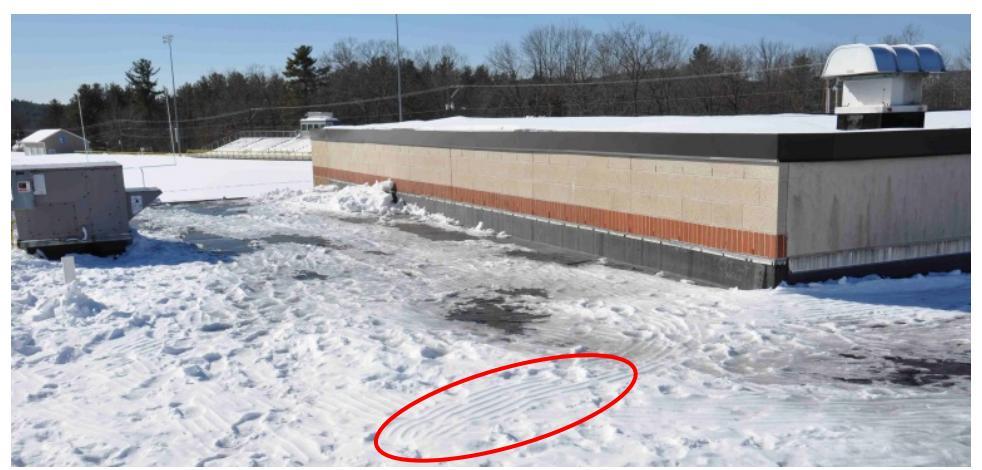
Figure 29: View of another area where drifts were removed. Note the shovel marks on the snow, indicating that some snow was deliberately left over the roof membrane to avoid damage

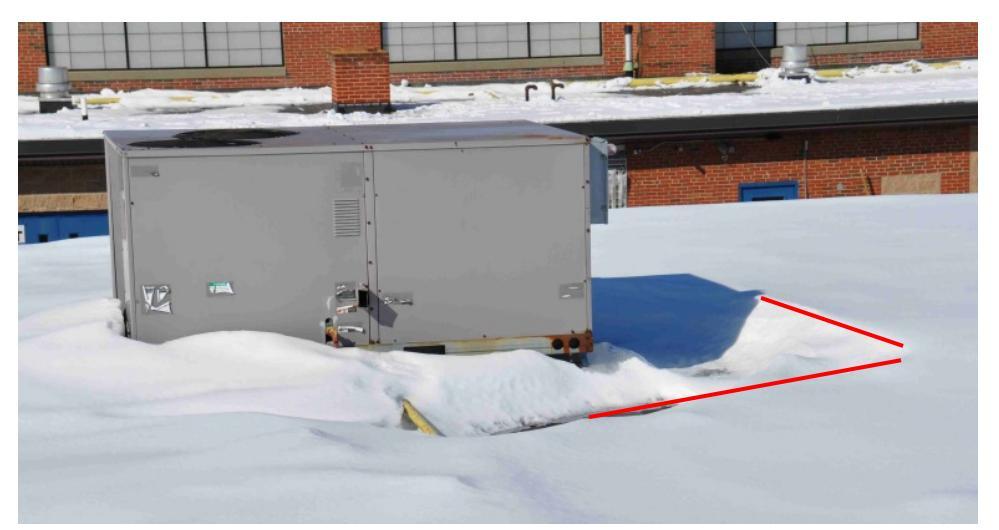
Figure 30: Snow was removed around HVAC units so that they would remain operational

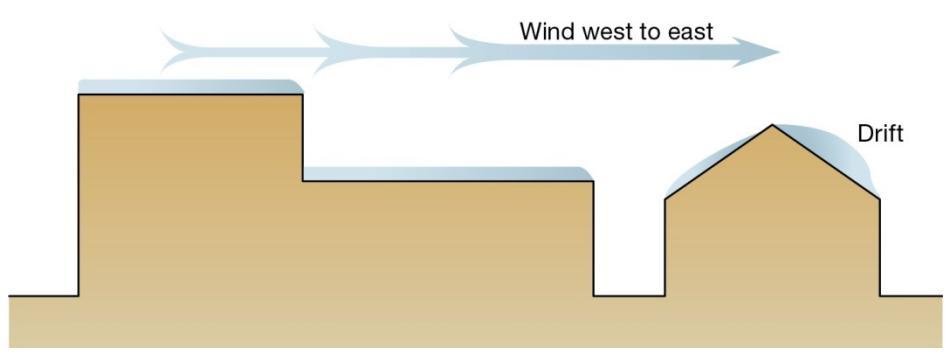
On Friday morning, February 20, 2015, school staff noticed deflection in the ceiling of Classrooms 18, 20, and 22. After consulting with the Director of Facilities, the decision was made to close school for the day because of safety concerns related to probable roof damage. Classrooms 18, 20, and 22 are located under the eastern (leeward) facing slope of the gable roof (pitch approximately 5:12) in the Eighth Grade Wing building (see Figures 32 and 33). Snow from the gym roof and other flat roofs to the west of the gable roof may have contributed to the drift over the damaged roof areas. The roof damage appeared to have been triggered by loading from snow drifts that formed on the leeward slope of the Eighth Grade Wing building.

Figure 32: Cross section of the drift area (looking northeast, not to scale)

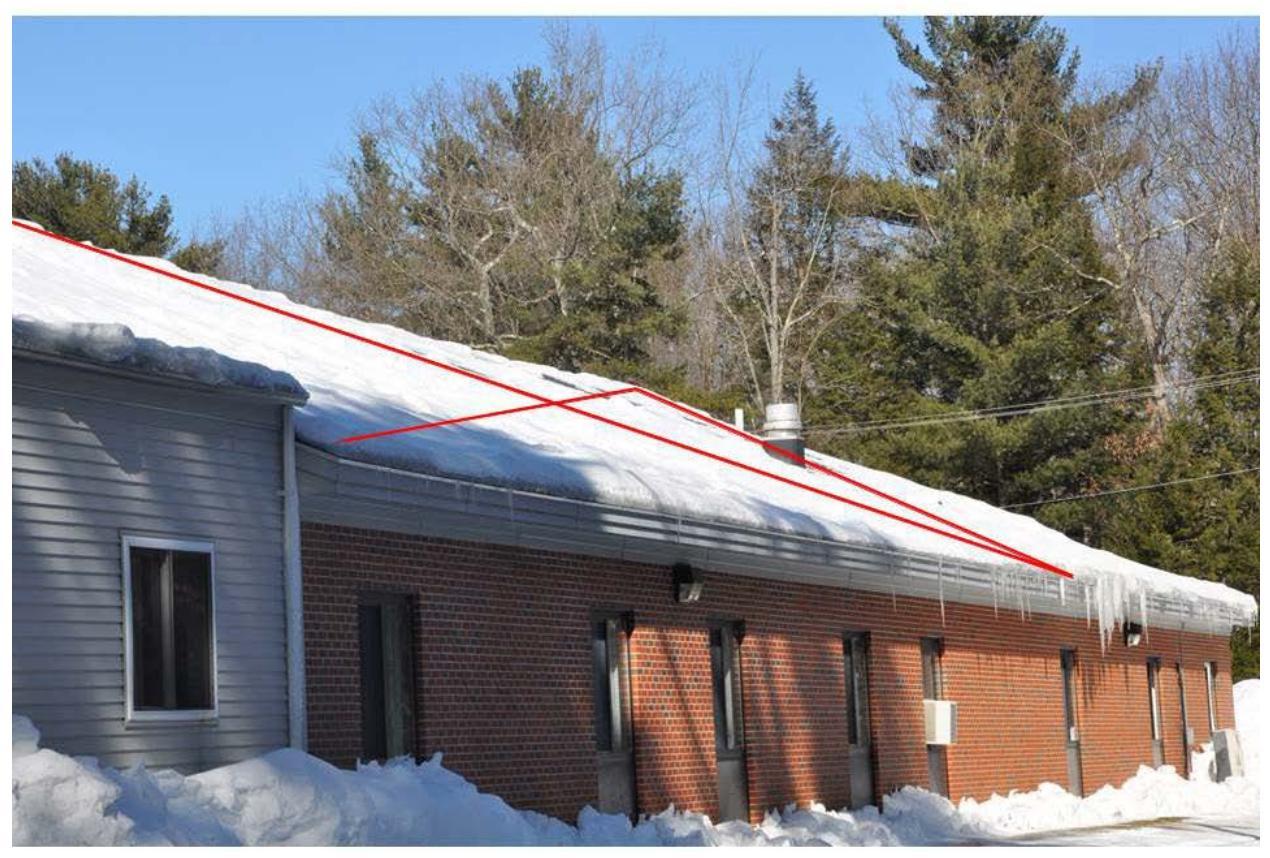
Figure 33: Sanborn Middle School Eighth Grade Wing (red lines show damage location)

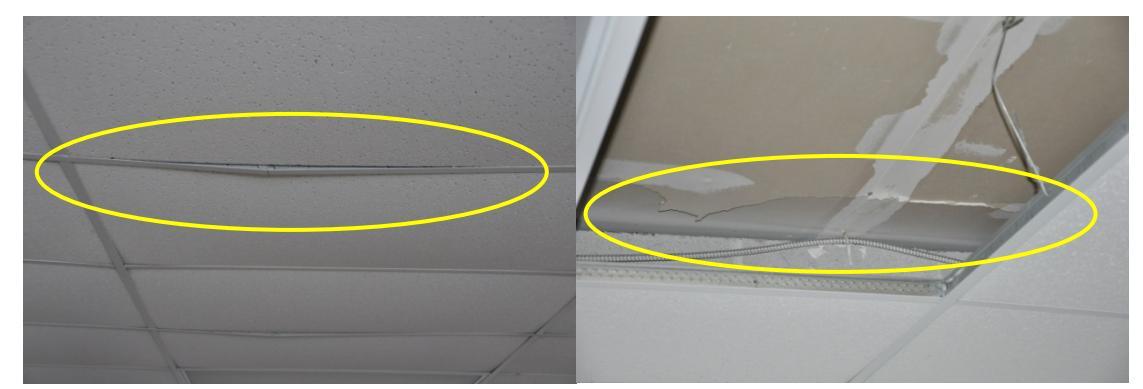
The assessment team observed deflected suspended acoustical ceilings above Classrooms 18, 20, and 22 and cracked gypsum board attached to the bottom chords of roof trusses (see Figure 34). The deflected ceilings and cracked gypsum board appeared to result from excessive roof truss deflection. Upon request, the assessment team was allowed to access the attic to observe truss conditions above the damaged ceiling.

Figure 34: Deflected suspended ceiling T-bar and cracked gypsum board roof truss sheathing above affected Eighth Grade Wing classroom areas (shown in yellow circles)
