# Snow Study Summary Report

Observations of Snow Load Effects on Four School Buildings in New England

October 2016

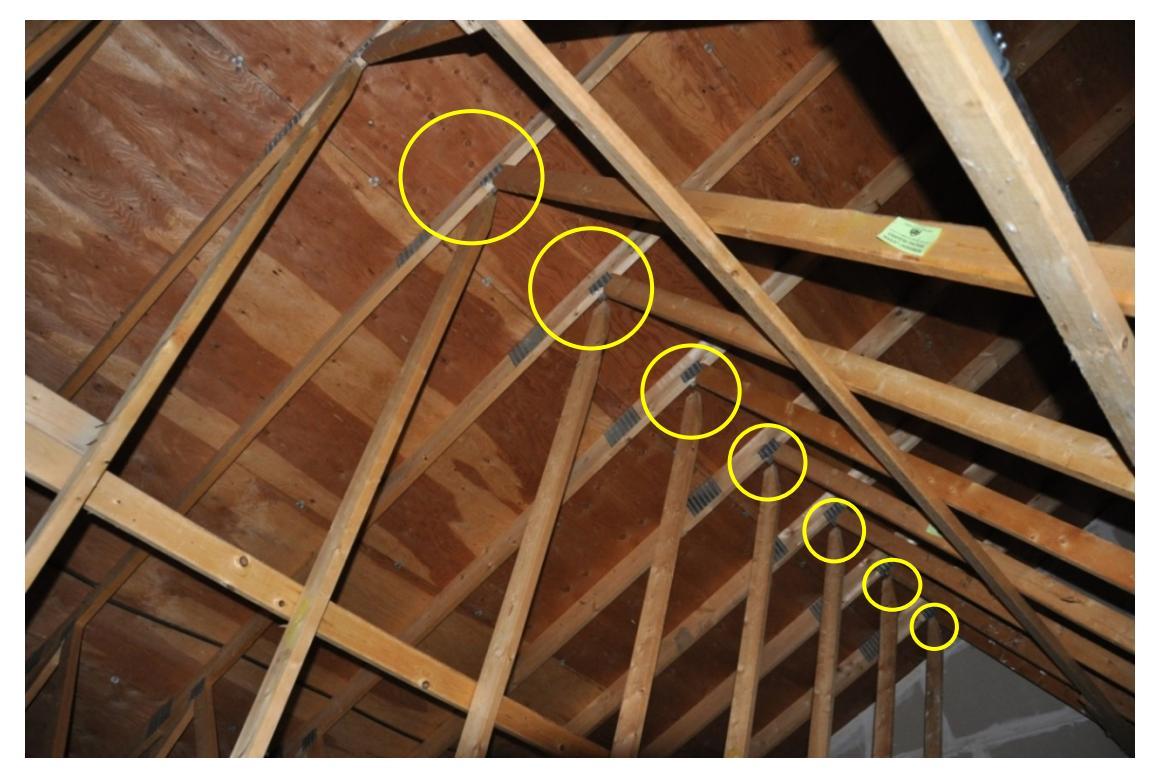
meet the top chord of the truss on the opposite side of the corridor to form the ridge over the center of the corridor. Approximately 18 consecutive roof trusses (24-inch spacing) above Classrooms 18 and 20 had separated at the same web-to-top-chord location, as shown in Figure 35 (looking southwest from attic access opening; additional damaged trusses observed toward the northeast not shown) and Figure 36 (close-up of typical gap between chords). Each connection had been made with 3-inch by 4-inch truss connector plates. The attic space above Classroom 22 could not be viewed, but damage to the ceiling followed the same pattern as the other classrooms, although it appeared to be less severe.

Figure 35: Separation of the web-to-top-chord connection in mono-slope trusses southeast of ridge line (shown in yellow circles)

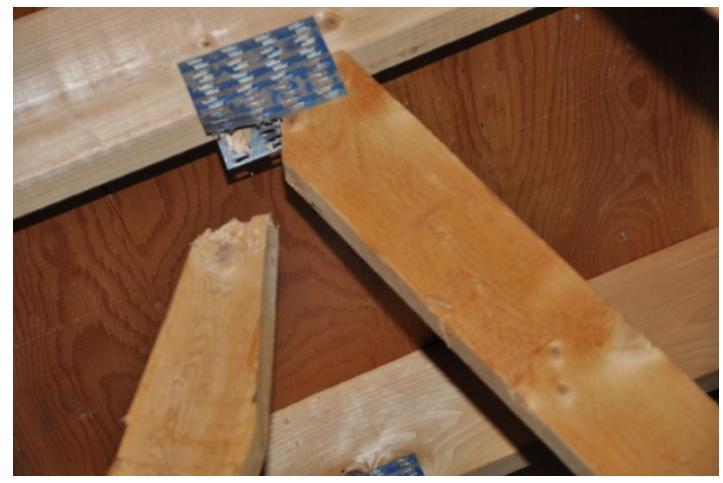
Figure 36: Close-up of separated web to top chord connection
