Environmental Assessment - Appendices

**City of Kingman Parks Repair and Flood
Hazard Mitigation**

Project Number PA-07-KS-4449-PW-00760(0)- GM-
137376

September 2022

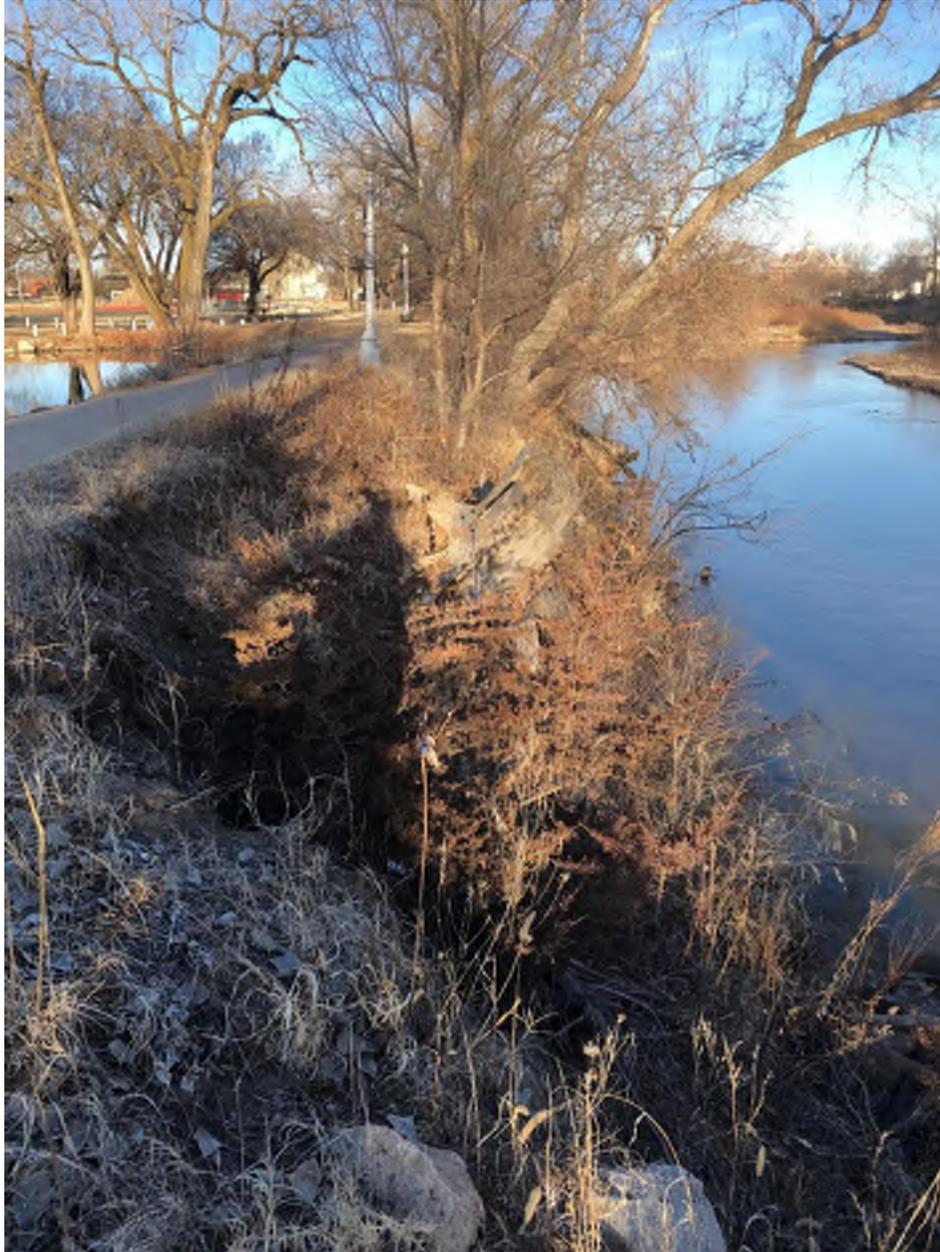
Figure 4: Ground Level Photo of the 2021 Slope Conditions

Based on aerial images (See Figure 2) of the site prior to the disaster, it appears that the slope prior to 2019 has a large tree that is no longer on the slope. This removal of the tree has created a 30-ft hole on the slope that is within 3-feet of impacting the sidewalk and park pond embankment (See Figure 3). If this slope The City has indicated that this hole is continuing to grow along the embankment to impact other sections. The geographical limits of the damage is included in Figure 2 below.

Along with rebuilding the embankment, riprap will need to be replaced on the slope. The image below shows that riprap is located on the slope to protect against the Ninescah River velocities. The Engineers estimate listed on the next page will outline the requirements to bring the slope back to pre-disaster conditions.

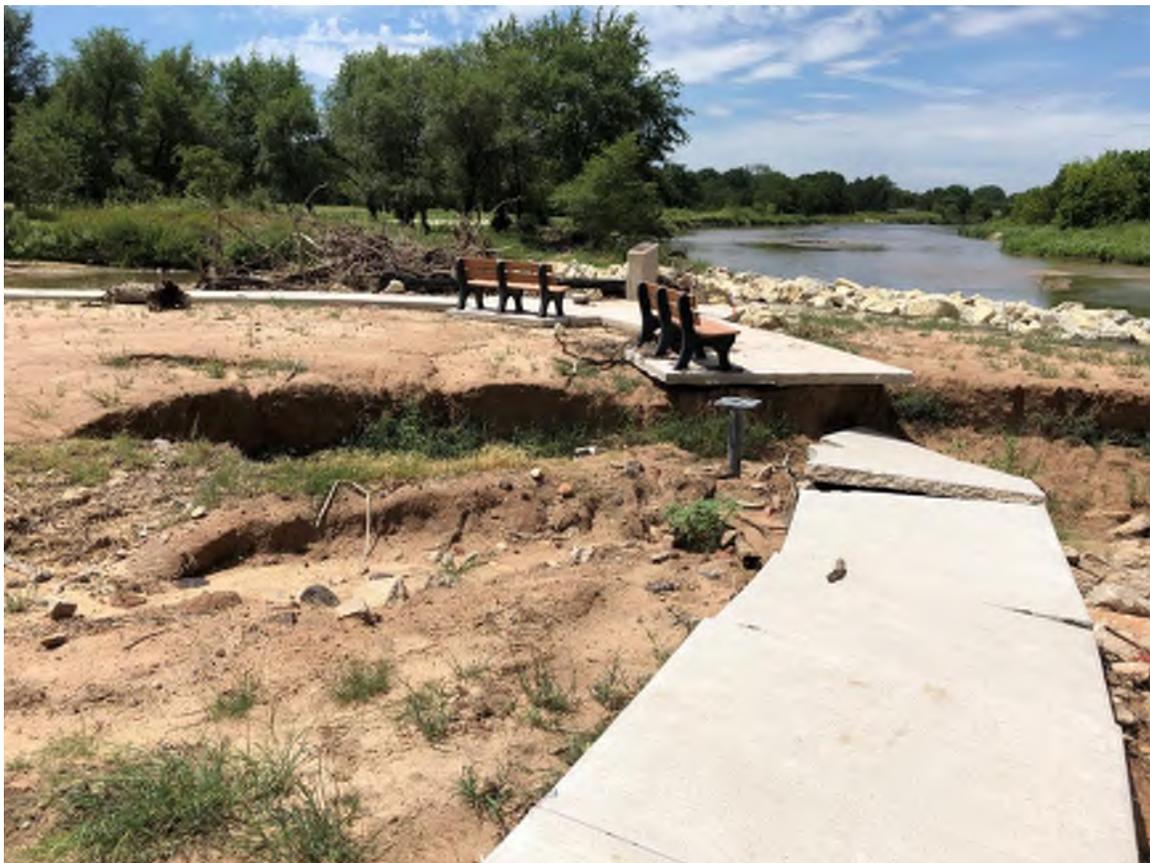
Figure 6: 2019 South Fork Ninescah River South Bank Damage Conditions

In addition to improving the interior park conditions on the western portion of the facility, nearly 100 feet of the Ninescah River south bank and over 900 feet of the Mill Race north bank should be protected as erosion is continuing to encroach on the park facilities in these locations. Ground level photos in Figures 4 and 5 show the disaster conditions from 2019 at the Ninescah River and Mill Race, respectively.

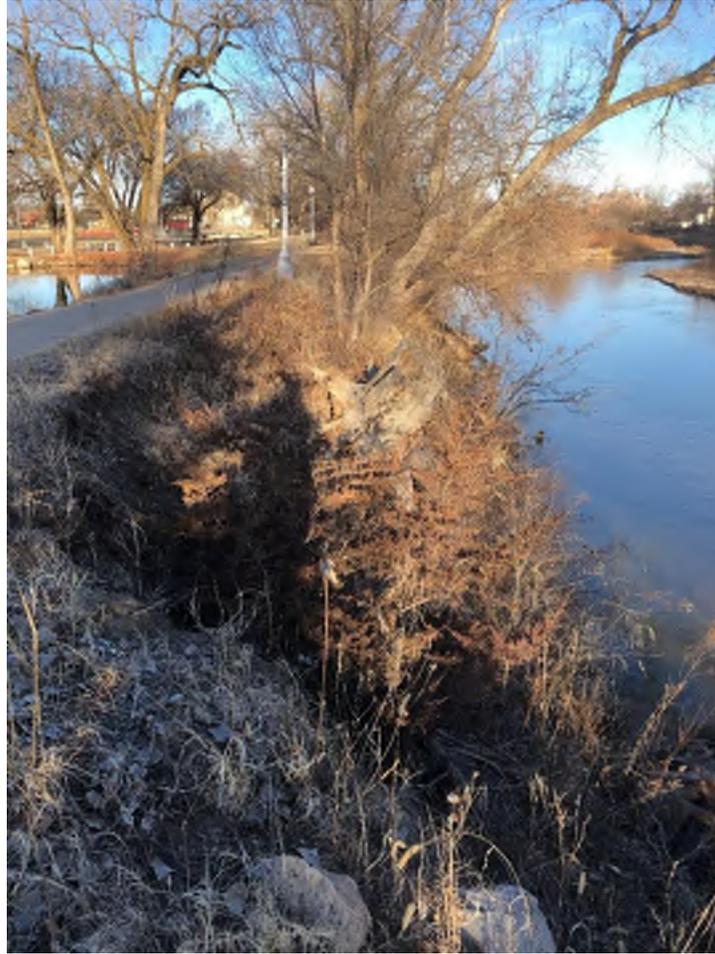
Figure 10: 2021 Ground Level Photos at Eastern End of Eastern Bank Conditions

Park pond on the eastern portion of the facility. Aerial images from 2016, shown in Figure 7, show that significant large trees were established on the bank with at least 6-ft of distance between the northern edge of the sidewalk and the top of bank. Ground level photos from 2021, shown in Figure 8, show that a large portion of the bank has either been removed by the removal of a tree with large roots or erosion and the top of bank is now within 3 feet of the edge of sidewalk. Outside of this being a pedestrian safety hazard, there is significant concern that the existing pond embankment would be breached if this embankment were to fail.

The proposed improvement to stabilize this bank would be to use a combination of a longitudinal peaked stone toe protection (LPSTP) at the toe of the slope to reduce the risk for future erosion from undermining the improvements and a vegetated geogrid slope with native slope plantings to stabilize the slope above the ordinary high water mark. The velocities within the channel section are between 7 fps and 10 fps. The LPSTP improvements below the ordinary high water mark would help to reduce the risk for toe erosion in the future where the velocities would be the highest and the vegetate geogrid slope will be able to withstand the lower velocities along the upper bank. The goal for the overall bank slope would be to maintain the past slope conditions of approximately 1.5:1 to 2:1, which were obtained from the LiDAR before the disaster. Any potential upstream water surface increases from these improvements would be mitigated by the channel overbank grading immediately upstream of the location.

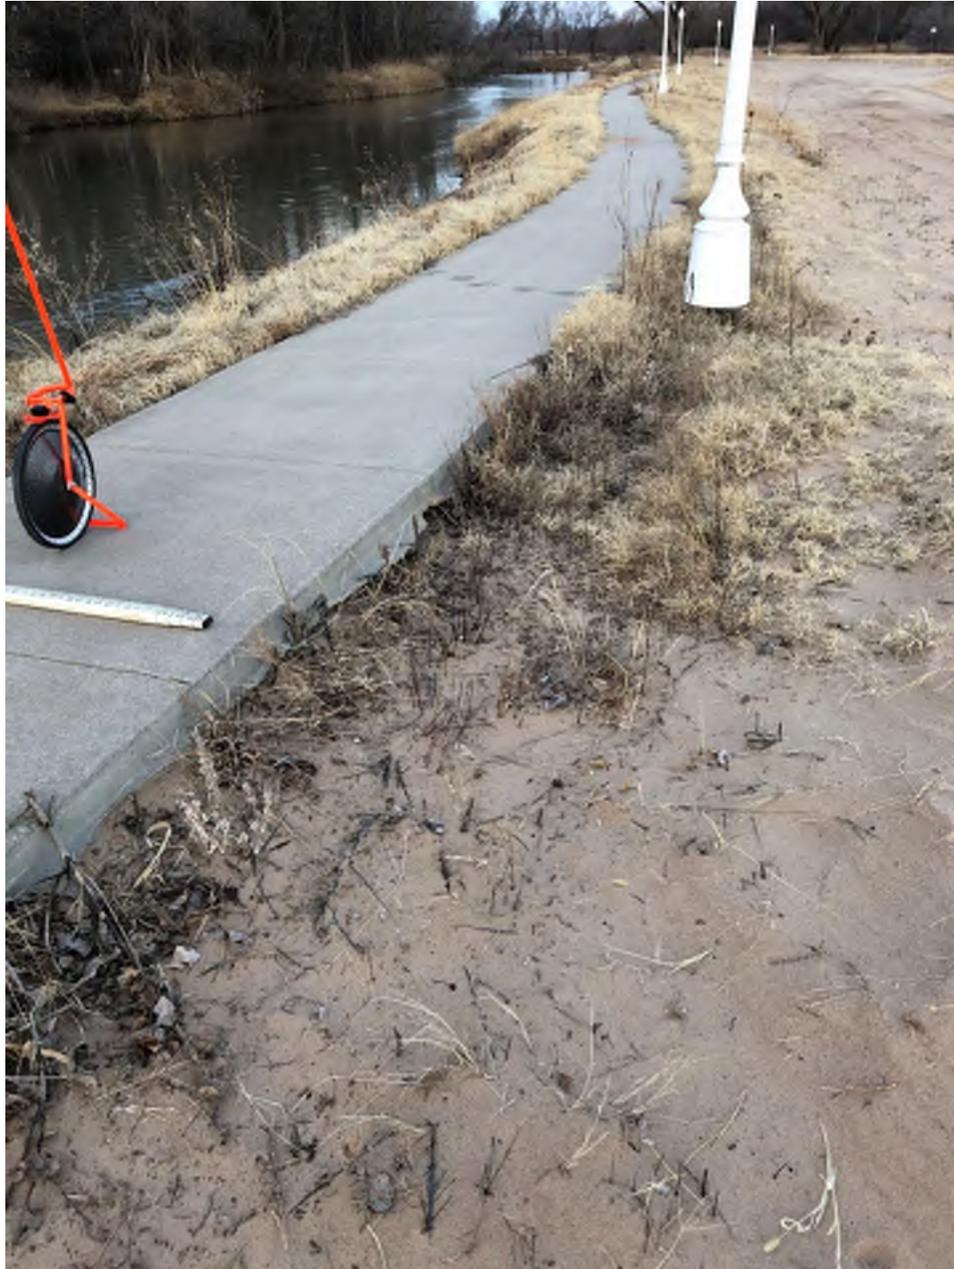
Photo 1

- Station 6+00.00 to Station 8+00.00 – Replace 35 cubic yards of Sidewalk Embankment, which was washed away during the flood events. Replacement will consist of 3-feet of sidewalk shoulder at 6" and then slope down at a 3:1 side slope to existing ground.

Replace 35 cubic yards of Sidewalk Embankment

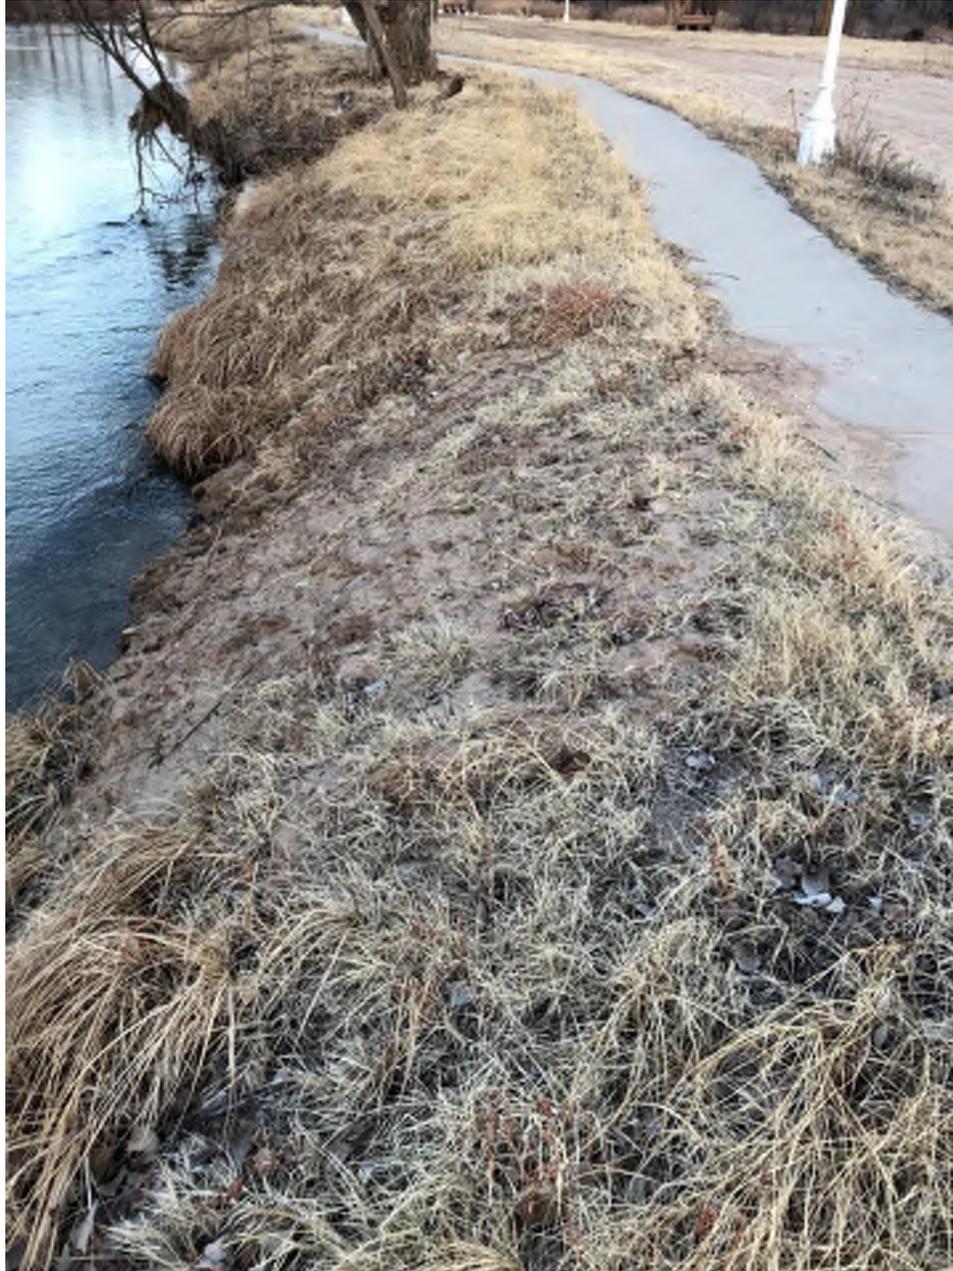
Photo 2

- Station 7+06.60 to Station 7+87.31 – Replace 45 cubic yards of Mill Race North Bank, which washed back approximately 5-feet during to flood events. Replacement will consist of a 2:1 slope to existing bank toe at 6.5-feet high.

Replace 45 cubic yards of Mill Race North Bank

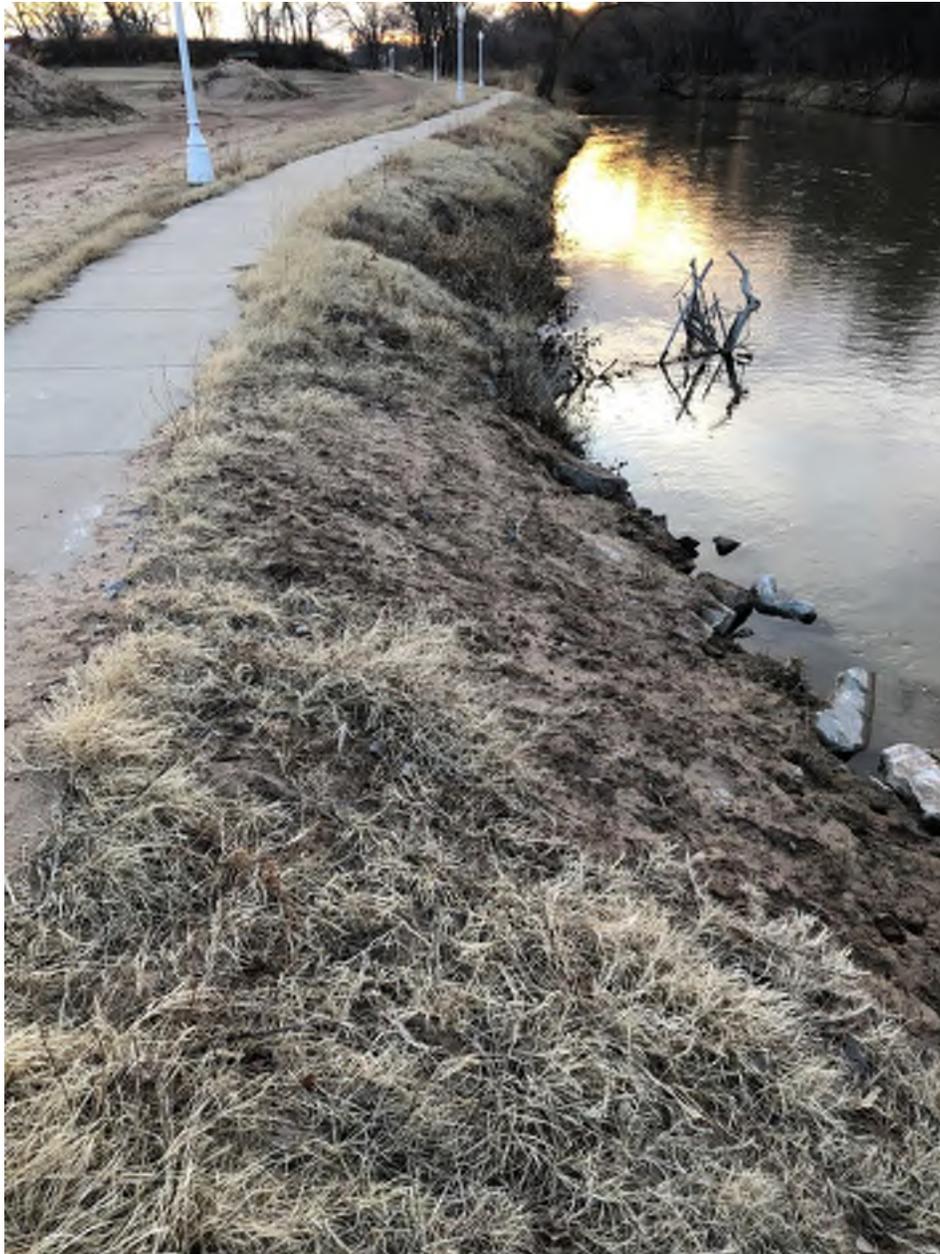
Photo 3

- Station 8+67.38 to Station 9+94.19 – Replace 155 cubic yards of Mill Race North Bank, which washed back approximately 5-feet during to flood events. Replacement will consist of a 2:1 slope to existing bank toe at 6-feet high.

Replace 155 cubic yards of Mill Race North Bank

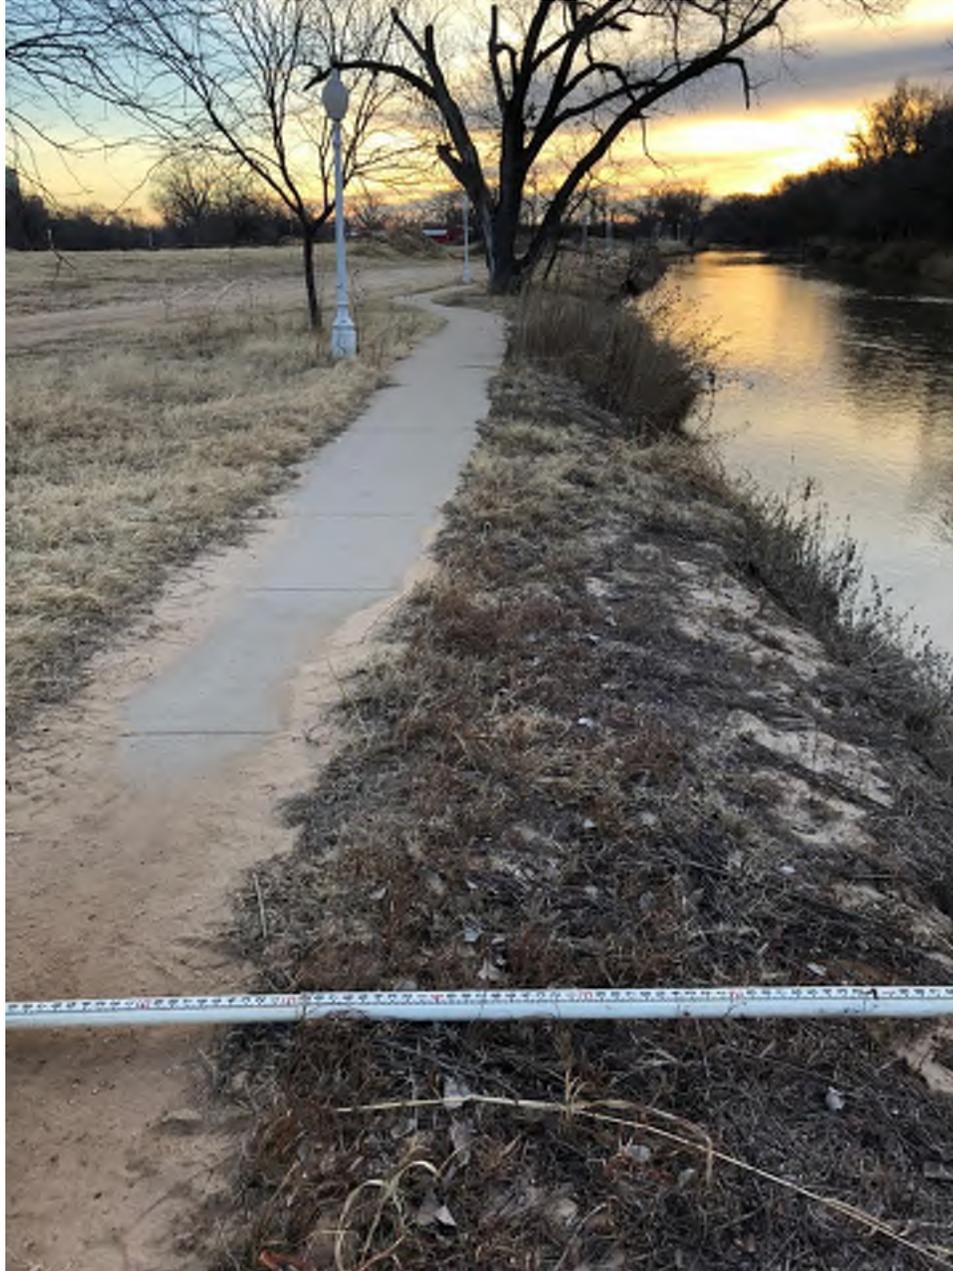
Photo 4

- Station 11+31.17 to Station 12+01.23 – Replace 80 cubic yards of Mill Race North Bank, which washed back approximately 5-feet during to flood events. Replacement will consist of a 2:1 slope to existing bank toe at 6-feet high.

Replace 80 cubic yards of Mill Race North Bank

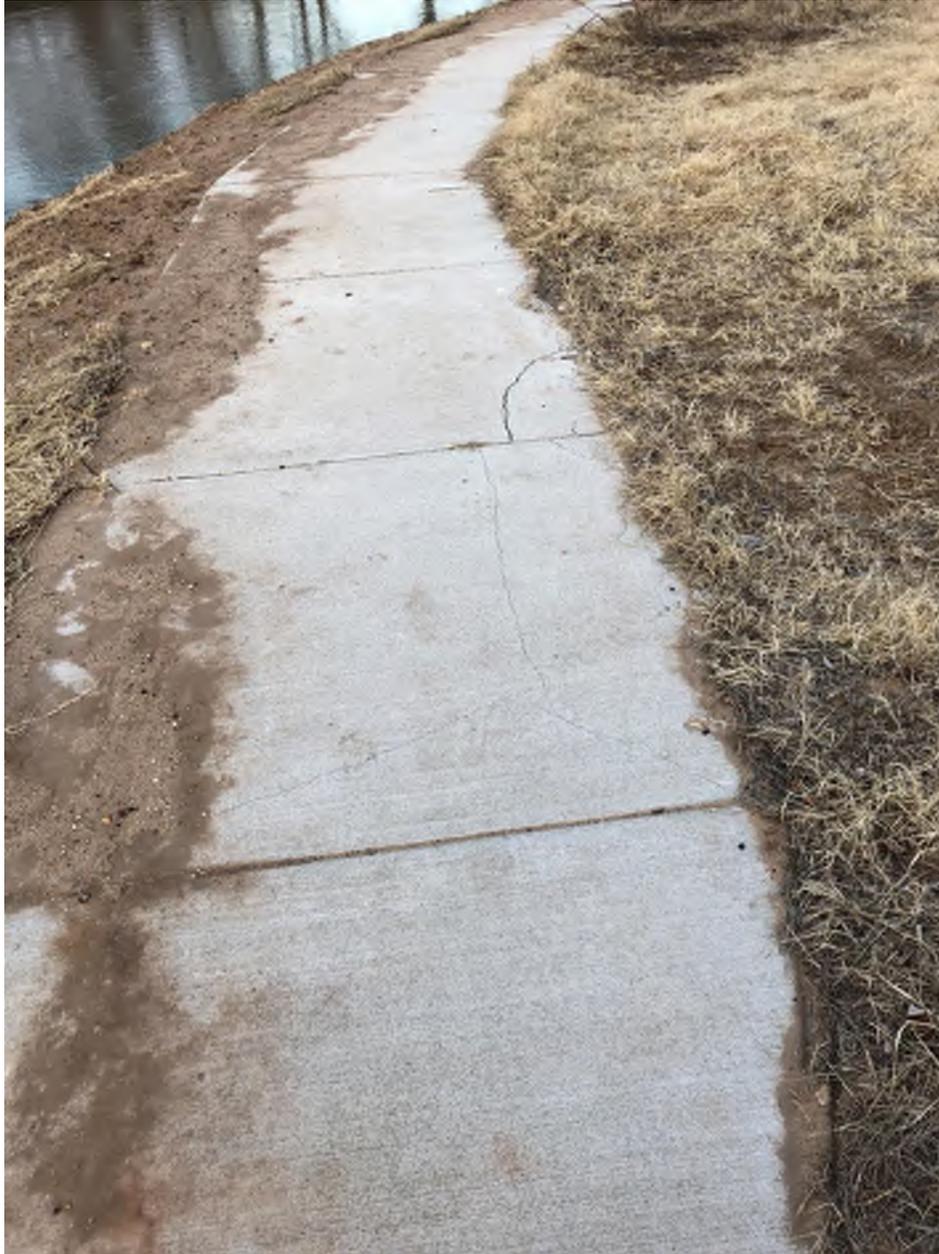
Photo 5

- Station 12+50.00 to Station 12+69.08 – Replace 50 square feet of 6" Concrete Sidewalk, which cracked at several locations due to removal of gravel base by storm events. Replacement will consist of 5-feet wide 6" standard KDOT sidewalk concrete.

Replace 50 square feet of 6" Concrete Sidewalk

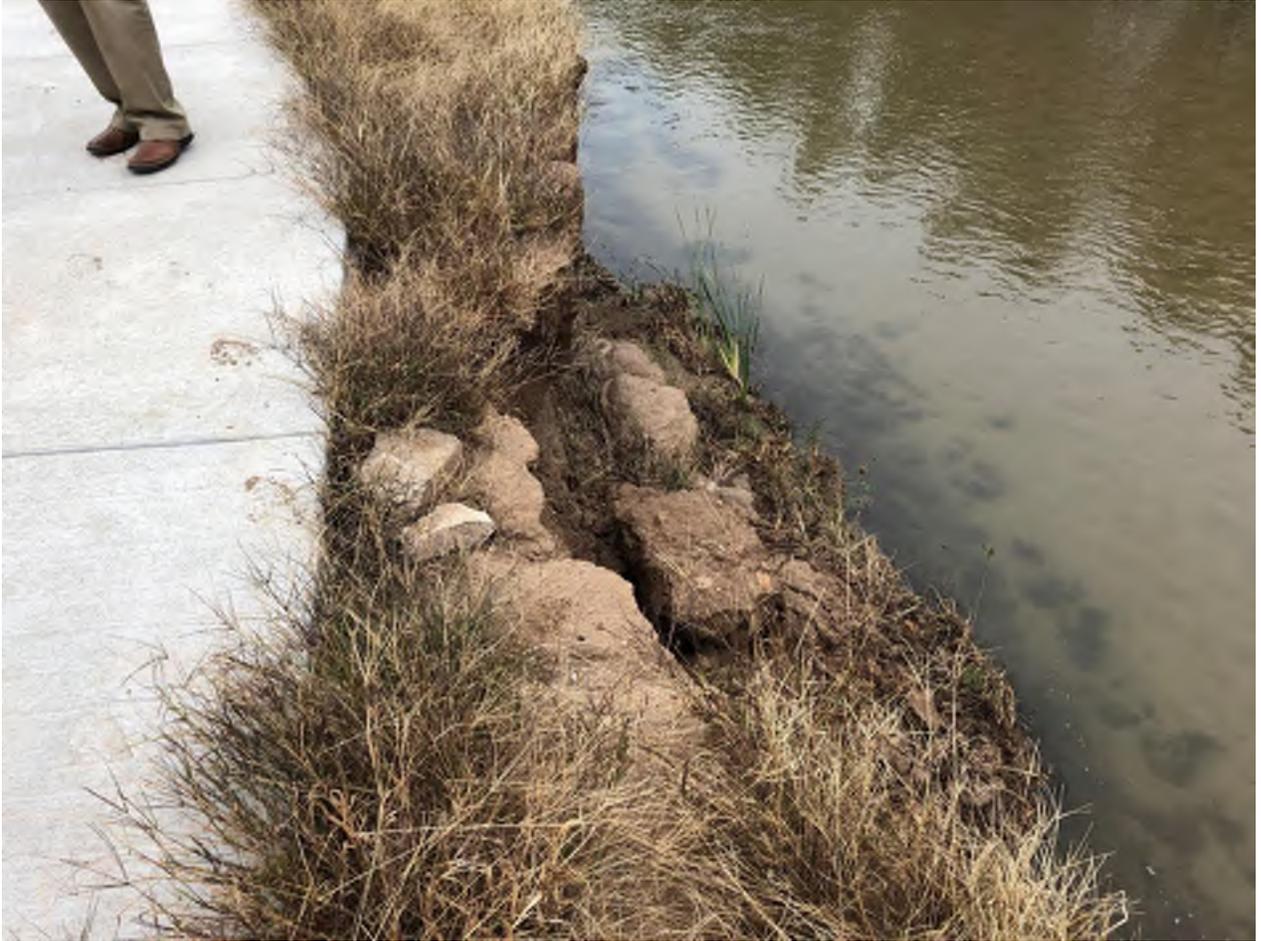
Photo 6

- Station 12+54.89 to Station 13+30.06 – Replace 145 cubic yards of Mill Race North Bank, which washed back approximately 10-feet during to flood events. Replacement will consist of a 2:1 slope to existing bank toe at 7-feet high.

Replace 145 cubic yards of Mill Race North Bank

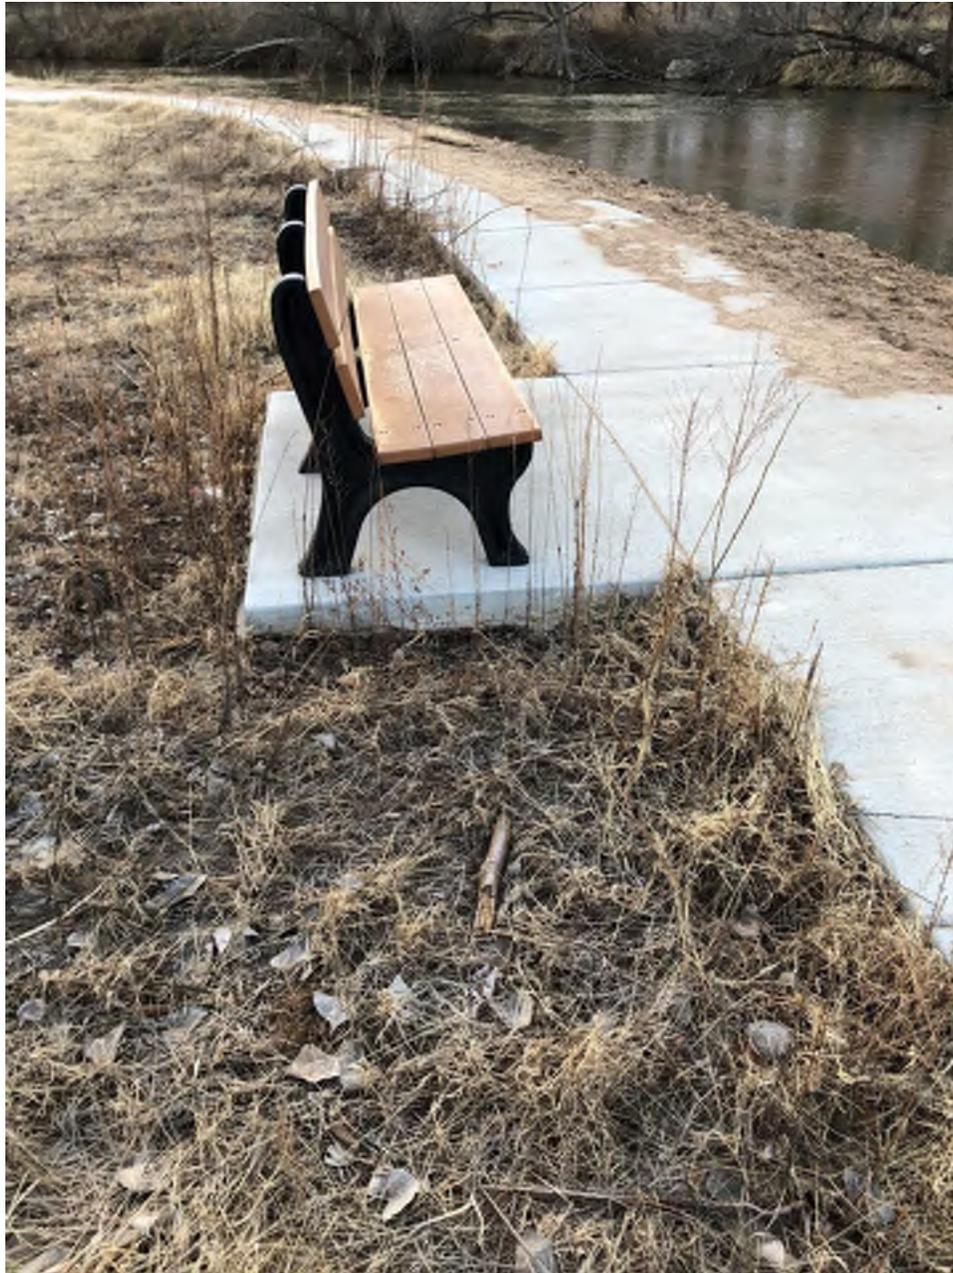
Photo 7

- Station 12+96.98 to Station 13+29.19 – Replace 2 cubic yards of Sidewalk Embankment, which was washed away behind the park bench foundation during the flood events. Replacement will consist of 3-feet of sidewalk shoulder at 6" and then slope down at a 3:1 side slope to existing ground.

Replace 2 cubic yards of Sidewalk Embankment

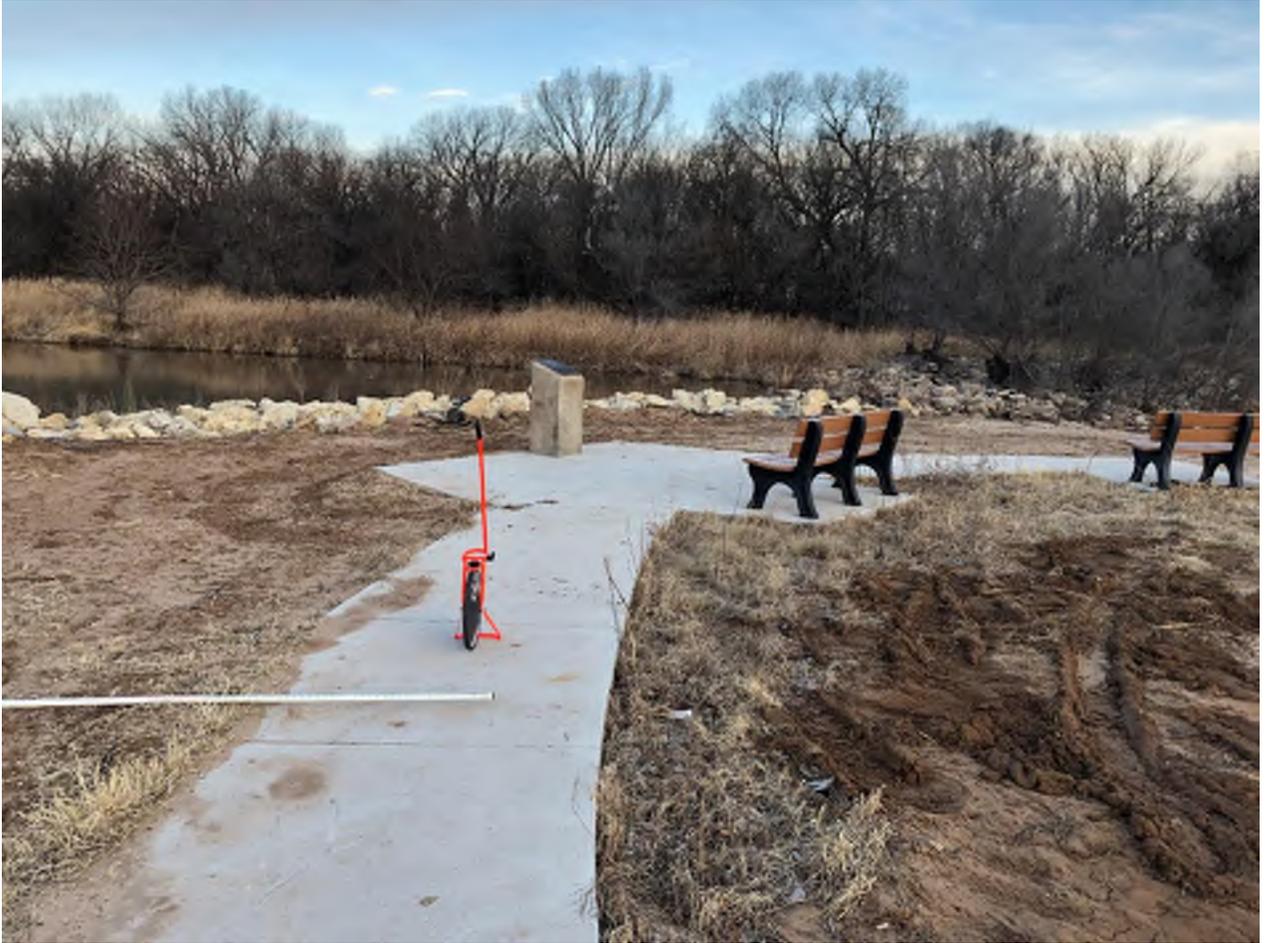
Photo 8

- Station 13+43.16 to Station 13+64.71 – Replace 2 cubic yards of Sidewalk Embankment, which was washed away behind the park bench foundation during the flood events. Replacement will consist of 3-feet of sidewalk shoulder at 6" and then slope down at a 3:1 side slope to existing ground.

Replace 2 cubic yards of Sidewalk Embankment

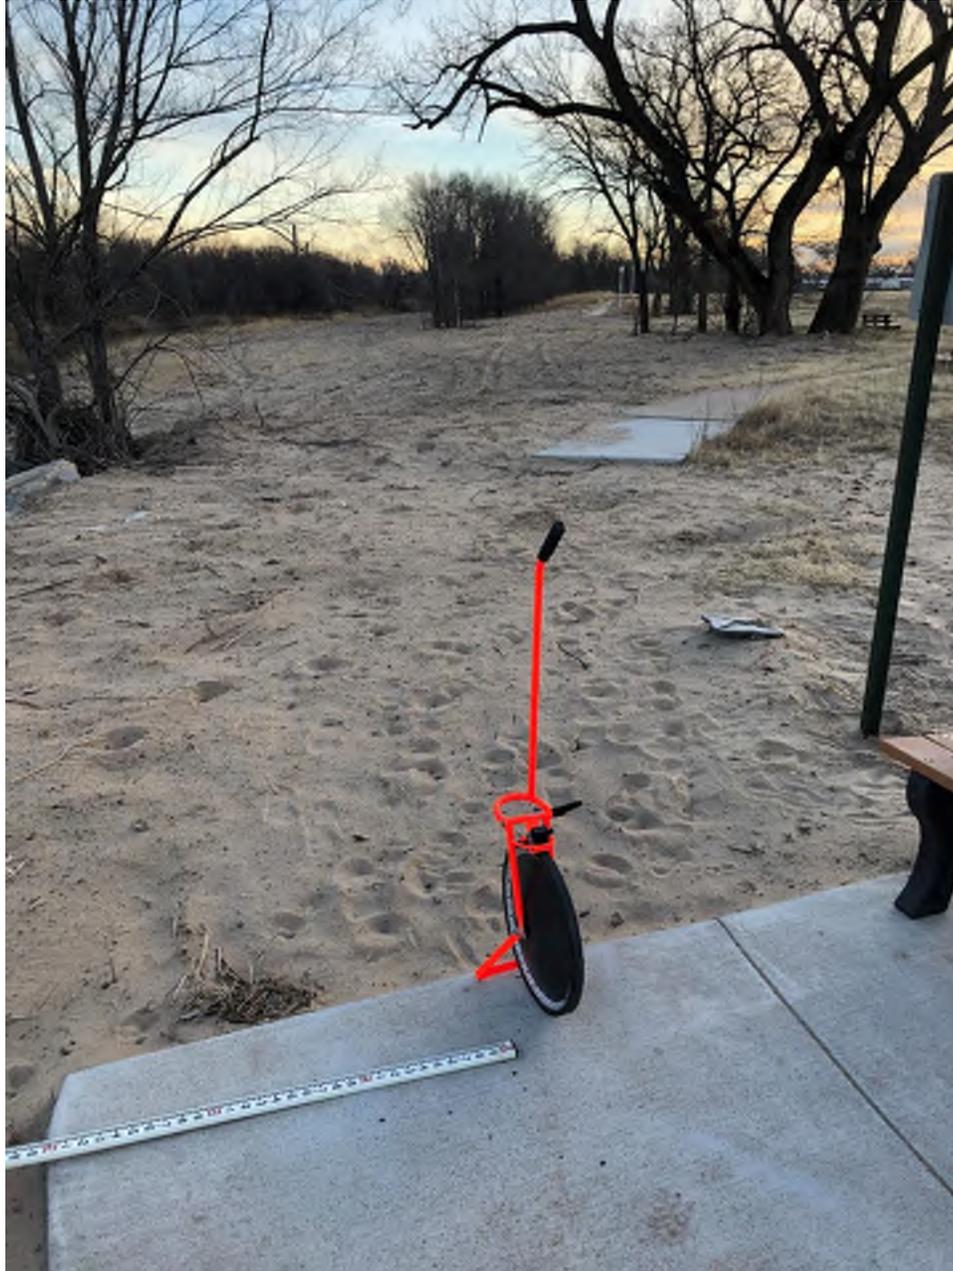
Photo 9

- Station 13+75.15 to Station 14+00.00 – Replace 125 square feet of 6" Concrete Sidewalk, which was completed undermined and displaced through the entire length due to removal of gravel base by storm events. Replacement will consist of 5-feet wide 6" standard KDOT sidewalk concrete.

Replace 125 square feet of 6" Concrete Sidewalk

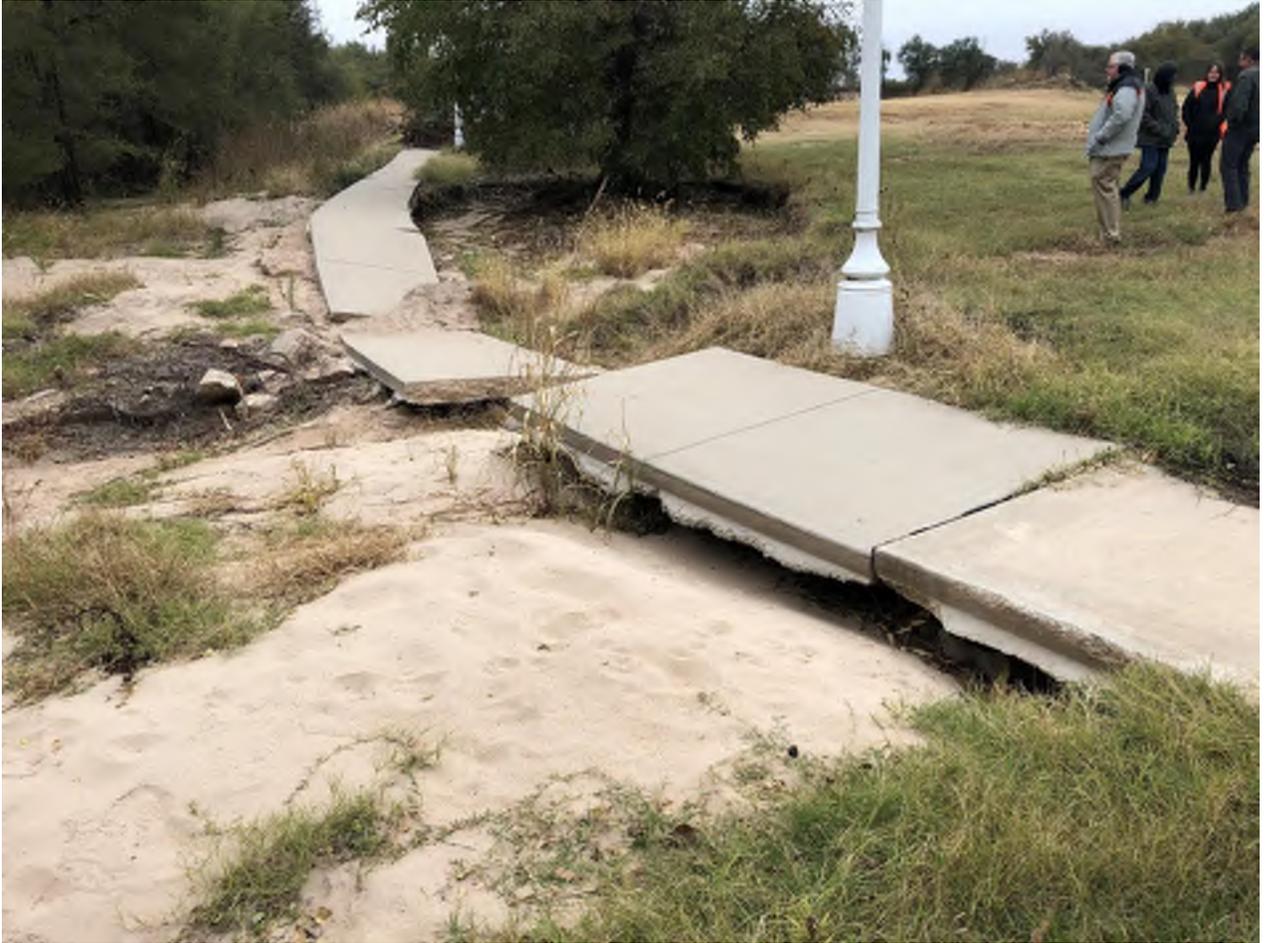
Photo 10

- Station 15+90.00 to Station 16+50.00 – Replace 300 square feet of 6" Concrete Sidewalk, which was completed undermined and displaced through the entire length due to removal of gravel base by storm events. Replacement will consist of 5-feet wide 6" standard KDOT sidewalk concrete.

Replace 300 square feet of 6" Concrete Sidewalk

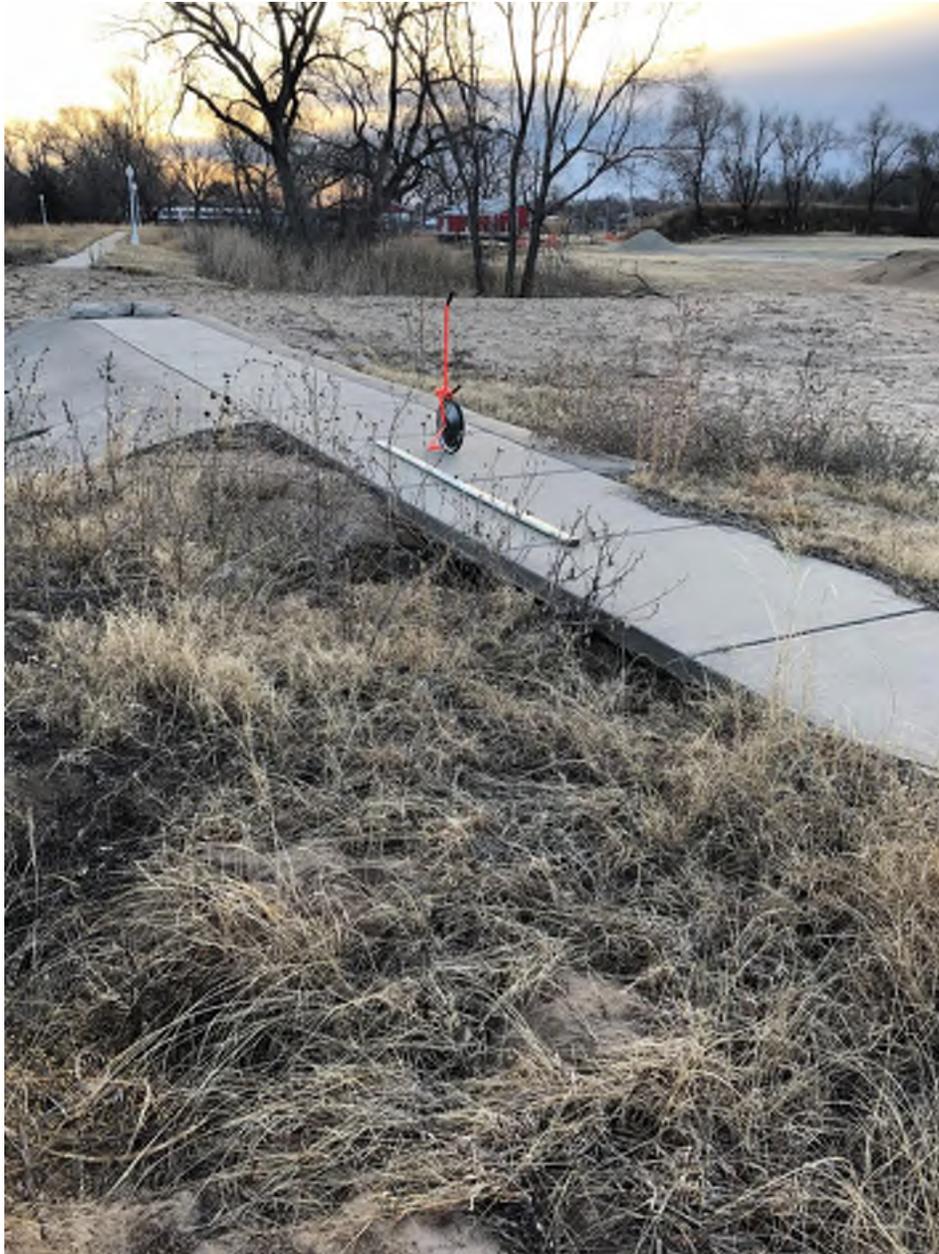
Photo 11

- Station 20+85.64 to Station 21+08.01 – Replace 3 cubic yards of Sidewalk Embankment, which was washed away during the flood events. Replacement will consist of 3-feet of sidewalk shoulder at 6" and then slope down at a 3:1 side slope to existing ground.

Replace 3 cubic yards of Sidewalk Embankment

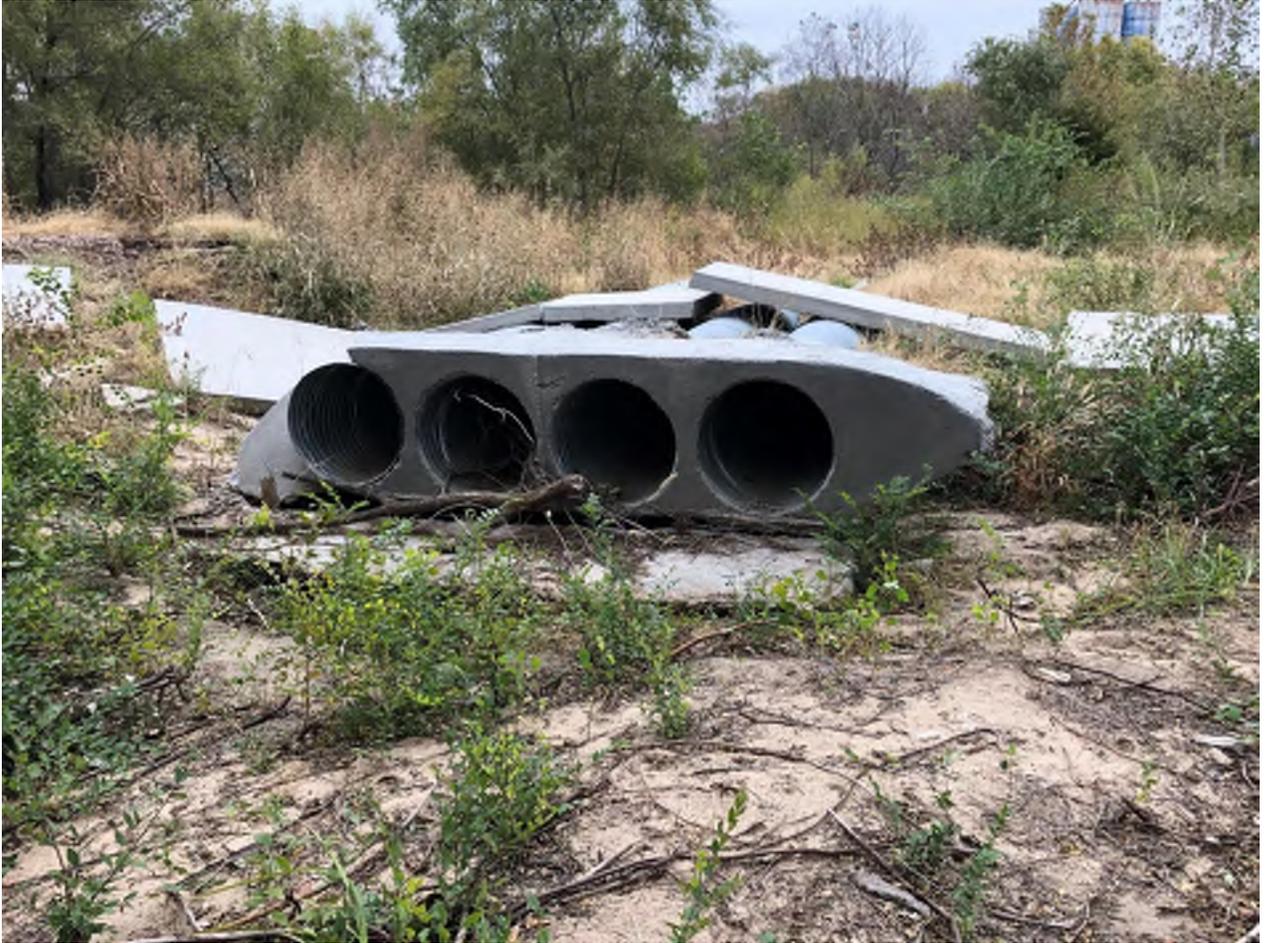
Photo 13

- Station 25+35.00 – Replace 120 linear feet of 24” Corrugated Metal Pipe, which was removed during flood events. Replace with 24” Corrugated Metal Pipe and upstream concrete headwall.

Replace 120 linear feet of 24" Corrugated Metal Pipe with Concrete Headwall
