# Mitigation Assessment Team Report

# Hurricanes Irma and Maria in the U.S. Virgin Islands

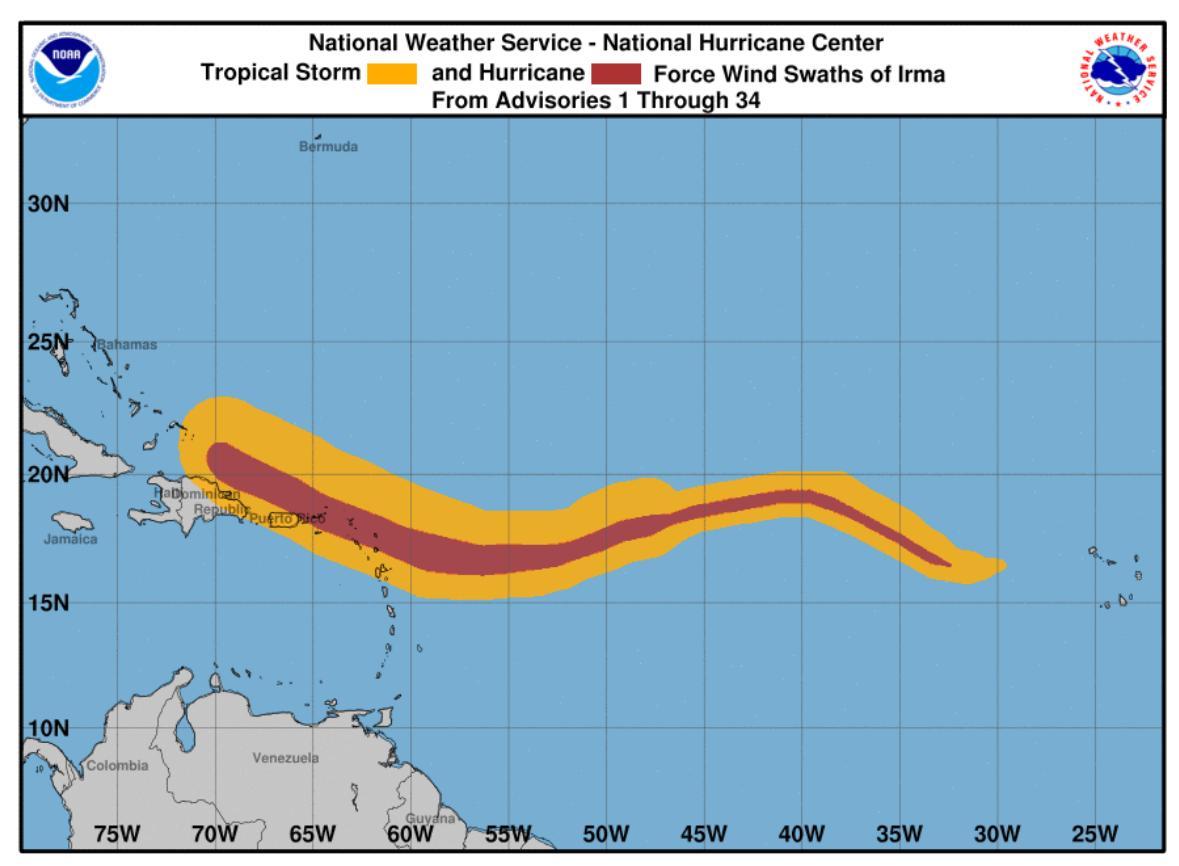
Figure 1-1: Wind swaths of Hurricane Irma as it passed by the USVI and Puerto Rico from August 30, 2017 to September 7, 2017. (Source: NOAA, 2018c).

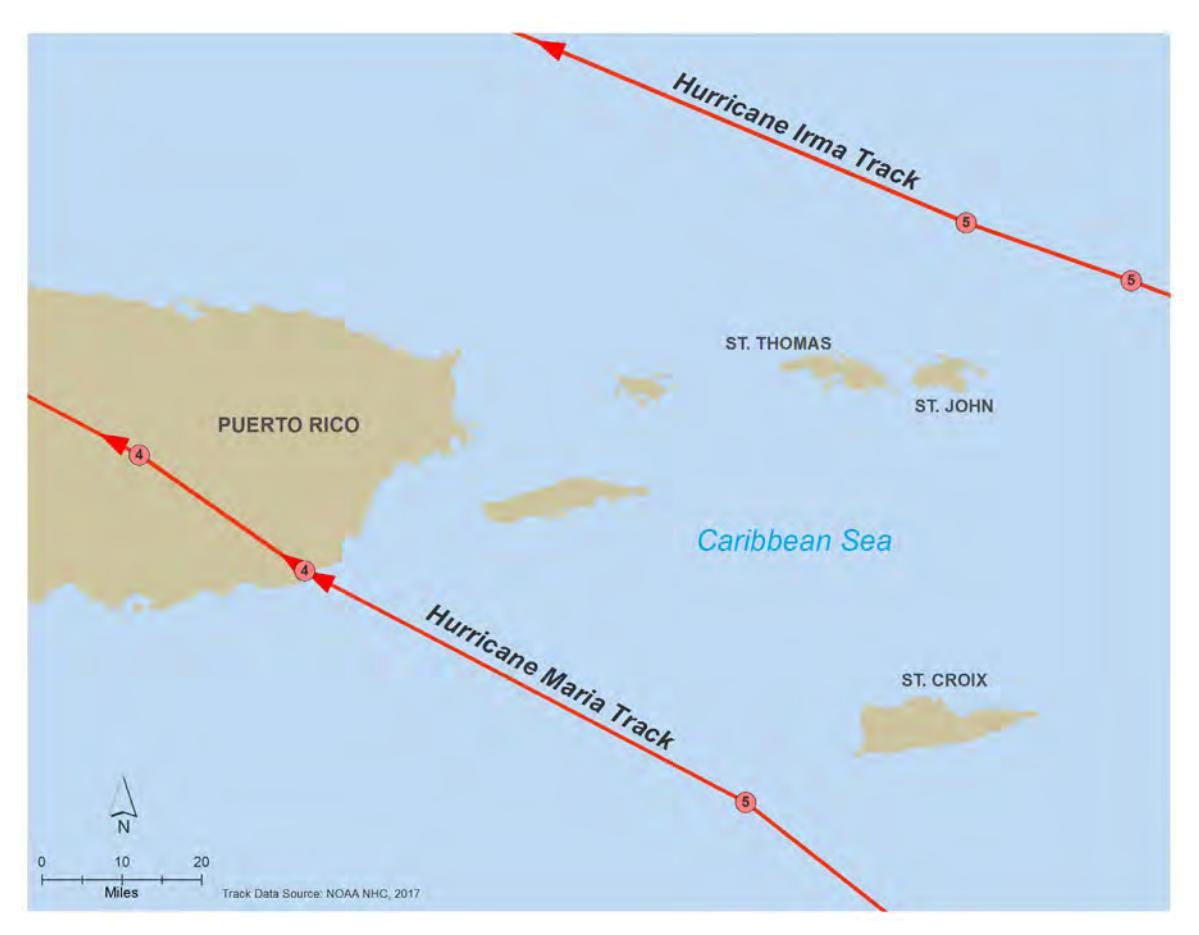
Figure 1-3: Paths of the eyes of Hurricanes Irma and Maria. Hurricane Irma passed by the USVI on September 6, 2017; Hurricane Maria passed by on September 20, 2017. (Source: NOAA, 2018a).

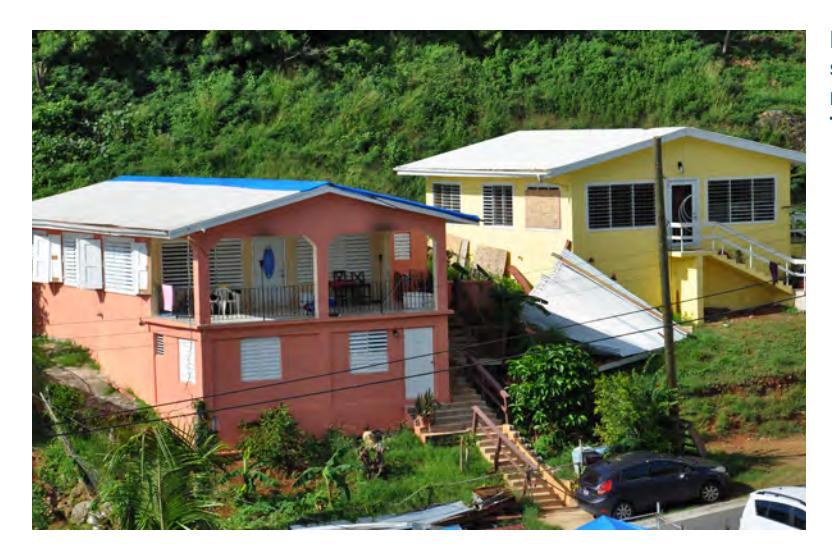
Figure 1-4: Inadequate attachment of steel roof framing led to metal panel roof loss failure in Anna's Retreat on St. Thomas.

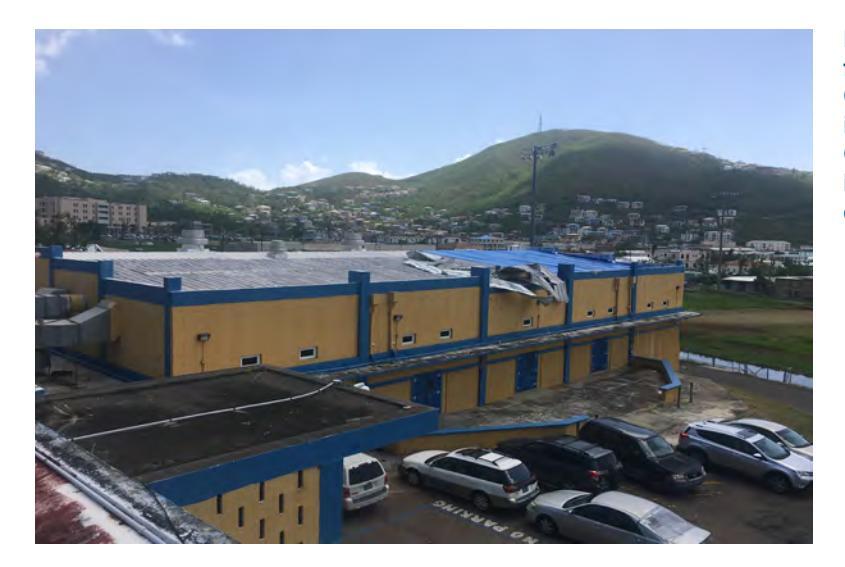
Figure 1-5: This auditorium experienced failure of the metal roof system. Classroom buildings experienced water intrusion from aged roof members. Groundwater intrusion was an issue in classrooms from inadequate site drainage. St. Thomas.

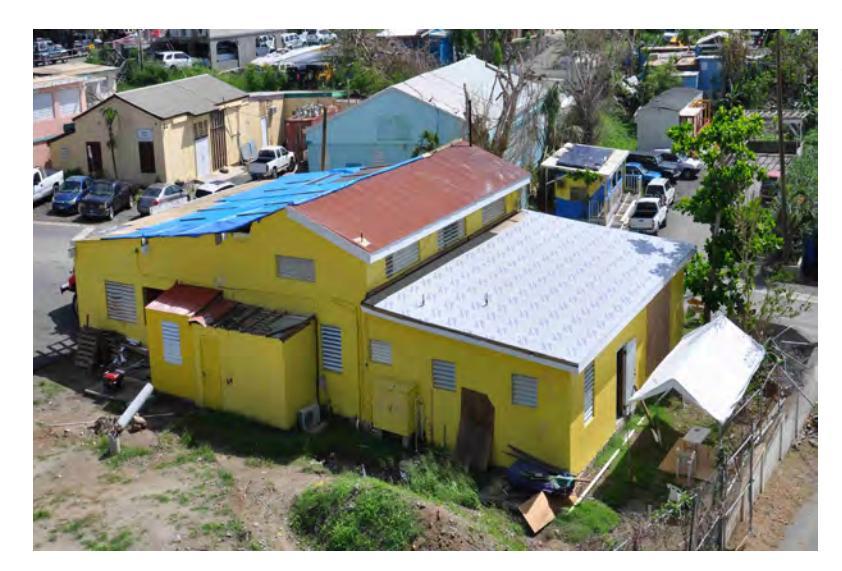
Figure 1-6: Captain Robert O'Connor, Sr. Fire Station displaying significant roof covering damage on St. John.

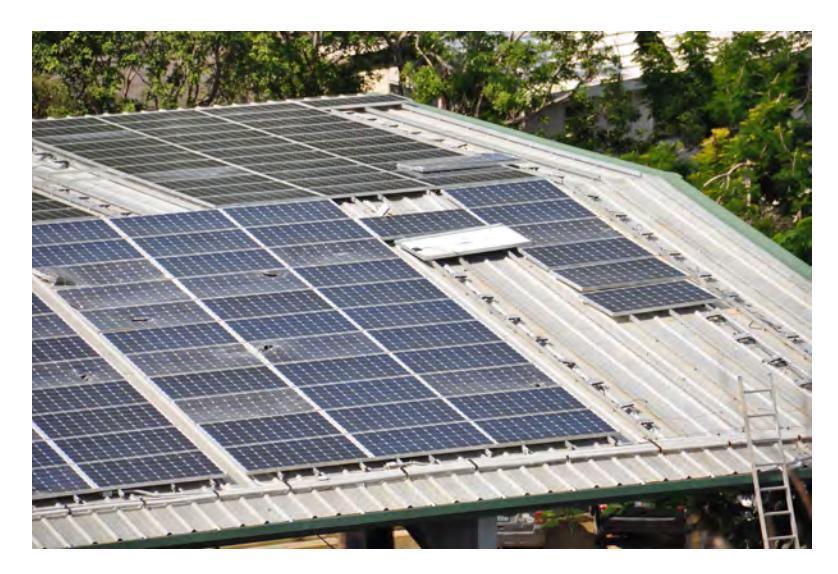
The Flood Insurance Study (FIS) for the USVI warns that flood waters have inundated large areas of St. Croix in and around Christiansted in the past, causing landslides (also known as landslips) and major damage. The MAT noticed a substantial number of places on the steep slopes of the three islands where flood water activated such landslides.

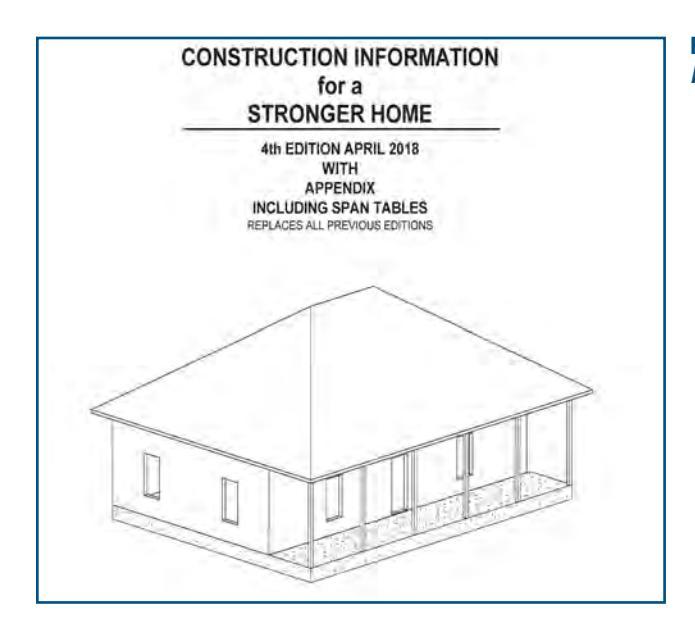
The USVI and FEMA developed *Construction Information for a Stronger Home* (the *Stronger Home Guide*) to support natural hazards-resilient home construction in the USVI. The first edition of this document was published following Hurricane Marilyn and the second in December 1995. The third edition was published in February 1996. The fourth edition (USVI DPNR, 2018) continues to advance residential construction mitigation measures and resilience techniques (Figure 2-1). This edition uses the latest advances in building code development by referencing the 2018 IRC©, 2018 IBC©, and ASCE/SEI 7-16. The previous edition was based upon the 1995 CABO One and Two-Family Dwelling Code and the 1994 UBC.

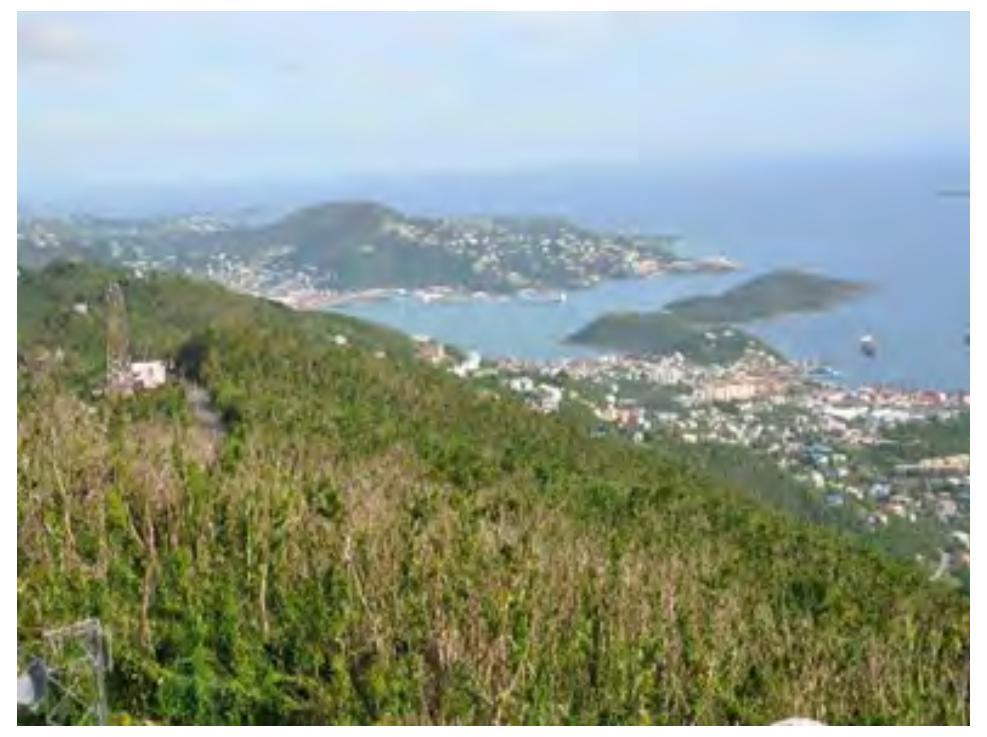
Figure 2-2: Effects on vegetation due to wind speed due to topography.

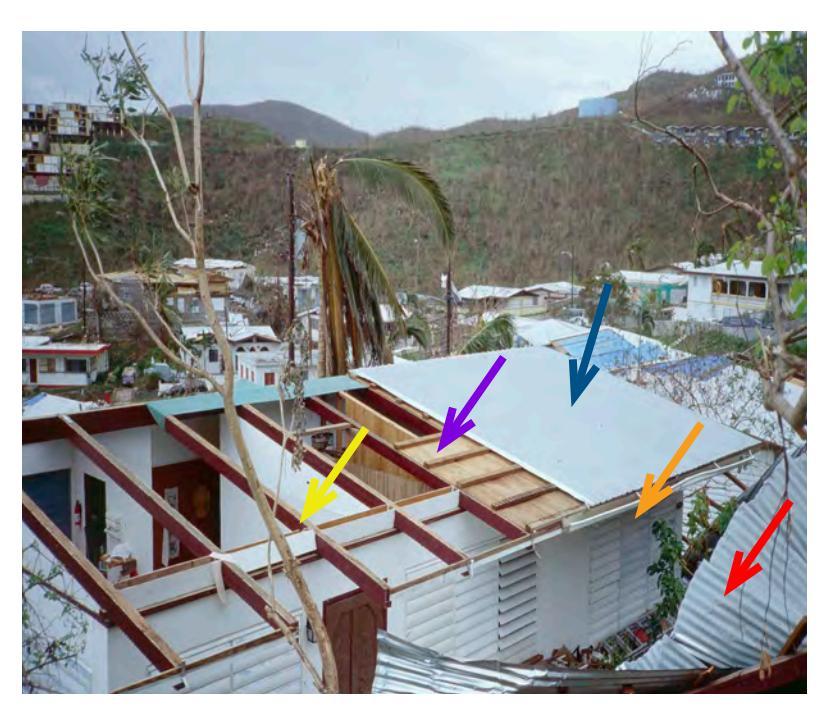
Figure 3-1: Typical residential construction and wind performance during Hurricane Marilyn (1995). The red arrow indicates a corrugated metal roof panel, the blue arrow indicates a nailer, the puple arrow indicates textured plywood, the yellow indicates a beam, and the orange arrow indicates a metal jalousie.

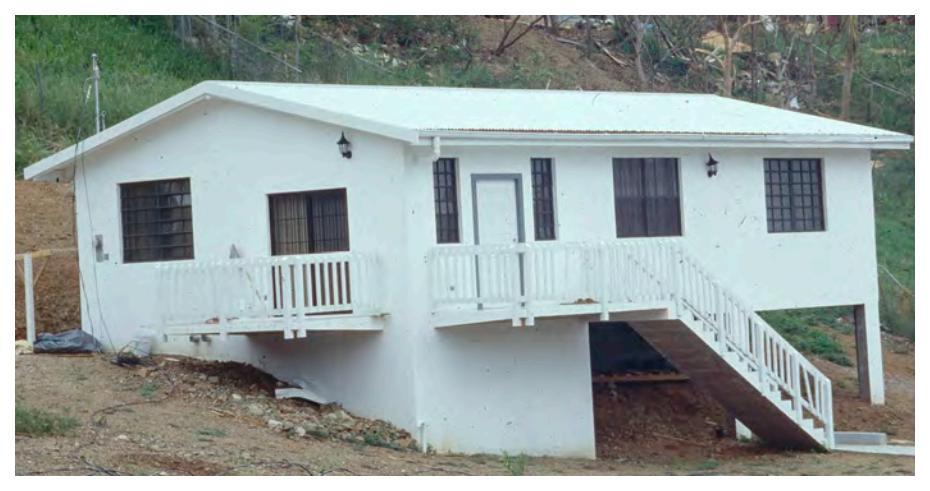
Figure 3-2: Successful metal roof covering performance, attributed to use of screws to attach the corrugated panels and enhanced attachment at eaves and the ridge.

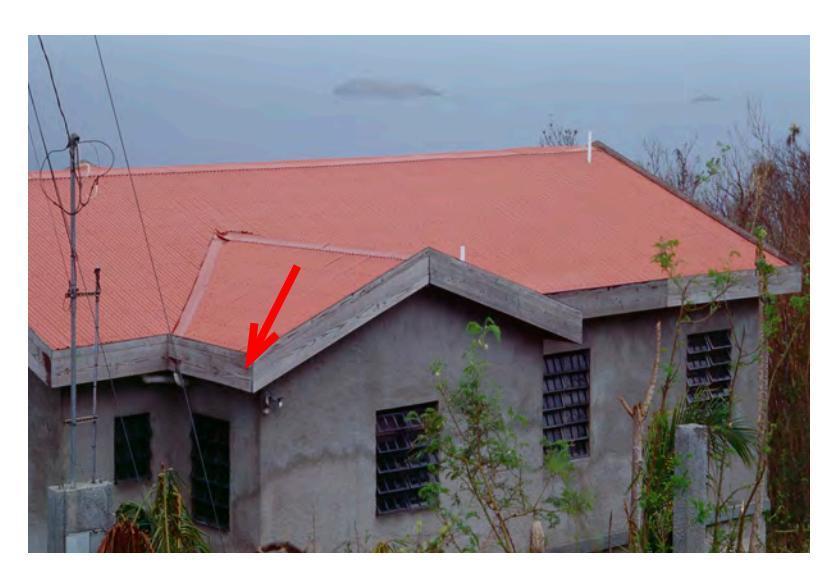
Figure 3-5: Corrugated metal roof panels with an integral wood gutter are shown at the red arrow.

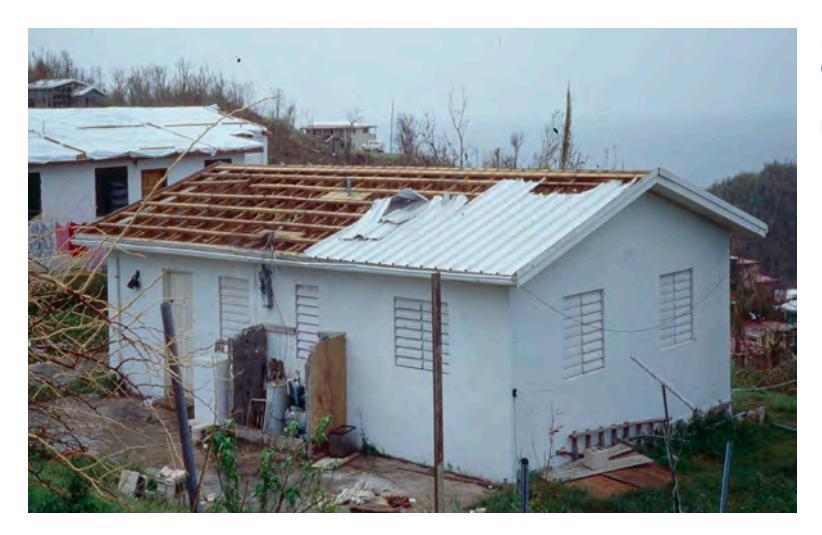
Figure 3-6: View of metal roof panel damage after Hurricane Marilyn. See Figure 3-7 for a view during roof reconstruction.

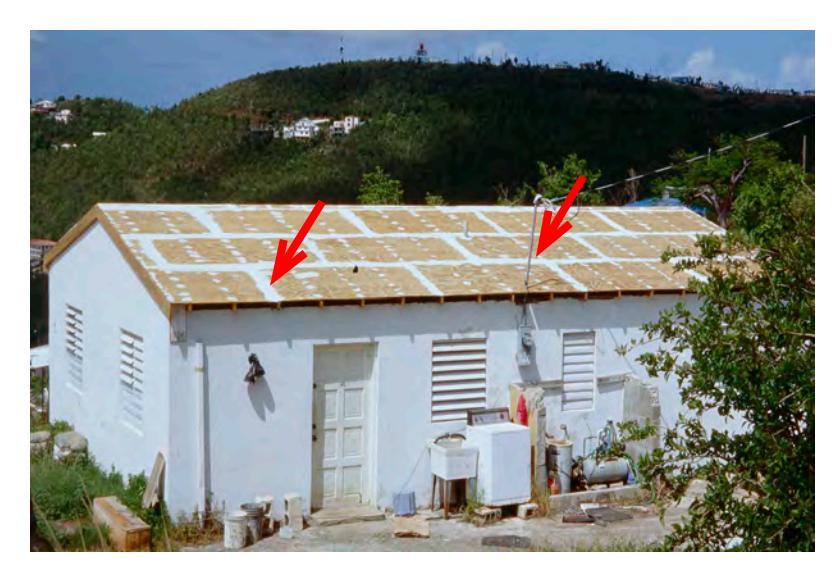
Figure 3-7: Roof reconstruction at the house shown in Figure 3-6. The red arrows indicate special treatment at plywood joints and screws.

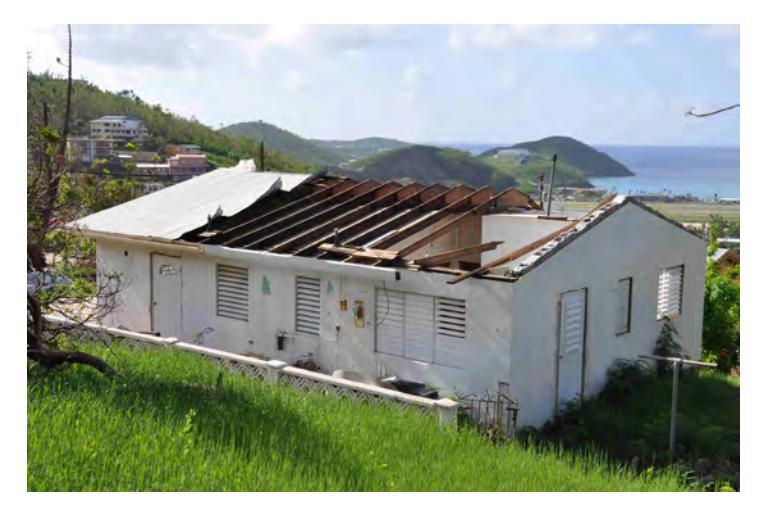
Figure 3-8: View of damage caused by the 2017 hurricanes. The roof assembly is indicative of pre-Hurricane Marilyn construction. St. Thomas.

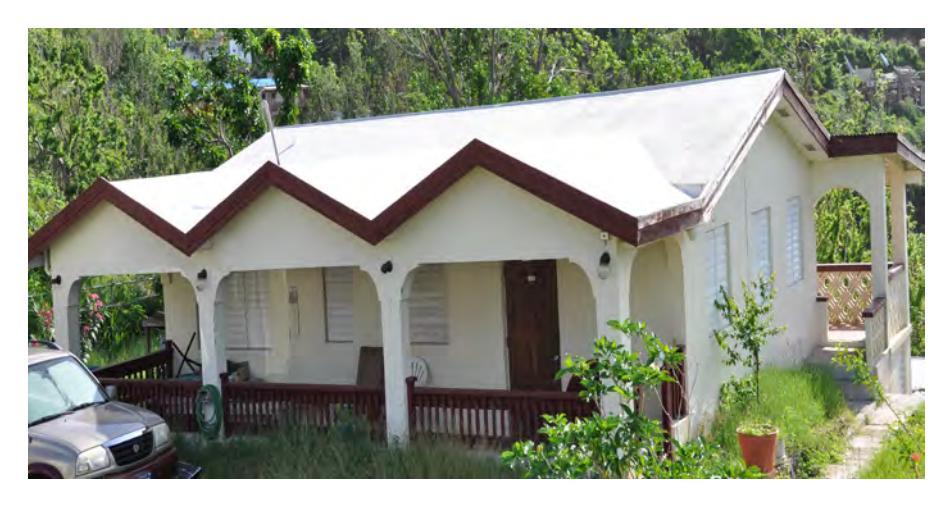
Figure 3-9: View of a residence with a liquidapplied membrane roof and integral gutters. It was near the residence shown in Figure 3-8.

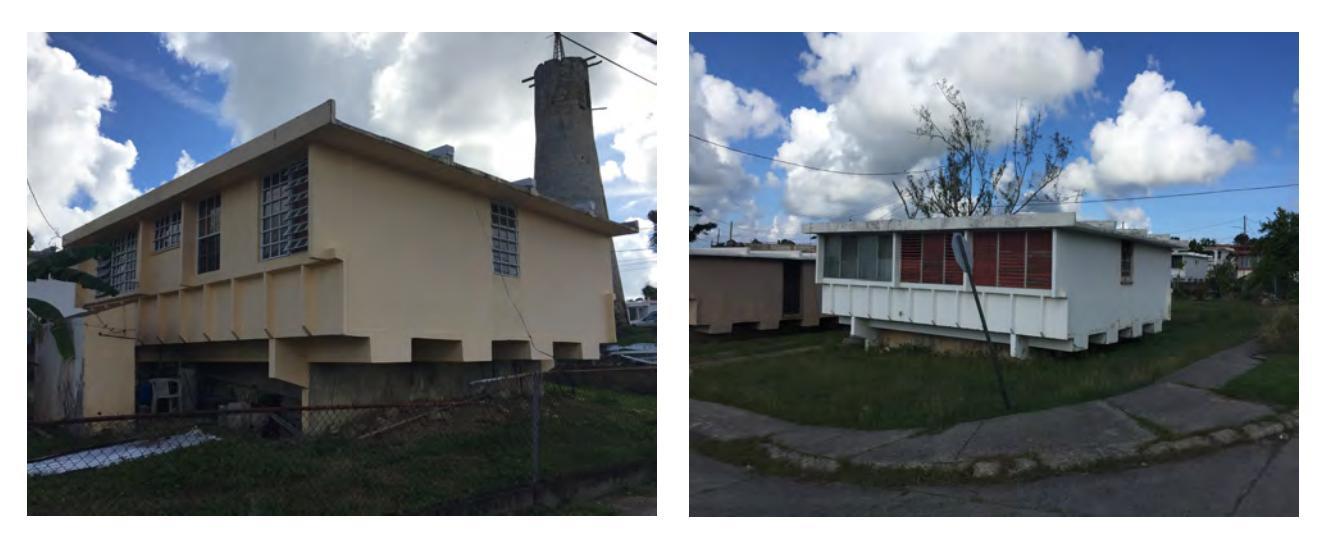
Figure 3-10: Two examples of partially modular buildings constructed out of pre-cast concrete wall and roof panels. These buildings and their concrete roofs performed very well in response to wind loads. Sion Farm neighborhood, St. Croix.

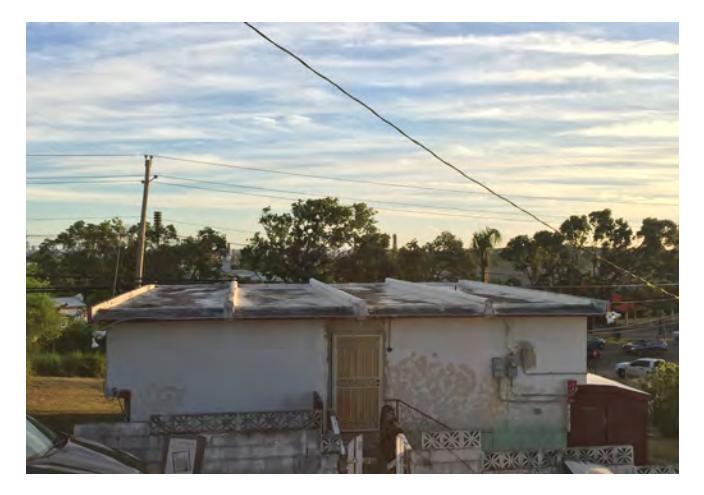
Figure 3-11: Example of ponding at low-points on pre-cast concrete roofs where leaks developed. These buildings and their concrete roofs performed very well in response to wind loads. Sion Farm, St. Croix. Some traditional CMU homes suffered extensive damage, primarily from high winds. For one home, the side that faced into the peak hurricane winds lost most of its roof structure, as shown in Figure 3-12.

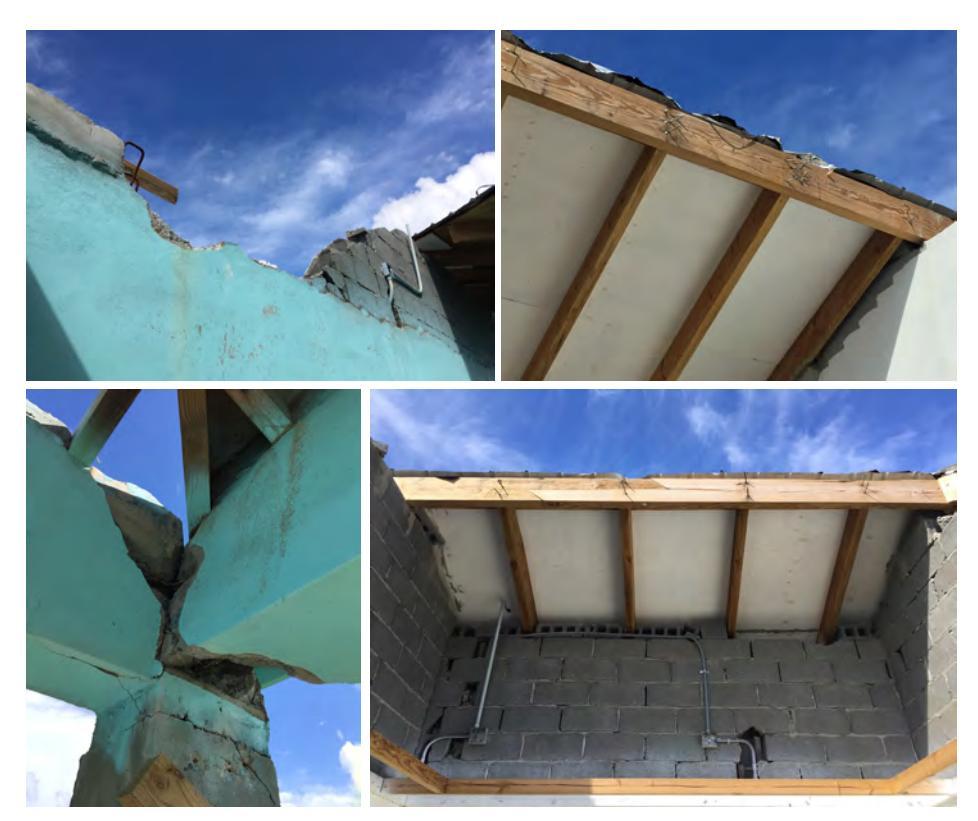
Figure 3-12: Examples of multiple structural failures at a CMU home with wood-framed roof. Losing the roof to uplift and outward pressure resulted in impacts to CMU masonry walls (top left), concrete ring beam (bottom left), and roof structure (top and bottom right). These buildings and their concrete roofs performed very well in response to wind loads. St. Croix.

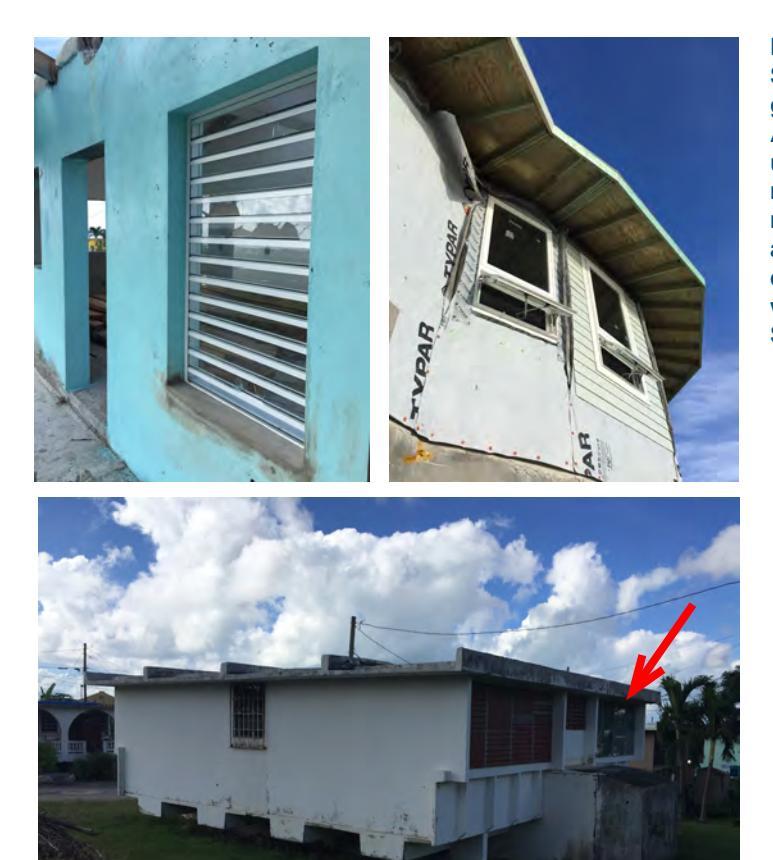
Figure 3-14: Examples of windows used on St. Croix: metal jalousie, glass jalousie, and glass casement and single-hung windows. A damaged glass jalousie window and undamaged pressure-rated windows (top right) on buildings. The lower picture had metal jalousies that remained unharmed while a green tarp indicated by the red arrow is covering damage to a separate glass jalousie window. La Grange, Grapetree, and Sion Farm, St. Croix.

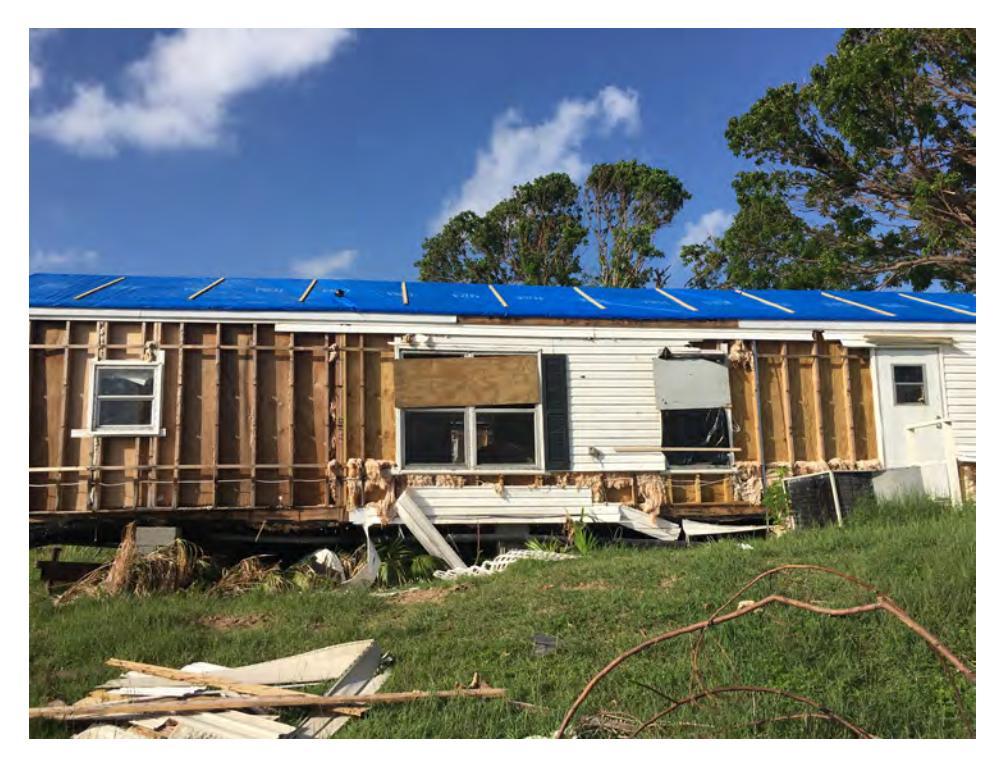
Figure 3-15: Manufactured home that lost roof covering, roof decking, siding, and wall cladding. St. Croix. Another home on St. Croix suffered damage extensive enough that finished interior walls were blown into the home. The home was missing siding, sheathing, roofing, windows, and interior finish walls, and the interior was inundated with wind-driven rain (Figure 3-16). Water was driven into the space for the floor framing and the floor insulation. This area had a covering that kept the insulation in place but also made removal and replacement of the water-logged insulation impractical. For these reasons, the damage to the home was beyond repair.

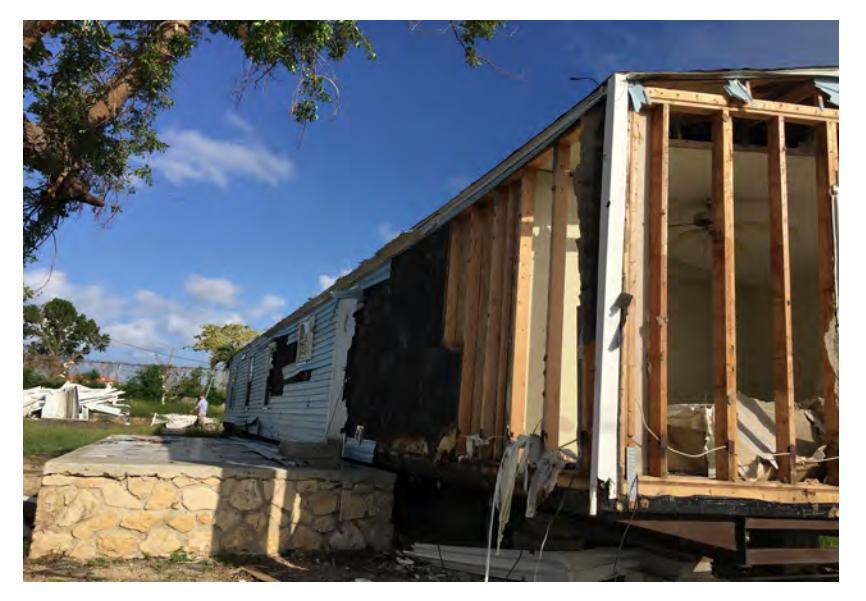
Figure 3-16: Manufactured home that lost roof covering, siding, and wall cladding. St. Croix.

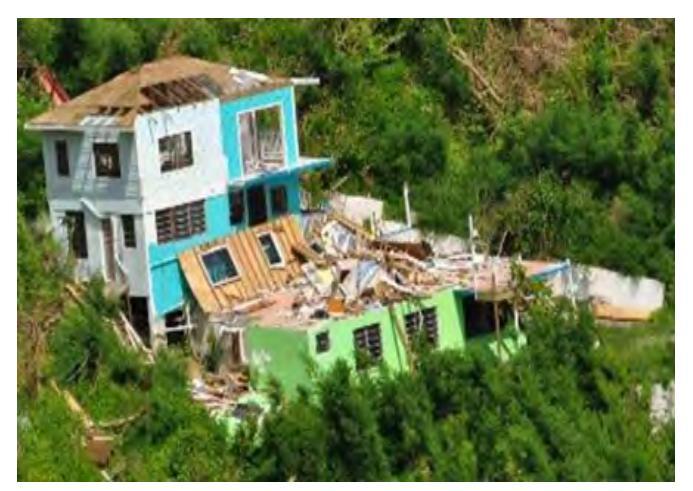
Figure 3-17: Home with roof sheathing blown off the upper roof. The wood-framed walls and roof of the lower portion collapsed.

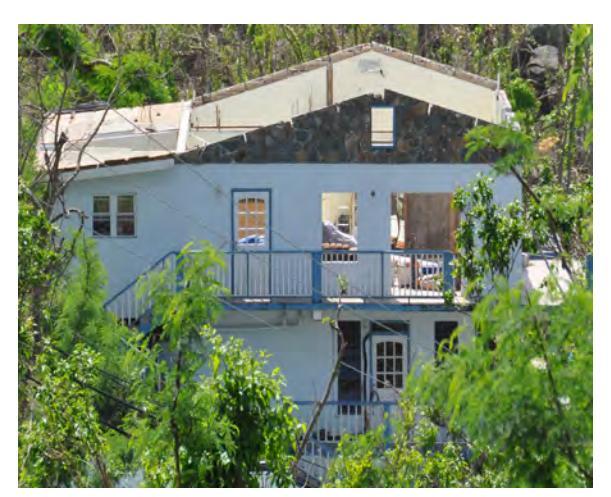
Figure 3-18: Home with entire roof structure missing. The assembly was blown off during the storm.

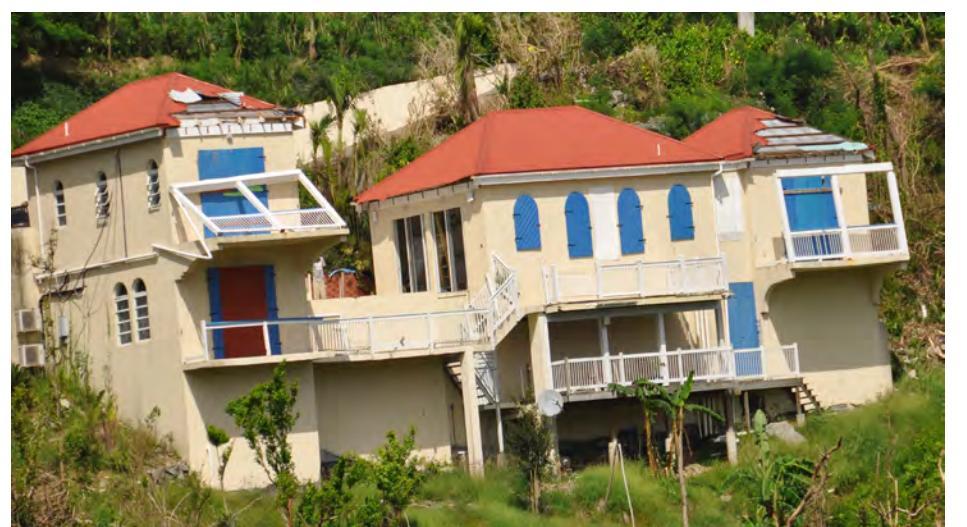
Figure 3-19: Two porch overhangs blew off and caused progressive lifting of the corrugated metal roof panels on the adjacent main roof indicated by the yellow circles. The gutter was blown off where indicated by the red arrow. Several of the doors and windows were protected by traditional wood shutters.

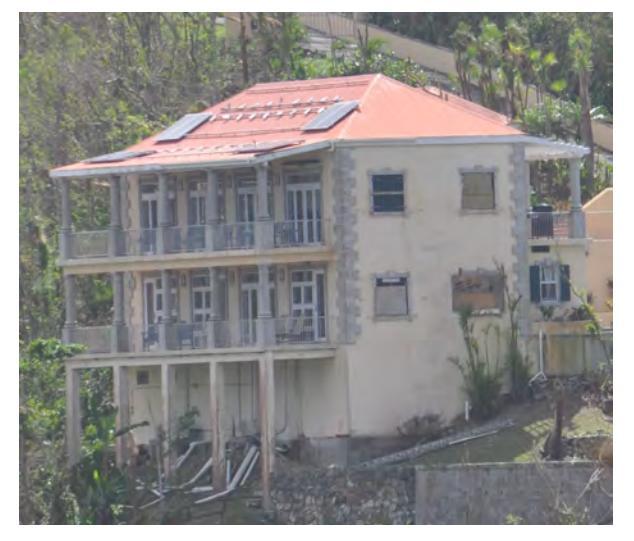
Figure 3-20: This corrugated metal roof sustained no apparent damage, but portions of the gutters and several solar panels blew off.

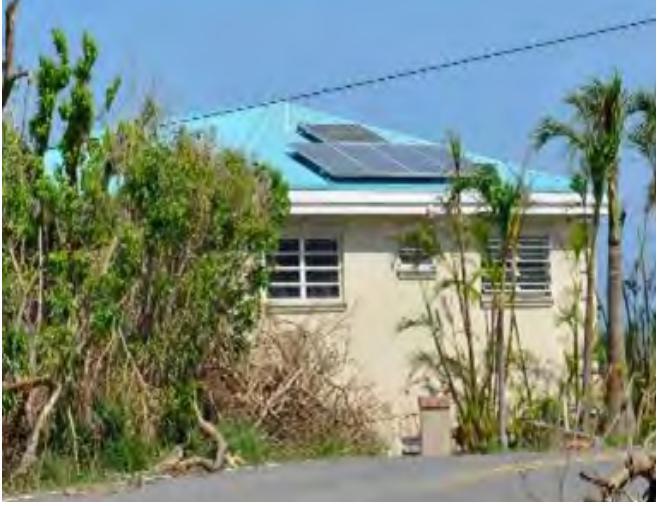
Figure 3-21: There was no apparent damage to this residence. It had corrugated metal panels and an integral gutter.

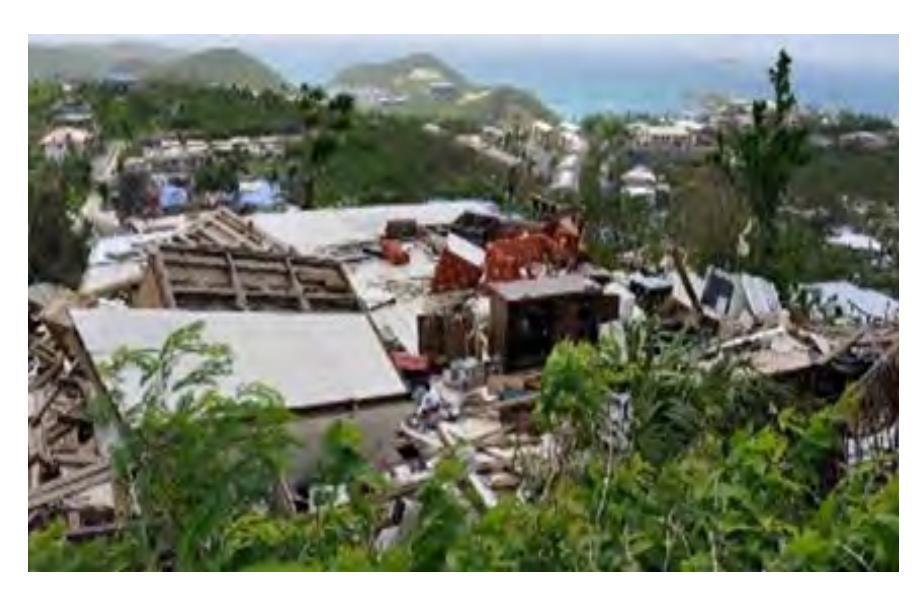
Figure 3-22: Collapsed home with wood-frame walls and roof in St. Thomas.

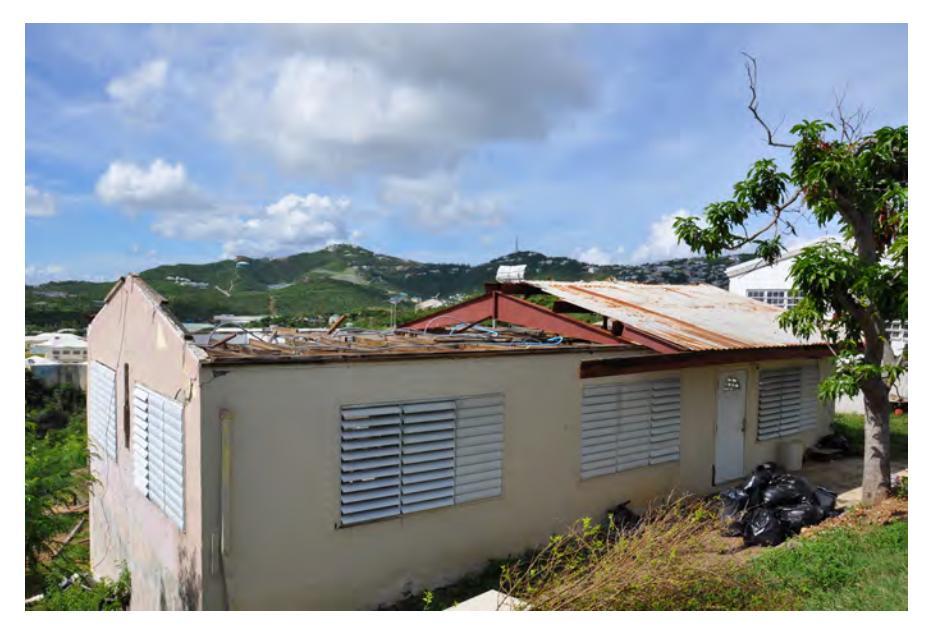
Figure 3-23: Blow-off of a steel roof structure.

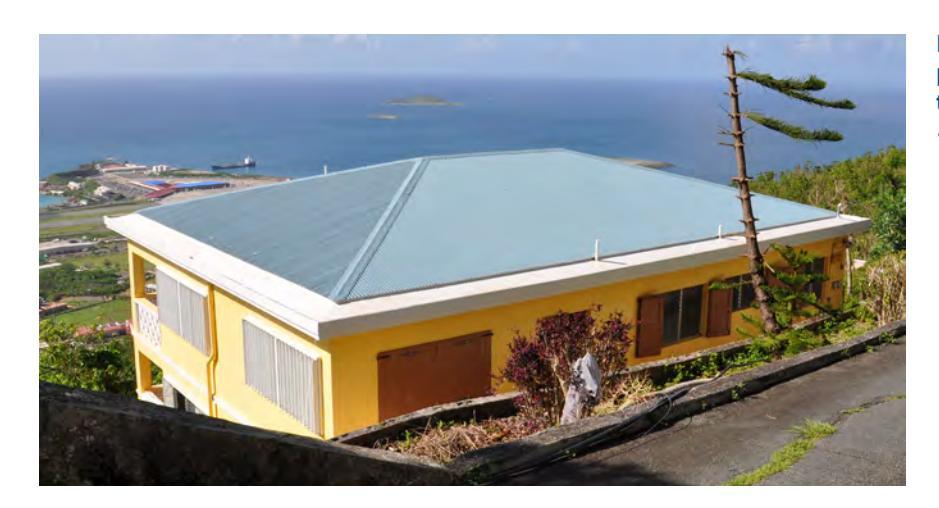
Figure 3-24: A corrugated metal panel roof with integral gutter that appeared to comply with the *Stronger Home Guide.*

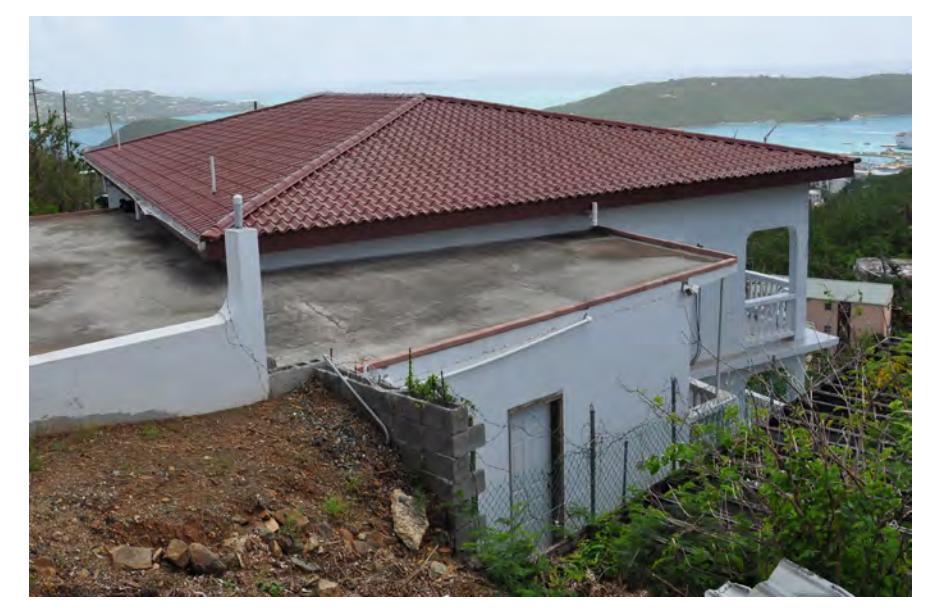
Figure 3-26: This residence appears to have a tile roof; however, it has metal panels formed to simulate tile. The panels were attached with exposed fasteners. There was no apparent damage.

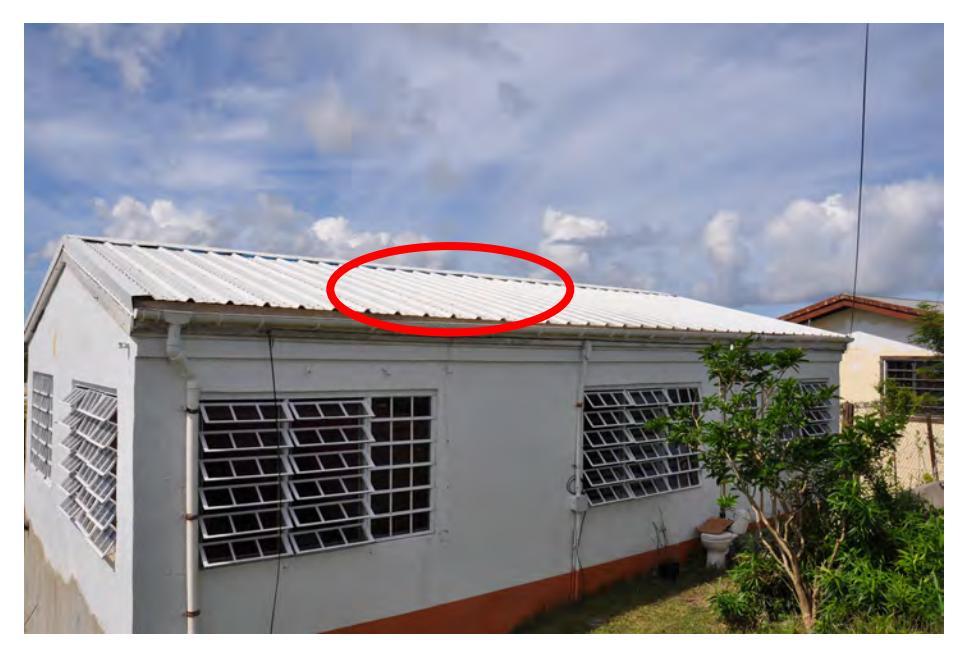
Figure 3-27: This residence had a metal R-panel roof. Figure 3-29 is a close-up of the ridge flashing indicated in the red oval.

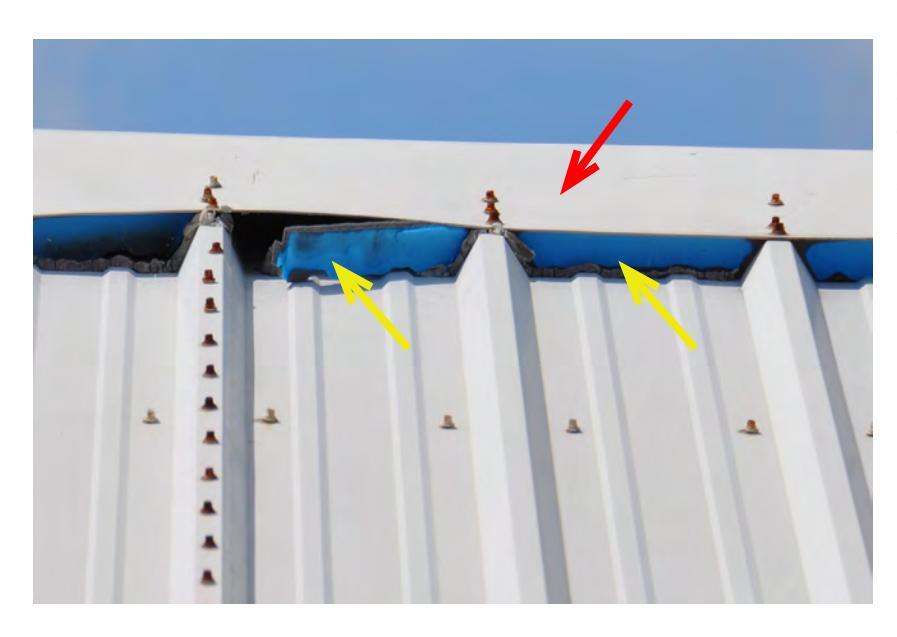
Figure 3-29: View of the ridge flashing indicated by red arrow. The yellow arrows indicate foam closures (one closure is dislocated). The panel and flashing screws are corroded, thus jeopardizing the service life of the roof system.

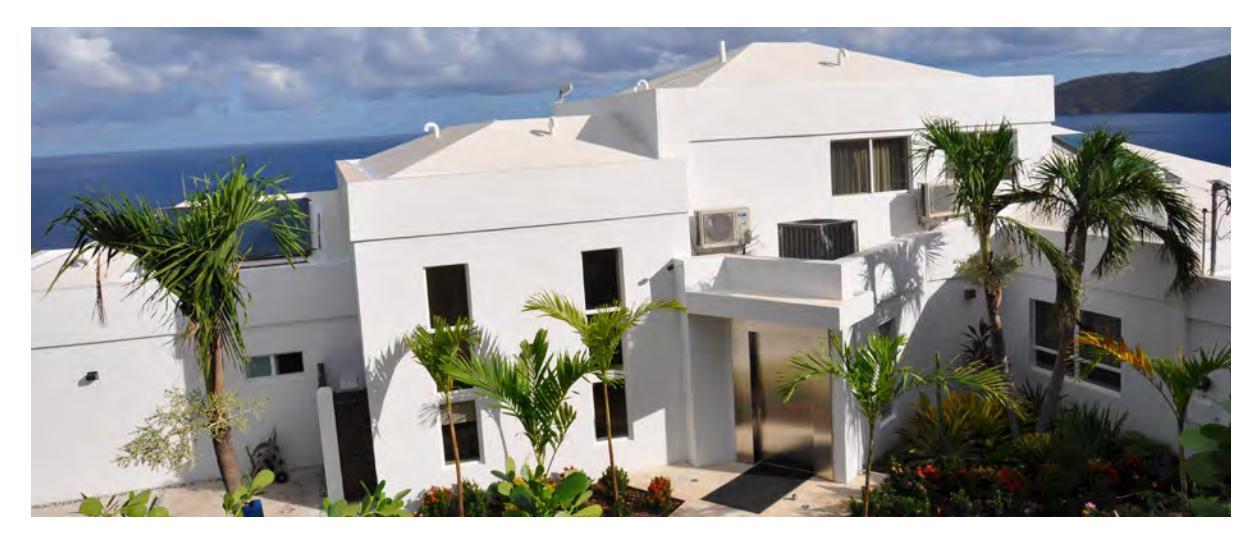
Figure 3-30: Water entered at the ceiling/wall interface in the vicinity of the red arrow. That leakage was likely associated with inadequate sealing of the lines serving the condensers at the blue arrow.

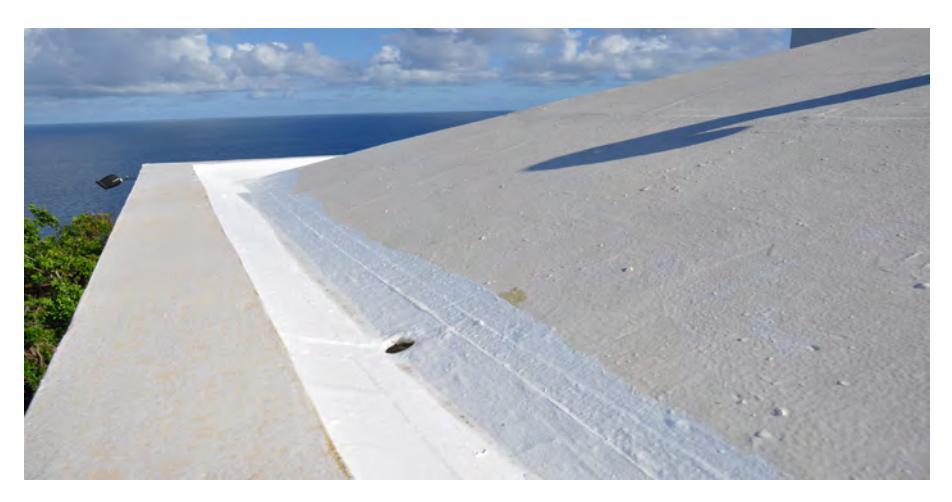
Figure 3-31: View of the integral gutter shown by the red arrow in Figure 3-30. There was a single small diameter outlet tube in this area. It did not have a strainer. It is likely that water accumulated in the gutter and leaked through membrane breaches. The bright white area is a recent recoating.

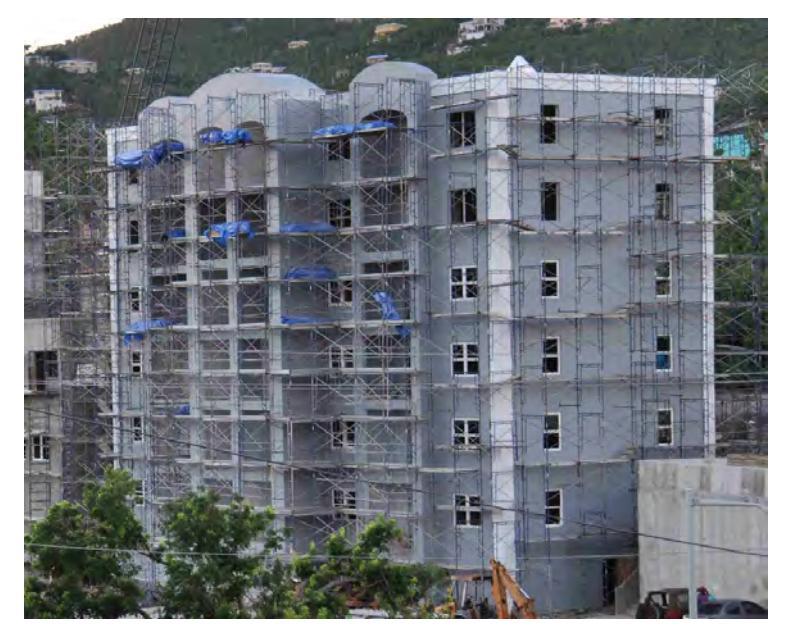
## Figure 3-32: View of multi-family housing building under construction.

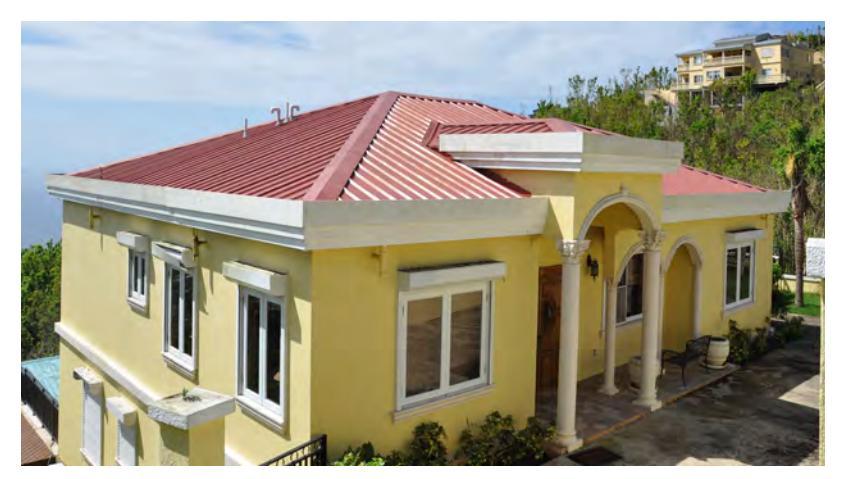
Figure 3-34: This residence has roll-down storm shutters. The roof covering is an exposed-fastener R-panel roof with integral gutter. There was no apparent damage; however, it was not determined whether there was water infiltration at the doors or windows.

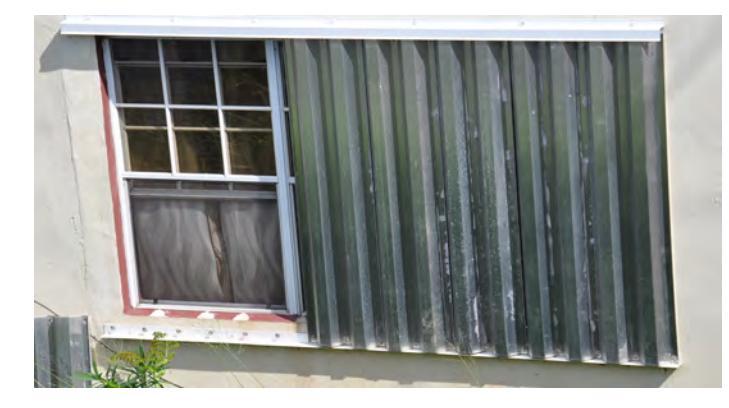
Figure 3-35: View of double-hung windows protected by metal panel shutters. Shutter tracks are permanently mounted to the wall indicated by the red arrow. The panels are installed prior to hurricane landfall.

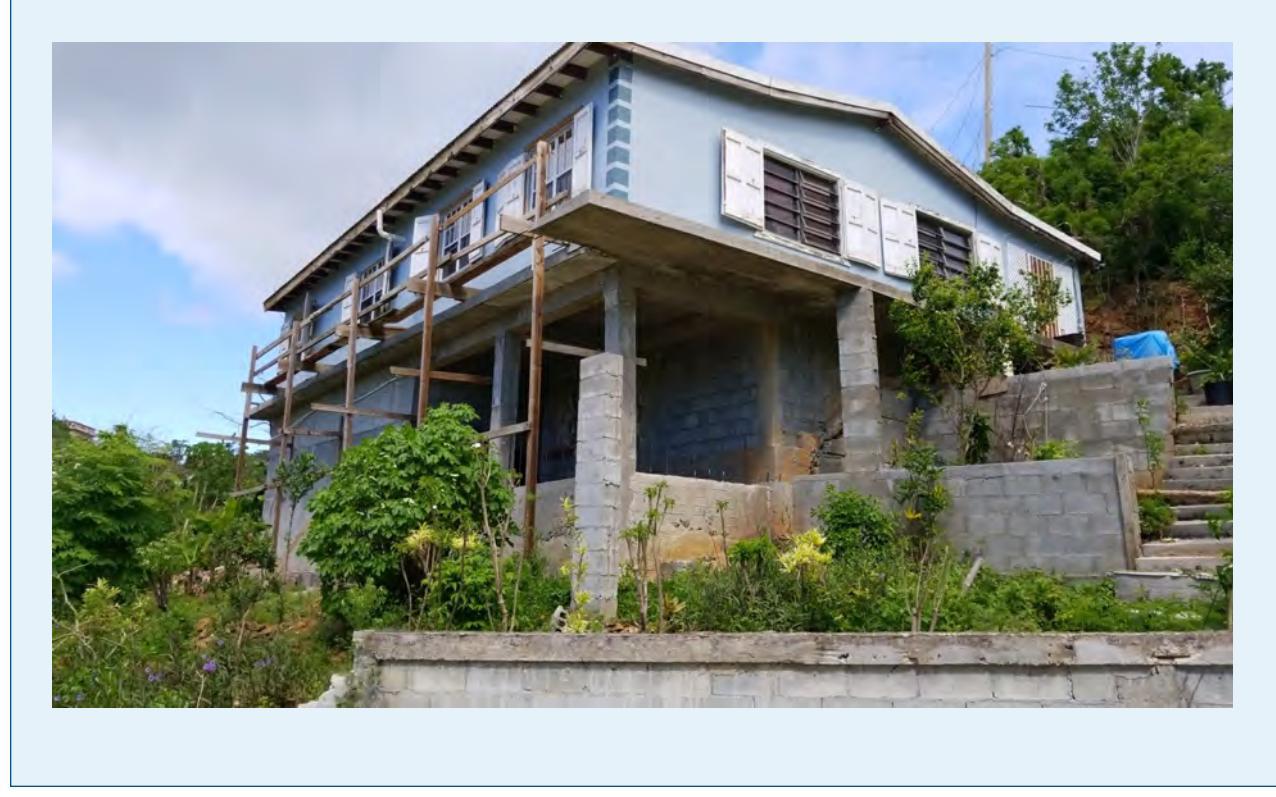
#### **3.3 Home Protection Roofing Program**
