# Mitigation Assessment Team Report

# Hurricanes Irma and Maria in the U.S. Virgin Islands

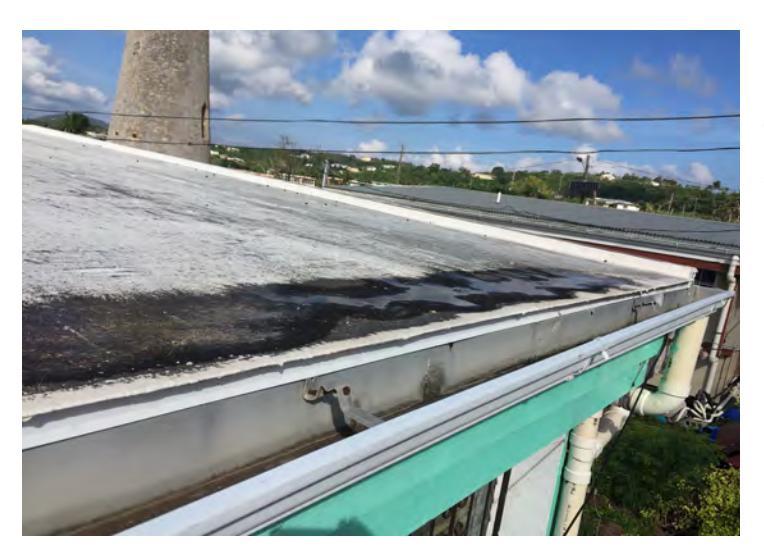
Figure 3-36: Liquid-applied membrane roof covering on an HPRP home that developed leaks. Overall roof performance was positive for HPRP homes, but small leaks led to minor interior damage. The gutter did not comply with HPRP specifications. Sion Farm, St. Croix.

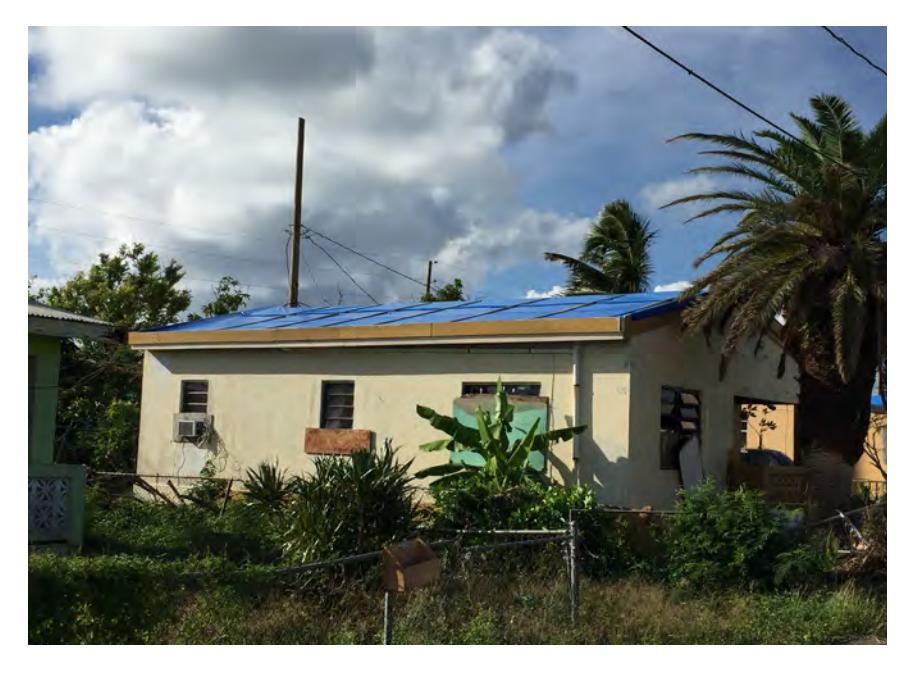
Figure 3-37: Roof damage was evident on the HPRP home. It was the only home with moderate damage of the 11 HPRP building evaluated by the MAT. Camporico, St. Croix.

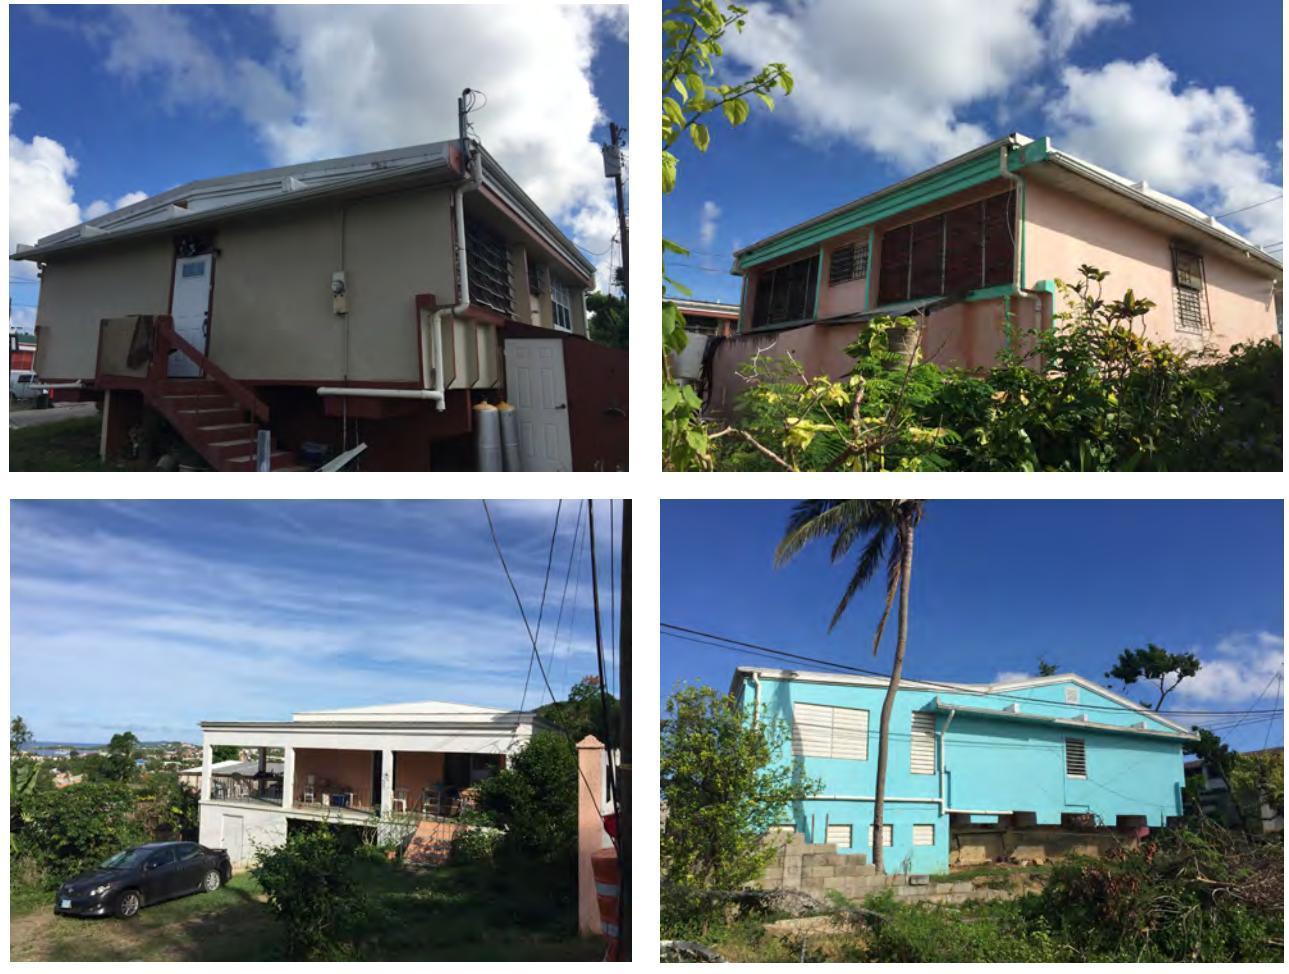
Figure 3-38: The three different roof types exhibited by the HPRP homes included gable roofs (top left and right), tiered pyramid hip roofs (bottom left), and combination gable roofs (bottom right). Sion Farm and Frederiksted, St. Croix.

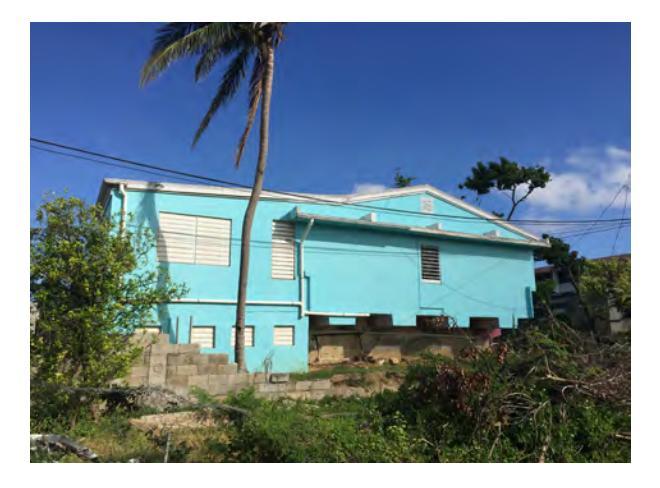
Figure 3-40: HPRP home with examples of both glass jalousie (left) and metal jalousie (right) windows. This type of louvered window protection was typical for most of the HPRP homes and performed with limited damage to the windows themselves. Wind-driven rain remained an issue and would frequently enter the homes through jalousie openings. Sion Farm, St. Croix.

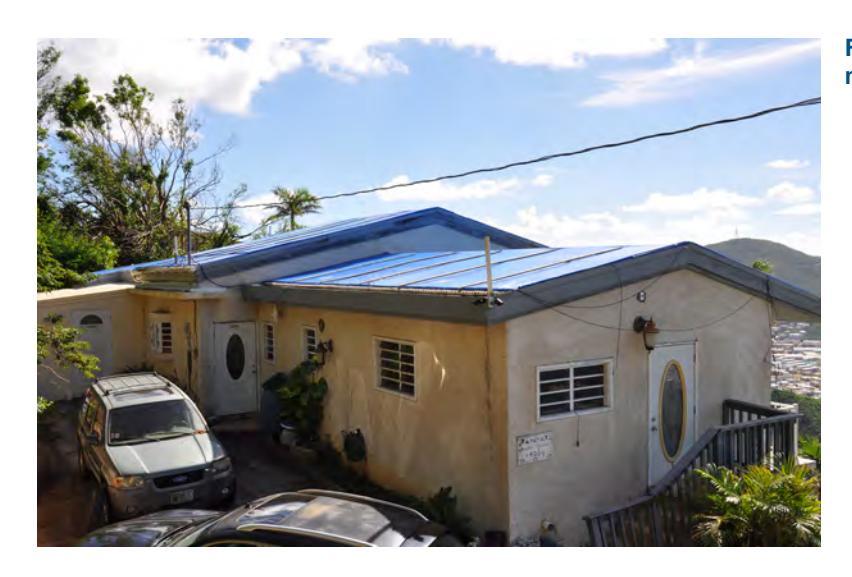
Figure 3-41: View of a tarped corrugated metal roof.

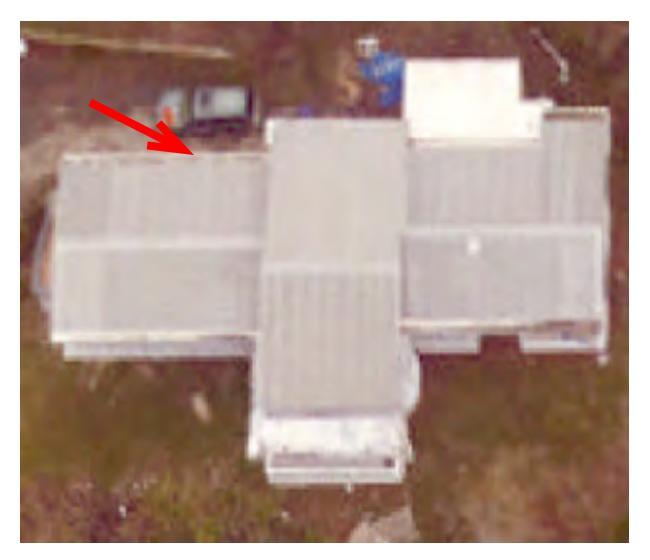
Figure 3-42 is a view of the roof after Hurricane Irma but before tarps were put in place. There is no apparent wind damage to the roof panels or the ridge flashings. It is likely that the tarps were placed to avoid water leakage from entering at panel side laps or the ridge flashing. The HPRP specifications required triple side laps, sealant tape at side laps, and an underlayment. Without performing destructive sampling, the MAT was unable to determine if these specifications were followed. If the specifications were followed, interior water leakage would have been unlikely. However, since only a single foam closure at the ridge was specified (a non-conservative design decision), rain may have been driven past the closures. USVI Recovery Advisory 3, *Installation of Residential Corrugated Metal Roof Systems* (Appendix D) provides a more conservative ridge detail.

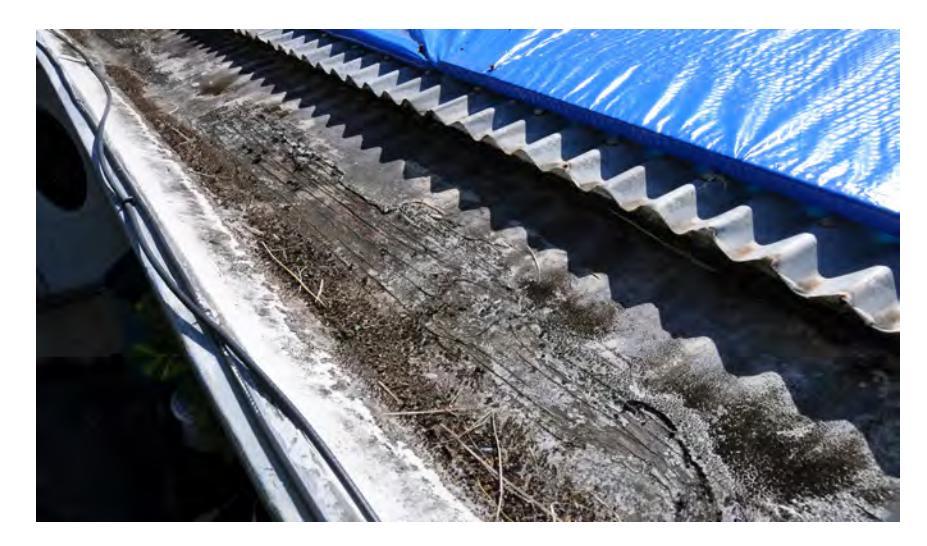
Figure 3-43: View of the integral gutter indicated by red arrow. Exposed plywood occurs within the yellow oval. Figure 3-44 shows a different house with a corrugated metal panel roof. There was only a single row of screws at the eave and hip of the roof. The panel and flashing screws were not made of stainless steel, as specified by the HPRP. There was no apparent wind damage to the roof. Although the fastener deficiencies did not result in wind problems during the 2017 hurricanes, this success does not guarantee that the roof will perform well in the future or indicate that HPRP specifications were overly conservative. Similar or stronger storms and higher wind speeds are possible that would likely stress the integrity of this design.

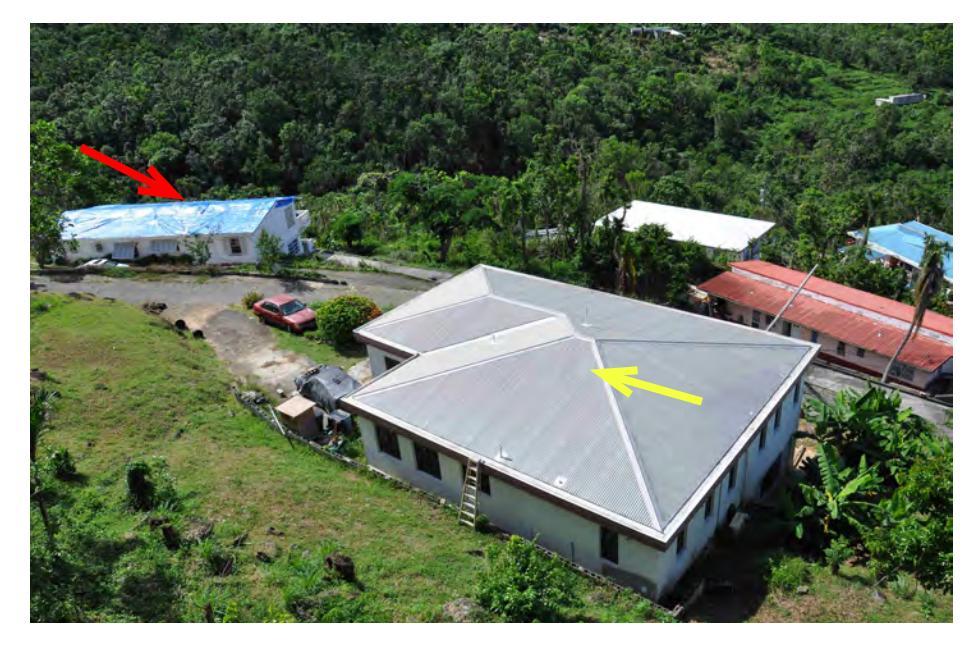
Figure 3-44: The yellow arrow indicated the HPRP corrugated metal panel roof and integral gutter. The red arrow indicated a tarped roof. The blue roof at the right was not tarped, but rather had blue metal roof panels.

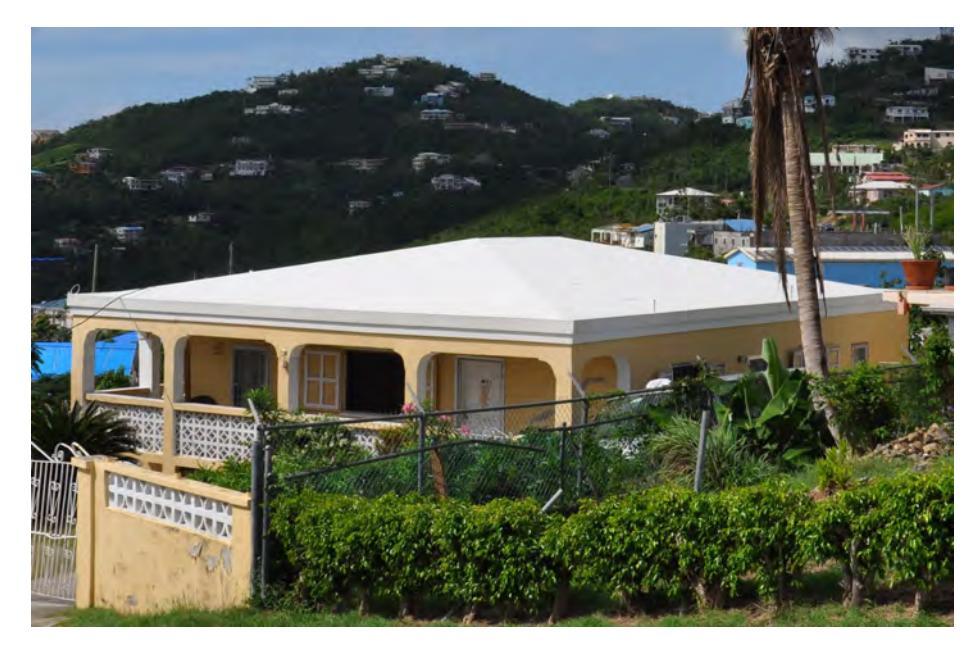
Figure 3-45: Liquid applied membrane roof with integral gutter.

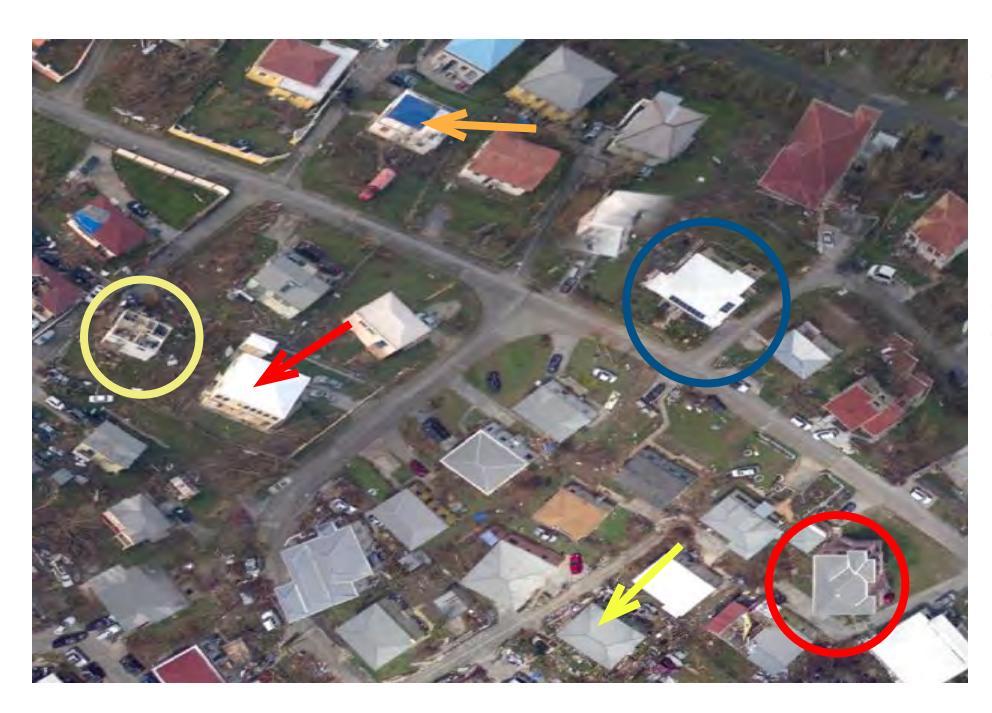
Figure 3-47: Aerial view of the neighborhood with the roofs shown in Figure 3-45 indicated by red arrow and Figure 3-46 indicated by vellow arrow occur. The entire roof structure blew off the house within the yellow circle, and part of the roof structure blew off the house within the red circle. The orange arrow indicates where a portion of the roof was tarped. The house within the blue circle had solar panels, some of which blew off during the storms. (Photo by NOAA).

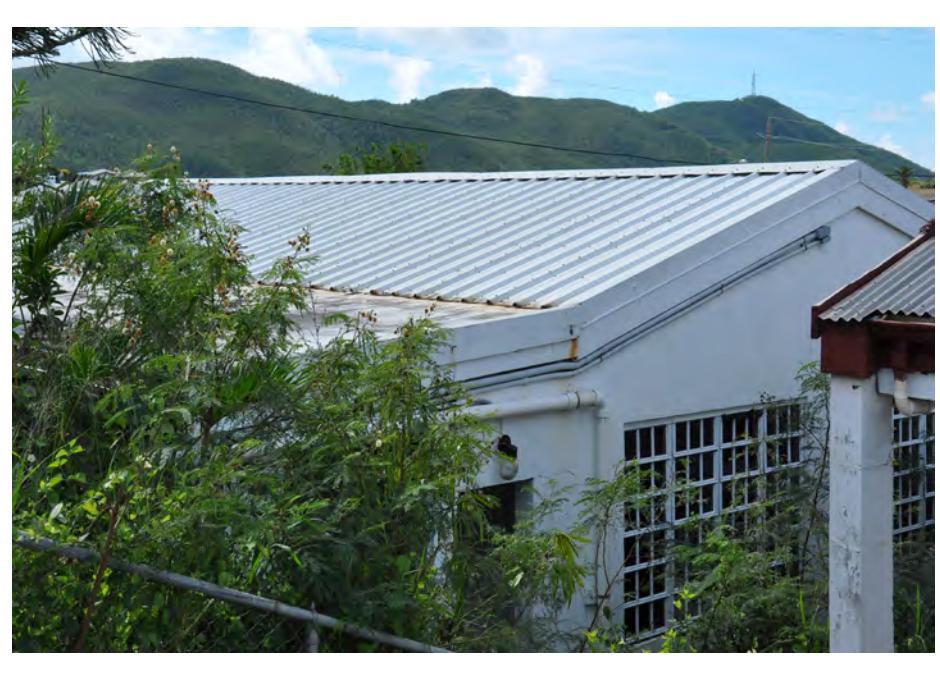
Figure 3-48: Metal R-panels at the steep- slope portion of the roof and liquidapplied membrane with external gutter at the lowslope portion.

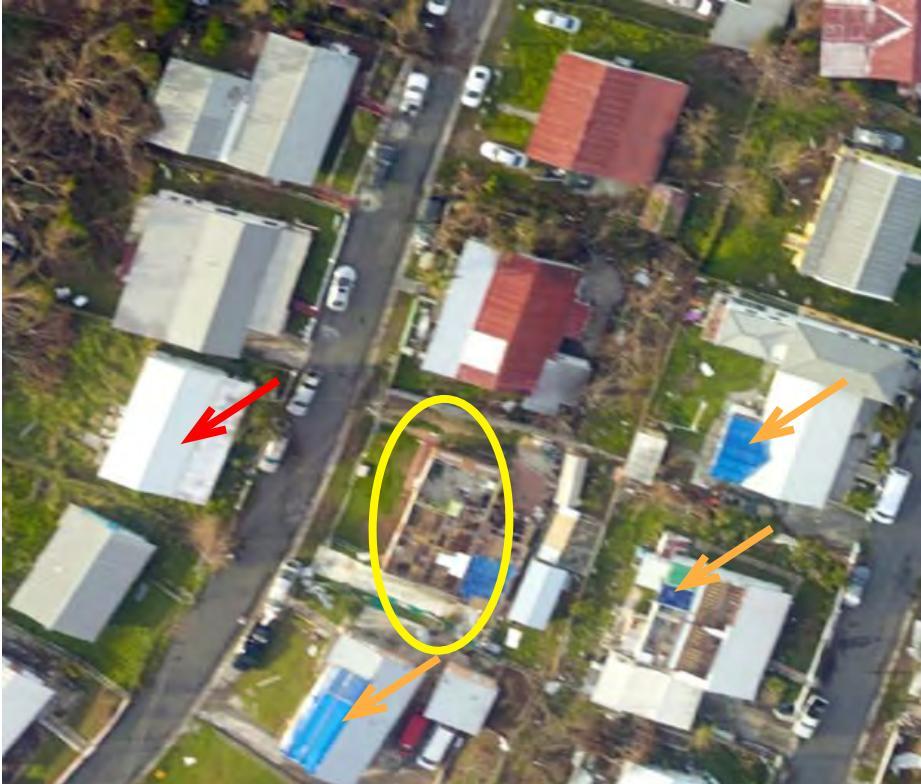
Figure 3-49: Aerial view of the neighborhood where the roof shown in Figure 3-48, as indicated by red arrow, was located. The entire roof structure blew off the house within the yellow oval. The orange arrows indicate where a portion of the roof was tarped or blown off. (Photo by NOAA).

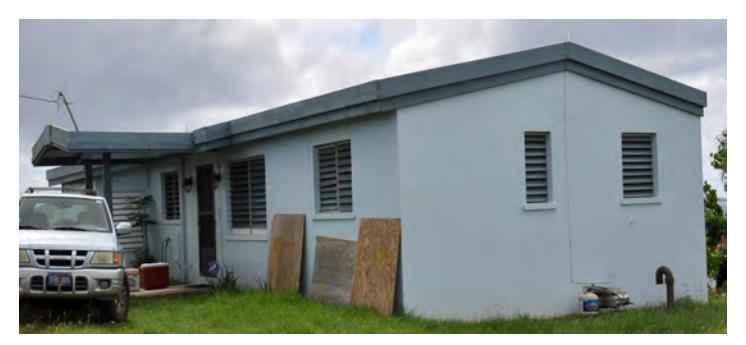
Figure 3-50: Liquid-applied membrane roof with external gutter. The porch on the other side of the house blew away (see Figure 3-51). (Exposure D).

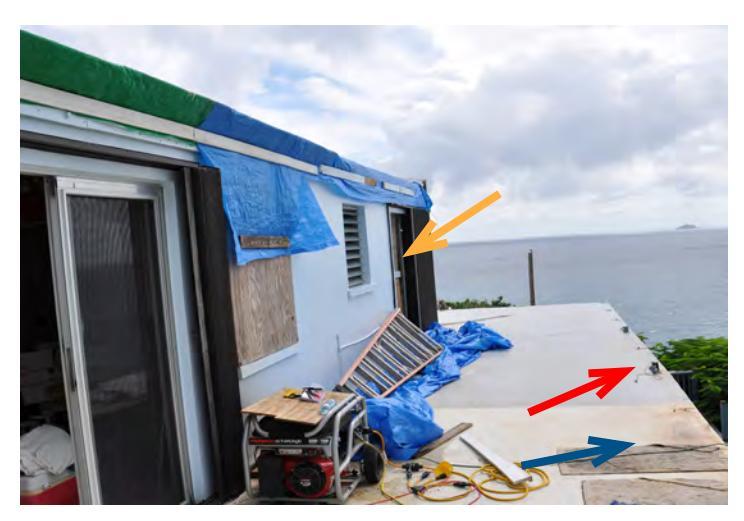
Figure 3-51: An open porch over the slab area. The red arrow indicated a metal connector that was still in place. The blue arrow indicates where the connector bolts pulled out of the slab. The orange arrow indicates the door shown in Figure 3-53.

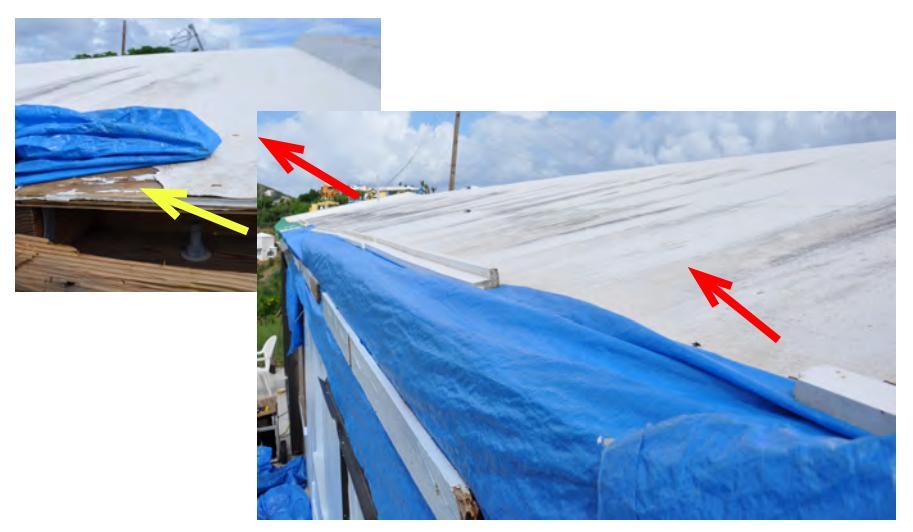
Figure 3-52: View of the interface between the porch and main roof. The red arrows indicate the liquidapplied membrane. The yellow arrow indicates where there was localized lifting and peeling of the membrane.

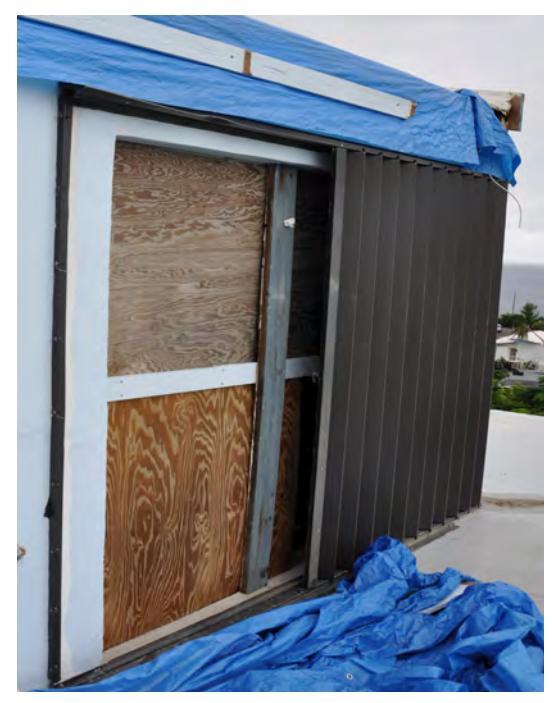
Figure 3-54 shows a house that had its entire roof structure blown off during Hurricane Marilyn. However, there was no apparent damage to the liquid-applied membrane during the 2017 hurricanes. The MAT was advised that there were no roof leaks; however, water did enter the house at the door and windows. The driveway to the house sloped down towards the entry door. A curb directed water away from the door, but it was too short to divert all of the stormwater runoff. The double-hung windows had accordion shutters. Shutters can reduce the wind-driven rain demand on windows, but to avoid water infiltration, the window assembly itself needs to be designed to resist the rain.

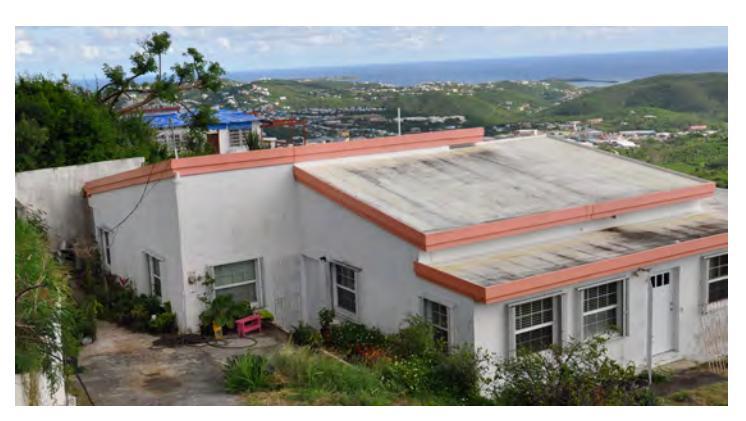
Figure 3-54: The liquid-applied membrane with integral gutters did not leak. However, water did enter at the door and windows.

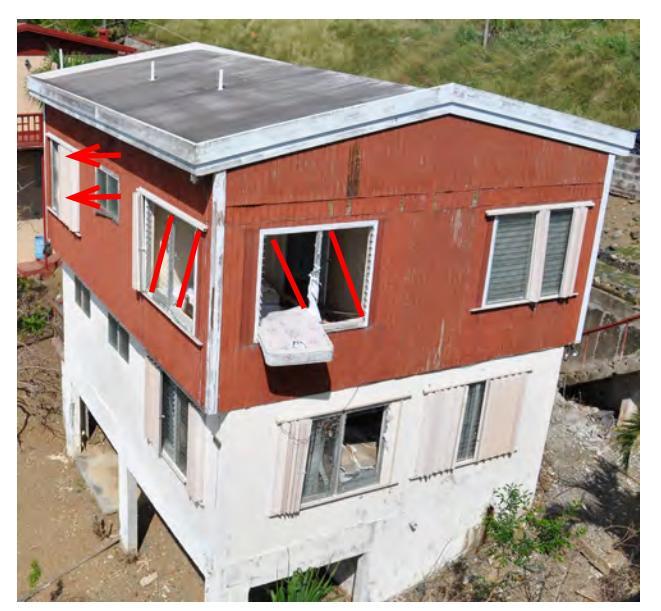
The glazing breaches resulted in the development of high internal pressures. The roof assembly was strong enough to resist the wind uplift, but there was significant deformation of one of the side walls (Figure 3-56).

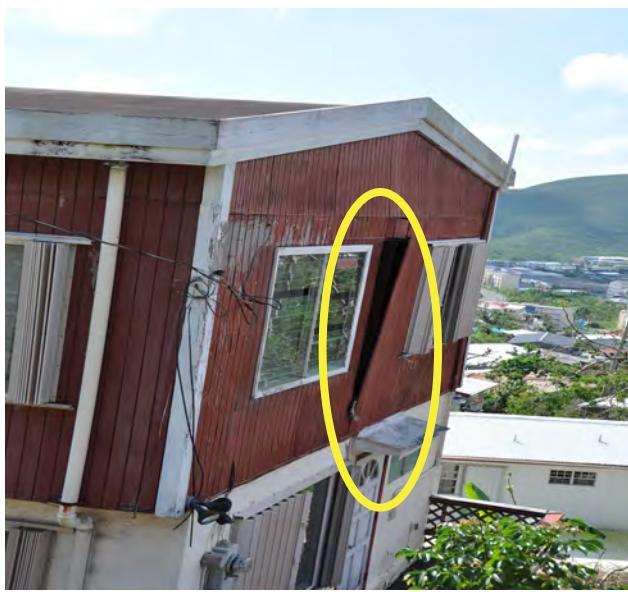
Figure 3-55: The red lines and arrows indicate broken glass jalousies.

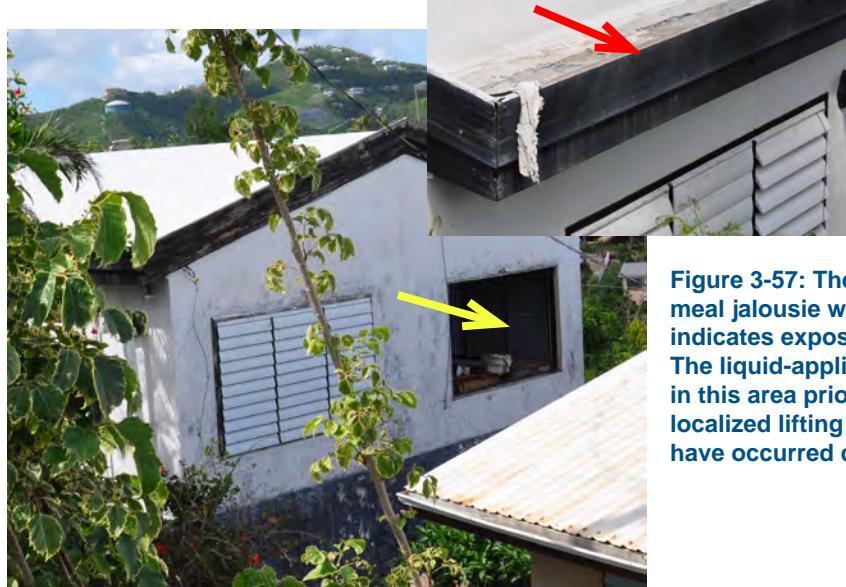
Figure 3-57: The yellow arrow indicates where the meal jalousie windows blew out of the wall. The inset indicates exposed plywood indicated by red arrow. The liquid-applied membrane likely deteriorated in this area prior to the 2017 hurricanes. Some localized lifting and peeling of the membrane may have occurred during the storms.

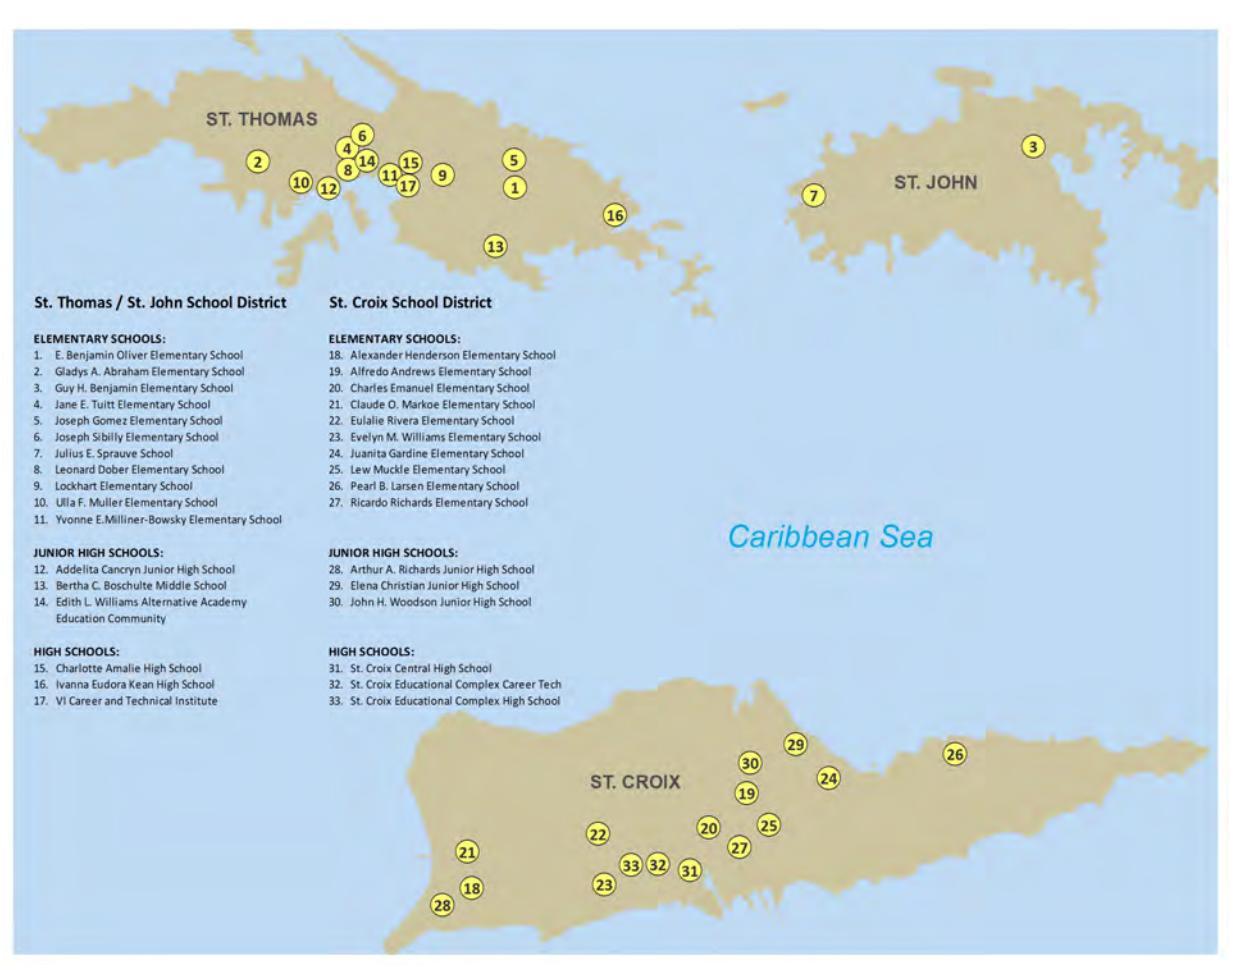
Figure 4-1: Elementary, junior high, and high schools in the USVI.

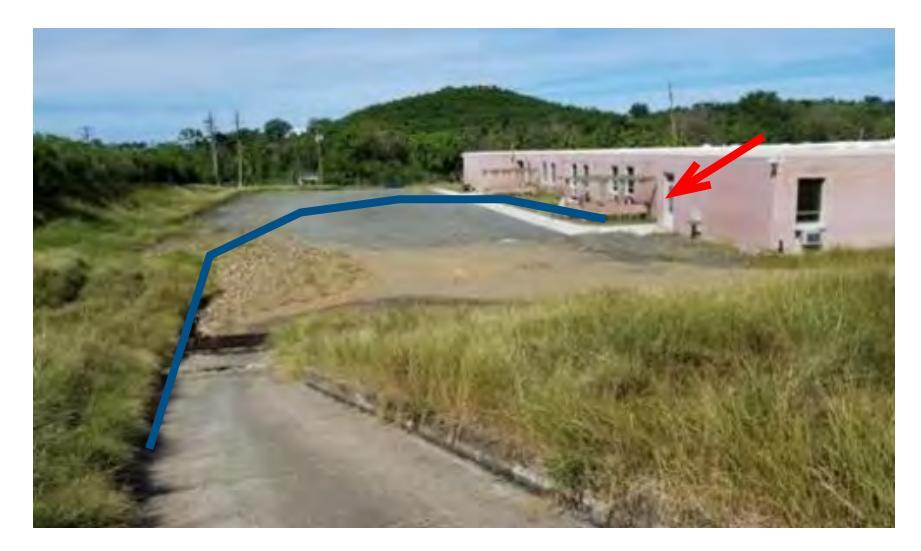
Figure 4-2: Channelized flow (blue line) from higher grade at the gym to a parking lot at the same grade as the finished floor. This allowed water to enter at the door indicated by red arrow.

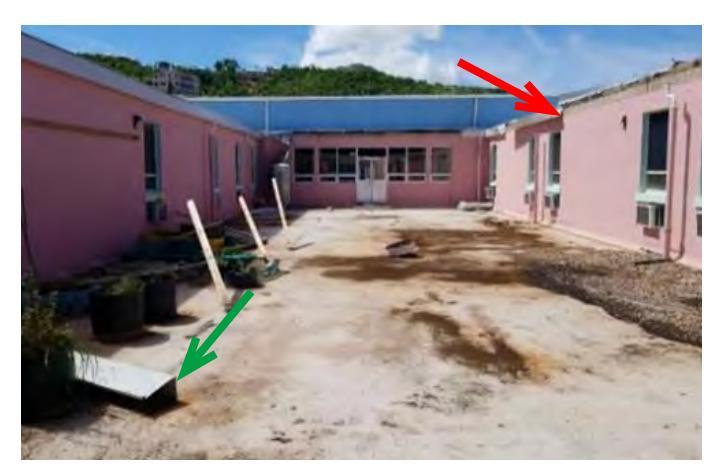
Figure 4-3: Larsen Courtyard flooded after gutters and downspouts failed. The red arrow indicates missing gutters. The green arrow is a gutter laying on the ground.

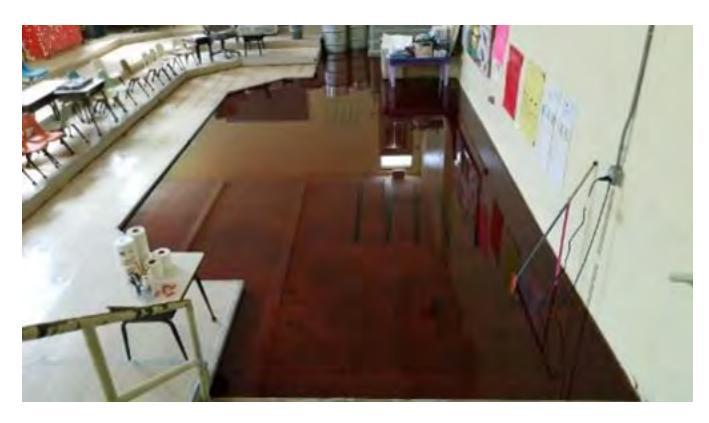
Figure 4-4: Flooding in music room after cistern overflow at Larsen School.

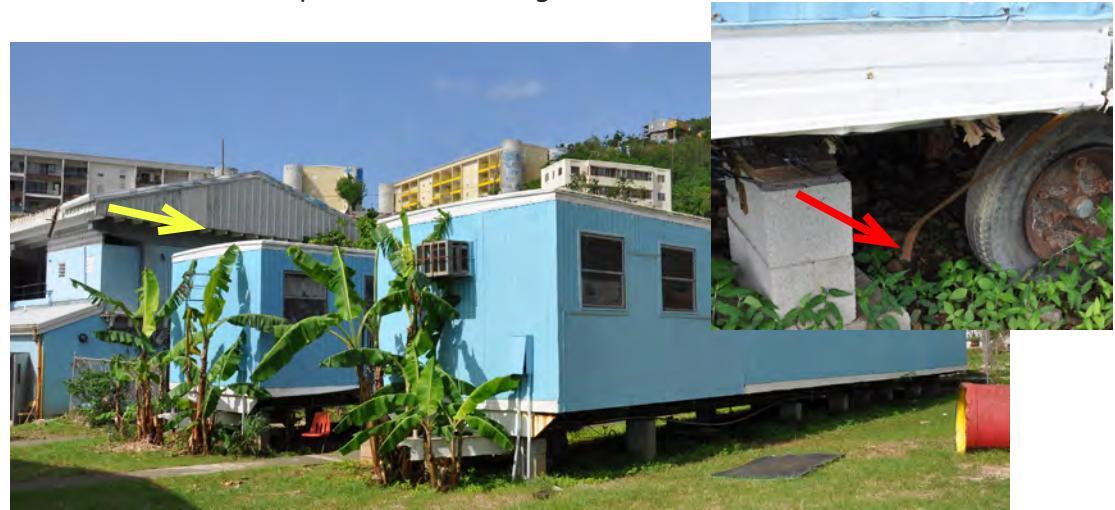
Figure 4-6: These portable classrooms were shielded by the main building indicated by the yellow arrow. The inset shows a broken metal strap indicated by red arrow between one of the classrooms and a ground anchor.

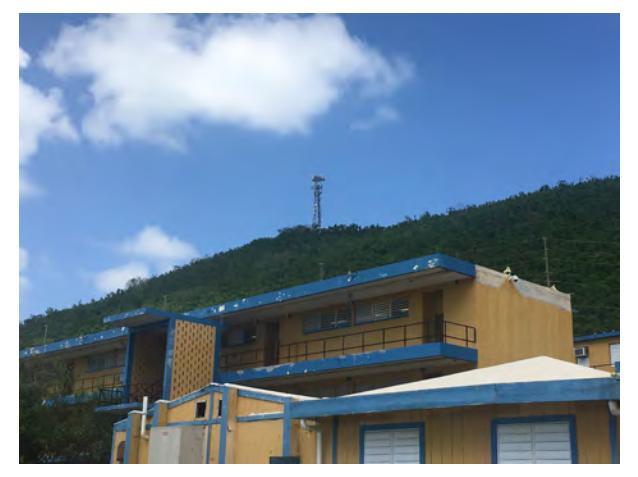
Figure 4-7: View of Charlotte Amalie High School with reinforced concrete construction showing little damage to the classroom buildings after the hurricanes. The damage to buildings at Eulalie Rivera Elementary School ranged from minor to complete devastation. The school campus has two types of construction (Figure 4-8). The first type was a traditional CMU wall building with a wood-framed roof. This type of construction had minor to moderate damage and could be repaired. There was also damage to the metal roof panels and vents.

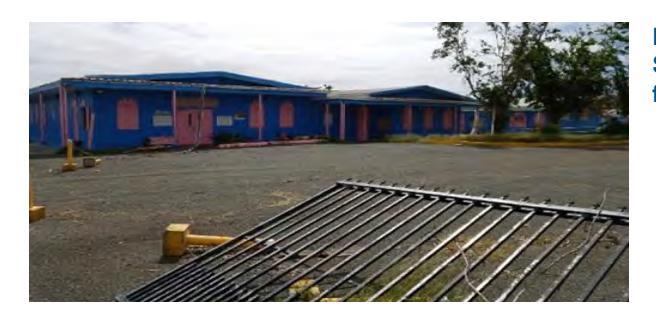
Figure 4-8: Front office of Eulalie Rivera Elementary School showing traditional construction that exhibited fair to good performance.

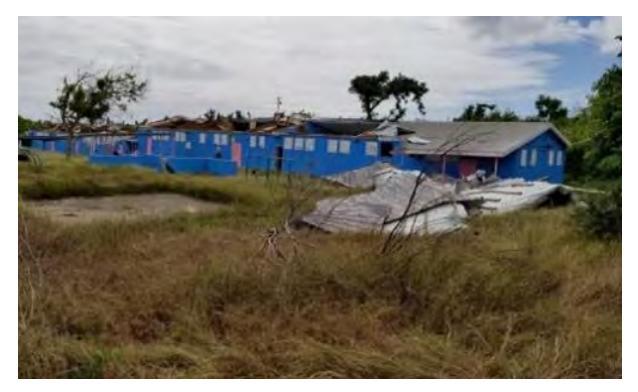
Figure 4-9: Corrugated metal roof overlay removed in large sections from the composite panel system wing of the school.

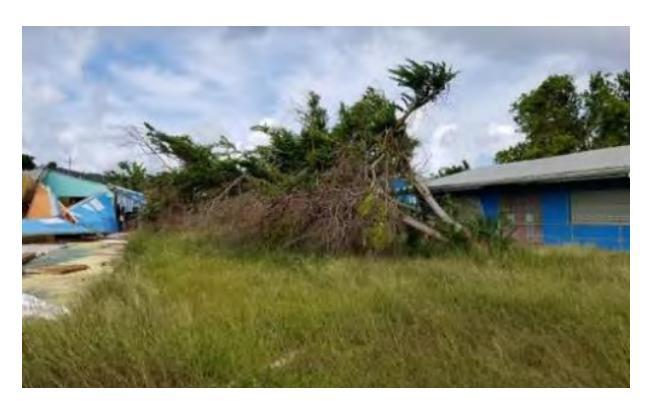
Figure 4-12: The newer composite panel construction is visible on the left while the older traditional CMU construction is shown on the right.

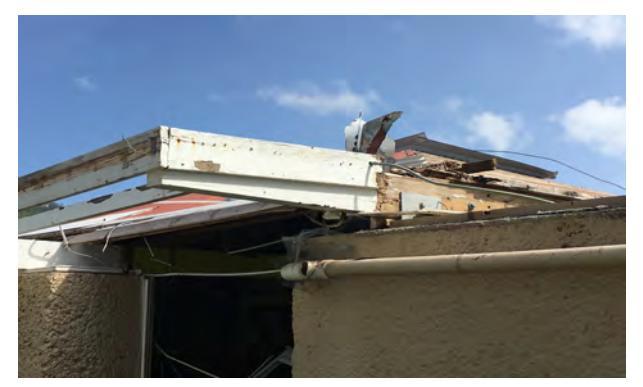
Masonry construction with engineered lumber performed poorly at Cancryn Middle School on St., Thomas (Figure 4-13). The engineered wooden elements appeared to be in advanced stages of decay.

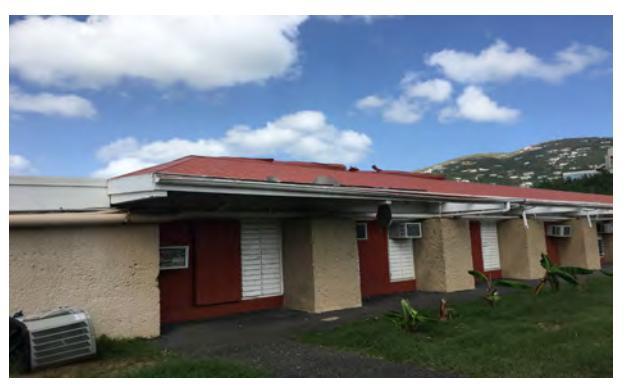
Figure 4-13: Cancryn Middle School in St. Thomas performed poorly due to extensive decay in the engineered wood roof.

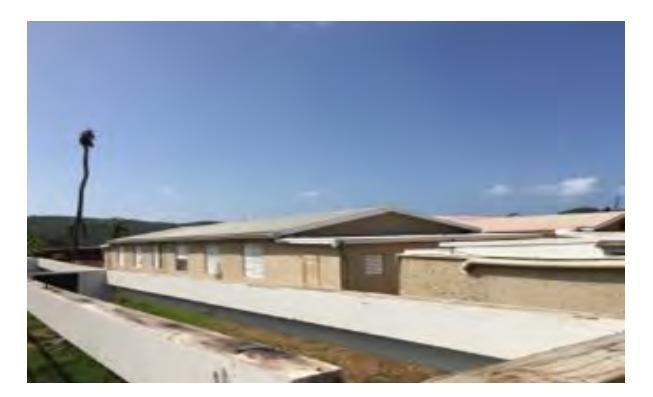
The wood-framed roof system (utilizing sawn lumber) performed well at Addelita Cancryn Junior High School in St. Thomas, despite impacts to the metal jalousie windows (Figure 4-14).

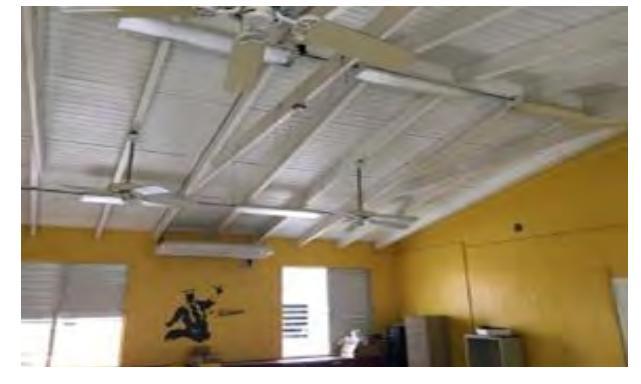
Figure 4-14: View of Addelita Cancryn Junior High School. The building has metal louvered windows (left). The common framed roof system performed well even after debris impacts to the windows (right).

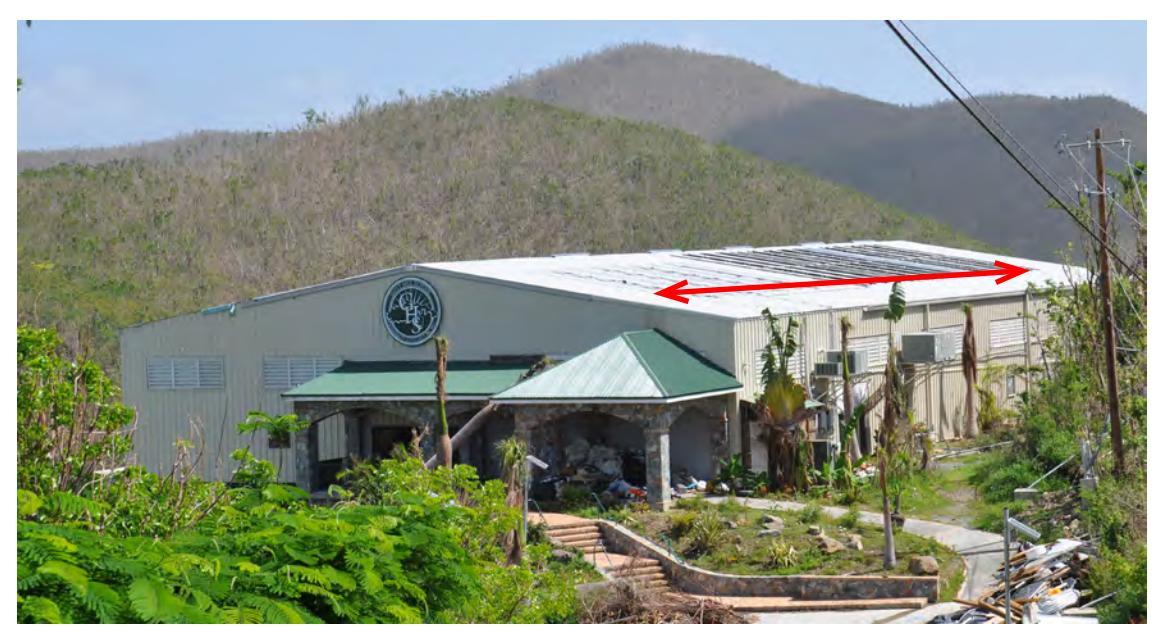
Figure 4-15: Front view of Gifft Hill School. The red arrow indicates the area where the solar panel damage occurred.

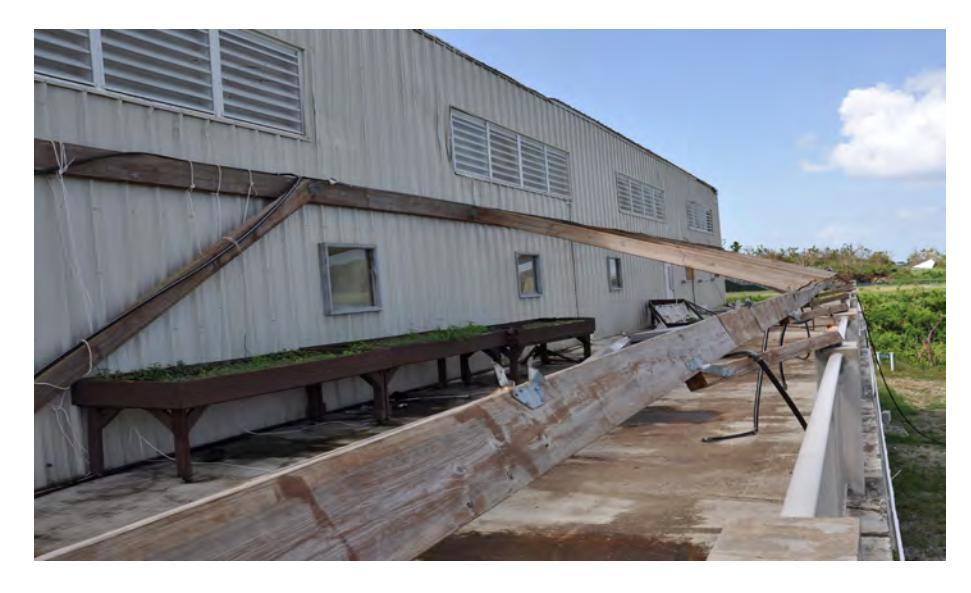
Figure 4-16: View of damaged wood trellis. The red arrow indicates wall louvers. Gutters were also torn from the upper building edge as indicated by green arrow.

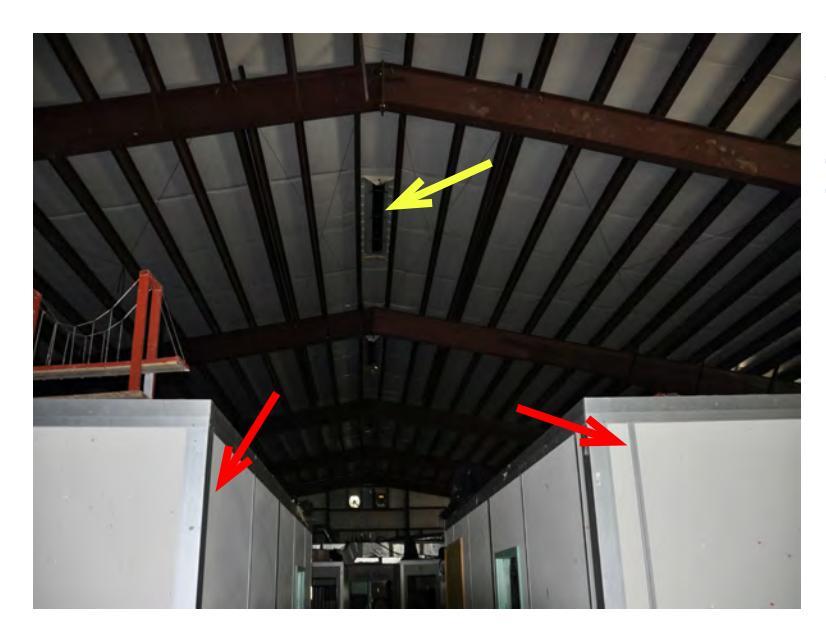
Figure 4-17: Interior view of the Gifft Hill School gymnasium. The yellow arrow indicates a skylight that was damaged by the storm. The red arrows indicate classroom modules. The classroom ceilings were damaged by water infiltration from the louvers.

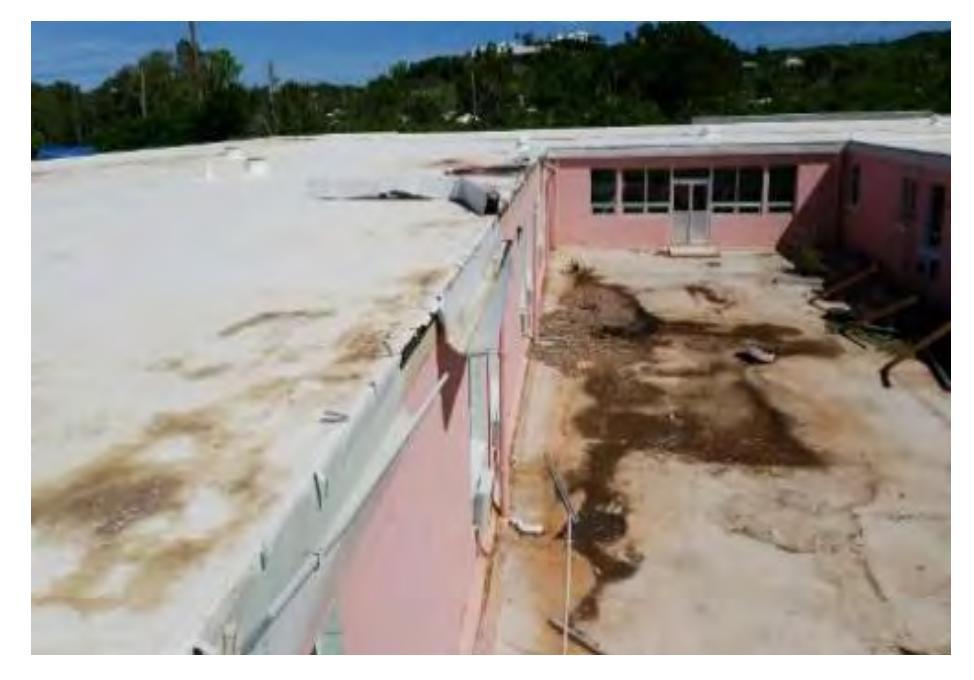
Figure 4-18: Roof of the Pearl B. Larsen School showing vent blown off indicated by red arrows, gutter damage and missing gutters indicated by blue arrow, downspout damage indicated by magenta arrow, and flashing damage indicated by green arrow.

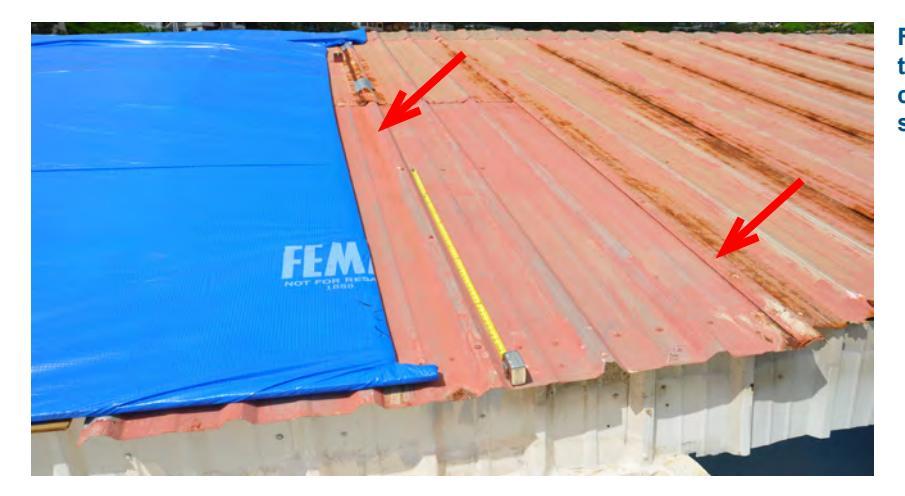
Figure 4-19: The R-panels on this school roof had significant corrosion and inadequate fastener spacings indicated by red arrows.

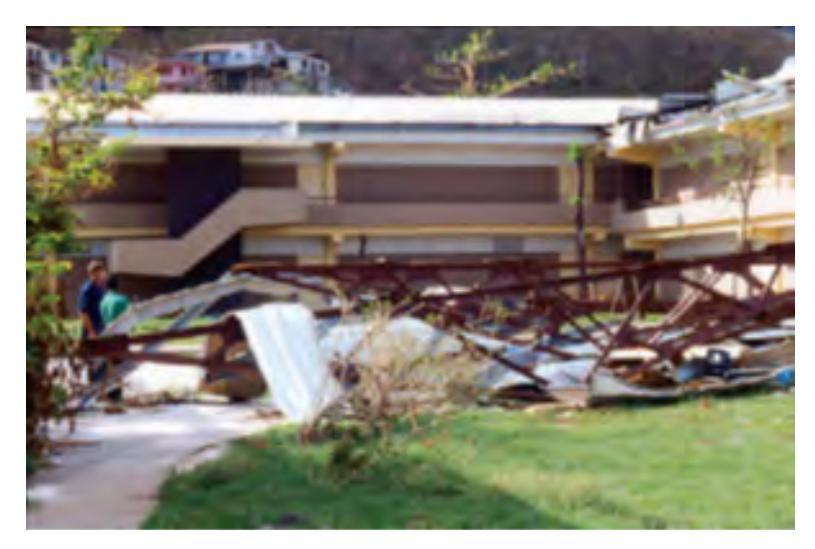
Figure 4-20: View of the steel truss superstructure in the Muller courtyard after Hurricane Marilyn. (FEMA P-424, Figure 6-122).

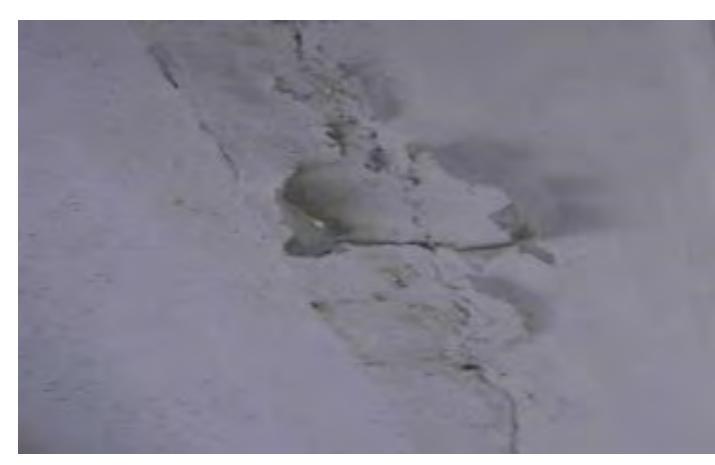
Figure 4-21: View of the underside of precast double tee roof panels in a Mueller classroom. The liquid-applied membrane had ruptured over a panel joint, allowing rain to enter the building.

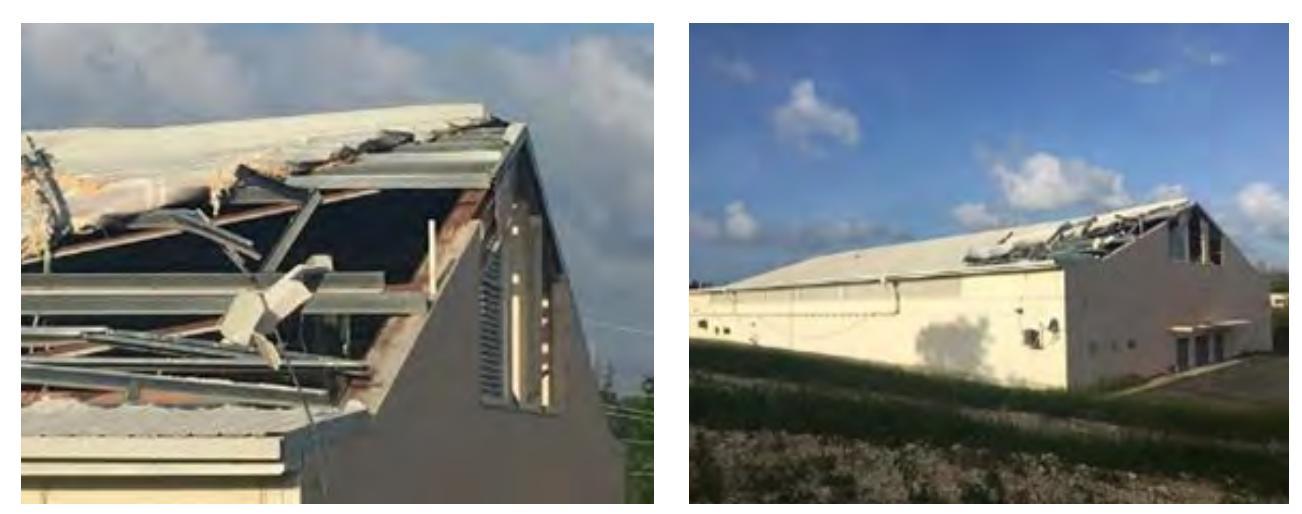
Figure 4-22: School in St. Croix with metal roof covering torn free from supports.

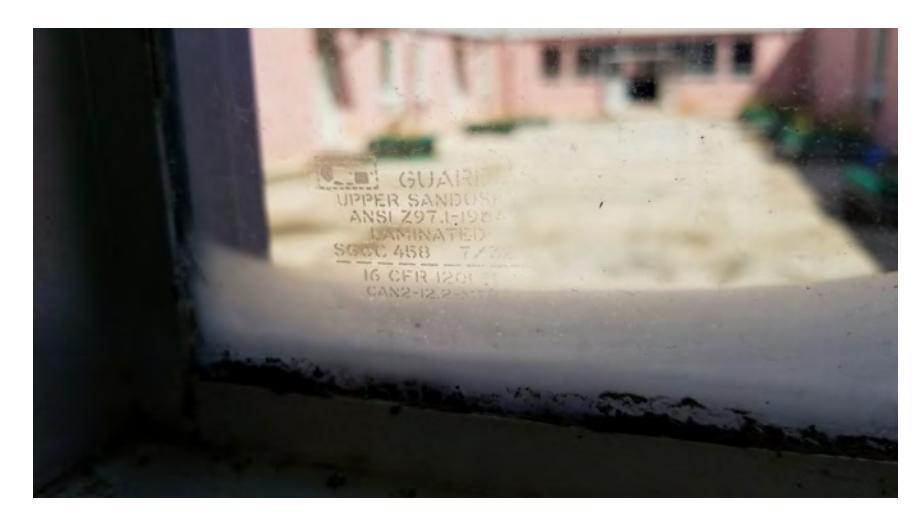
Figure 4-23: Corridor window at Pearl B. Larsen Elementary School with etched note of date and name of manufacturer indicating 1984 date of manufacture.
