# Mitigation Assessment Team Report

# Hurricanes Irma and Maria in the U.S. Virgin Islands

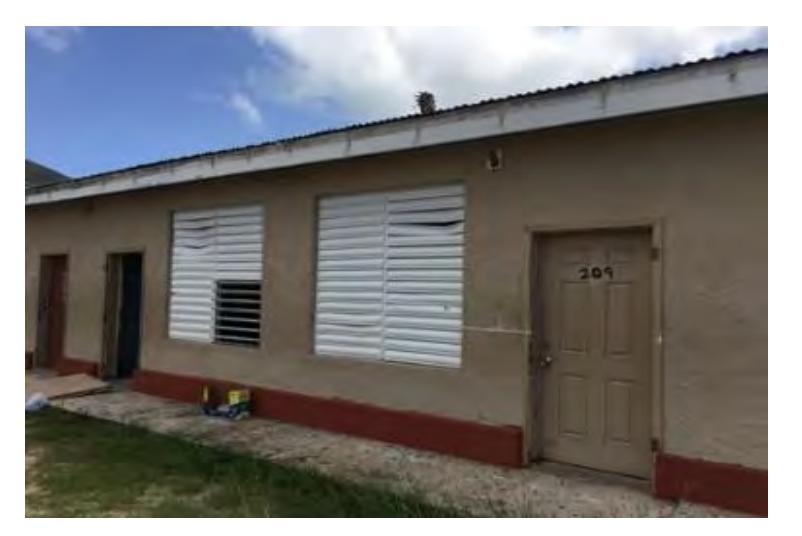
At Addelita Cancryn Junior High School, most of the classrooms were observed to have metal jalousie window systems to allow air circulation. These jalousies served to keep debris out even after the substantial impacts that left the louvers damaged but intact (Figure 4-24). However, metal jalousies are typically not tested to meet the wind-borne-debris criteria given in ASTM D1996. Metal jalousies breached by wind-borne debris were observed at other buildings.

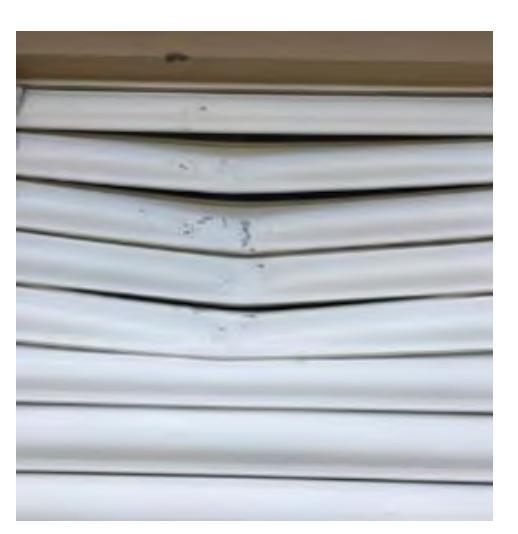
Figure 4-24: View of metal jalousies that had wind-borne debris impacts but stayed intact.

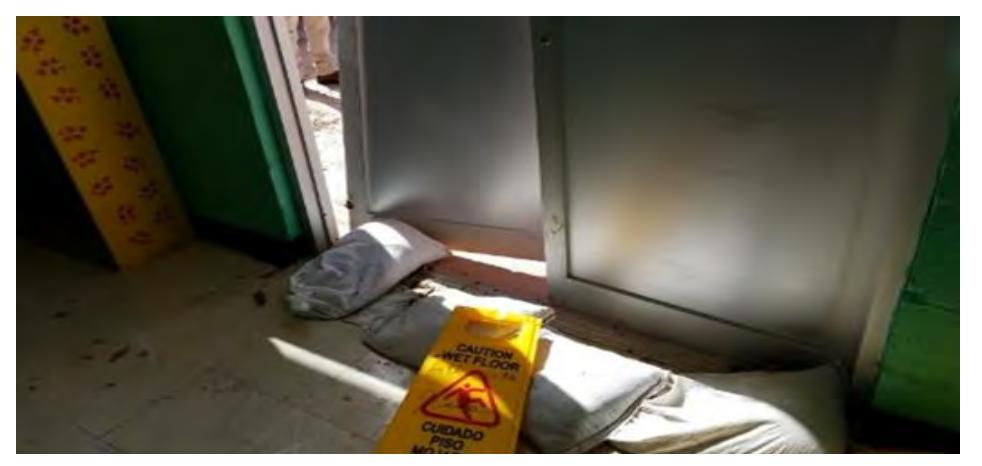
Figure 4-26: Door to interior courtyard at Pearl B. Larsen showing the sandbagging effort against the rising waters and the damaged door itself after the storm.

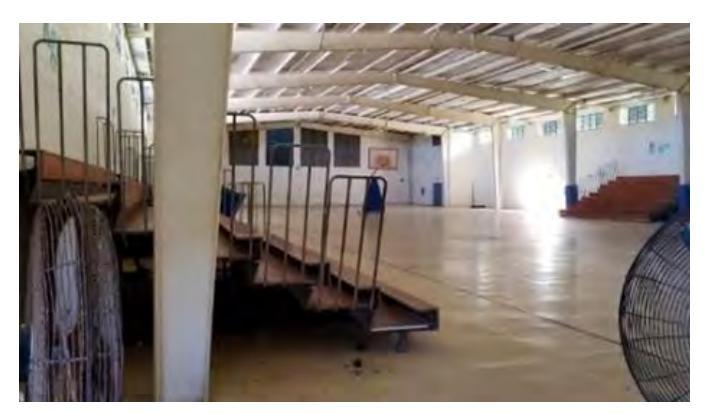
Figure 4-27: The Pearl B. Larson Elementary School gym survived with some minor damage to secondary elements.

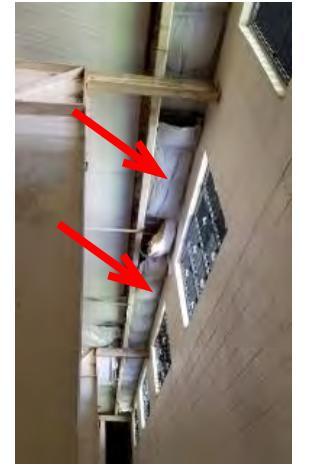
Figure 4-28: The left image shows movement between the steel frame and infill CMU wall, as indicated by red arrow. Similarly, the middle image shows daylight between the frame and the infill wall, as indicated by red arrow. The image on the right shows broken bracing straps that restrain the roll over effects on the light gage purlins, as indicated by red arrows. Pearl B. Larsen Elementary School Gym.

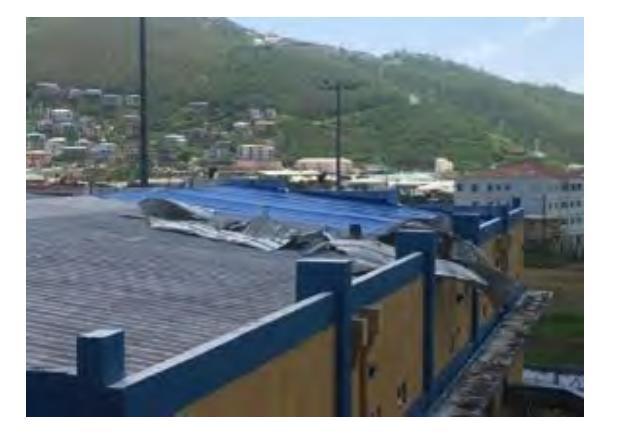
Figure 4-29: Long-span roofs at Charlotte Amalie High School that lost large sections of metal roof panels.

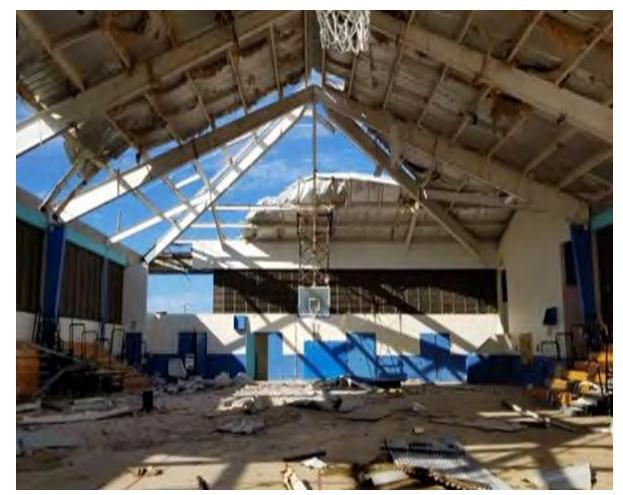
Figure 4-30: A classroom at Arthur A. Richards Junior High School showing heavy damage. The metal roof panels and steel framing were blown off, exposing the room contents to the full effects of the hurricane.

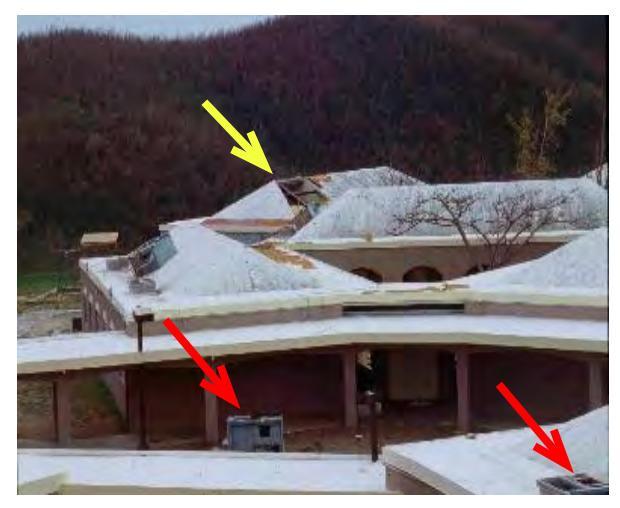
Figure 4-31: E. Benjamin Oliver after Hurricane Marilyn. The red arrows indicate blownoff HVAC units. The yellow arrow indicates blownoff roof decking.

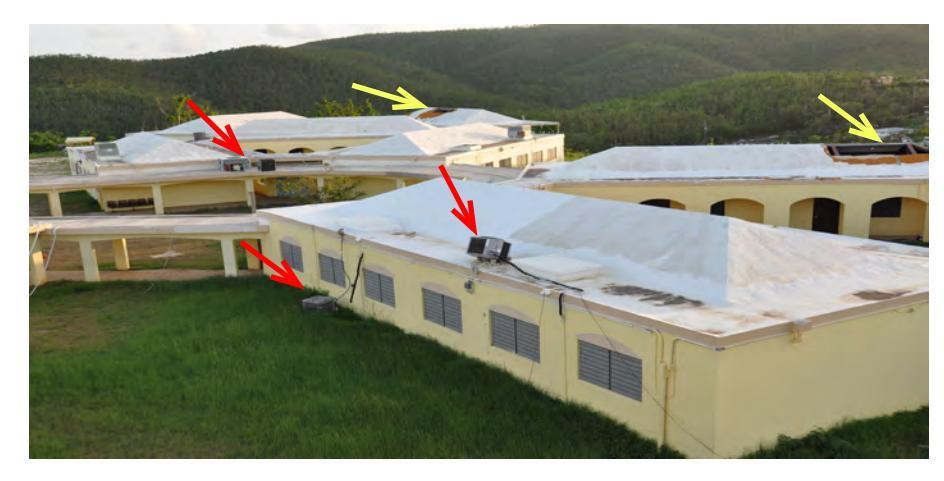
Figure 4-32: E. Benjamin Oliver Elementary School after the 2017 hurricanes. The red arrows indicate blown off HVAC units and condensers. One condenser unit is on the ground adjacent to the building, having fallen from its rooftop location. The yellow arrows indicate blown-off cementitious woodfiber roof decking.

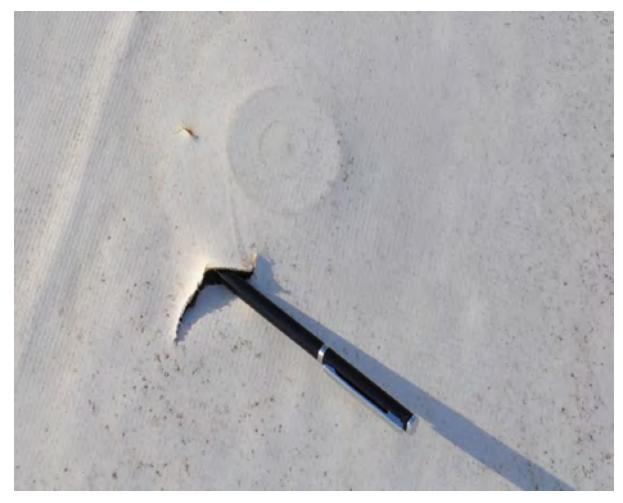
Figure 4-33: The single-ply roof membrane on this school was punctured in several locations by HVAC access panels and/or sheet metal unit enclosures. An ink pen shows the scale of the large tear.

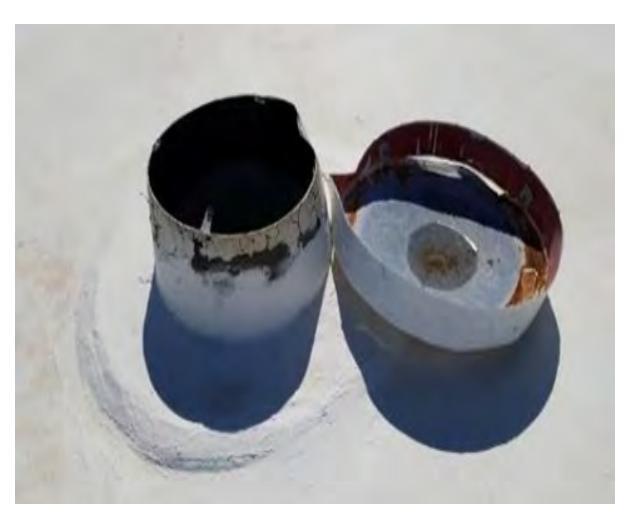
Figure 4-34: Rooftop gravity air vent with protective cover blown off. This failure was common on the roof of the school.

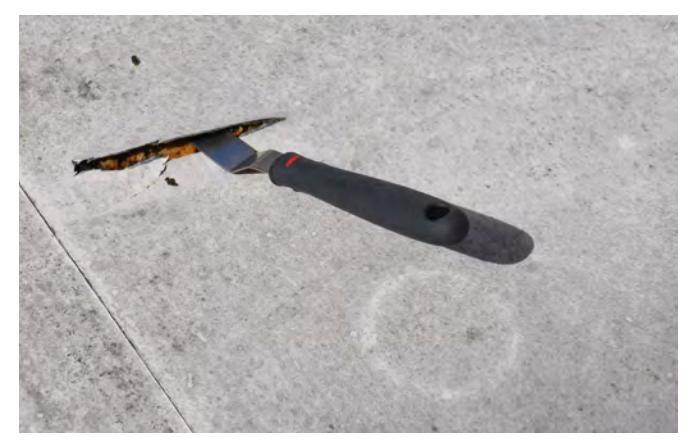
Figure 5-2: View of a roof membrane tear caused by wind-borne debris at an upper-level roof. The instrument in the photo is shown for scale. The lower roof coverings on the east and west side of the facility performed very differently. The lowerlevel west side roof covering performed similarly to the fifth-floor roofs noted above. However, the lower-level roof covering on the east side of Schneider experienced complete failure and loss of the roof membrane, including loss of some polyisocyanurate insulation boards beneath the roof covering itself. Figure 5-3 show the portion of the roof where the roof covering was lost. The clean, white roof covering over the entire area outlined in red was damaged and had to be replaced. This same section of the facility lost its roof during Hurricane Marilyn (1995) (Figure 5-4).

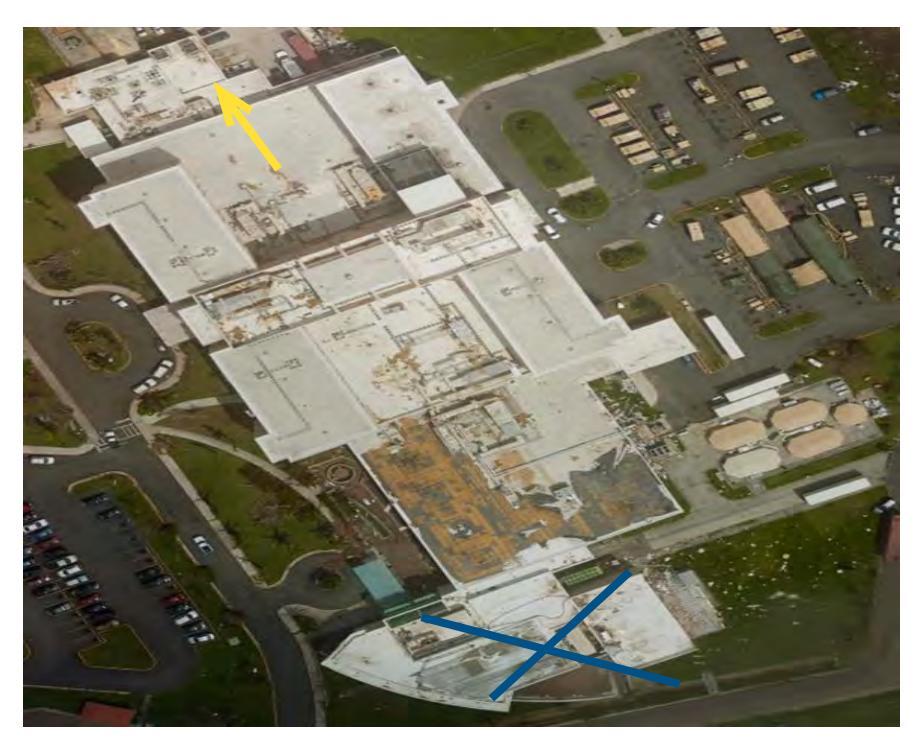
Figure 5-3: Aerial view of the Schneider Regional Medical Center after Hurricane Irma. The red arrows indicate where the roof membrane blew off (Figure 5-5). The blue X indicates where the roof over the Kimelman facility blew off (Figure 5-7). The yellow arrow indicates the roof over the mechanical equipment room (Figure 5-9). The red circles indicates areas of damaged ductwork. The green arrows indicate where duct insulation was blown off. The yellow circle indicates temporary facilities brought in after Hurricane Irma. (Photo by NOAA).

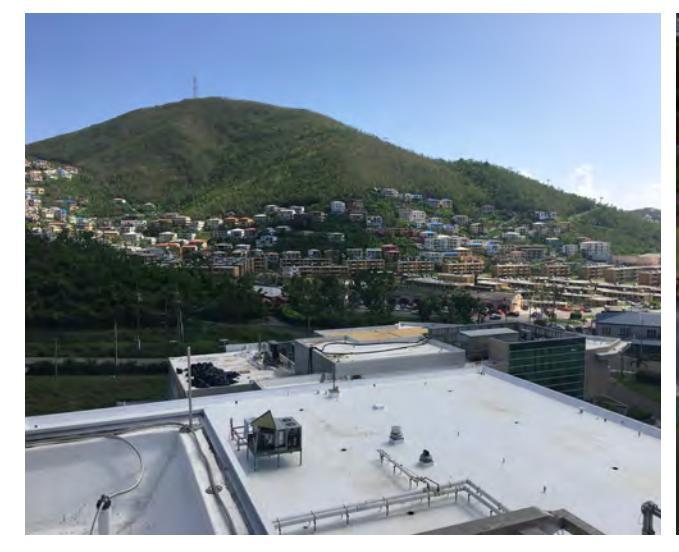
Figure 5-4: Lower roof of Schneider that lost roof covering in both Hurricanes Marilyn and Irma.

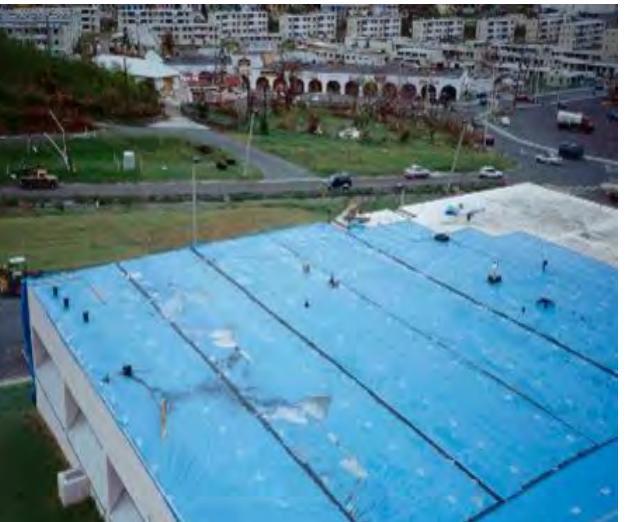
Figure 5-5: View of the roof shown in Figure 5-3 after Hurricane Marilyn.
Kimelman facility experienced major roof covering damage during Hurricane Irma. Figure 5-6 shows a portion of the roof that lost its covering; a mechanically-attached single-ply membrane was over gypsum roof board over polyisocyanurate insulation over a steel deck. With no secondary membrane over the steel deck, water leaked into the interior of the building. The facility was shut down at the time of MAT observation, 44 days after Hurricane Irma made landfall.

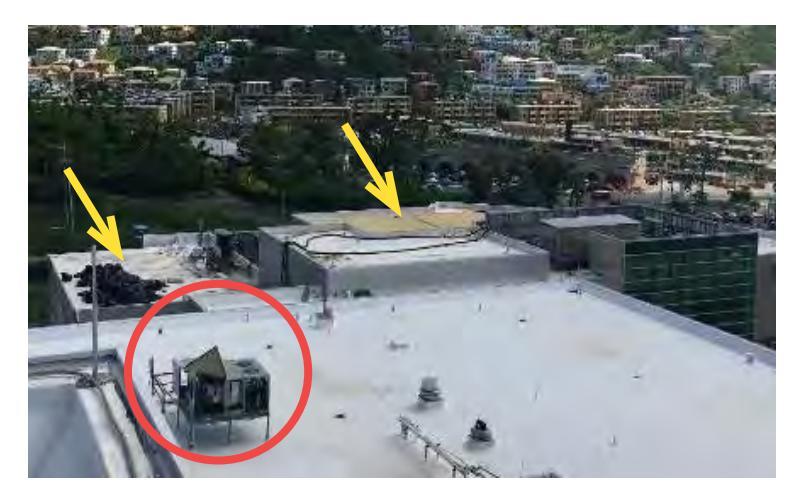
Figure 5-6: Roof of the Kimelman addition that was heavily damaged (yellow arrows) resulting in significant water intrusion within the facility. At the HVAC unit within the red circle, portions of the sheet metal unit enclosure cabinet blew off.

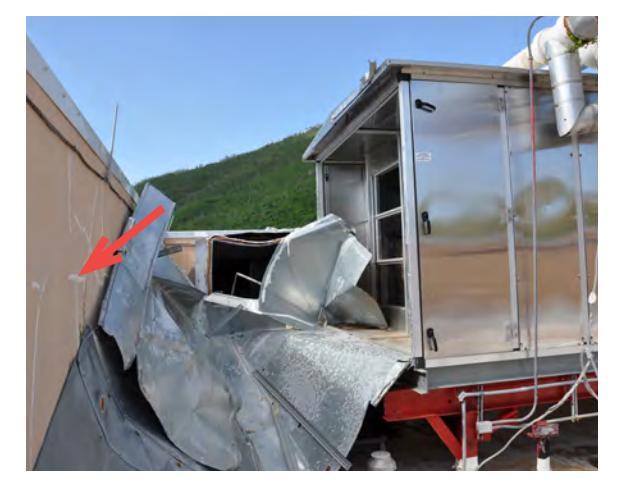
Figure 5-8 shows rooftop equipment damage at the mechanical equipment room roof. Figure 5-9 shows the same area after Hurricane Marilyn.

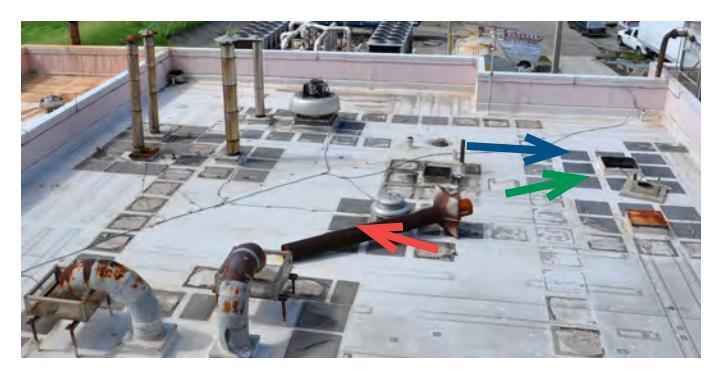
Figure 5-8: One of the boiler stacks toppled indicated by red arrow. A fan indicated by blue arrow and fan cowling indicated by green arrow were blown off. The lightning protection system also detached.

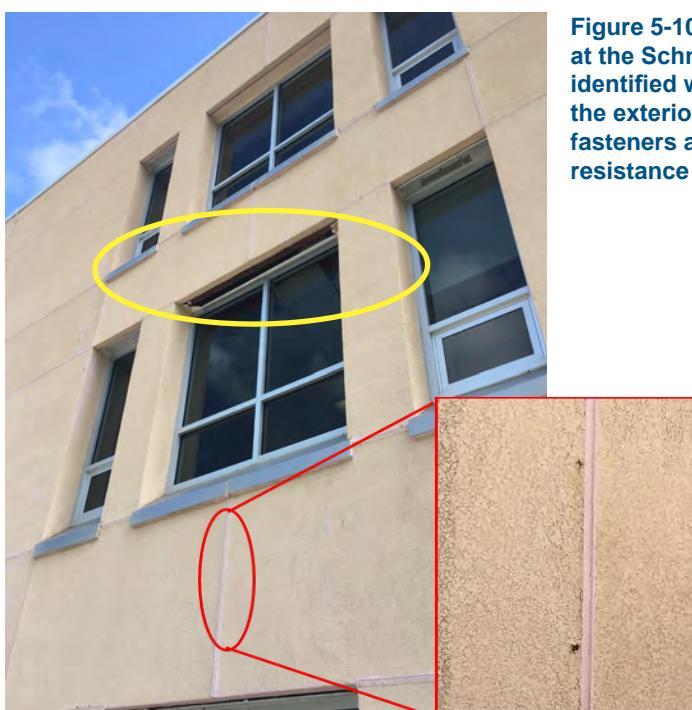
Figure 5-10: Exterior wall on the 5-story tower (east side) at the Schneider facility. The missing soffit/vent area is identified with the yellow circle. The inset illustrates how the exterior wall panels were retrofitted with additional fasteners and caulked along the seams to improve resistance to high winds and wind-driven rain.

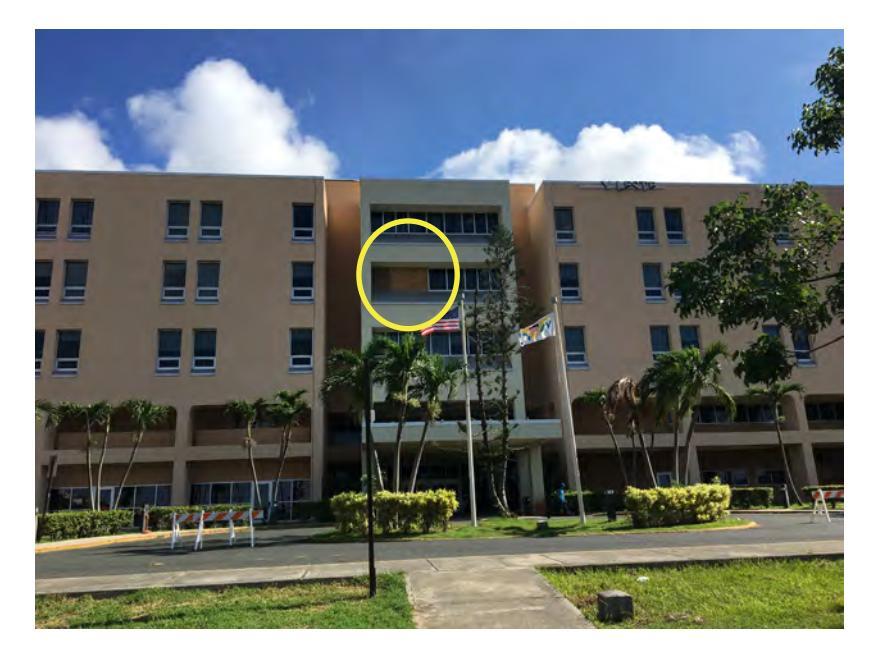
Figure 5-11: Location of window systems blown-in during Hurricane Irma indicated by yellow circle. This was the only window system where the frame separated from the supporting wall structure. Some soffits near the main entry also failed (Figure 5-12). The primary failure was detachment of the gypsum board from the metal framing.

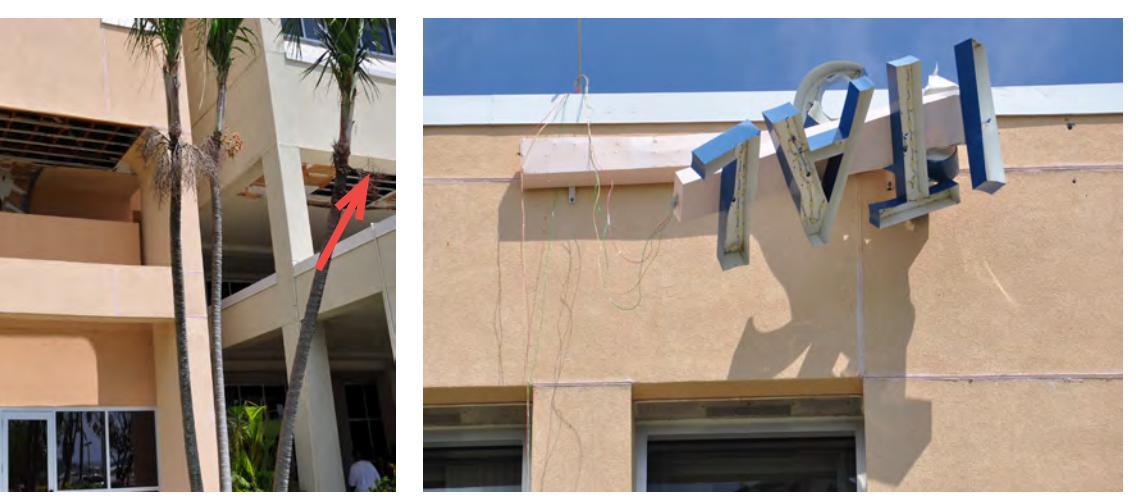
Figure 5-12: Soffit failure, as indicated by red arrows.

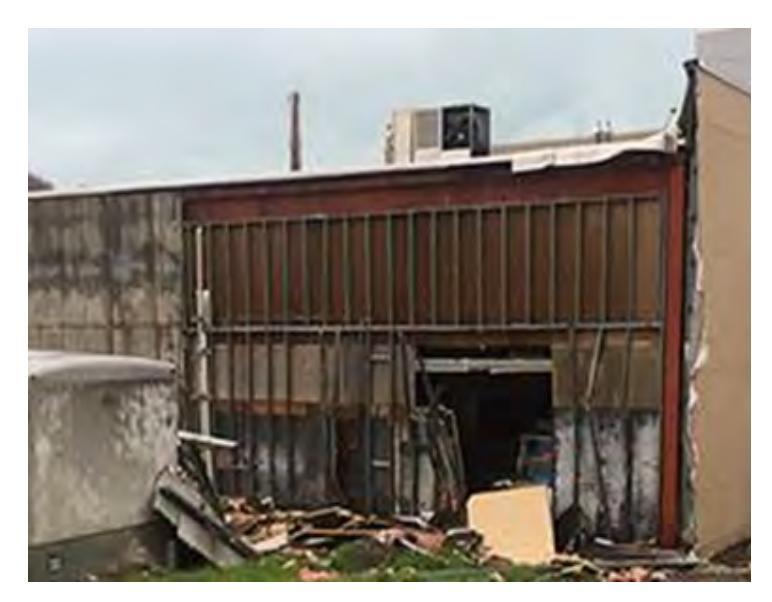
Figure 5-14: View of the eastern side of the Kimelman addition EIFS that failed during Hurricane Irma.

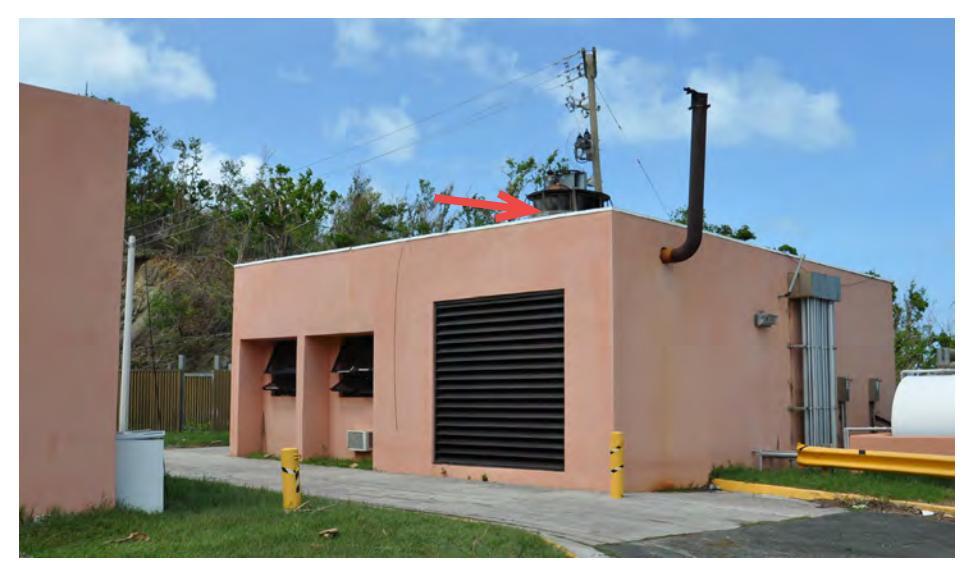
Figure 5-16: View of the emergency generator building. The cowling was blown off the exhaust fan, indicated by red arrow.

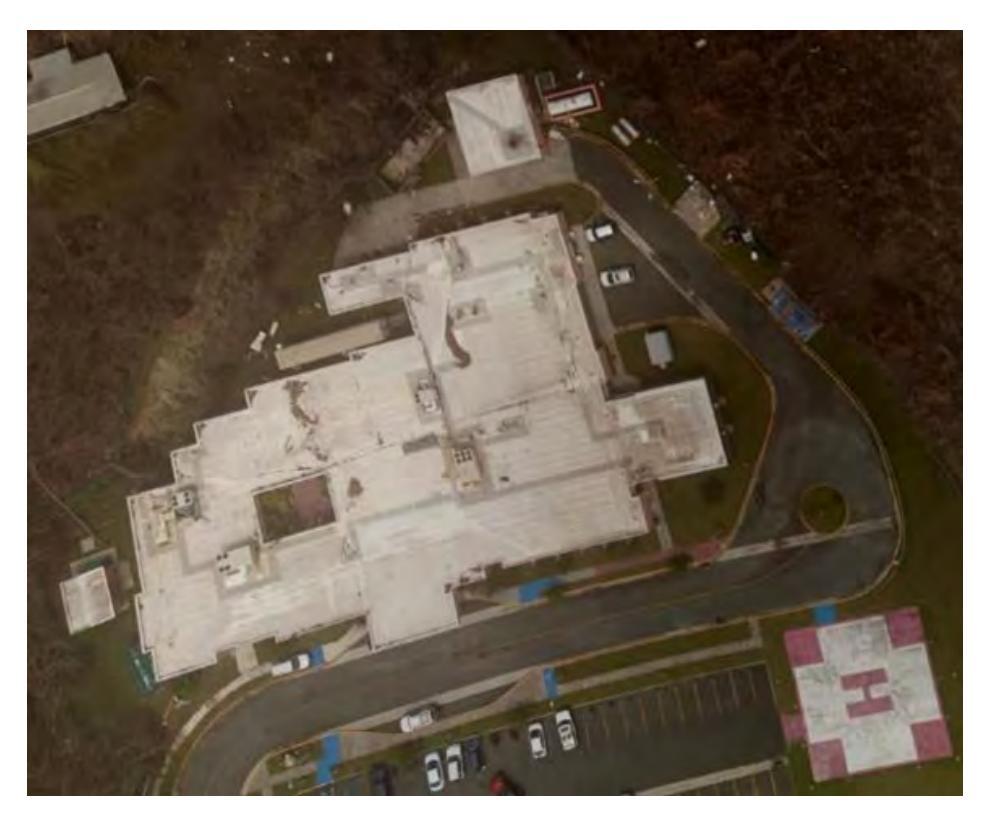
Figure 5-17: Aerial view of the Myrah Keating Smith Community Health Center after Hurricane Irma. The yellow arrow indicates the emergency generator building. The red line indicates the approximate location of the roof membrane tear shown in Figure 5-19. The roof membrane did not blow off. (Photo by NOAA).

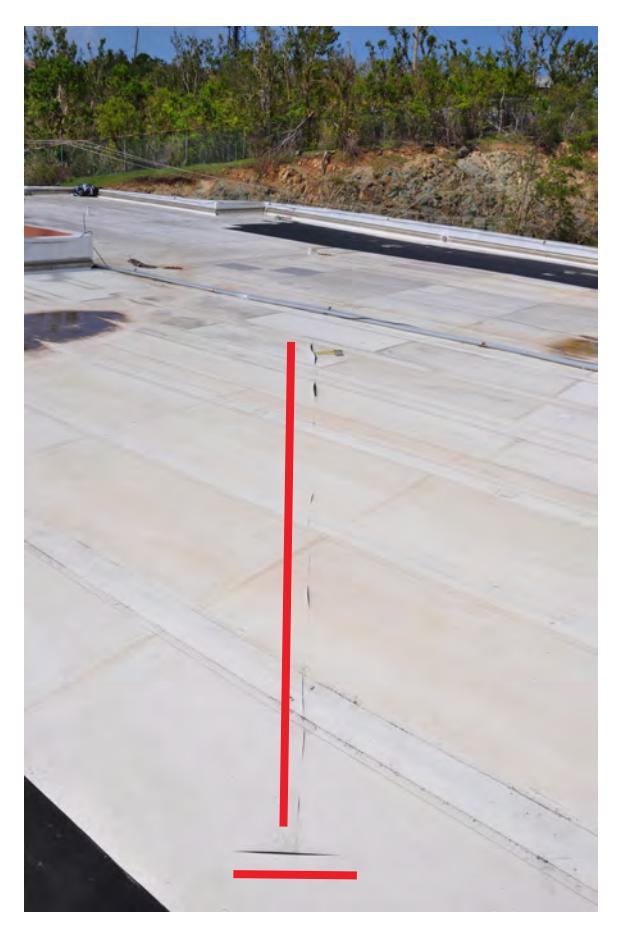
Figure 5-18: View of Health Center roof system. The red lines indicate membrane tears caused by wind-borne rooftop equipment debris (see also Figure 5-20). The tear was approximately 18 feet long. The black areas at the lower left and upper right of the figure are self-adhering modified bitumen that had been installed over the singleply membrane for temporary protection.

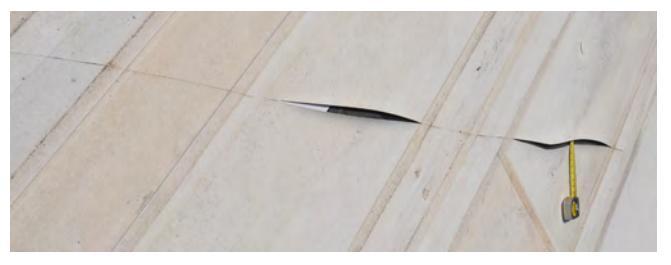
Figure 5-19: Close-up view of the red area in Figure 5-18.

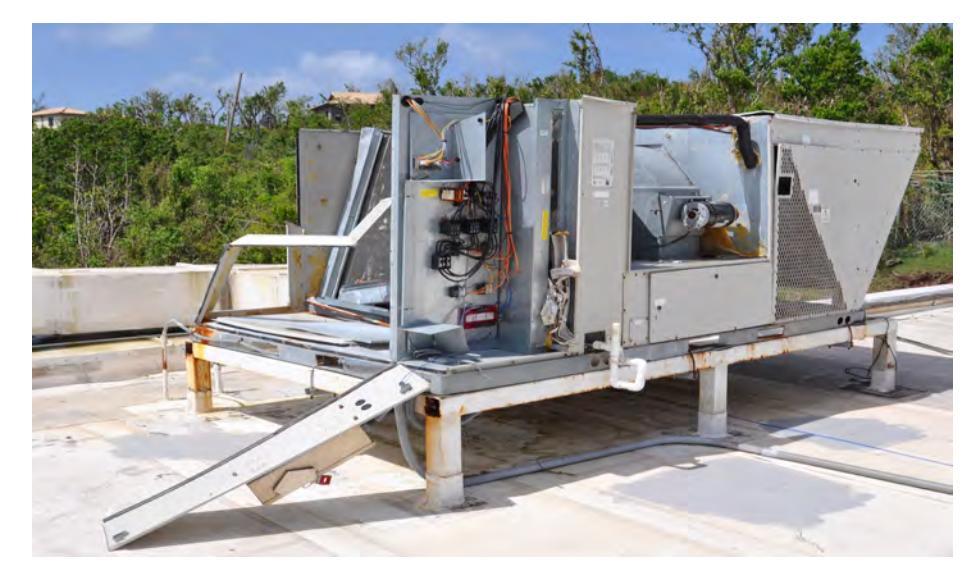
Figure 5-20: The sheet metal enclosure (cabinet) blew off this HVAC unit. An access panel was also blown off. It appeared that wind-blown enclosure debris caused some of the roof membrane tears. Figure 5-21 shows an exhaust fan that blew off its curb because it was attached with only two screws. This is less than the recommended number of fasteners in FEMA P-577. Water was able to enter the facility at the curb opening. Further design guidance is provided in USVI Recovery Advisory 2, *Attachment of Rooftop Equipment in High-Wind Regions* (Appendix D).

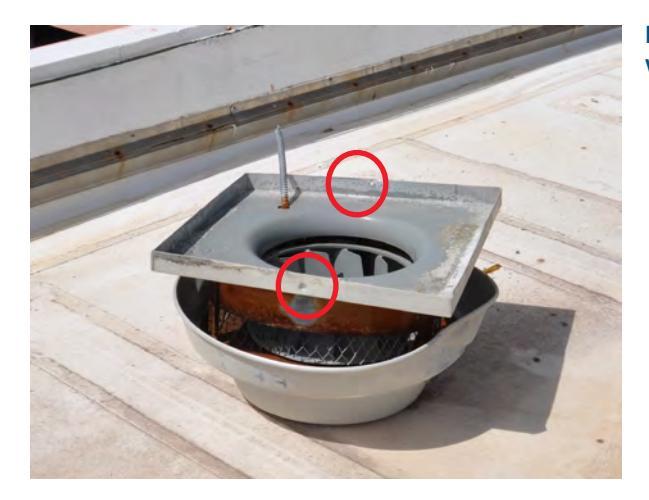
Figure 5-21: This exhaust fan was attached to its curb with only two fasteners as indicated by red circles.

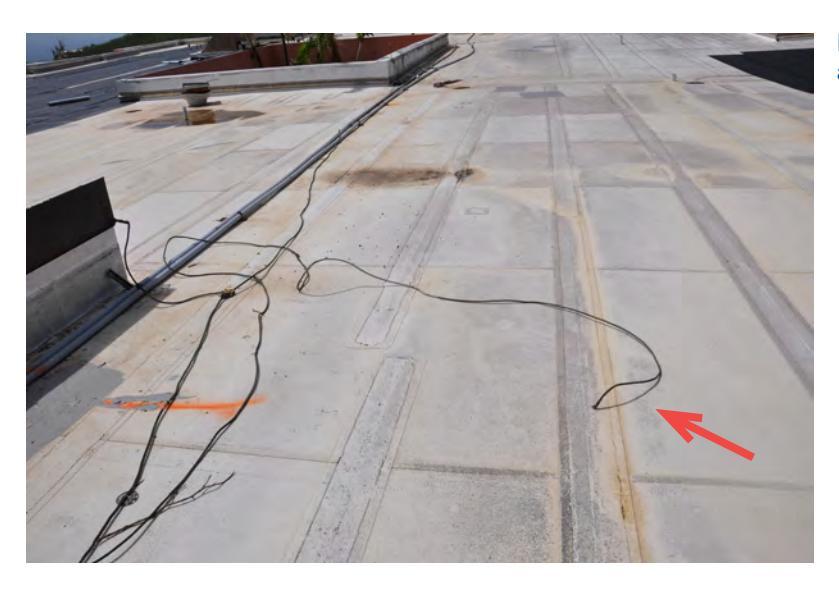
# Figure 5-22: Detached LPS conductors as indicated by red arrow.

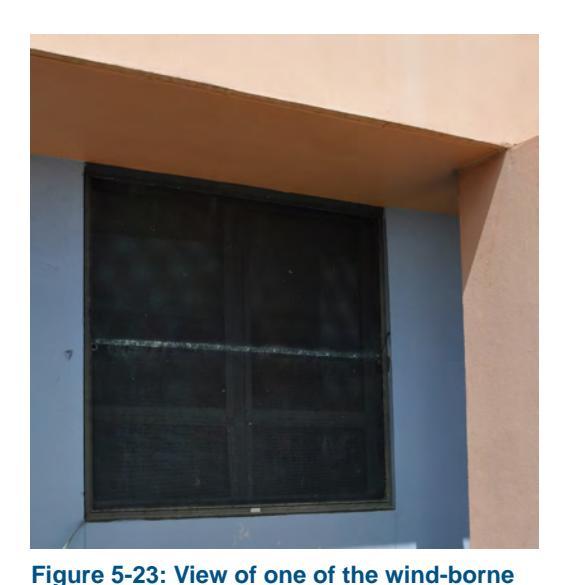
debris resistant screens.

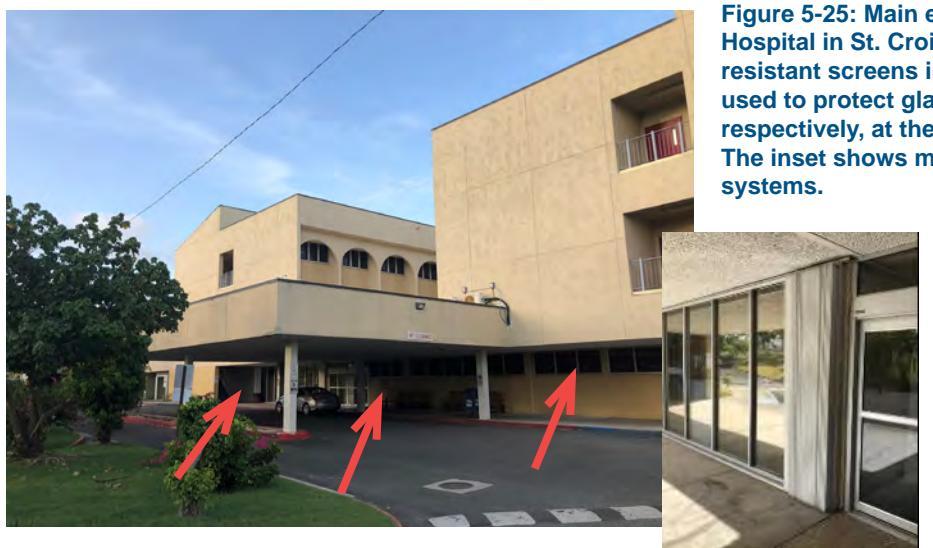
Figure 5-25: Main entrance photo of Juan F. Luis Hospital in St. Croix. Storm shutters and impactresistant screens indicated by red arrows, were used to protect glazed doors and windows respectively, at the front entrance of the facility. The inset shows more detail of the large shutter systems.

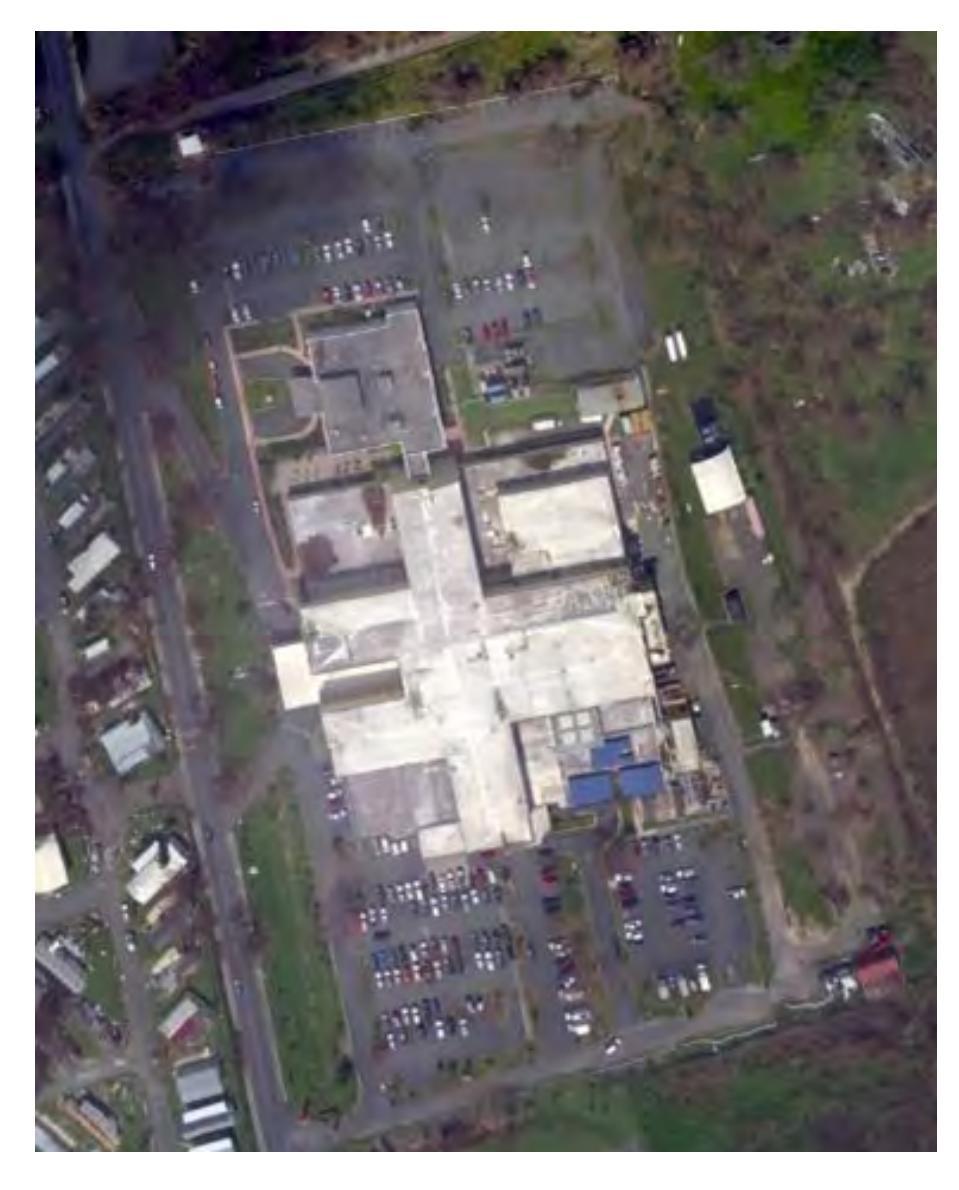
Figure 5-26: Aerial view of the Juan F. Luis Hospital in St. Croix. Yellow circles identify building areas that experience interior flooding during rain events. (Photo by NOAA).

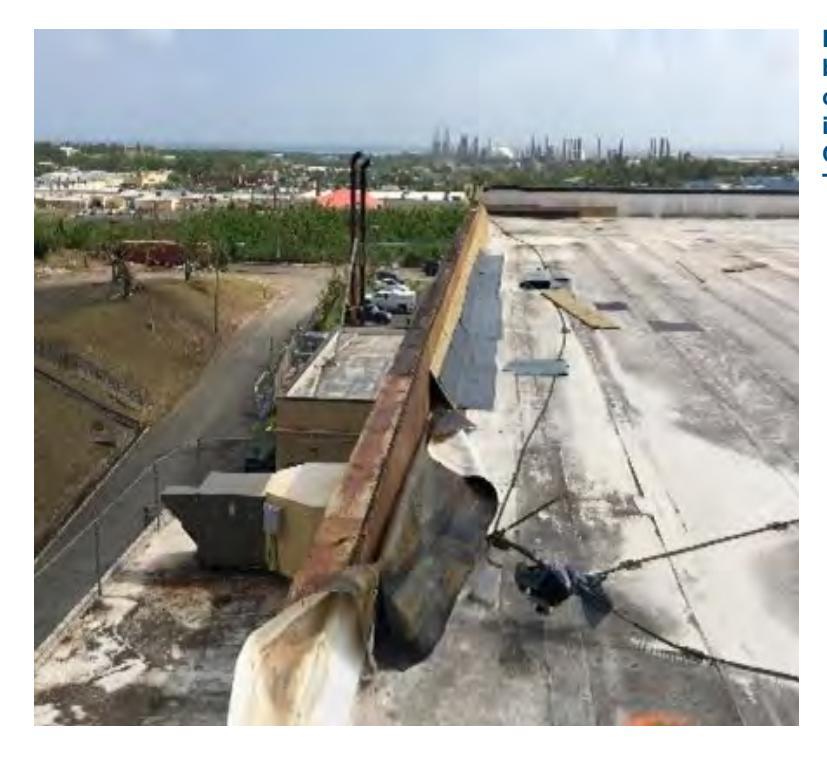
Figure 5-27: Loss of coping and parapet base flashing on the third floor of the original hospital led to significant water intrusion into the hospital Emergency Operating Center (EOC) located below. The LPS is also displaced. Water intrusion occurred through numerous roof punctures caused by wind-borne debris. There were several locations where the roof covering had lost its bond at the seams, allowing water to penetrate through the roof covering and into the facility below (Figure 5-28). With no secondary membrane over the steel deck, water easily leaked into the interior of the building.

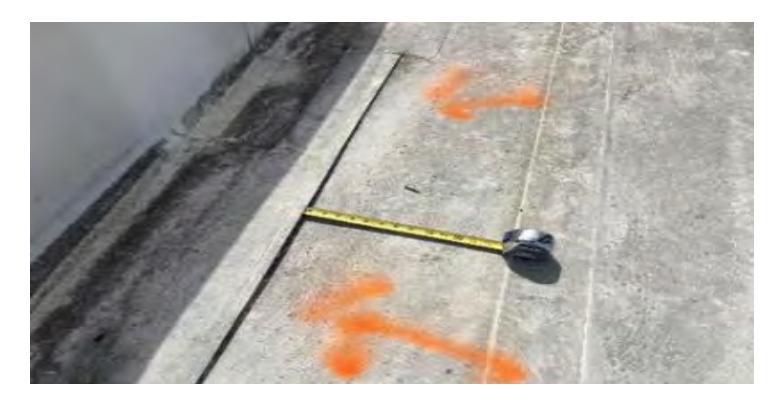
Figure 5-28: Unbonded roof seams contributed to water infiltration through the roof covering behind the parapet.

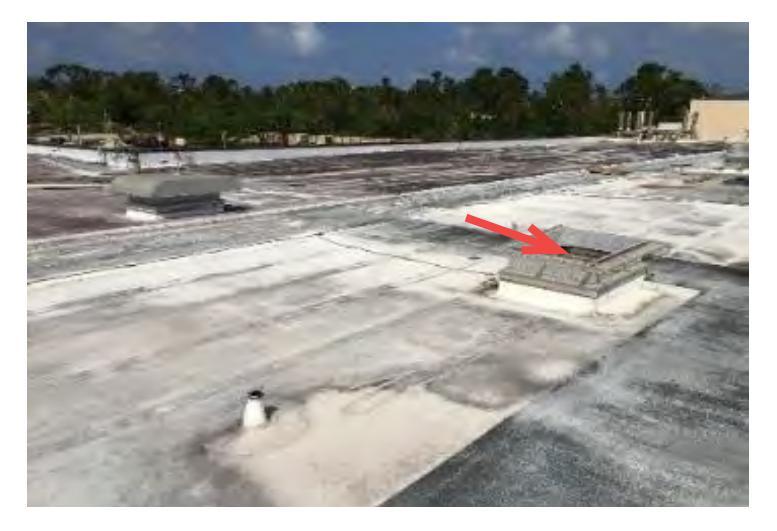
Figure 5-29: Loss of the elevator vent hood, indicated by red arrow, led to significant water intrusion into the hospital EOC located below elevator shafts resulting in loss of elevator service in two elevator systems.

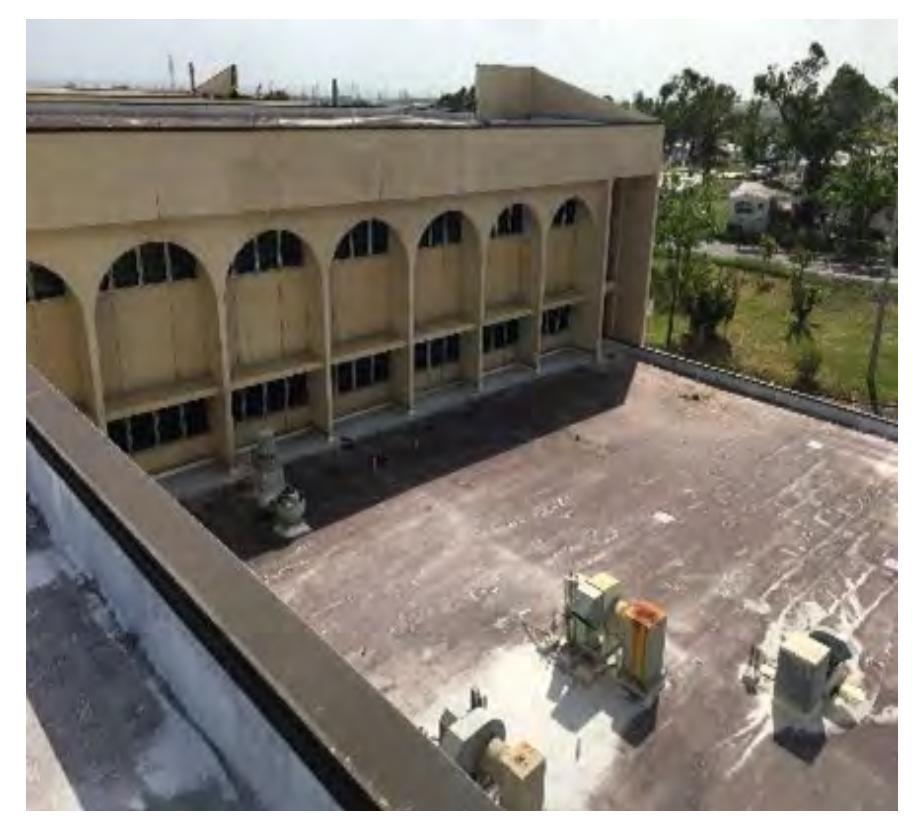
Figure 5-30: View of the exterior cladding systems, windows (with protective screens), and a lower roof of the original hospital.

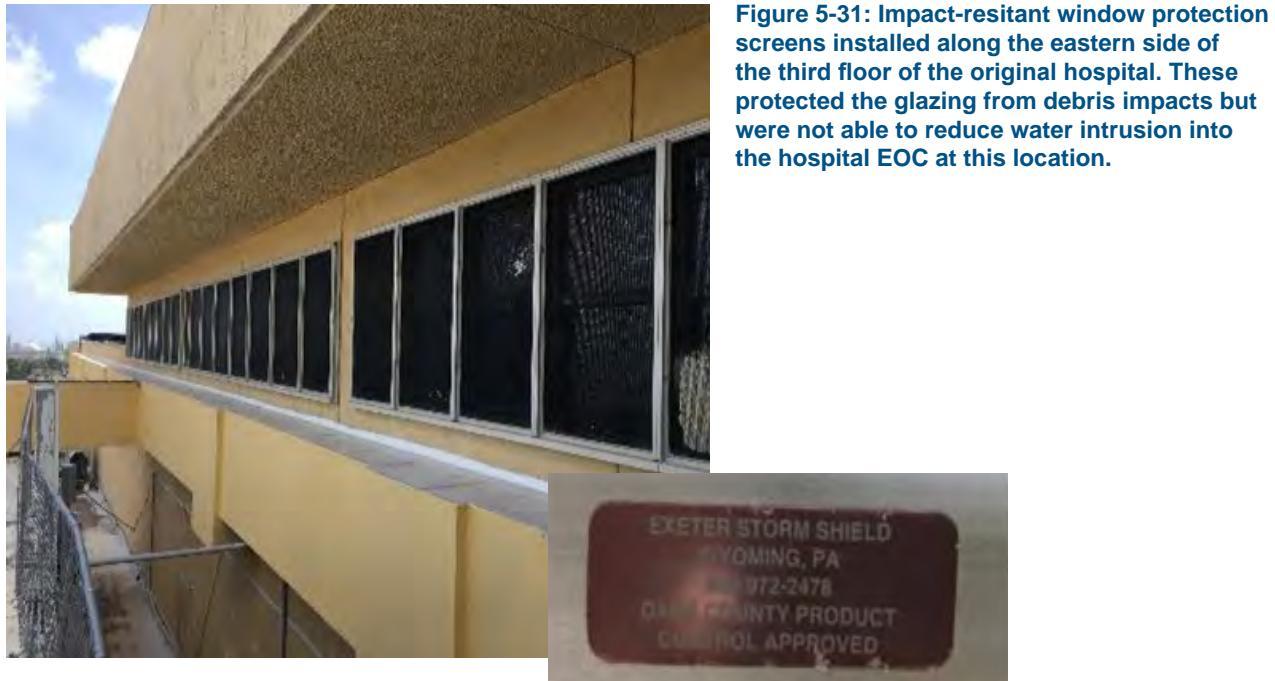
Figure 5-32: Typical windows along a corridor in the original hospital facility. These windows experienced water intrusion significant enough to damage the floor covering below them.

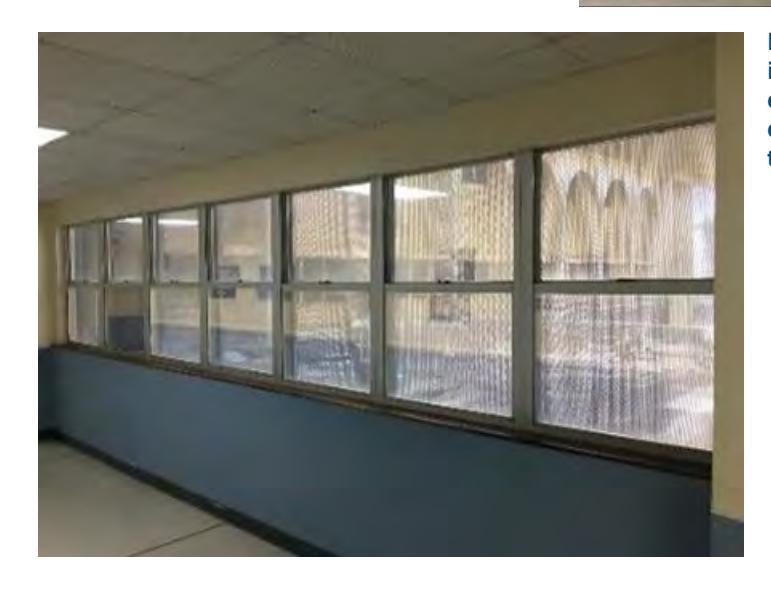
HURRICANES IRMA AND MARIA IN THE U.S. VIRGIN ISLANDS There were several locations where large, louvered systems failed from wind forces. The louvers appeared to fail due to inadequate attachment to the supporting wall framing (Figure 5-33). Two louver panels that failed were 5-section wide louvers (the widest configuration at the hospital). The 3- and 4-section wide louvers notably performed better with a similar exposure to wind. The roof mounted PV-systems in this area experienced minor damage.

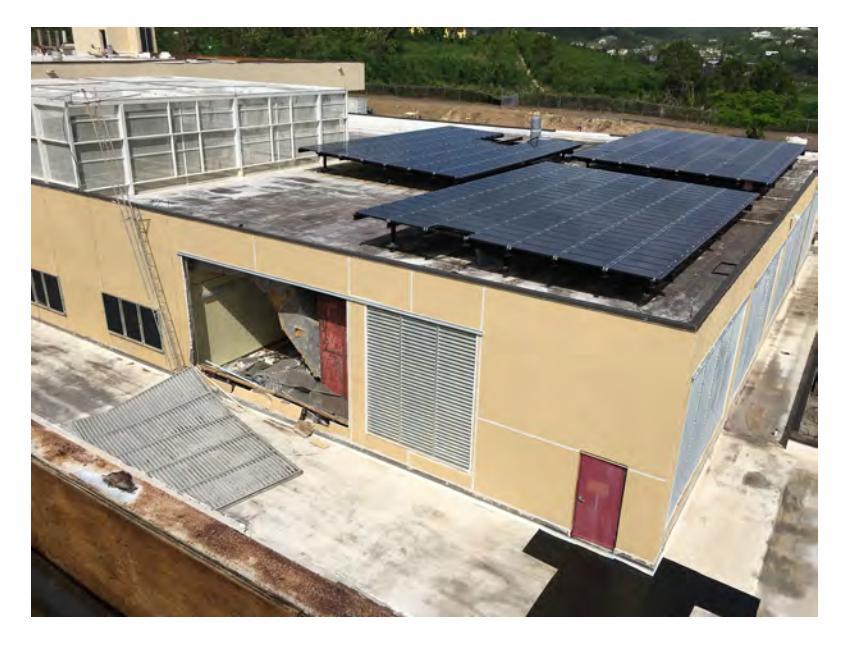
Figure 5-33: View of large louver systems that failed due to wind pressure.

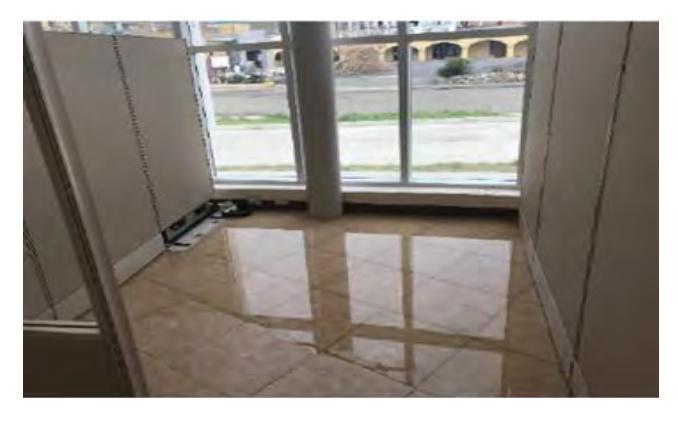
Figure 6-1: Water in lobby of Hotel Company Omar Brown Fire Station, St. Thomas. (Photo by the USVI Department of Public Works).

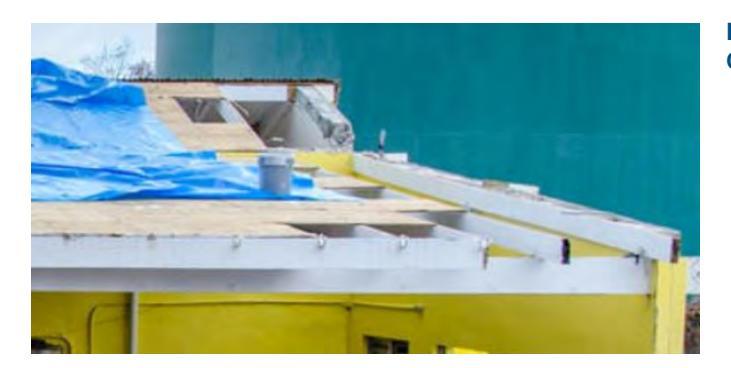
The Captain Robert O'Connor Sr. Fire Station located at Cruz Bay, St. John experienced major roof damage. Debris impacts from high winds damaged large portions of the wood sheathing of the roof (Figure 6-2). The structure is comprised of masonry load-bearing walls supporting wood beams and wood roof joists. The structure lacks apparatus bay doors, and high winds could easily access the interior areas of the apparatus bays. This caused additional uplift pressure on the roof from the interior side of members, as well as exerting uplift pressures on the exterior side of members. The duel effect resulted in roof joists exhibiting twisting action from the high winds. Damage was also observed at the roof where a concrete pole adjacent to the building fell and impacted the masonry wall.

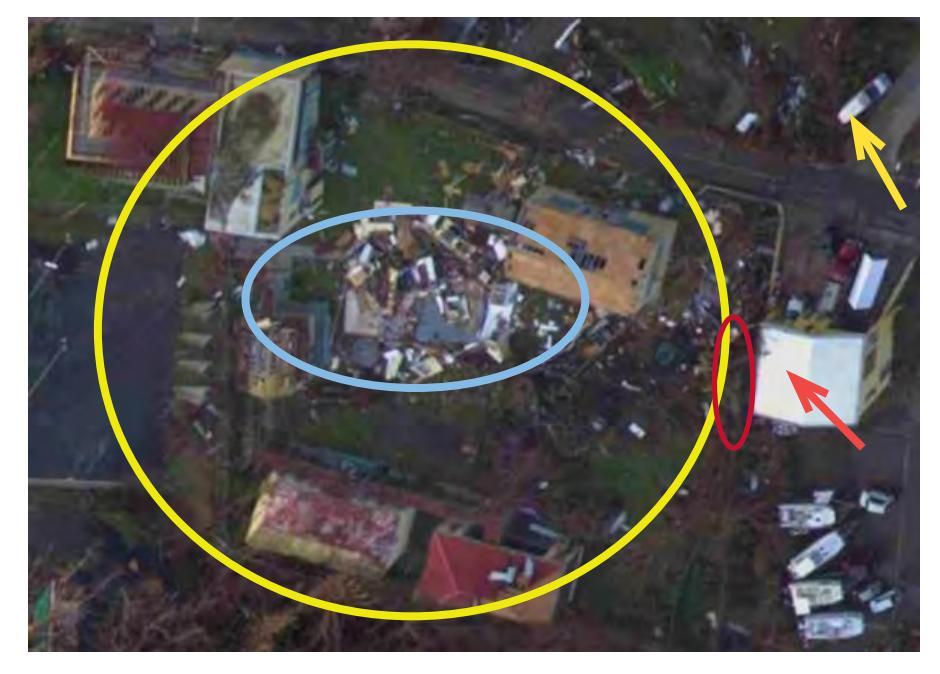
Figure 6-3: Aerial view of Coral Bay Fire Station indicated by red arrow. The buildings within the yellow oval are the community center (previously a school). The building within the blue oval collapsed (Figure 6-3). The red oval indicates the emergency generator. The yellow arrow indicates the ambulance shown at Figure 6-4 inset. (Photo by NOAA). Figure 6-4 is a general view of the fire station. The two apparatus bays were not equipped with bay doors and vehicles within the bays were susceptible to wind-borne debris. An ambulance was parked across the street under a car port which was blown away and was damaged by wind-borne debris (Figure 6-4, inset). Figures 6-5 and Figure 6-6 provide different views of the damage.

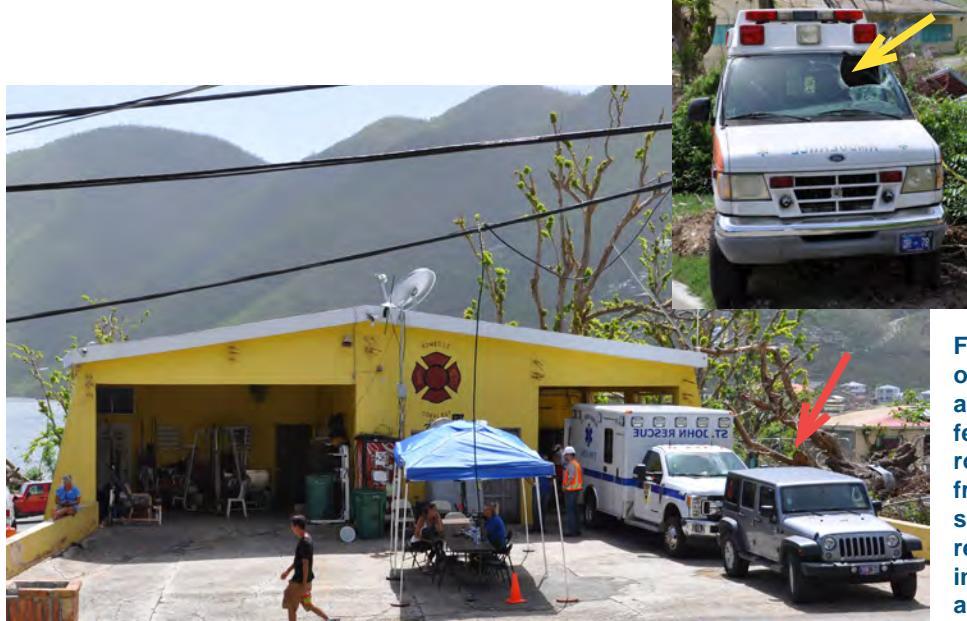
Figure 6-4: General view of the fire station. The red arrow indicates the tree that fell on the generator and the roof. A temporary canopy in front of the station provided shade for residents seeking recovery assistance. The inset shows the damaged ambulance.
