# Mitigation Assessment Team Report

# Hurricanes Irma and Maria in the U.S. Virgin Islands

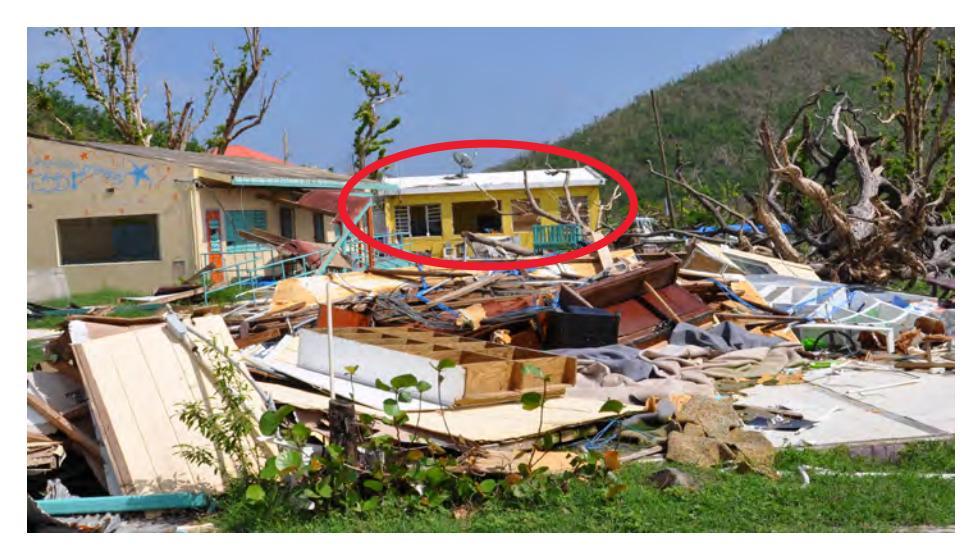
Figure 6-5: View of the fire station, shown in the red oval, from the community center. The primary wind direction during Hurricane Irma was to the east, i.e., from the community center towards the fire station.

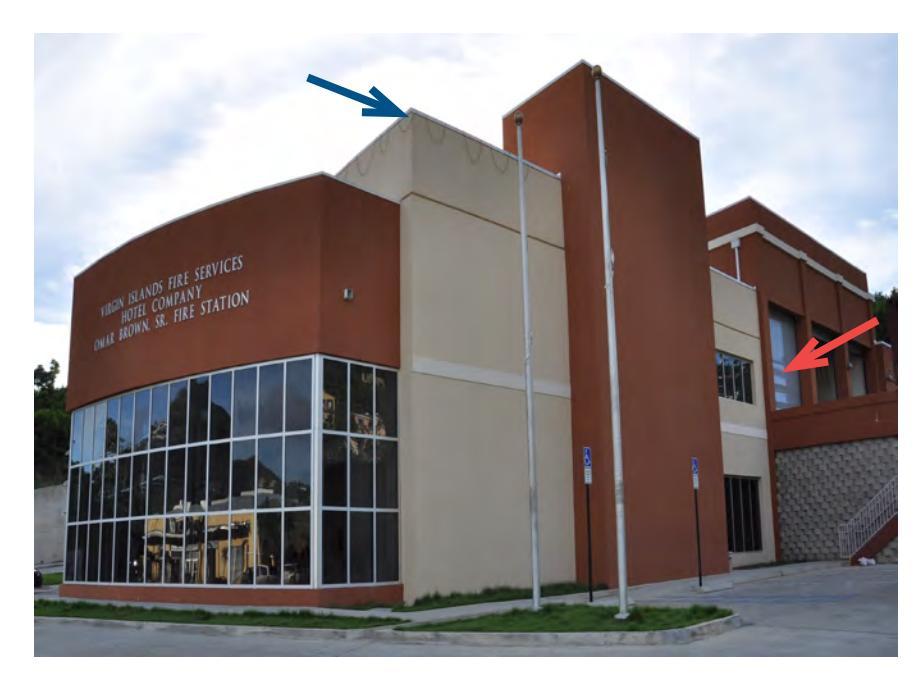
Figure 6-7: View of the fire station. The red arrow indicates the apparatus bay. The blue arrow indicates the roof shown in Figure 6-8. Rain was driven between the door to the roof and its frame during Hurricane Irma. Water flowed down the stairs all the way to the first floor. At the second floor of the facility, rooms adjacent to the balcony experienced water infiltration underneath doors that lacked weather stripping. As high winds developed, water accumulating on the balcony deck was forced towards the building and seeped underneath these doors.

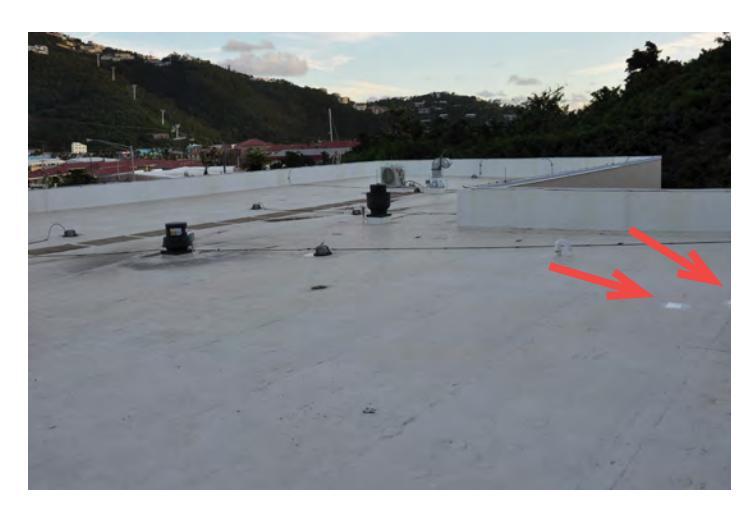
Figure 6-8: General view of the main roof. The red arrows indicate patches where the roof membrane was punctured by debris.

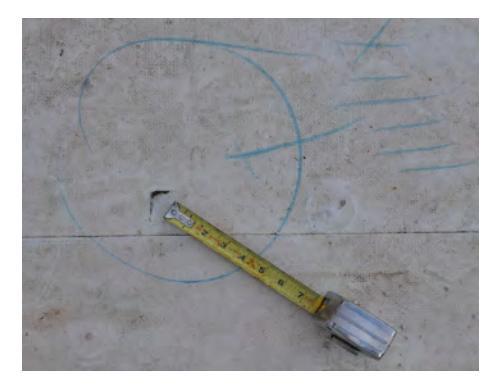
Figure 6-9: View of a roof membrane puncture that had not been patched.

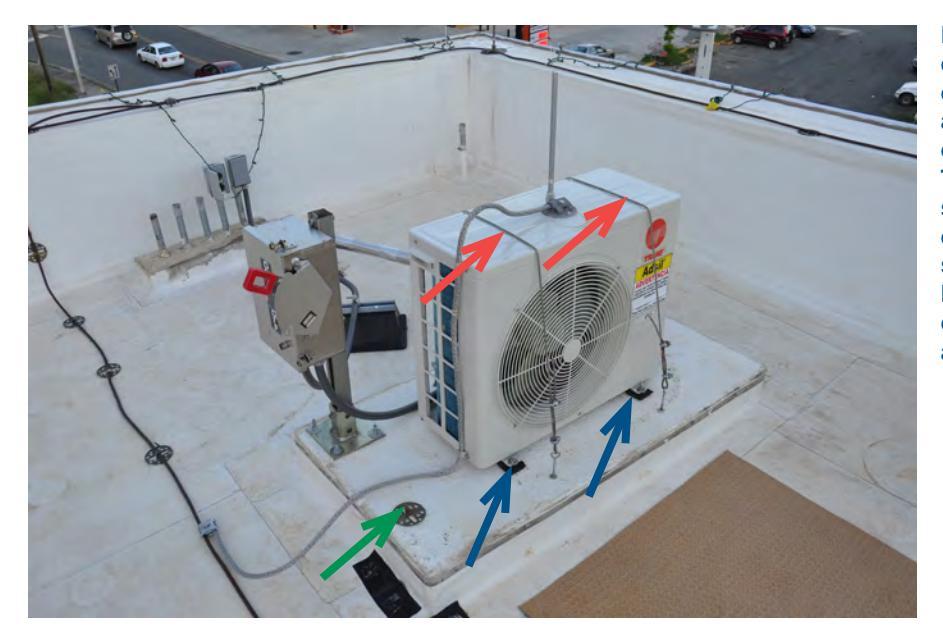
Figure 6-10: The base of the condenser was bolted to the curb indicated by the blue arrows and had tie-down cables indicated by red arrows. The support for the disconnect switch was bolted to the curb. The lightning protection system conductor was no longer secured by the pronged connector indicated by green arrow.

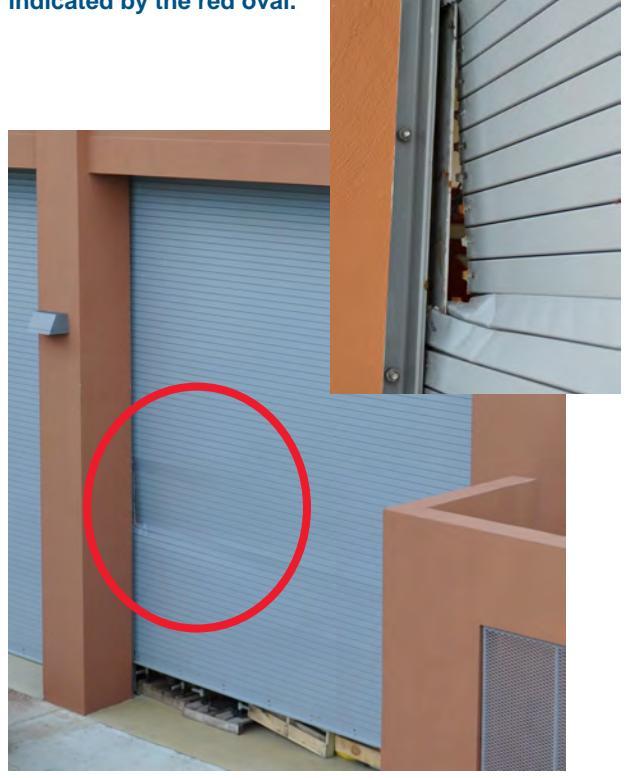
The emergency generator was mounted outdoors (Figure 6-13). Generators located outdoors are susceptible to damage from wind-borne debris (Figure 6-6). If an outdoor generator malfunctions during a hurricane, it is problematic to attempt repair during the storm.

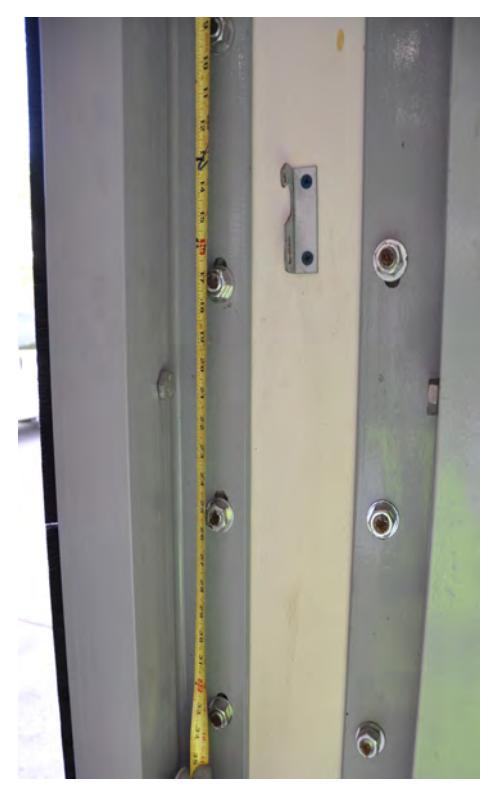
Figure 6-12: View of rolling door tracks on either side of a column. The tracks were bolted to the column with closelyspaced bolts.

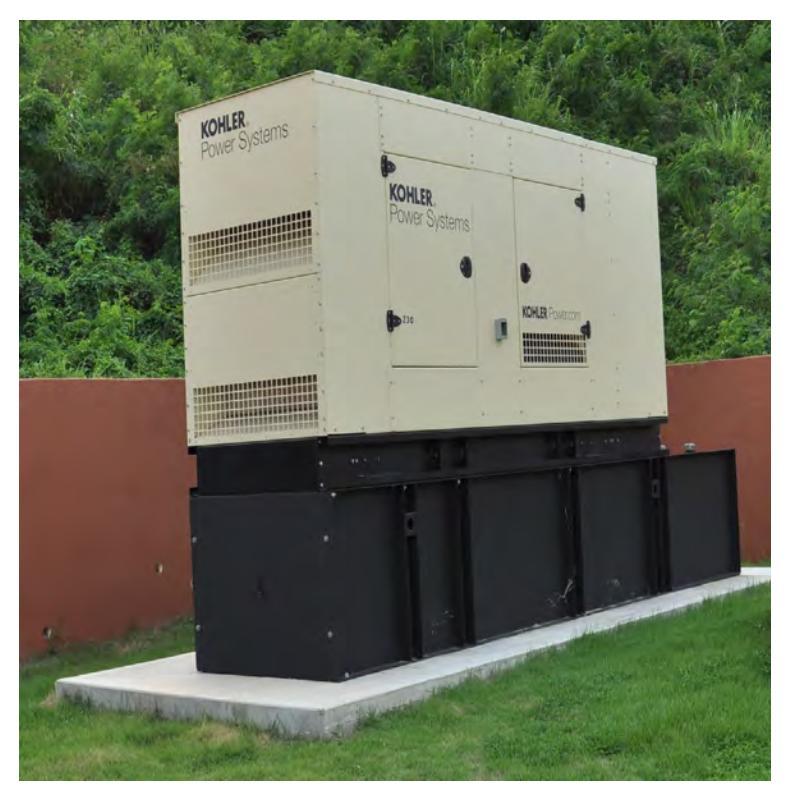
Figure 6-13: View of the emergency generator. FEMA P-543 recommends placing emergency generators within a building.

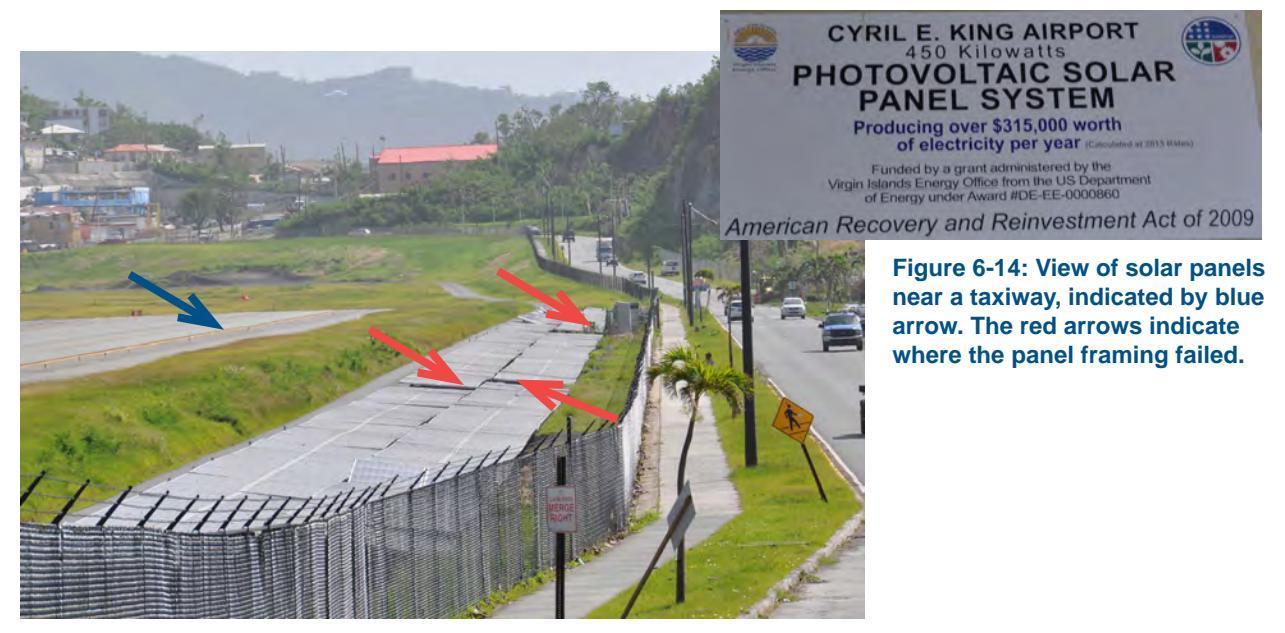
The Cyril E. King Airport Terminal Building in St. Thomas opened in 1990. It experienced significant building envelope damage during Hurricane Marilyn (1995) and again during Hurricane Irma. Many ground-mounted solar panels were adjacent to one of the taxiways (Figure 6-14), and a few of the panels were damaged by wind-borne debris. The framing that supported the panels failed in several areas (Figures 6-14 and 6-15).

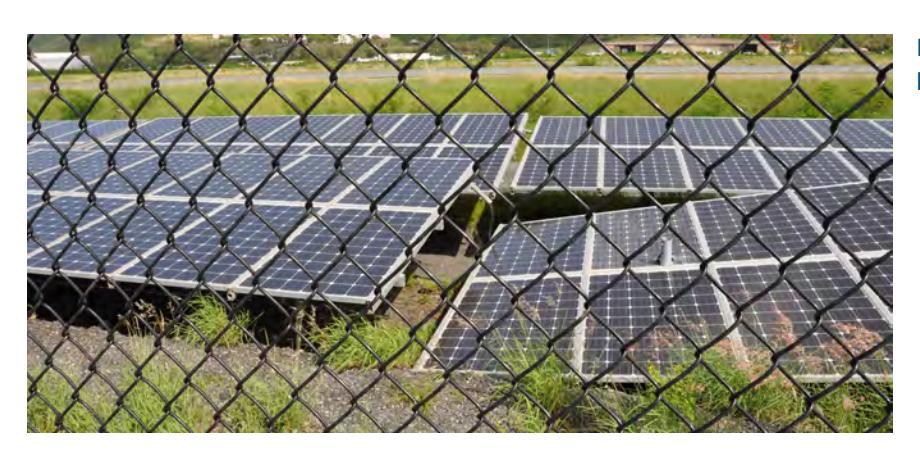
Figure 6-15: View of failed solar panel support framing.

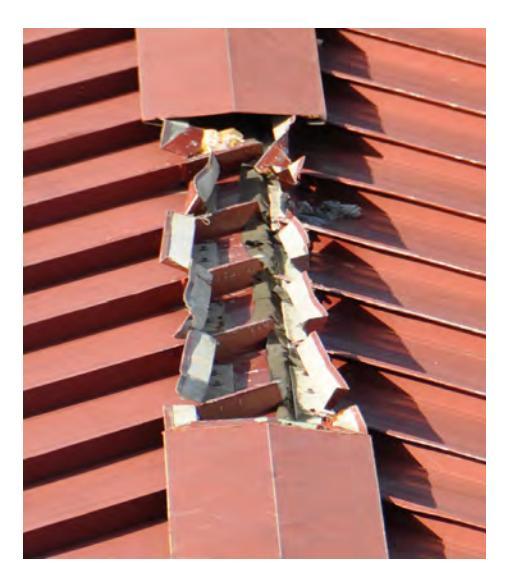
Figure 6-16: View of blown-off hip flashing.

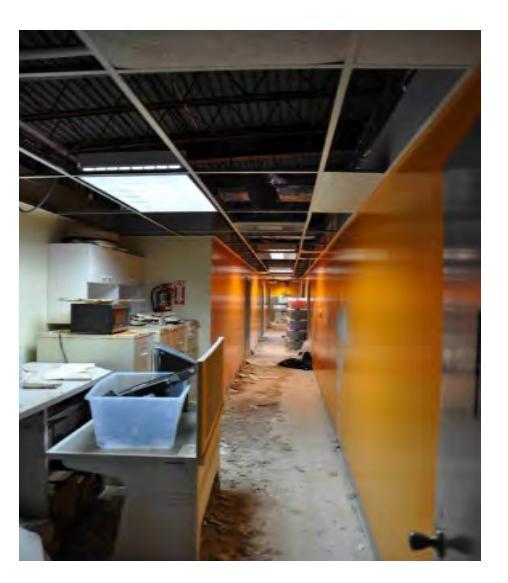
Figure 6-17: View of interior damage below blownoff metal roof panels.

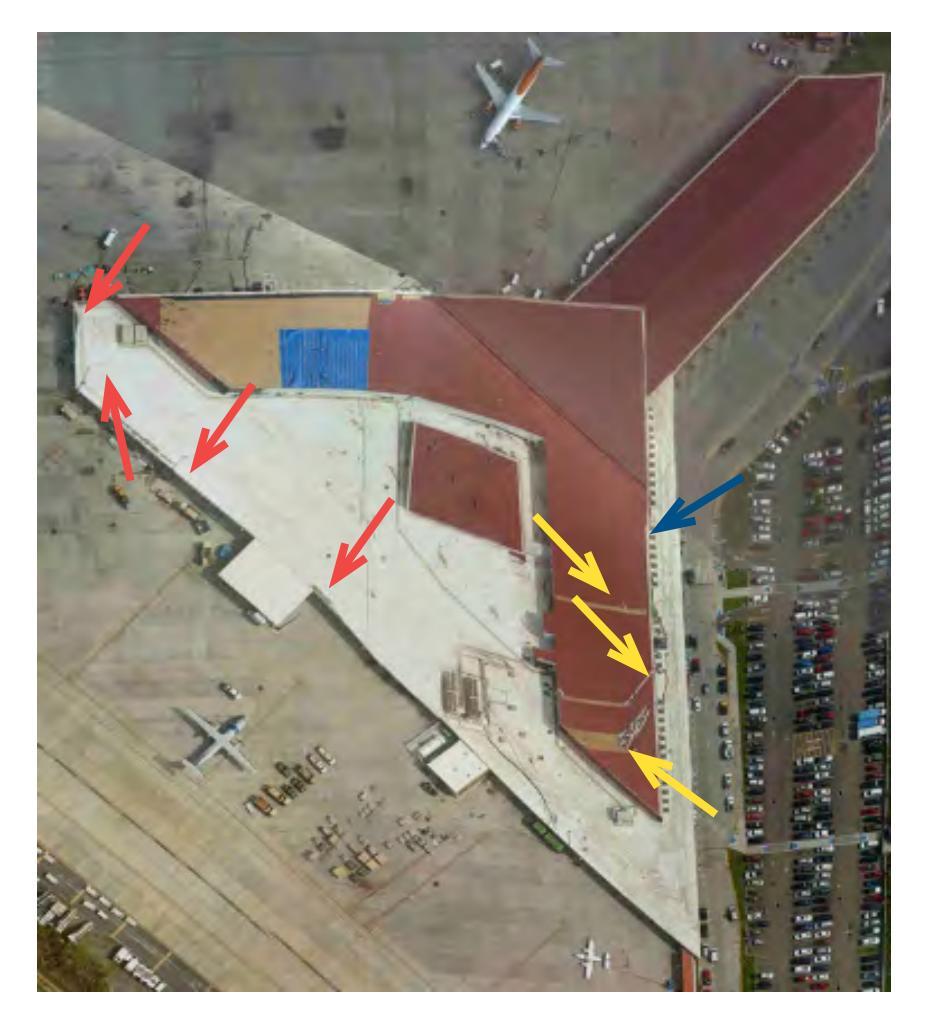
Figure 6-18: Aerial view of the Cyril E. King Airport Terminal Building after Hurricane Irma. The metal panel roofs are red; yellow arrows indicate where panels blew off. The white area is the single-ply membrane. The red arrows indicate damaged areas (see blue tarps, Figure 6-17). The blue arrow indicates a row of skylights. (Photo by NOAA).

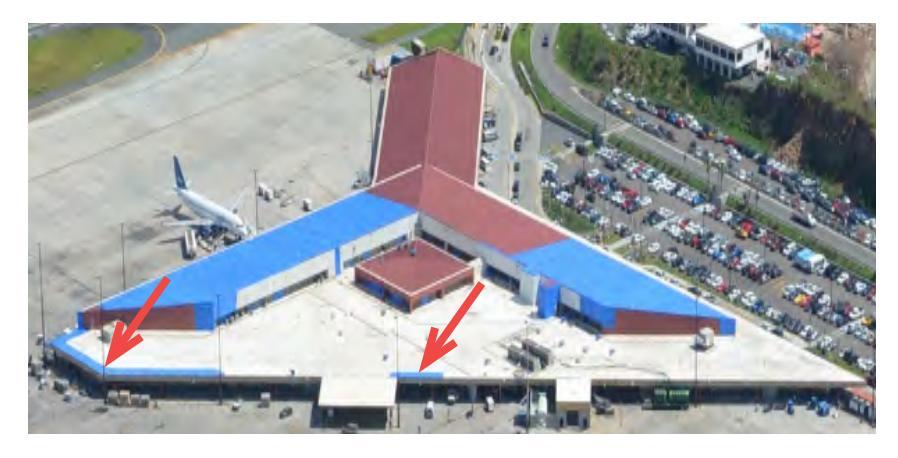
Figure 6-19: Aerial view after Hurricane Maria. The red arrows indicate tarps at the single-ply membrane roof. (Photo by the Civil Air Patrol).

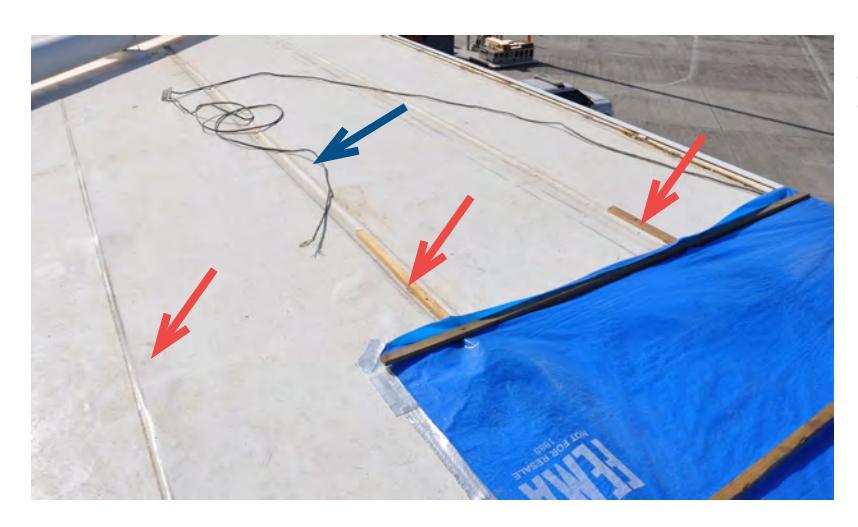
Figure 6-22: View of one of the tarped areas at the roof perimeter. The red arrows indicate the membrane fastener rows. The blue arrow indicates a lightning protection system conductor.

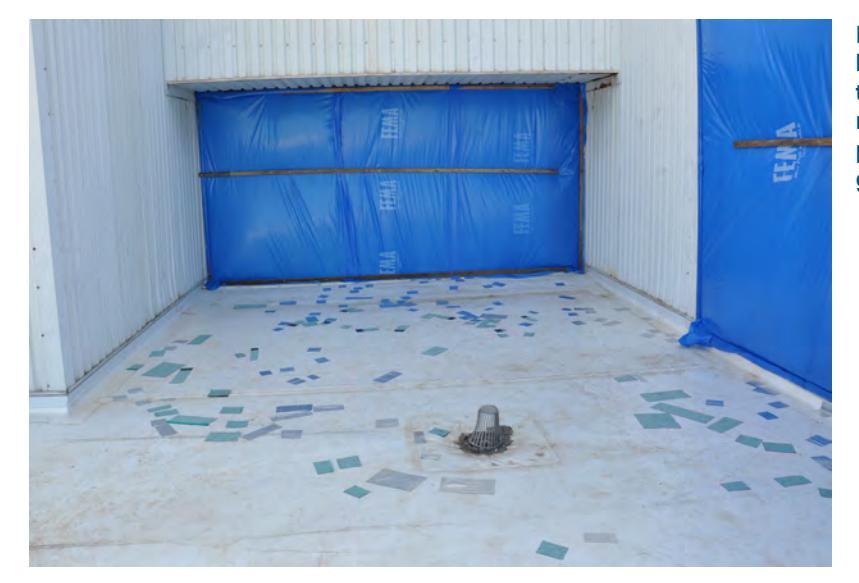
Figure 6-23: The blue tarps are over broken windows. A large number of temporary patches are shown on the roof. Several of the roof membrane punctures/tears were likely caused by glass shards.

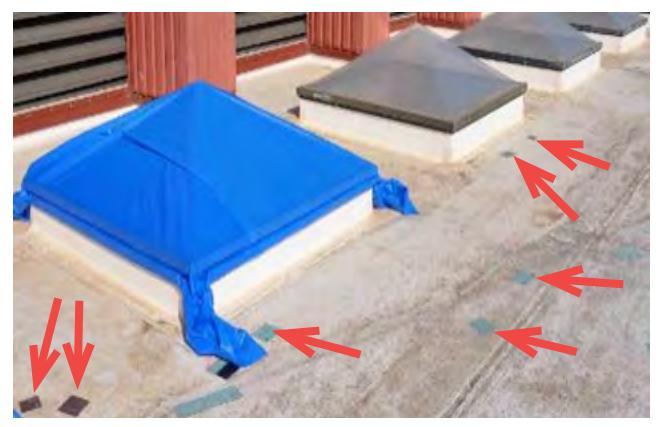
Figure 6-24: Skylight damaged by wind-borne debris. The red arrows indicate patches.

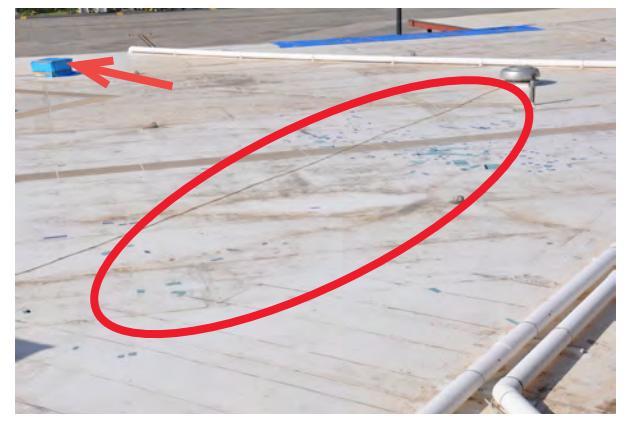
Figure 6-25: A large number of roof membrane patches are shown within the red oval. The red arrow indicates a tarp at a piece of rooftop equipment.

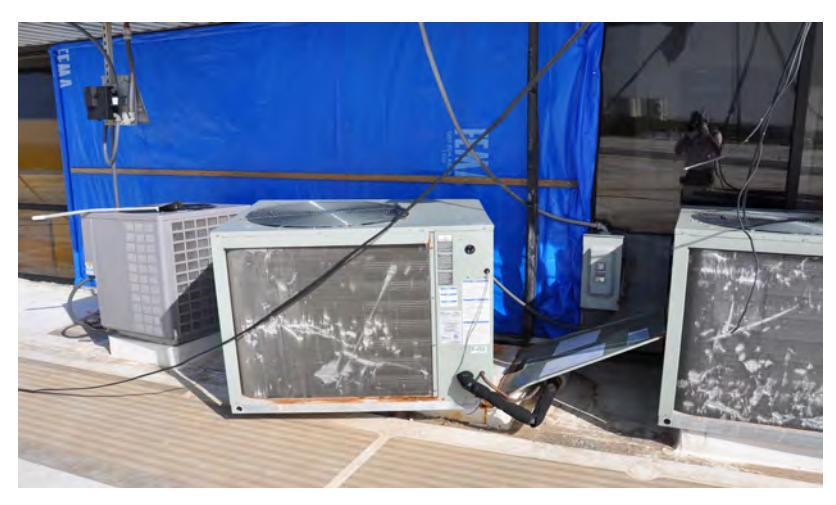
Figure 6-26: None of these condensers were attached. The blue tarp is covering broken windows.

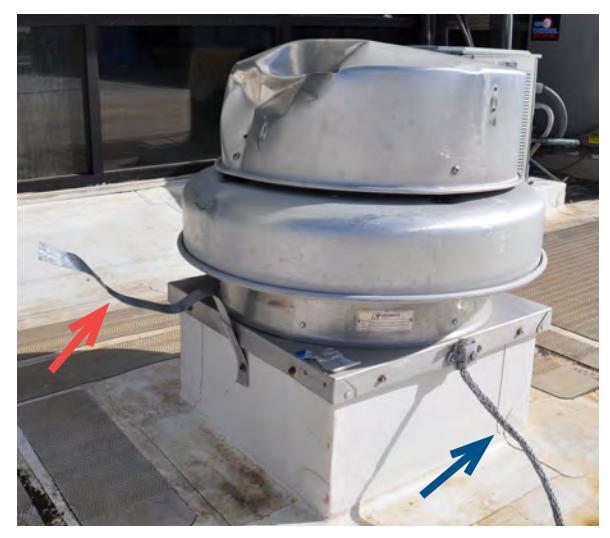
Figure 6-27: This fan cowling had a tie-down strap on two sides of the curb. One of the straps indicated by red arrow was damaged by debris impact. The blue arrow indicates a lightning protection system conductor.

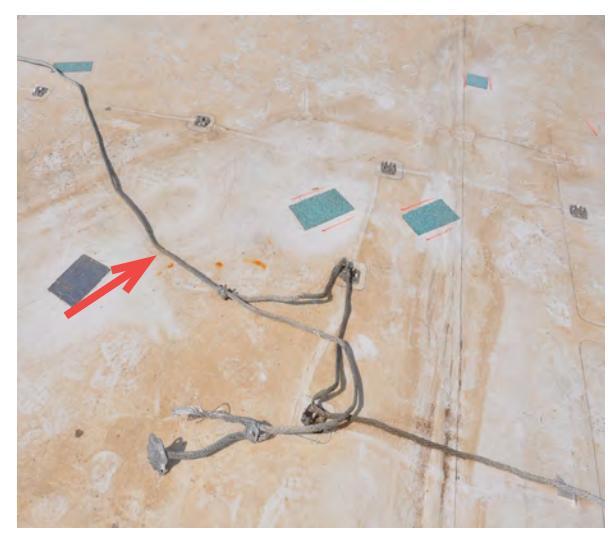
Figure 6-28: Several temporary patches were made after the hurricane. The LPS inidicated by red arrow also detached during Hurricane Marilyn (1995).

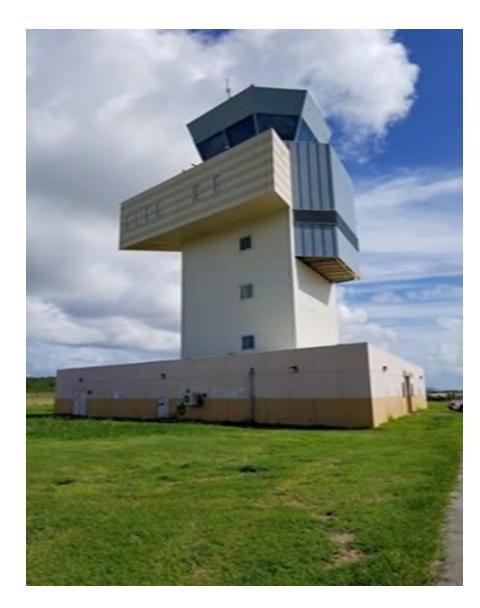
#### Figure 6-29: Henry E. Rohlsen airfield control tower on St. Croix.

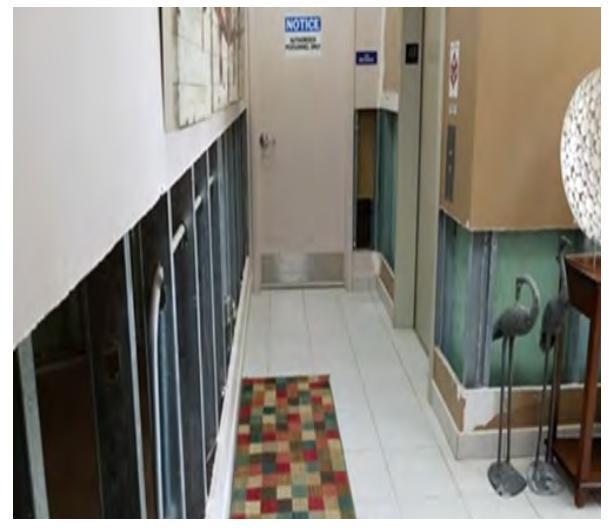
Water entered the lower level bathrooms from the lower roof. The bathroom on the ground level became unusable due to the backflow through the toilets. It appears that the storm-force winds, possibly combined with the plumbing vent location, created a substantial pressure differential. The ensuing waste water contamination on a majority of the bathroom interior surfaces required a large clean-up effort (Figure 6-31).

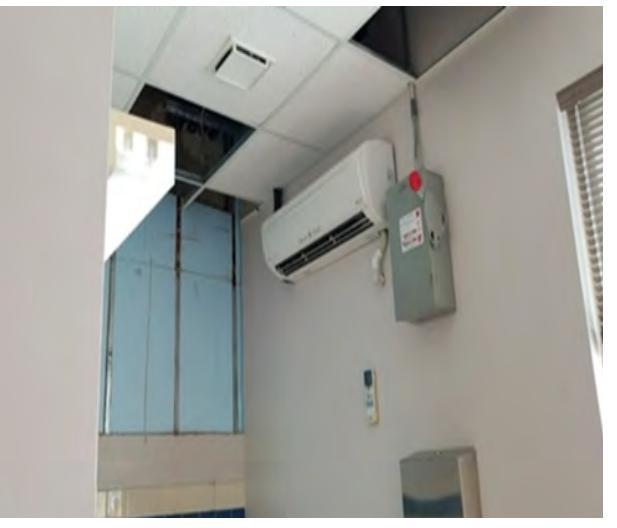
Figure 6-30: Lobby and elevator shaft with drywall removed. A fire alarm pull station on this wall had wire damage.

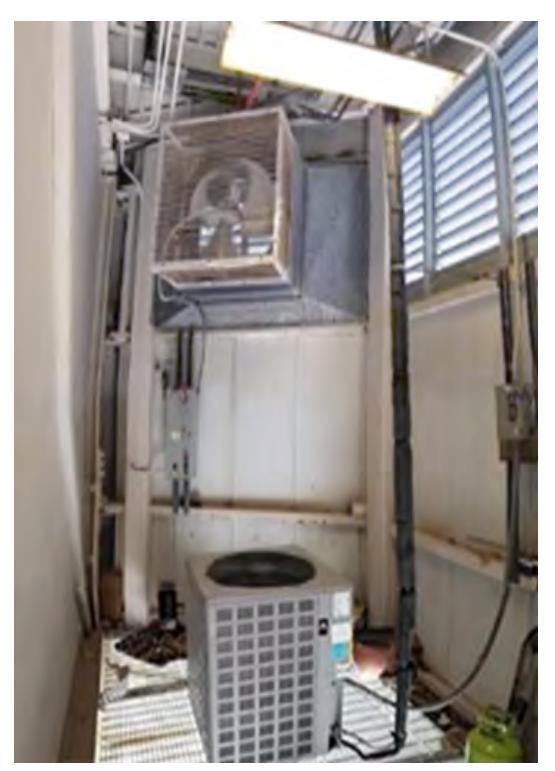
Figure 6-32: Exterior elevated open floor used to house HVAC condensers. The exhaust fans above the condenser units were damaged from debris on the floor that was lifted into the fan housing by the high winds.

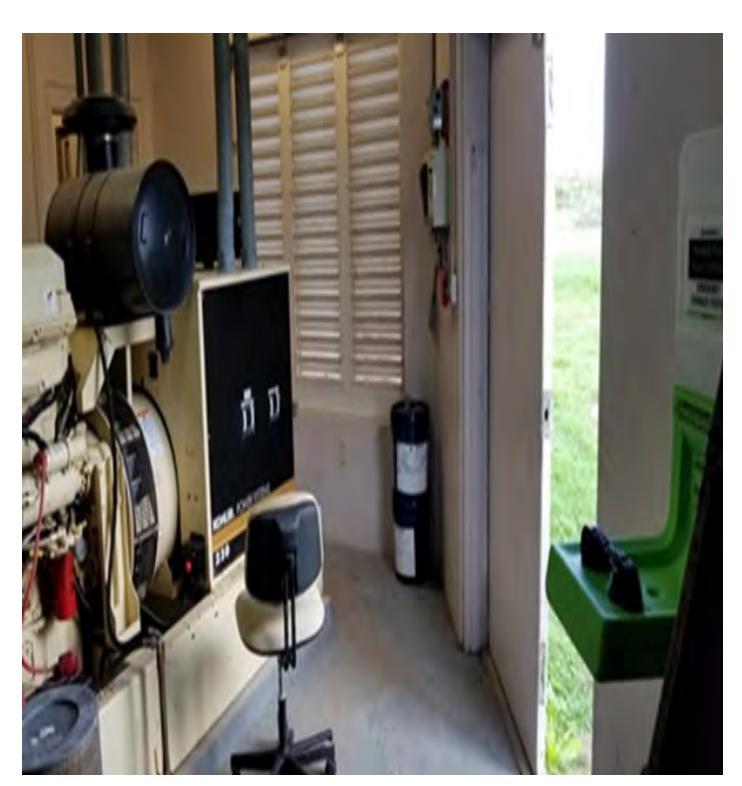
Figure 6-33: Image of generator room and door that opened during the hurricane allowing wind-driven rain into the generator room.

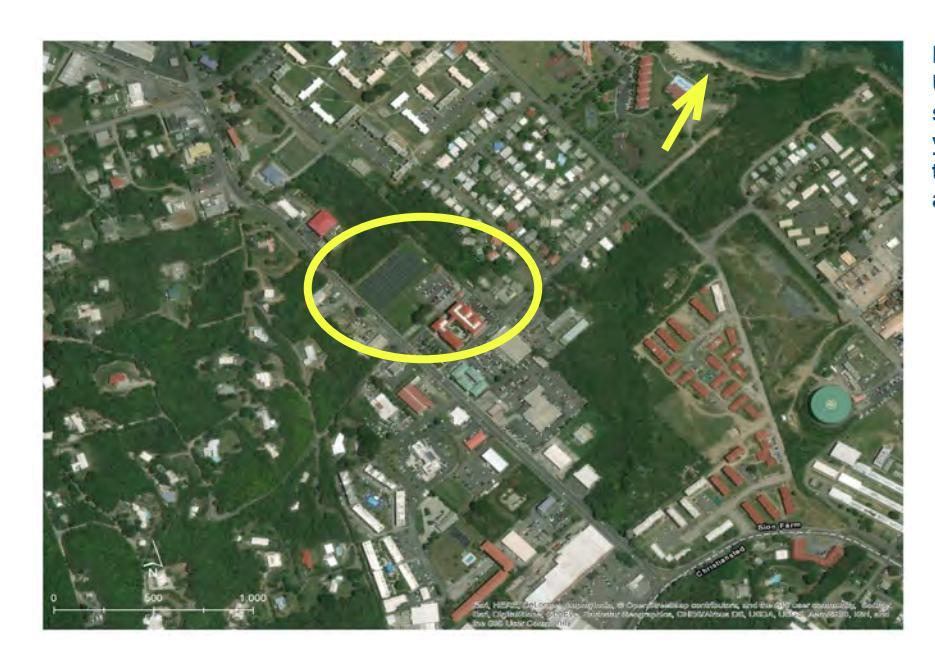
Figure 7-2: Aerial view of site of U.S. Federal District Courthouse solar array project indicated by yellow oval with the shoreline in the distance indicated by yellow arrow, Christiansted, St. Croix.

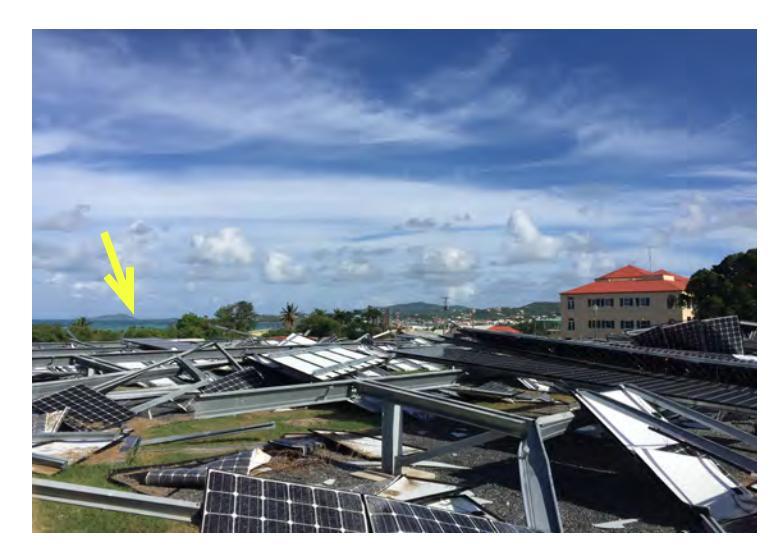
Figure 7-3: View of the failed damaged solar array at the U.S. federal district courthouse. The yellow arrow indicates the shoreline in the distance. Christiansted, St. Croix.
Similarly, the lateral rails between the beams frequently failed. As panels fluttered and the support arms were eventually pulled from the rails of the frames, many of these rails were bent or pulled from the rest of the frames themselves (Figure 7-4).

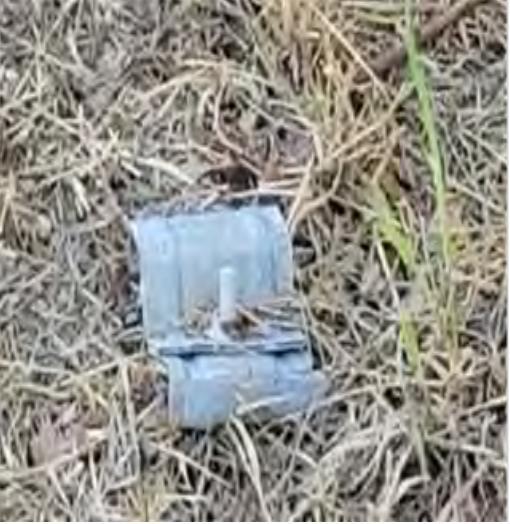
Figure 7-4: View of failed clip and fastener, as still attached and highlighted by the yellow circle (left), and separated from the rails (right). As the edges of the panels detached from the frame, they loosened and exposed nearby panels and damaged the frame in the process.

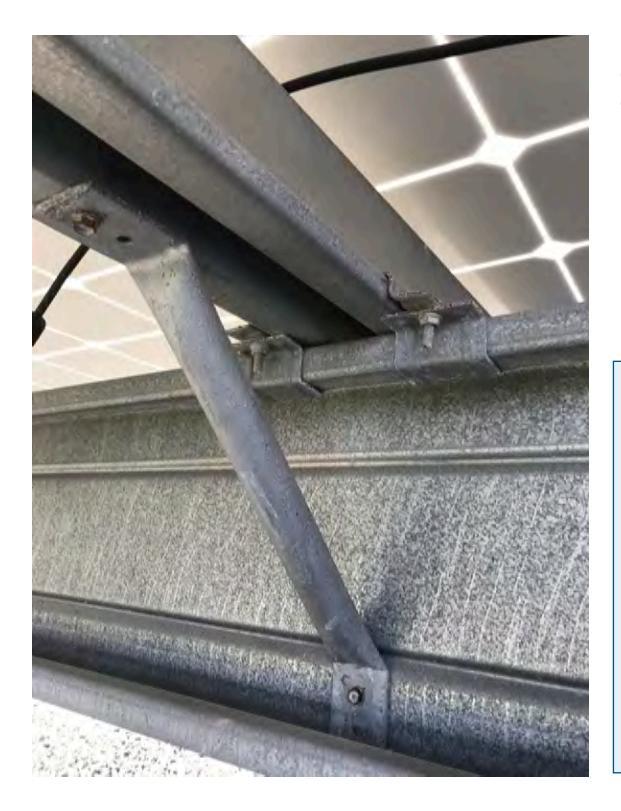
Figure 7-5: Single self-tapping screws used to attach the diagonal strut and rail-to-beam clamps were both a source of failure during Hurricane Irma at this PV system on St. Croix (photo by Andy Walker, National Renewable Energy Laboratory).

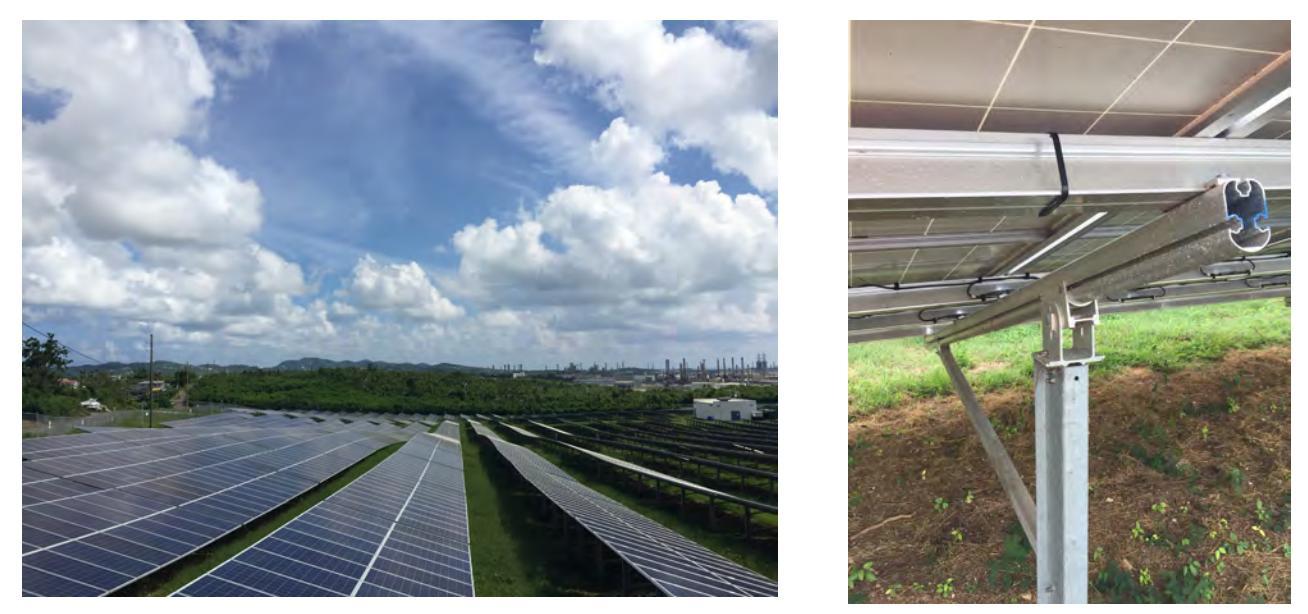
Figure 7-6: View of the mostly intact solar array at Estate Spanish Town, St. Croix, after the hurricanes (left) and the design of beams, posts, and rails of its framing system (right).

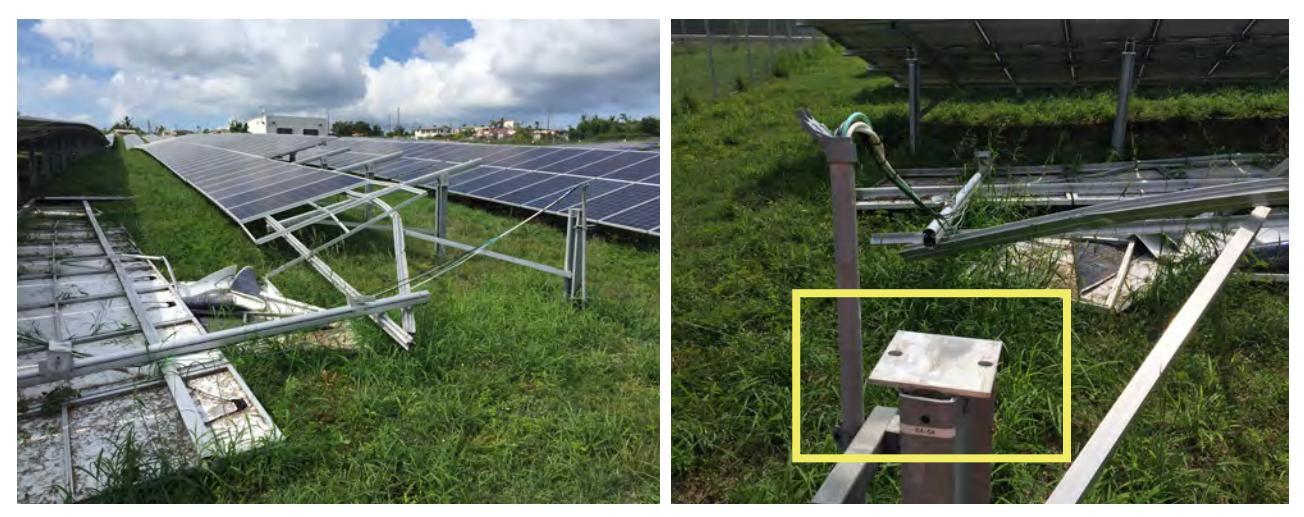
Figure 7-7: Overturned solar panels at the edge of the array at Estate Spanish Town. Failed bolts, shown missing in the yellow box, allowed the rails and panels to pull loose and lift additional sections of the array (left image). The wind load-loosened bolts were found immediately adjacent to the damage.

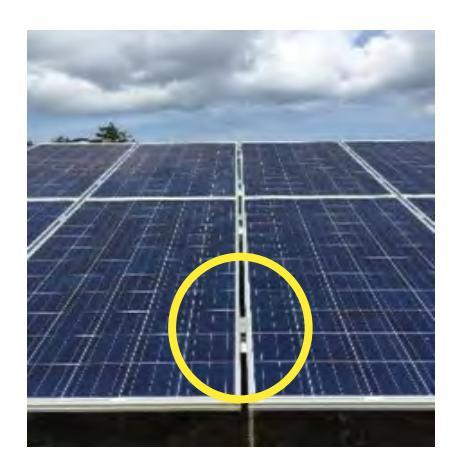
Figure 7-8: Close-up view of clips that held the PV panels to the rails of the array at Estate Spanish Town. These clips were used at the end of frame sections (left) and in-between panels within a frame section (right), as indicated by the yellow circles. Their design of extruded aluminum was robust and performed well; even in one section where the rails detached from the rest of the frame, the panels mostly remained clipped to the rails.

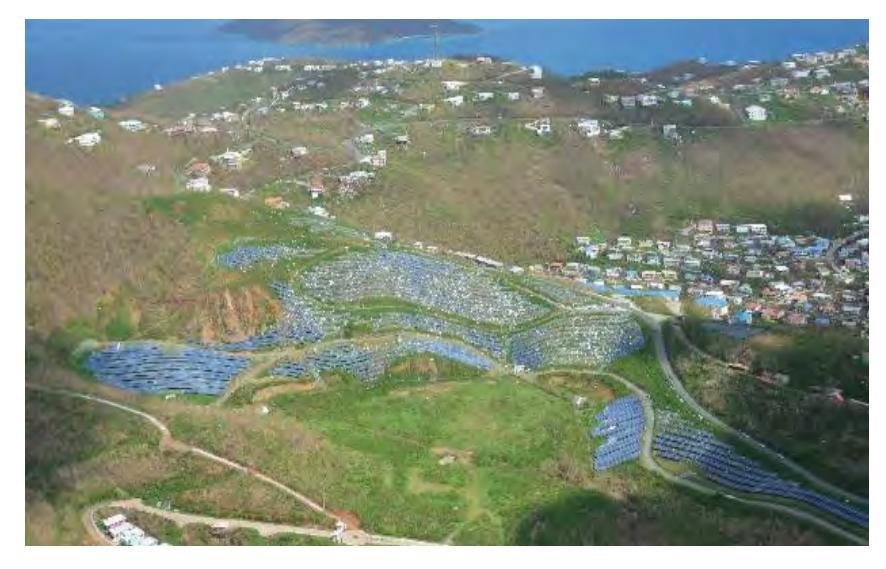
Figure 7-9: Aerial view of the Estate Donoe Solar Array on St. Thomas. (Photo by Civil Air Patrol).

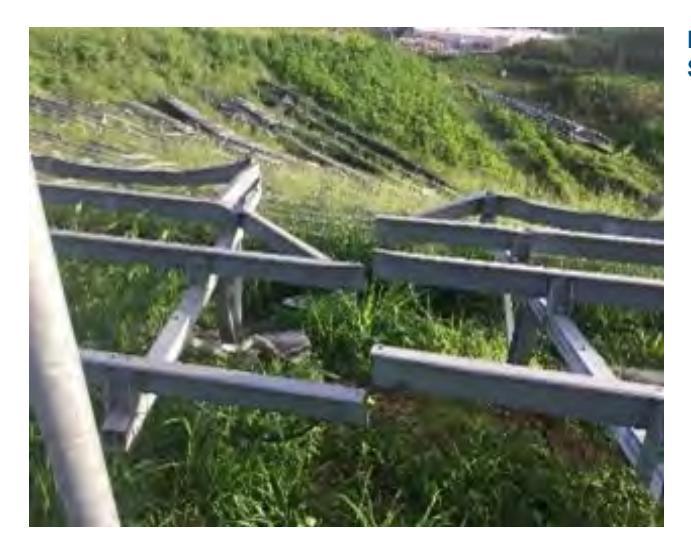
# Figure 7-10: View of the framing for the Estate Donoe Solar Array.

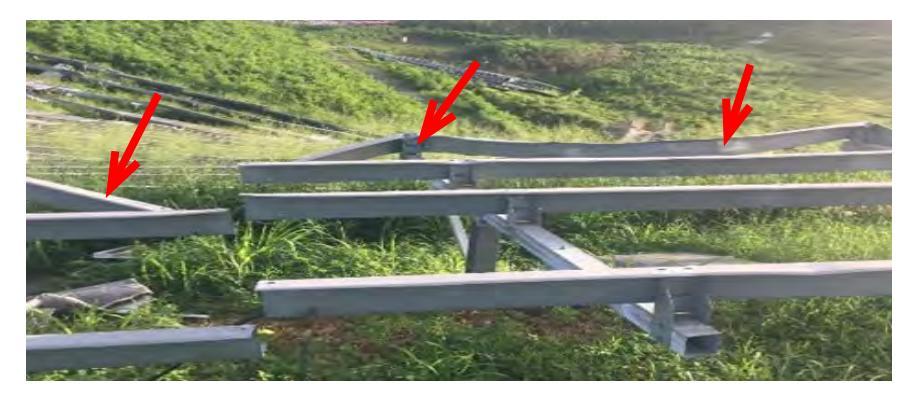
Figure 7-11: Damaged purlings and solar panels at the Donow Solar Array indicated by red arrows.

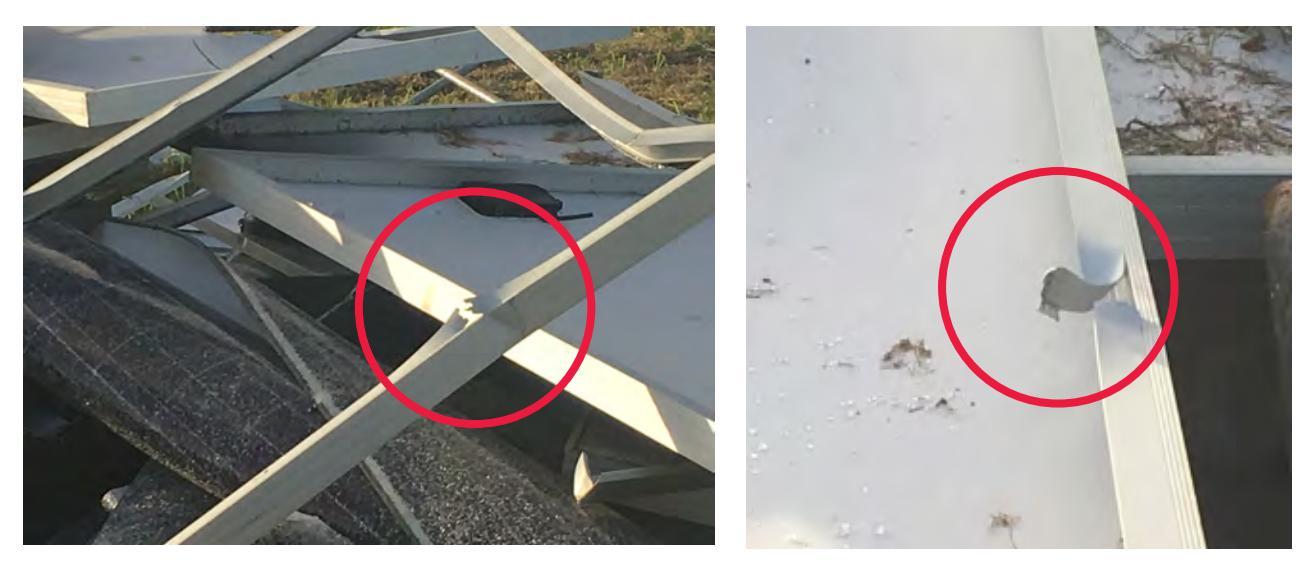
Figure 7-12: View of failure of the metal frames supporting the solar panels. Only four bolts were used to connect the panels to the supporting frame through the light gauge metal frame on the panel itself. Red circles identify failure points.

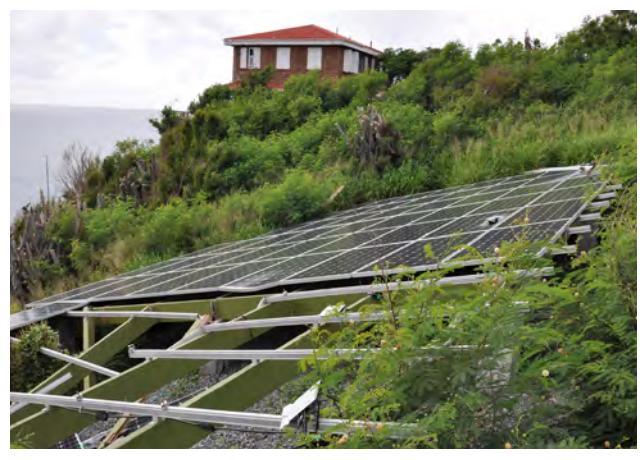
Figure 7-13: View of a small ground-mounted array.

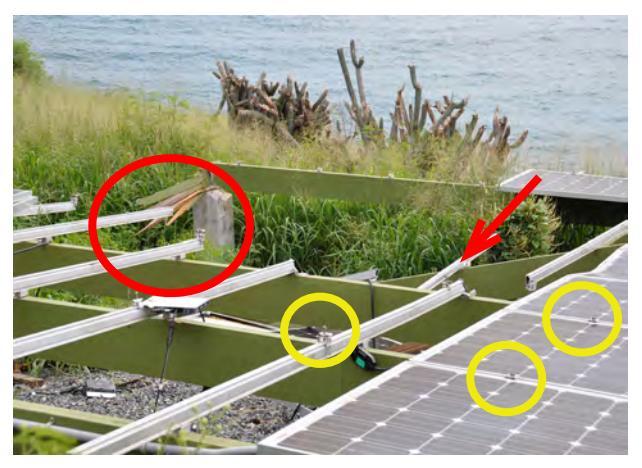
Figure 7-14: The broken perimeter beam is within the red oval. The red arrow indicates one of the beams that dropped after the perimeter beam failed. The yellow circles indicate panel clamps.

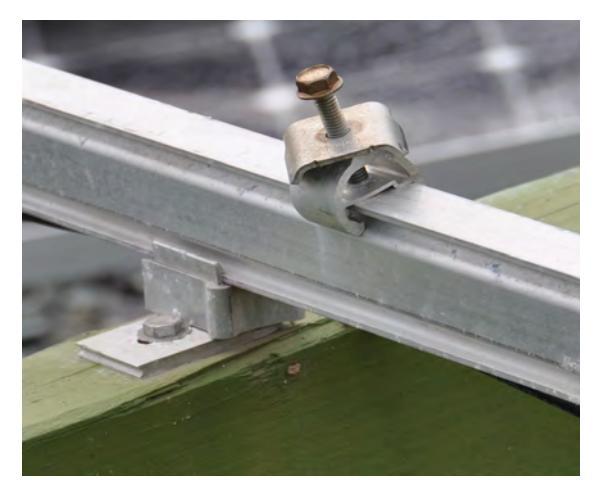
Figure 7-15: View of a panel clamp, rail, and connection of the rail to the beam.

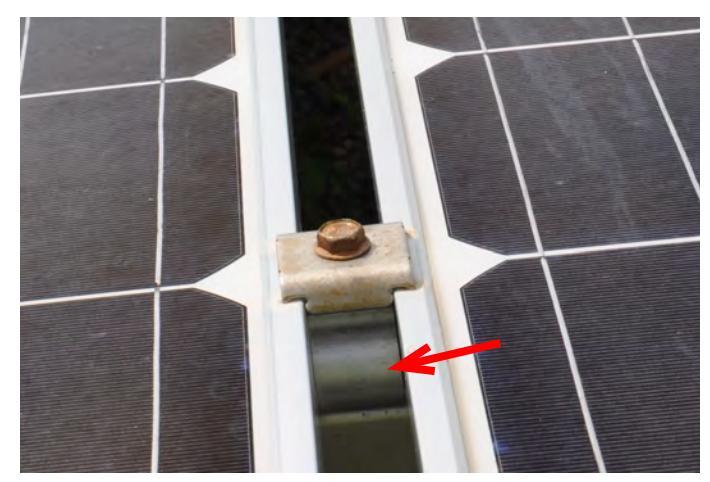
Figure 7-16: View of undamaged panel clamp. The clamp connects two adjacent panels. The red arrow indicates the rail underneath the panels.

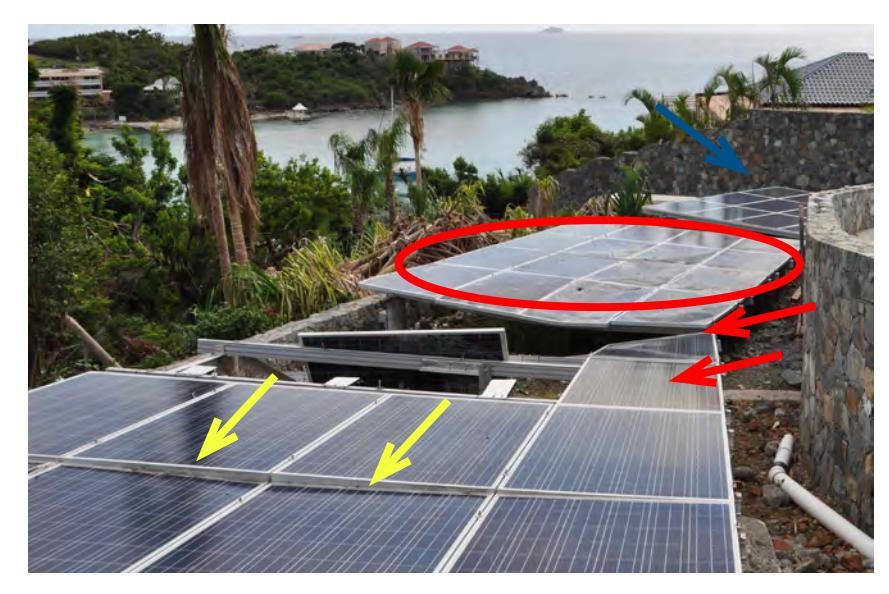
Figure 7-17: The panels within the red oval and the panels indicated by the red arrows had been damaged by wind-borne debris. Six panels to the left of the panels with the red arrows detached from the rails. The yellow arrows indicate panels that lifted. There was no apparent damage at the array shown by the blue arrow.

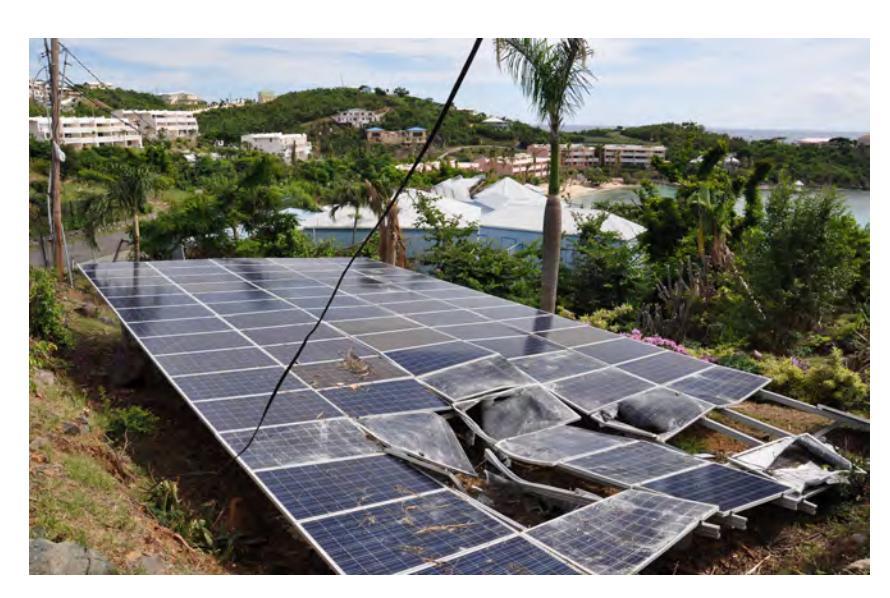
Figure 7-18: In addition to the windborne debris damage to panels and rails in the foreground, some panels beyond were damaged. A few panels detached from the rails but did not blow away (similar as shown at the yellow arrows in Figure 7-17).

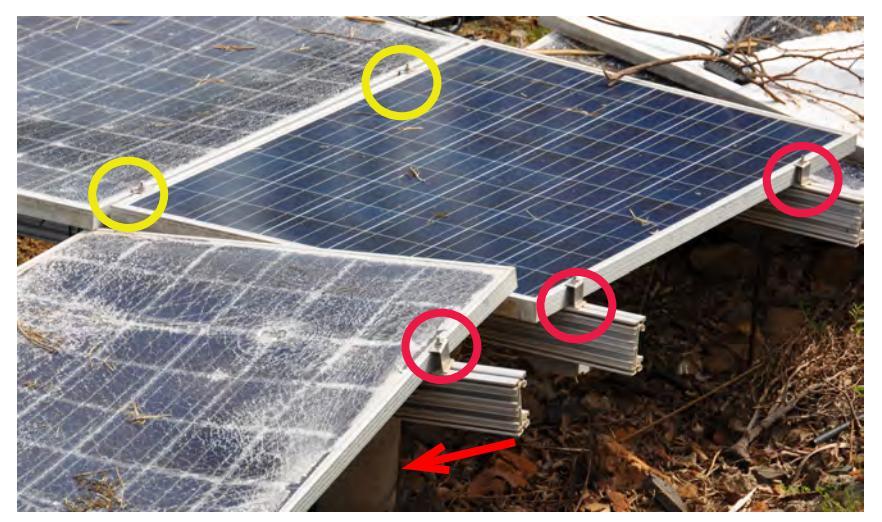
Figure 7-19: View of panel clamps. The red circles indicate end clamps. The yellow circles indicate clamps that connect two panels. The red arrow indicates a concrete column. The two panels to the left had been broken by wind-borne debris.

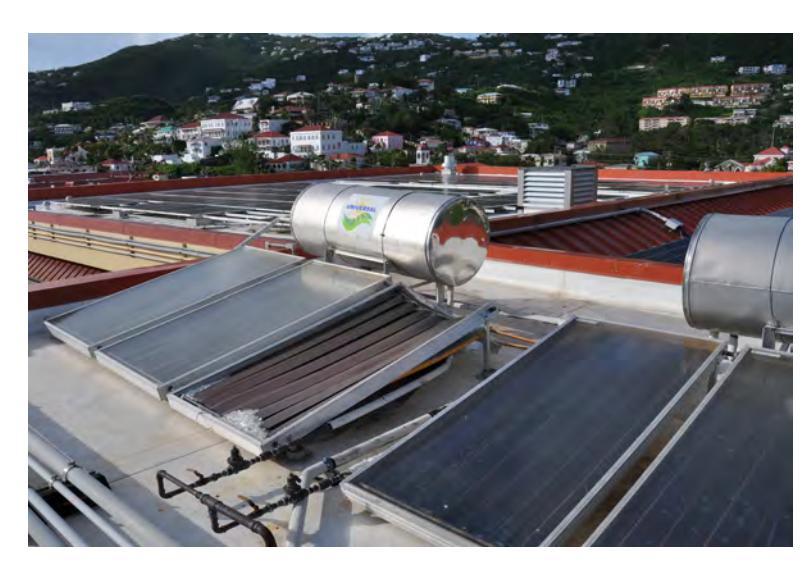
Figure 7-20: View of solar hot water heaters. The red arrow indicates windborne debris damage. The yellow arrow indicates PV panels beyond.
