# Mitigation Assessment Team Report

# Hurricanes Irma and Maria in the U.S. Virgin Islands

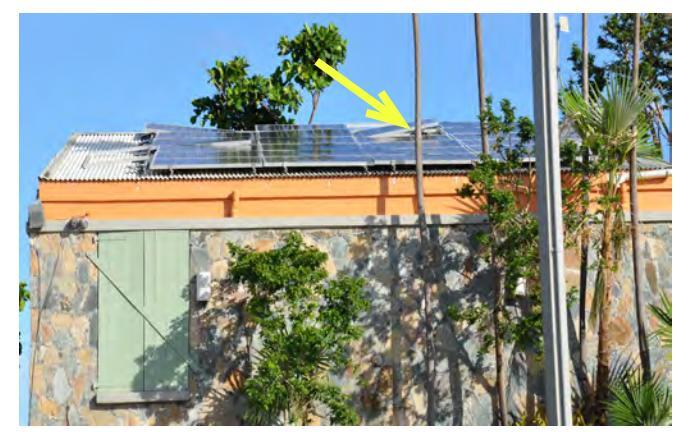
Figure 7-21: Blow-off of panels adjacent to the rake was initiated by failure of a rail connection, indicated by red arrow (Figure 7-22). The yellow arrow indicates a panel that lifted but did not blow off. The adjacent up-slope panel did blow off, indicated by orange arrow.

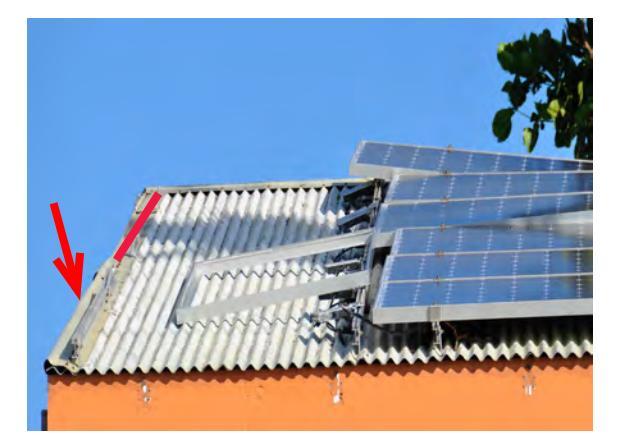
Figure 7-22: View of damaged rails. The red arrow indicates a rail that is still attached. The red line indicates where a rail blew off. It was attached with two clip angles. The bolts connecting the angles to the rail pulled out of the rail.

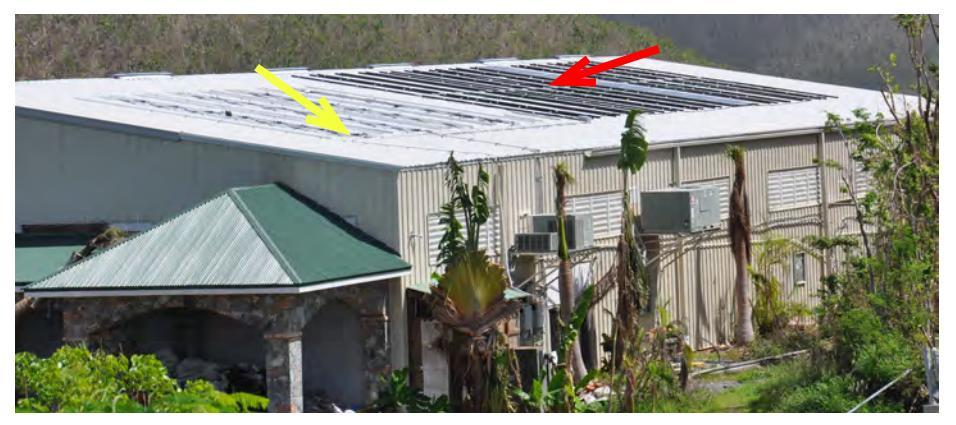
Figure 7-23: View of the severely damaged solar panel array indicated by yellow arrow. The nine panels that remained on the roof are indicated by the red arrow.

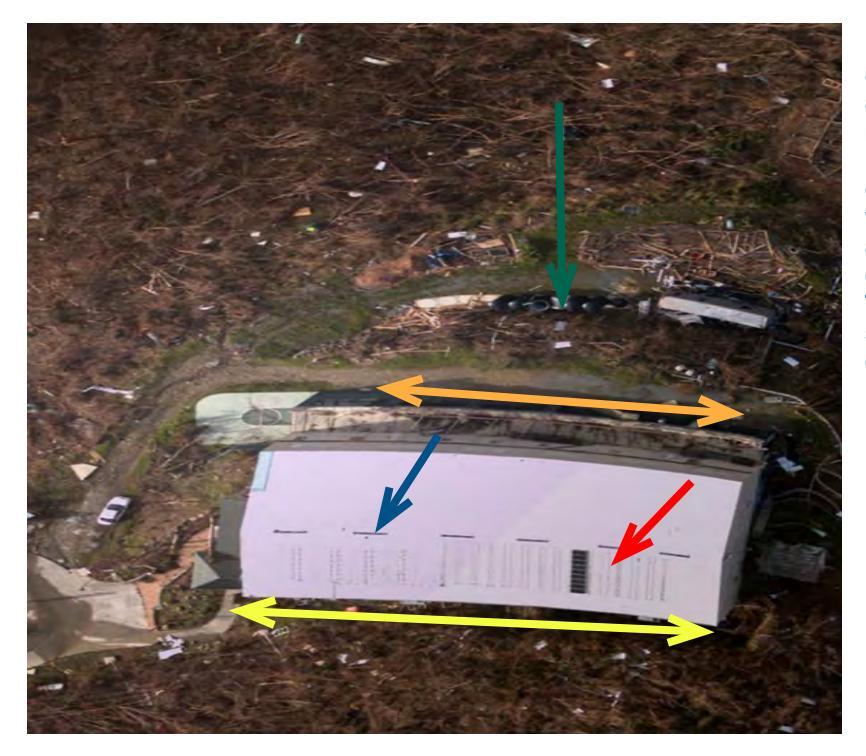
Figure 7-24: Aerial view. The yellow arrow indicates the array. The red arrow indicates the nine panels that remained on the roof. The blue arrow indicates skylights at the ridge. The orange arrow indicates a damaged wood trellis structure. The green arrow indicates the primary wind direction during Hurricane Irma. The hillside slopes up towards the school. The severity of the tree damage was typical of the hurricane impacts. (Photo by NOAA)

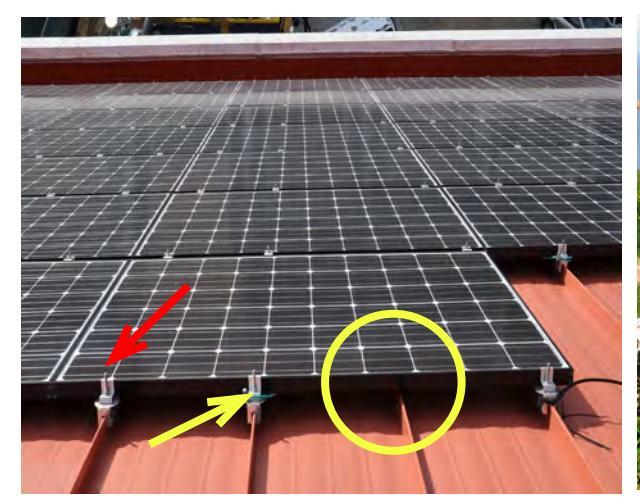
Figure 7-25: View of damaged panel clamps. The red arrow indicates a panel clamp. The yellow arrow indicates an external seam clamp. Clamps were not installed at each seam as indicated by yellow circle, which can lead to overstressing.

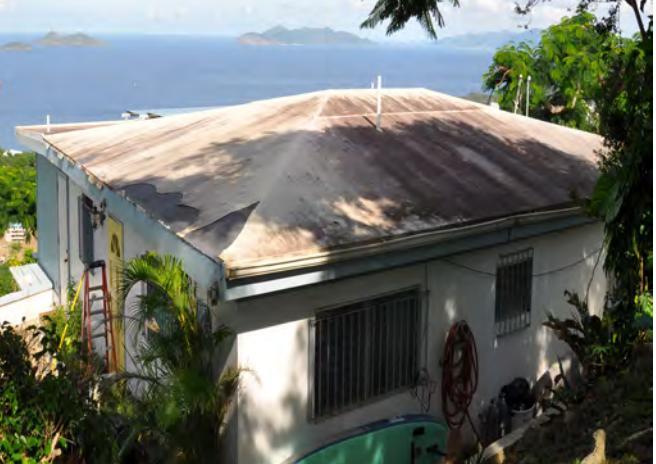
Figure 7-26: View of residential rooftop. The red arrow shows a small portion of the array that is on the backside of the roof. The yellow arrow indicates an area where the liquid-applied membrane had peeled away.

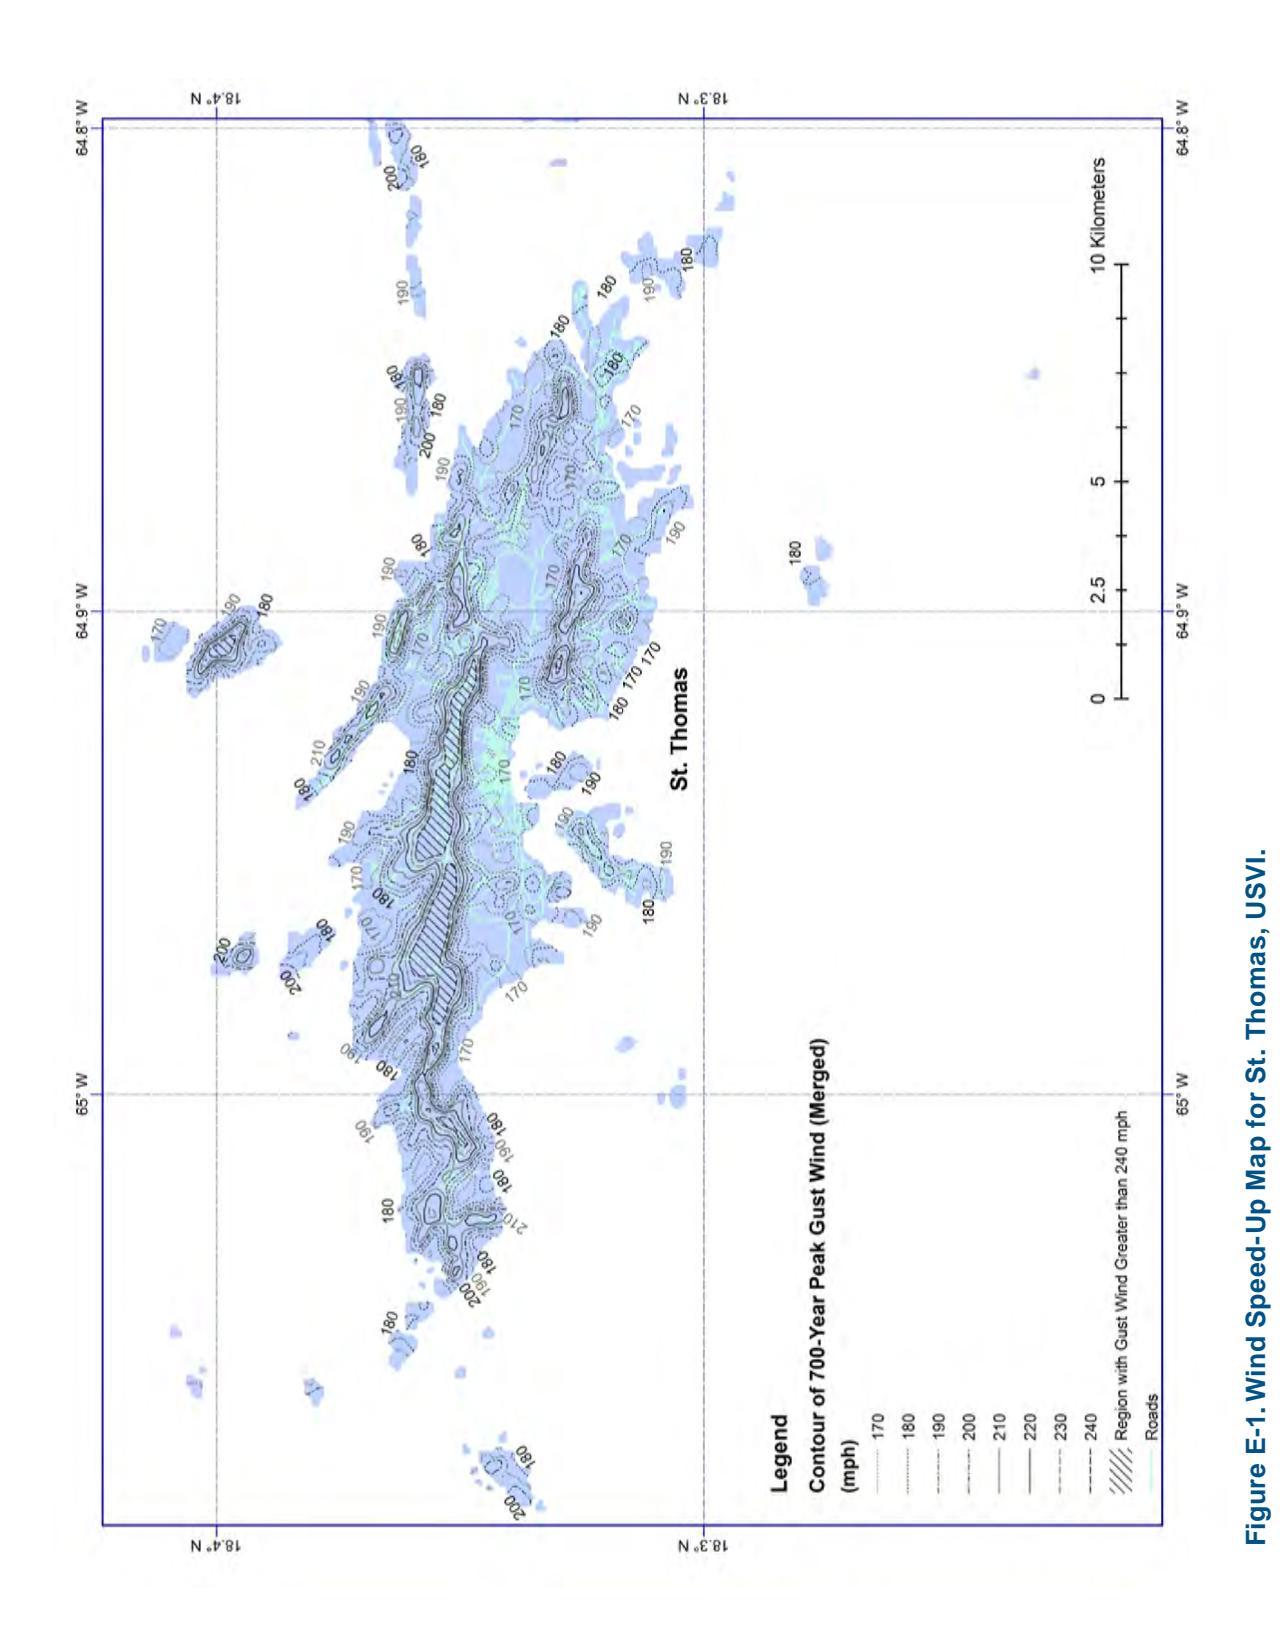
The USVI can evaluate the wind speeds from these revised basic wind speed maps that consider topographic effects for use as a simplified alternative method to determine wind loads and pressures (using a  $K_{zt}$ =1.0 during calculations) on a building or structure. The revised basic wind speed maps do not change the design wind criteria of ASCE 7. Rather, if these wind speed maps are adopted for use as an alternative method for calculating design wind pressures, they will enable a designer to more quickly determine wind loads and pressures on a building where topographic effects must be considered without requiring design professionals to perform additional, and complex, calculations.
