8.1 INTRODUCTION

8.1.1 Contents of Chapter

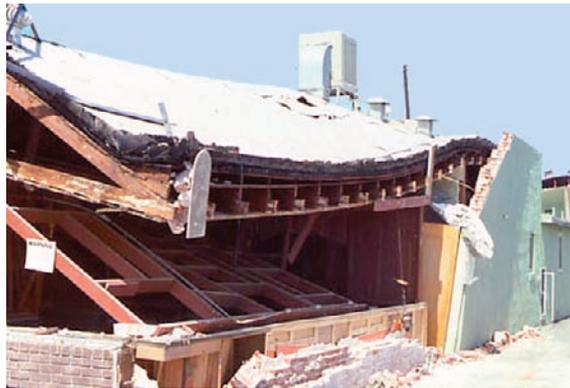
Figure 8-1: Example of buildings with no code design. Damage shows classic URM deficiencies.

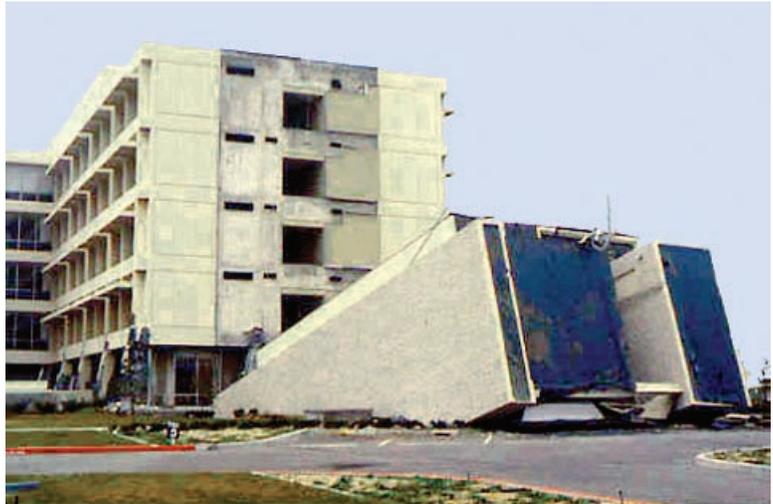
Figure 8-2: Olive View Hospital. A brand new facility that was damaged beyond repair in the 1971 San Fernando earthquake due to a shaking intensity that exceeded what was expected at the site and a design that, although technically complying with code at the time, contained several structural characteristics now considered major deficiencies. The lateral system contained nonductile concrete frames, discontinuous shear walls, and a significant weak story.

Similar to advancements in structural analysis and the understanding of building performance, enormous advancements have been made in the understanding of ground motion, particularly since the 1950s and 1960s. The seismicity (that is, the probability of the occurrence of various-sized earthquakes from each source) of the country, the likely shaking intensity from those events depending on the distance from the source and the local soil conditions, and the exact dynamic nature of the shaking (the pattern of accelerations, velocities, or displacements) are all far better understood. These advancements have caused increases in seismic design forces from a factor of 1.5 in regions very near active faults (on the West Coast) to a factor of 2 to 3 in a few other areas of the country (e.g. Utah; Memphis, Tennessee). The damage to the first Olive View Hospital (Figure 8-2), in addition to other issues, was a result of inadequate zoning.

Current codes contain many rules to minimize configurations that could cause dangerous nonlinear response, as well as special design rules for elements potentially affected (e.g., columns supporting discontinuous shear walls). Olive View Hospital featured a weak first story in the main building, causing a permanent offset of more than one foot and near collapse; discontinuous shear walls in the towers caused a failure in the supporting beam and column frame, resulting in complete overturning of three of the four towers. Figure 8-4 shows a typical “tuck-under” apartment building in which the parking creates a weak story.

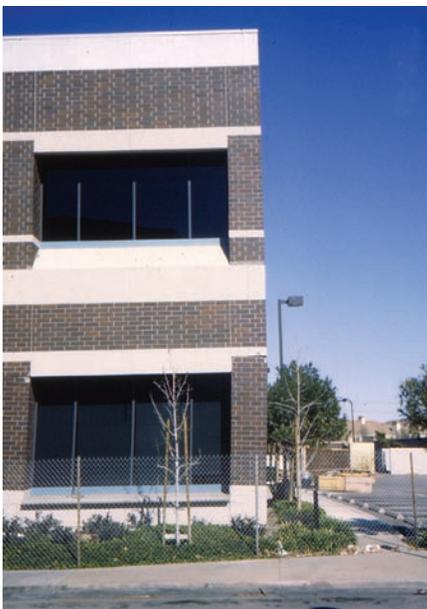
Figure 8-3: An example of a recently designed building with seismic deficiencies not understood at the time of design. In this case, the deficiency was “pre-Northridge” moment-frame connections, which proved to be extremely brittle and unsatisfactory. Hundreds, if not thousands, of these buildings were designed and built in the two decades before the Northridge earthquake (1994).

Other buildings designed with systems assumed to possess certain ductility have been proven inadequate. Figure 8-3 shows typical steel moment-frame damage in the Northridge earthquake caused by brittle behavior in a structural system previously thought to be of high ductility.

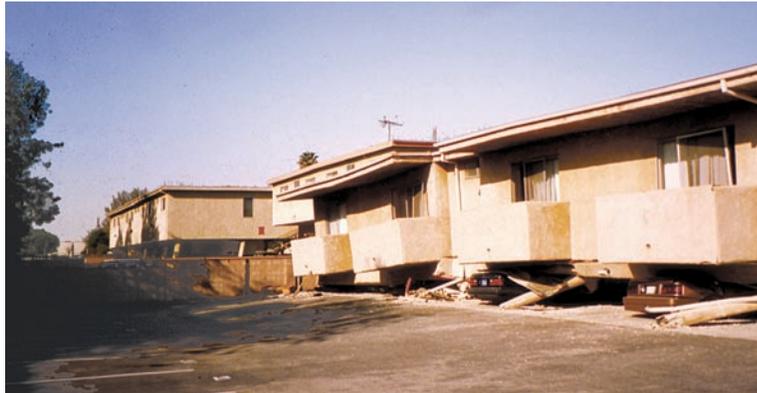
Figure 8-5: A tuck-under similar to Figure 8-4, but much more modern and designed at a time when the weakness of the parking level was more understood. In this case, the detailing of the small wood shear walls at that level was poor. This practice created another set of deficient “existing” buildings.

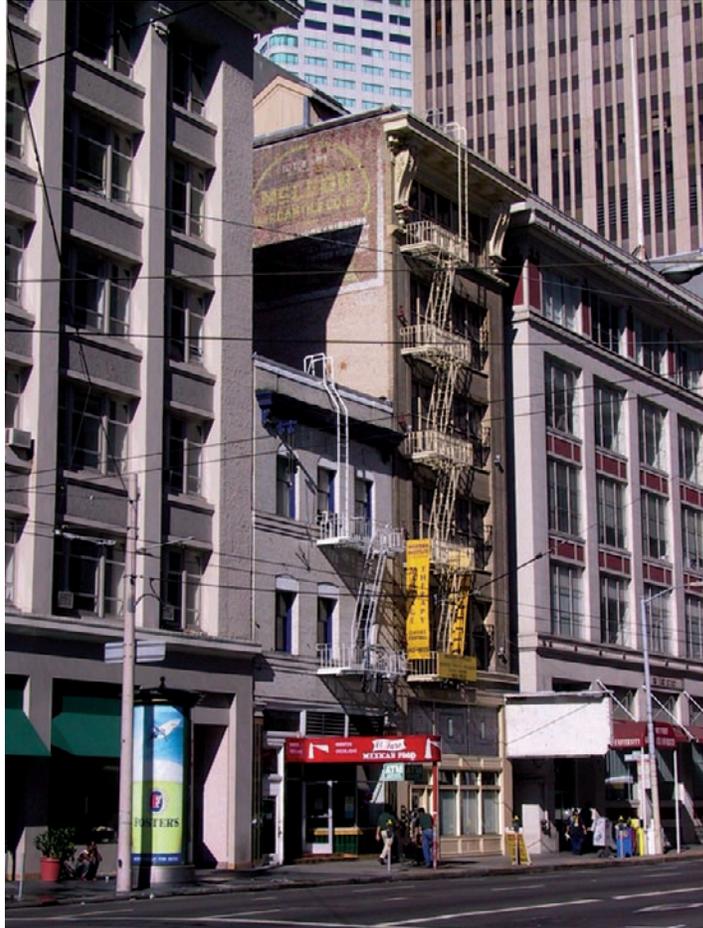
The small building in the center clearly cannot fail side to side, but this condition is not considered in mandatory retrofit ordinances that assume the adjacent buildings may be removed. In fact, however, the small building is in great danger from falling debris from its taller neighbors. In addition, the taller buildings are at risk from receiving serious damage to the corner columns from pounding against the shorter building.

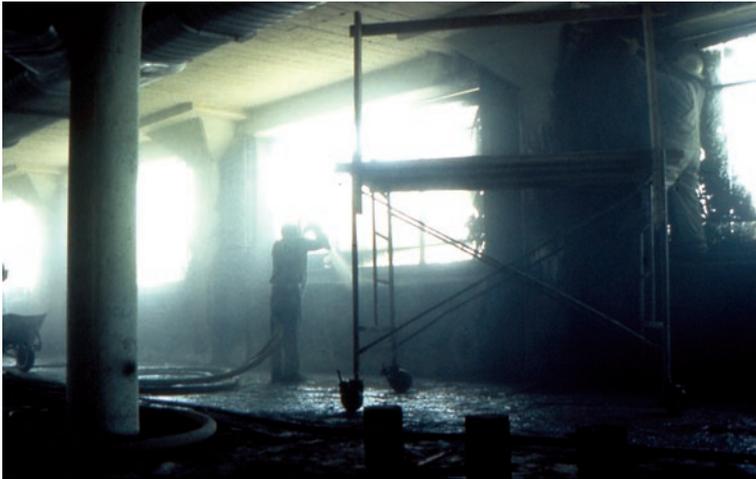
Figure 8-10: Intense construction activity and disruption from interior shotcrete.

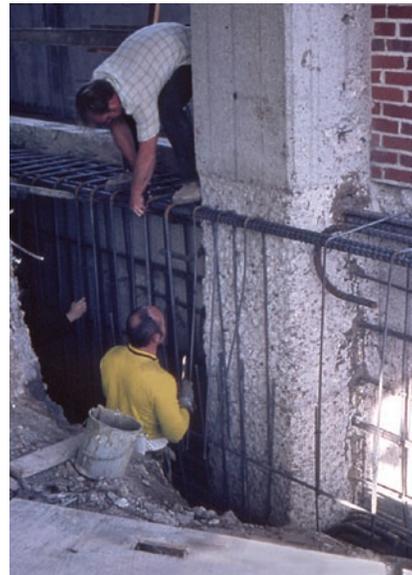
Figure 8-11: Retrofit activities inside buildings are most often not surgical or delicate. Here work on a new foundation for a shear wall is prepared for casting.

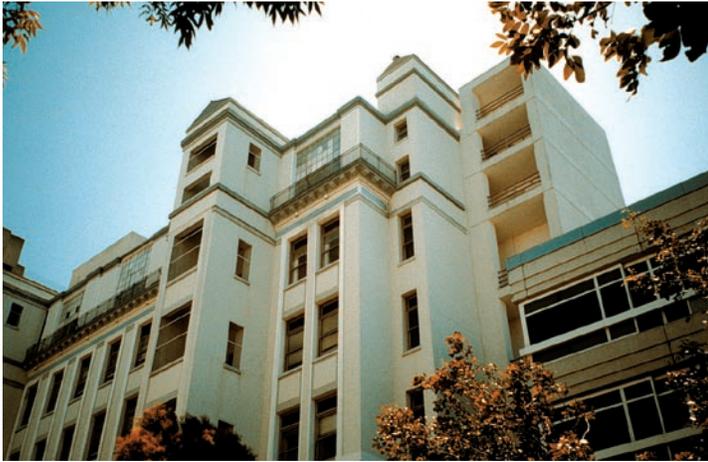
Figure 8-12: External towers were added to strengthen this building from the outside. The new tower is the element at center-left of the figure. The retrofit scheme for this building is discussed in detail in Figure 8-9.

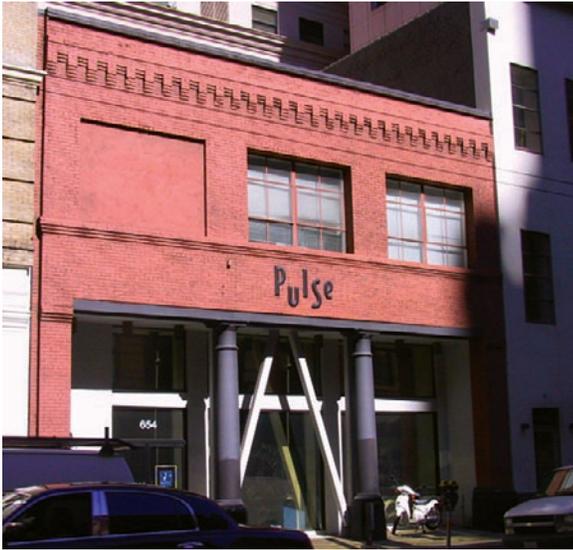
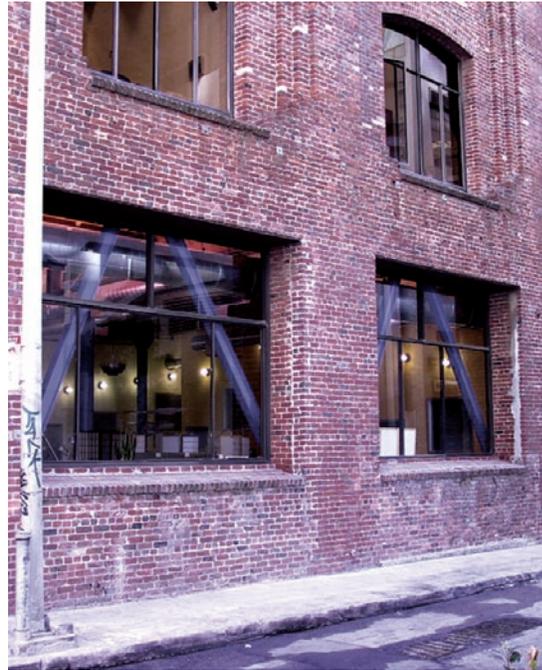
Figure 8-13: Examples of the many configurations of steel braced frames used in commercial retrofit in San Francisco.

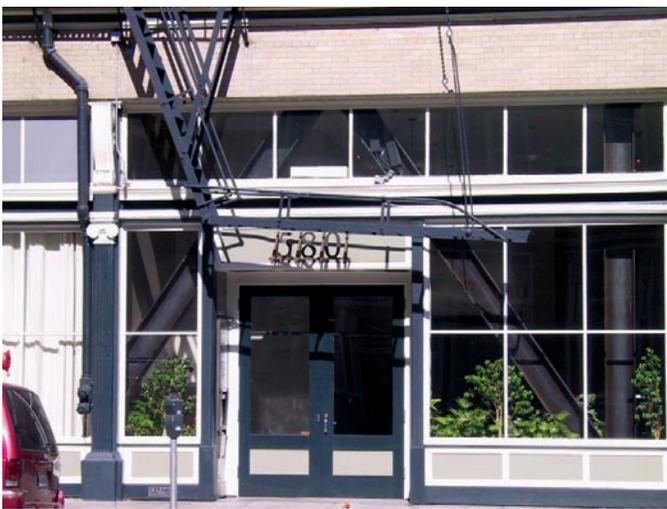
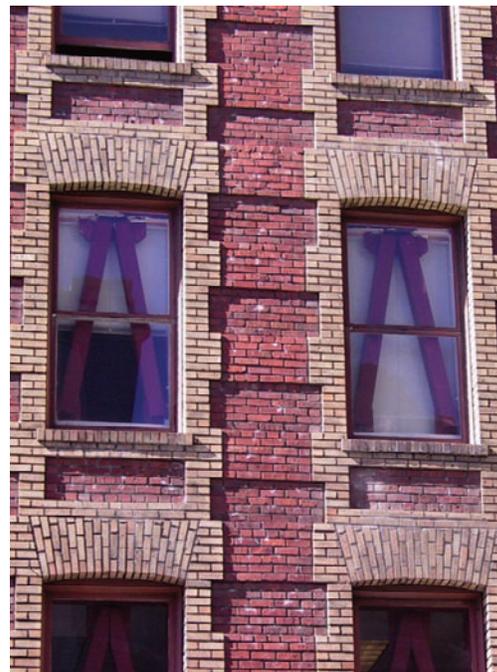
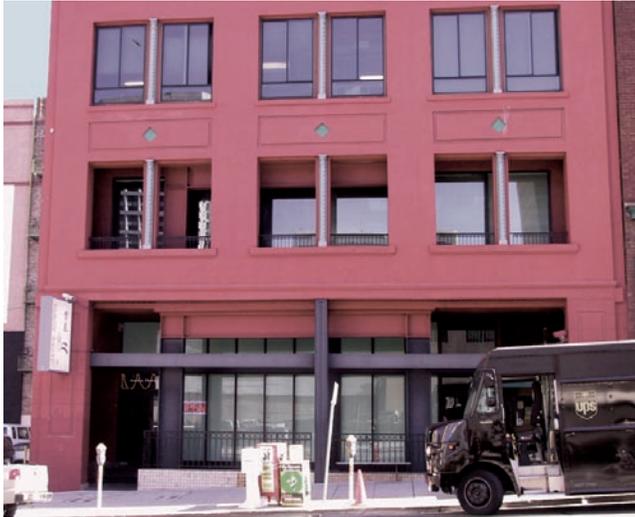
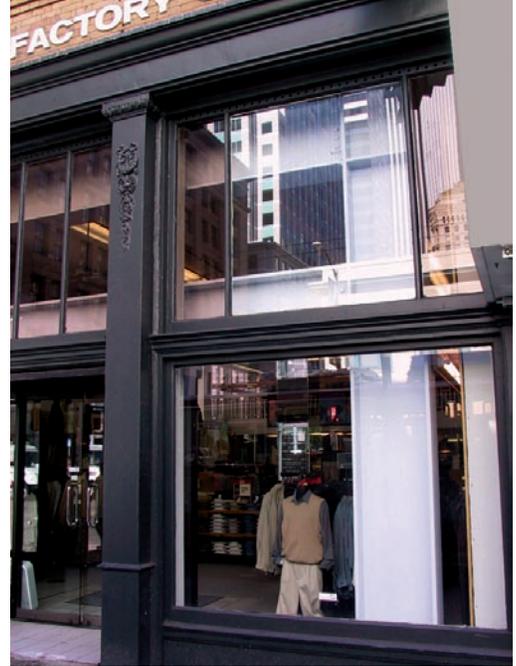
Figure 8-14: Examples of steel moment frames in similar commercial retrofits. Right: Note the large white column and double beam arrangement. Left: The moment frame is placed against the wall of the recess. The first floor columns are gray and the balance is pink. The frame can be seen on both the first and second floors.

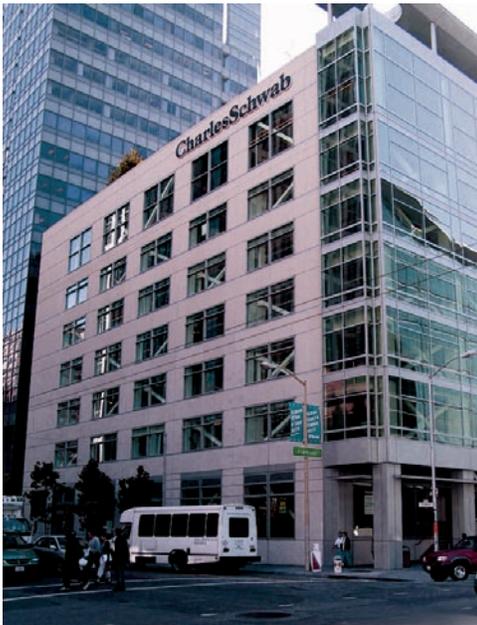
Figure 8-16: Steel braced frames on exterior of building to avoid construction on the inside of the building.

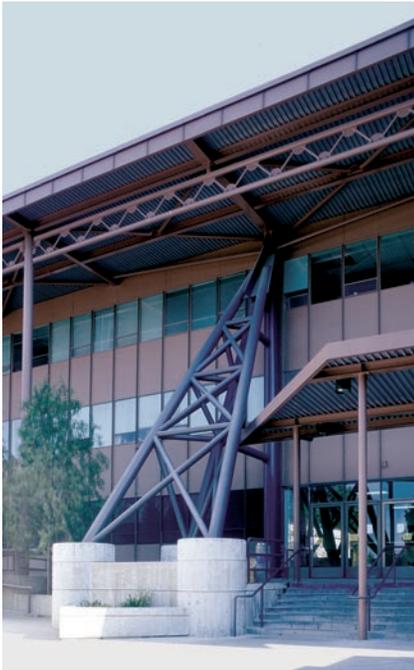
Figure 8-17: A modern exterior buttress used for seismic strengthening.

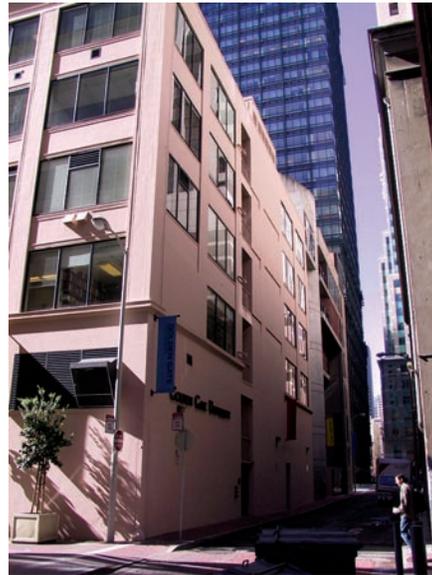
Figure 8-19: Examples of addition of a new wall on the exterior of the building.

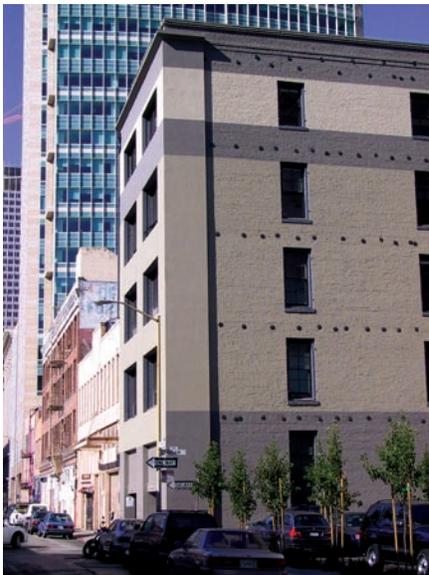
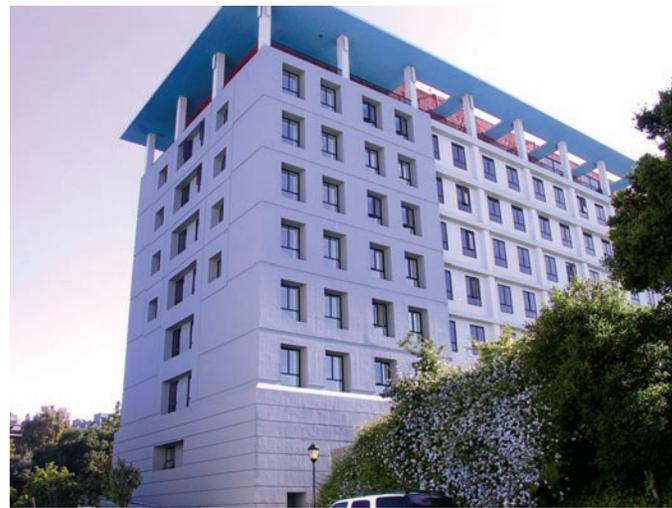
Left: The end wall has a new layer of concrete that wraps around the side for a short distance. This solution is unusual in an urban setting because of property lines. Right: a large academic building with more extensive C-shaped end elements. This solution facilitated construction while the building was occupied, although there was considerable noise and disruption experienced by the occupants.

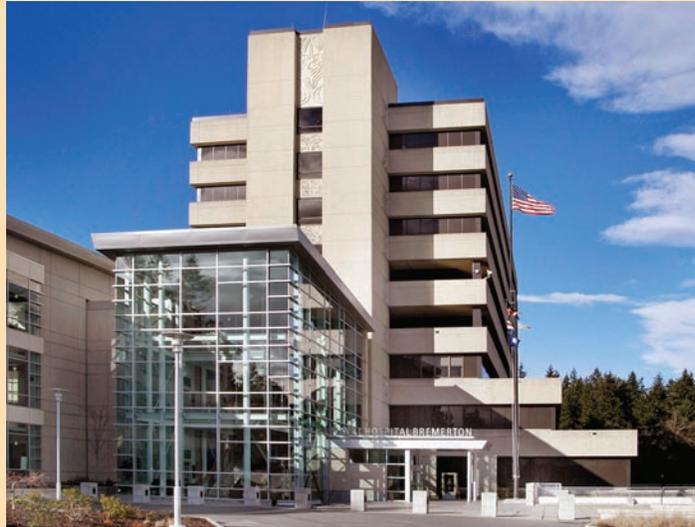
Box 3 CASE STUDY: SEISMIC RETROFIT BREMERTON NAVAL HOSPITAL WASHINGTON

The building's lateral-resisting system, constructed in the "pre-Northridge" 1960s, is comprised of steel moment-resistant frames at all beam-column connections. Although highly redundant, it is too flexible, resulting in excessive drift. The cladding panel connections were not designed to accommodate the expected drifts from a design-level earthquake, and presented a potential falling hazard. Additionally, there was incompatibility between the flexible structure and the rigid concrete stair tower.

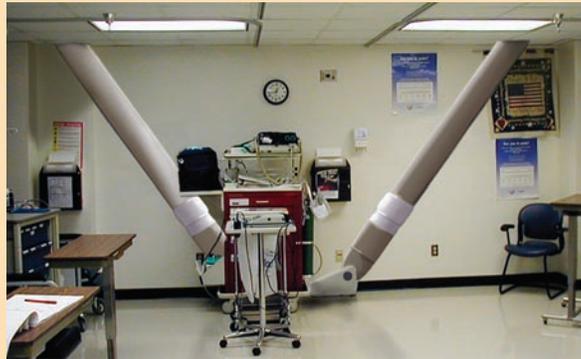
The use of supplemental passive damping devices proved to be the best approach to improve the seismic performance of the structure by reducing drift, while minimizing disruption during construction. Seismic forces, displacements, and floor accelerations would be substantially reduced by dissipation of the earthquake's energy through heat created in the damping devices. A total of 88 seismic dampers were installed at 44 select locations in the building.

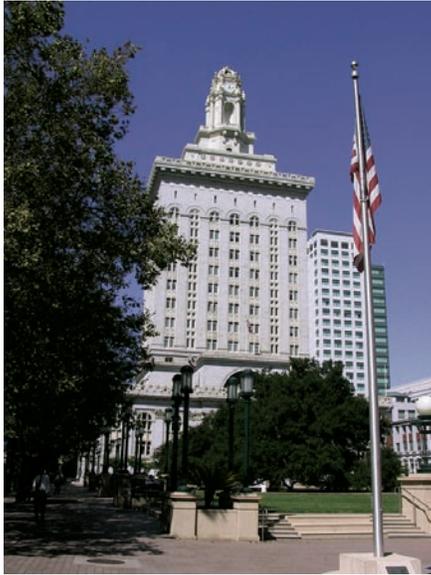
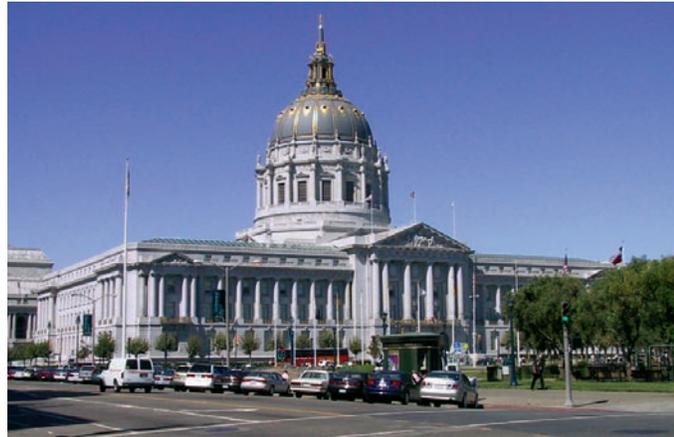
Figure 8-20: Several examples of historical buildings seismically retrofit and protected by seismic isolation.

Upper left: Oakland City Hall (Engineer: Forell/Elsesser). Upper right: San Francisco City Hall (Engineer: Forell/Elsesser). Bottom: Hearst Mining Building at University of California, Berkeley (Engineer: Rutherford & Chekene). Installation of an isolation system under an existing building is complex and often expensive, but the system minimizes the need to disrupt historic fabric in the superstructure with shear walls or braces, and is designed to protect the superstructure from significant damage in a major event.

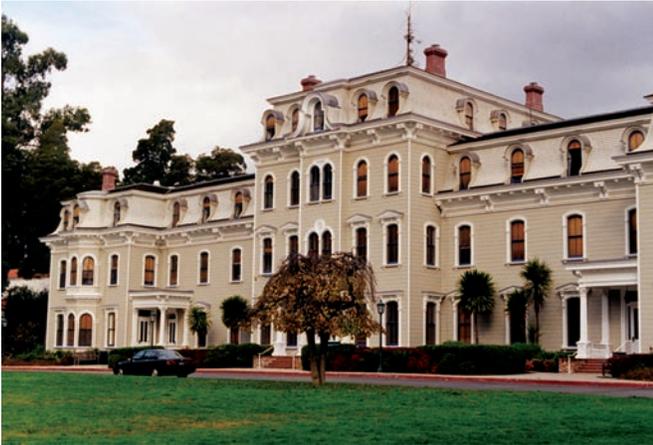
Figure 8-21: Mills Hall, Mills College, California. Structure is wood studs and sheathing. Interior shear walls were created by installing plywood on selected interior surfaces.

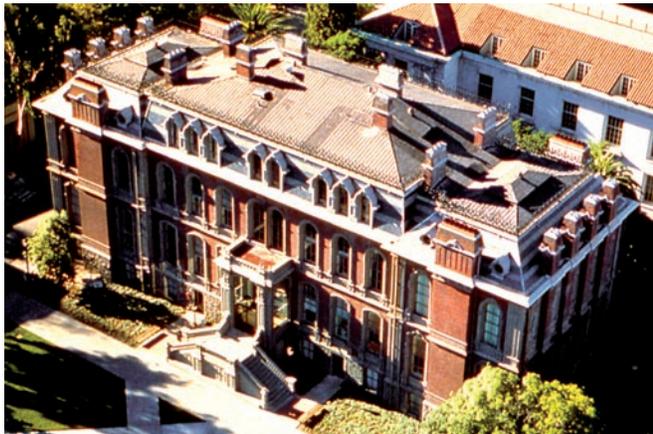
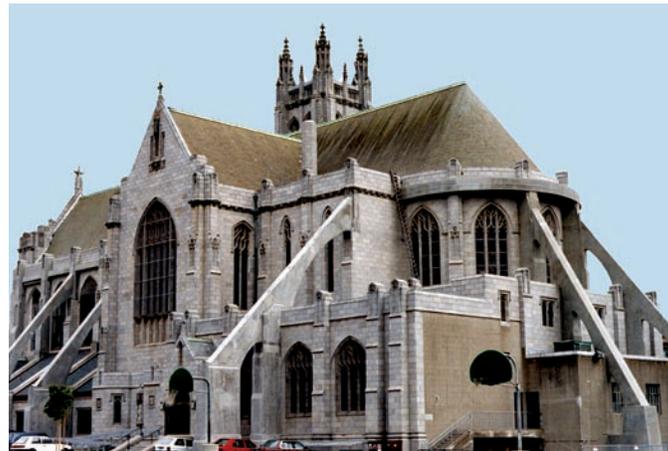
Figure 8-22: St. Dominic's Church in San Francisco was seismically retrofitted using exterior buttresses.

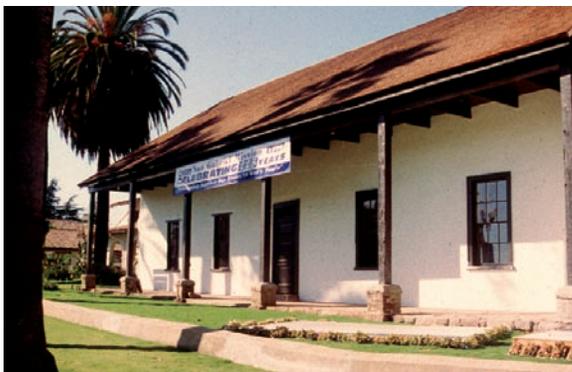
Figure 8-26: The museum at San Gabriel Mission, southern California, a historic adobe structure damaged by earthquakes in 1987 and 1994. It was repaired and strengthened, including installation of a bond beam of steel in the attic, anchor bolts into the wall, and stitching of cracks back together on the interior walls.

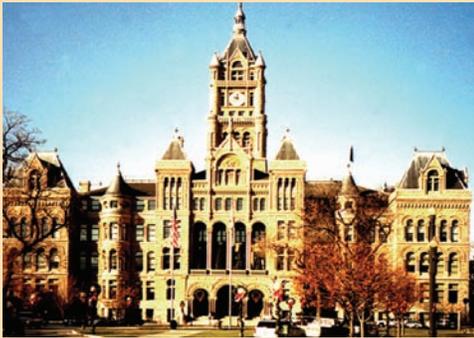
Figure A: The Salt Lake City and County Building.

The Salt Lake City and County Building was completed in 1894. It is now the seat of government for Salt Lake City, Utah. The historic landmark also housed offices for Salt Lake County until the 1980s but still retains its original name. The building is an unreinforced masonry bearing-wall structure with a 250-foot-high central clock tower (Figure A).

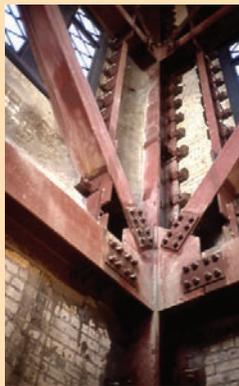
Figure C: Steel space frame inserted within tower
