Rapid Visual Screening of Buildings for Potential Seismic Hazards

A Handbook

FEMA 154, Edition 2 / March 2002

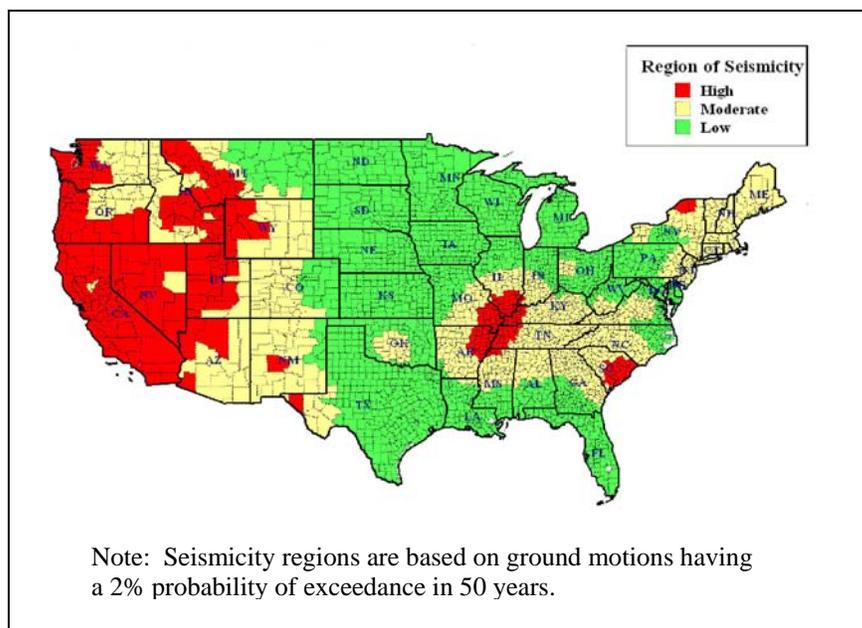
Figure 1-1 High, moderate, and low seismicity regions of the conterminous United States. A different RVS Data Collection Form has been developed for each of these regions. Enlarged maps are available in Appendix A.

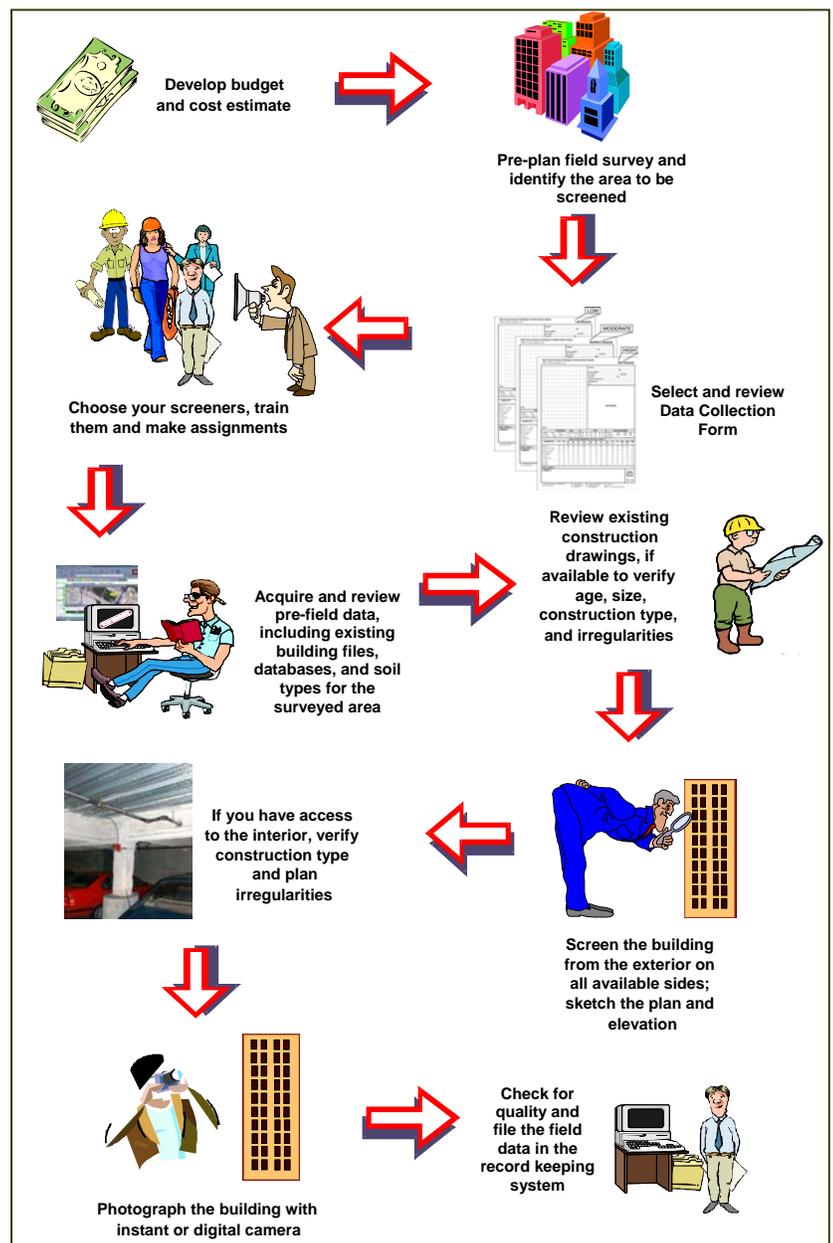
Figure 2-1 Rapid visual screening implementation sequence.

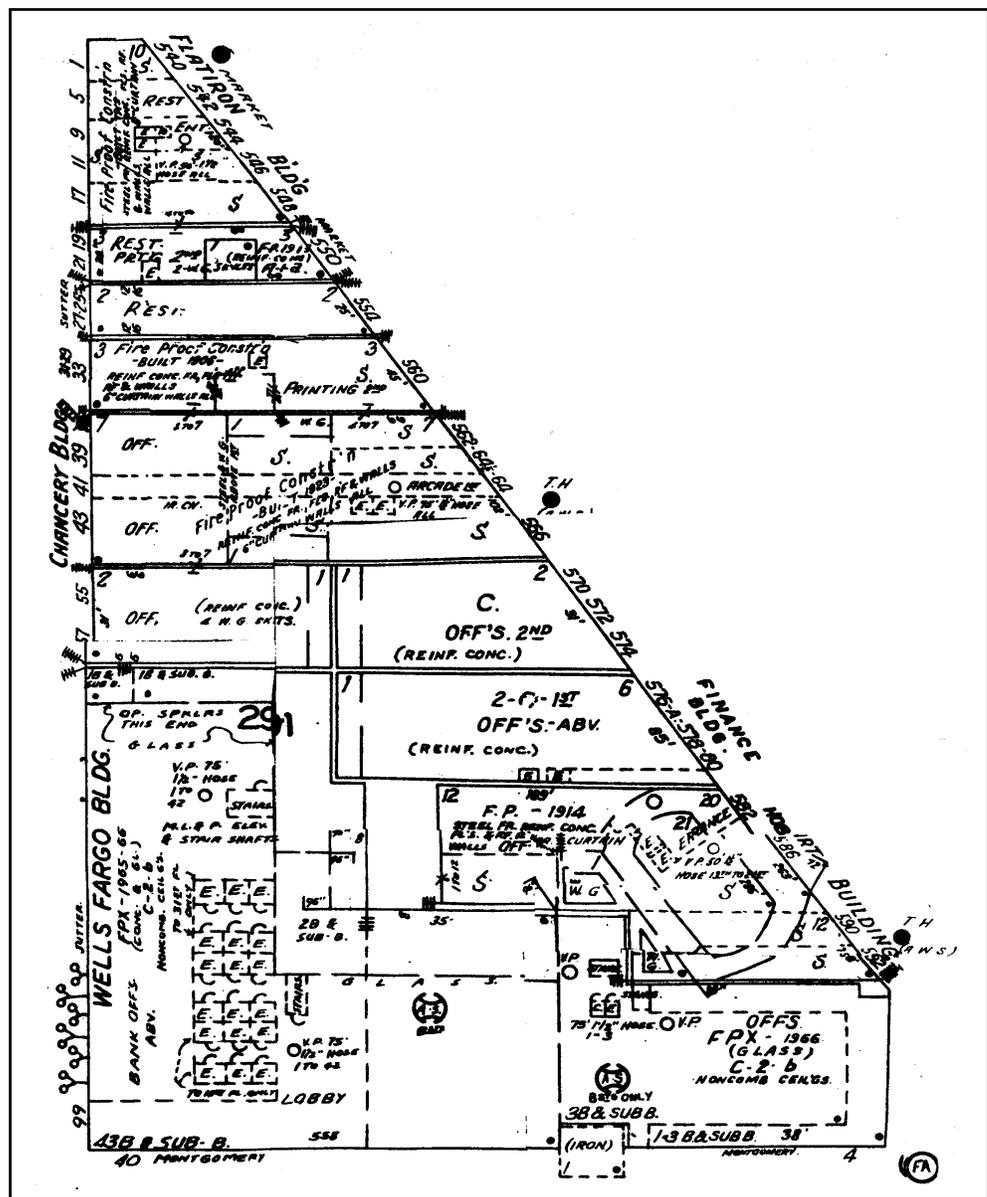
Figure 2-5 Example Sanborn map showing building information for a city block.

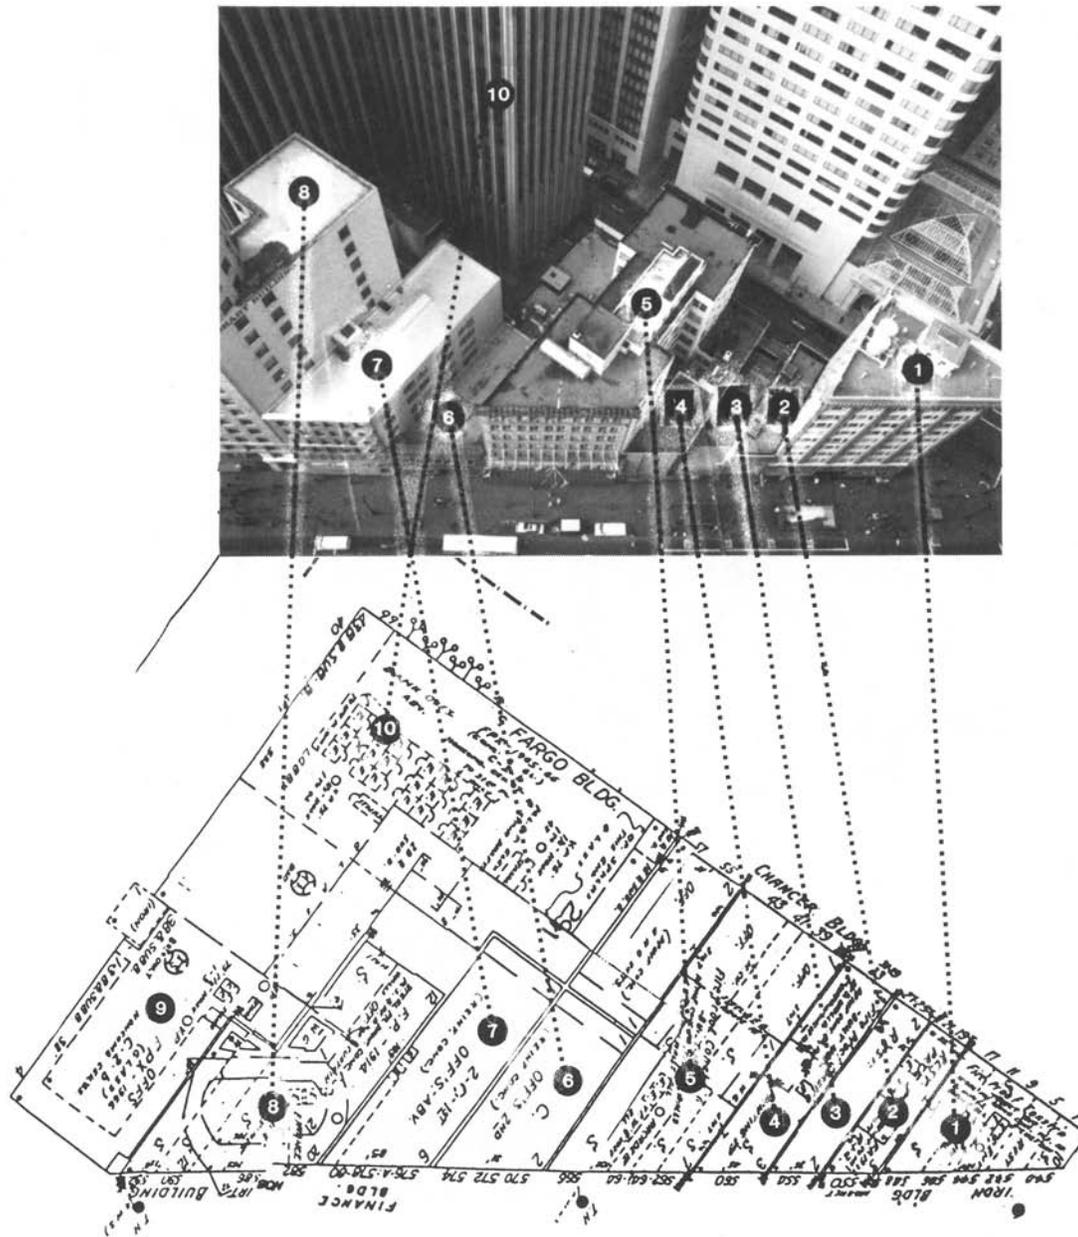
1. 10 story commercial office
2. 3 story commercial, built 1913
3. 2 story commercial
4. 3 story commercial, reinforced concrete frame, built 1906
5. 7 story commercial office, reinforced concrete frame, built 1923
6. 2 story commercial, reinforced concrete
7. 5 story commercial office, reinforced concrete
8. 20 story commercial office, steel frame with reinforced concrete, built 1914
9. 4 story commercial, built 1966
10. 40 story commercial office, built 1965-66, concrete and glass exterior

Figure 2-7 Sanborn map and corresponding aerial photograph of a city block.

Figures 2-7 and 2-8 show a Sanborn map and photographs of a city block. Building descriptions obtained from the Sanborn maps are also included.

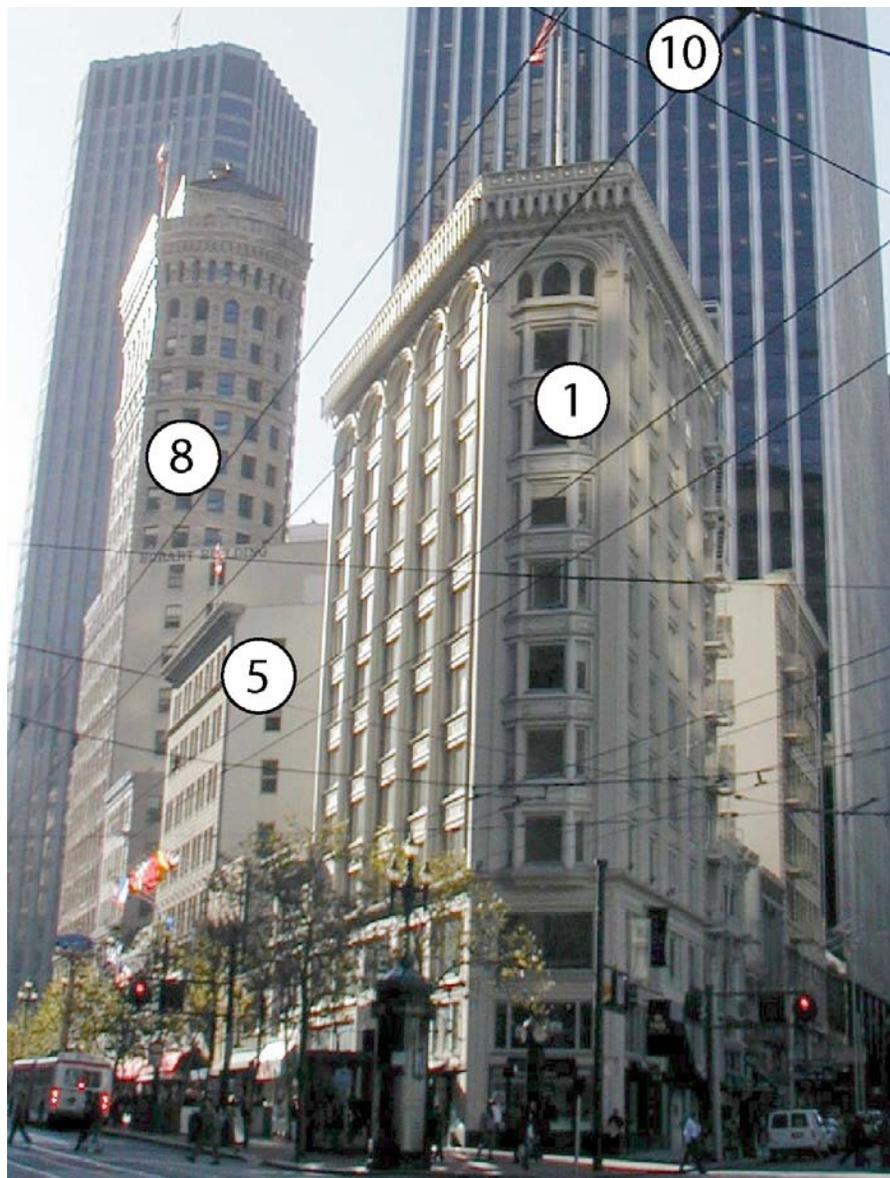
Figure 2-8 Photographs of elevation views of buildings shown in Figure 2-7.

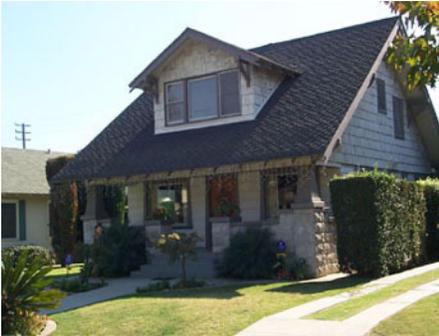
<i>Building Identifier</i>	<i>Photograph</i>	<i>Basic Structural Hazard Score</i>	<i>Characteristics and Performance</i>
<p>W1 Light wood frame residential and commercial buildings equal to or smaller than 5,000 square feet</p>

<p>H = 2.8 M = 5.2 L = 7.4</p>	<ul style="list-style-type: none"> ● Wood stud walls are typically constructed of 2-inch by 4-inch vertical wood members set about 16 inches apart (2-inch by 6-inch for multiple stories). ● Most common exterior finish materials are wood siding, metal siding, or stucco. ● Buildings of this type performed very well in past earthquakes due to inherent qualities of the structural system and because they are lightweight and low rise. ● Earthquake-induced cracks in the plaster and stucco (if any) may appear, but are classified as non-structural damage. ● The most common type of structural damage in older buildings results from a lack of connection between the superstructure and the foundation, and inadequate chimney support.

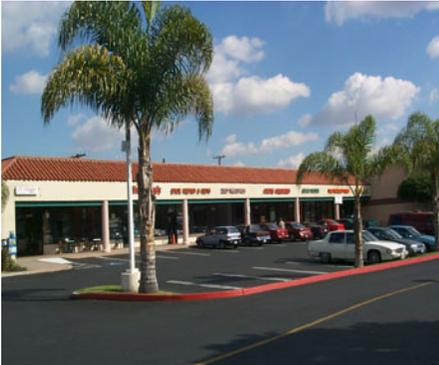
<p>W2 Light wood frame buildings greater than 5,000 square feet</p>

<p>H = 3.8 M = 4.8 L = 6.0</p>	<ul style="list-style-type: none"> ● These are large apartment buildings, commercial buildings or industrial structures usually of one to three stories, and, rarely, as tall as six stories.

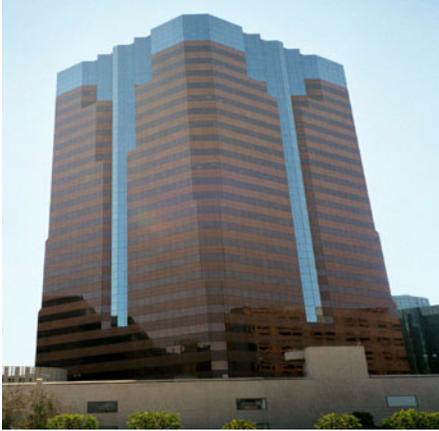
<i>Building Identifier</i>	<i>Photograph</i>	<i>Basic Structural Hazard Score</i>	<i>Characteristics and Performance</i>
<p>S1 Steel moment-resisting frame</p>

<p>H = 2.8 M = 3.6 L = 4.6</p>	<ul style="list-style-type: none"> • Typical steel moment-resisting frame structures usually have similar bay widths in both the transverse and longitudinal directions, around 20-30 ft. • The floor diaphragms are usually concrete, sometimes over steel decking. This structural type is used for commercial, institutional and public buildings. • The 1994 Northridge and 1995 Kobe earthquakes showed that the welds in steel moment-frame buildings were vulnerable to severe damage. The damage took the form of broken connections between the beams and columns.
<p>S2 Braced steel frame</p>

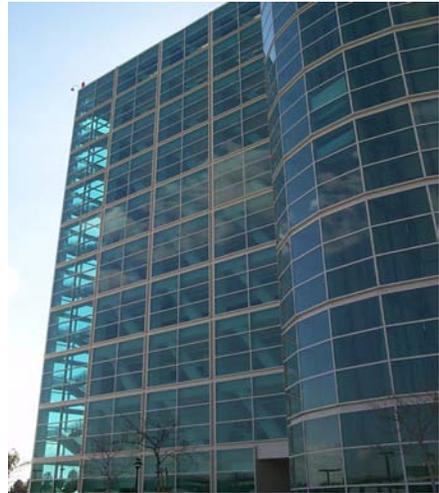
<p>Zoom-in of upper photo</p>	<p>H = 3.0 M = 3.6 L = 4.8</p>	<ul style="list-style-type: none"> • These buildings are braced with diagonal members, which usually cannot be detected from the building exterior. • Braced frames are sometimes used for long and narrow buildings because of their stiffness. • From the building exterior, it is difficult to tell the difference between steel moment frames, steel braced frames, and steel frames with interior concrete shear walls. • In recent earthquakes, braced frames were found to have damage to brace connections, especially at the lower levels.

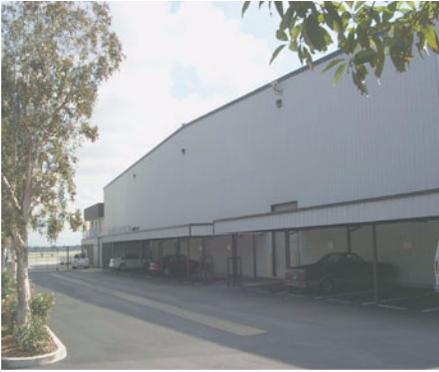
<i>Building Identifier</i>	<i>Photograph</i>	<i>Basic Structural Hazard Score</i>	<i>Characteristics and Performance</i>
<p>S3 Light metal building</p>

<p>H = 3.2 M = 3.8 L = 4.6</p>	<ul style="list-style-type: none"> ● The structural system usually consists of moment frames in the transverse direction and braced frames in the longitudinal direction, with corrugated sheet-metal siding. In some regions, light metal buildings may have partial-height masonry walls. ● The interiors of most of these buildings do not have interior finishes and their structural skeleton can be seen easily. ● Insufficient capacity of tension braces can lead to their elongation and consequent building damage during earthquakes. ● Inadequate connection to a slab foundation can allow the building columns to slide on the slab. ● Loss of the cladding can occur.
<p>S4 Steel frames with cast-in-place concrete shear walls</p>

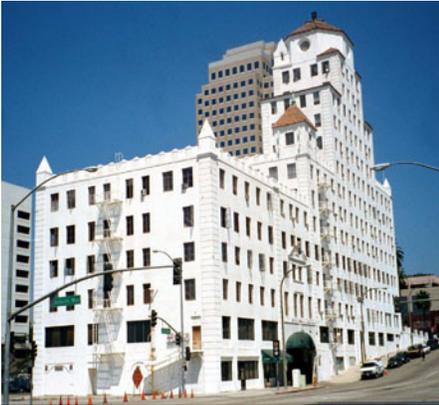
<p>H = 2.8 M = 3.6 L = 4.8</p>	<ul style="list-style-type: none"> ● Lateral loads are resisted by shear walls, which usually surround elevator cores and stairwells, and are covered by finish materials. ● An interior investigation will permit a wall thickness check. More than six inches in thickness usually indicates a concrete wall. ● Shear cracking and distress can occur around openings in concrete shear walls during earthquakes. ● Wall construction joints can be weak planes, resulting in wall shear failure below expected capacity.

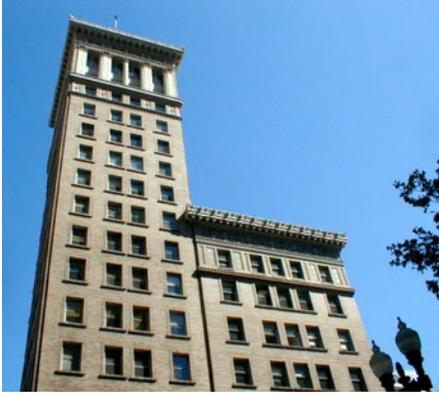
<i>Building Identifier</i>	<i>Photograph</i>	<i>Basic Structural Hazard Score</i>	<i>Characteristics and Performance</i>
<p>S5 Steel frames with unreinforced masonry infill walls</p>

<p>H = 2.0 M = 3.6 L = 5.0</p>	<ul style="list-style-type: none"> ● Steel columns are relatively thin and may be hidden in walls. ● Usually masonry is exposed on exterior with narrow piers (less than 4 ft wide) between windows. ● Portions of solid walls will align vertically. ● Infill walls are usually two to three wythes thick. ● Veneer masonry around columns or beams is usually poorly anchored and detaches easily.
<p>C1 Concrete moment-resisting frames</p>

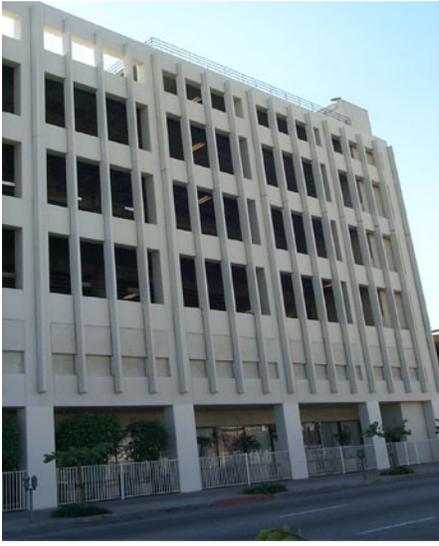
<p>H = 2.5 M = 3.0 L = 4.4</p>	<ul style="list-style-type: none"> ● All exposed concrete frames are reinforced concrete (not steel frames encased in concrete). ● A fundamental factor governing the performance of concrete moment-resisting frames is the level of ductile detailing. ● Large spacing of ties in columns can lead to a lack of concrete confinement and shear failure. ● Lack of continuous beam reinforcement can result in hinge formation during load reversal. ● The relatively low stiffness of the frame can lead to substantial nonstructural damage. ● Column damage due to pounding with adjacent buildings can occur.

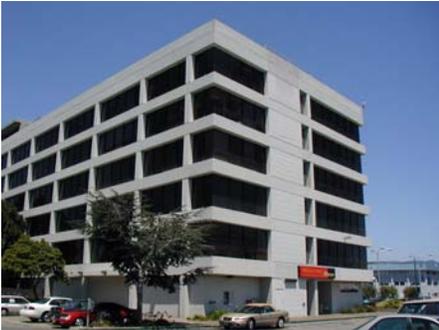
<i>Building Identifier</i>	<i>Photograph</i>	<i>Basic Structural Hazard Score</i>	<i>Characteristics and Performance</i>
<p>C2 Concrete shear wall buildings</p>

<p>H = 2.8 M = 3.6 L = 4.8</p>	<ul style="list-style-type: none"> ● Concrete shear-wall buildings are usually cast in place, and show typical signs of cast-in-place concrete. ● Shear-wall thickness ranges from 6 to 10 inches. ● These buildings generally perform better than concrete frame buildings. ● They are heavier than steel-frame buildings but more rigid due to the shear walls. ● Damage commonly observed in taller buildings is caused by vertical discontinuities, pounding, and irregular configuration.
<p>C3 Concrete frames with unreinforced masonry infill walls</p>

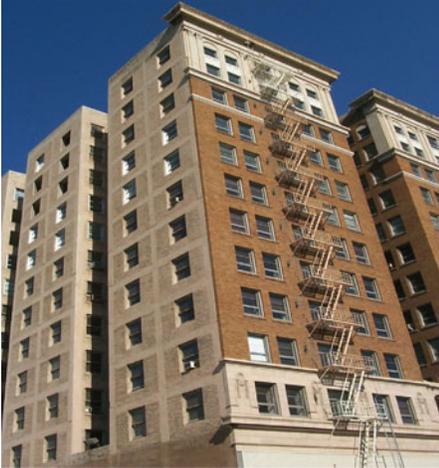
<p>H = 1.6 M = 3.2 L = 4.4</p>	<ul style="list-style-type: none"> ● Concrete columns and beams may be full wall thickness and may be exposed for viewing on the sides and rear of the building. ● Usually masonry is exposed on the exterior with narrow piers (less than 4 ft wide) between windows. ● Portions of solid walls will align vertically. ● This type of construction was generally built before 1940 in high-seismicity regions but continues to be built in other regions. ● Infill walls tend to buckle and fall out-of-plane when subjected to strong lateral out-of-plane forces. ● Veneer masonry around columns or beams is usually poorly anchored and detaches easily.

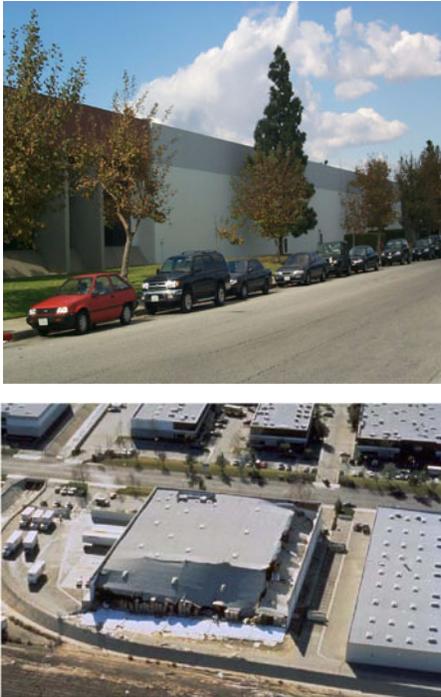
<i>Building Identifier</i>	<i>Photograph</i>	<i>Basic Structural Hazard Score</i>	<i>Characteristics and Performance</i>
<p>PC1 Tilt-up buildings</p>

<p>Partial roof collapse due to failed diaphragm-to-wall connection</p>	<p>H = 2.6 M = 3.2 L = 4.4</p>	<ul style="list-style-type: none"> ● Tilt-ups are typically one or two stories high and are basically rectangular in plan. ● Exterior walls were traditionally formed and cast on the ground adjacent to their final position, and then “tilted-up” and attached to the floor slab. ● The roof can be a plywood diaphragm carried on wood purlins and glulam beams or a light steel deck and joist system, supported in the interior of the building on steel pipe columns. ● Weak diaphragm-to-wall anchorage results in the wall panels falling and the collapse of the supported diaphragm (or roof).

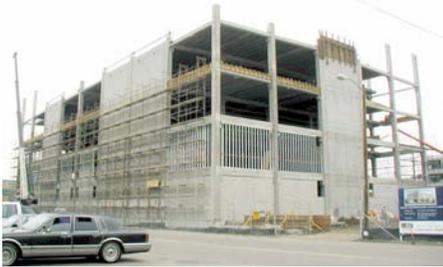
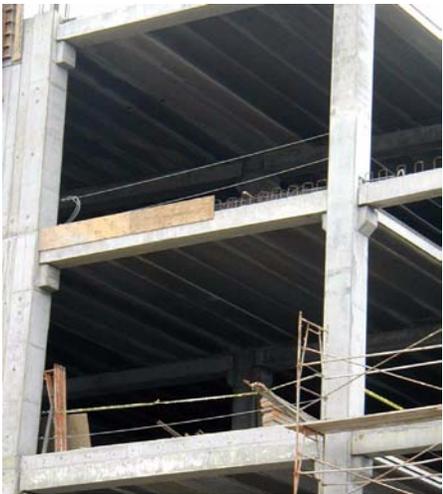
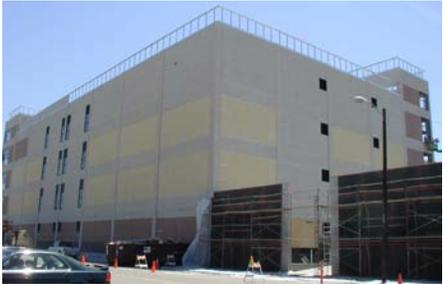
<i>Building Identifier</i>	<i>Photograph</i>	<i>Basic Structural Hazard Score</i>	<i>Characteristics and Performance</i>
<p>PC2 Precast concrete frame buildings</p>

<p>Building under construction</p>

<p>Detail of the precast components</p>

<p>Building nearing completion</p>	<p>H = 2.4 M = 3.2 L = 4.6</p>	<ul style="list-style-type: none"> ● Precast concrete frames are, in essence, post and beam construction in concrete. ● Structures often employ concrete or reinforced masonry (brick or block) shear walls. ● The performance varies widely and is sometimes poor. ● They experience the same types of damage as shear wall buildings (C2). ● Poorly designed connections between prefabricated elements can fail. ● Loss of vertical support can occur due to inadequate bearing area and insufficient connection between floor elements and columns. ● Corrosion of metal connectors between prefabricated elements can occur.

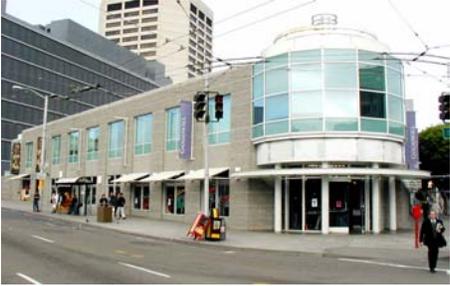
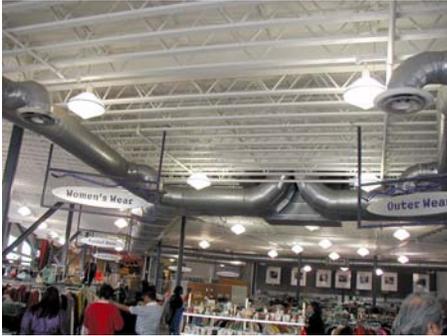
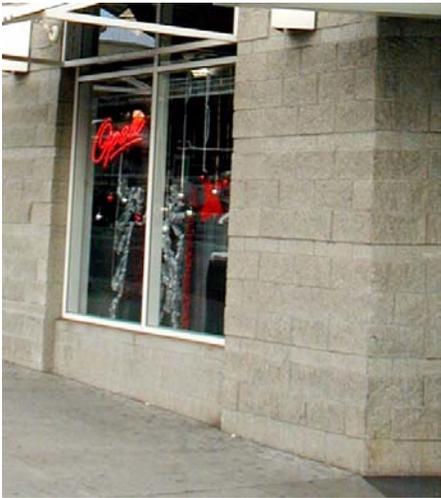
<i>Building Identifier</i>	<i>Photograph</i>	<i>Basic Structural Hazard Score</i>	<i>Characteristics and Performance</i>
<p>RM1 Reinforced masonry buildings with flexible diaphragms</p>

<p>Truss-joists support plywood and light-weight concrete slab</p>

<p>Detail showing reinforced masonry</p>	<p>H = 2.8 M = 3.6 L = 4.8</p>	<ul style="list-style-type: none"> ● Walls are either brick or concrete block. ● Wall thickness is usually 8 inches to 12 inches. ● Interior inspection is required to determine if diaphragms are flexible or rigid. ● The most common floor and roof systems are wood, light steel, or precast concrete. ● These buildings can perform well in moderate earthquakes if they are adequately reinforced and grouted, with sufficient diaphragm anchorage. ● Poor construction practice can result in ungrouted and unreinforced walls, which will fail easily.

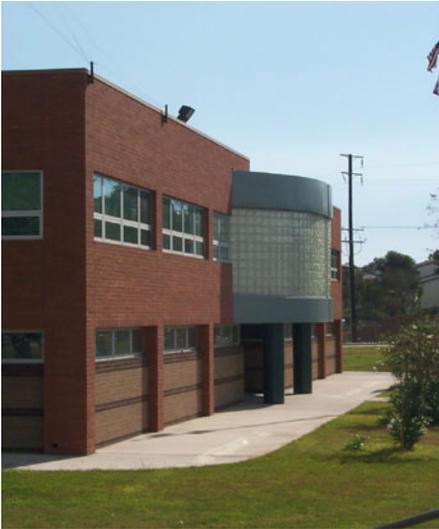
<i>Building Identifier</i>	<i>Photograph</i>	<i>Basic Structural Hazard Score</i>	<i>Characteristics and Performance</i>
<p>RM2 Reinforced masonry buildings with rigid diaphragms</p>

<p>H = 2.8 M = 3.4 L = 4.6</p>	<ul style="list-style-type: none"> ● Walls are either brick or concrete block. ● Wall thickness is usually 8 inches to 12 inches. ● Interior inspection is required to determine if diaphragms are flexible or rigid. ● The most common floor and roof systems are wood, light steel, or precast concrete. ● These buildings can perform well in moderate earthquakes if they are adequately reinforced and grouted, with sufficient diaphragm anchorage. ● Poor construction practice can result in ungrouted and unreinforced walls, which will fail easily.
<p>URM Unreinforced masonry buildings</p>

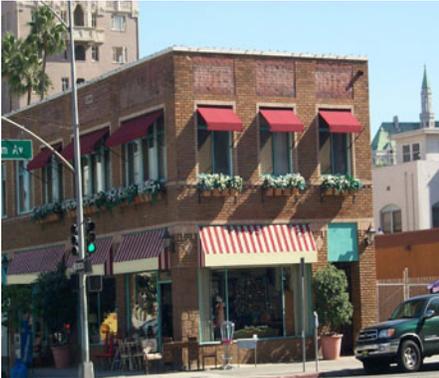
<p>H = 1.8 M = 3.4 L = 4.6</p>	<ul style="list-style-type: none"> ● These buildings often used weak lime mortar to bond the masonry units together. ● Arches are often an architectural characteristic of older brick bearing wall buildings. ● Other methods of spanning are also used, including steel and stone lintels. ● Unreinforced masonry usually shows header bricks in the wall surface. ● The performance of this type of construction is poor due to lack of anchorage of walls to floors and roof, soft mortar, and narrow piers between window openings.

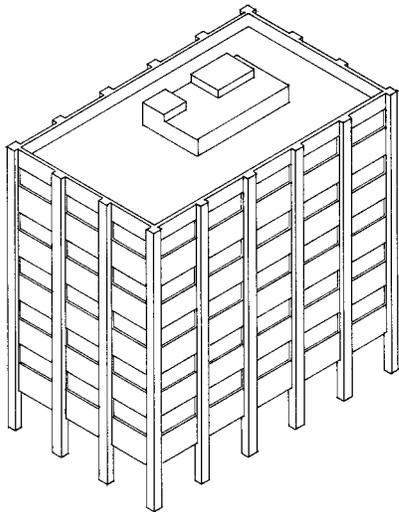
Figure 3-8 Typical frame structure. Features include: large window spans, window openings on many sides, and clearly visible column-beam grid pattern.

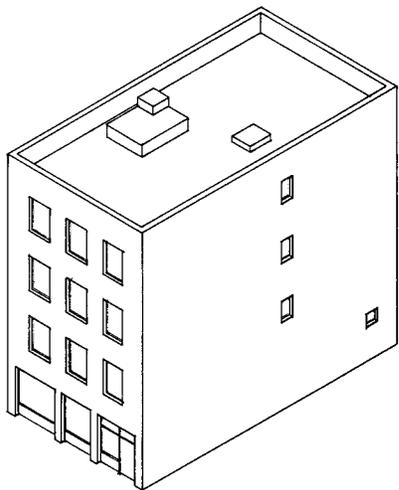
Figure 3-9 Typical bearing wall structure. Features include small window span, at least two mostly solid walls, and thick load-bearing walls.

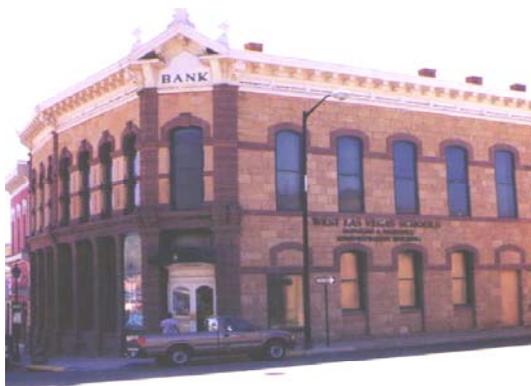
Example of a Bearing Wall Structure

A bearing wall system is sometimes called a box system.

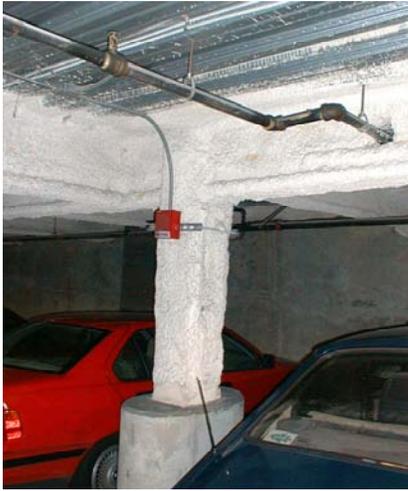
Figure 3-11 Interior view showing fire-proofed columns and beams, which indicate a steel building (S1, S2, or S4).

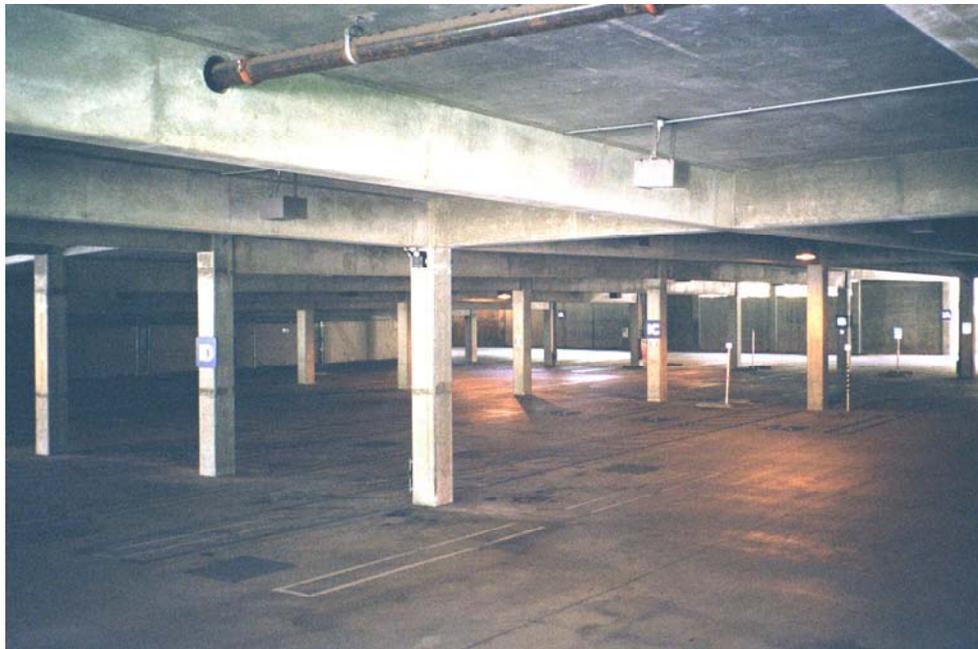
Figure 3-12 Interior view showing concrete columns and girders, which indicate a concrete moment frame (C1).

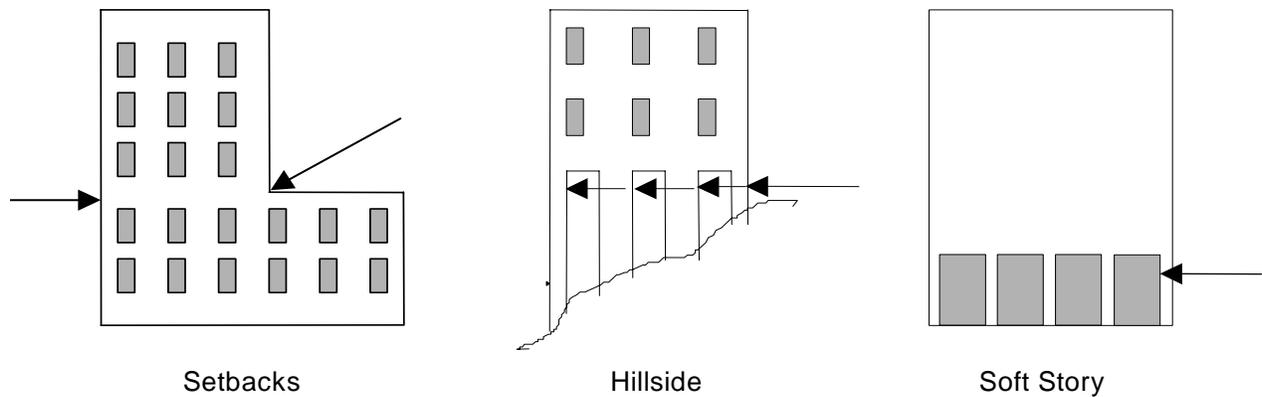
Figure 3-14 Elevation views showing vertical irregularities, with arrows indicating locations of particular concern.

If the building is on a steep hill so that over the up-slope dimension of the building the hill rises at least one story height, a problem may exist because the horizontal stiffness along the lower side may be different from the uphill side. In addition, in the up-slope direction, the stiff short columns attract the seismic shear forces and may fail. In this case the performance modifier is applicable. See Figure 3-14 for an example.

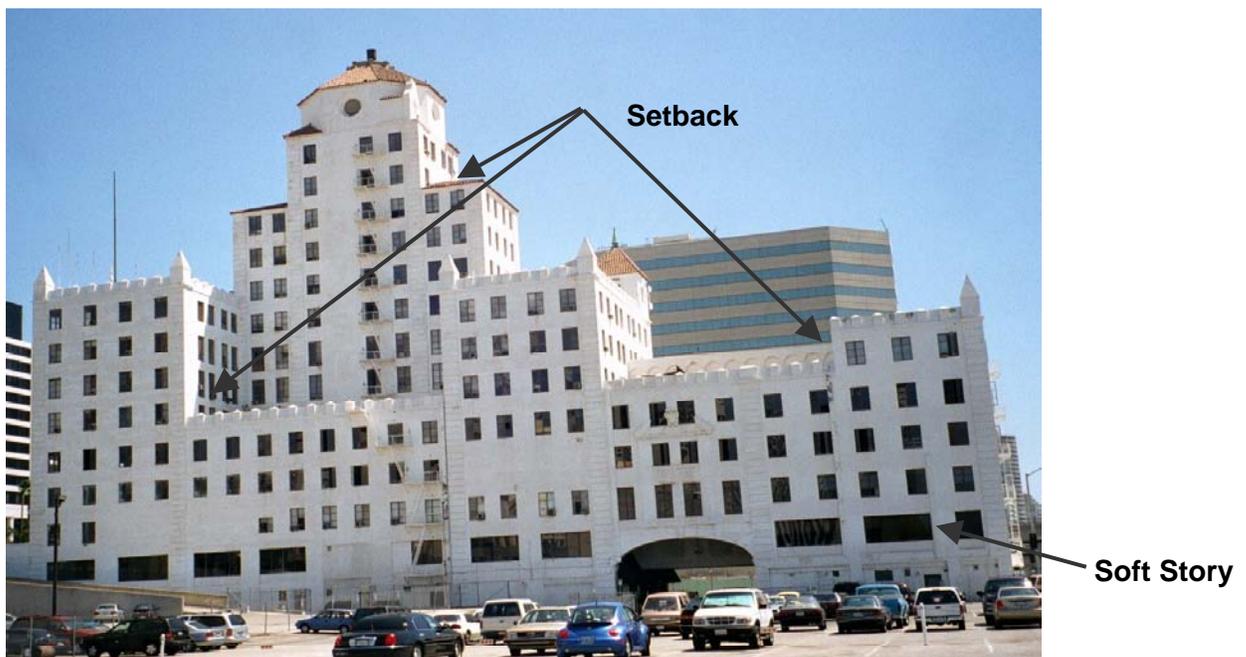
Figure 3-15 Example of setbacks (see Figure 3-14) and a soft first story.

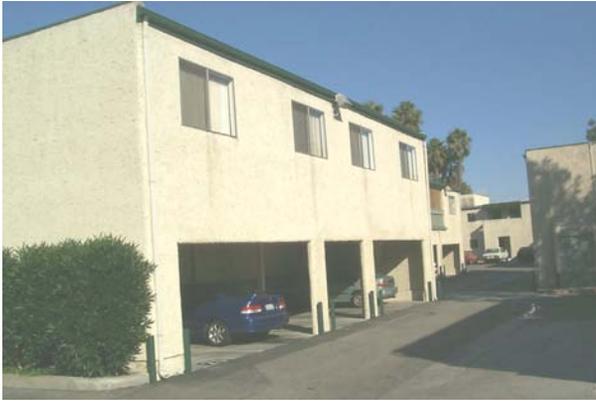
Figure 3-16 Example of soft story conditions, where parking requirements result in large weak openings.

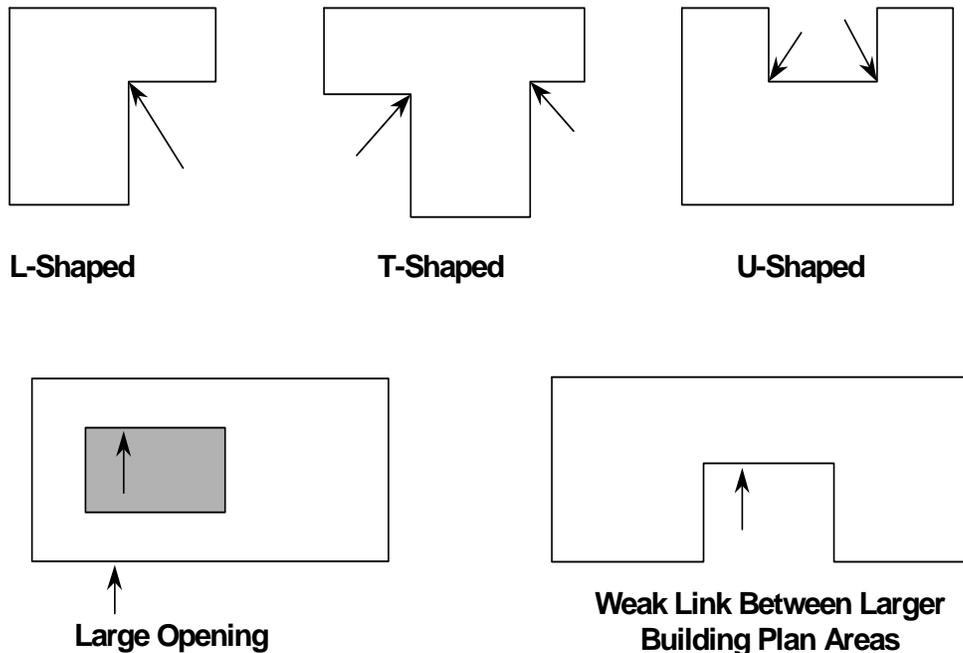
Figure 3-17 Plan views of various building configurations showing plan irregularities; arrows indicate possible areas of damage.

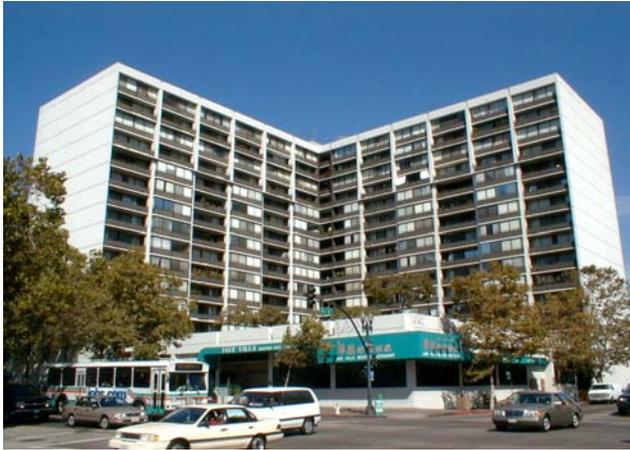
Figure 3-18 Example of a building, with a plan irregularity, with two wings meeting at right angles.

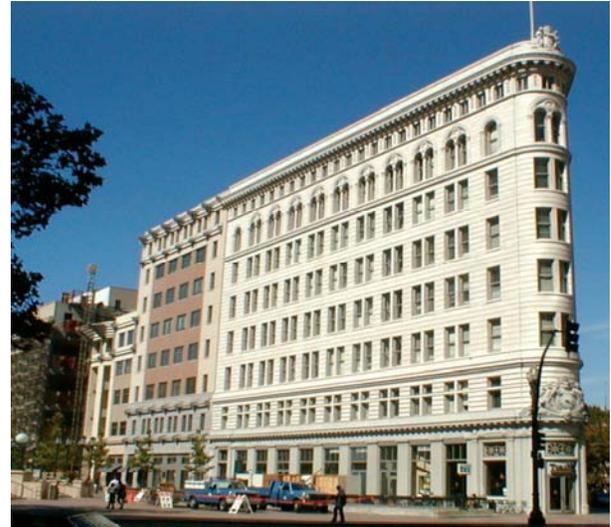
Figure 3-19 Example of a building, triangular in plan, subject to torsion.

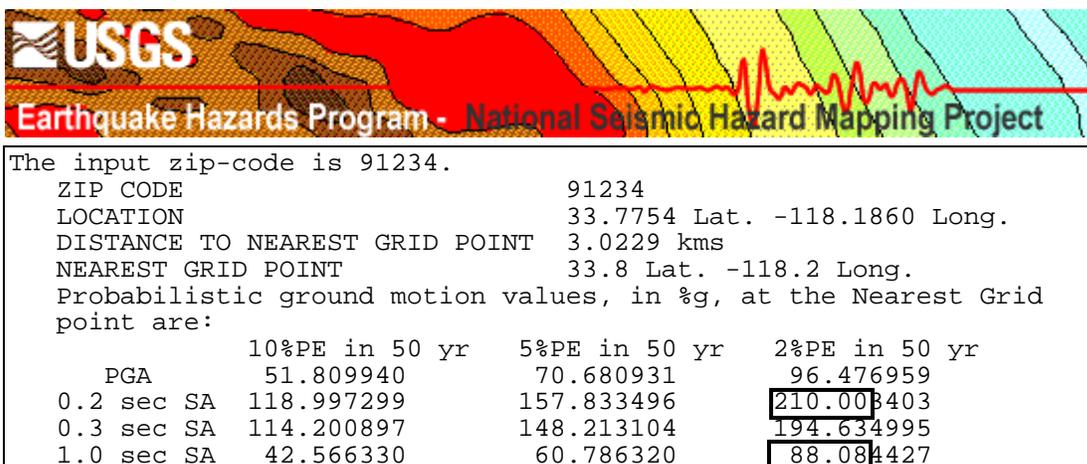
Figure 5-1 Screen capture of USGS web page showing SA values for 0.2 sec and 1.0 sec for ground motions having 2% probability of being exceeded in 50 years (values shown in boxes).

To choose the correct Data Collection Form, the RVS authority elected to establish the seismicity for Anyplace USA by using Method 2 (see Section 2.4.1), rather than by selecting the seismicity region from the maps in Appendix A. Method 2, using the zip-code option, provides more precision than the Appendix A maps which use county boundaries. Method 2 was executed by accessing the USGS seismic hazard web site (<http://geohazards.cr.usgs.gov/eq/>), selecting Hazard by Zip Code, entering the zip code, 91234, and obtaining spectral acceleration (SA) values for 0.2 second and 1.0 second for ground motions having a 2% probability of being exceeded in 50 years (see Figure 5-1). The values of 2.10 g and 0.88 g for 0.2 second and 1.0 second, respectively, were multiplied by 2/3 to obtain the reduced values of 1.40 g and 0.59 g, respectively, for 0.2

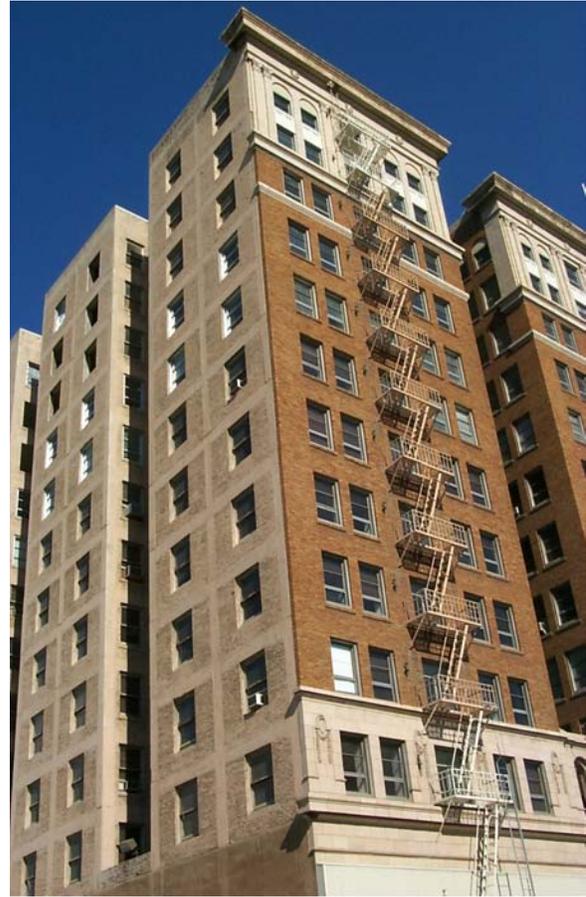
Figure 5-9 Exterior view of 3711 Roxbury.

Upon arrival at the site, the screeners observed the building as a whole (Figure 5-9). Unlike Example 1, there was little information in the building identification portion of the form (only street address, zip code, and parcel number were provided). The screeners determined the number of stories to be 12 and the building use to be commercial and office. They paced off the building plan dimensions to estimate the plan size to be 58 feet x 50 feet. Based on this information, the total square footage was estimated to be 34,800 square feet (12 x 50 x 58), and the number of stories, use, and square footage were written on the form. Based on a review of information in Appendix D of this *Handbook*, the year of construction was estimated to be 1944 and this date was written on the form.

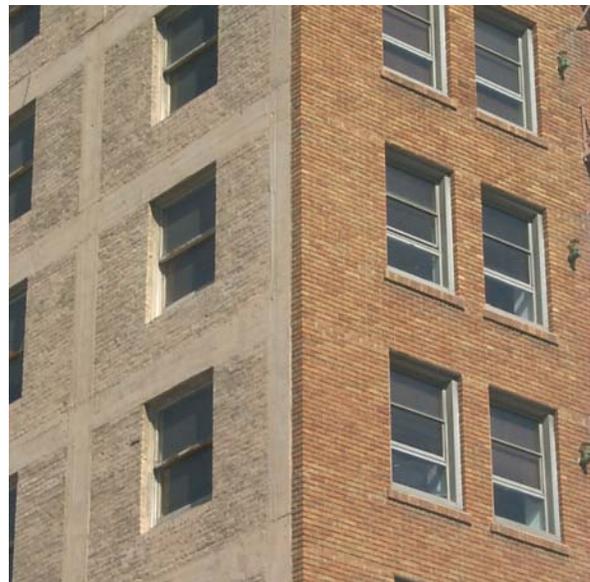
Figure 5-10 Close-up view of 3711 Roxbury Street building exterior showing infill frame construction.

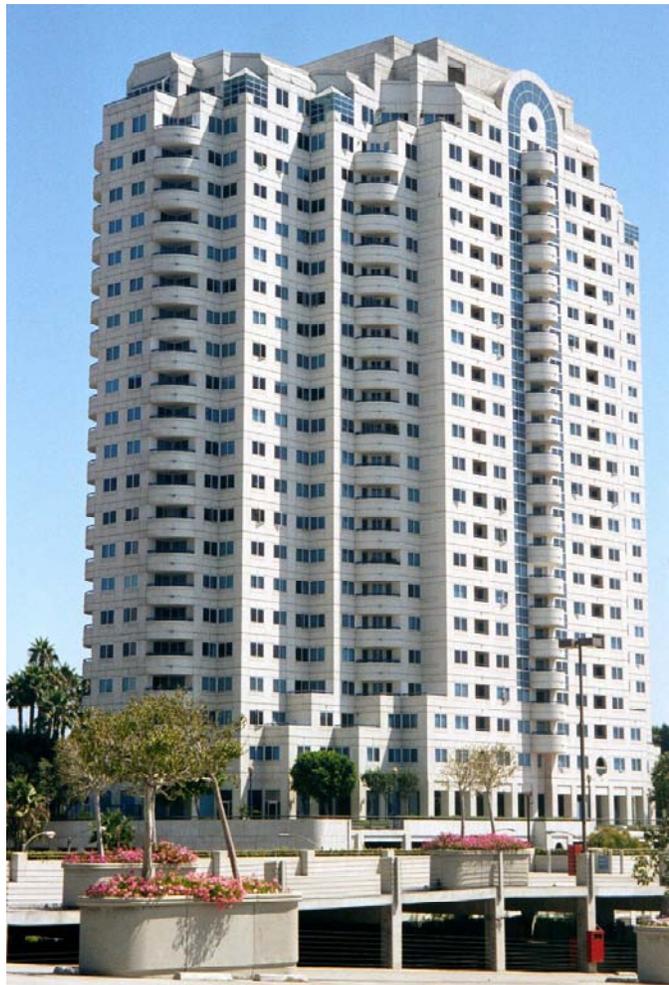
Figure 5-12 Exterior view of 5020 Ebony Drive.

The window spacing in the upper stories and the column spacing at the first floor level indicated the building was either a steel moment-frame building, or a concrete moment-frame building. The screeners attempted to view the interior but were not provided with permission to do so. They elected to indicate that the building was either an S1 or C1 type on the Data Collection Form and
