# Reducing the Risks of Nonstructural Earthquake Damage

**Third Edition**

**FEMA 74/September 1994**  
**Supersedes 1985 Edition**

Third Edition by  
**WISS, JANNEY, ELSTNER ASSOCIATES, INC.**  
For the Federal Emergency Management Agency (FEMA)  
Under the National Earthquake Technical Assistance Contract (NETAC) EMW-92-C-3852

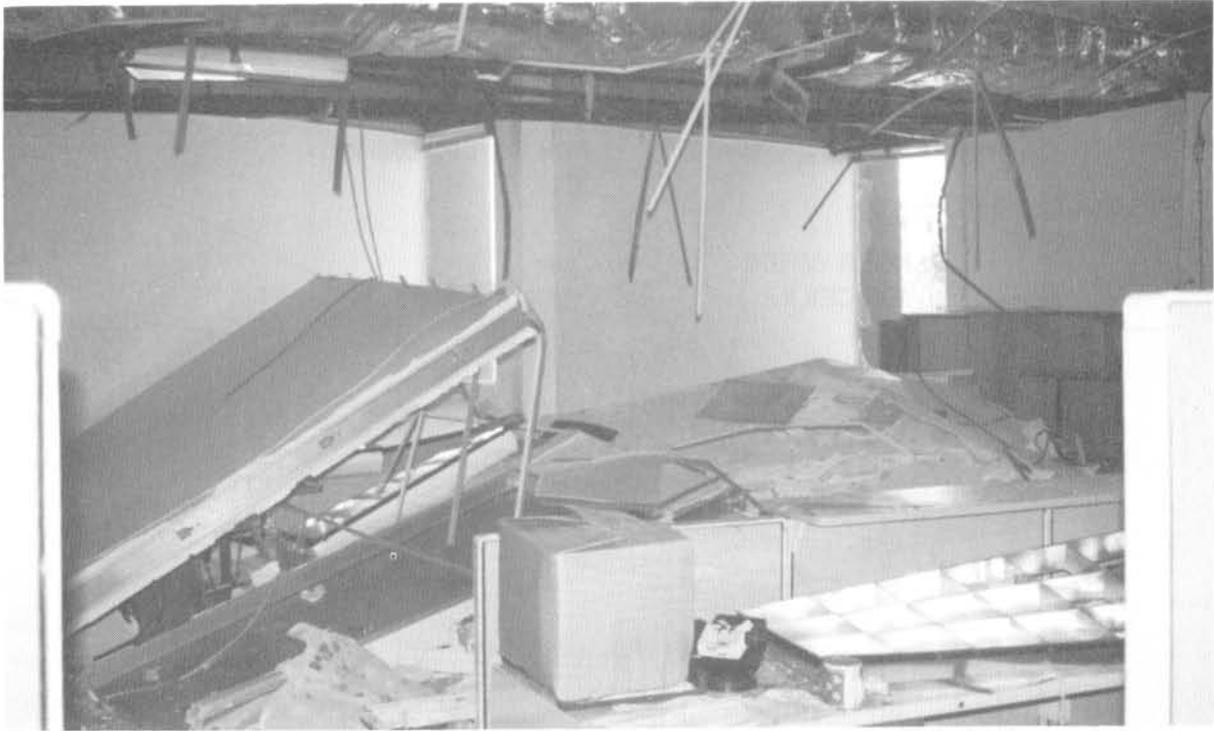
**Figure 2 - Examples of Hazardous Nonstructural Damage**

Failure of office partitions, ceilings, and light fixtures  
Earthquake Damage: 1994, Northridge, California  
Photo Credit: Wiss, Janney, Elstner Associates, Inc.

has occurred during past earthquakes include broken glass, overturned tall and heavy cabinets or shelves, falling ceilings or overhead light fixtures, ruptured gas lines or other piping containing hazardous materials, damaged friable asbestos materials, falling pieces of decorative brickwork or precast concrete panels, and collapsed masonry walls or fences. (Figures 2 and 3).

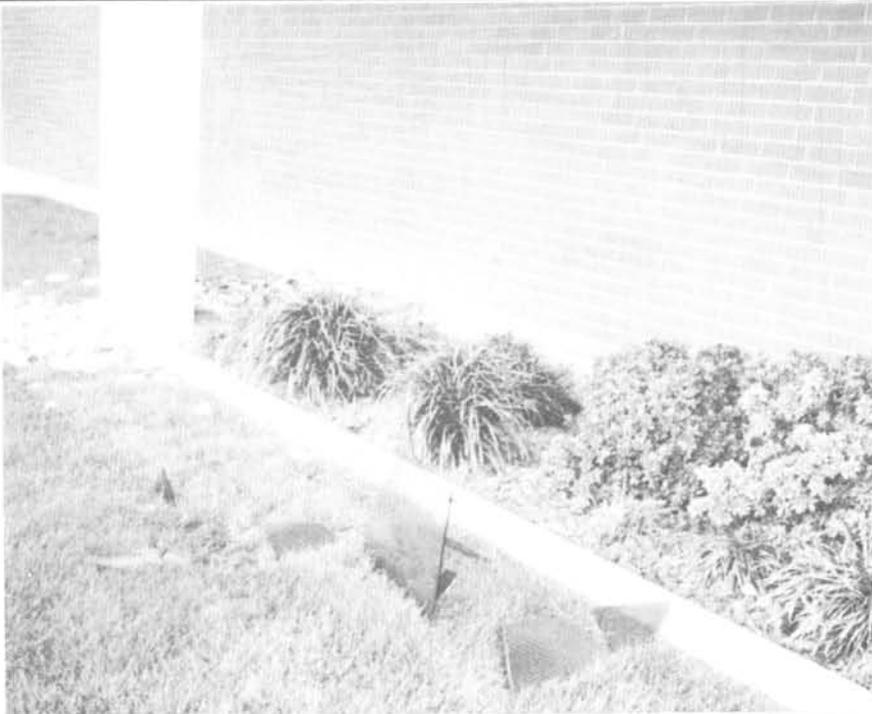
Shard of broken nontempered glass that fell several stories from a multistory building  
Earthquake Damage: 1994, Northridge, California  
Photo Credit: Wiss, Janney, Elstner Associates, Inc.

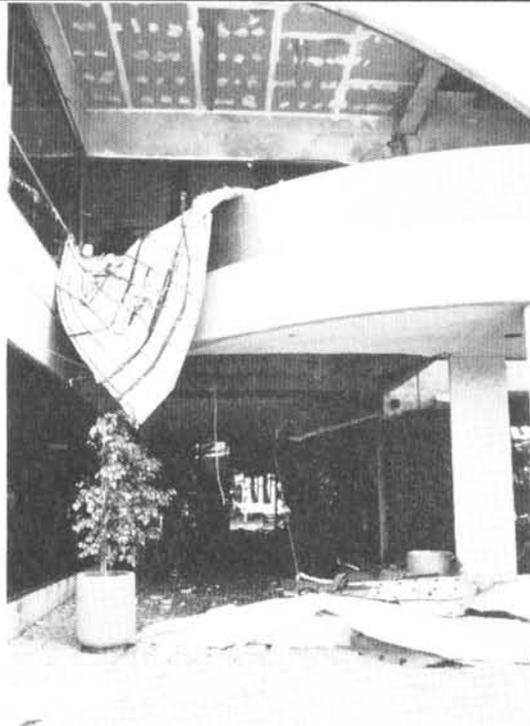
**Figure 3 - Examples of Hazardous Nonstructural Damage**

Failure of heavy stucco soffit at building entrance  
Earthquake Damage: 1994, Northridge, California  
Photo Credit: Robert Reitherman

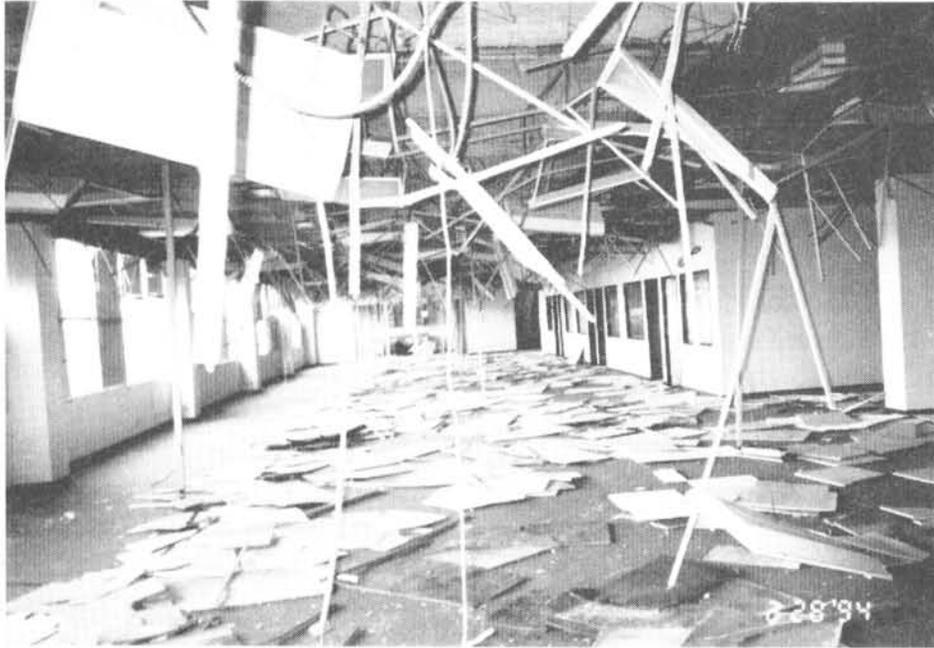
**Figure 4 - Examples of Property Loss Due to Nonstructural Damage**

Complete loss of suspended ceiling and light fixtures  
Earthquake Damage: 1994, Northridge, California  
Photo Credit: Wiss, Janney, Elstner Associates, Inc.

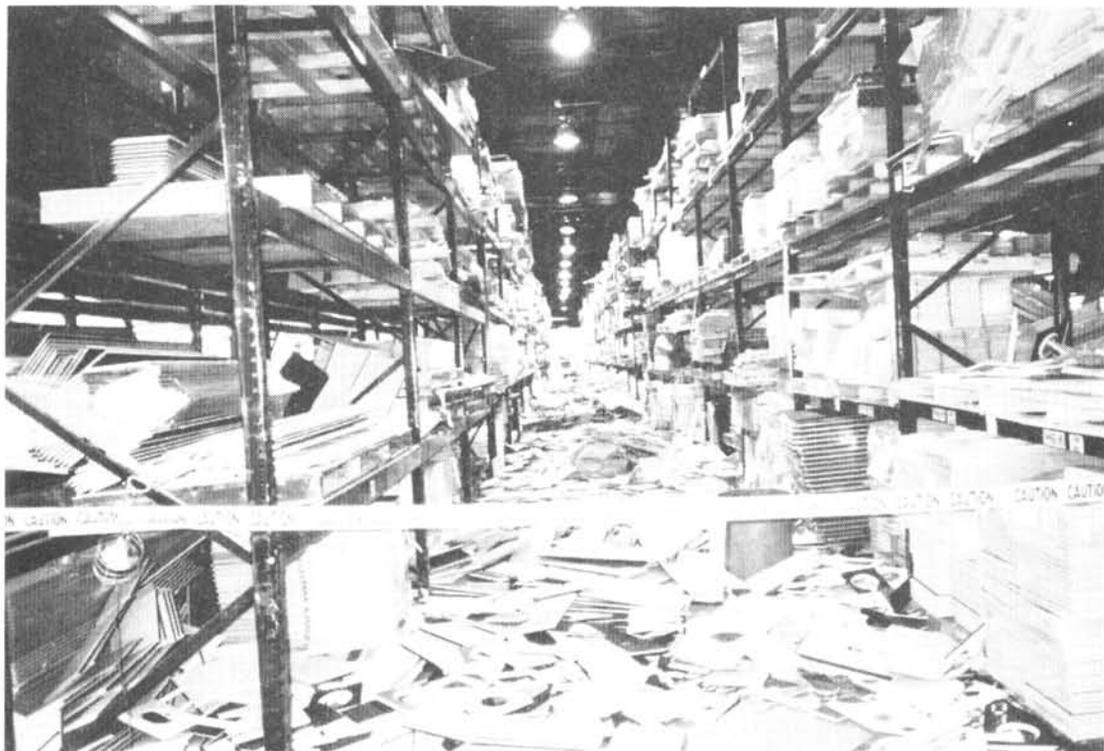
Damage to inventory on industrial storage racks  
Earthquake Damage: 1994, Northridge, California  
Photo Credit: Wiss, Janney, Elstner Associates, Inc.

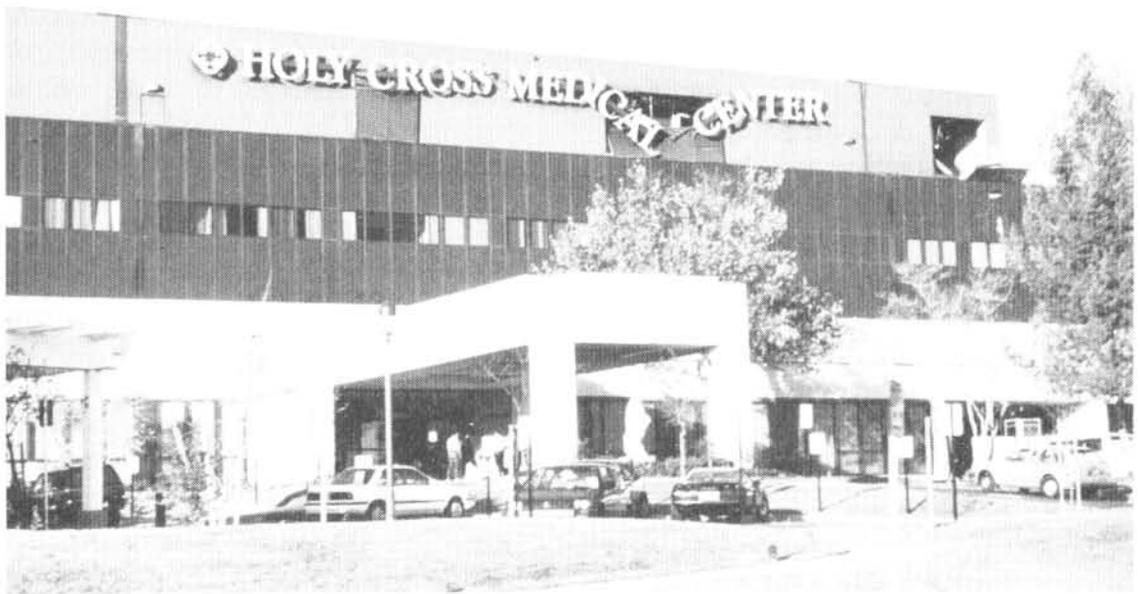
**Figure 5 - Examples of Loss of Function Due to Nonstructural Damage**

HVAC damage at Holy Cross Medical Center in Sylmar—damage to signage and louvers caused when suspended fans in the mechanical penthouse swung and impacted the louver panels. HVAC service outage caused the temporary evacuation of all patients.  
Earthquake Damage: 1994, Northridge, California  
Photo Credit: Robert Reitherman

in some cases water was flowing for many hours. At one facility, water up to 2 feet deep was reported at some locations in the building as a result of damage to the domestic water supply tank on the roof. At another, the emergency generator was disabled when its cooling water line broke where it crossed a separation joint. Other damage at these facilities included broken glass, dangling light fixtures, elevator counterweight damage, and lack of emergency power due to failures in the distribution or control systems. Two of these facilities, Los Angeles County Olive View Medical Center and Holy Cross Medical Center, both in Sylmar, California, had suffered severe structural damage or collapse during the 1971 San Fernando earthquake and had been demolished and entirely rebuilt [3]. (See Figure 5).
