A Bridge Over Powered Water

Full Mitigation Best Practice Story

Stephens County, Oklahoma

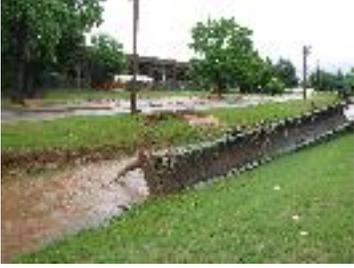
Picture of a bridge damaged in 2007 floods.

The wet summer months of 2007 resulted in four pedestrian bridges being damaged or completely washed away with the exception of the elevated bridge Vaughn had built above the BFE, which sustained no damage.

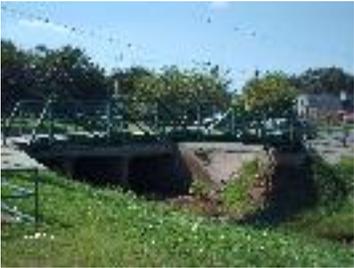
Elevated Footbridge on Main Street

Vaughn's experience as a public works director taught him the power of water, especially moving water. With that experience in mind, Vaughn built a pedestrian bridge on Main Street in the late 1990s at a height three feet above the BFE.

The elevated bridge project took 30 months to complete and included a concerted effort to educate the City Council regarding the benefits of building above the BFE prior to construction. The bridge now stands about four feet above street level supported by deep footings, and according to Vaughn includes access from both sides of the bridge in compliance with the Americans with Disabilities Act.
