FEMA

Mitigation Practices Tested During Flooding

Chanute, KS - Hans Harold and his wife, Donna, woke up around 4:30 a.m. on June 30, 2007 to find their house surrounded by water.

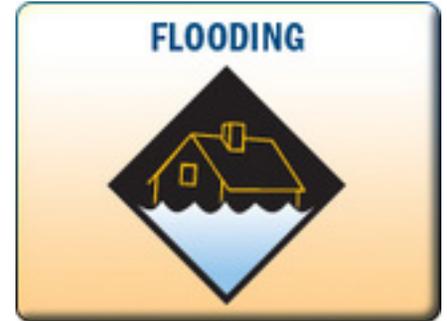
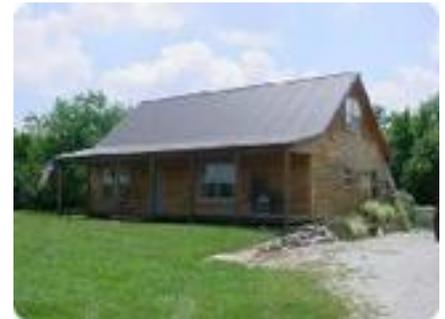
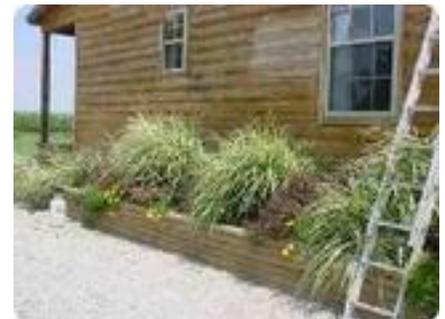
The front of the house was elevated four feet using fill dirt. The back of the yard slopes naturally and was built up by the concrete foundation.

As a result, Harold devised a system of swinging windows that were constructed by a local welder, and his contractor incorporated them into the foundation. This made him eligible for a lower flood insurance rate.

Harold had to elevate his new house one foot above the 1951 flood line of the nearby Neosho River, which was marked on a fence post in his front yard at 2-feet, 5-inches above the ground. The Harold's home was three feet above water when the Neosho River flooded the Chanute area.
