## Successful Rebuilding After Previous Ruidoso Flood Proves it Can be Done

**Ruidoso, NM** - On Highway 70, as the New Mexico desert landscape ascends into mountains, a yellow road sign warns northbound travelers that the area may close due to flooding. In 2006, the continuous summer rains caused that to happen. The storms created overland flooding throughout Lincoln County, New Mexico. On September 18th at the base of the Gavilan Canyon in the Village of Ruidoso, rapid waters from the Rio Ruidoso washed out a bridge crossing.

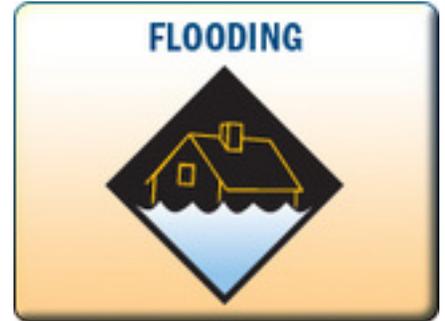
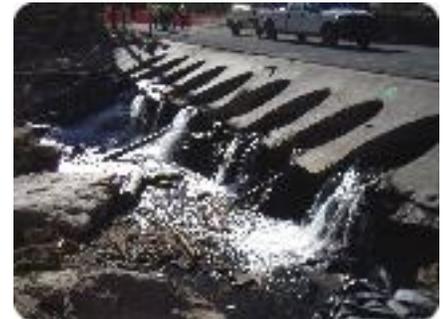
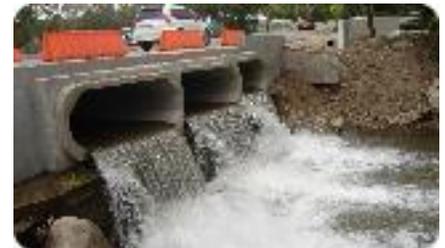
The Gavilan Canyon Road bridge consists of nine side-by-side, 30-inch round culverts packed with gravel, covered by a concrete decking, and paved with asphalt. In incidents prior to the 2006 floods, water topped over the bridge but did not wash out as it did in the 2006 flooding event.

After the floodwaters subsided, village officials inspecting the bridge crossing discovered heavy debris clogging. A video camera extended into the 30-foot length of each corrugated metal culvert revealed the reasons. "What the camera showed was rusted metal with giant cavities around five of the culverts. The only thing holding the bridge [together] was the concrete on top of it," said J.R. Baumann, Street Director for the Village of Ruidoso. The Gavilan Canyon bridge was considered extensively damaged.

In response, the Village of Ruidoso selected significantly larger prefabricated, concrete-box culverts to improve the bridge. The new culverts double the capacity to 500 cubic feet per second.

In March 2008, the crossing was closed to traffic and the damaged culverts removed. Three new culverts with a 3-foot by 5-foot capacity were installed. The river banks were widened and covered with gravel and the upstream side "straightened" and expanded to allow better flow. A new pedestrian walkway was added to the bridge with exterior handrails installed. However, custom guardrails for the interior that were ordered had not arrived in time for the Memorial Day weekend opening.
