Hurricane Rita Rapid Response Wind Water Line Report – Louisiana

Task Order 447

February 28, 2006 (Final)

Hazard Mitigation Technical Assistance Program
Contract No. EMW-2000-CO-0247
Task Order 447
Hurricane Rita Rapid Response
Wind Water Line (WWL) Data Collection – Louisiana
FEMA-1607-DR-LA

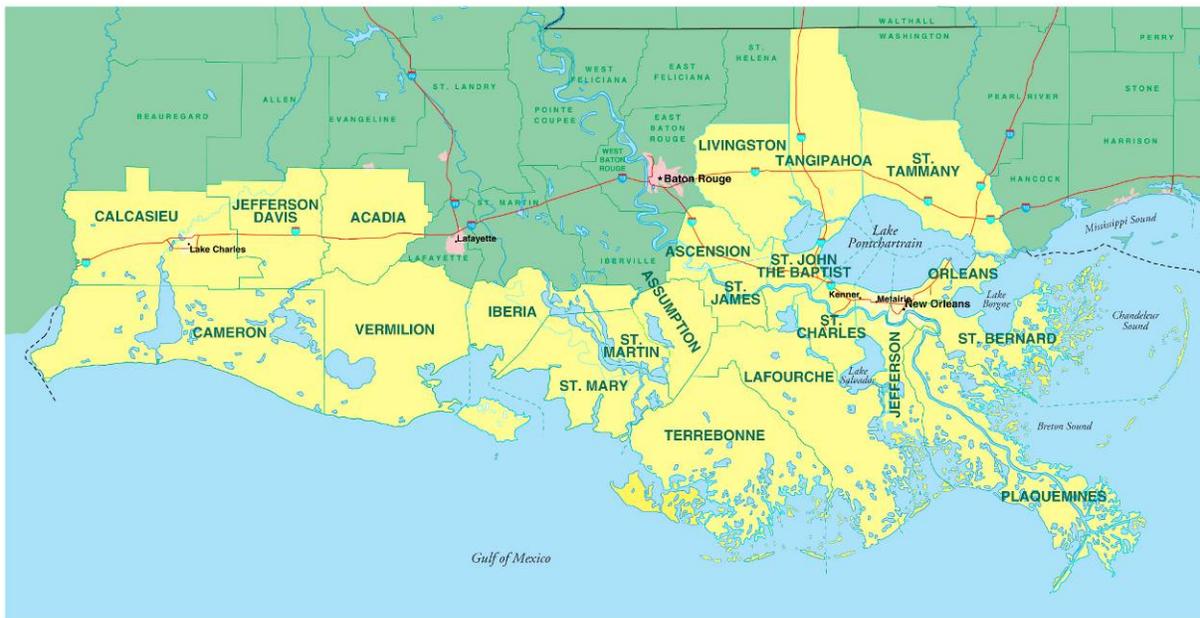
Figure 3: Study Area

The WWL study extended from the northern portion of the Gulf Coast of Texas eastward through southwestern Louisiana. This report focuses on the determinations based on data collected in Louisiana, where the entire coastline was studied. Figure 3 shows the WWL Study Area within Louisiana.

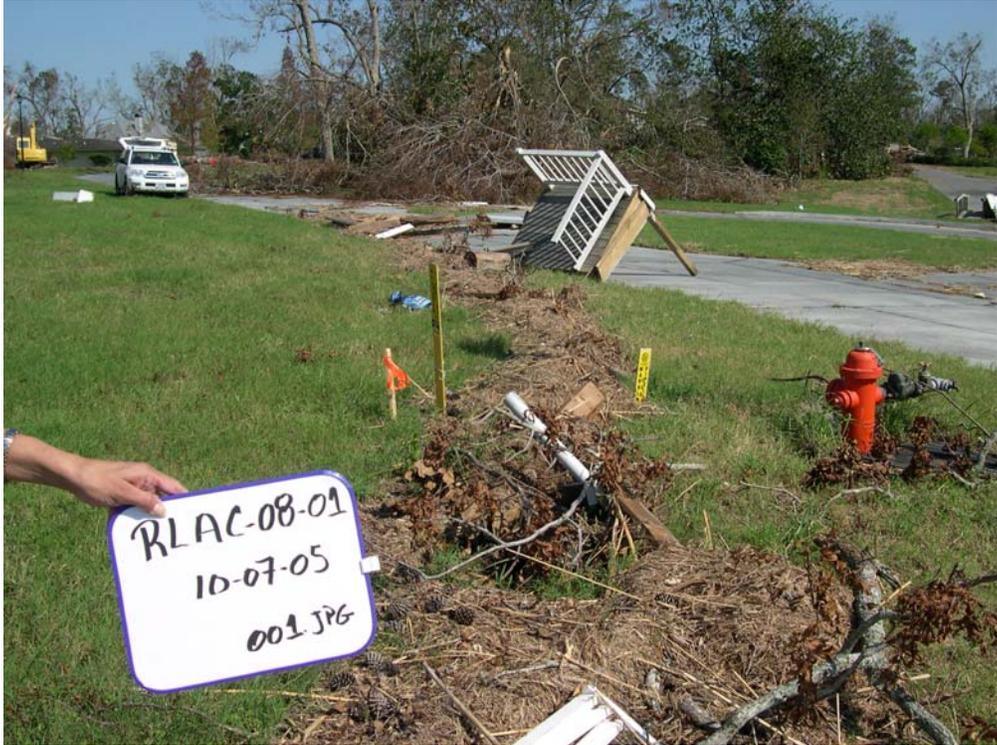
Figure 5: Example Debris Field

Each field crew was tasked with identifying and documenting the WWL and collecting pertinent data points along the coastlines. The WWL were documented using a standardized flagger form to collect detailed information about the point. To define points along the WWL, field crews visited areas of known flood damage. Traveling away from the coast to the edge of damage, they attempted to locate debris fields (see Figure 5) or water marks close to the ground, and to trace them along topographic features to determine the extent of flooding (see Figure 6) and flood damages.

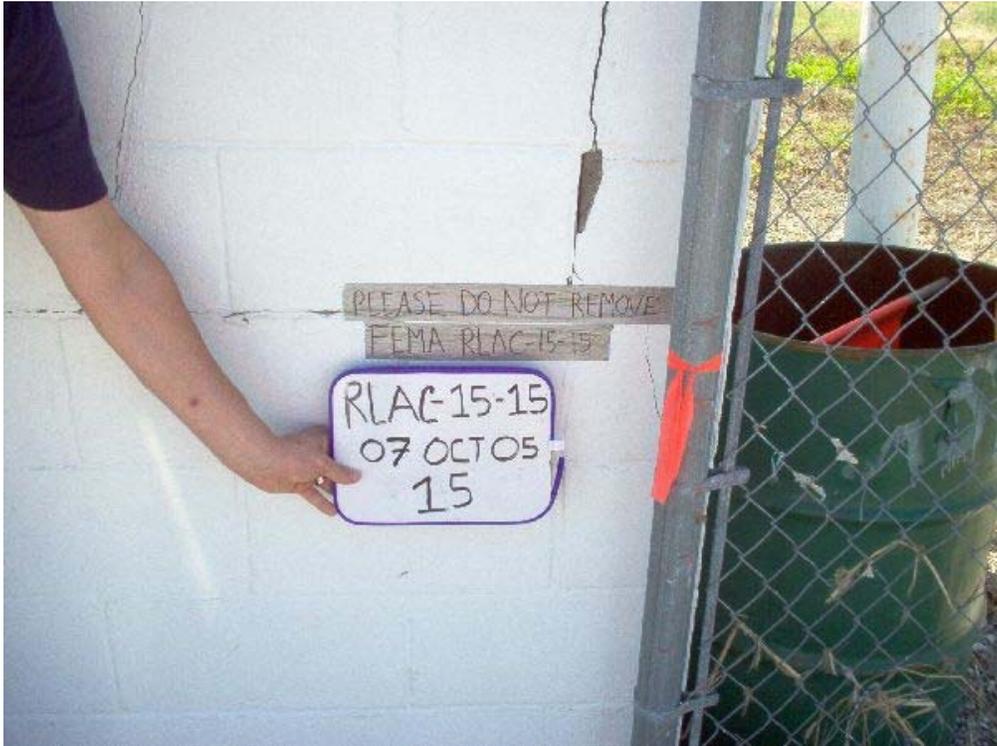
Figure 6: Example Water Marks¹

¹ This HWM illustrates the concept of a water mark on a structure, but would be too high to be considered a WWL data point.

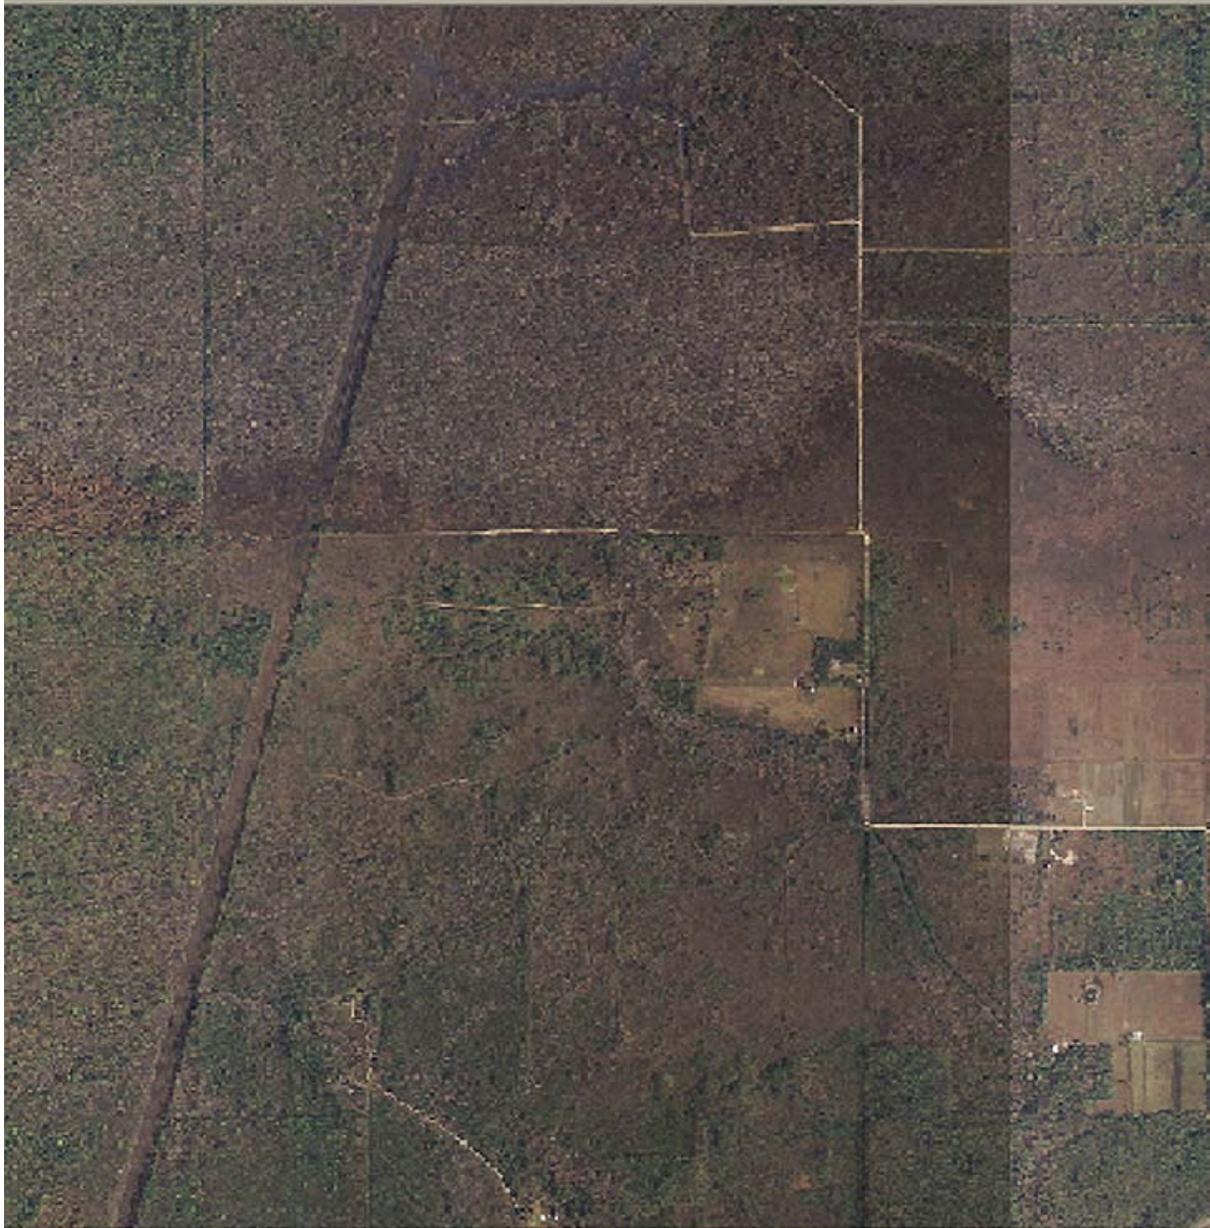
When flood waters recede quickly before the photographs are taken, analysts are confronted with a more complex interpretation assessment. In these cases, analysts look for signatures in the photographs, such as leaning trees, standing water, deposited debris (mud, silt, vegetation, etc.) and other features, that indicate the presence of inland flood waters. Figure 2 depicts an area which was interpreted to have been entirely inundated with water that receded before the photo was taken. This was determined by the presence of mud, fallen trees and saturated ground indicated by brown coloration throughout the image.

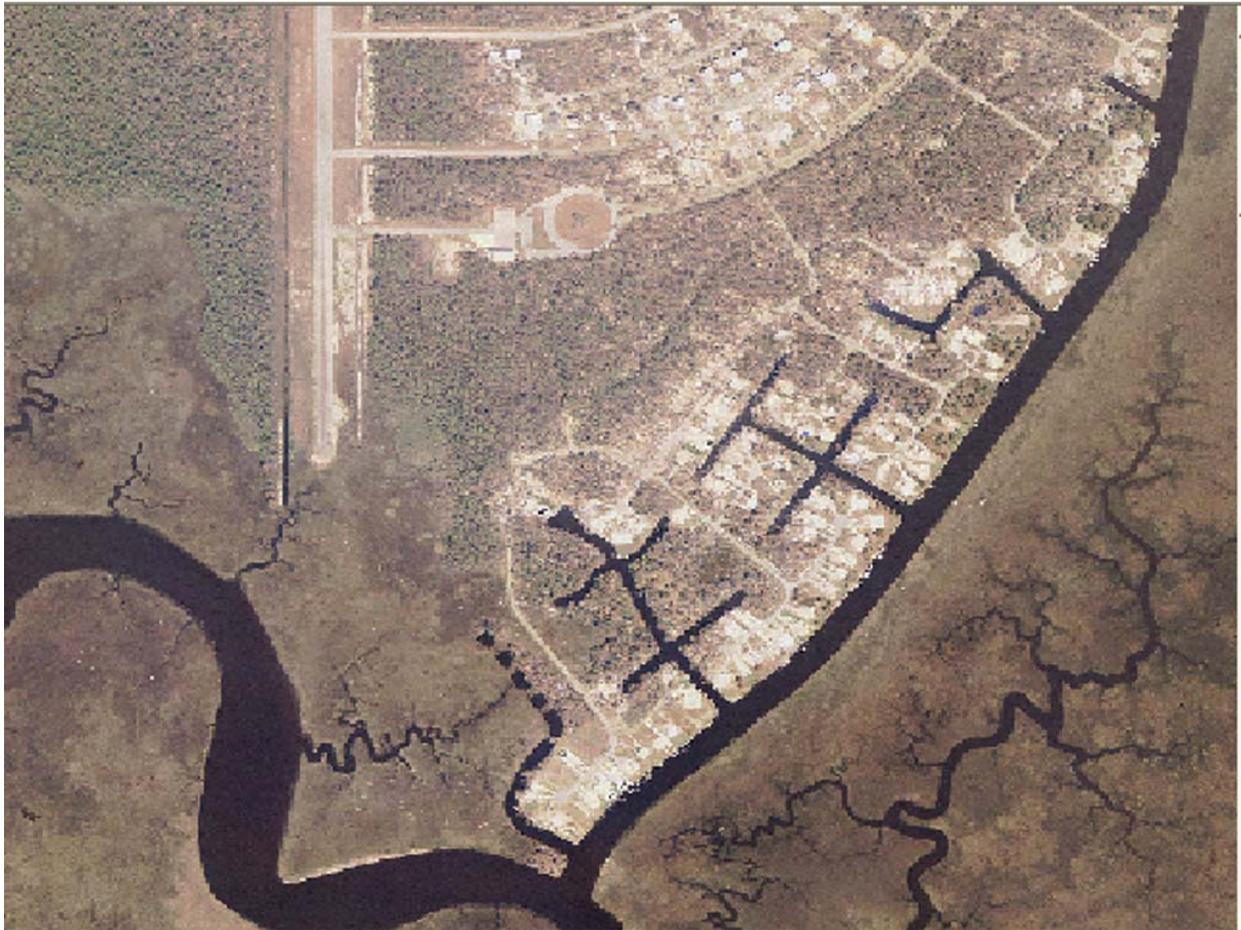
Figure 3 represents an area where the presence of marsh results in a unique situation whereby debris no longer collects as it would typically do on dry land. What is normally a visible debris line on dry land becomes less obvious for photo-interpretation when over marsh and other standing water bodies. In such cases, analysts may use contour lines, the presence of high water marks, deposited mud and silt, and/or any damage to vegetation that has been submerged by flood waters. The marsh in Figure 3 is evident in the lower left and lower right sectors of the image. URS engineers judged final placement of the wind/water line in such areas where photo interpretation alone was not conclusive.

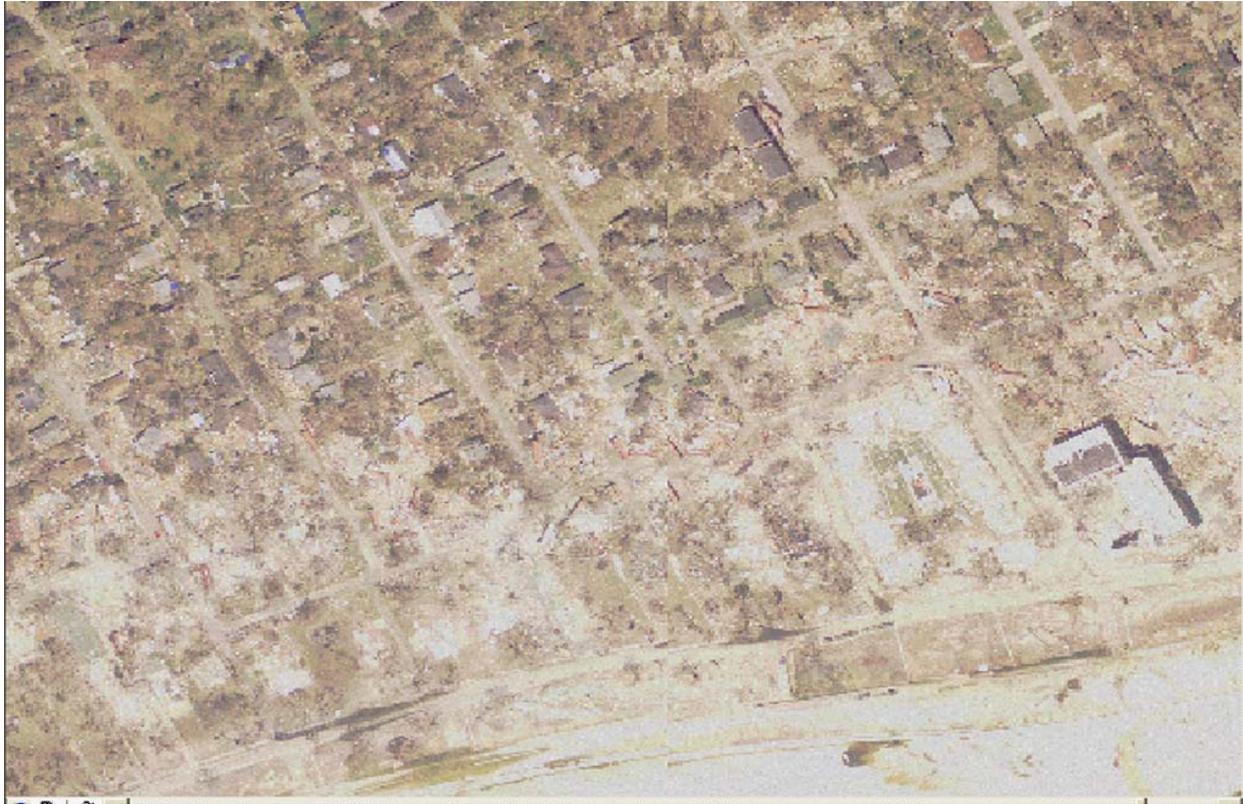
Figure 4 depicts the presence of multiple debris lines. In such cases, the analyst must decide whether all debris was deposited by the ocean surge or some debris was later swept up by inland flooding caused by heavy rain. If tide waters are present along the coast, it can result in multiple debris lines being left behind. Typically, the analyst will place the debris line at the most evident and consistent debris line or along the furthest inland point (high water mark).

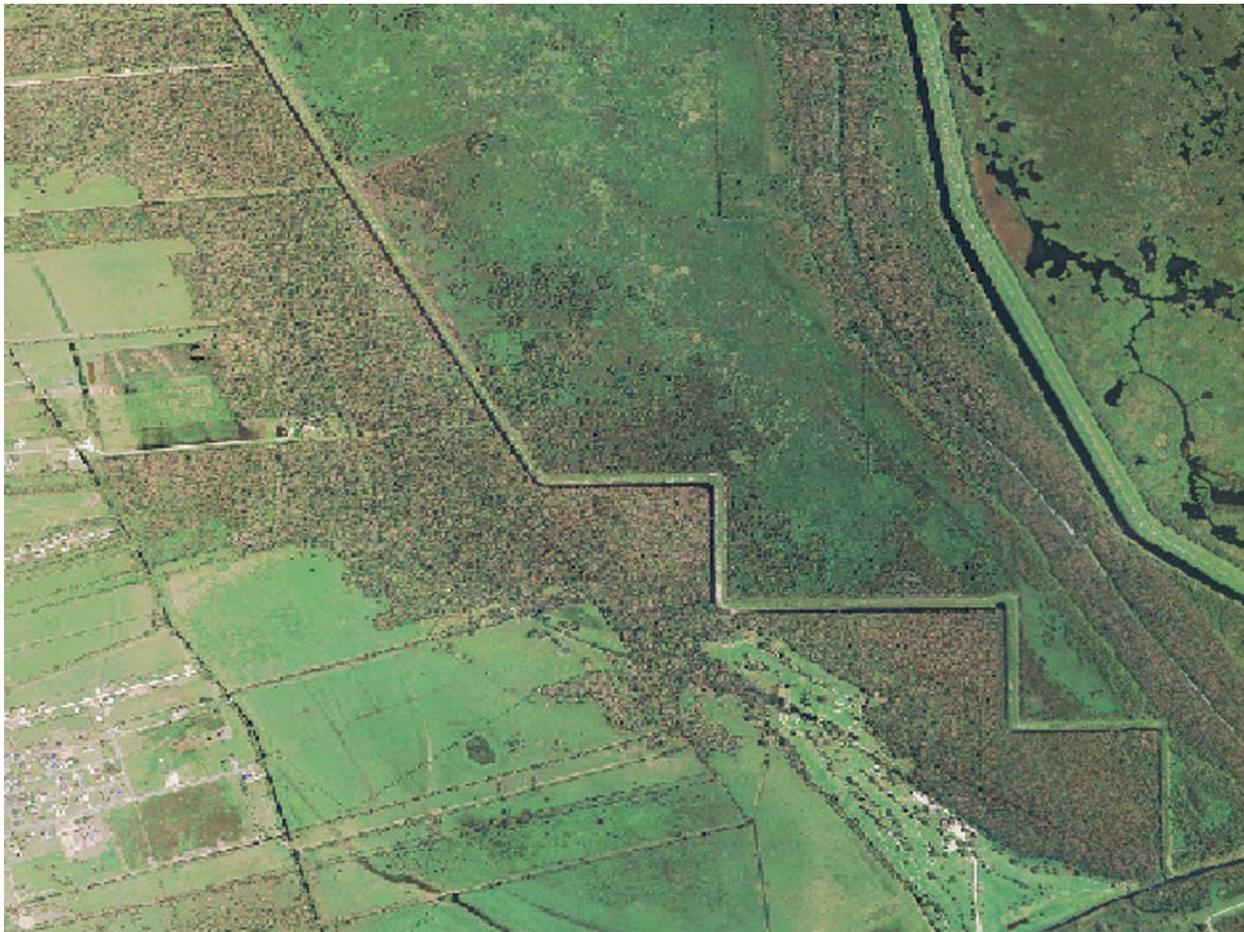
Coastal areas containing salt marshes and other low-lying areas such as that represented in Figure 5 can pose a challenge to photo-interpreters delineating flood waters. An analyst must determine whether or not to represent an area as flooded. There are many cases in which land appears to be flooded, but the area is really a marsh and always has saturated characteristics. In these cases analysts often review other sources such as secondary maps, historical data, and field surveyed conditions. Analysts also look for deposited mud and the condition of nearby vegetation to determine whether an area has been flooded or whether it is simply a marsh.
