# Building Performance: Basement Buildings and Urban Flooding

Hurricane Ida NYC MAT Technical Report 1

June 2023

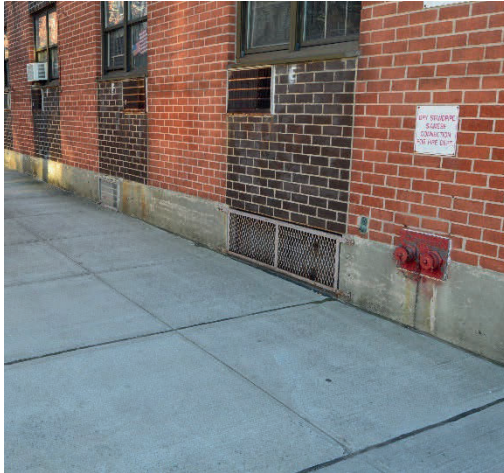
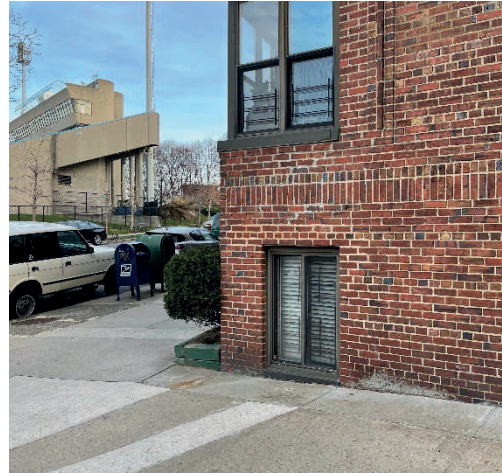
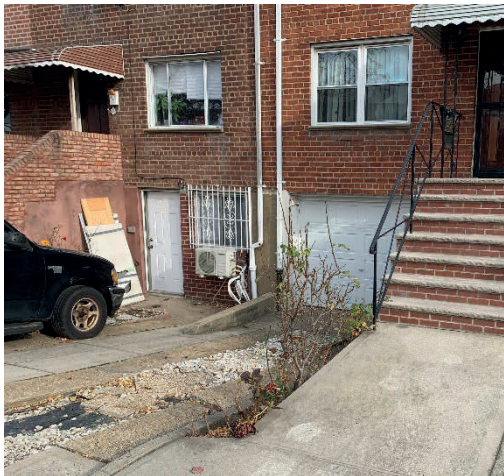
In some one- and two-family dwellings, water entered below-grade garages after street flooding reached the crests of driveways (Figure 5c). In others, it flowed down exterior basement access stairs as floodwater crested the stairway threshold (Figure 5d). Rectangular “slot” drains were observed at the base of driveways for many homes. Floor drains were seen at the base of the access stairs to many basement spaces, but most did not have sump pumps. These drains are intended to divert incoming water to the stormwater drainage system, with or without pumping. Team observations suggest that operating sump pumps could help limit accumulation of runoff from limited areas of driveways, access ramps, and exterior stairs. Most sump pumps installed in dwelling basements may have adequate capacity to remove some accumulated water. However, the typical sump pump is not designed for the volume of water that crested ramps and driveways and overtopped basement stairs, flowing into and filling many basements.

a. Ventilation openings near sidewalk level

b. Basement window sill near sidewalk level

c. Driveway sloping down to converted basement

d. Basement stairway threshold at sidewalk level

**Figure 5. Examples of points of entry for surface flooding**

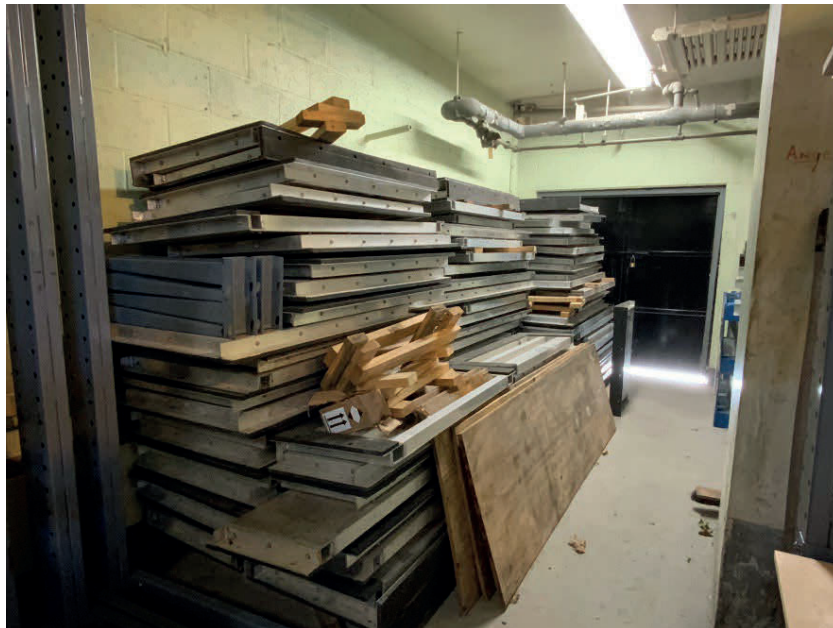
The Team observed some commercial buildings with basements that are dry floodproofed and equipped with dry floodproofing panels. When installed in openings such as doorways and windows, these panels can substantially prevent water from entering the buildings. Manually installed dry floodproofing measures can require significant planning, organization, and manual labor, especially for large buildings. To be effective, installations must be started well before the anticipated onset of flooding. The large number of stored panels shown in Figure 6 suggests that if those responsible for installation wait too long when intense rain events could cause sudden surface flooding, they may not have time to prepare the building and safely evacuate basements.

**Figure 6. Dry floodproofing panels stored in basement of dry floodproofed building in NYC**

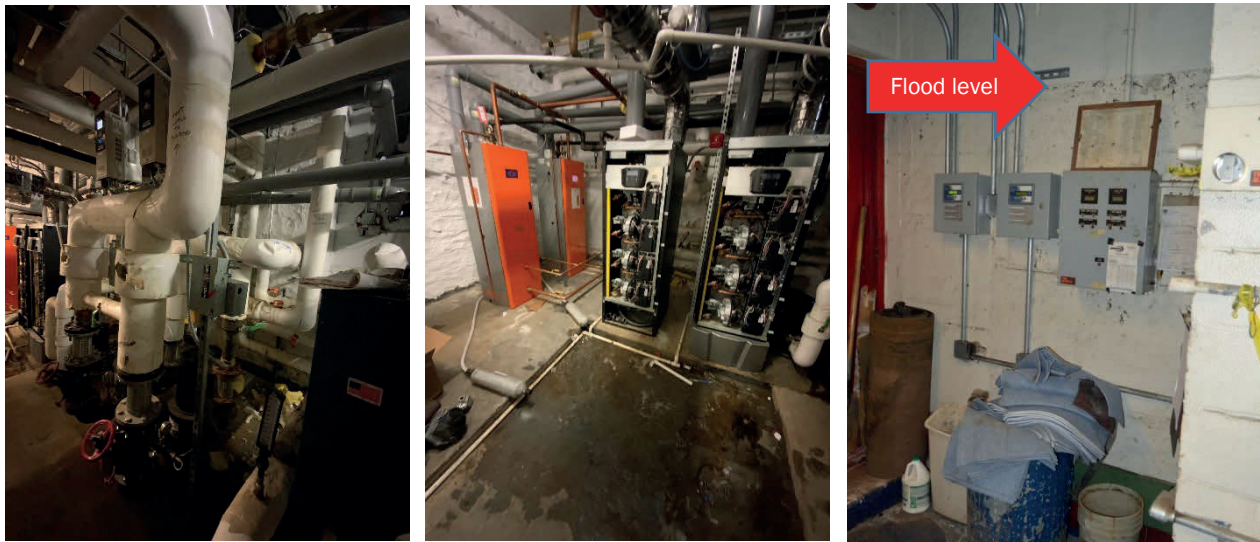
- Electric service components and building service equipment in basements must be inspected and repaired or replaced (Figure 7).
- Water-damaged materials used for interior walls and floors must be replaced (Figure 8).
- Saturated contents typically cannot be recovered and must be disposed.
- Vehicles in below-grade garages may be damaged or total losses, depending on the depth of flooding.

**Figure 7. Damage to equipment in flooded basements**

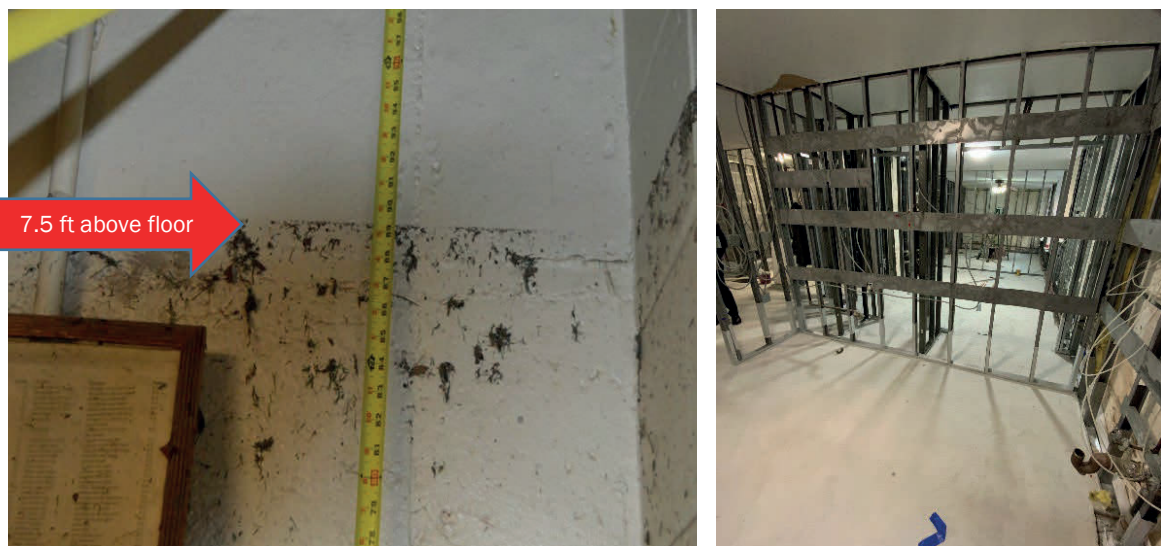
**Figure 8. Water-damaged interior surfaces and interior walls in basements**

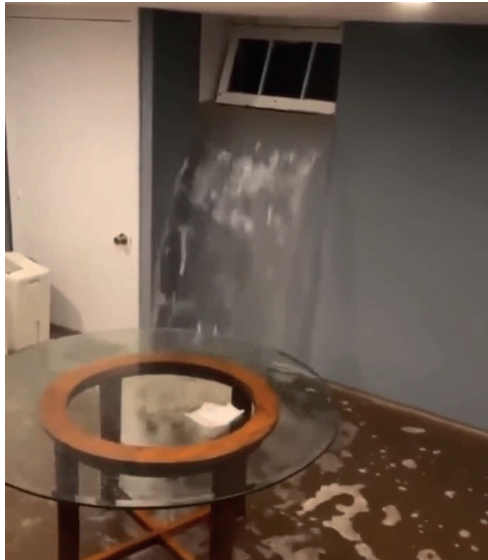
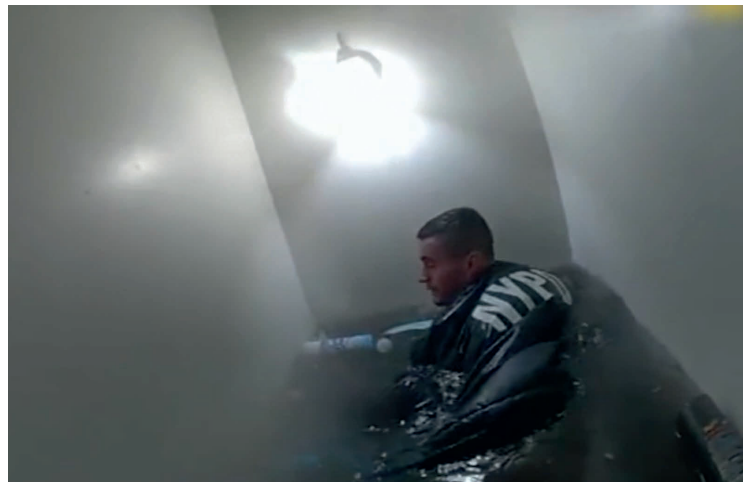
During the rainfall caused by remnants of Hurricane Ida, basement flooding put occupants at extreme risk, since the water inflow was often through windows and down entry stairways (Figure 9). Sometimes those windows and stairways are the only ways that people can get out of basements. In addition, typical exterior doors to exit stairways open outward. When stairwells fill with runoff water, the hydrostatic pressure against doors can make it difficult, if not impossible, to open doors that swing outward. Compromised egress from occupied basement units can result in injuries and loss of life during flood events. The FEMA Hurricane Ida NYC MAT Technical Report 2, Egress from Floodprone Basements (FEMA P-2333), includes brief summaries of New York City's requirements and agency programs and responsibilities related to egress.

**Figure 9. Surface water entering below-grade dwelling unit through window (left). NYPD officer searching flooded basement where three fatalities occurred (right).**

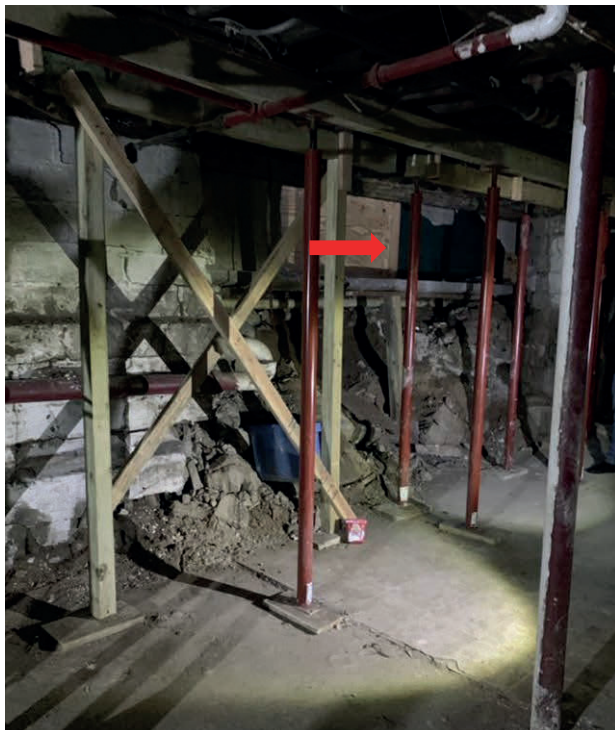
Another consequence of the flooding of buildings with basements can be structural damage. The Team observed a single-family home in Queens with a collapsed basement wall that was constructed of unreinforced masonry blocks (Figure 10). Its collapse was likely the result of the low out-of-plane bending and shear capacity of the wall. This capacity was exceeded by lateral pressure of the soil, plus increased hydrostatic pressure on the exterior of the wall caused by the surface flooding. In addition to jeopardizing the structural integrity of the building supported by this wall, the collapse created a large opening. That opening may have allowed surface water to fill the basement rapidly.

One death in this basement was reported, although it is not known if it was due to trauma from the wall collapse or drowning.

That home and others like it in the neighborhood are approximately 100 years old. They were constructed before modern hazard-resistant building codes. Current building codes require new homes to have foundation drainage and basement walls reinforced to resist lateral earth pressure. The owners and occupants of these older buildings should be aware of the increased risk of basement wall collapse, which may allow a rapid flow of surface water into the basements. Those conditions can jeopardize the structural support for the house above and endanger occupants. Owners should also learn how to pump water out of basements to minimize damage to the basement walls.

**Figure 10. Failure of unreinforced masonry foundation wall at single-family home in Queens. Arrows point to a large opening in the foundation wall, as seen from the outside and inside of the building.**

The city should consider whether it is feasible to identify one- and two-family homes with basements and cellars that were constructed before building codes required reinforced foundation walls and foundation drainage. Those older foundation walls may be susceptible to failing under hydrostatic and lateral earth pressures when soils become saturated. Then, if those homes are located in areas where urban flooding is a known risk, the city could inform owners and occupants of the risk of basement flooding and foundation wall collapse. Owners can be encouraged to seek advice from qualified professionals and contractors to learn more about whether their basement walls are at risk and options to minimize future damage.

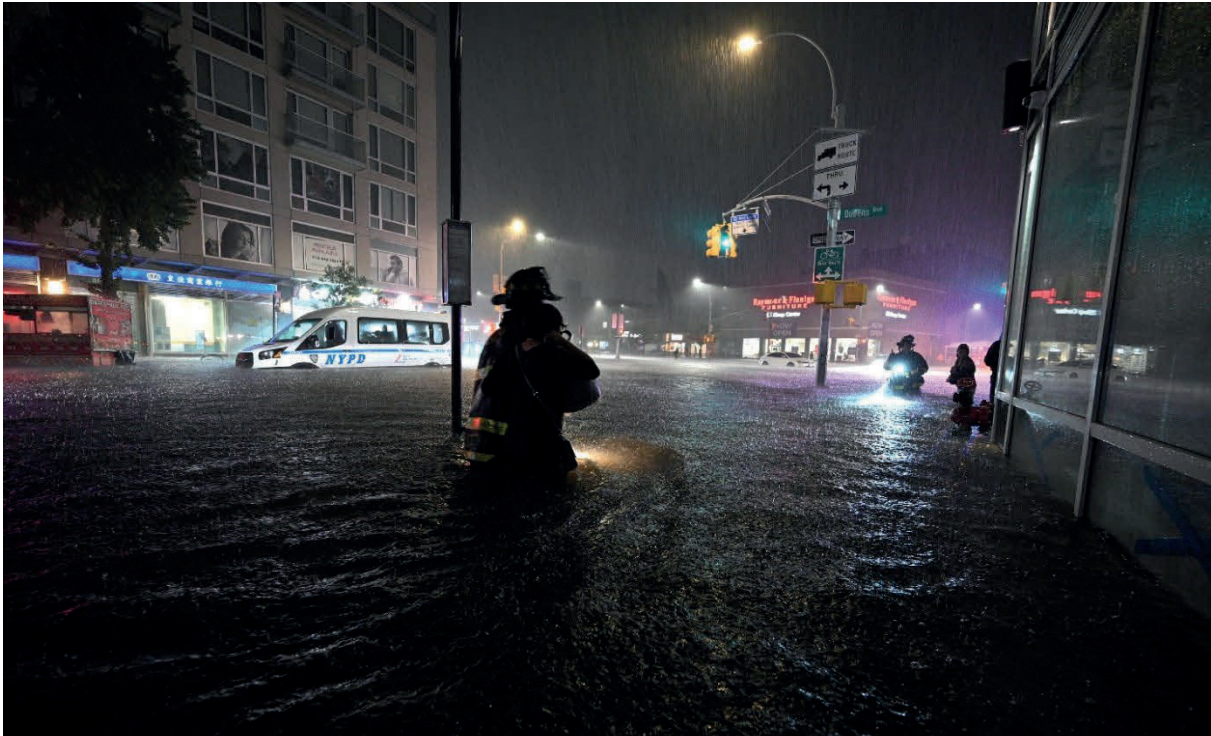
The rainfall runoff during the storm overwhelmed the stormwater drainage system in many parts of the city. This resulted in the accumulation of surface water on roadways and sidewalks, particularly in lower lying areas (Figure 11). In some areas, the runoff overtopped curbs and entered many building basements and below-grade areas.

**Figure 11. Street flooding caused by the remnants of Hurricane Ida**

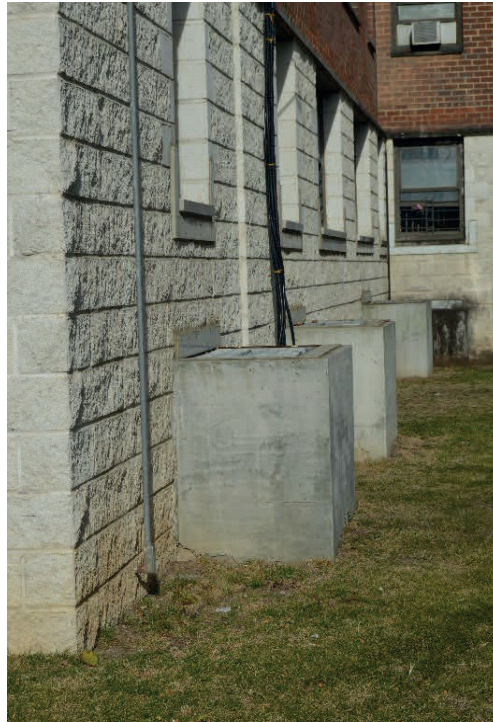
**Figure 12. Vents retrofit by extending vent wells above ground level**
