Hazus Hurricane Wind for Puerto Rico and the U.S. Virgin Islands

May 2021

FEMA

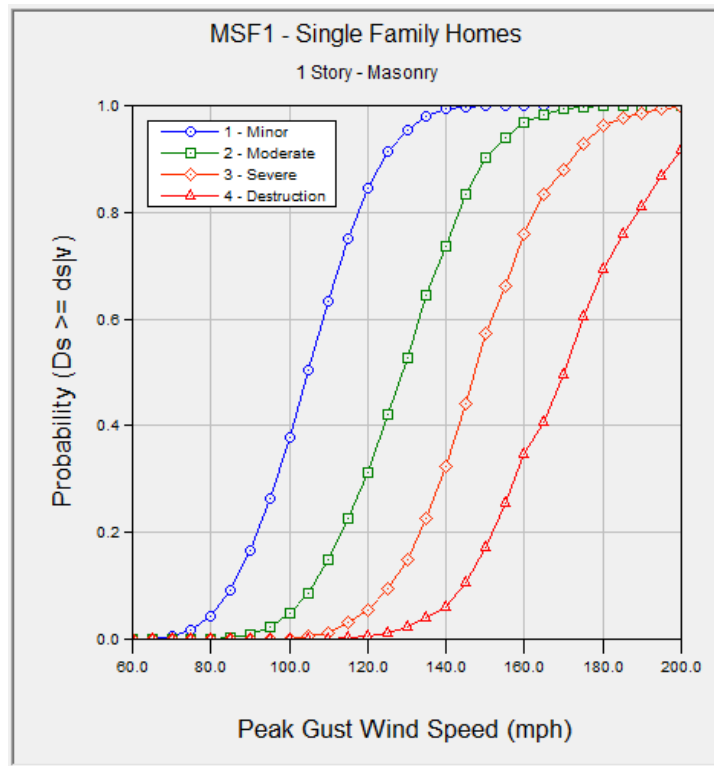
The wind component of Hazus Hurricane uses a set of mathematical functions to estimate damage to structures, with each structure type having its own curve that represents structural damage as a function of wind speed. The curves are developed using a combination of building characteristics of the structures themselves, such as construction materials or the presence of damage mitigation features, or the surrounding environment that might contribute to faster or slower wind speeds.

Figure 2-2: Sample Hazus Hurricane Damage Curve

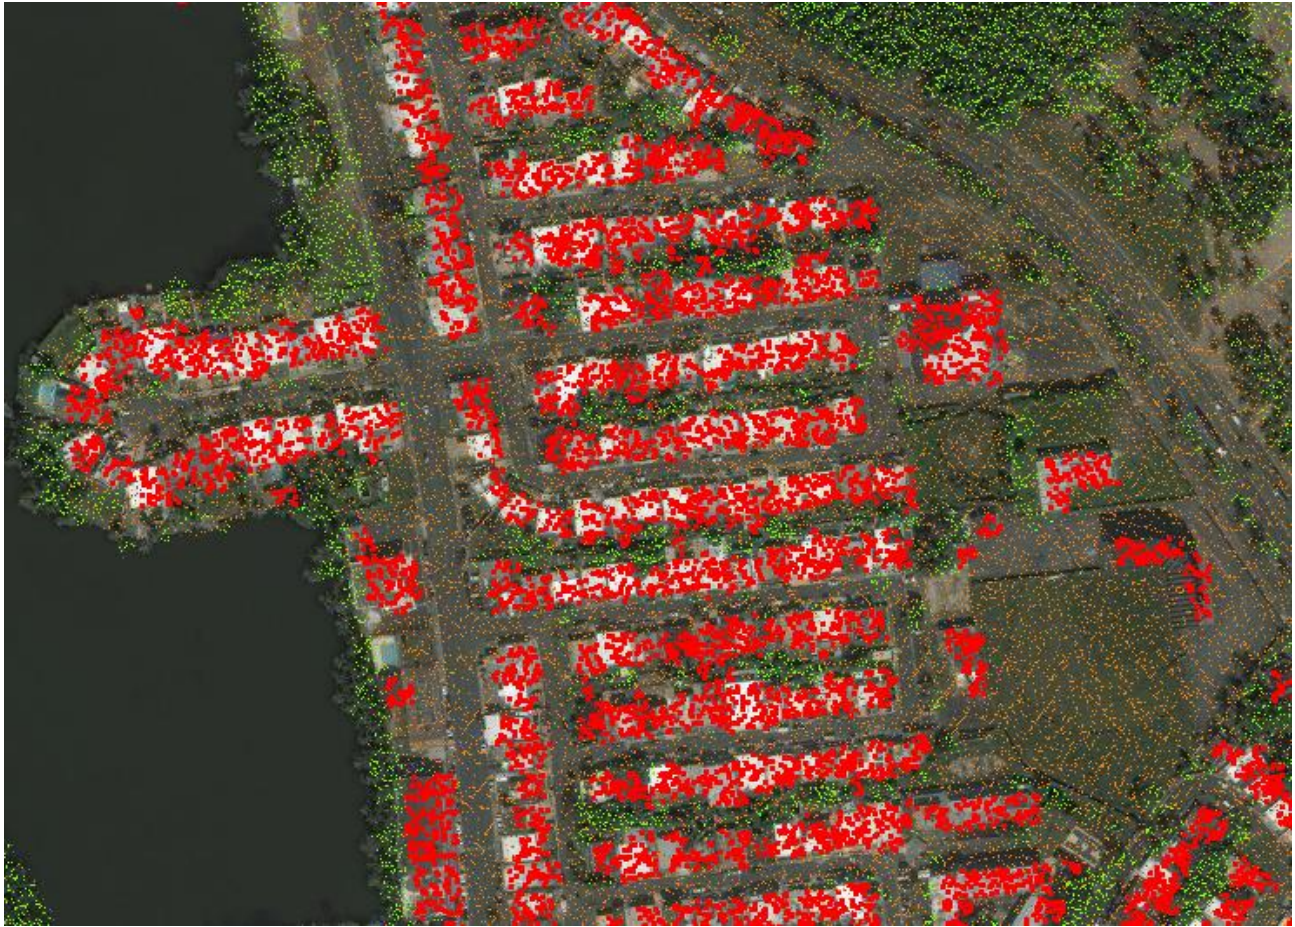
cloud and identify regions of points that exhibit planarity akin to roof surfaces. The parameters associated with the planarity and the area/size were then manipulated to extract points as desired. Points defining planar surfaces were classified as Class 6 (building) and the outline of Class 6 building point clusters was later individually vectorized using LP360 into an Esri Shapefile.

Figure 3-3: Example Area of Point Cloud Classified Points

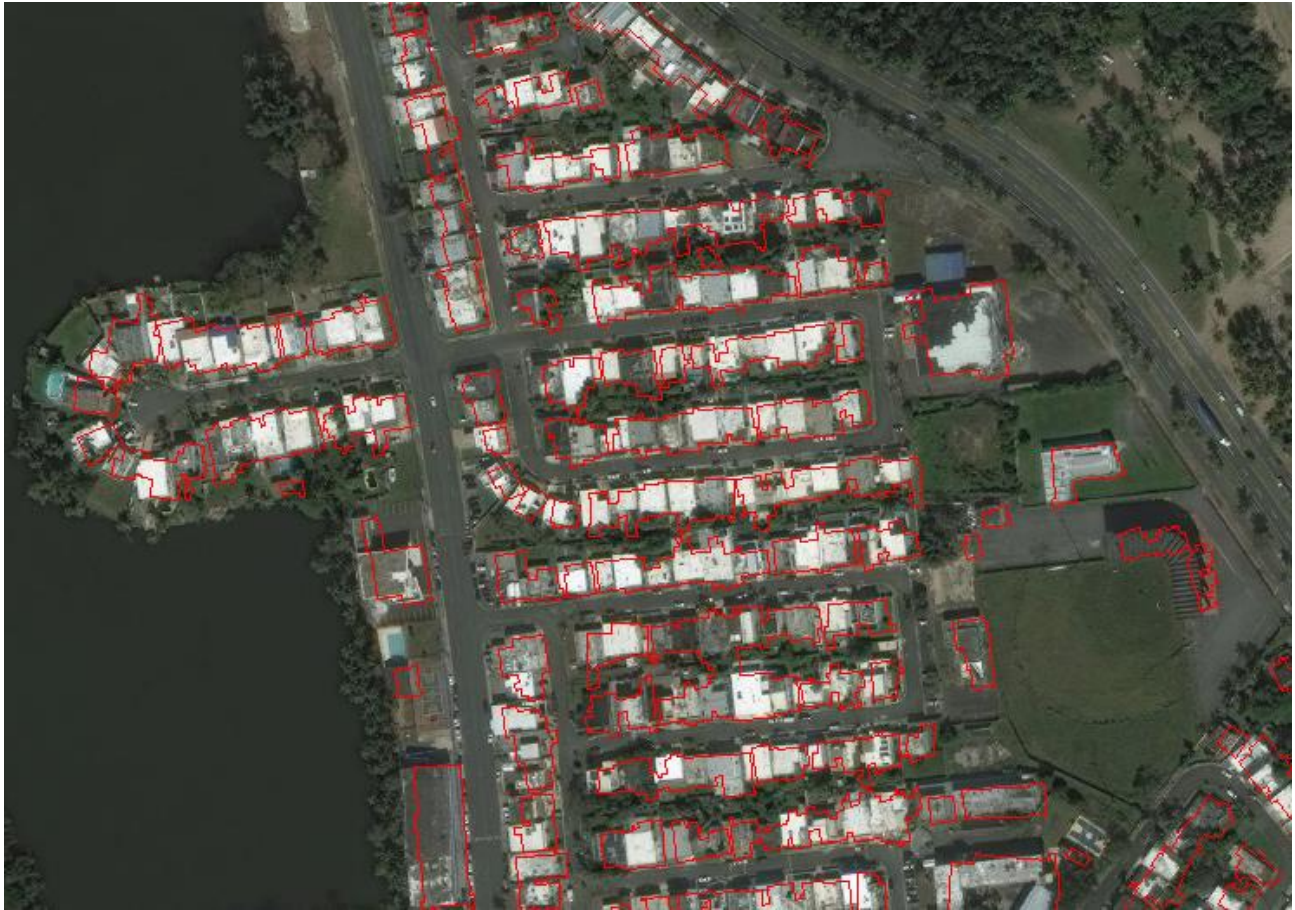
Figure 3-4: Example Area of Building Footprints

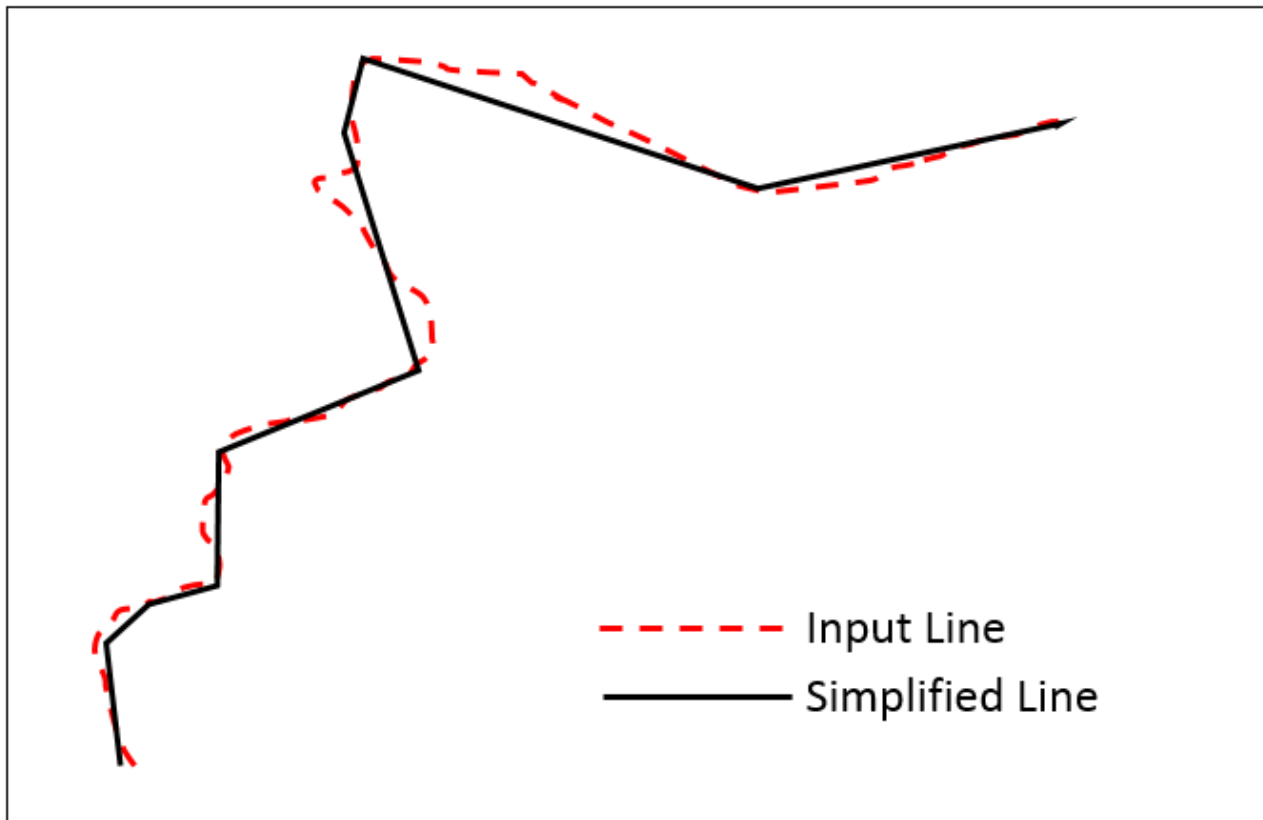
5. Perform a Generalize function on parcel spatial layer.
 - a. Tolerance of 0.333333 m was used

Figure 3-6: Generalize Parcels Process

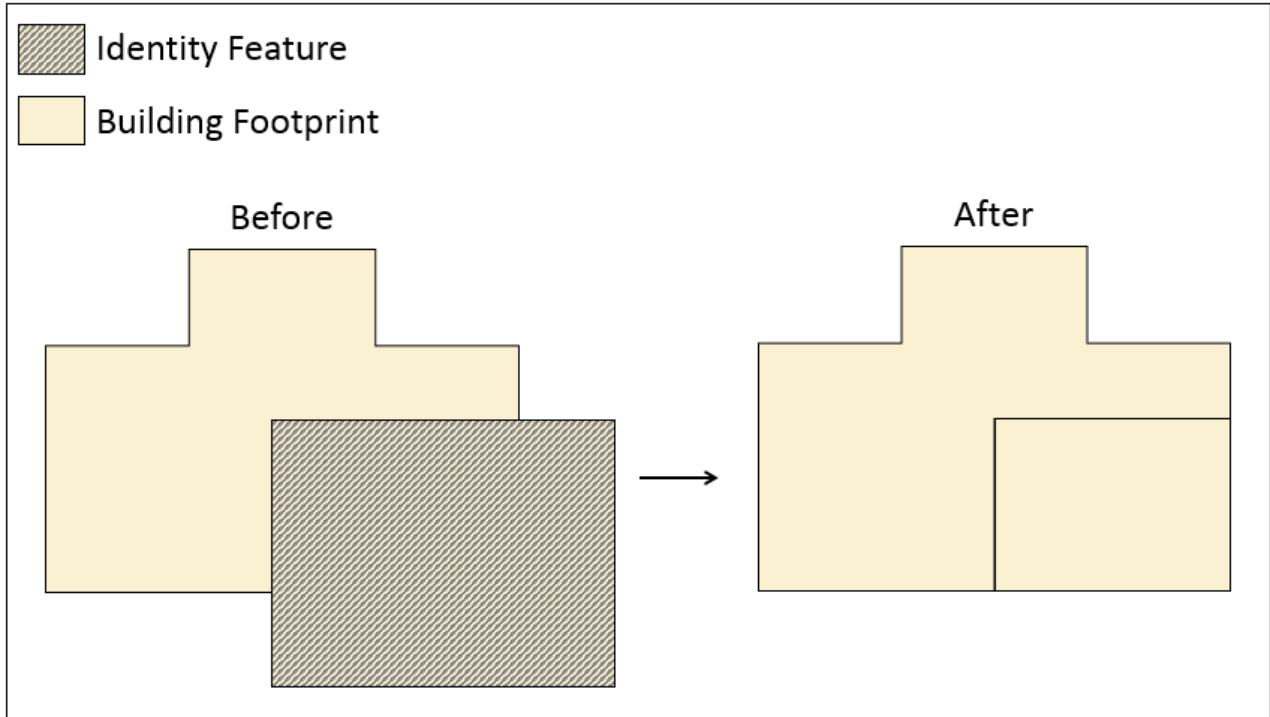
6. Create a grid index feature for buildings.
 - a. 12800 x 12800 m
7. Create a grid index feature for parcels.
 - b. 25600 x 25600 m
8. Perform a Spatial Join using buildings/buildings grid as inputs.
 - c. "HAVE_THEIR_CENTER_IN" was used as the match option
9. Perform a Spatial Join using parcels/parcels grid as inputs.
 - d. "INTERSECT" was used as the match option
10. Use a definition query to select a block of buildings/overlapping parcels.
11. Perform an Identity function to split buildings at parcel boundaries for each grid.

Figure 3-7: Identity Function

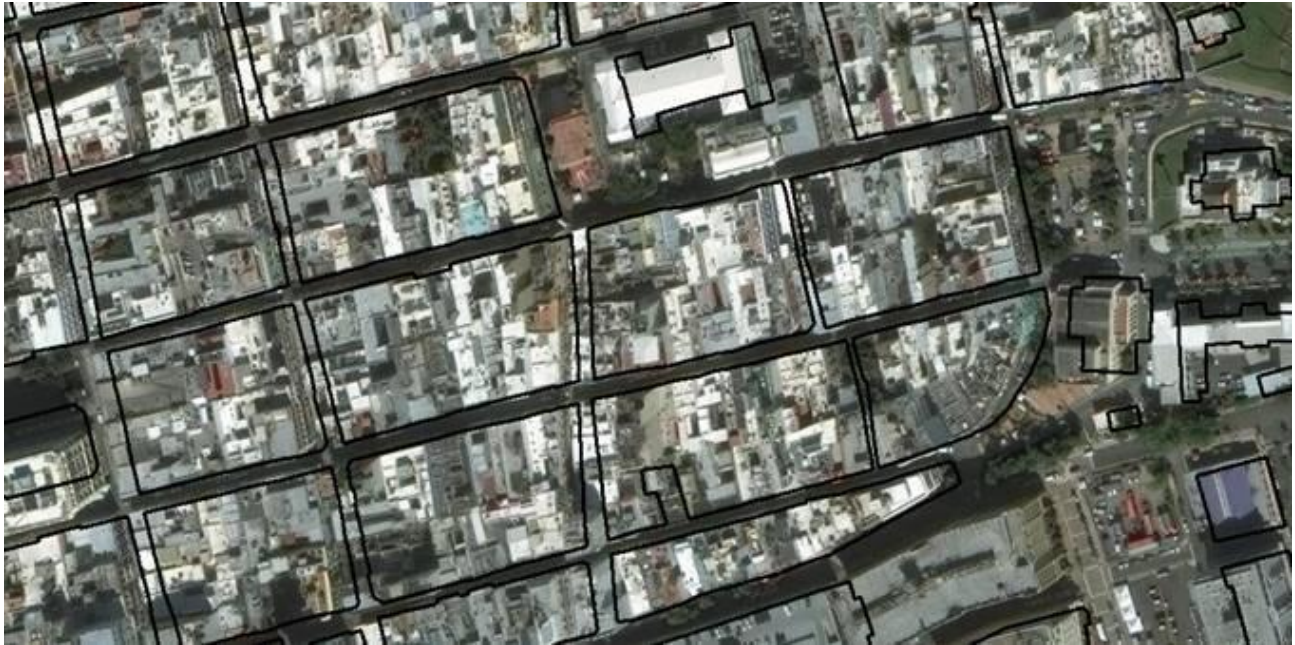
1. **Deleting false positives:** Reviewers deleted building footprints that were not the actual location of a corresponding building from DigitalGlobe™. Examples included tree canopies, cars, ships in harbors, livestock, etc.
2. **Identifying false negatives:** Reviewers identified locations where imagery showed a building while the classification process did not identify a structure. For these locations, reviewers placed a point on the building’s location according to imagery, building a separate point shapefile for missing footprints. Across the territory, 86,376 such points were identified.
3. **Splitting unsplit rowhome buildings:** Reviewers used the split polygon function to manually split single-structure, multiple-owner homes that were not split apart by the parcel-split process.

Figure 3-8: Rowhome Buildings Unsplit

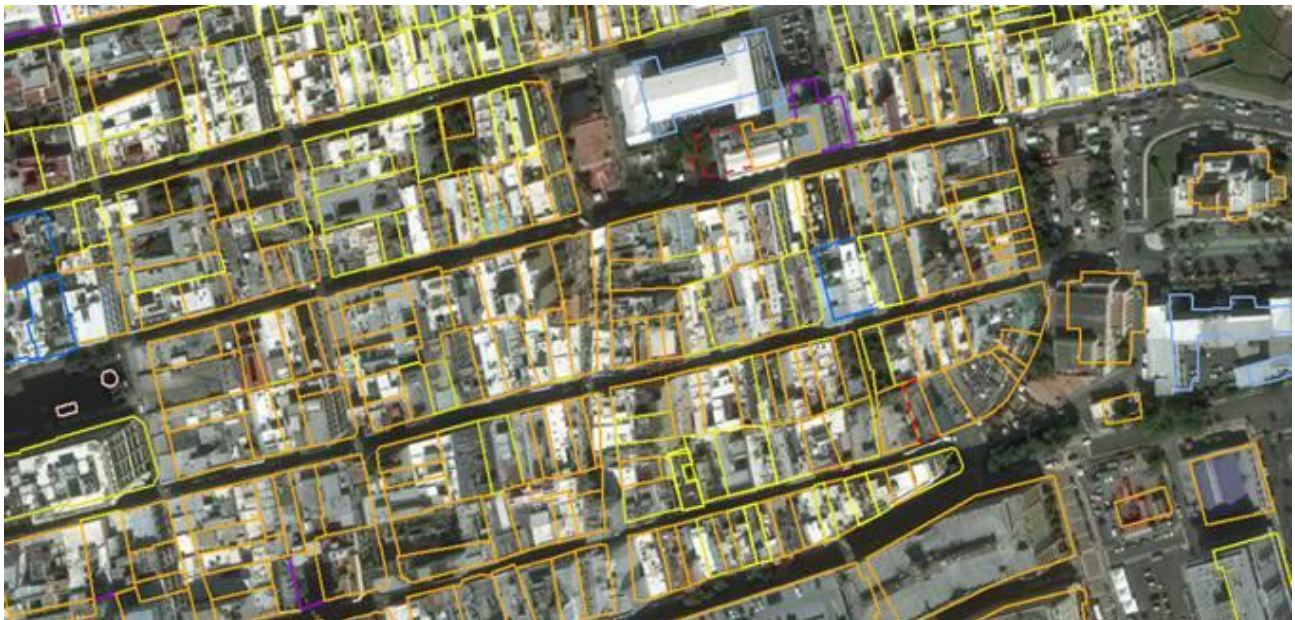
Figure 3-9: Rowhome Buildings Split Using Manual Process

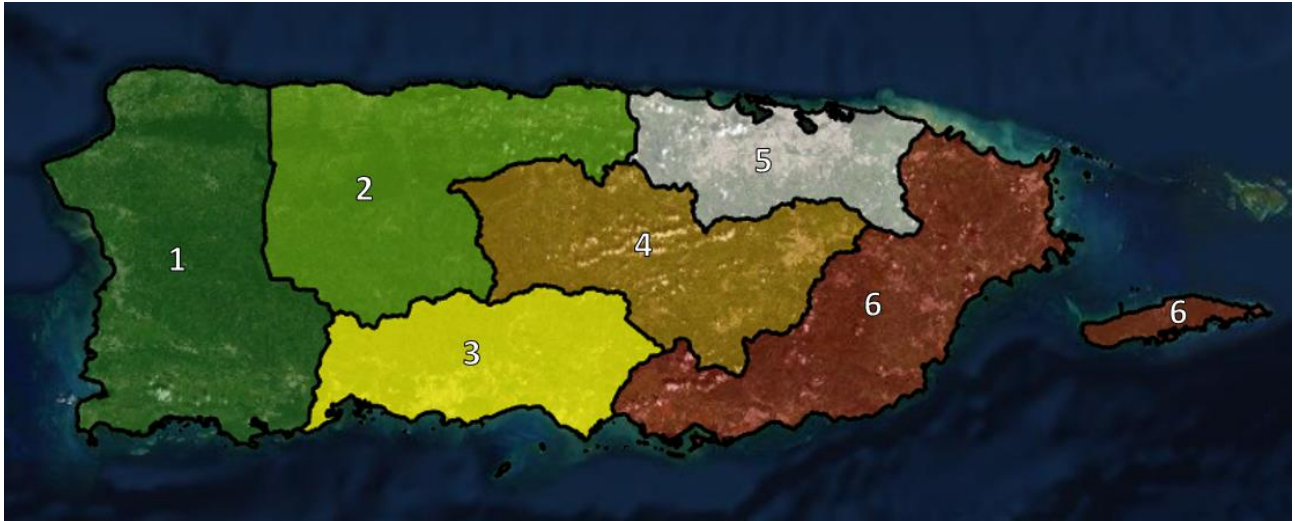
Figure 3-11: Puerto Rico Divided into Six Sections for Manual Review

After the automated processing was completed, Puerto Rico was divided into six sections for a manual review.

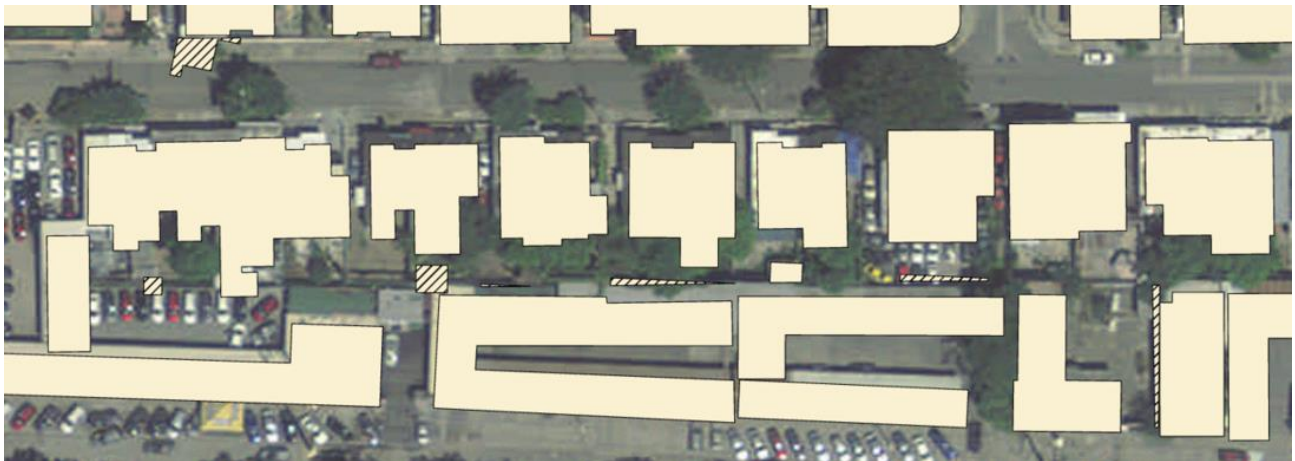
- **Non-Existing Buildings:** polygons that were not over a structure. These buildings were deleted based on imagery.

Figure 3-12: Example of Non-Existing Building Polygons Identified

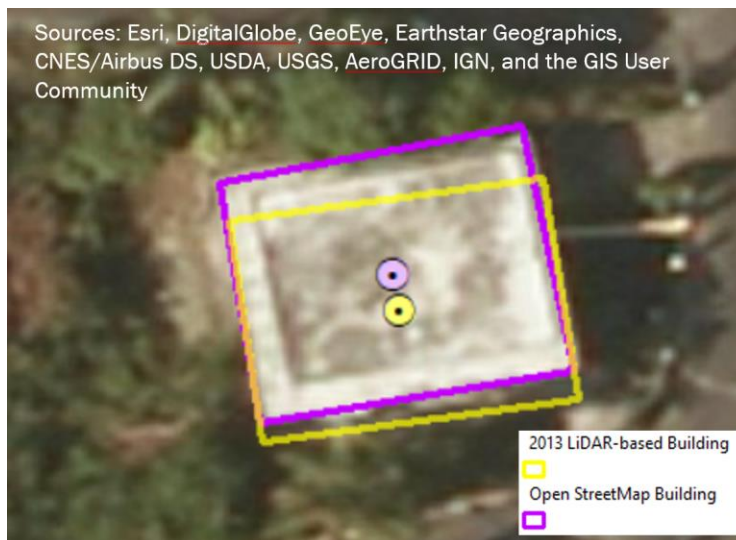
Figure 3-17 demonstrates instances where the Lidar-based footprint largely coincides with the OSM footprint and intersects with the OSM centroid. In these instances, the Lidar-based footprints were retained.

Figure 3-17: Example of Lidar-Based Footprint Corresponding to OSM Footprint and Centroid

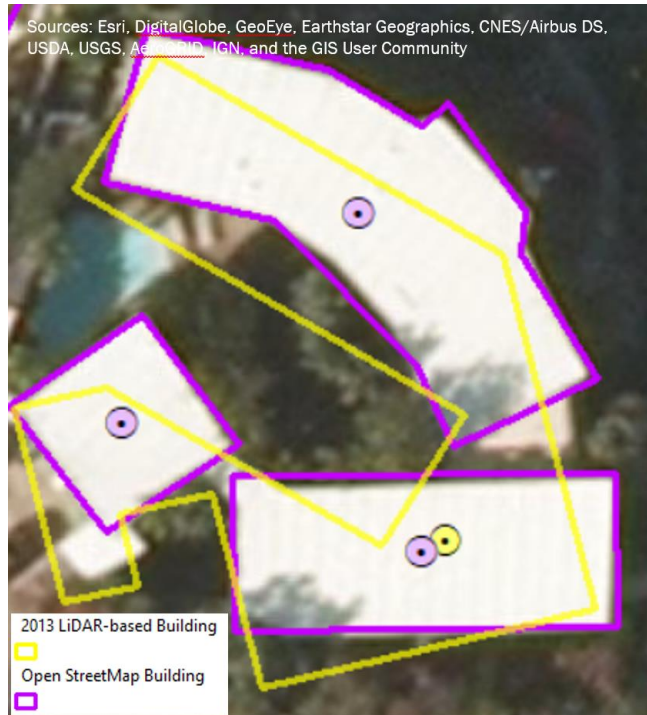
Figure 3-18 demonstrates an instance where there is only one Lidar-based footprint, but multiple OSM footprints for the same location. In these instances, the OSM building footprints were retained.

Figure 3-18: Example of One Lidar-Based Building Footprint to Many OSM Building Footprints

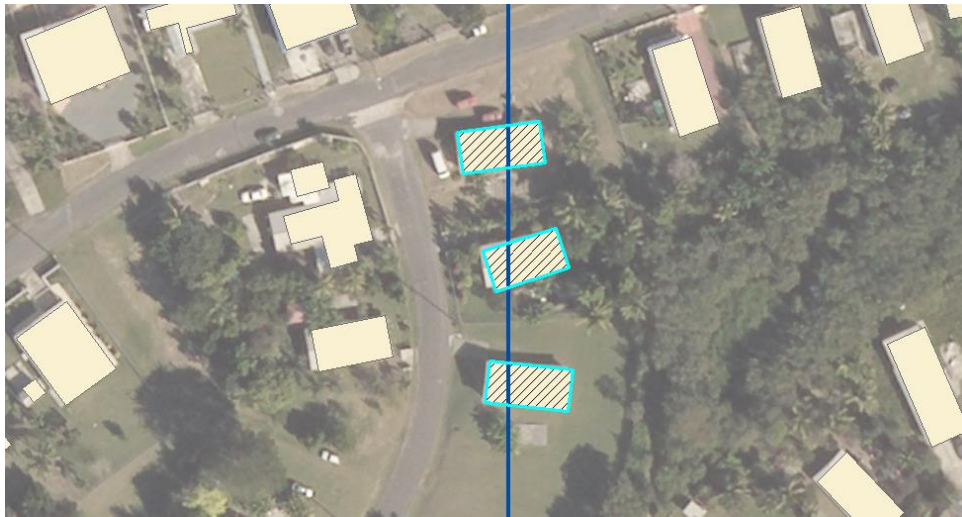
Figure 3-23: Grid Sample

The random sampling was performed on structures using a combination of a grid system and the availability of Google Street View imagery/photos. A 5,000 feet grid system was created to cover all three islands. Building footprints that intersected the grid system was a baseline for sampling. This ensured some sort of building footprint sampling across all Island geographies. Figure 3-23 provides an example of a group of buildings where the hashed polygons are buildings that were selected for random sampling analysis.

Further refinement of the random sampling came from where there was availability of Google Street View. Since many of the building characteristics (e.g., Shutters and Window Area) needed a street view or oblique imagery for a determination, sampling was weighted to areas having this type of data availability. Additional structures may have been added or removed from the initial grid intersection to obtain the needed sample size. Once footprints were identified for data collection, this guided users on where to collect needed attribution. Additional structures were added to the needed sampling to make sure if street view imagery had any visual obstructions when determining a building characteristic, it could be skipped. In many cases, the minimum sample size of collected data was exceeded for the U.S. Virgin Islands.

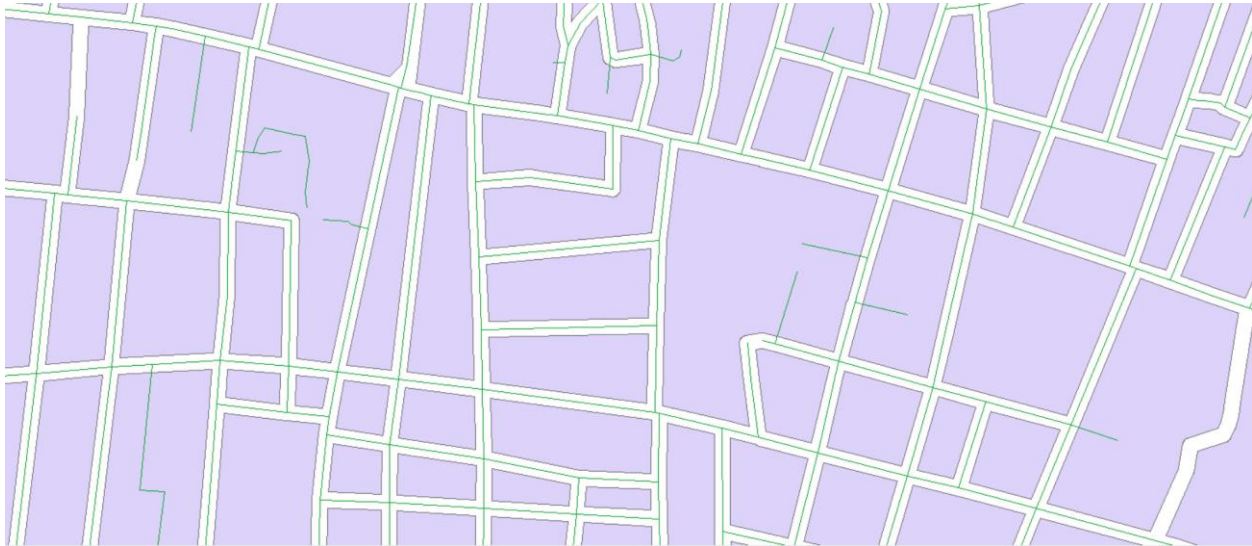
Figure 5-6. Roads and Block Boundaries With Negative Buffer of 25 Feet

For Puerto Rico, a negative buffer of 25 feet was applied to the 2010 Census blocks. The purpose of the negative buffer is to avoid the inclusion of roads that define the Census block boundary (see Figure 5-6). The use of 25 feet as a buffer is consistent with the assumed perimeter collection area described in Section 6.3 of the *Hazus Hurricane Model Technical Manual* (FEMA, 2021). That is, downed tree

debris within 25 feet of bounding roads would most likely be cleared from the right-of-way and collected for disposal.

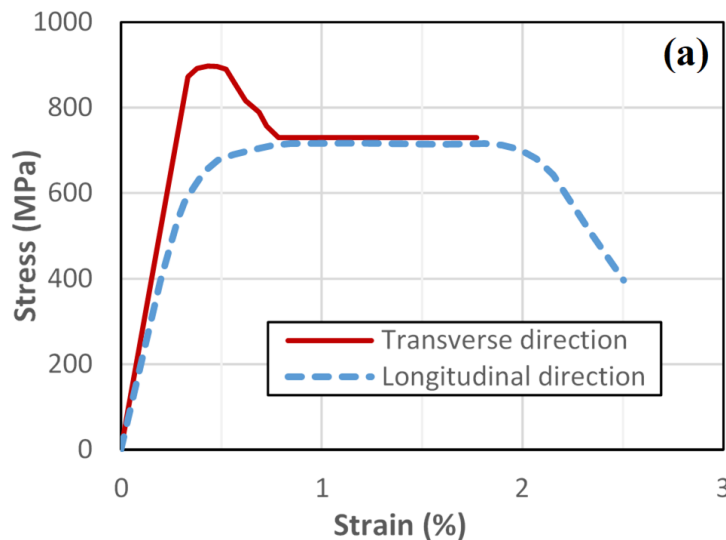
Figure 6-2: Uniaxial Stress-Strain Response of G550 Corrugated Metal Sheet from Xu and Teng (1994) and Lovisa et al. (2013)

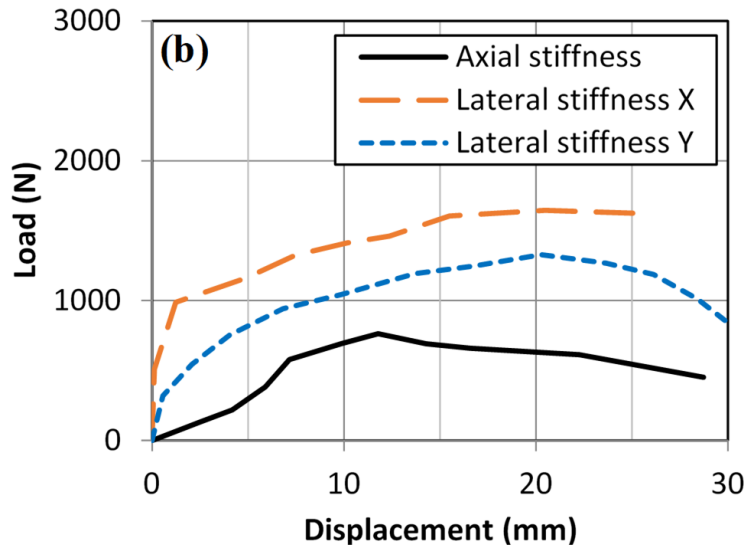
Figure 6-3: Force-Displacement Relationships Used for Nonlinear Springs Representing 8d Nails Connecting Metal Cladding to Wood Battens (Thampi, 2010)

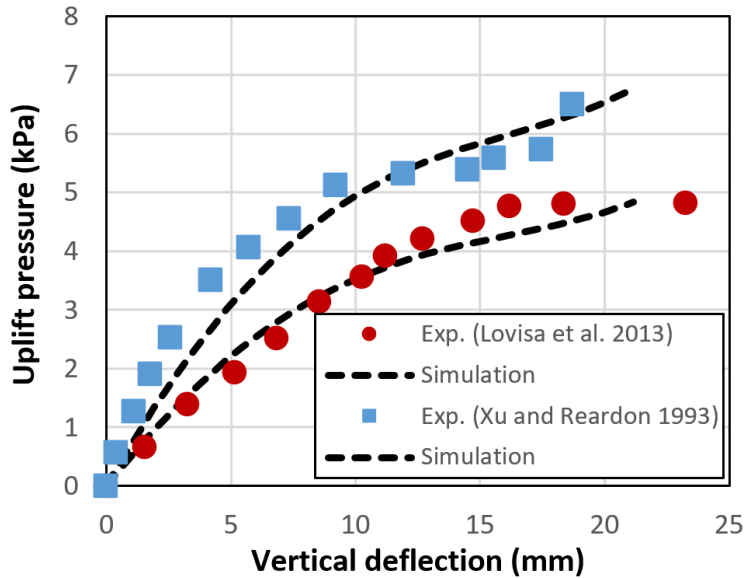
Figure 6-4: Comparison of Uplift Pressure-Vertical Displacement Responses Between Experiment (Lovisa et al. 2013) and Simulation

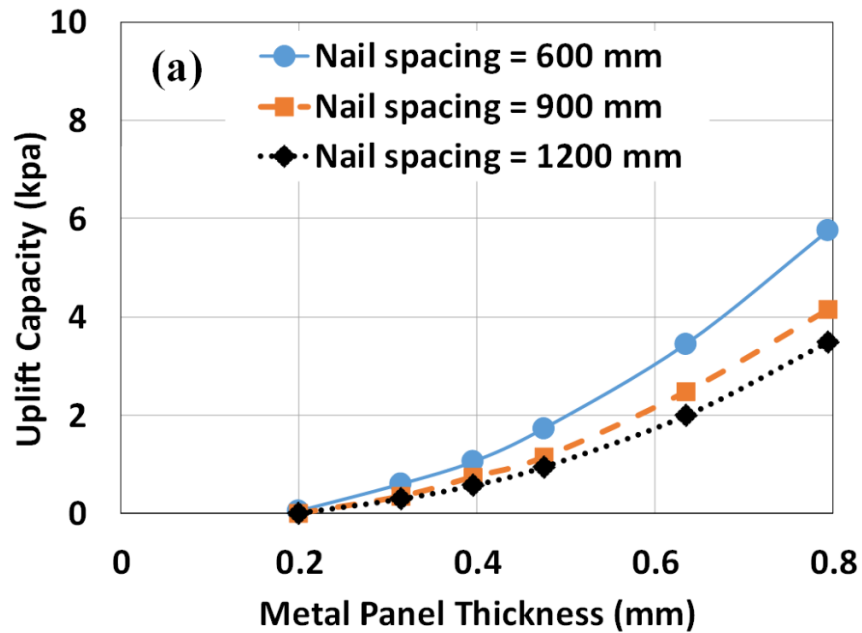
Figure 6-5: Modeled Uplift Resistances of Corrugated Metal Roof with Nail Connections to Battens

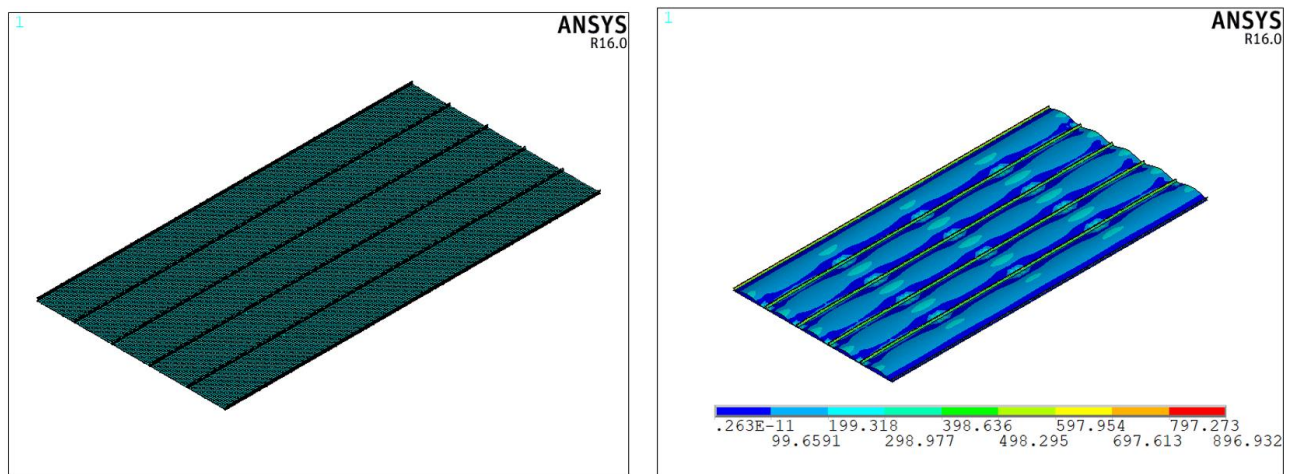
Figure 6-7: Finite Element Mesh of Standing Seam Metal Roof and Corresponding von-Mises Stress Contours

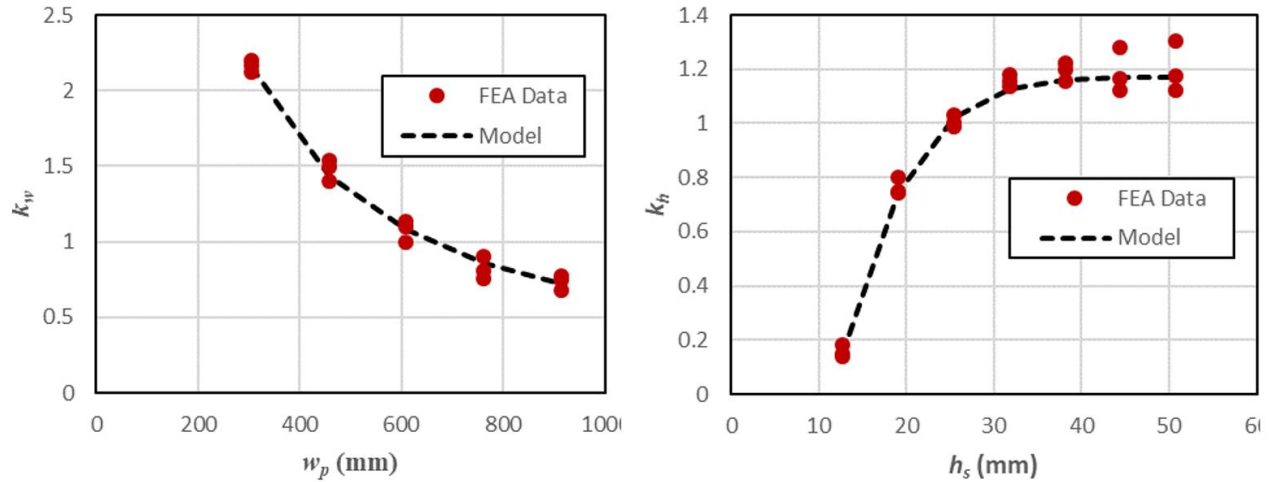
Figure 6-10: Normalized Uplift Resistance of Standing Seam Metal Roof for Different Panel Widths (w_p) and Seam Heights (h_s)

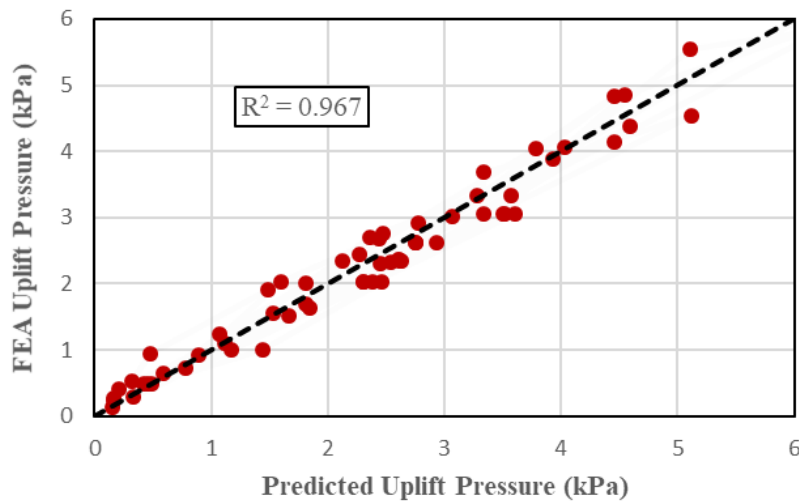
Figure 6-11: Equity Line Plot Showing Uplift Resistance Comparison Between Finite Element Model Simulation Results and Predicted Responses from Equation 6-4
