Phase I Environmental Site Assessment

Niagara Engine Co. No. 6 Property

114-118 Fort Road

November 12, 2012

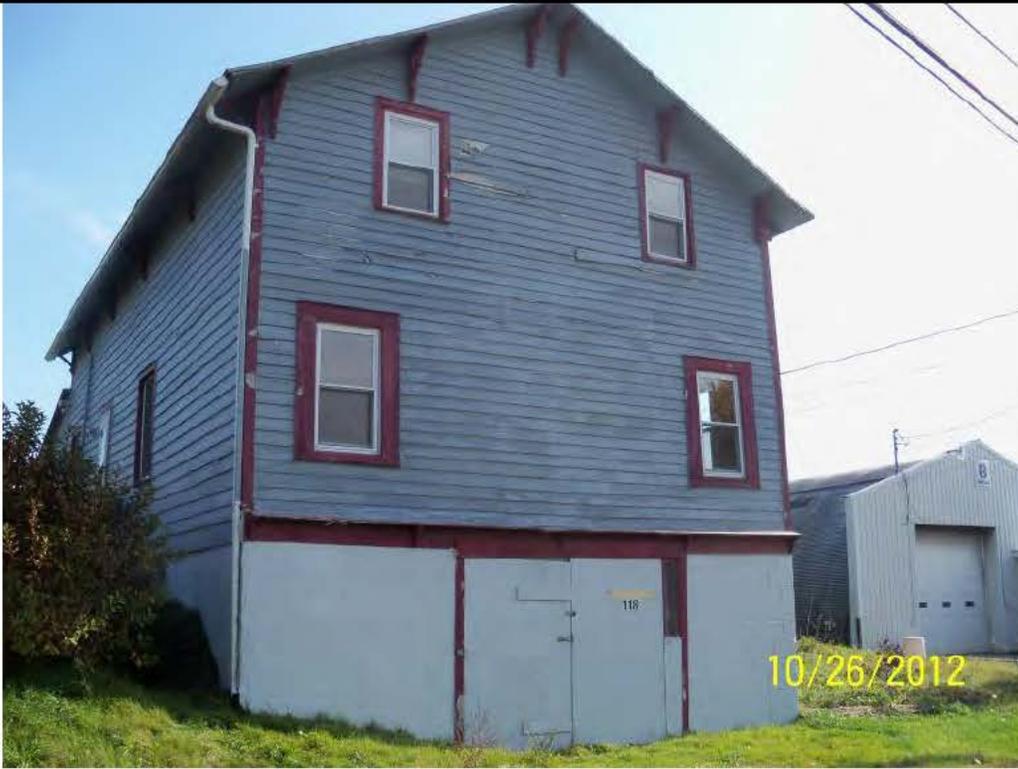
Photo #1 - An overview of the west side of the house, facing east.

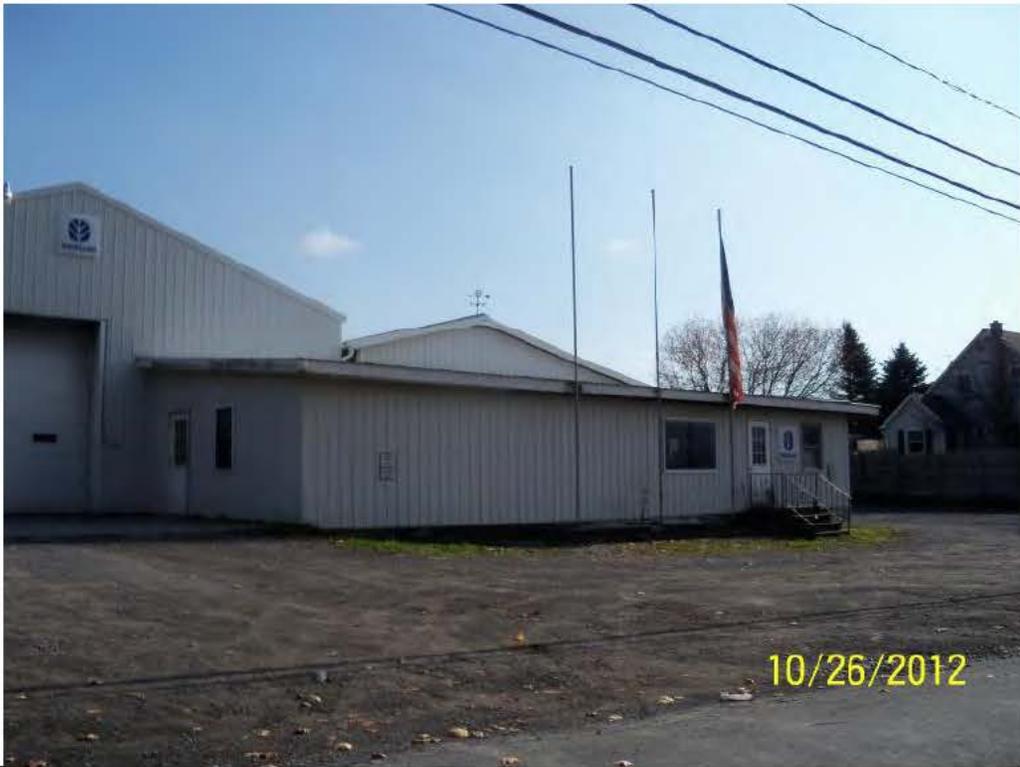
Photo #2 - An overview of the west side of the fire house and Quonset hut, facing east.

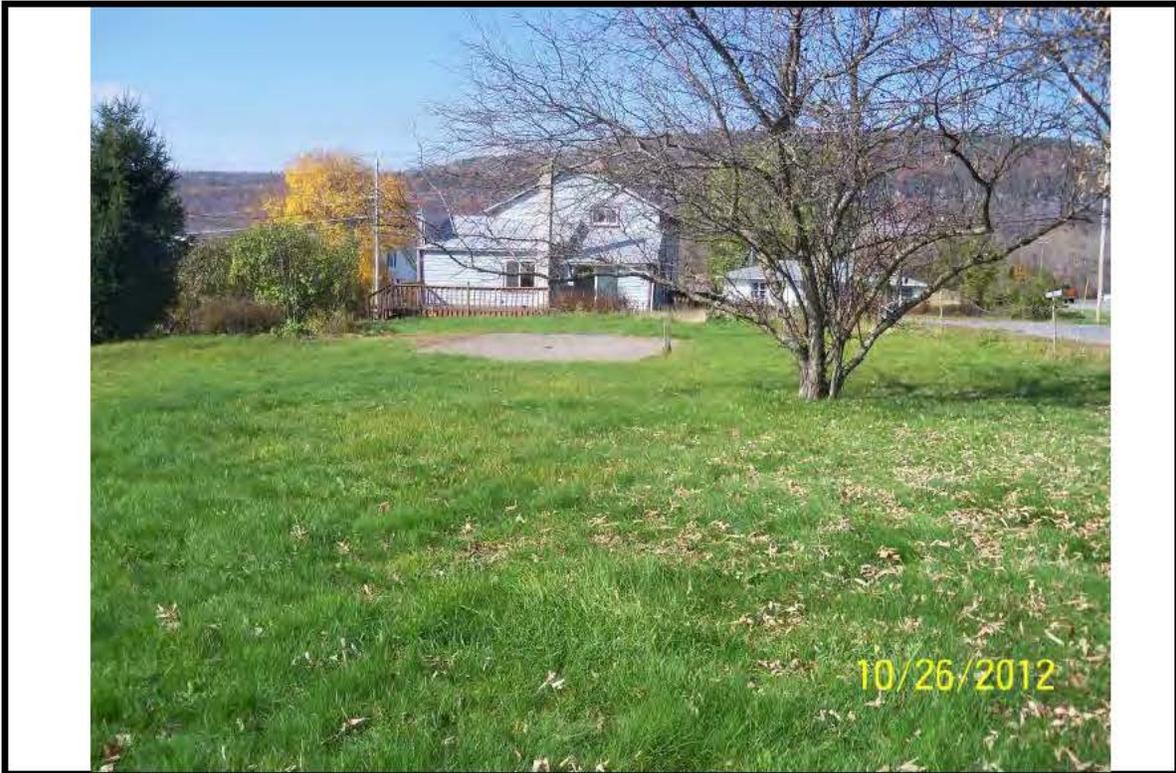
Photo #3 – An overview of the east side of the house facing west.

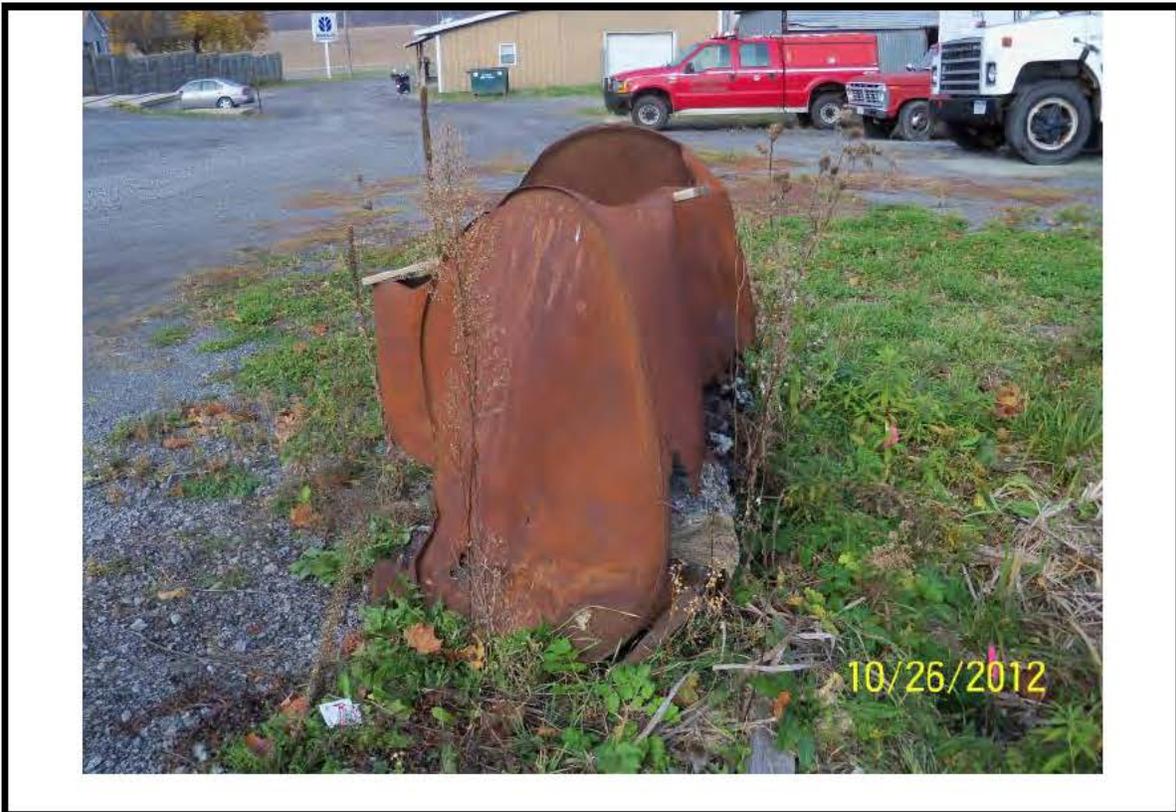
Photo #4 – A view of the east side of the fire station in background. AST with ash in foreground. Concrete loading docks in upper left corner of photo.

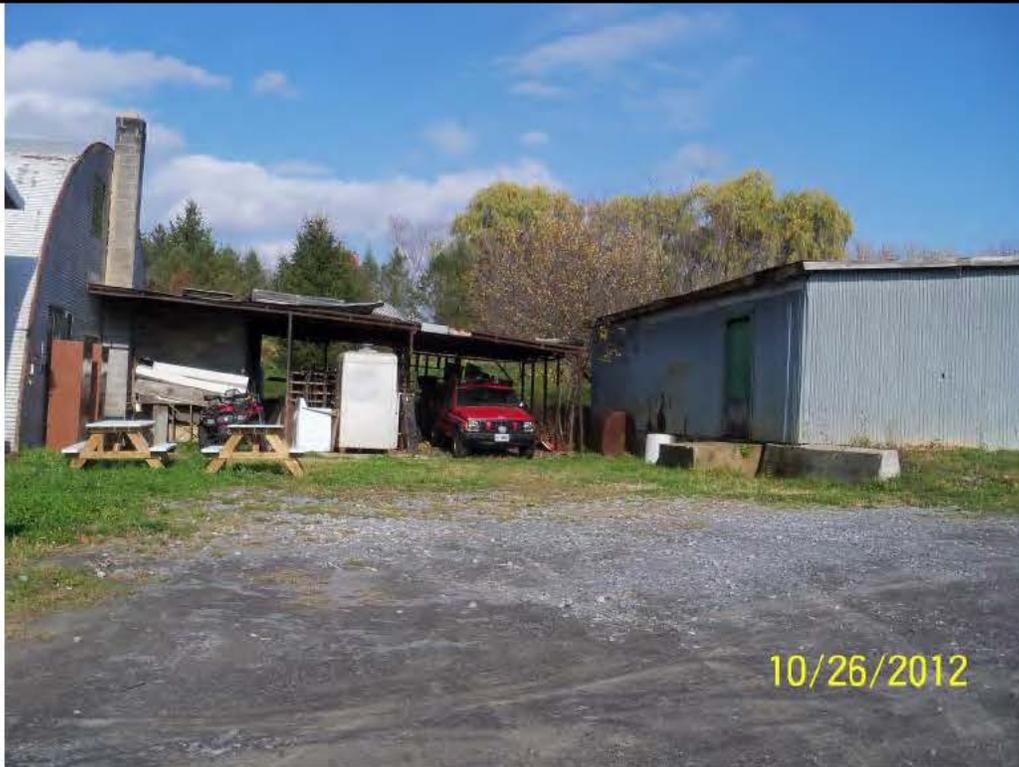
Photo #5 – A view of the former truck wash area, lean-to and pole barn facing north. Quonset hut on left side of photo.

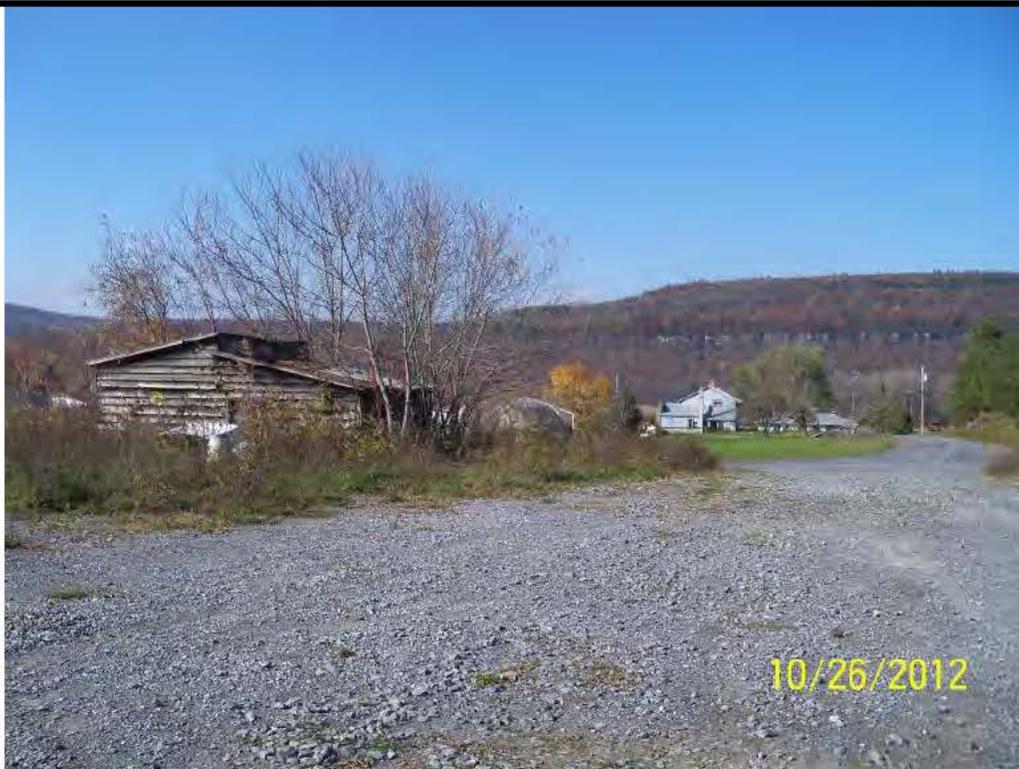
- The sectioned concrete floor in the Junk Shed exhibited some minor staining. This staining is considered **de minimis**.
 - No staining was observed beneath the AST in the fire house building or beneath the empty former waste oil AST. Therefore, these are not considered RECs.

Photo #6 – A view of the junk shed facing northwest.

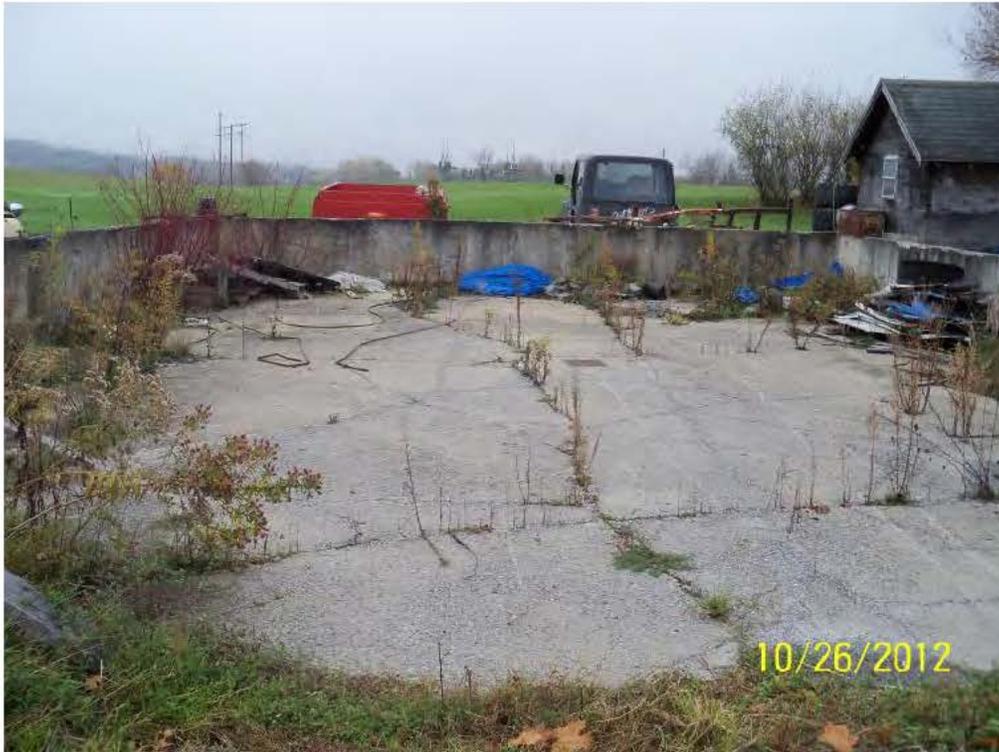
Photo #7 – A view of the concrete pad facing south. Floor drain in center of pad.

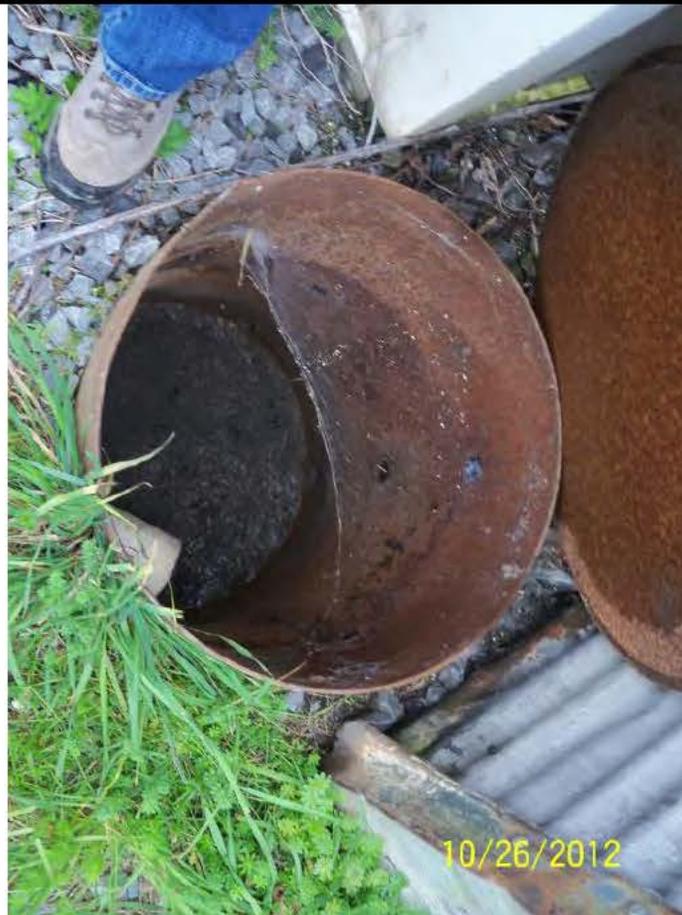
- A partially buried drum was installed in the ground between the tractor sales building and Quonset hut. The drum was observed to contain several inches of material that exhibited a strong petroleum odor. The drum does not appear to have a solid bottom (given its use for drainage). A pipe penetrating the eastern sidewall of this drum is on the side of the former tractor wash area. Differing information reports that this drum was installed to either:
 - 1) Drain water from the interior corner of the Quonset hut and discharge it towards the driveway, as noted by the current owner, although the prior owner, Mr. Keyser, did not recall drainage problems within the Quonset hut.

This drum and former tractor wash area represents a **REC** as impacted sludge was observed and the drum appears to have no bottom to allow drainage directly downward under the drum. Additional information would be needed to assess the potential impacts in and under this drum and under the former potential tractor wash area.

Photo #8 – Partially buried drum drain between Quonset hut and Fire Station. Inlet pipe is from direction of truck wash area. Sludge had visible and olfactory evidence of petroleum impacts.

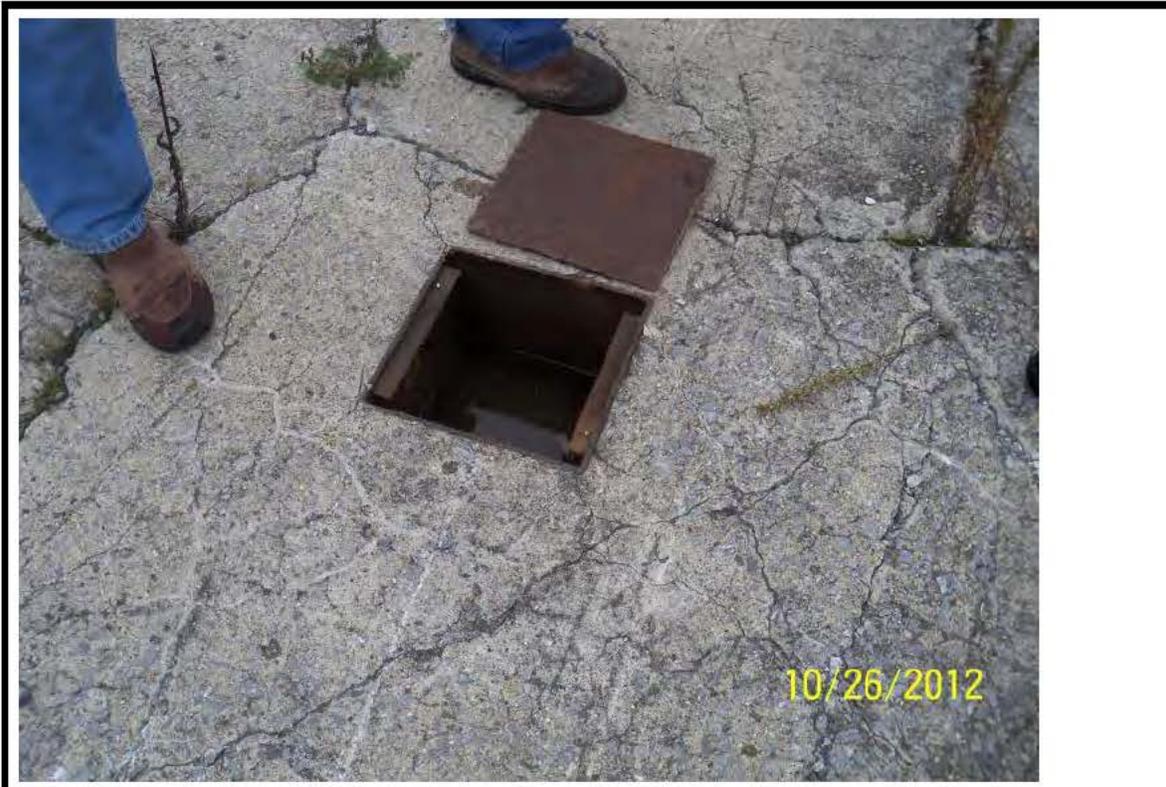
- A floor drain was observed in the concrete pad near the southern corner of the site. Several inches of sludge observed in this drain exhibited a strong petroleum odor. Although a pipe was observed penetrating the eastern sidewall of this floor drain, it is unknown to where, or from where, this pipe connects. This represents and **SDG** as the connection is unknown.

Photo #9 – Floor drain at concrete pad. Sludge had visible and olfactory evidence of petroleum impacts.

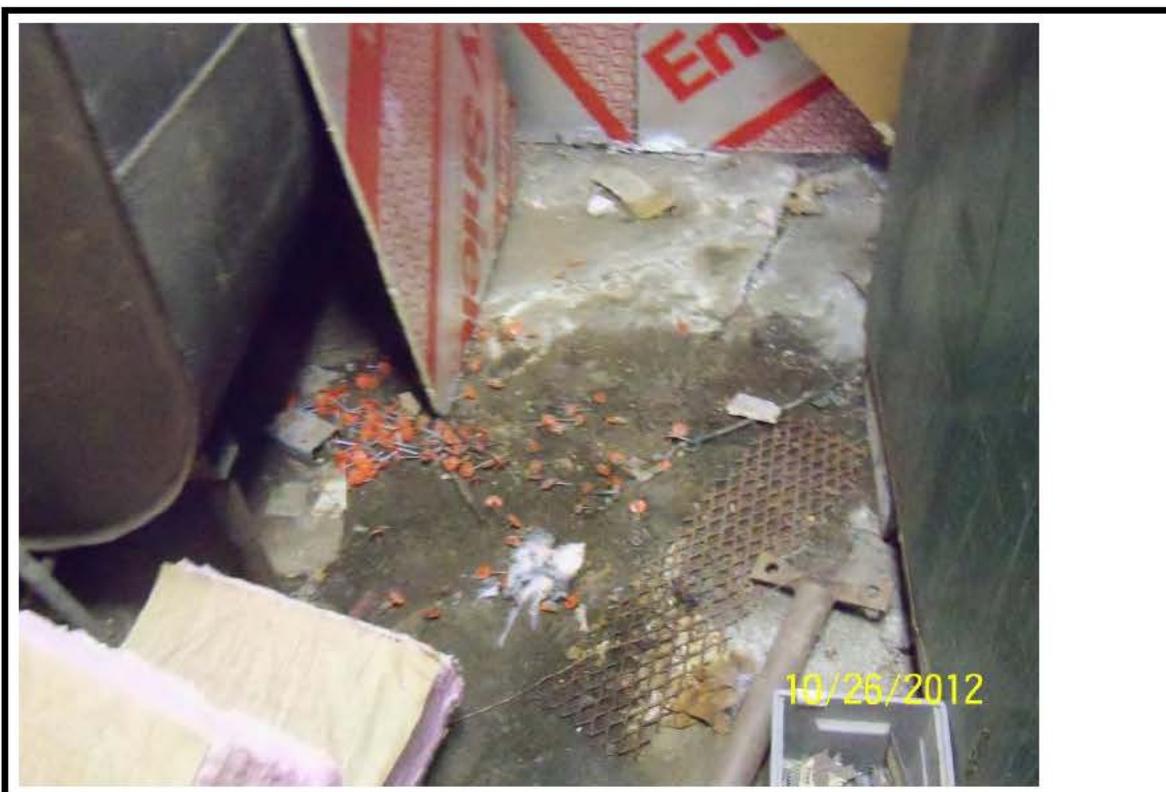
- Stained and damaged concrete were observed under the AST located in the Quonset hut. This is considered a **REC** as the damaged concrete provides a potential conduit for oil to migrate to the underlying soil and groundwater.

Photo #10 – AST in Quonset hut with staining and damaged concrete.

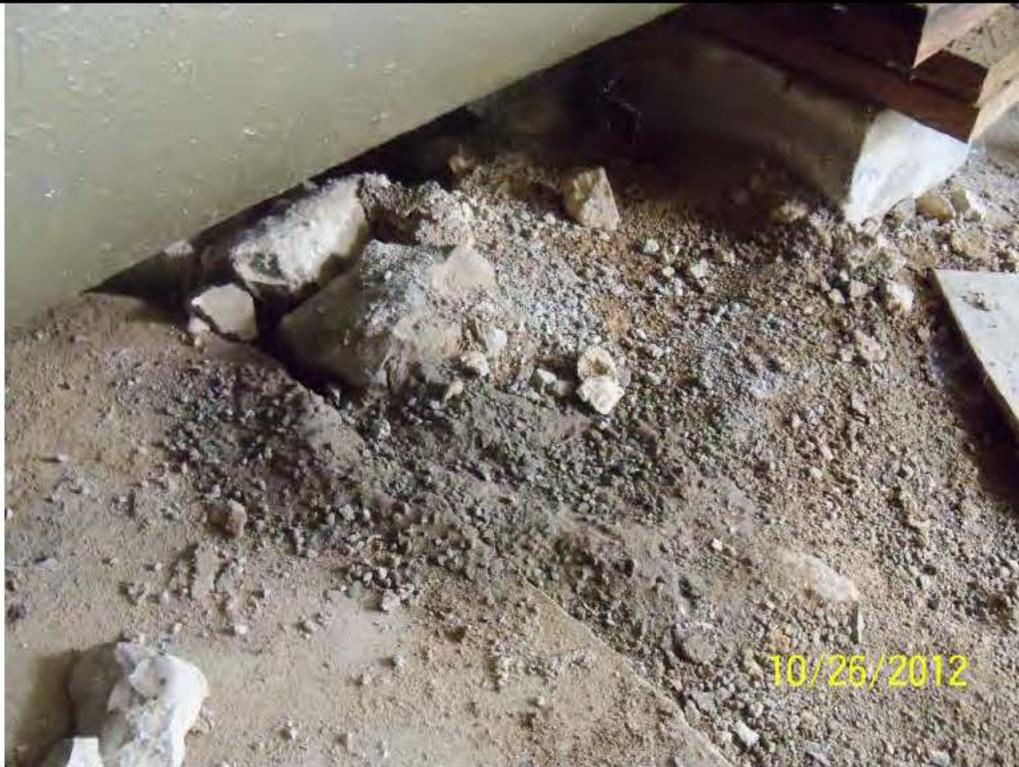
- Several areas of stained soil or concrete were observed at the site.
 - Stained soil was observed beneath the fuel oil AST in the house basement. This area also appears to have been used as a garage and staining was observed on the ground. This release to the ground is a **REC**.

Photo #11 – Stained soil beneath AST in basement of house.

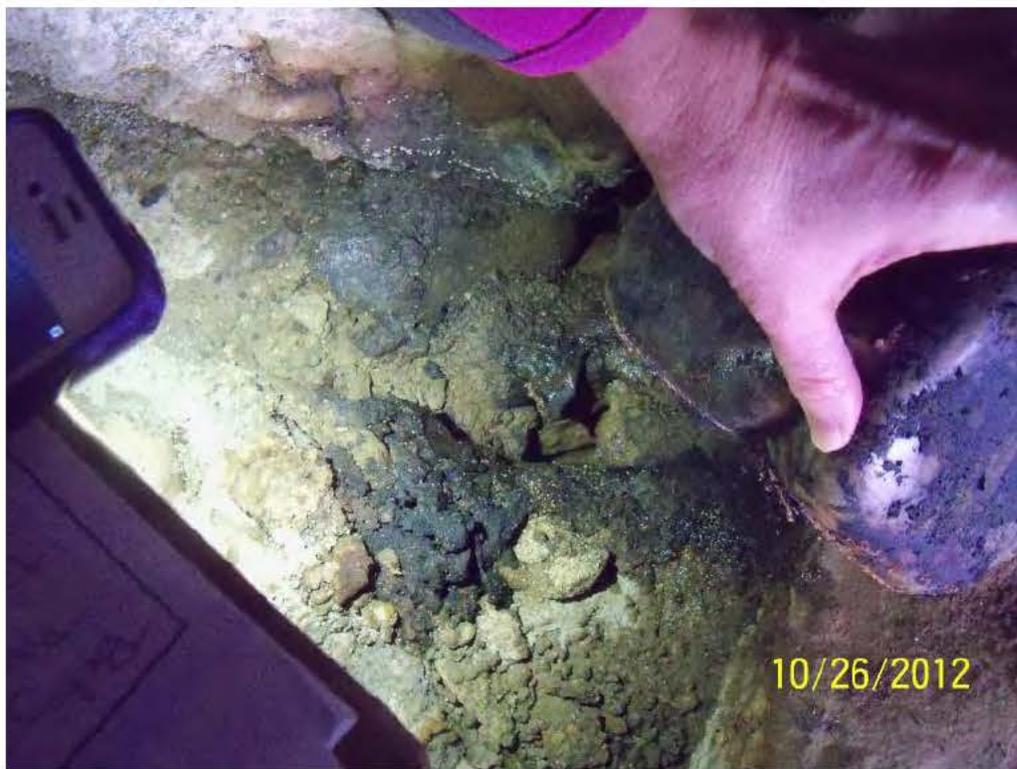
Photo #12 – Stained soil beneath AST pipe in basement of house.

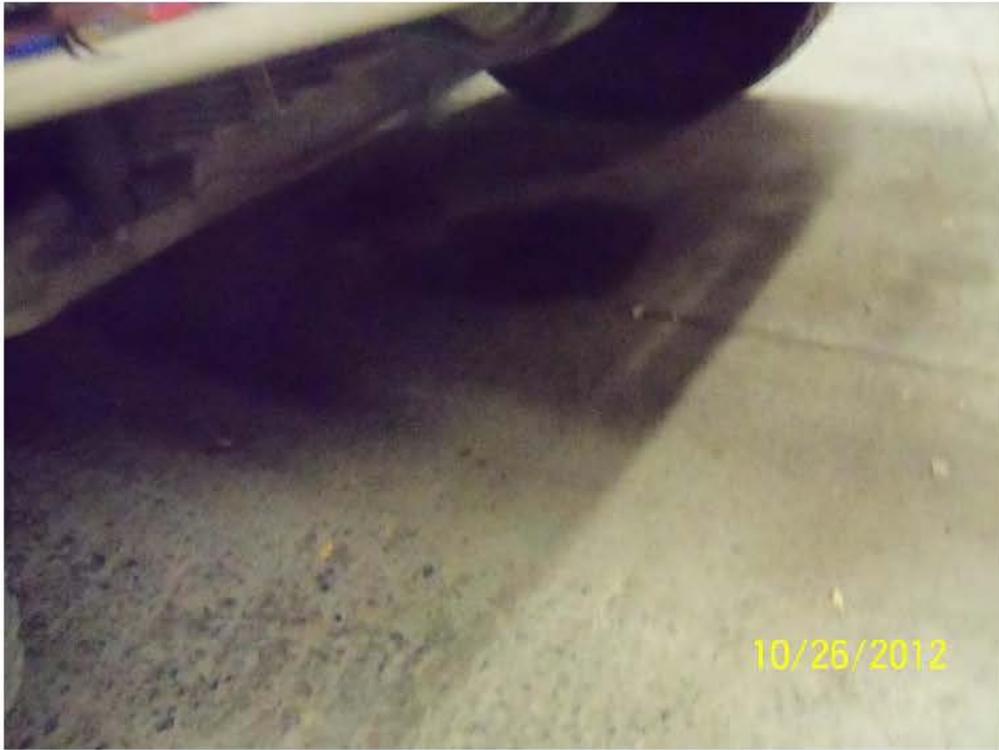
- Concrete staining was observed underneath fire trucks; however, visibility was limited and the condition of the concrete could not be confirmed. Therefore, this is considered an **SDG**.

Photo #13 – Staining under fire trucks (limited visibility due to parked vehicles).

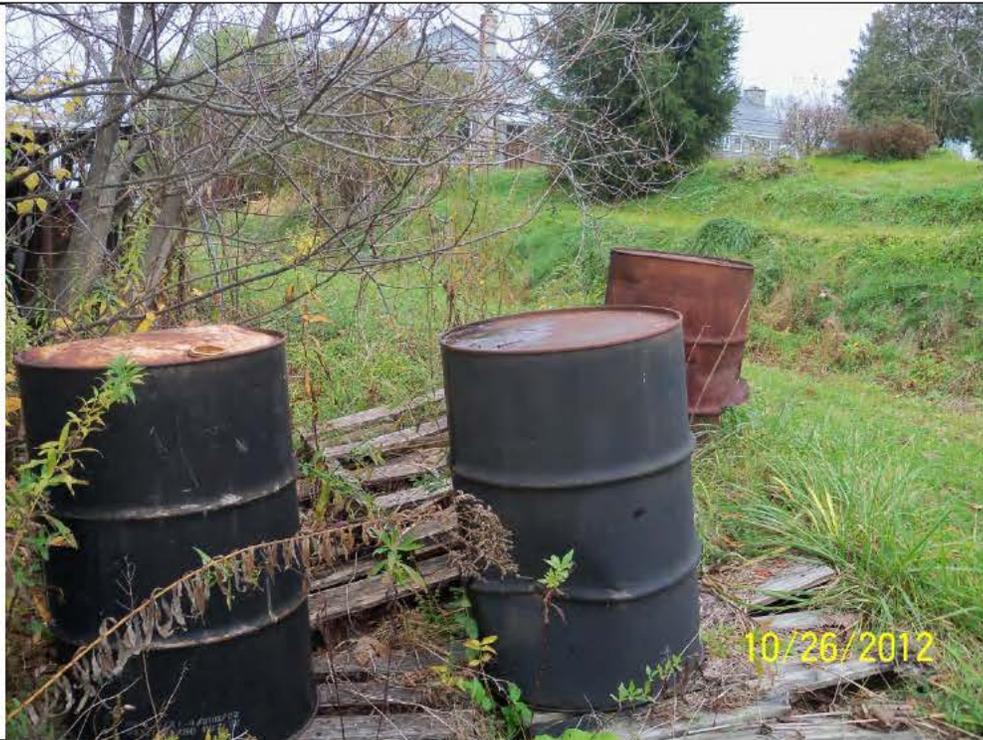
- Solid waste observed at the site includes empty oil and agricultural product drums that are not products used by the current occupant. Some drums and an old AST contained what appears to be wood ash. While no evidence of a release was observed from these empty containers, additional information would be needed to confirm whether the past use and storage of these types of materials were associated with some of the minor spills that the owner noted may have occurred. Therefore the empty waste oil drums are considered an **SDG**.

Photo #14 – Empty drum storage north of lean-to.
