APPENDIX C

SHOVEL TEST RECORDS

The Niagara Engine Company No. 6 Fire Station facility, located at 133 Grand Street was flooded with approximately 8 feet of water during the incident period of August 26, 2011 thru September 11, 2011. The damage to the structure was so extensive that replacement of the building has been determined to be more cost-effective than in-kind repairs of its elements. Rebuilding on site has been ruled out due to floodplain constraints. The Fire Department has been occupying a vacant tractor dealership, showroom and repair shop at 114 Fort Road since the damage occurred at their previous site. The existing building at 114 Fort Road is insufficient for their long term needs, but the Department has been given the opportunity to acquire the property to build a new firehouse (Figures 1 and 2).

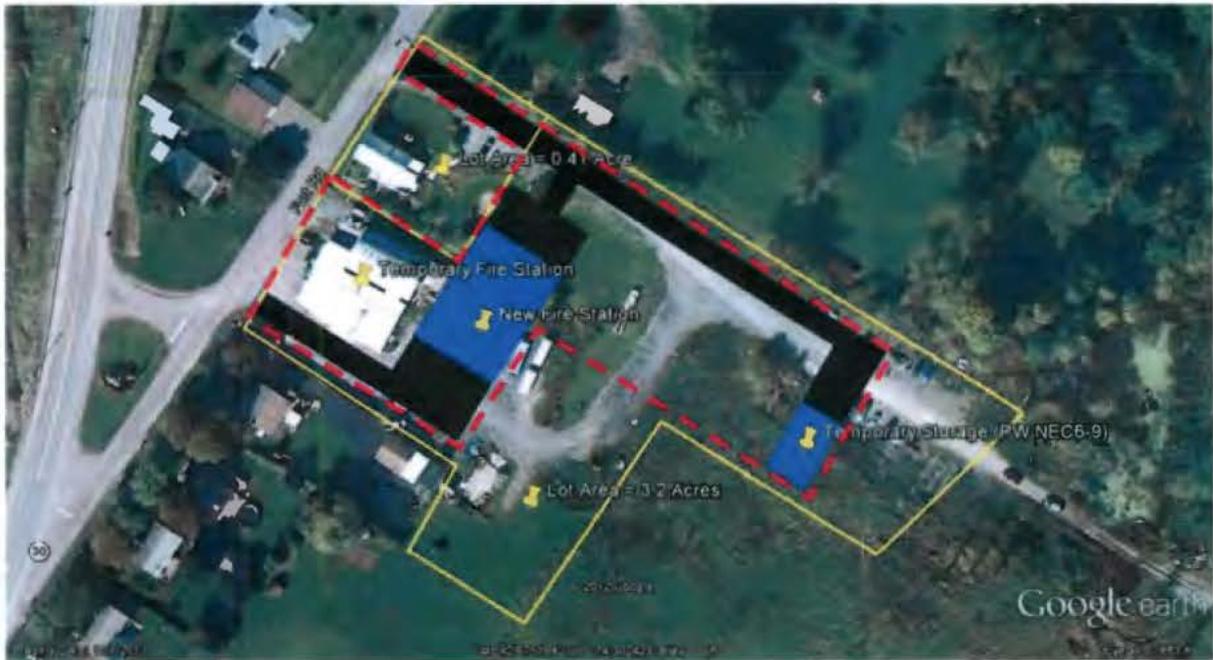
Figure 3. Preliminary site sketch showing approximate location of new buildings and paved areas. APE is indicated in red. Source: FEMA PA.

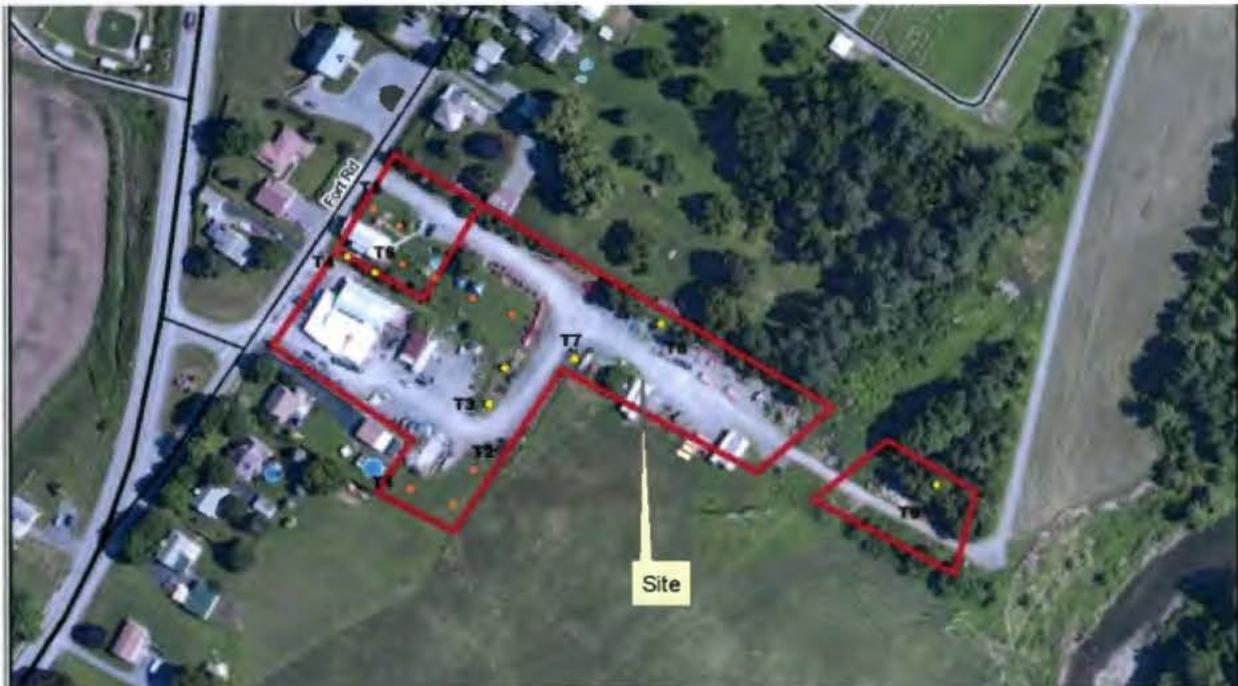
Figure 4. Shovel test results: orange dots indicate areas that yielded positive results and yellow dots areas with no cultural resources. Source: The Chazen Companies.

Confirmation shovel tests were excavated at 10' (3m) intervals at the cardinal points around the positive shovel tests on TR 4, TR 5 and TR 6, yielding additional prehistoric and historic cultural material. TR 5/STP 8 North 2 and TR 5/STP 8 West 2, which fell outside the boundary of the APE, were not excavated. A total of fifty-seven (57) fragments of debitage was recovered from this locus, along with a complete ovate biface/knife and a broken non-diagnostic biface base. A single fragment of Fire Cracked Rock (FCR) was also recovered.

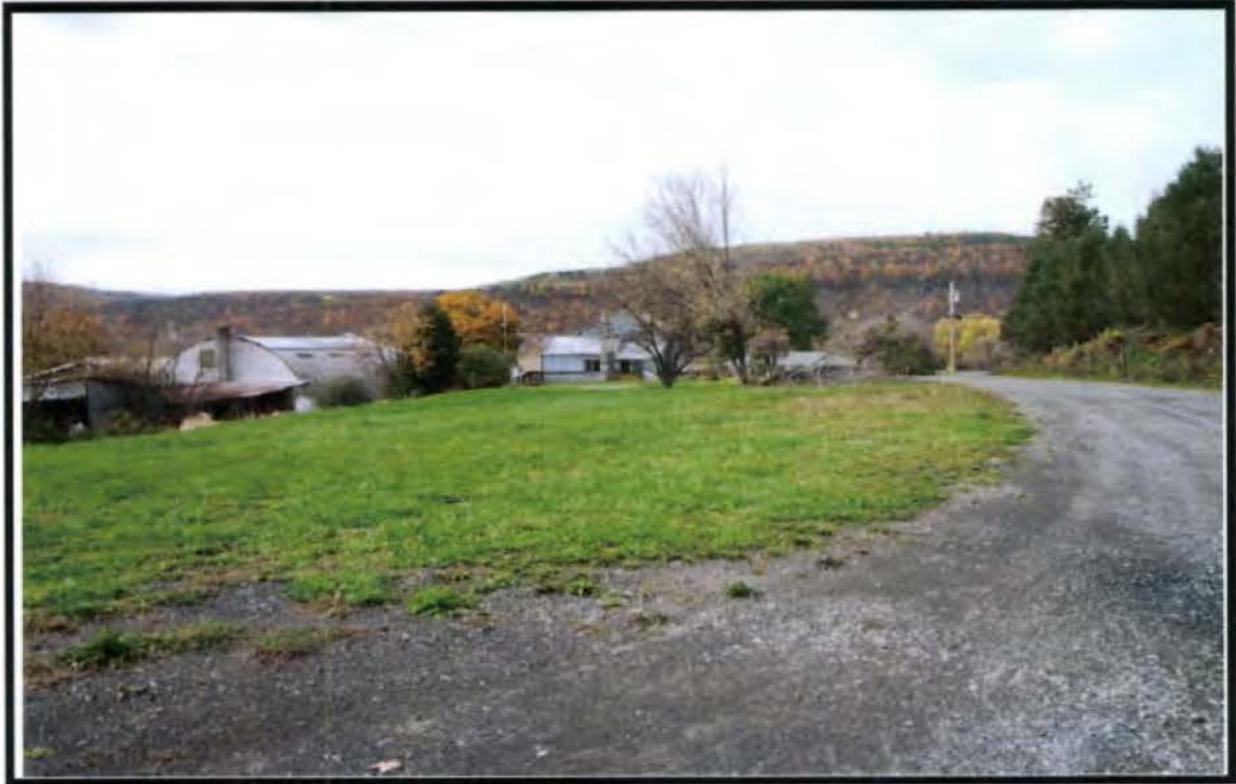
Figure 5. Looking southwest toward temporary fire station facilities at 114 Fort Road. Shovel tests in grassy area yielded prehistoric and historic cultural material. Source: CITY/SCAPE.
