# Seismic Considerations— Elementary and Secondary Schools

EARTHQUAKE HAZARDS REDUCTION SERIES 34

# **SEISMIC CONSIDERATIONS:**

## **ELEMENTARY AND SECONDARY SCHOOLS**

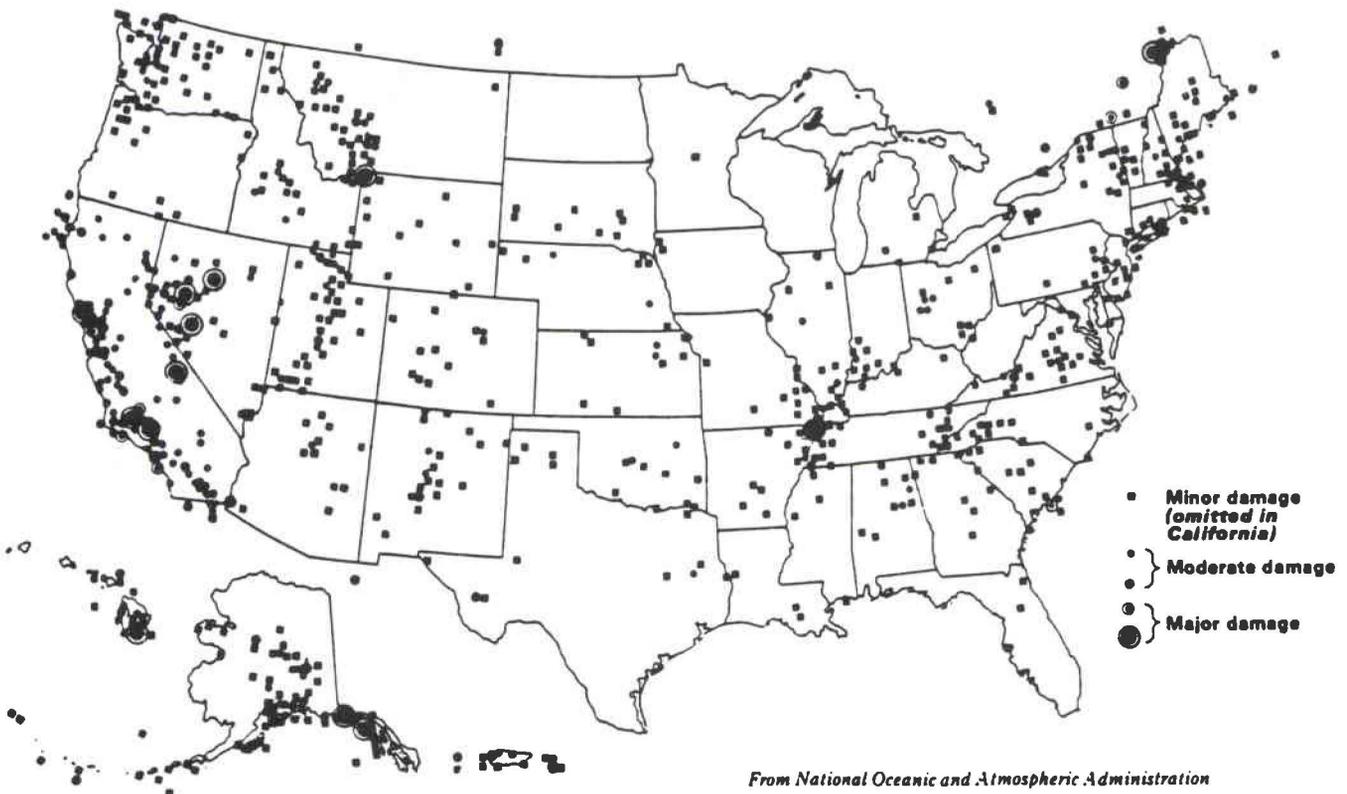
## Damaging U.S. earthquakes.

Many building owners and developers, like many Americans in general, tend to associate earthquakes only with California. They are unaware that earthquakes are a national hazard. In fact, earthquakes have occurred and continue to occur in the majority of states and some of the most severe earthquakes recorded in this nation have occurred, not on the West Coast, but in the Midwest and East.

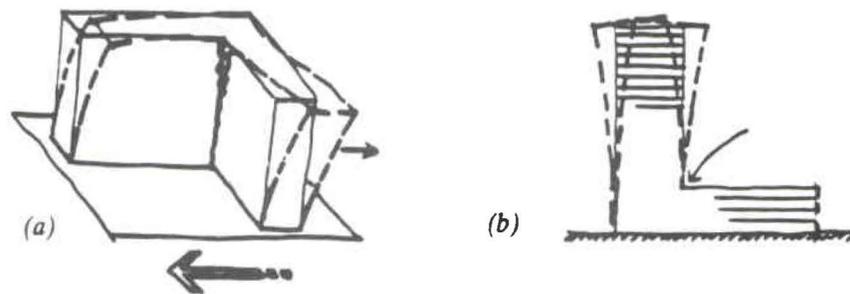
**FIGURE 5**  
*(a) movement of L-shaped building under ground motion and (b) point of stress concentration in setback building.*

These shapes tend to produce variations of rigidity and, hence, differential motions between different portions of the building that result in a local stress concentration at the "notch" or re-entrant corner (Figure 5a). In addition, the wings of a re-entrant corner building often are of different heights so that the vertical discontinuity of a setback in elevation is combined with the horizontal discontinuity of the re-entrant corner in plan, resulting in an even more serious problem. The setback form--a tower on a base or a building with "steps" in elevation--also has intrinsic seismic problems that are analogous to those of the re-entrant corner form. The different parts of the building vibrate at different rates, and where the setbacks occur, a "notch" is created that results in stress concentration (Figure 5b).

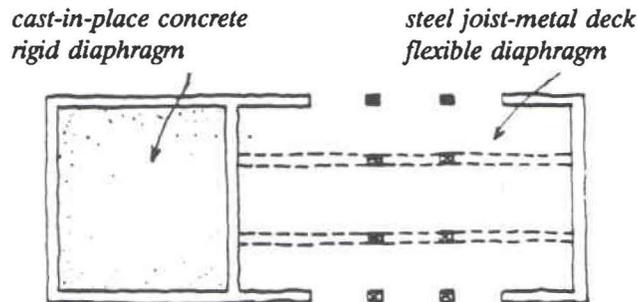
**FIGURE 7**  
*Discontinuity in strength.*

It is not generally recognized that large discontinuities (or abrupt changes) in the strength (Figure 7) or stiffness of a building can cause adverse seismic response effects. This is particularly the case where there are abrupt changes in the vertical arrangement of the structure that result in discontinuities (changes) of strength or stiffness from floor to floor.

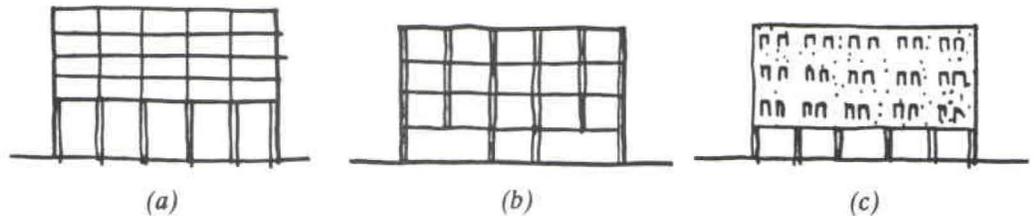
**FIGURE 8**  
*"Soft" first story:*  
*(a) tall, flexible columns, (b) interrupted vertical columns, and (c) heavy superstructure over slender frame.*

The most prominent of the problems caused by such a discontinuity is that of the "soft" first story (Figure 8), a term applied to a ground level story that is more flexible than those above. Although a "soft" story at any floor creates a problem, a stiffness discontinuity between the first and second floors tends to result in the most serious condition because forces generally are greatest near the base of a building.

- The first occurs when there is a significant discontinuity of strength and stiffness between the vertical structure of one floor and the remainder of the structure. This discontinuity may occur because one floor, generally the first, is significantly taller than the remainder, resulting in decreased stiffness (Figure 8a).
- Discontinuity also may occur when some vertical framing elements are not brought down to the foundation but are stopped at the second floor to increase the openness at ground level. This condition creates a discontinuous load path resulting in an abrupt change of strength and stiffness at the point of change (Figure 8b).

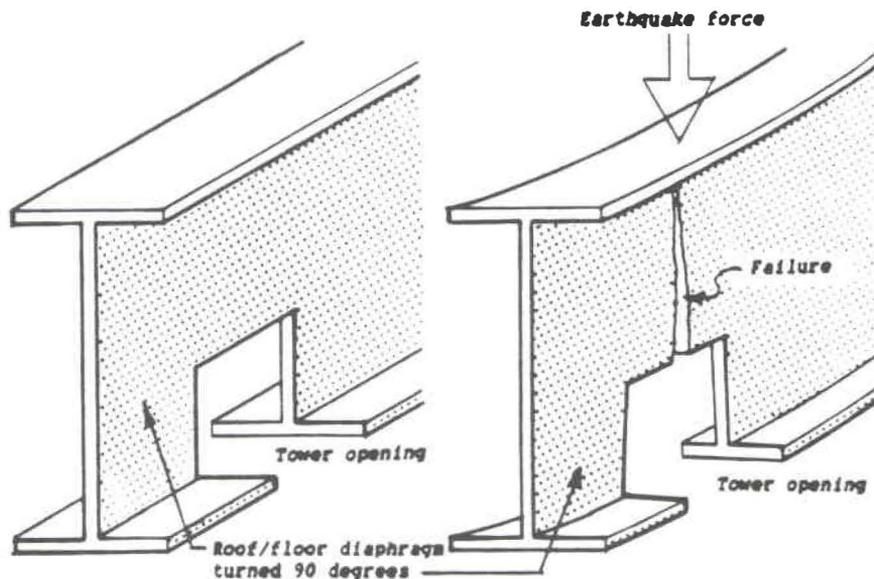
**FIGURE 11**  
*Openings in diaphragms.*

The earthquake loads at any level of a building will be distributed to the vertical structural elements through the roof and floor diaphragms. The roof/floor deck or slab (the horizontal diaphragm) responds to loads like a deep beam. The deck or slab is the web of the beam carrying the shear and the perimeter spandrel or wall is the flange of the beam resisting bending (Figure 11).

Inappropriate location or excessive size of openings (elevator or stair cores, atria, skylights) in the diaphragm create problems similar to those related to cutting a hole in the web of a beam. This reduces the natural ability of the web to transfer the forces and may cause failure in the diaphragm.

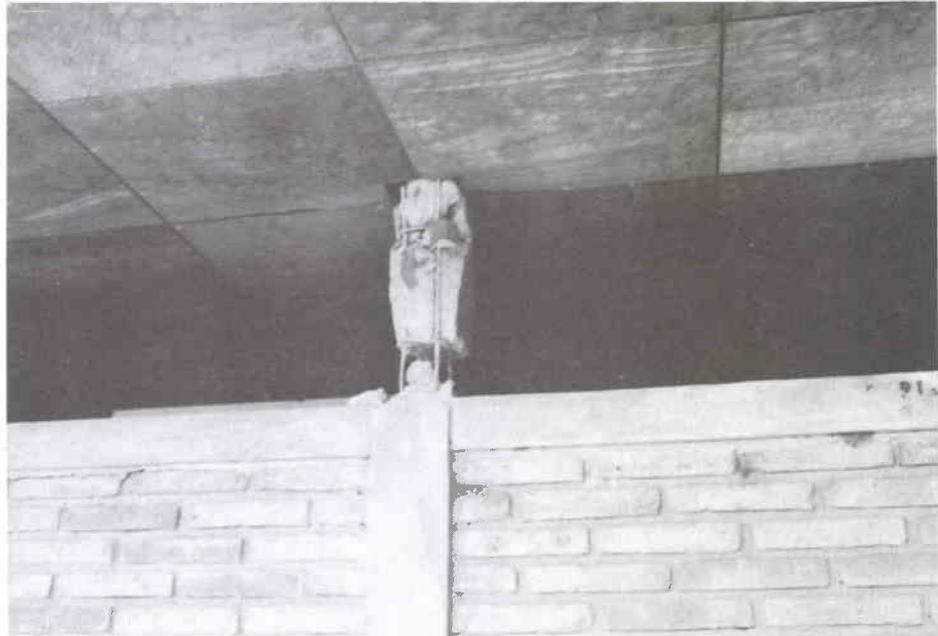
*FIGURE 13  
Recido School after  
1973 earthquake.*

The use of infill walls dramatically shortened the columns at the Recido School in Managua, Nicaragua (Figure 13). During the 1973 earthquake, the columns above the infill walls suffered extensive damage and barely escaped complete failure and roof collapse. Numerous other examples of damage attributed to such "shortened" columns were reported in Japanese schools following earthquakes in 1968 and 1978 (Figure 14).

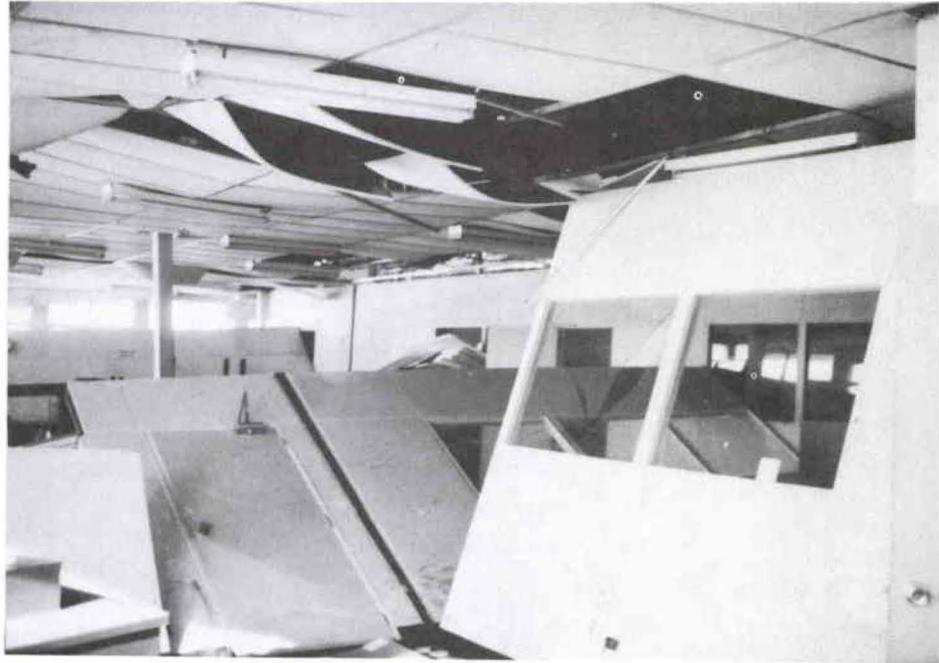
**FIGURE 18**  
*Collapse of  
interior structural  
partitions.*

In a moment resisting frame system, redundancy can be achieved by making all joints of the vertical load-carrying frame moment resisting. Of course, proper ductility must be provided in the members of the structural system. These multiple points of resistance can prevent a catastrophic collapse due to failure of a member or joint. However, if this system is designed with the moment resisting connections limited to exterior columns (a common practice) clad only in lightweight architectural curtain walls, the building may experience large deformations during an earthquake and, consequently, a great deal of interior damage.

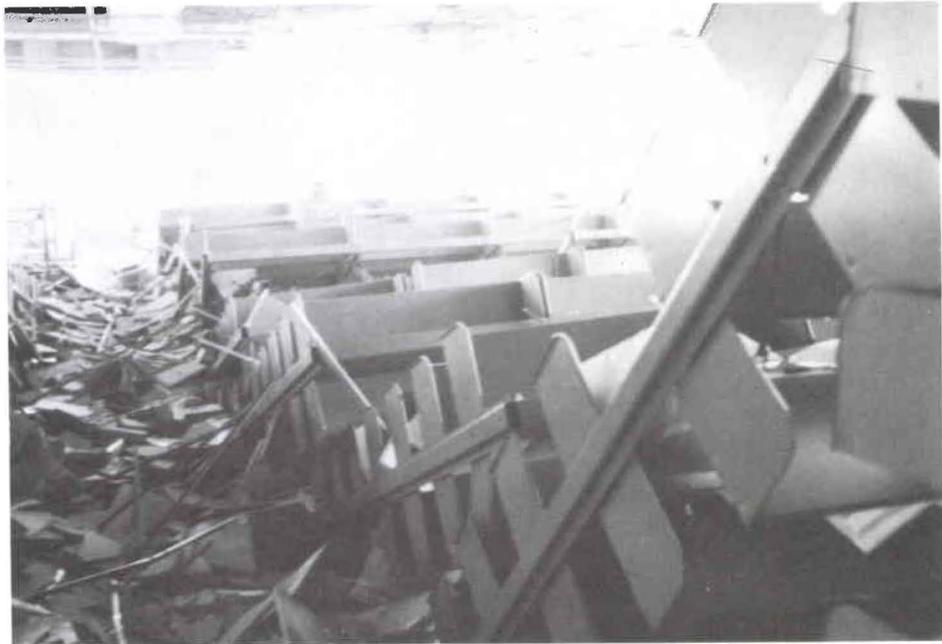
*FIGURE 30  
Overturned book  
stacks.*

Science laboratories should be designed to protect occupants from falling heavy equipment and hazardous chemicals should be stored so that they do not fall from shelves or spill. Industrial or vocational areas should be designed to be safe by anchoring and restraining all heavy, stationary equipment. Kitchen, chemistry, and shop hoods must be properly designed and anchored to resist falling. Canopies at exits should be checked to ensure that they will not collapse, and exit routes should not adjoin exterior glass areas. The safety of staff in mechanical rooms should be evaluated and precautions taken.

Bookcases, free-standing cabinets, and shelving fell. Movie screens and maps became projectiles. Storage cabinets attached to walls with molly bolts fell over.

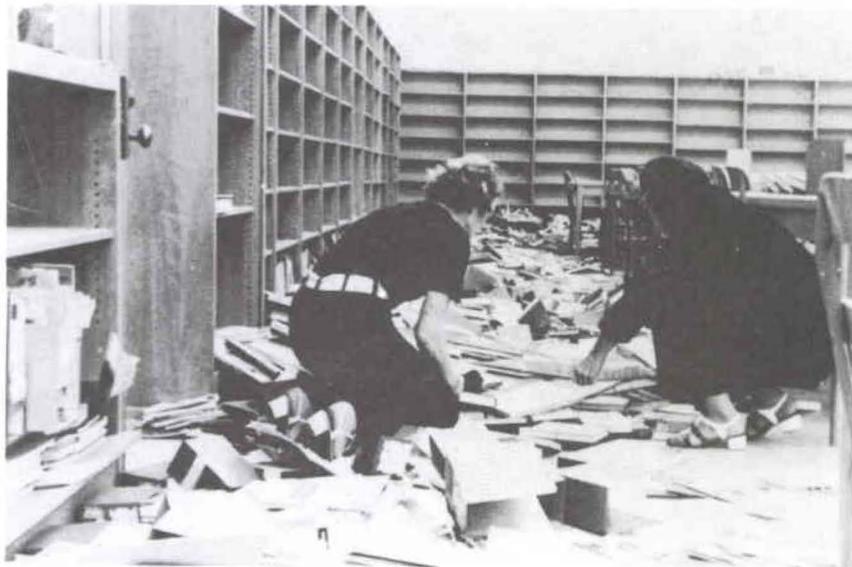
*FIGURE 31  
Sylmar High School  
after 1971 San  
Fernando earthquake.*

There were gas leakages in a number of schools, but no fires resulted. In the third-floor lab at the high school, cupboard doors flew open and chemicals spilled to the floor; they reacted with each other and burned through to the first floor. Noxious fumes--hydrogen sulfide among them--from the spilled chemicals permeated the building. Latches on file cabinet drawers did not hold and drawers "flew across the room."
