SEISMIC CONSIDERATIONS APARTMENT BUILDINGS

EARTHQUAKE HAZARDS REDUCTION SERIES 37

SEISMIC CONSIDERATIONS: APARTMENT BUILDINGS

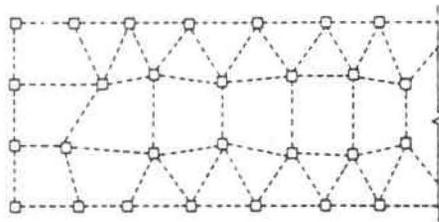
The most common structural system presently employed for medium- to high-rise apartment building construction is flat-plate cast-in-place reinforced concrete with randomly placed columns. This structural approach has certain advantages that make it particularly adaptable to apartment building construction since the possibility of placing columns randomly adapts well to the inherently irregular module generated by a typical apartment floor layout since columns can be buried in convenient locations within an efficient layout. Such structural eccentricities, coupled with the changing (however small) travel path of the earthquake forces, can put major stresses on joints and connections.

FIGURE 4
Irregular column placement in apartment buildings.

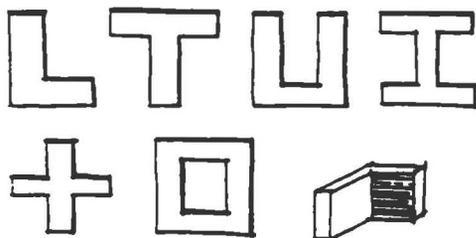
A common apartment building form that presents problems as a seismic design is that of the "re-entrant corner." The re-entrant corner is the common characteristic of overall building configurations that, in plan, assume the shape of an L, T, U, V, H, +, or a combination of these shapes (Figure 5). These building shapes are very useful for apartment complexes since they permit large plan areas to be accommodated in relatively compact form while still providing a high percentage of perimeter rooms with access to air and light. They are commonly used in apartment building design to provide a large number of windowed rooms. The courtyard form is also very common for apartments in tight urban sites. These configurations are so common and familiar that the fact that they represent one of the most difficult problem areas in seismic design may seem surprising. Examples of damage to re-entrant corner type buildings are common. First noted before the turn of the century, this earthquake problem generally was acknowledged by the experts of the day by the 1920s.

FIGURE 5
Re-entrant corner plan forms.

These shapes tend to produce variations of rigidity and, hence, differential motions between different portions of the building, resulting in a local stress concentration at the "notch" or re-entrant corner (Figure 6). In addition, it is common for the wings of a re-entrant

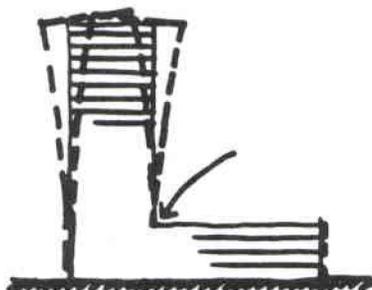
The setback form--a tower on a parking garage base or a building with "steps" in elevation--also has intrinsic seismic problems that are analogous to those of the re-entrant corner form. The different parts of the building vibrate at different rates, and where the setbacks occur, a "notch" is created that results in stress concentration (Figure 8).

FIGURE 8 Point of stress concentration in setback building.

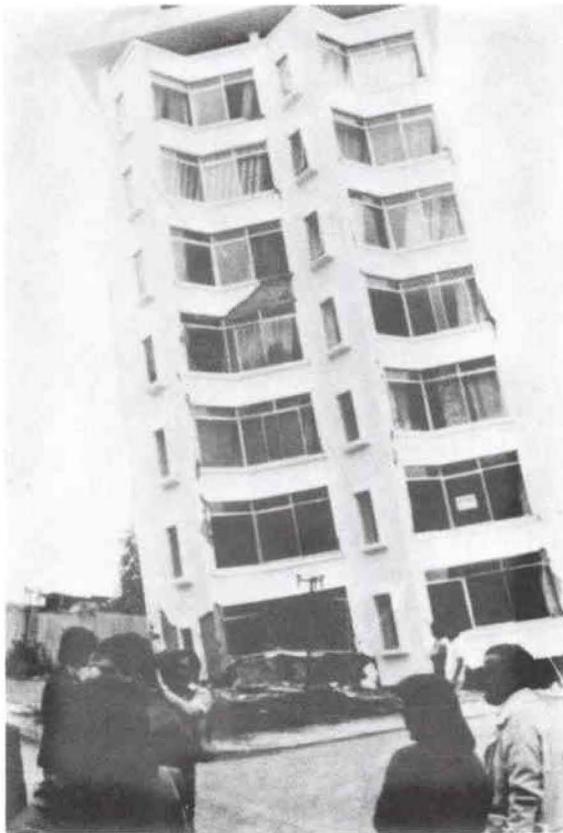
- A discontinuity may occur as a result of a common design concept in which some vertical framing elements are not brought down to the foundation but are stopped at the second floor to increase the openness at ground level. This condition creates a discontinuous load path resulting in an abrupt change of strength and stiffness at the point of change (Figure 10b). Discontinuities in the shear walls in the basement caused the failure of the El Faro apartment building during the 1985 earthquake in Chile (Figure 11).

FIGURE 11
The El Faro apartment building after the 1985 Chile earthquake.

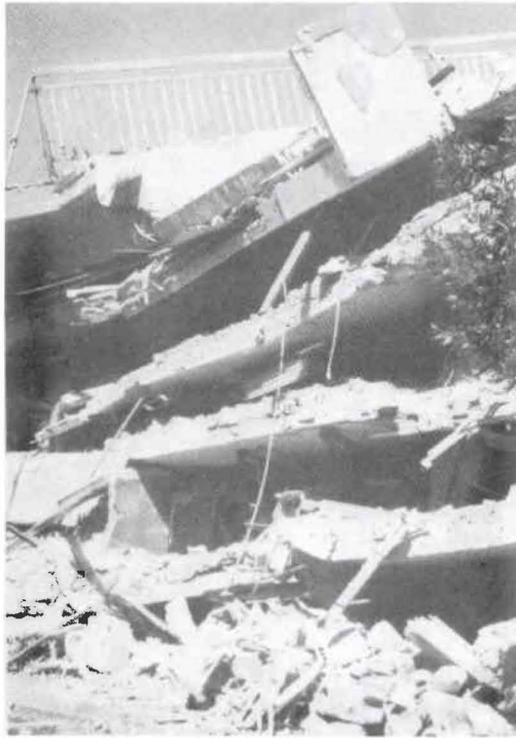
FIGURE 13
Apartment building collapse
after the 1986 earthquake
in Kalamata, Greece.

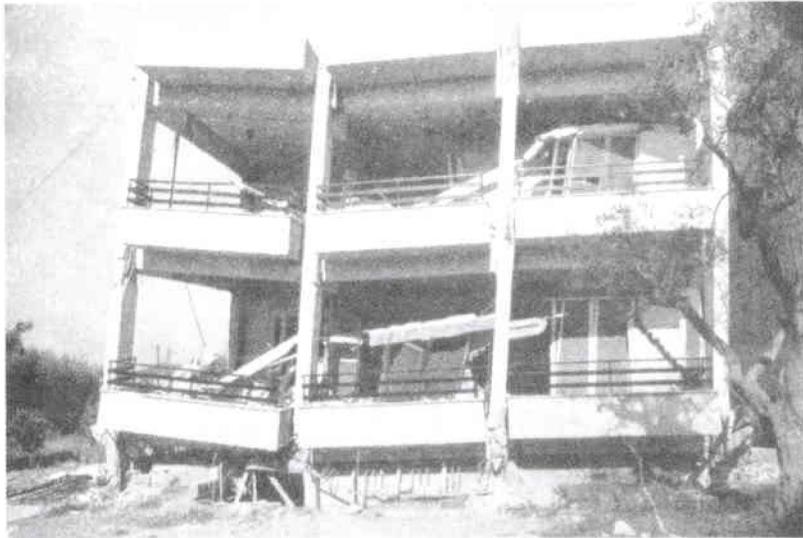
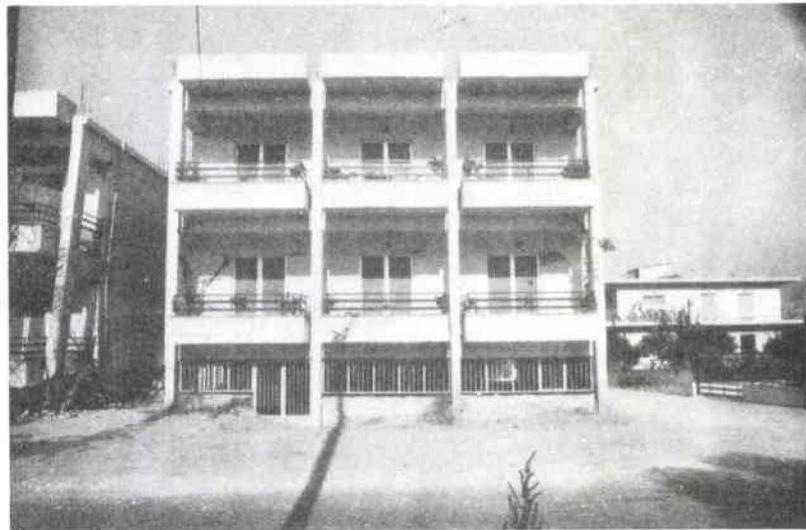
FIGURE 16
Apartment building with discontinuous shear walls (a) and
a neighboring building with continuous shear walls (b).
that suffered no damage during the 1986 Greece earthquake.

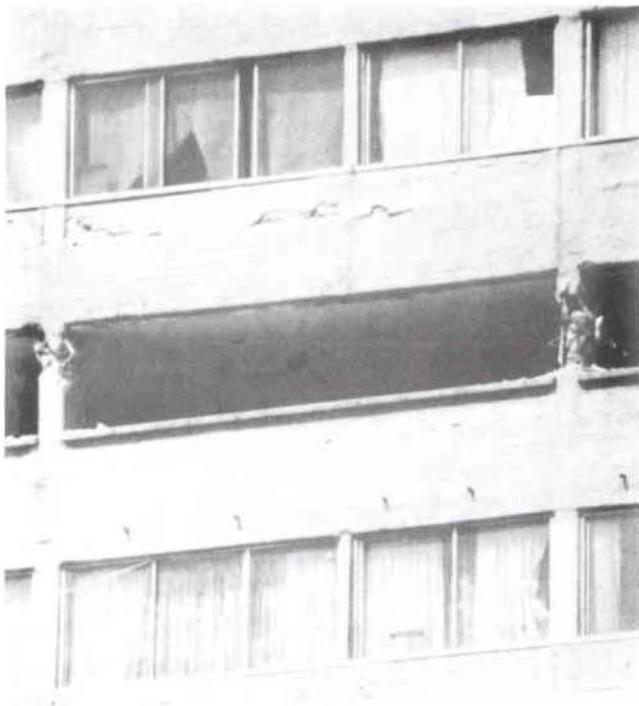
FIGURE 18
Tlatelolco apartment building after the 1985 earthquake in Mexico City.

The total collapse of two-thirds of one block of the apartment buildings in the Tlatelolco section of Mexico City during the 1985 earthquake received much publicity because of the disastrous life loss. These high-rise reinforced concrete apartment buildings had flexible first stories and more rigid upper floors that caused an unbalanced stiffness ratio (Figure 15).

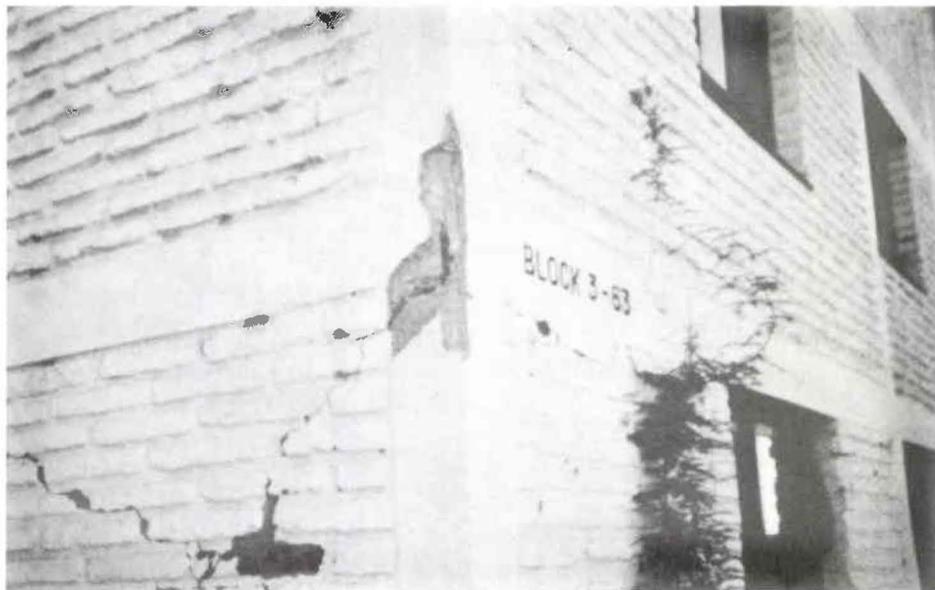
FIGURE 19
Damaged apartment building after the 1985 earthquake in Chile.

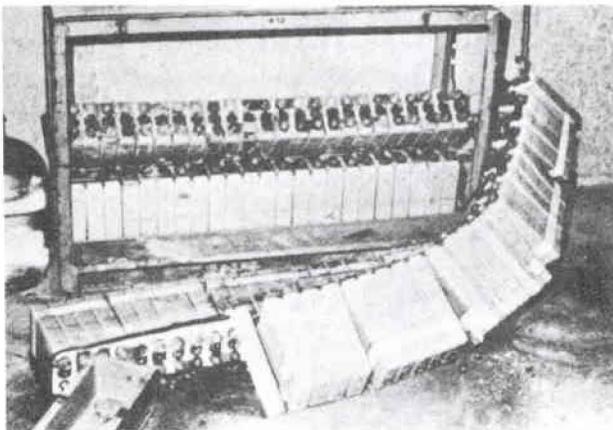
Electrical equipment including transformers, free-standing switchboards, emergency generators, and lighting systems can fall over, causing not only damage and injury but also fire (Figures 23-24).

FIGURE 23
Electrical equipment collapse.

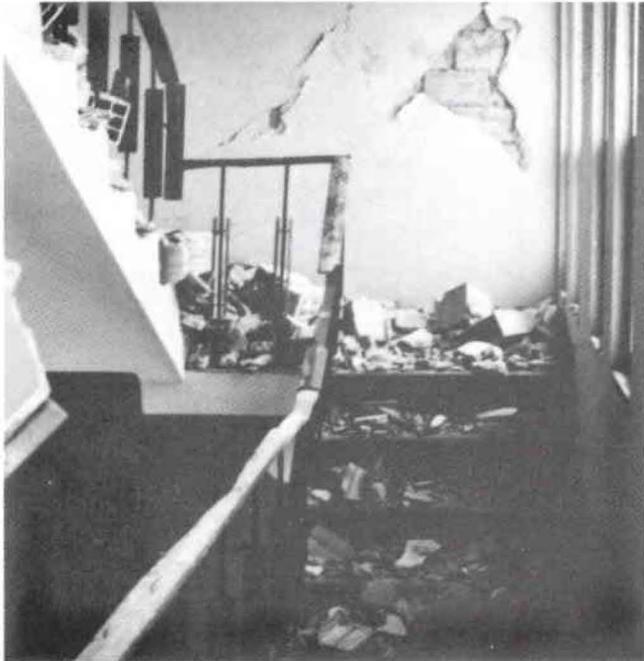
FIGURE 28
Debris blocking exit.

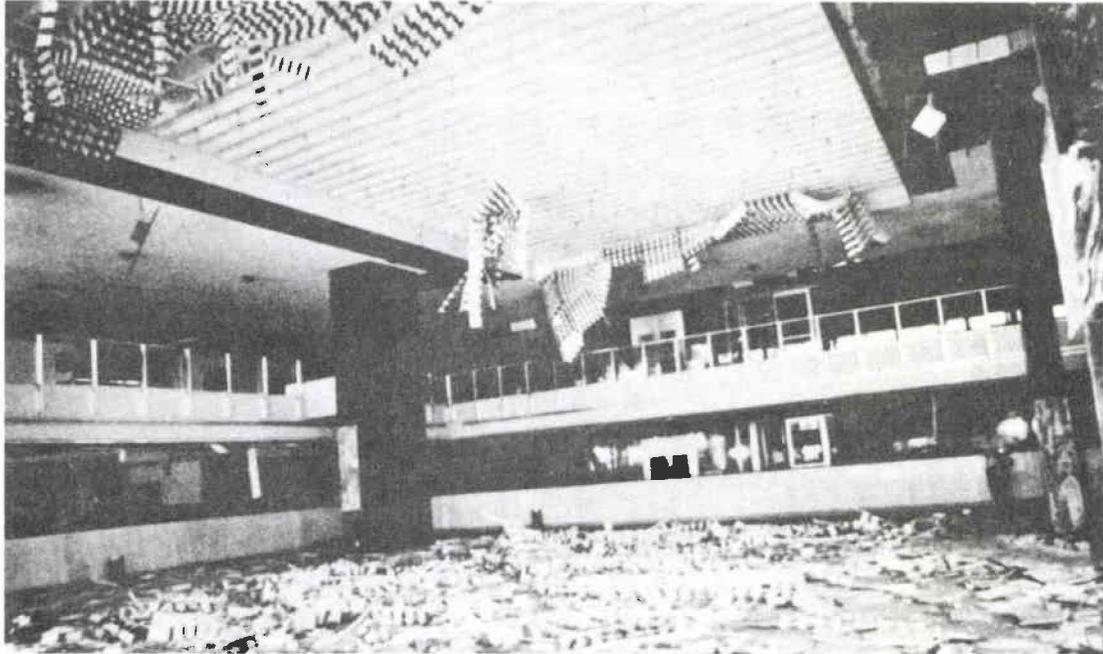
FIGURE 31
Failure of lobby lighting system.

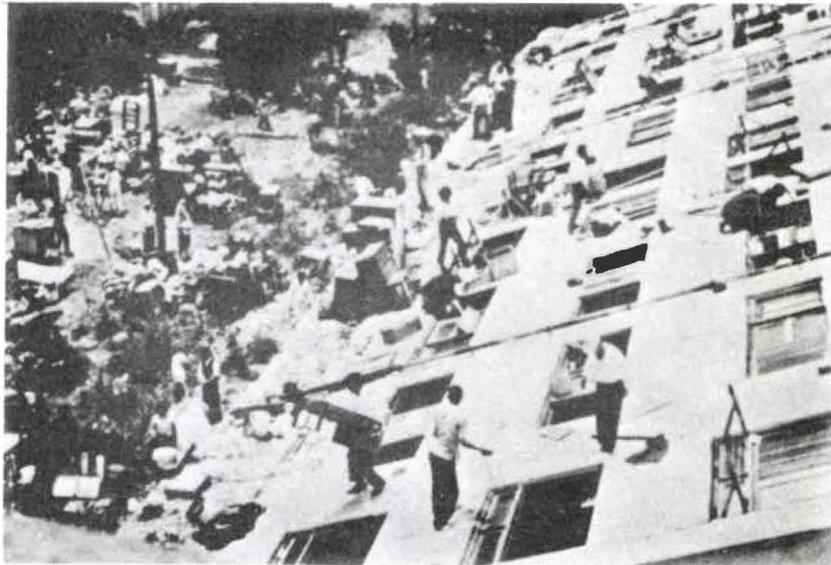
FIGURE 33
Apartment buildings after the 1964 earthquake in Niigata, Japan.

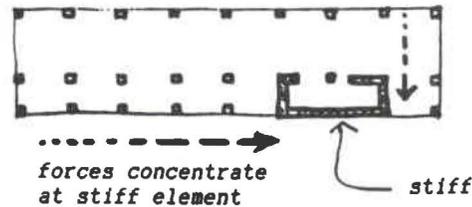
- Unbalanced or random rigid resisting elements--Any configuration that concentrates forces on a small number of rigid element(s) of the building risks failure of those elements (Figure 35).

FIGURE 35
Rigid elements in plan will attract earthquake forces.

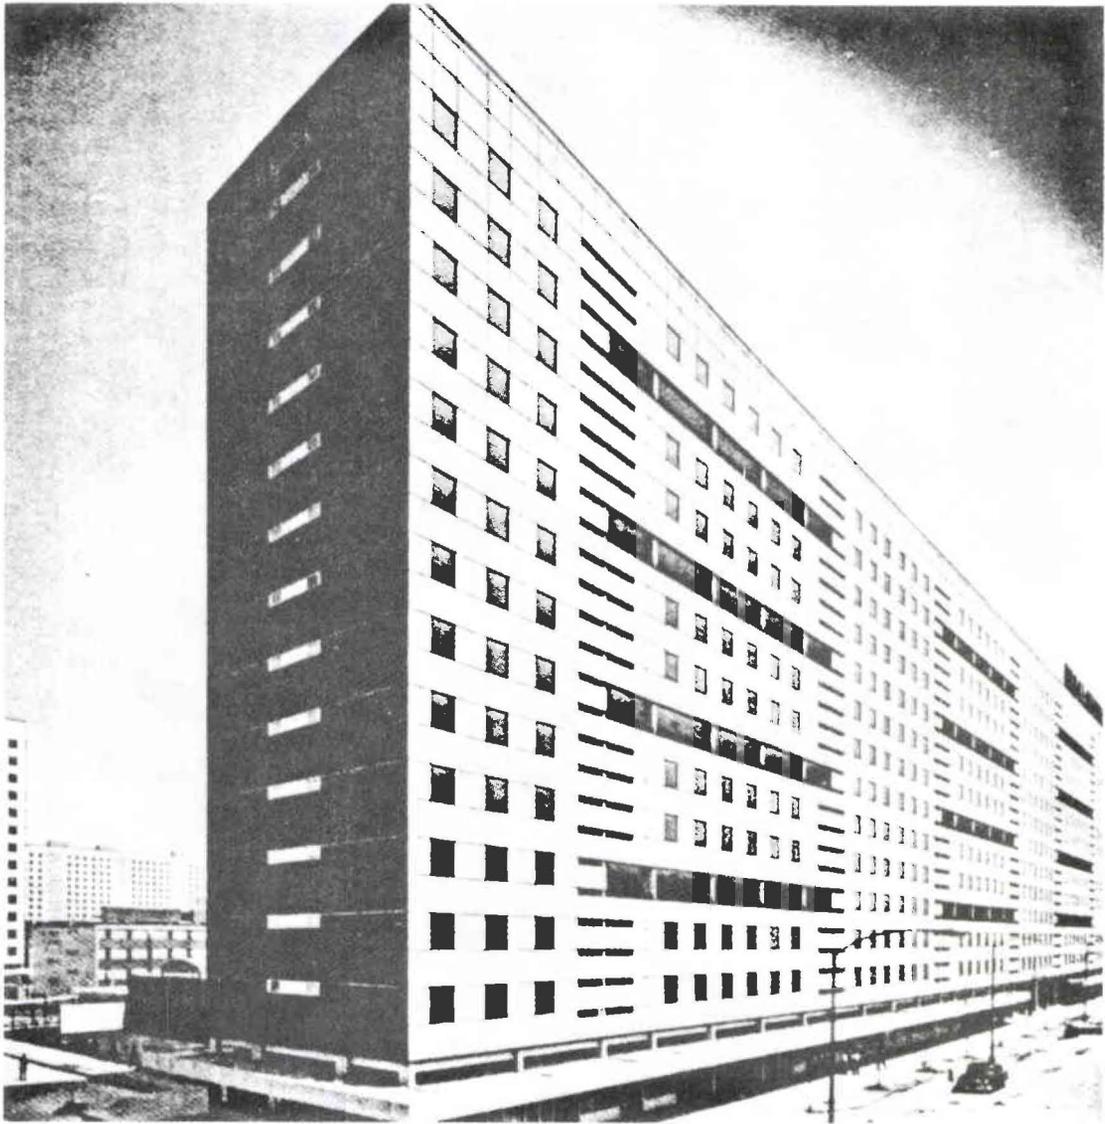
The Nueva Leon apartment building was a 14-story reinforced concrete building constructed as part of the Tlatelolco complex. The structure was about 45 feet wide and 550 feet long with a braced frame of concrete "X" bracing in both directions (Figure B-2). The collapse of this apartment building caused the worst single building death toll in the Mexico City earthquake--over 500 dead.

FIGURE B-2
The Nueva Leon apartment building
prior to the 1985 Mexico City earthquake.

The causes of collapse have not been determined precisely due to the almost total destruction of the building. Stub columns, which were located throughout the building, often are excessively loaded in shear during earthquakes due to their shortening and probably were a major factor in the collapse. In addition, the lack of a suitable number of column reinforcing ties may have contributed to the column failures. These failures may have led to a failure of the longitudinal "X" bracing, resulting in large story drifts and, thus, eccentric loading on the lateral "X" bracing which resulted in collapse. Since this was an apartment building, it was heavily occupied by families at the early hour when the earthquake occurred.
