Ticonderoga Chilson Water Transmission Main  
Facility Hazard Mitigation Relocation Project

Engineer's Preliminary Report/Photographs

## Project Damage Inspection: Chilson Water Transmission Main Failure

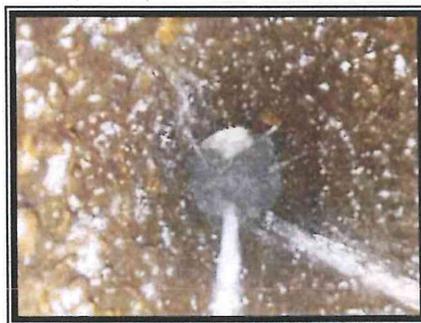
**Emptied Water Main**

Boil water orders were issued due to the fact that the water main break emptied sections of the main. Since the break was located in Chilson Brook, contaminated water entered the drinking water system (supplying some residences), as well as significant amounts of sediment from the washout of stream banks.

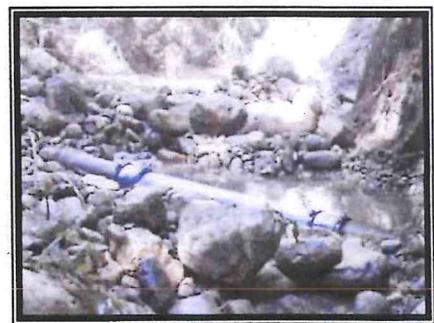
**Emergency Repair**

Town personnel located the water main breaks and installed (2) replacement sections of pipe, consisting of C-900 plastic pipe and Hymax couplers to return the water main to service. A small excavator was lowered into the brook valley to divert the stream and provide some protection of the exposed main within the brook bed.
