Ticonderoga Chilson Water Transmission Main
Facility Hazard Mitigation Relocation Project

Appendix E

Cultural Resources Consultations and Studies

**Phase I Cultural Resources Survey
Chilson Road Water System Improvements
Town of Ticonderoga, Essex County
New York**

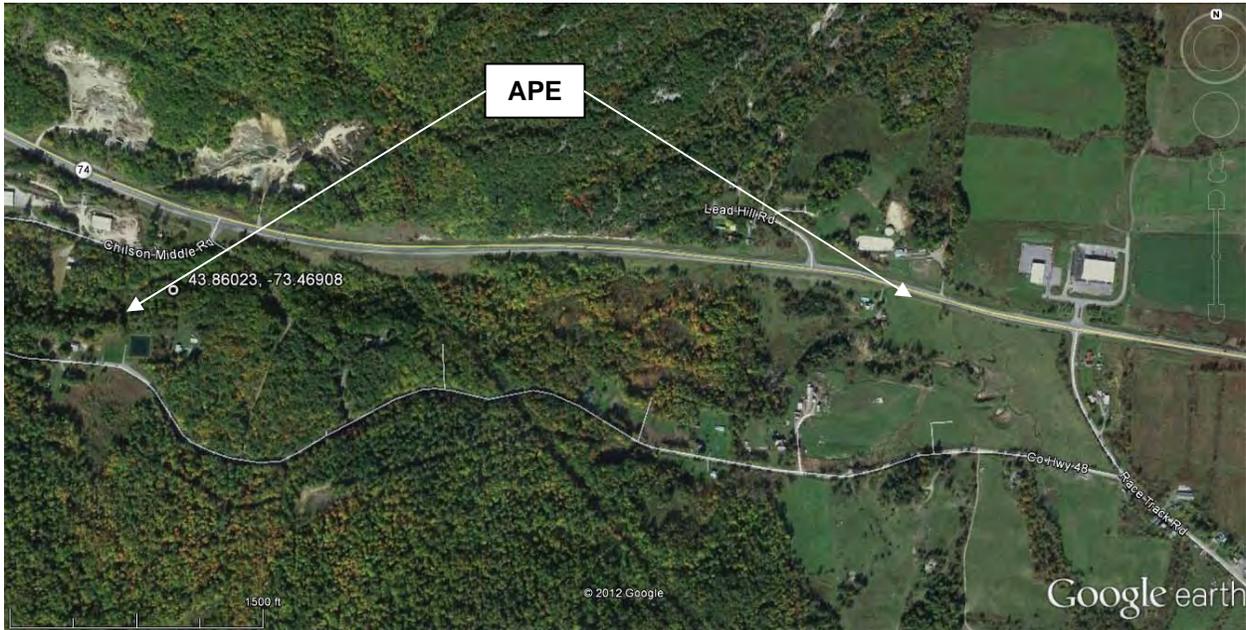
Figure 2. October 2011 aerial view of the APE, water line adjacent to Chilson Brook south of New York State Route 74.

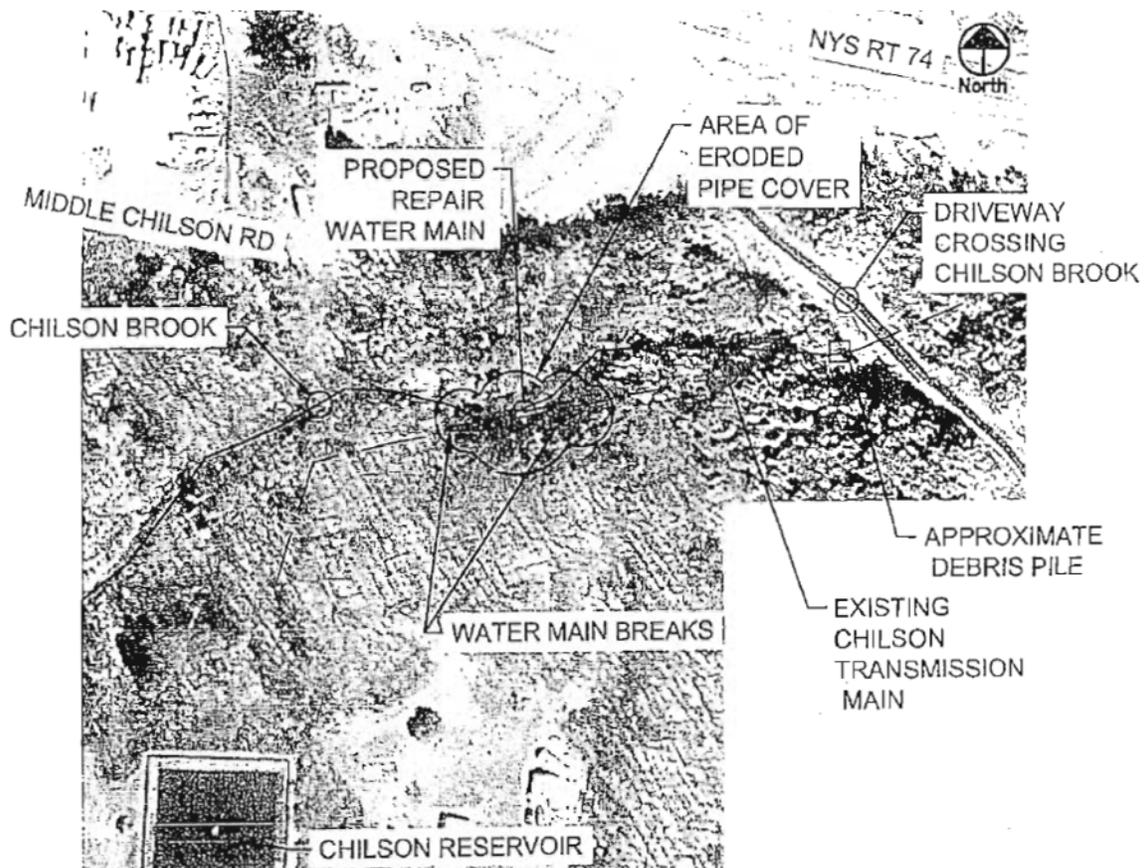
Figure 3. Chilson water main: break location and replacement on the same alignment.

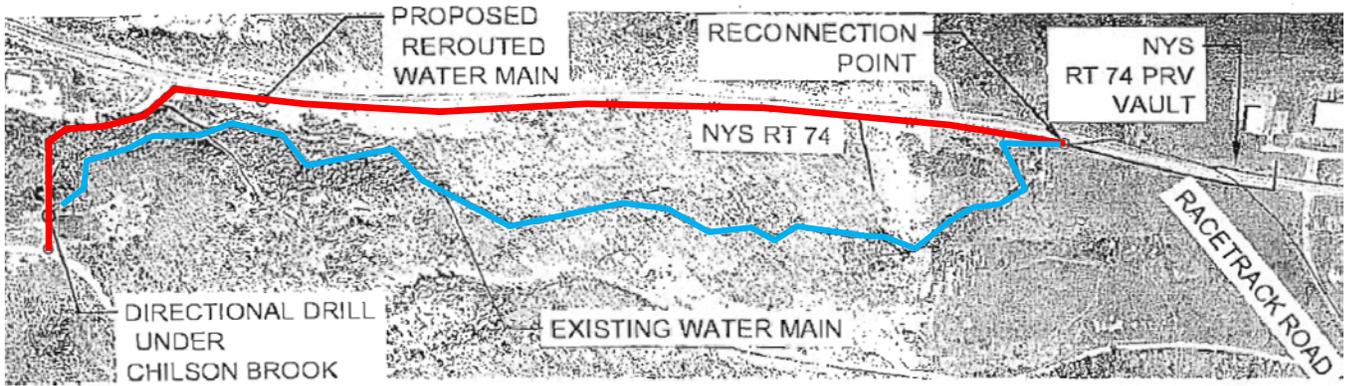
Figure 4. Chilson water main: proposed relocation (blue=existing, red=proposed).

Location and Resource:	Chilson Water Transmission Main located north of County Highway 48 and south of Chilson Middle Road (43.86023, -73.46908) in the Town of Ticonderoga (MCD 03115), Essex County (Figures 1-6).
Cause of Failure:	Heavy rains and flooding associated with Hurricane Irene resulted in damages to the underground Chilson water transmission main, a 12 inch diameter cast iron pipe likely installed in the 1890s to convey water from the Chilson Reservoir to the Town of Ticonderoga.
Description of Damage:	The damaged section of water line is located along and under Chilson Brook. During the storm, stream bank erosion and sediment movement impacted approximately 130 feet of the buried water line, leaving it within proper burial depth, exposing it in some locations, and breaking it in two places (43.86023, -73.46908 and 43.86038,-73.46868).
Undertaking:	The owner of the Chilson Water Transmission Main, the Town of Ticonderoga, made temporary repairs to the broken pipe sections (Figure 3), and is seeking to relocate the line out of Chilson Brook. Emergency temporary repairs to the two water main breaks were made using C-900 plastic pipe and Hymax couplers in order to restore water supply to affected Town residents until permanent repairs can be made. Under the proposed work scope, the water line will be relocated away from Chilson Brook in order to prevent future damages from a similar storm event. The western terminus of the new 12 inch ductile iron pipe (like the existing line) will be the Chilson Reservoir just north of County Highway 48. It will run to the north, with 326 feet of directional drilling under Chilson Brook, to the south side of Chilson Middle Road. From that point it will continue eastward with traditional trenching, following the south side of New York State Route 74 until the eastern terminus at the existing main where it crosses the highway (5,342 feet) (Figure 4).

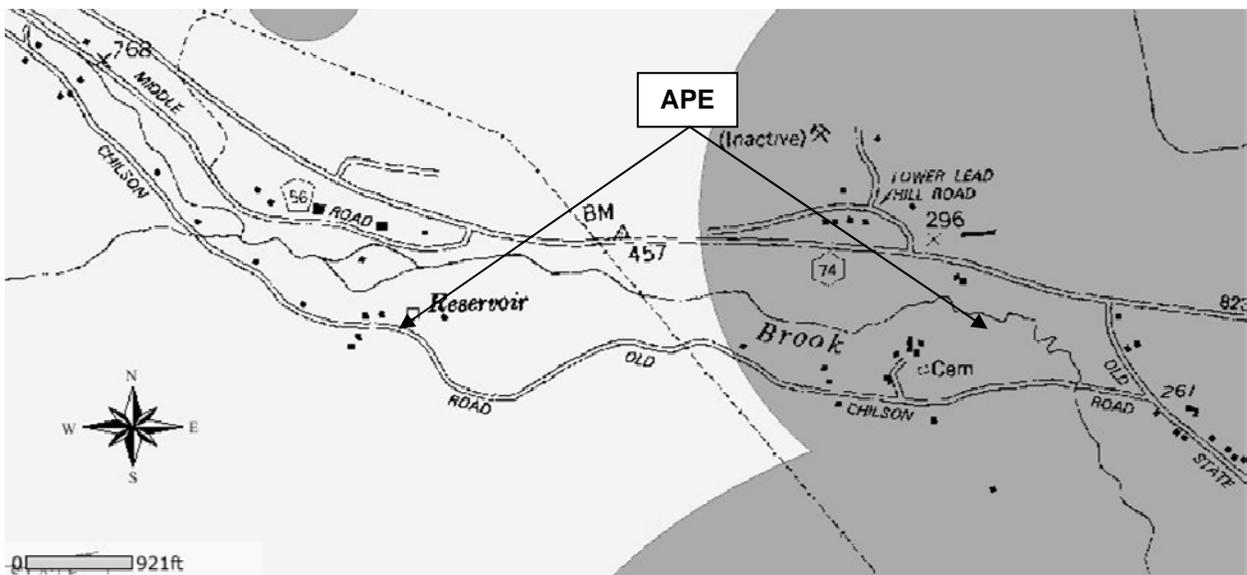
Figure 5. Archeological Sensitivity Area (gray circles); note there are no National Register listed properties in the vicinity (online SHPO GIS database, accessed August 13, 2012).

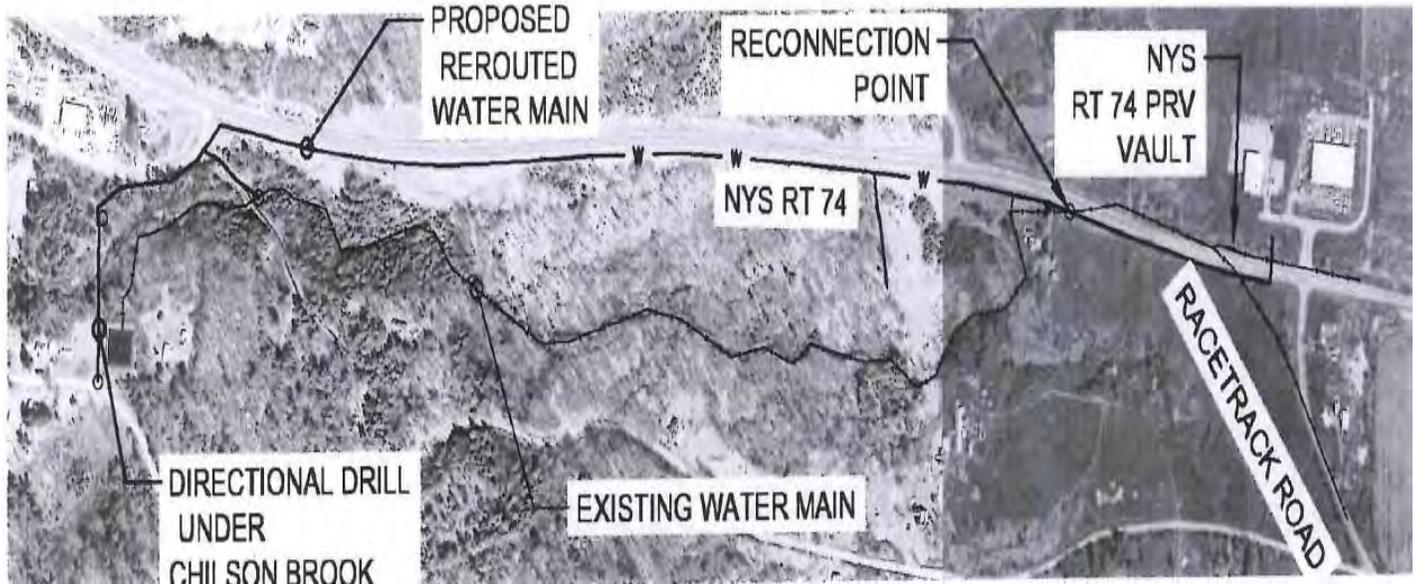
Figure 1: Location of the existing Chilson Brook water main line near Ticonderoga, along Chilson Brook between 253 Old Chilson Road and NYS Route 74. The Subgrantee provided the design plan where they would like to directional drill (bore) under Chilson Brook to place new water lines. The potential area of disturbance would include occur between 253 Old Chilson Road and Chilson Middle Road and along the NYS Route 74 (in the NYSDOT right-of-ways).

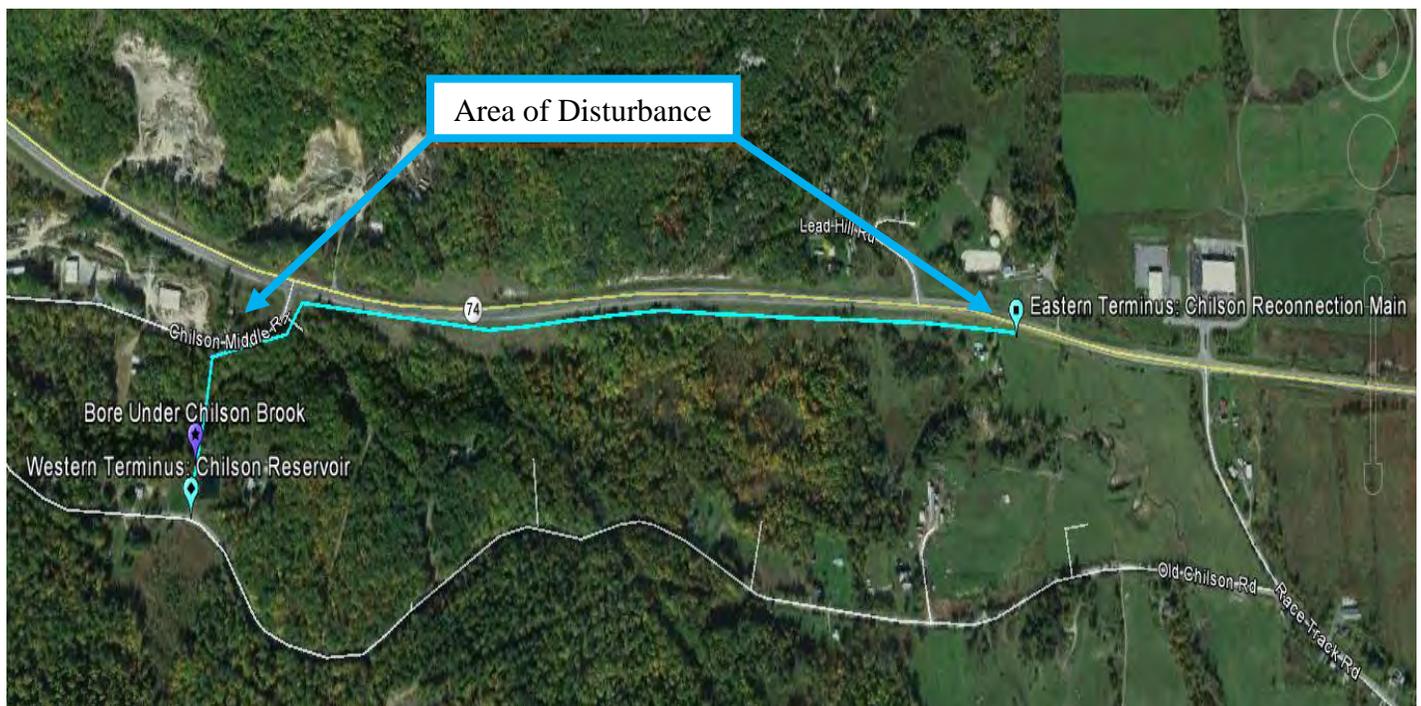
Figure 2: The blue line indicate where the proposed water main line would be located and potential area of disturbance. The main line would begin at Chilson Reservoir, go north parallel to an existing power line corridor to Chilson Middle Road, east along the NYSDOT right-of-way to NYS Route 74, and continue east on NYS Route 74 following the right-of-way to reconnection point near Race Track Road.

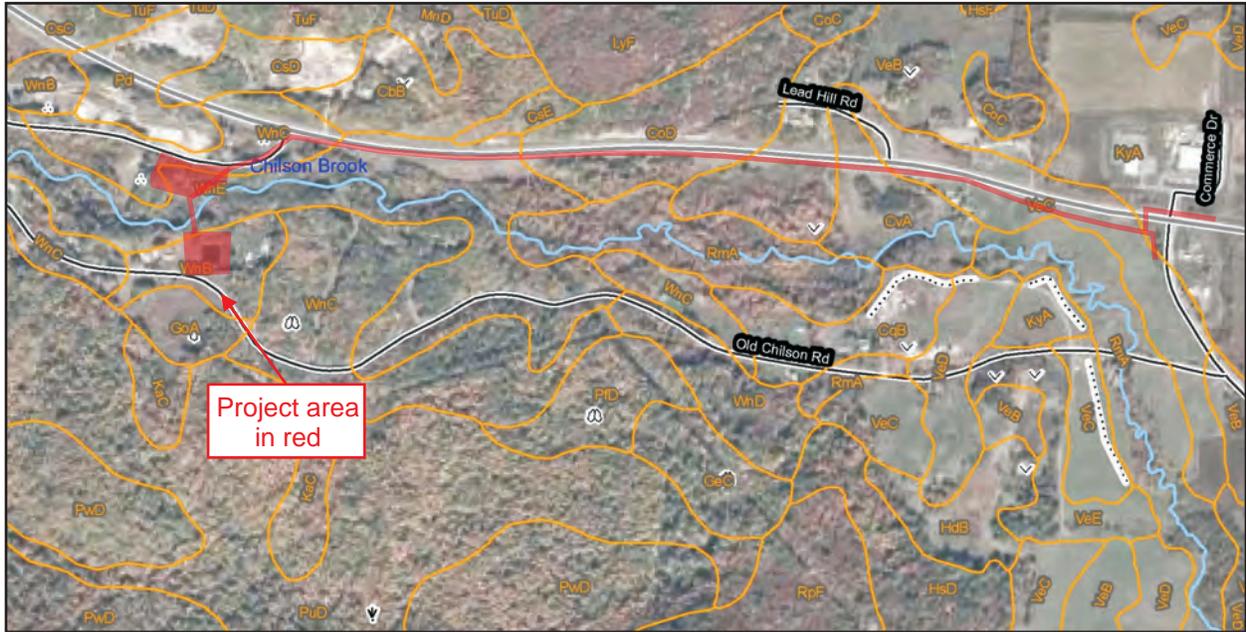
Figure 9. Portion of NRCS Soils map showing project area (NRCS 2012).

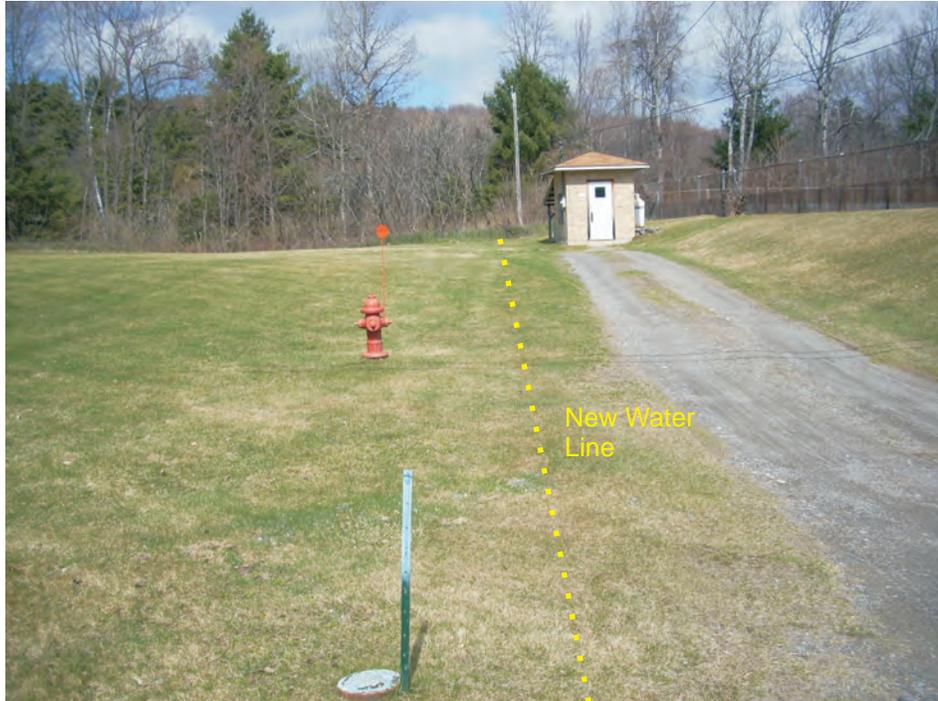
Photo 5. View of project area looking north at existing reservoir.
