**Owego Apalachin School District**  
**Owego Administration Building**

# PART 9 PACKAGE ADMINISTRATION BUILDING

**Part 9 Package**  
**Owego Apalachin Central School District**  
**Administration Building**  
January 3, 2013

Owego Apalachin Administrative Building  
Building Replacement Project  
December 26, 2012

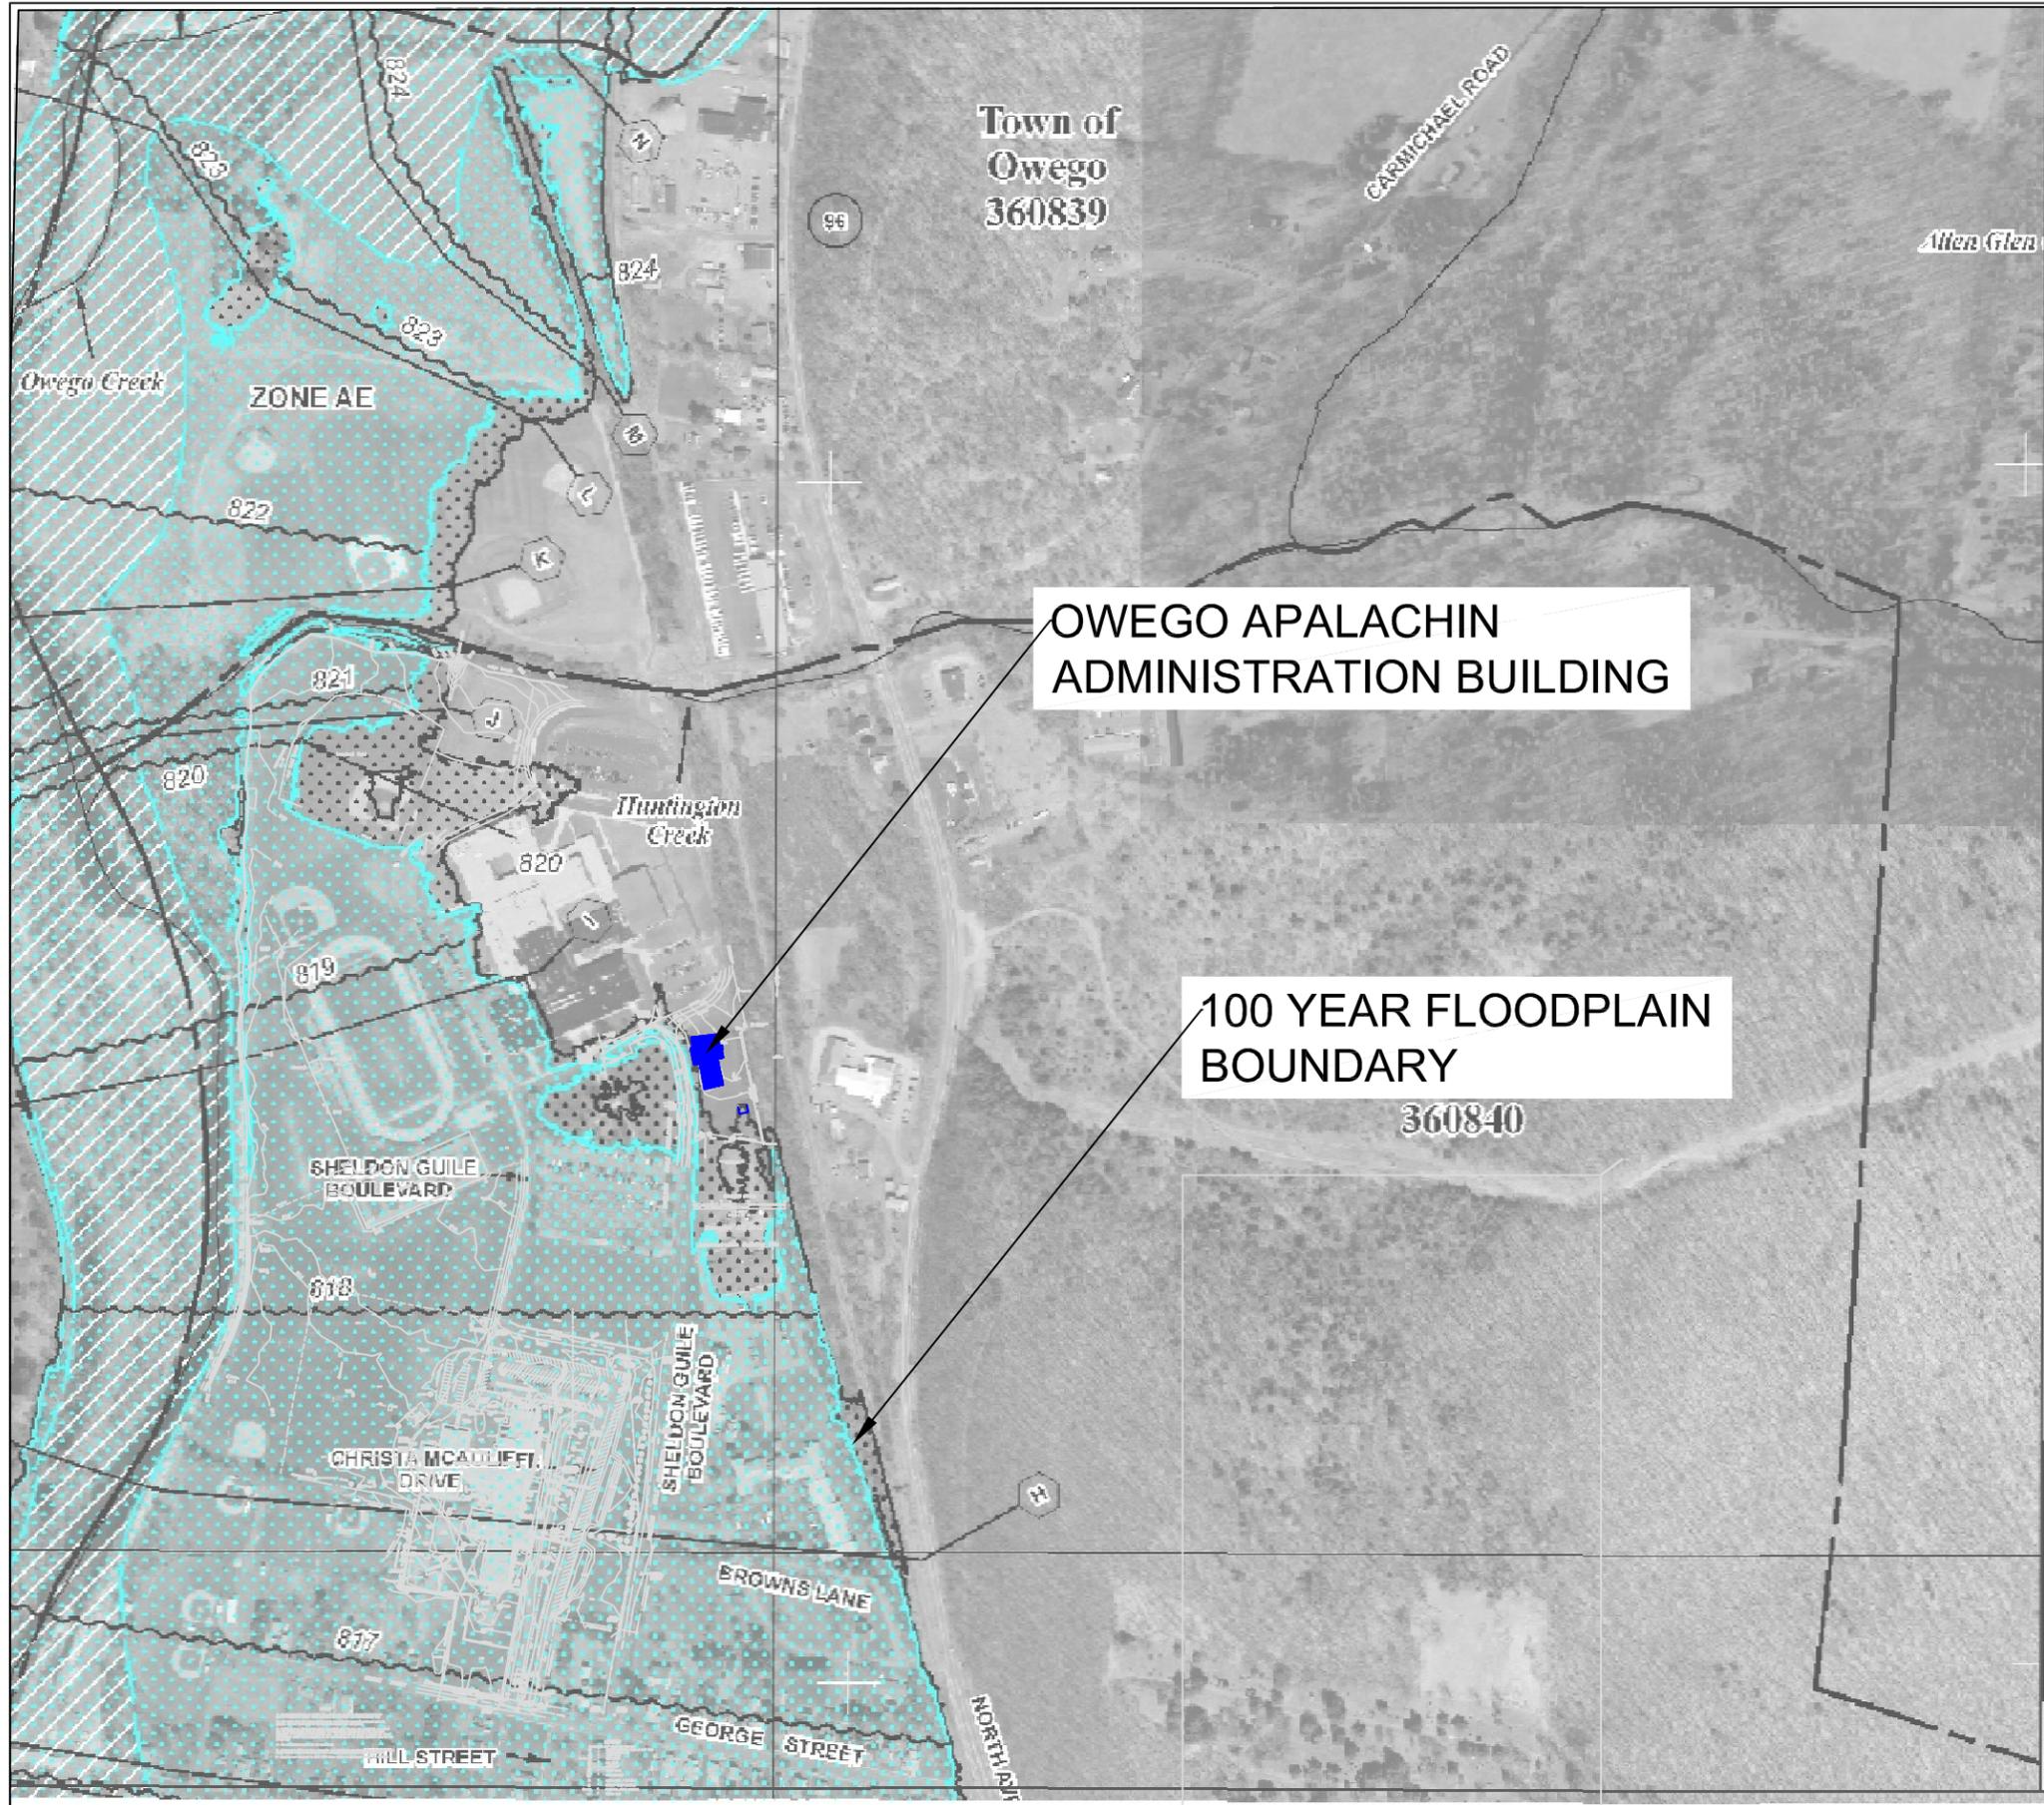
OWEGO ADMINISTRATION BUILDING WITH 100 AND 500 YEAR FLOODPLAIN

OWEGO-APALACHIN SCHOOL DISTRICT ADMINISTRATION BUILDING
