## **ADMINISTRATION BUILDING AREA JUSTIFICATIONS**

TITLE:  
**ADMINISTRATION BUILDING**

2012-368P

**Owego Administration Building  
 Owego, New York  
 Schematic Design**

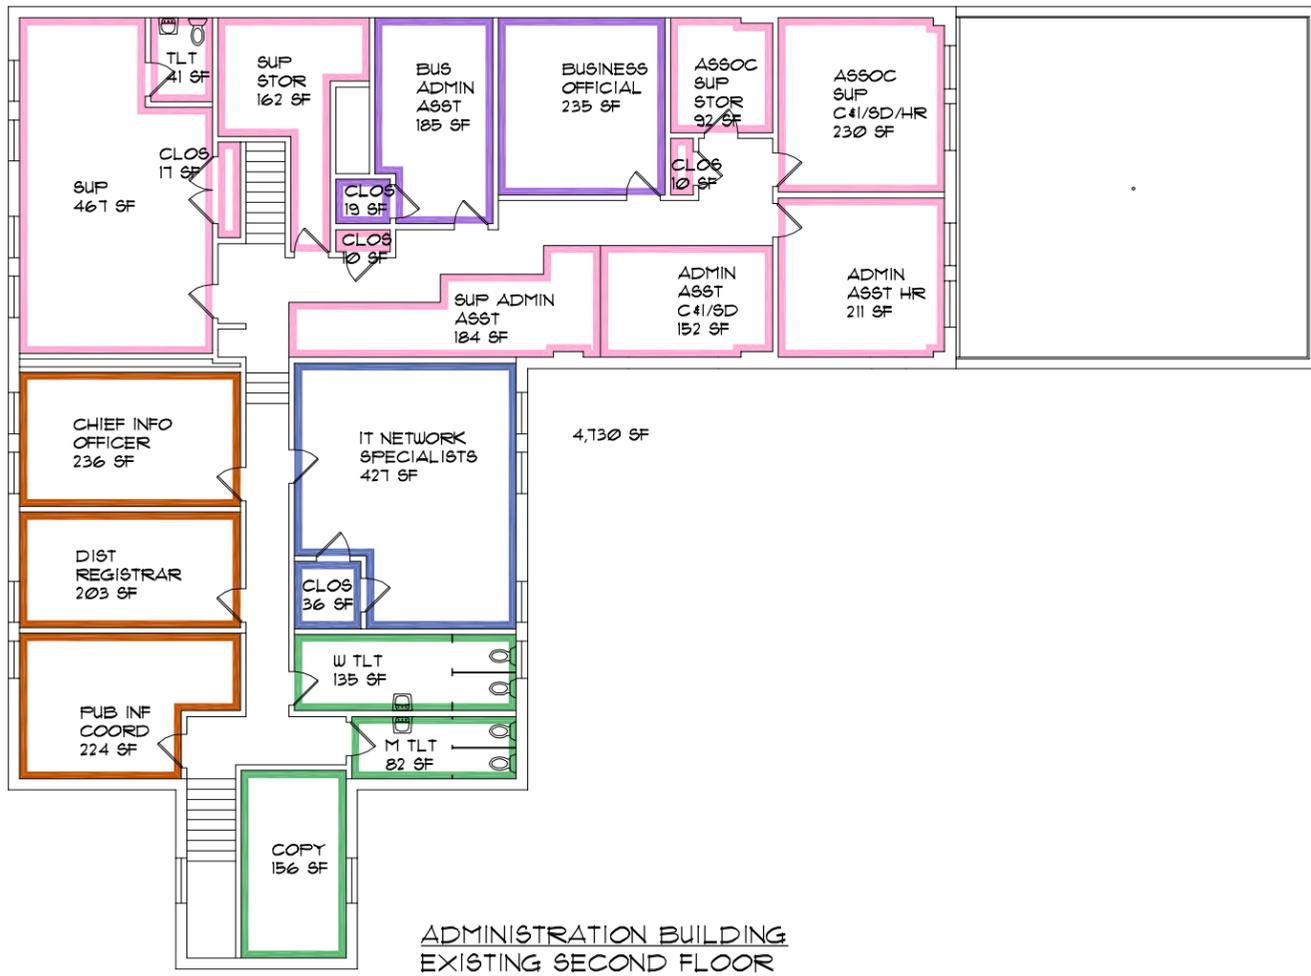
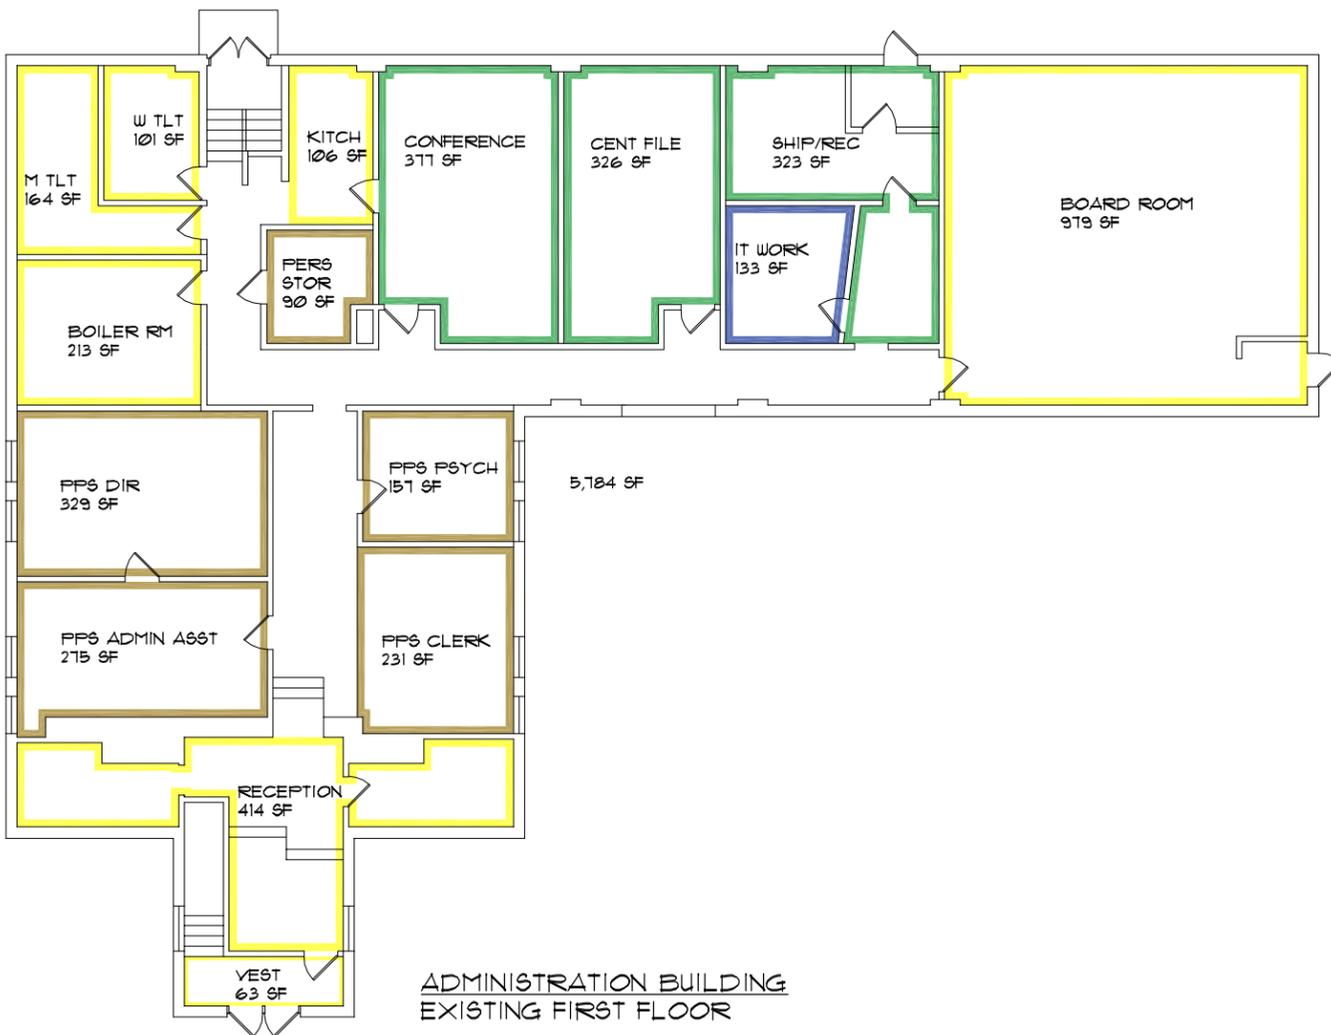
**ATTACHMENT A**

- PUBLIC SHARED
- PRIVATE SHARED
- ADMIN SUITE
- INFORMATION EXEC PR
- BUSINESS
- INFORMATION TECHNOLOGY
- PUPIL PERSONNEL SERVICES

4,730 SF 2ND FLOOR  
 5,784 SF 1ST FLOOR  
 10,514 SF TOTAL

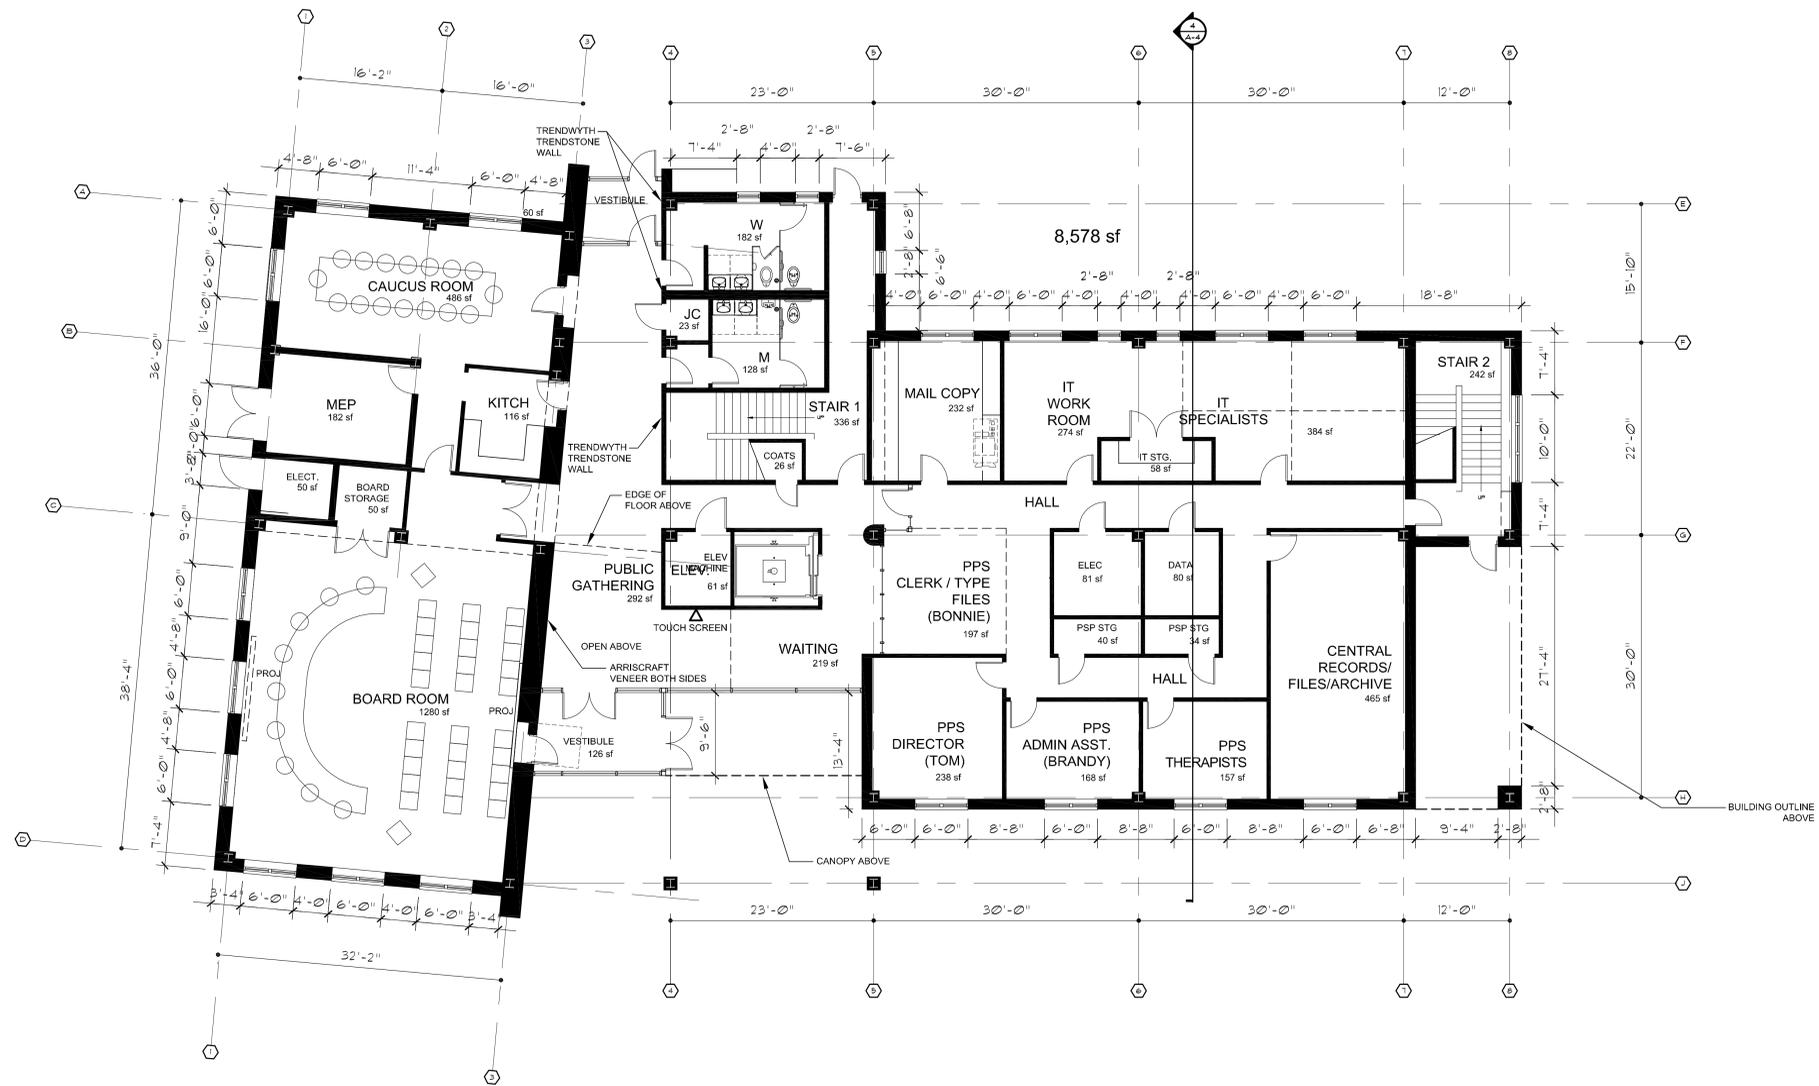
1  
A-1  
COMPOSITE FIRST FLOOR PLAN  
SCALE: 1/8"=1'-0"

**COMPOSITE BUILDING  
 FIRST FLOOR PLAN**

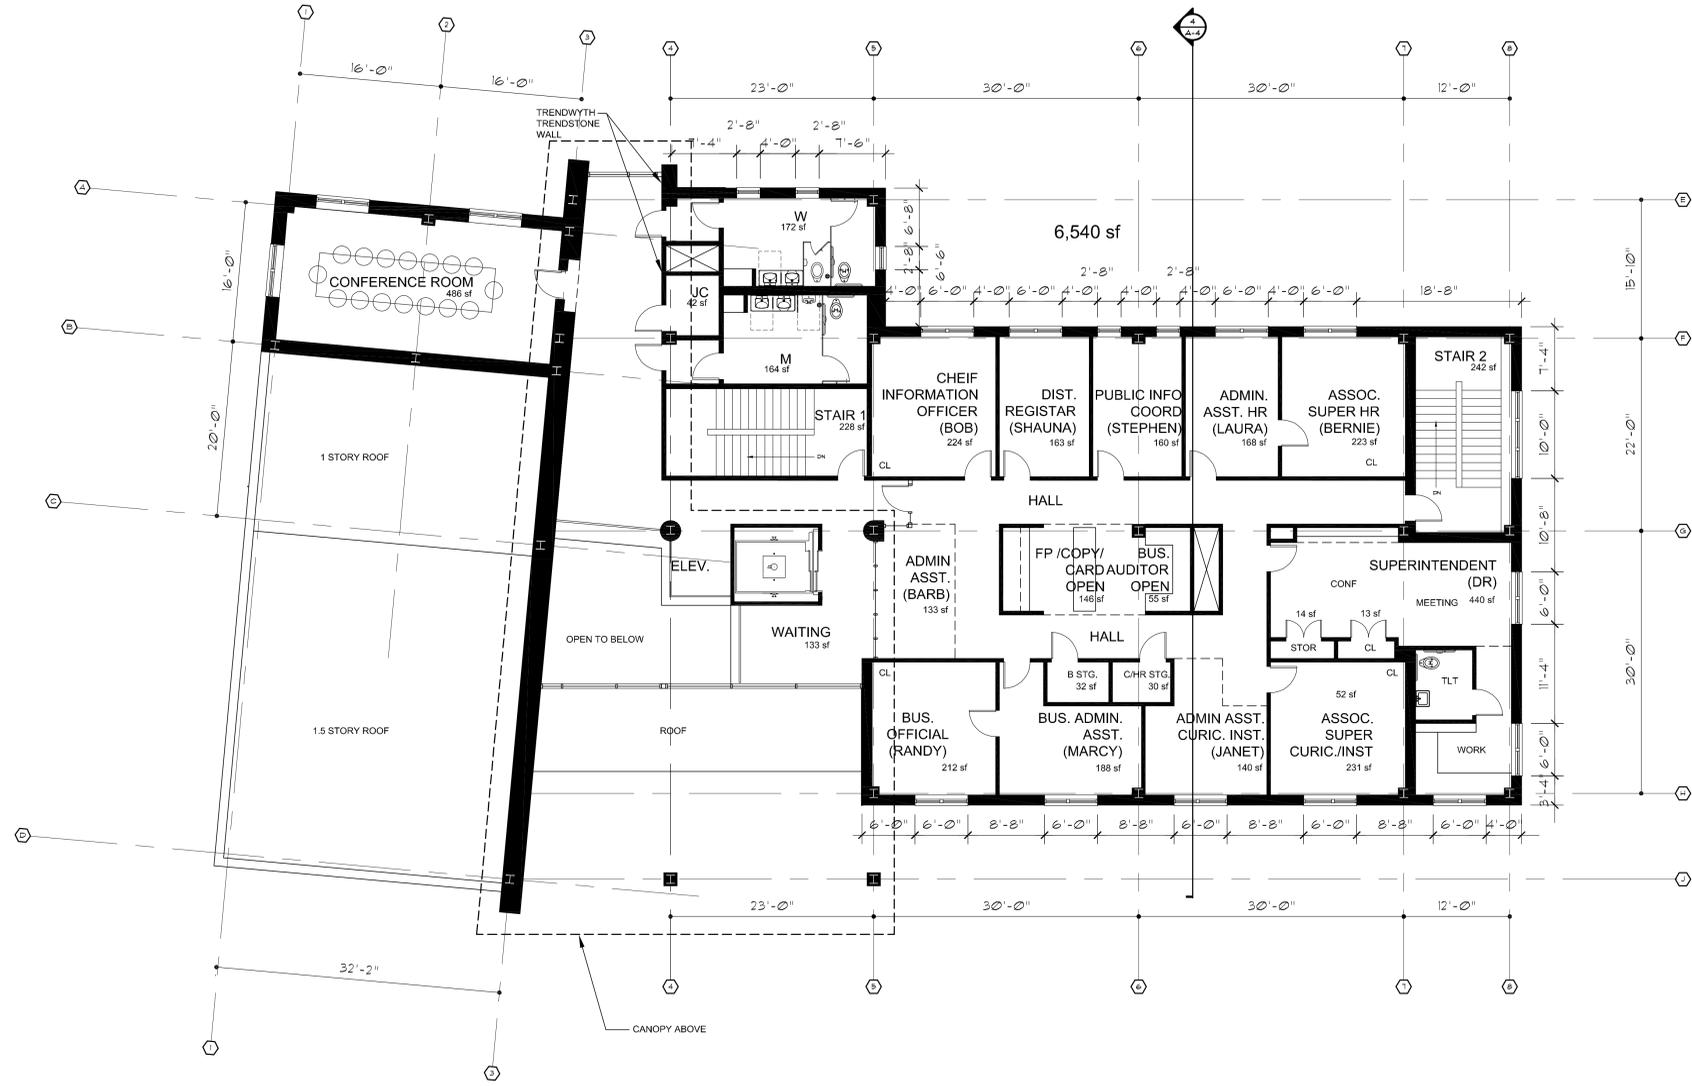
1 COMPOSITE SECOND FLOOR PLAN  
 SCALE: 1/8"=1'-0"

DRAWING TITLE:  
**COMPOSITE BUILDING SECOND FLOOR PLAN AND ROOF PLAN**

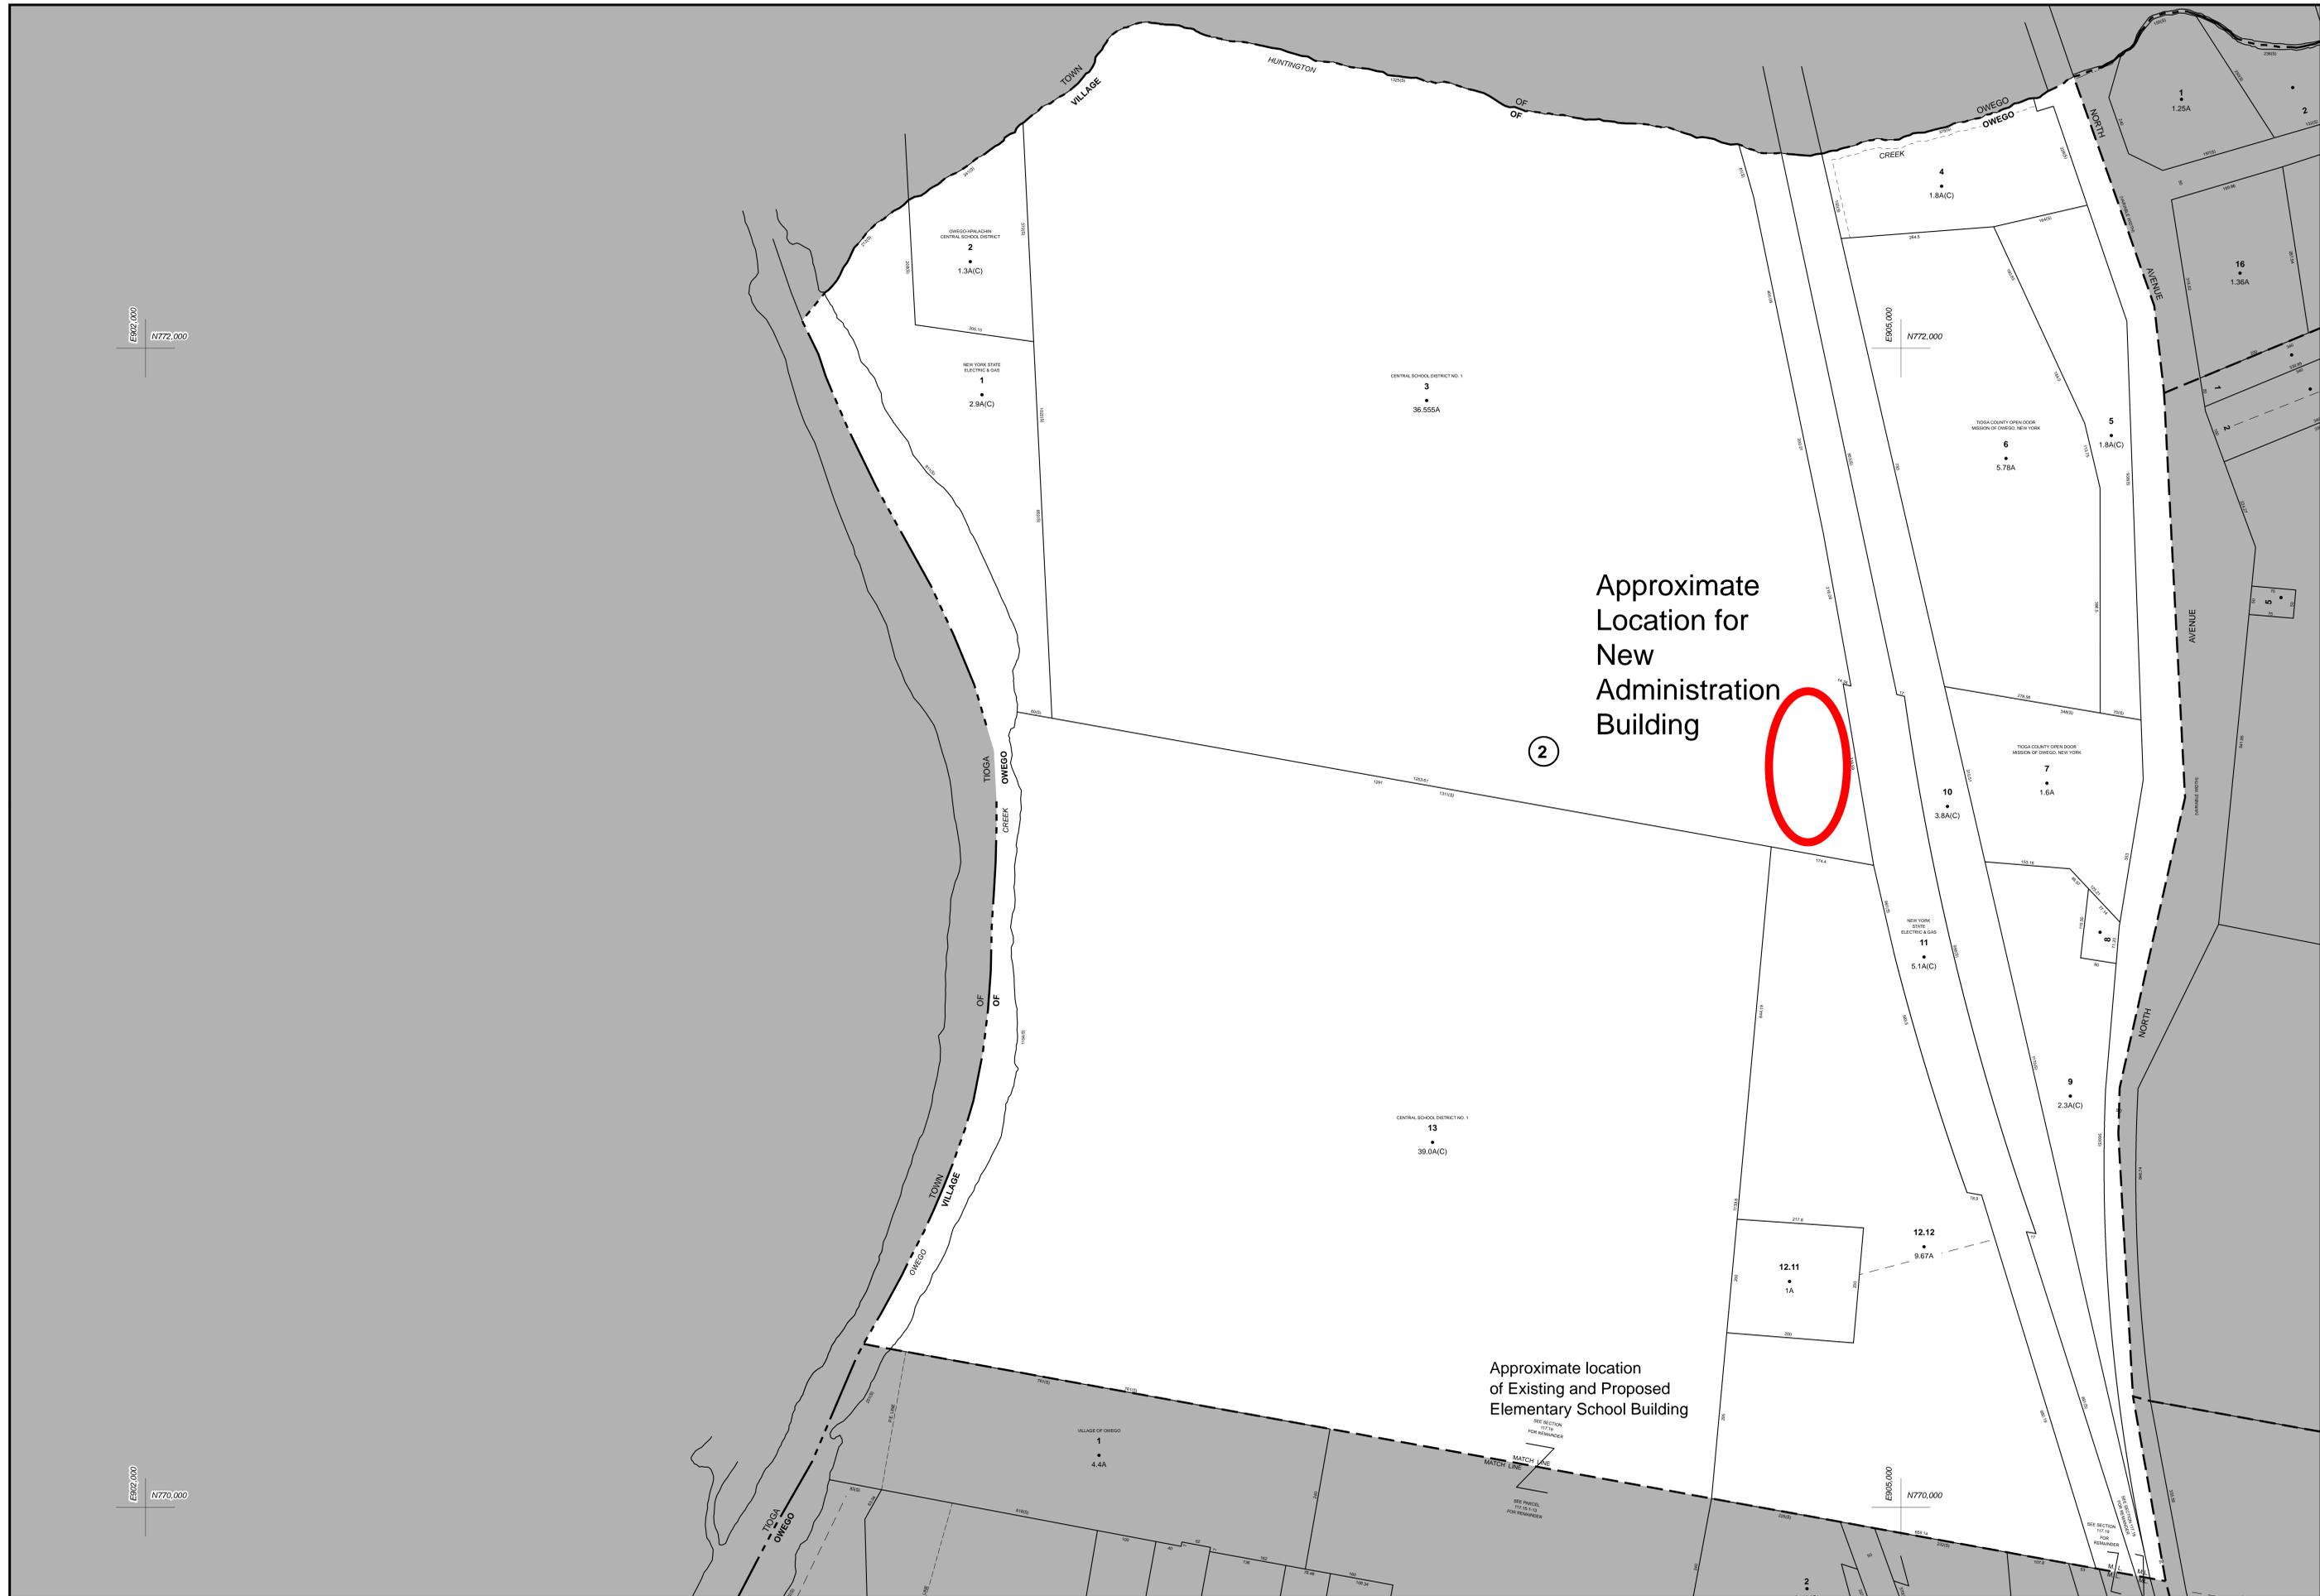
Approximate Location for New Administration Building

Approximate location of Existing and Proposed Elementary School Building

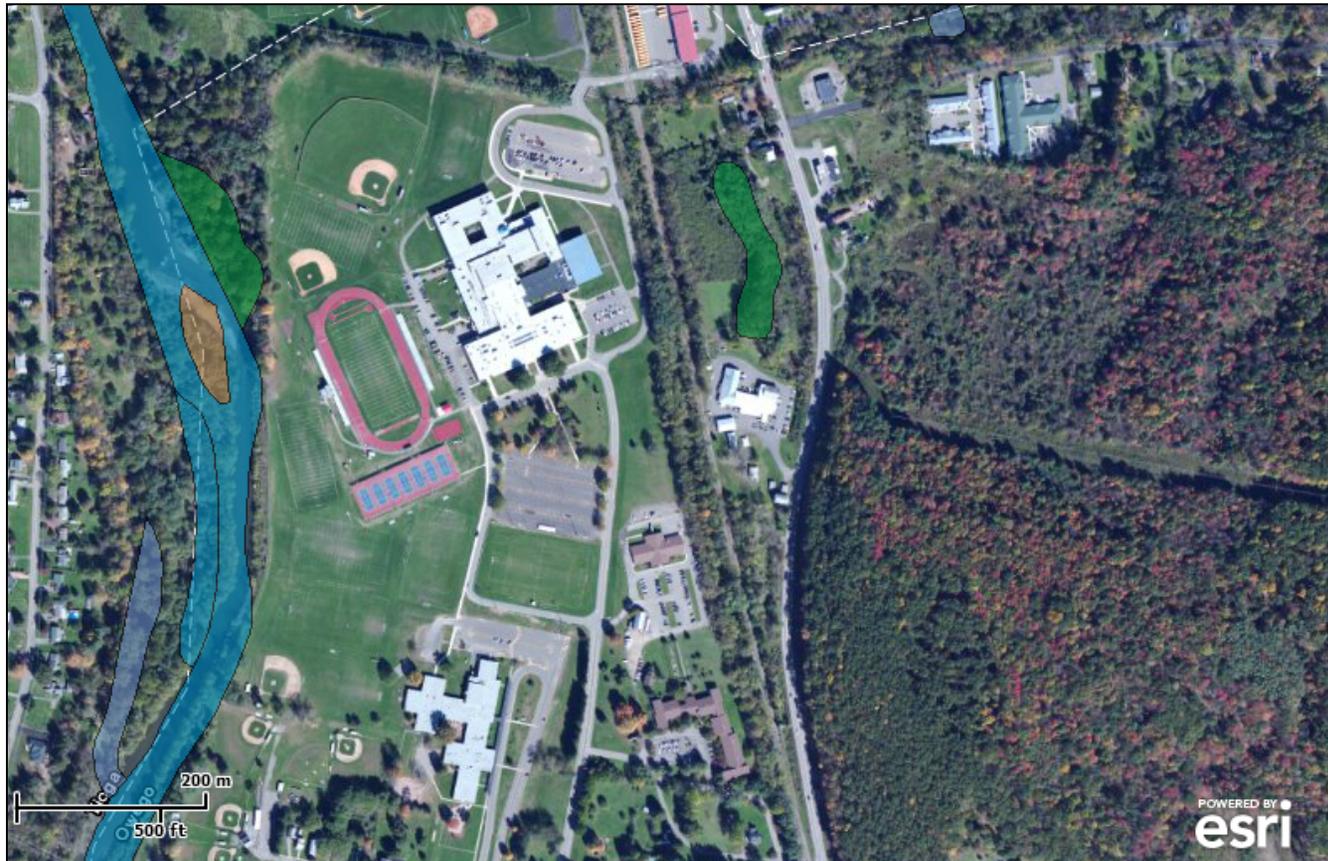
Admin Building

## Wetlands

- Freshwater Emergent
- Freshwater Forested/Shrub
- Estuarine and Marine Deepwater
- Estuarine and Marine
- Freshwater Pond
- Lake
- Riverine
- Other

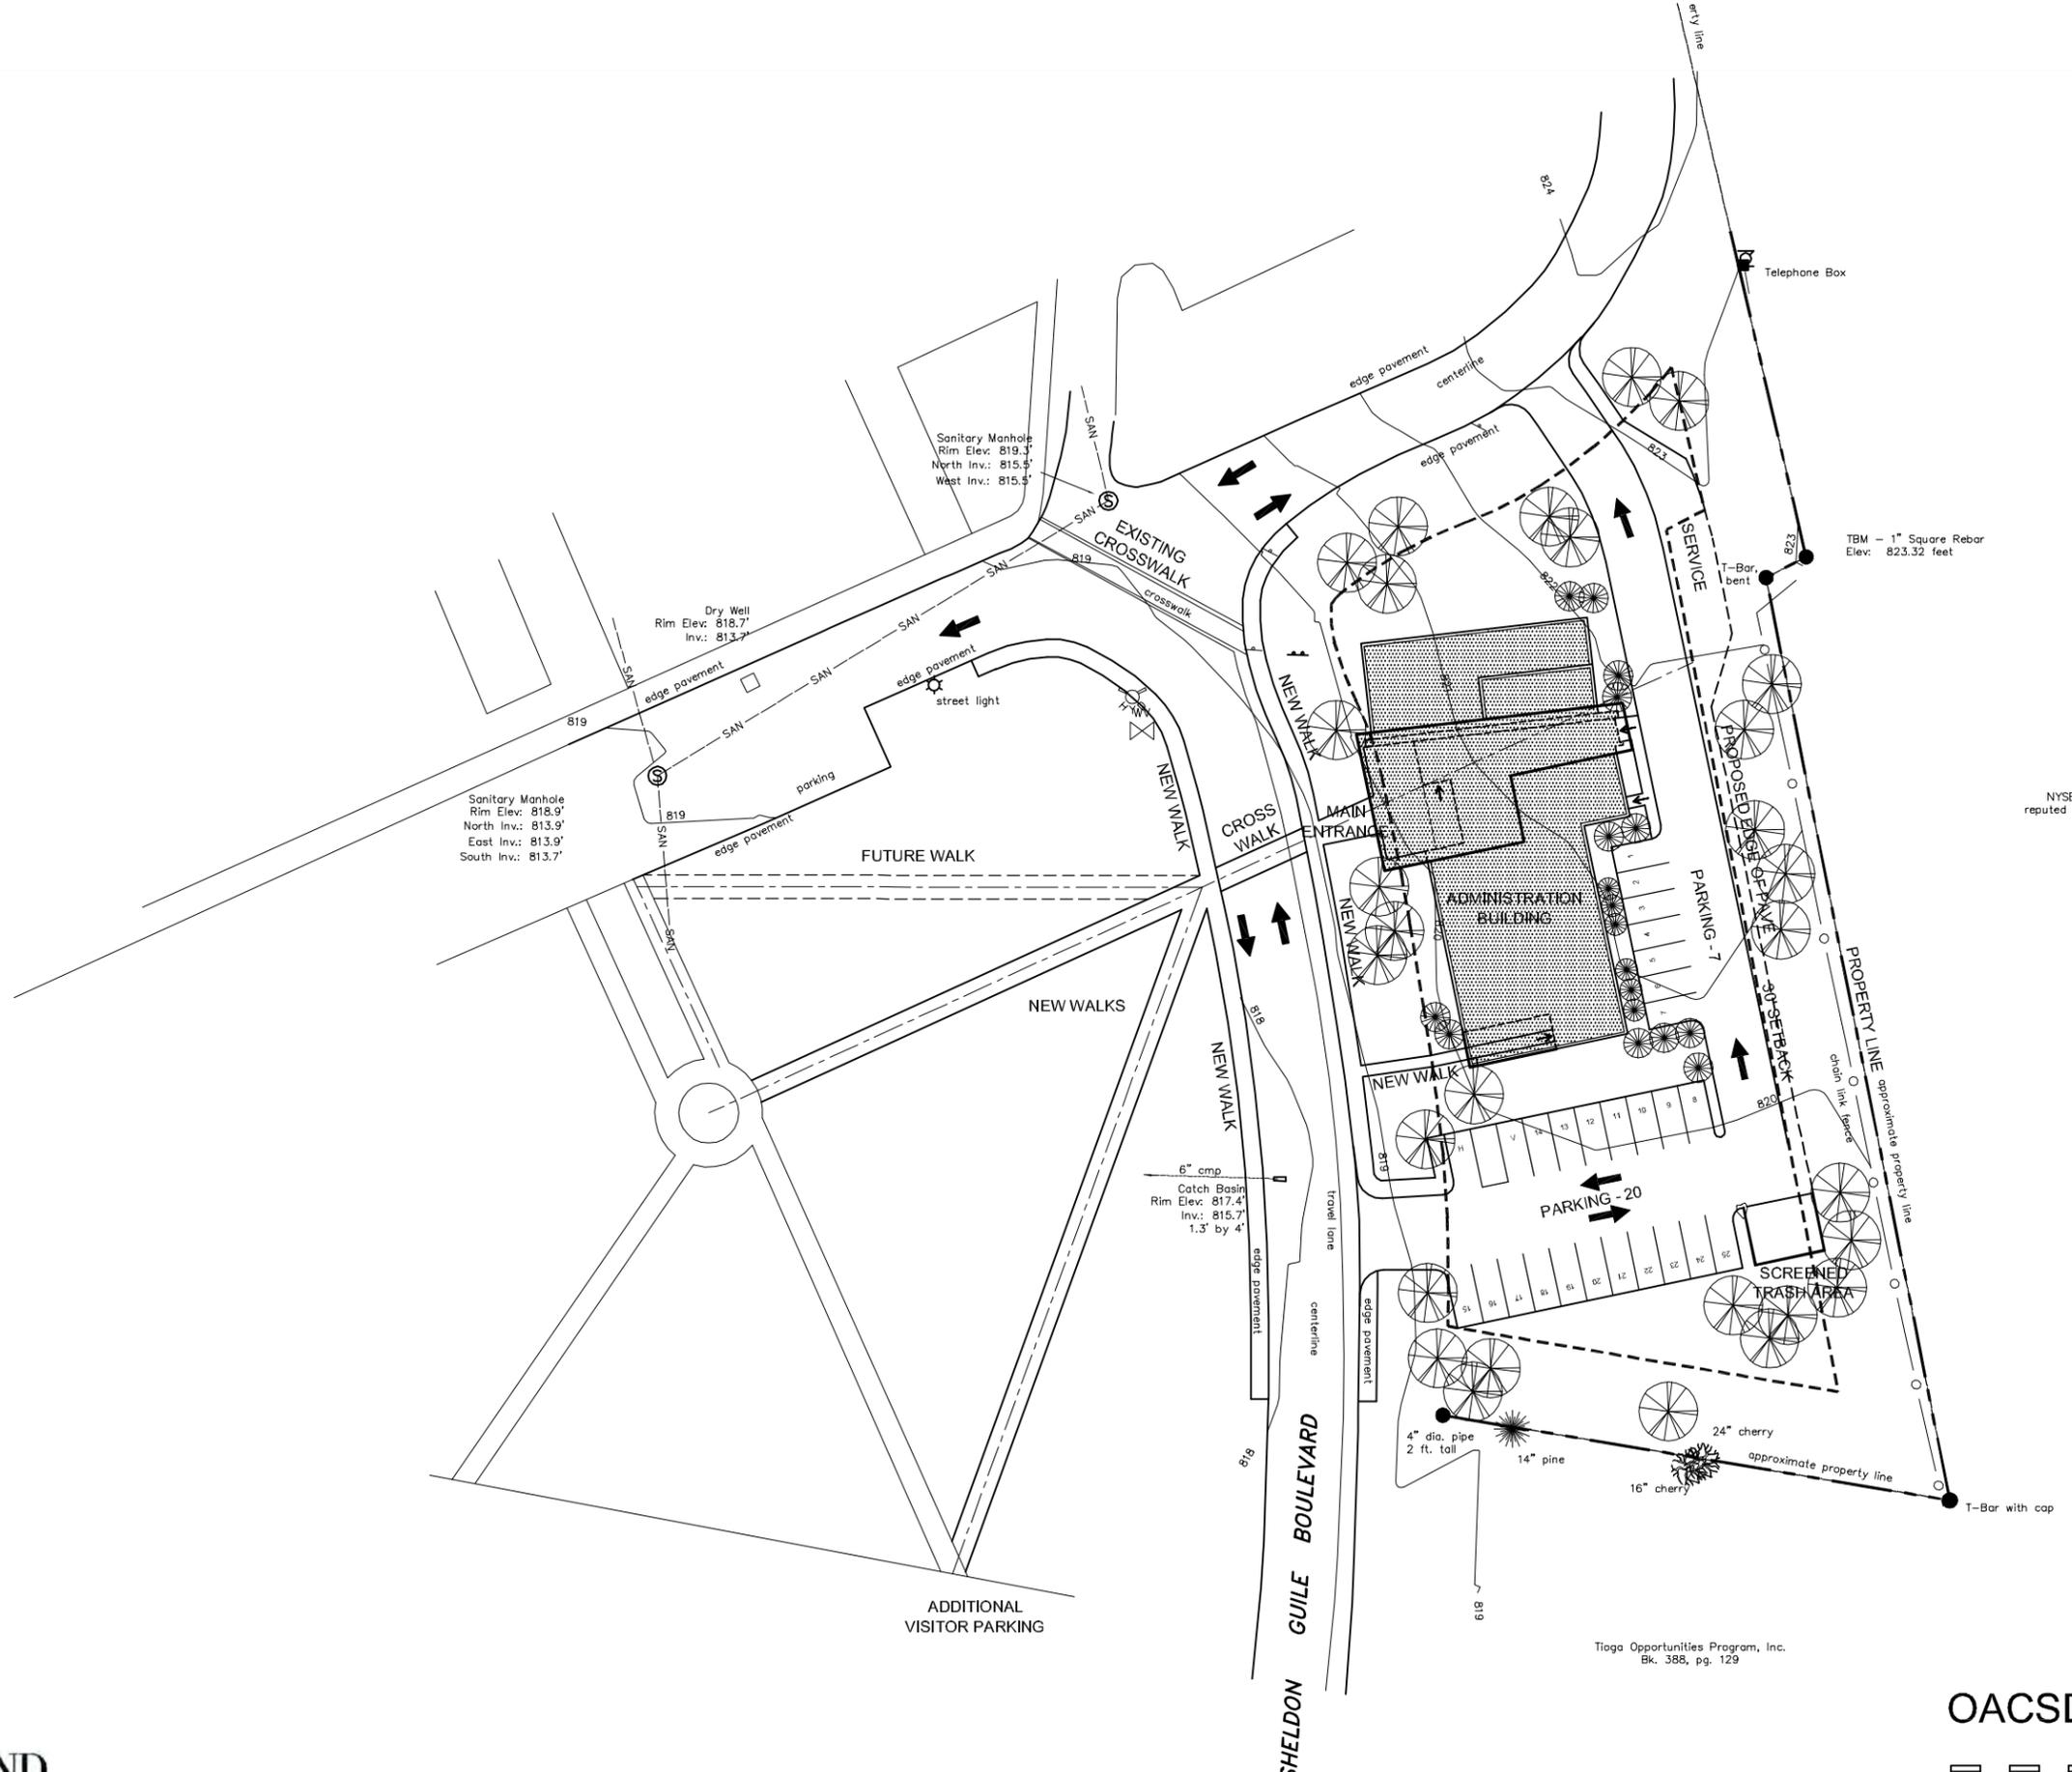
**OACSD ADMINISTRATION FACILITY**  
**Site Plan**

The proposed building finished first floor elevation (820.75) is above both the base flood and the 0.2% annual chance flood elevations. In addition, all associated site work is at or above the base flood elevation of 818.7. As such, I concur that the proposed facility is located outside the special flood hazard area, is in compliance with the Village of Owego Flood ordinances/codes and will not encroach into or displace base flood storage volume as currently designed.
