Environmental Assessment

Quiggins Sinkhole Flood Mitigation Project

City of Radcliff, Hardin County, Kentucky

February 12, 2015

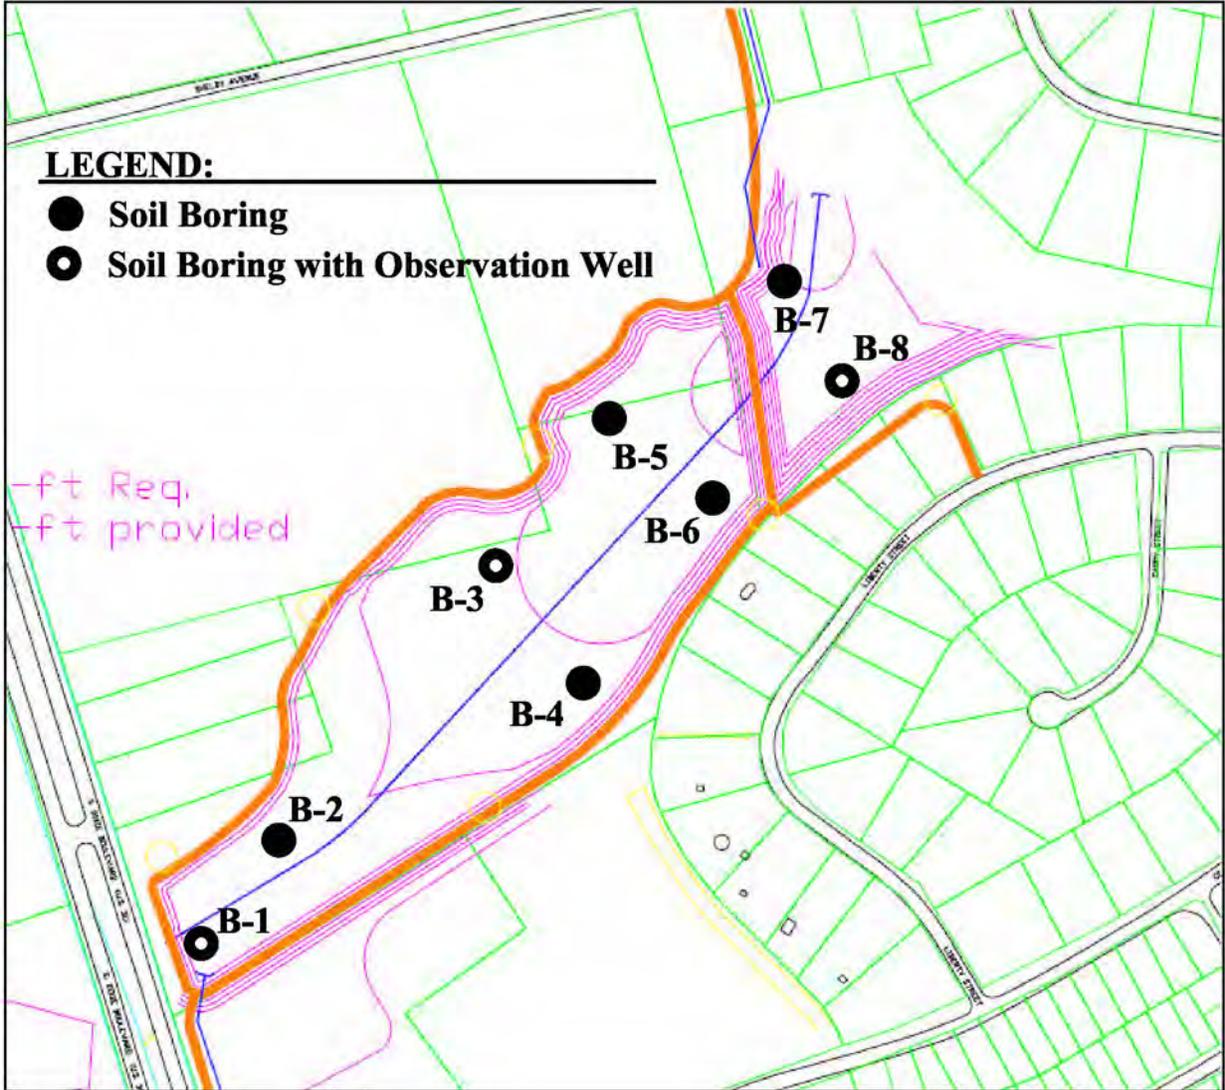
Attachment 1 – Boring Layout

Boring Layout
Quiggins Basin
Radcliff, Kentucky

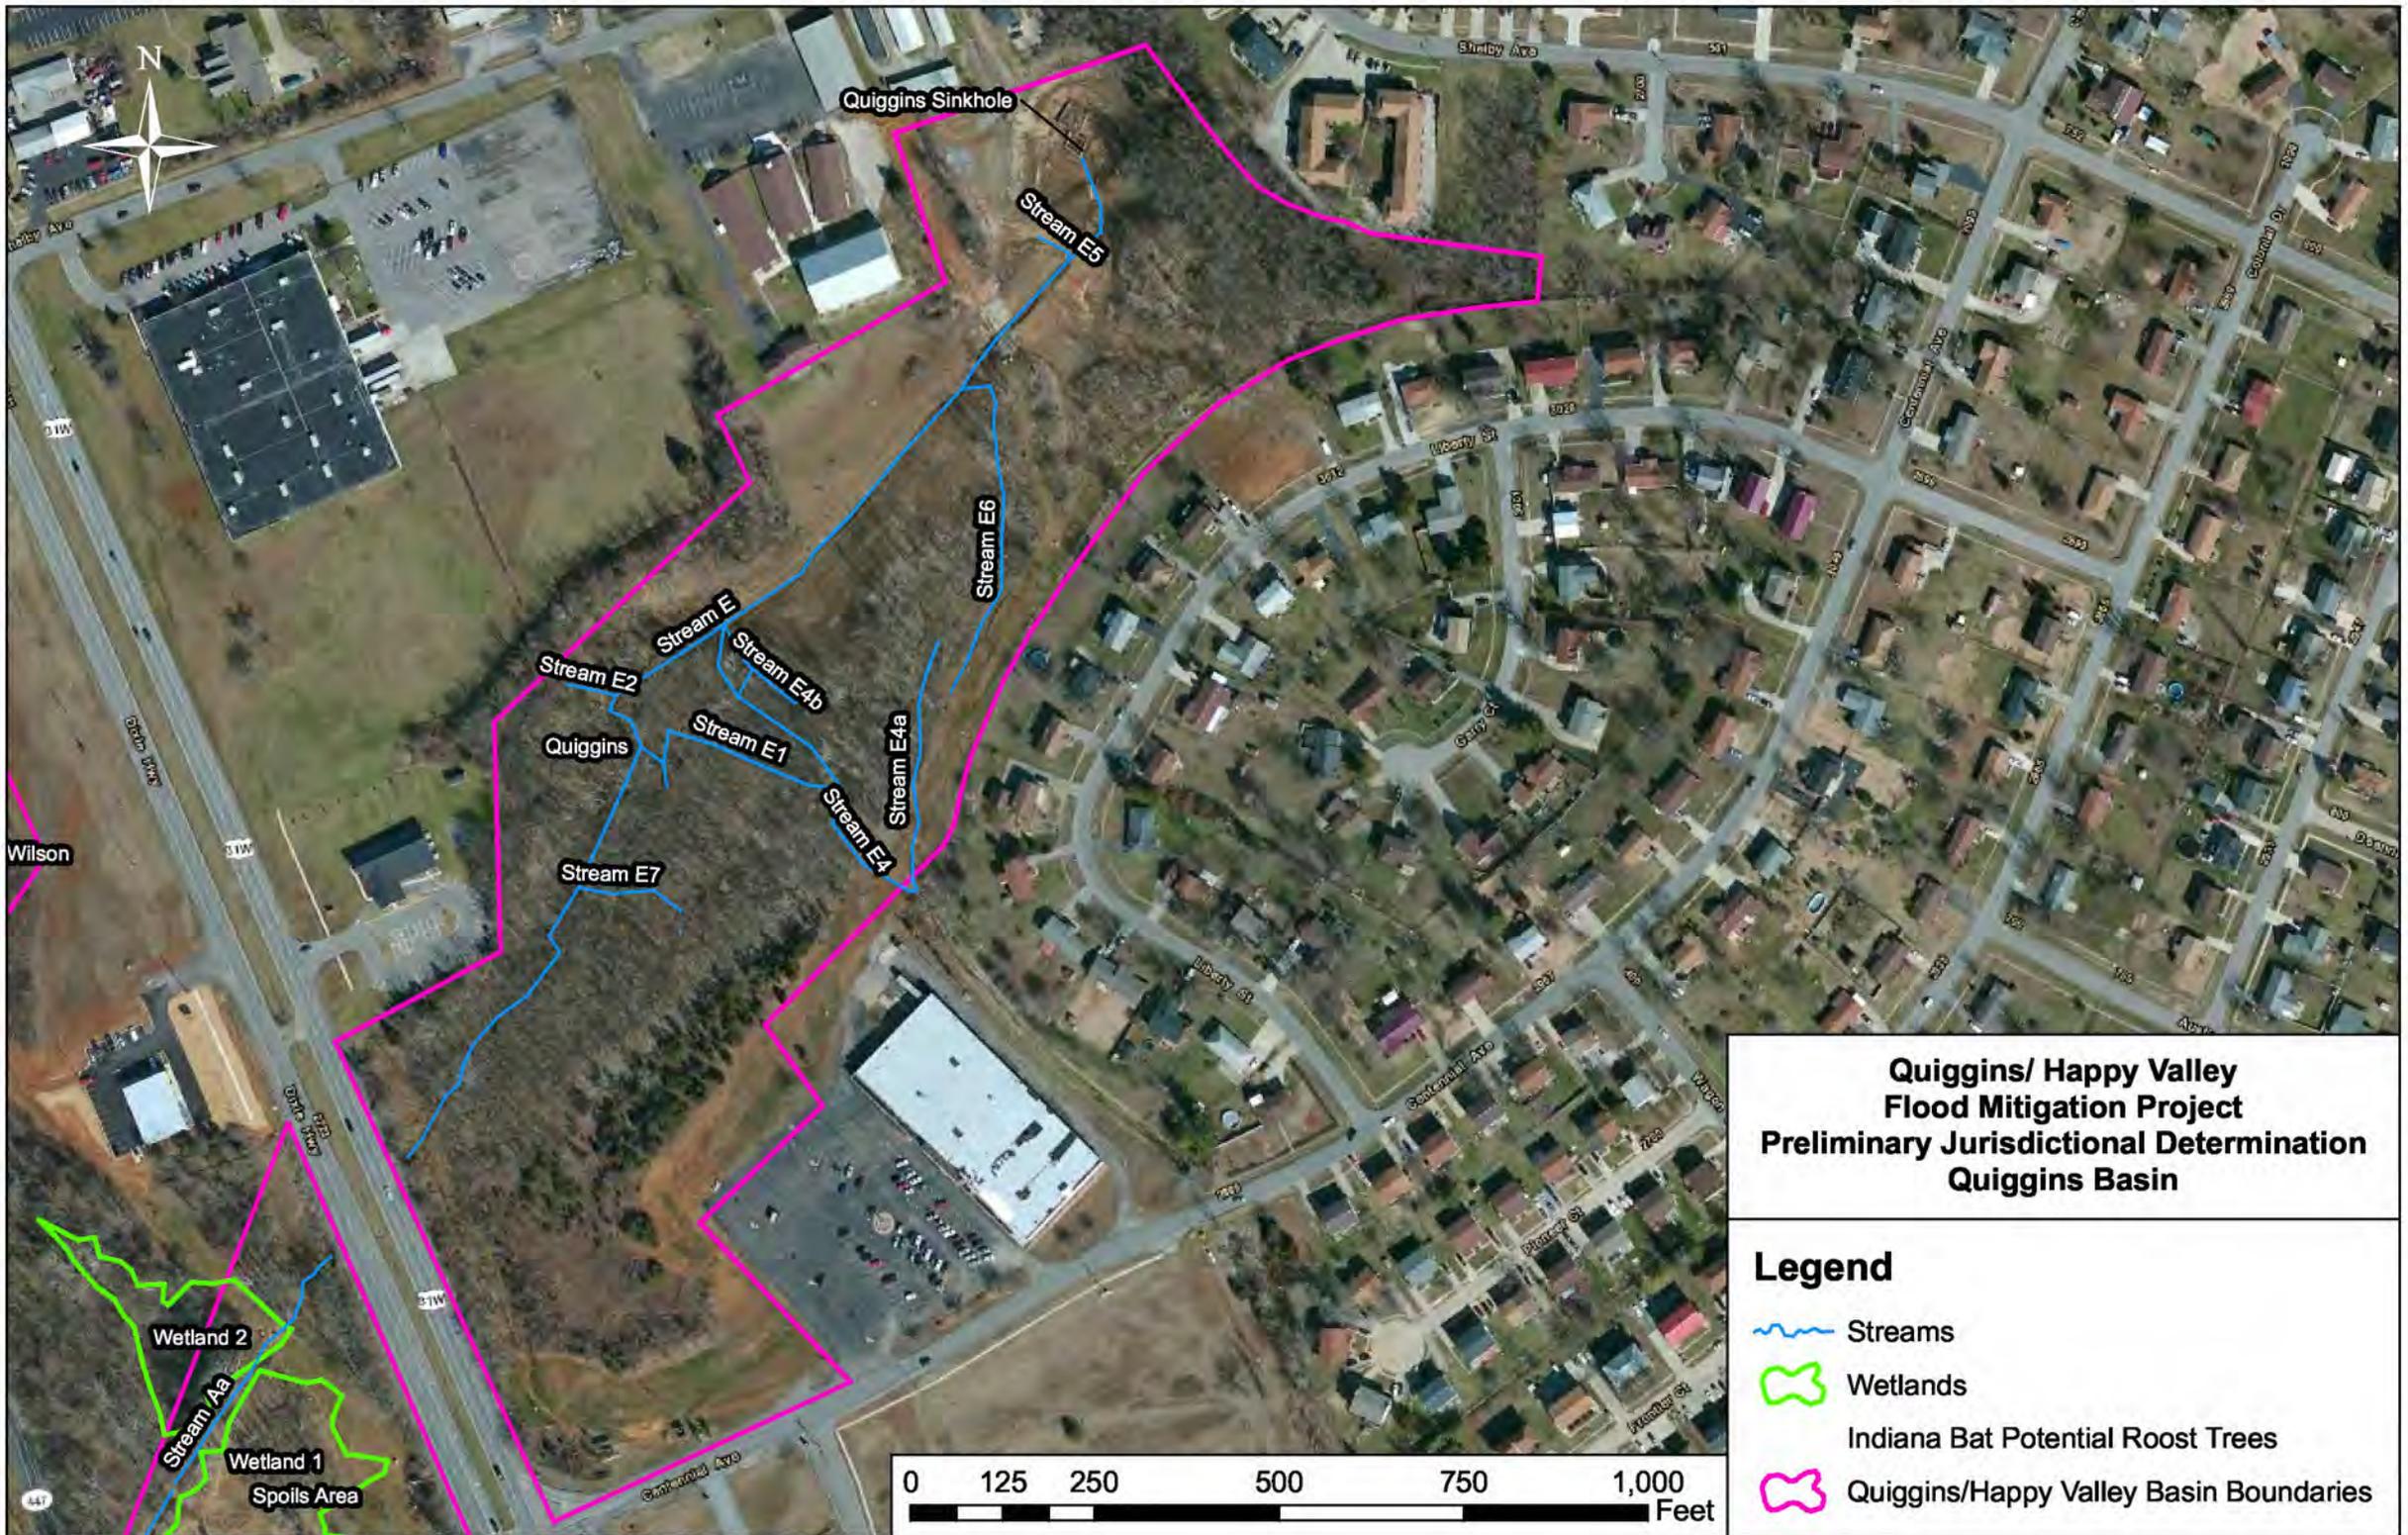
**Quiggins/ Happy Valley
Flood Mitigation Project
Preliminary Jurisdictional Determination
Quiggins Basin**

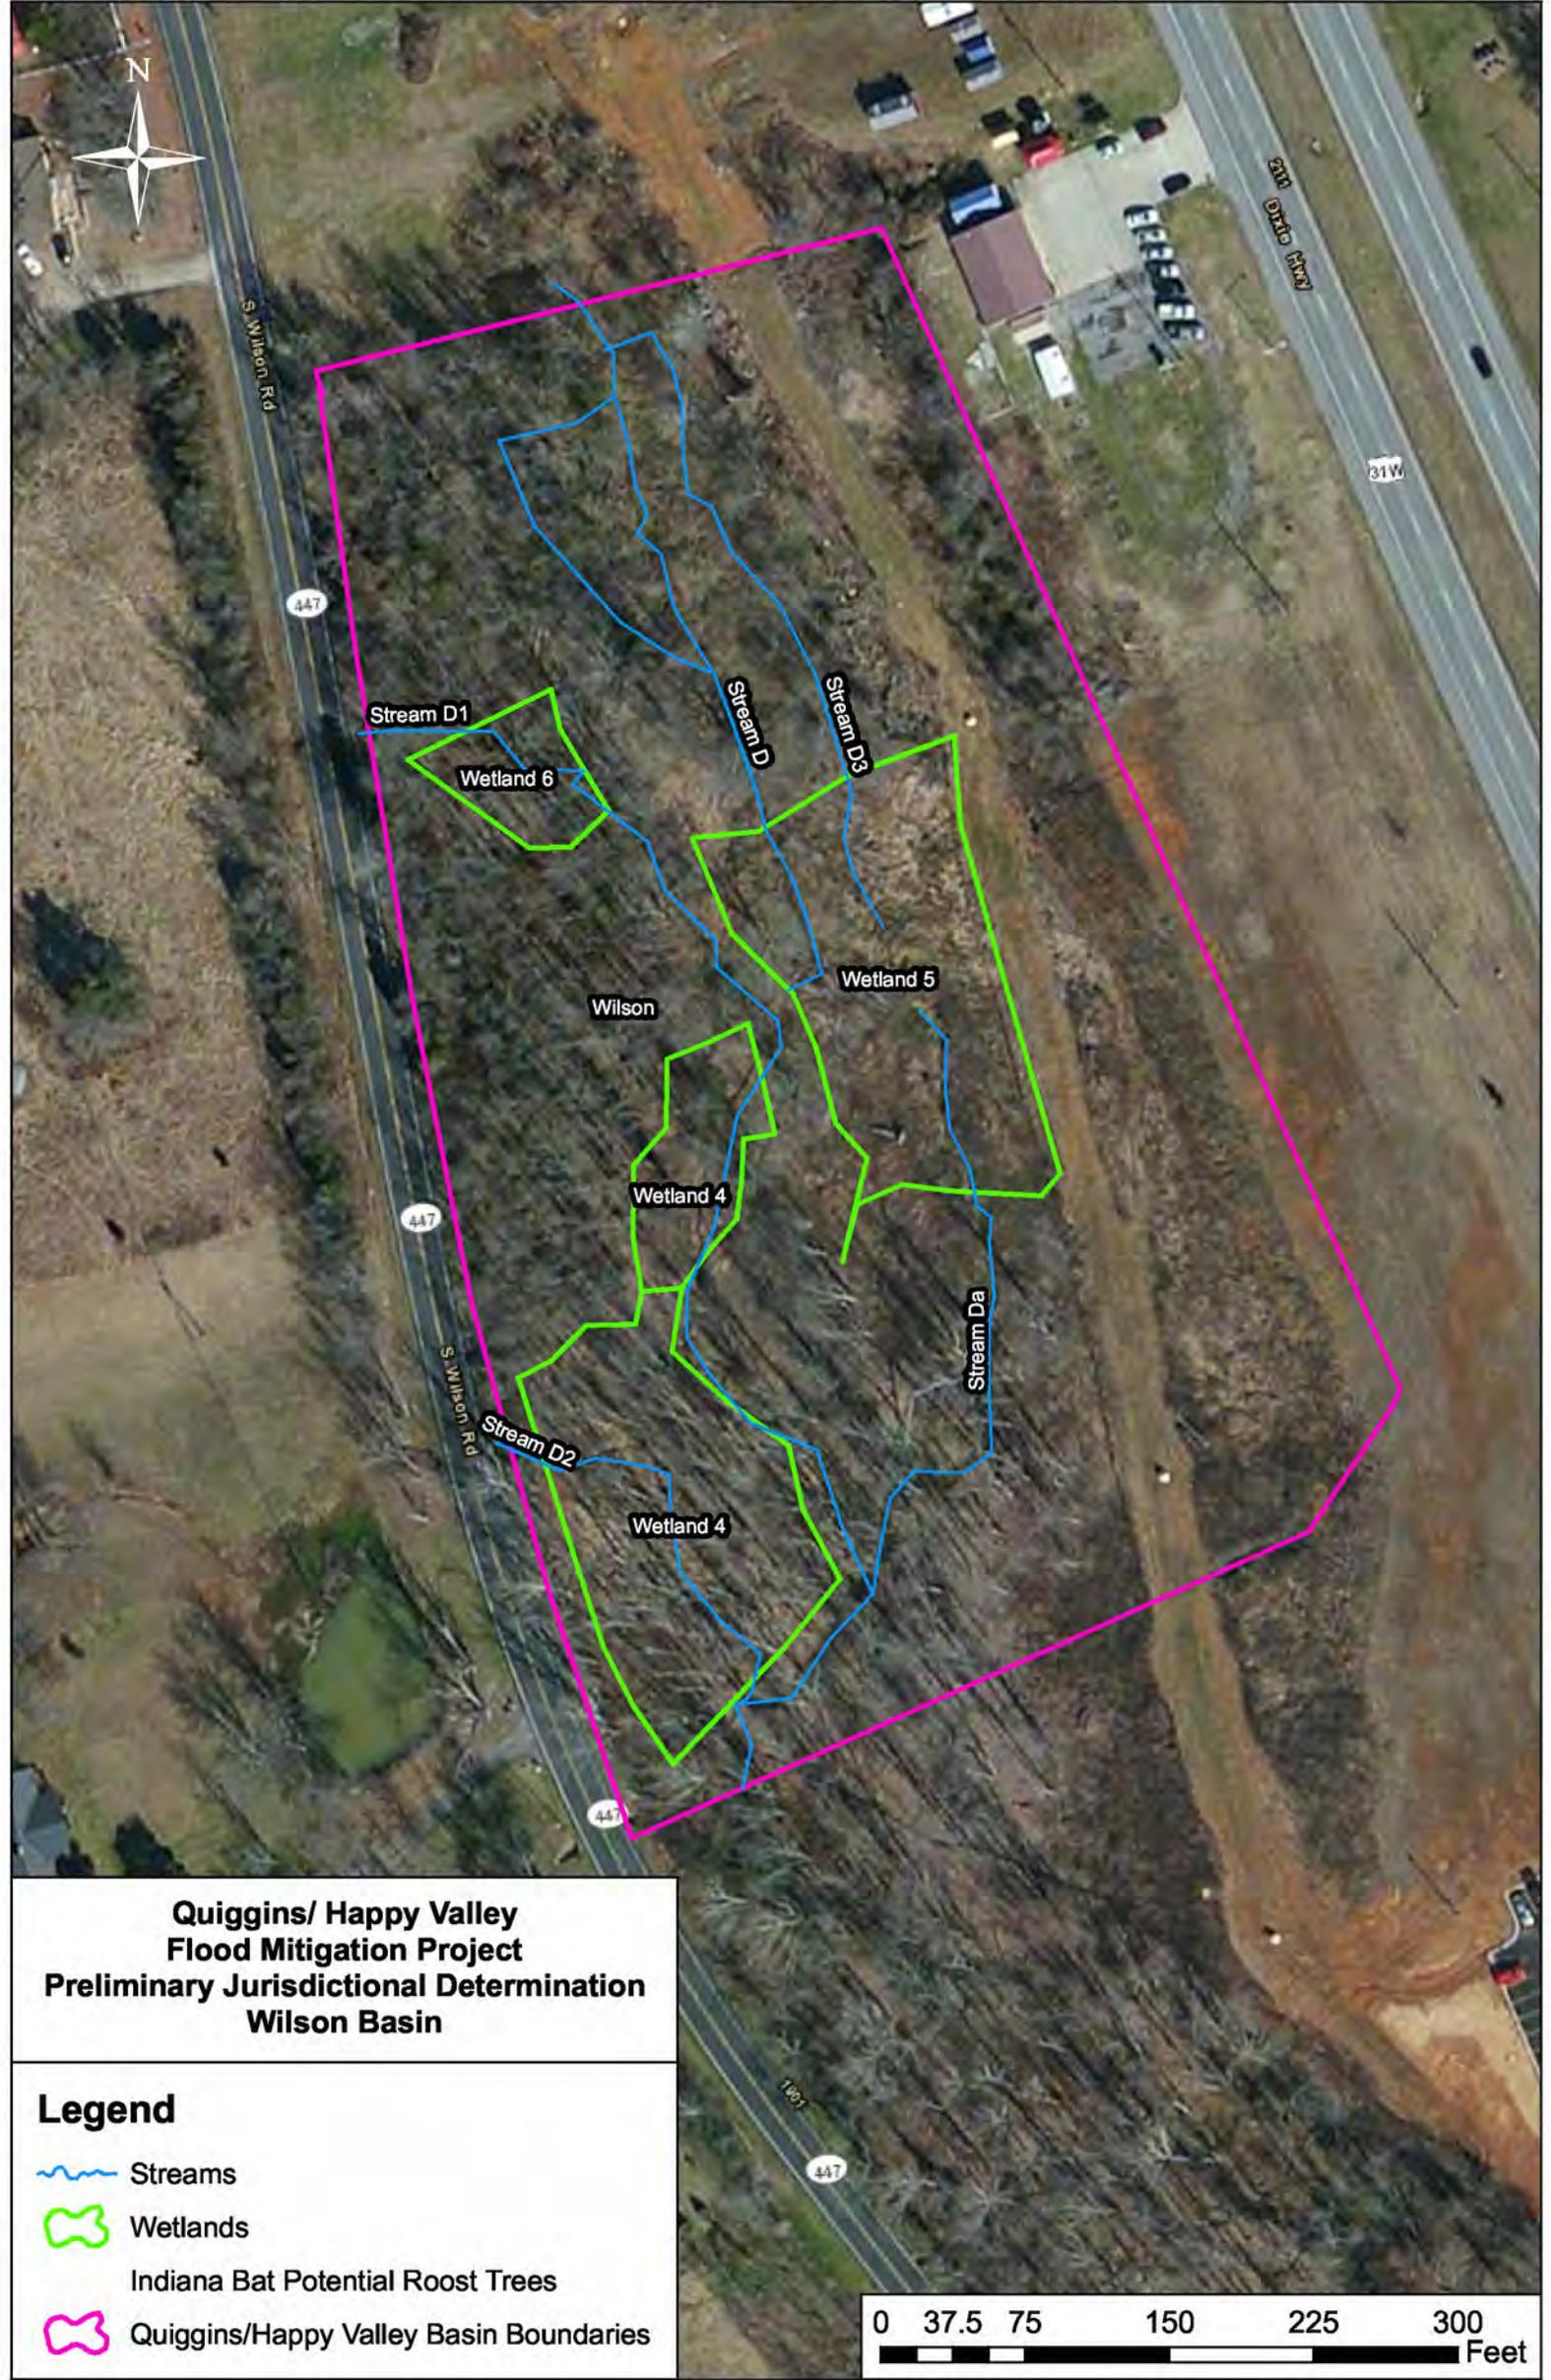
**Quiggins/ Happy Valley
Flood Mitigation Project
Preliminary Jurisdictional Determination
Wilson Basin**

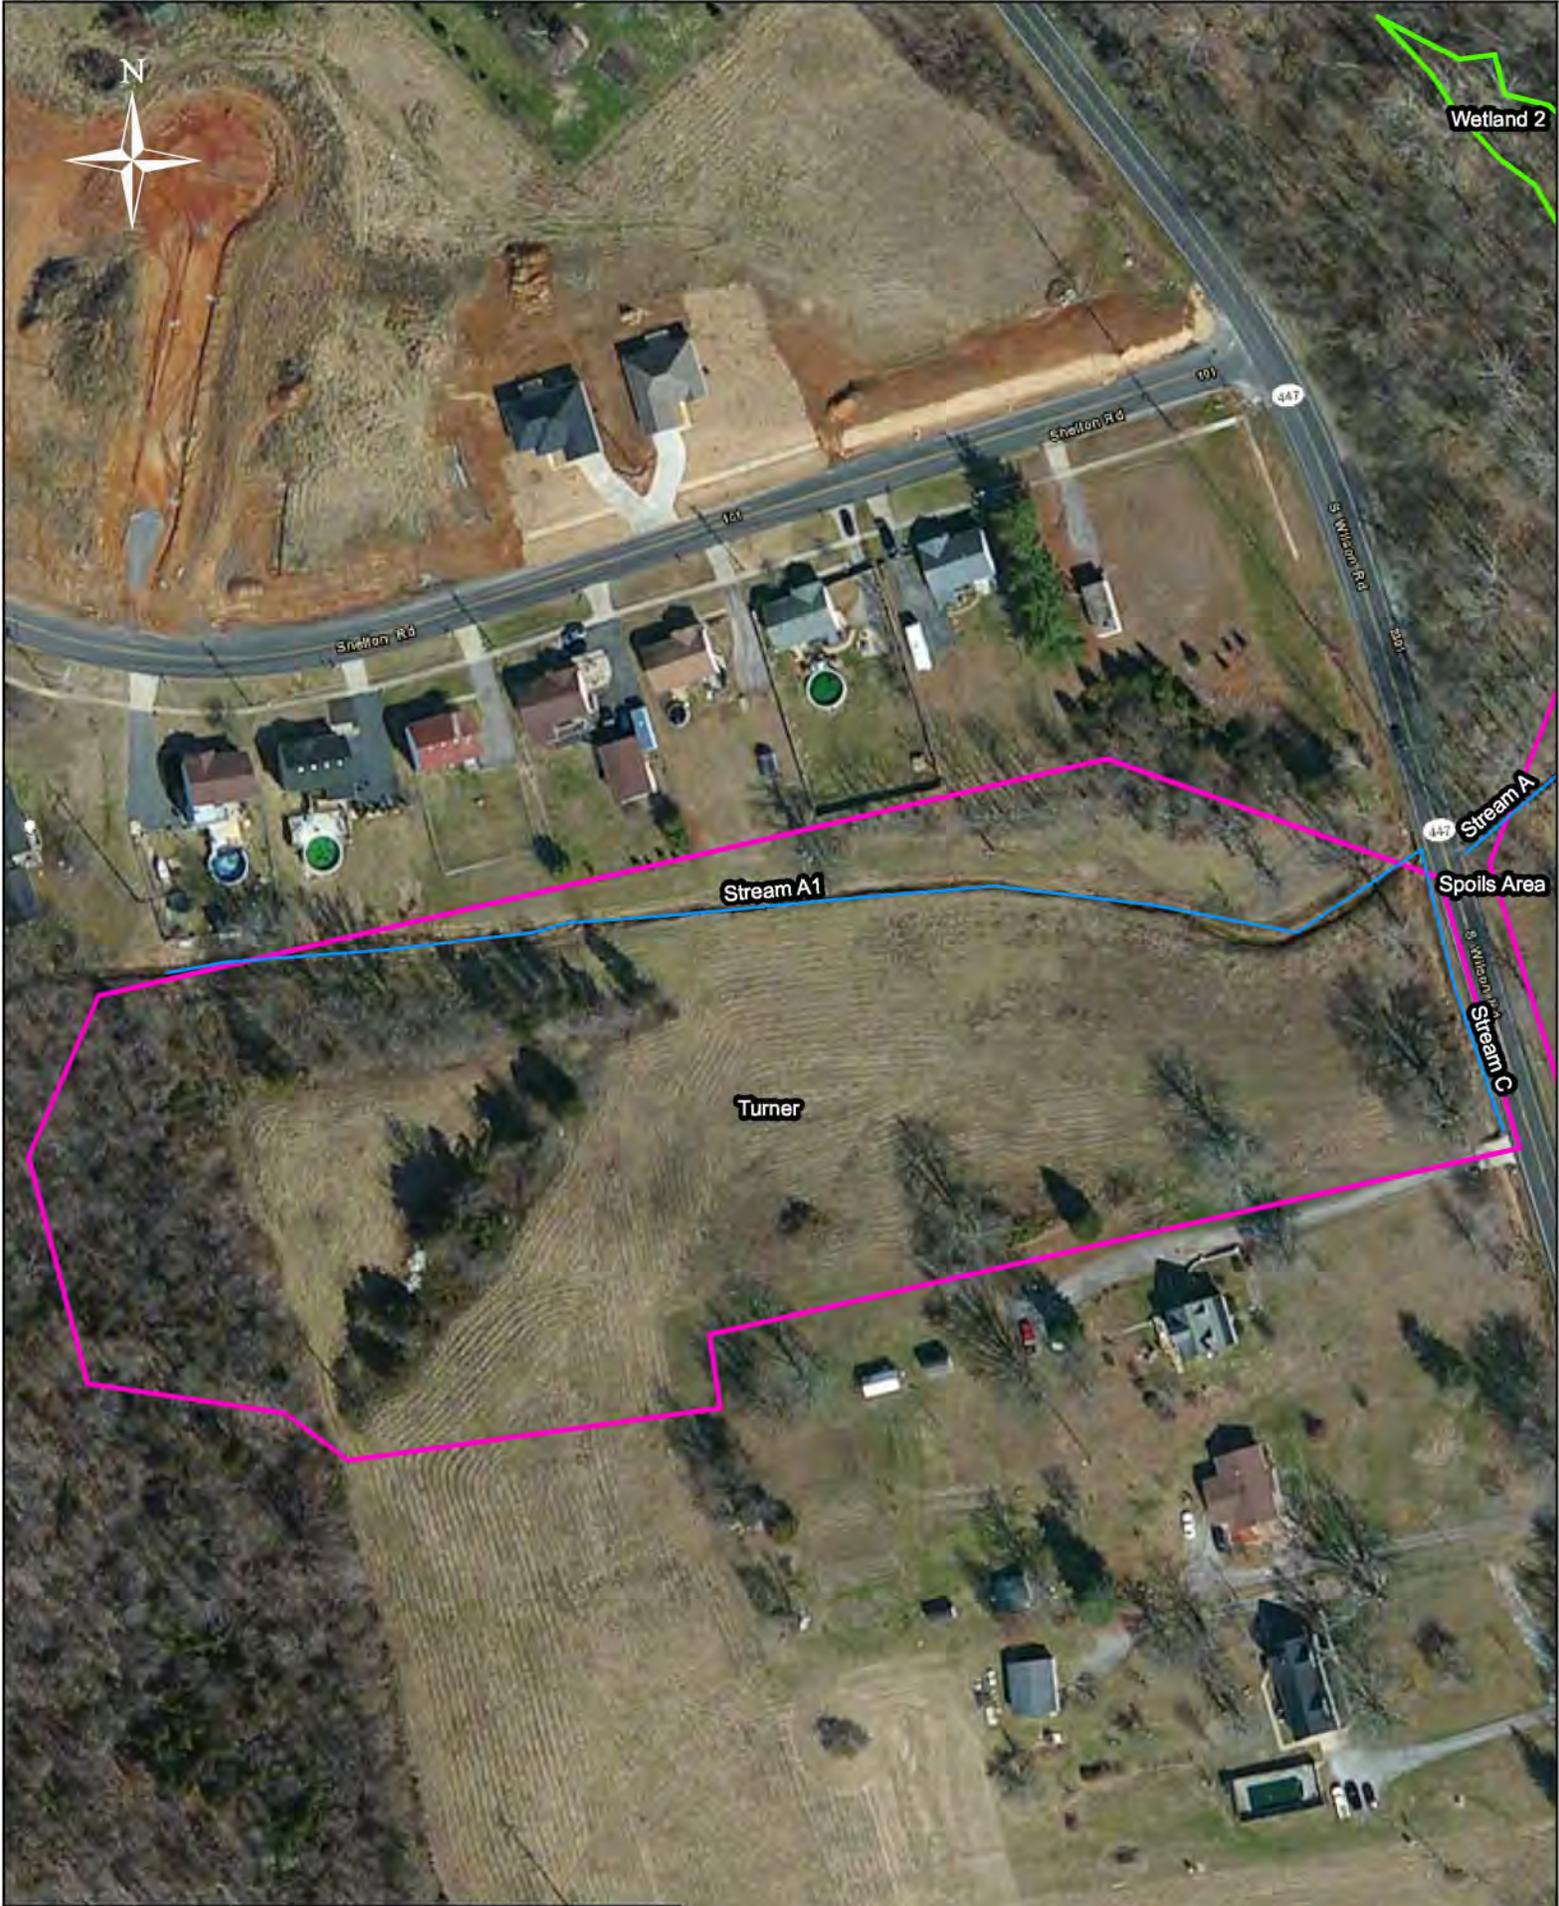
**Quiggins/ Happy Valley
Flood Mitigation Project
Preliminary Jurisdictional Determination
Turner Basin**

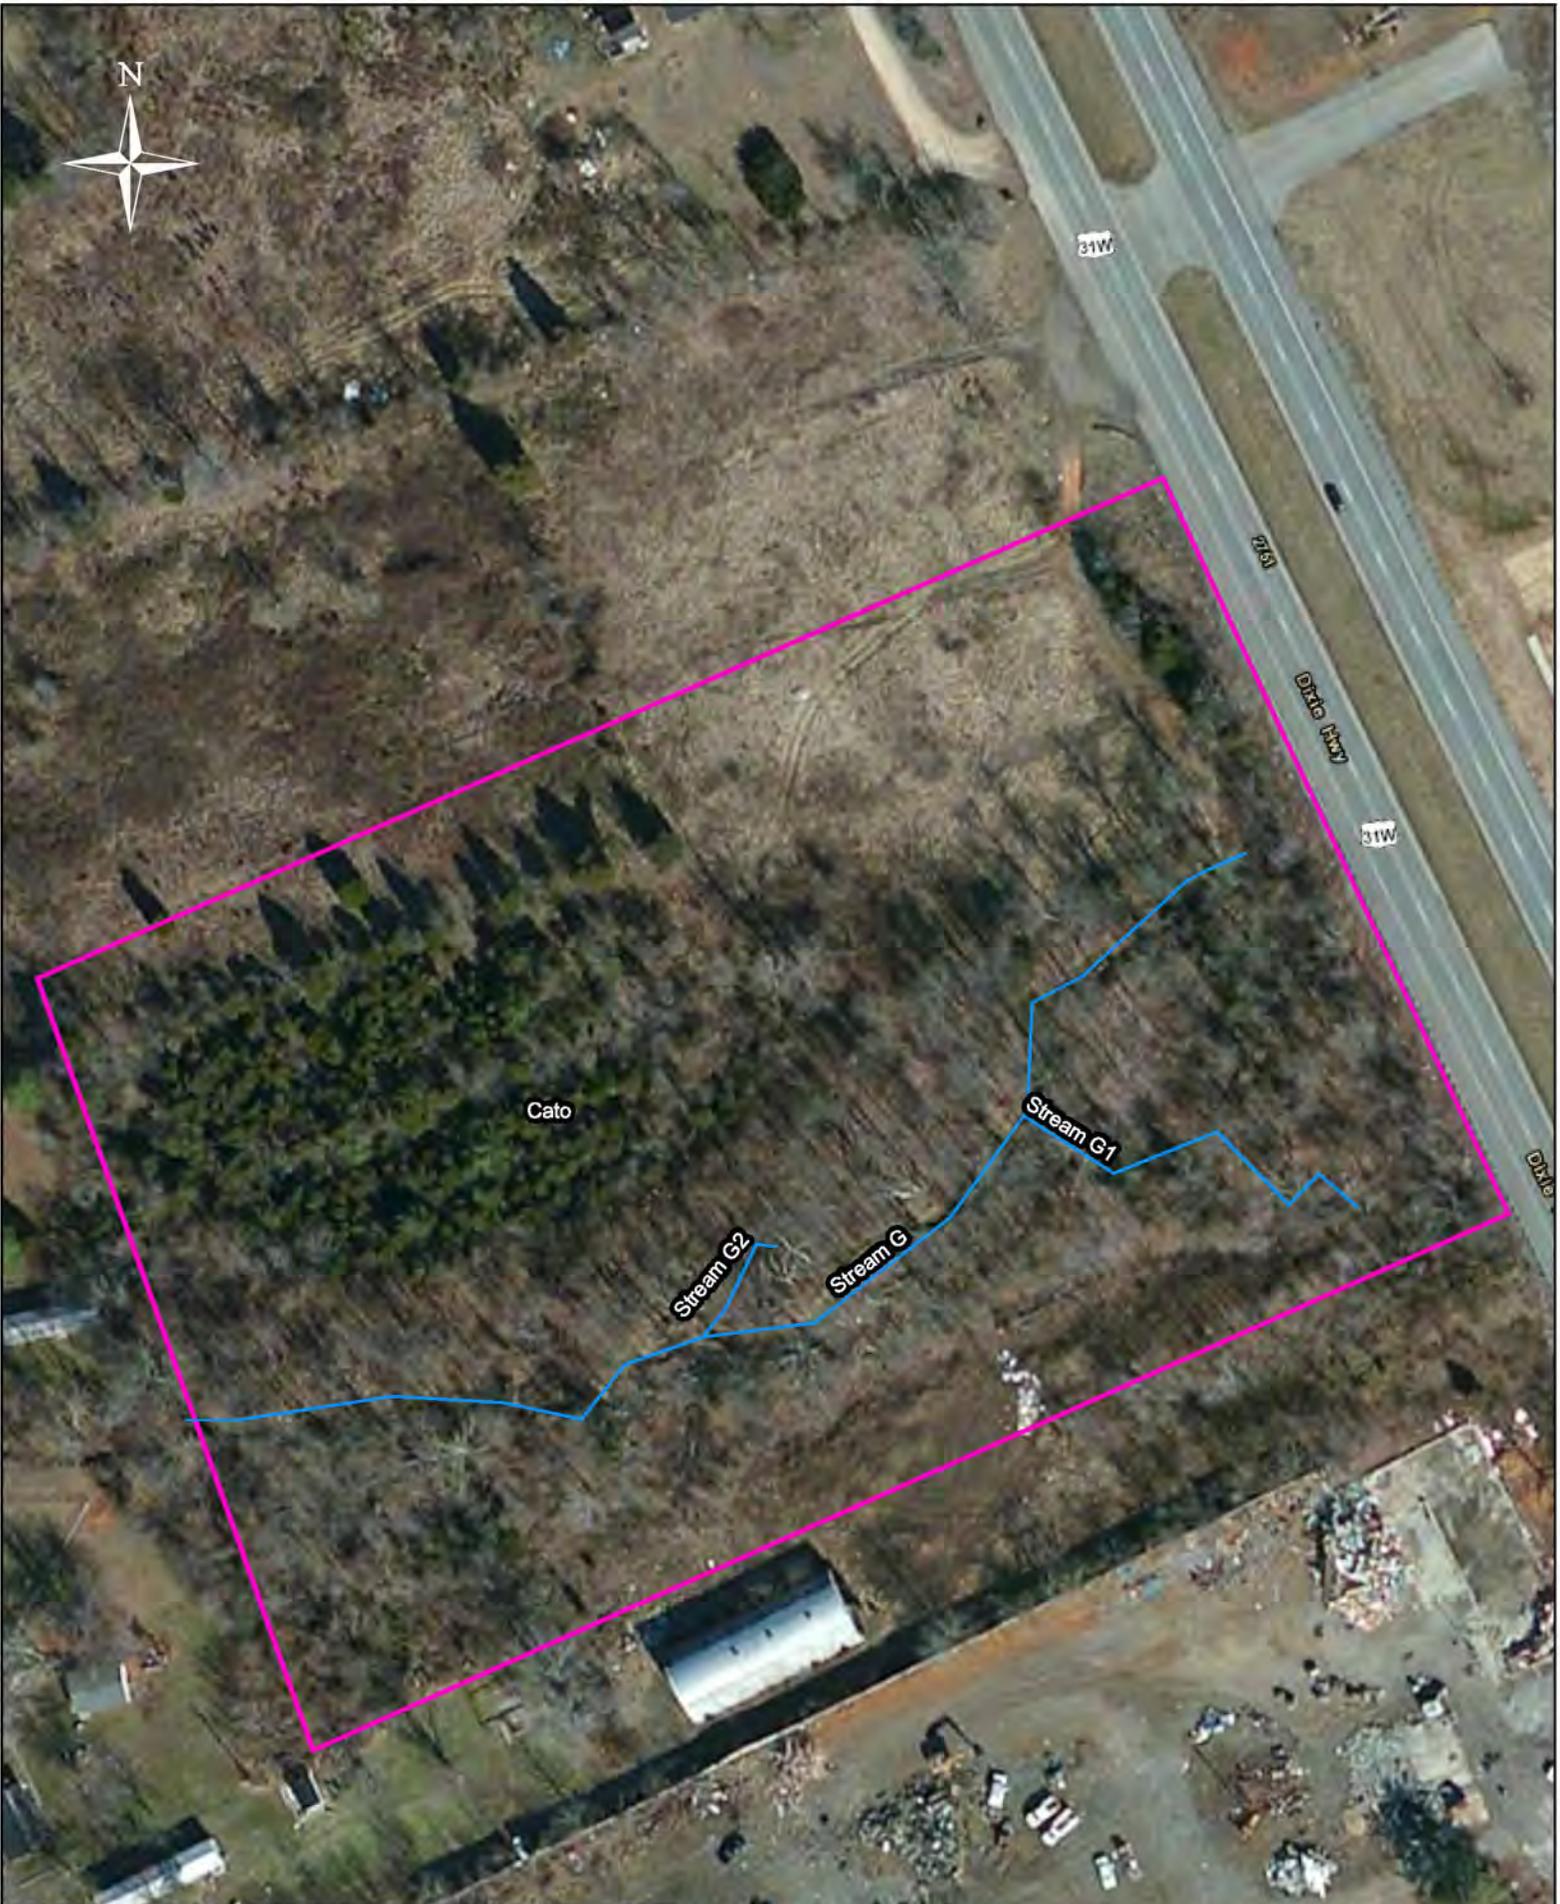
**Quiggins/ Happy Valley
Flood Mitigation Project
Preliminary Jurisdictional Determination
Cato Basin**

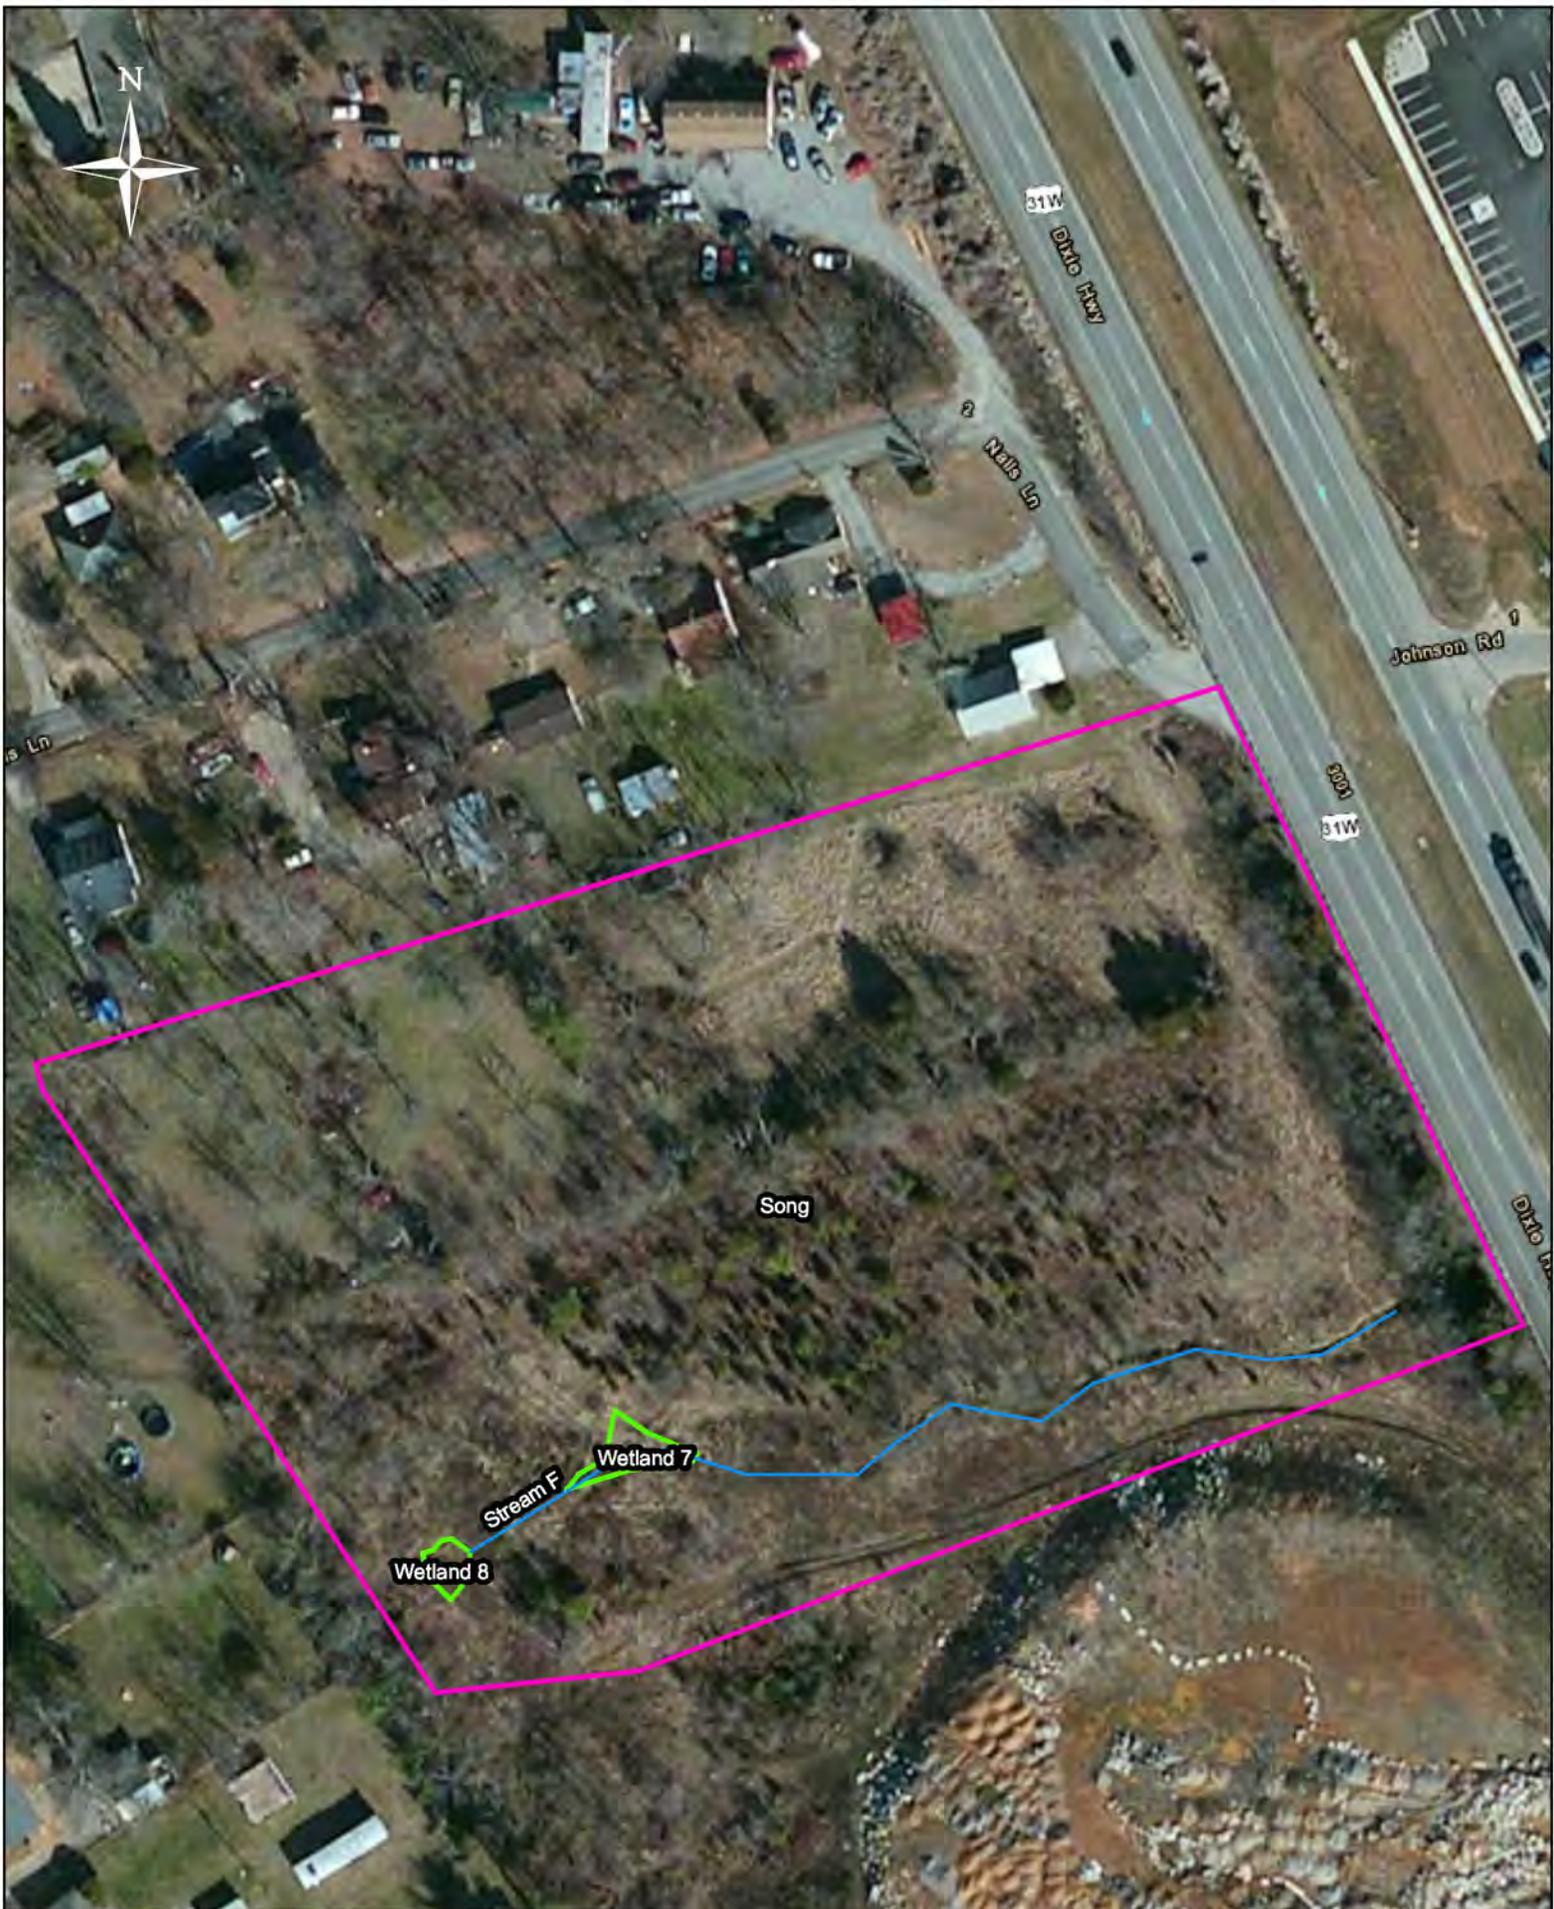
**Quiggins/ Happy Valley
Flood Mitigation Project
Preliminary Jurisdictional Determination
Song Basin**

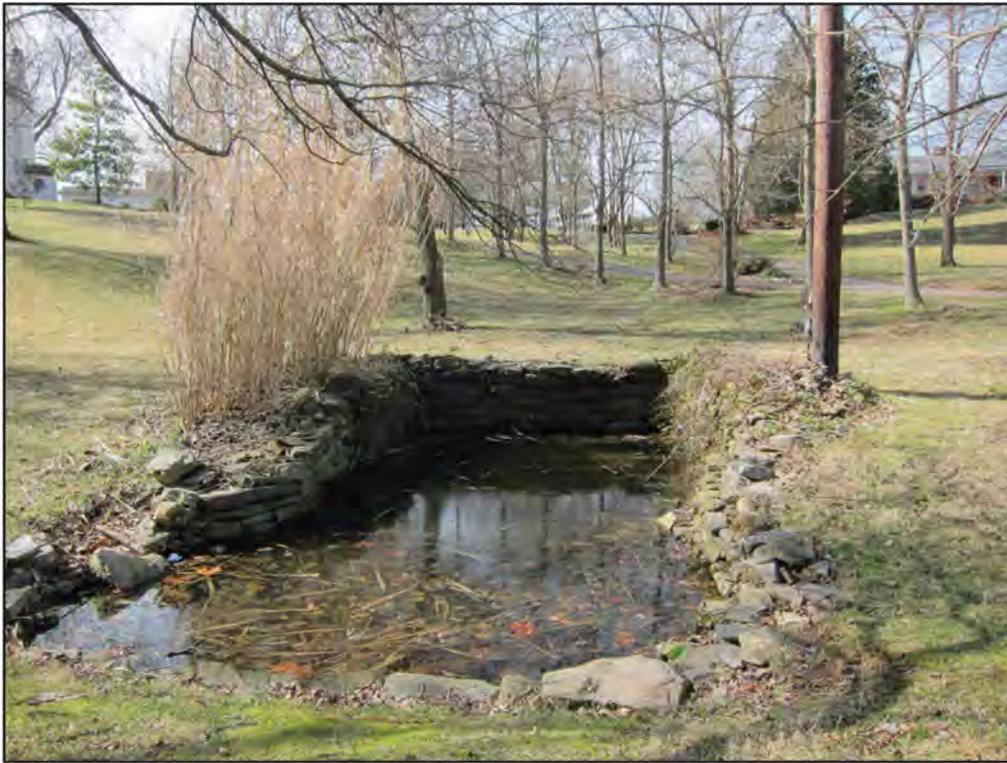
Figure 6-12. HD 15: Springhouse foundation.

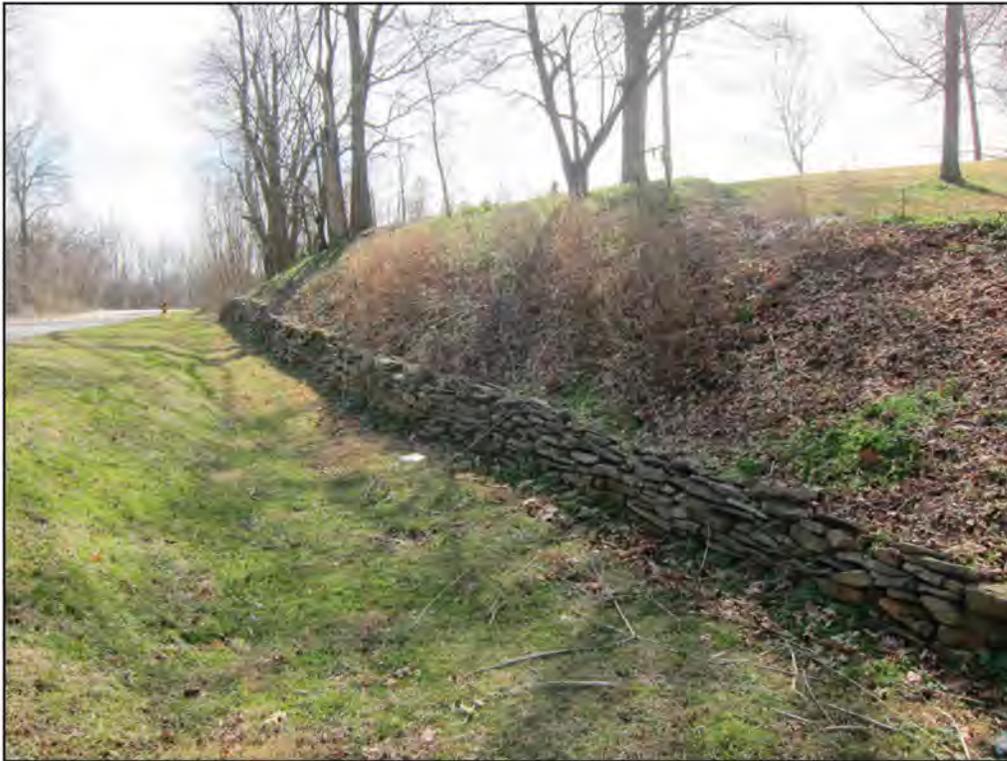
Figure 6-13. HD 15: Dry-laid rock retaining wall.

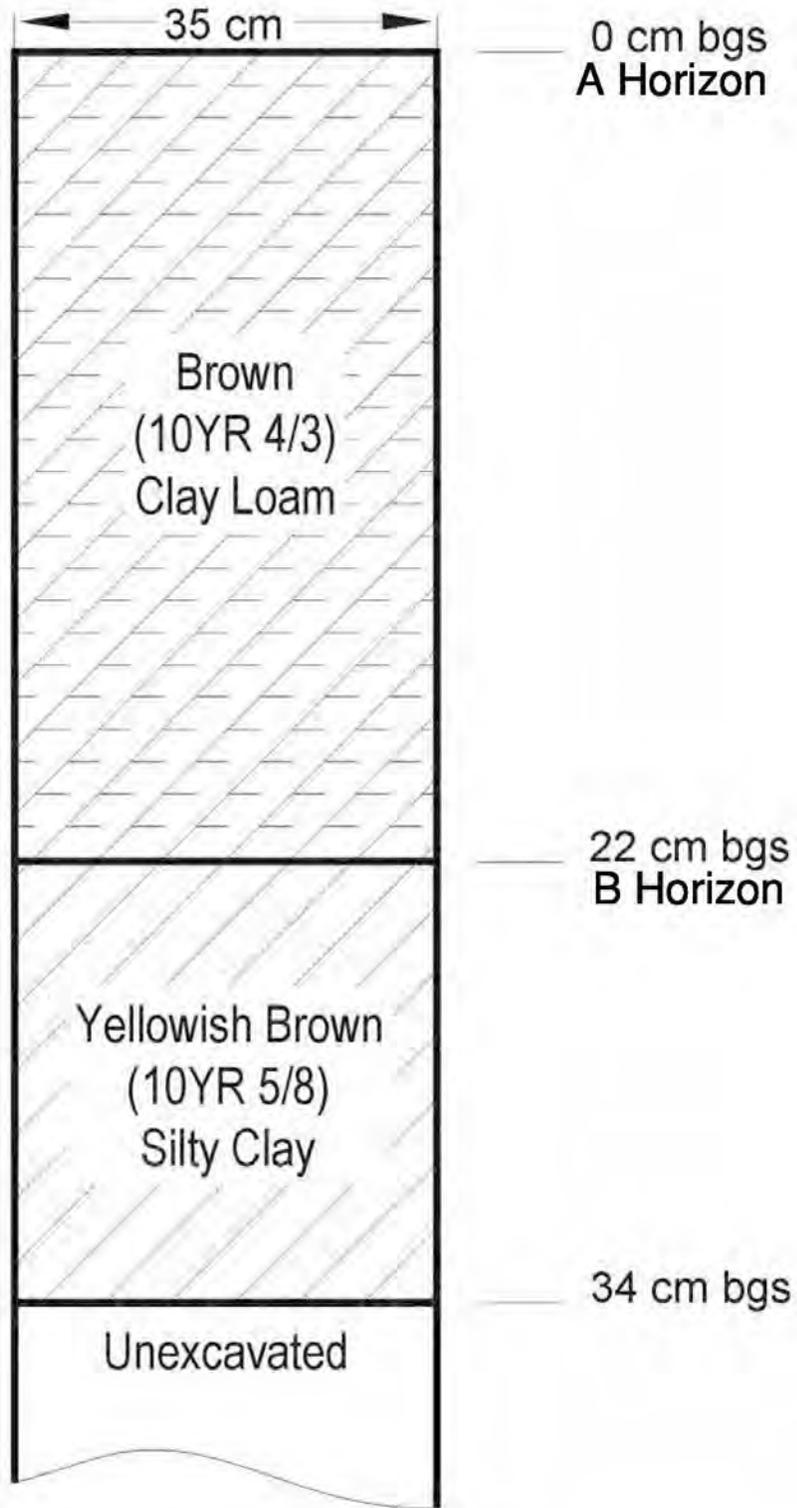
15Hd963 Typical Profile

CLIENT FEMA Region IV						TITLE Representative Soil Profile from Site 15Hd963				
PROJ Happy Valley Flood Mitigation, Hardin Co., KY						12420 Milestone Center Dr. Germantown, MD 20876				
REVISION NO	0	DES BY	BAK	04/17/2013						
SCALE	N/A	DR BY	BAK	04/17/2013	FIGURE	6-4				
<small>\\10.90.4.1\arm\FEMARegion IV - Quiggins Sinkhole Phase I Archaeology\G. Reports & Deliverables\1.2 Draft Deliverables\Figures\Phase I Arch</small>					CHK BY	SS	05/17/2013

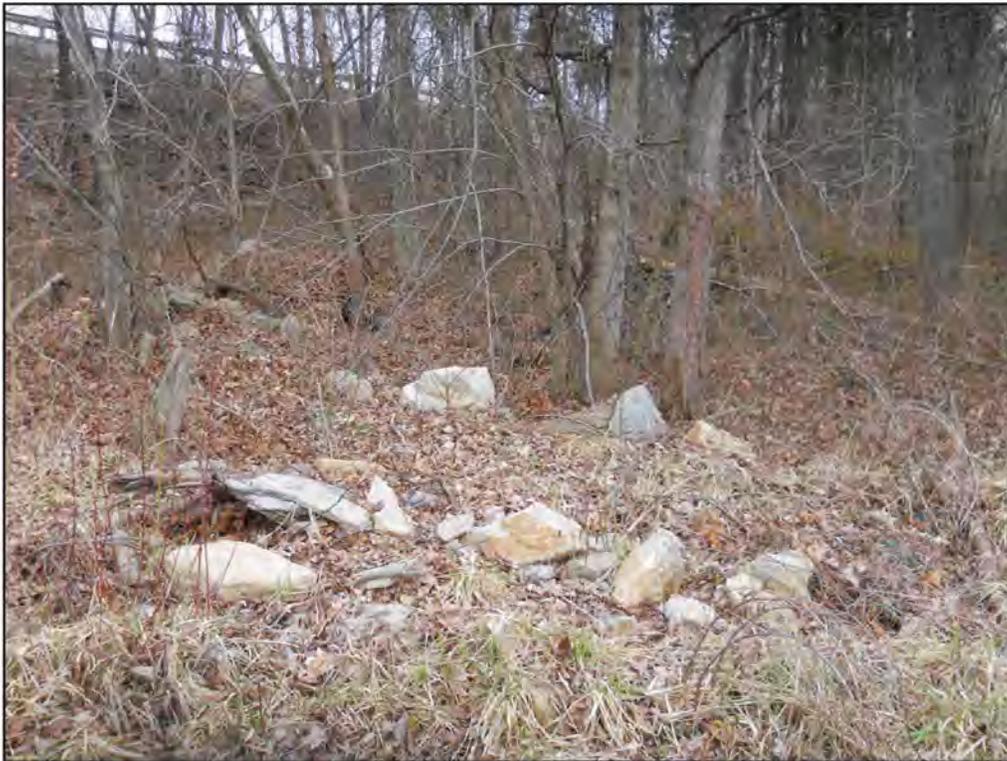
Figure 6-5. Construction Debris in Treeline Immediately South of Site 15Hd963, Facing South.
