**The University of Texas M. D. Anderson Cancer Center
Science Park - Research Division
Virginia Harris Cockrell Cancer Research Center
Smithville, Texas**

Figure 3-1 Proposed Fire Management Units Map

Appendix B

Photo Log

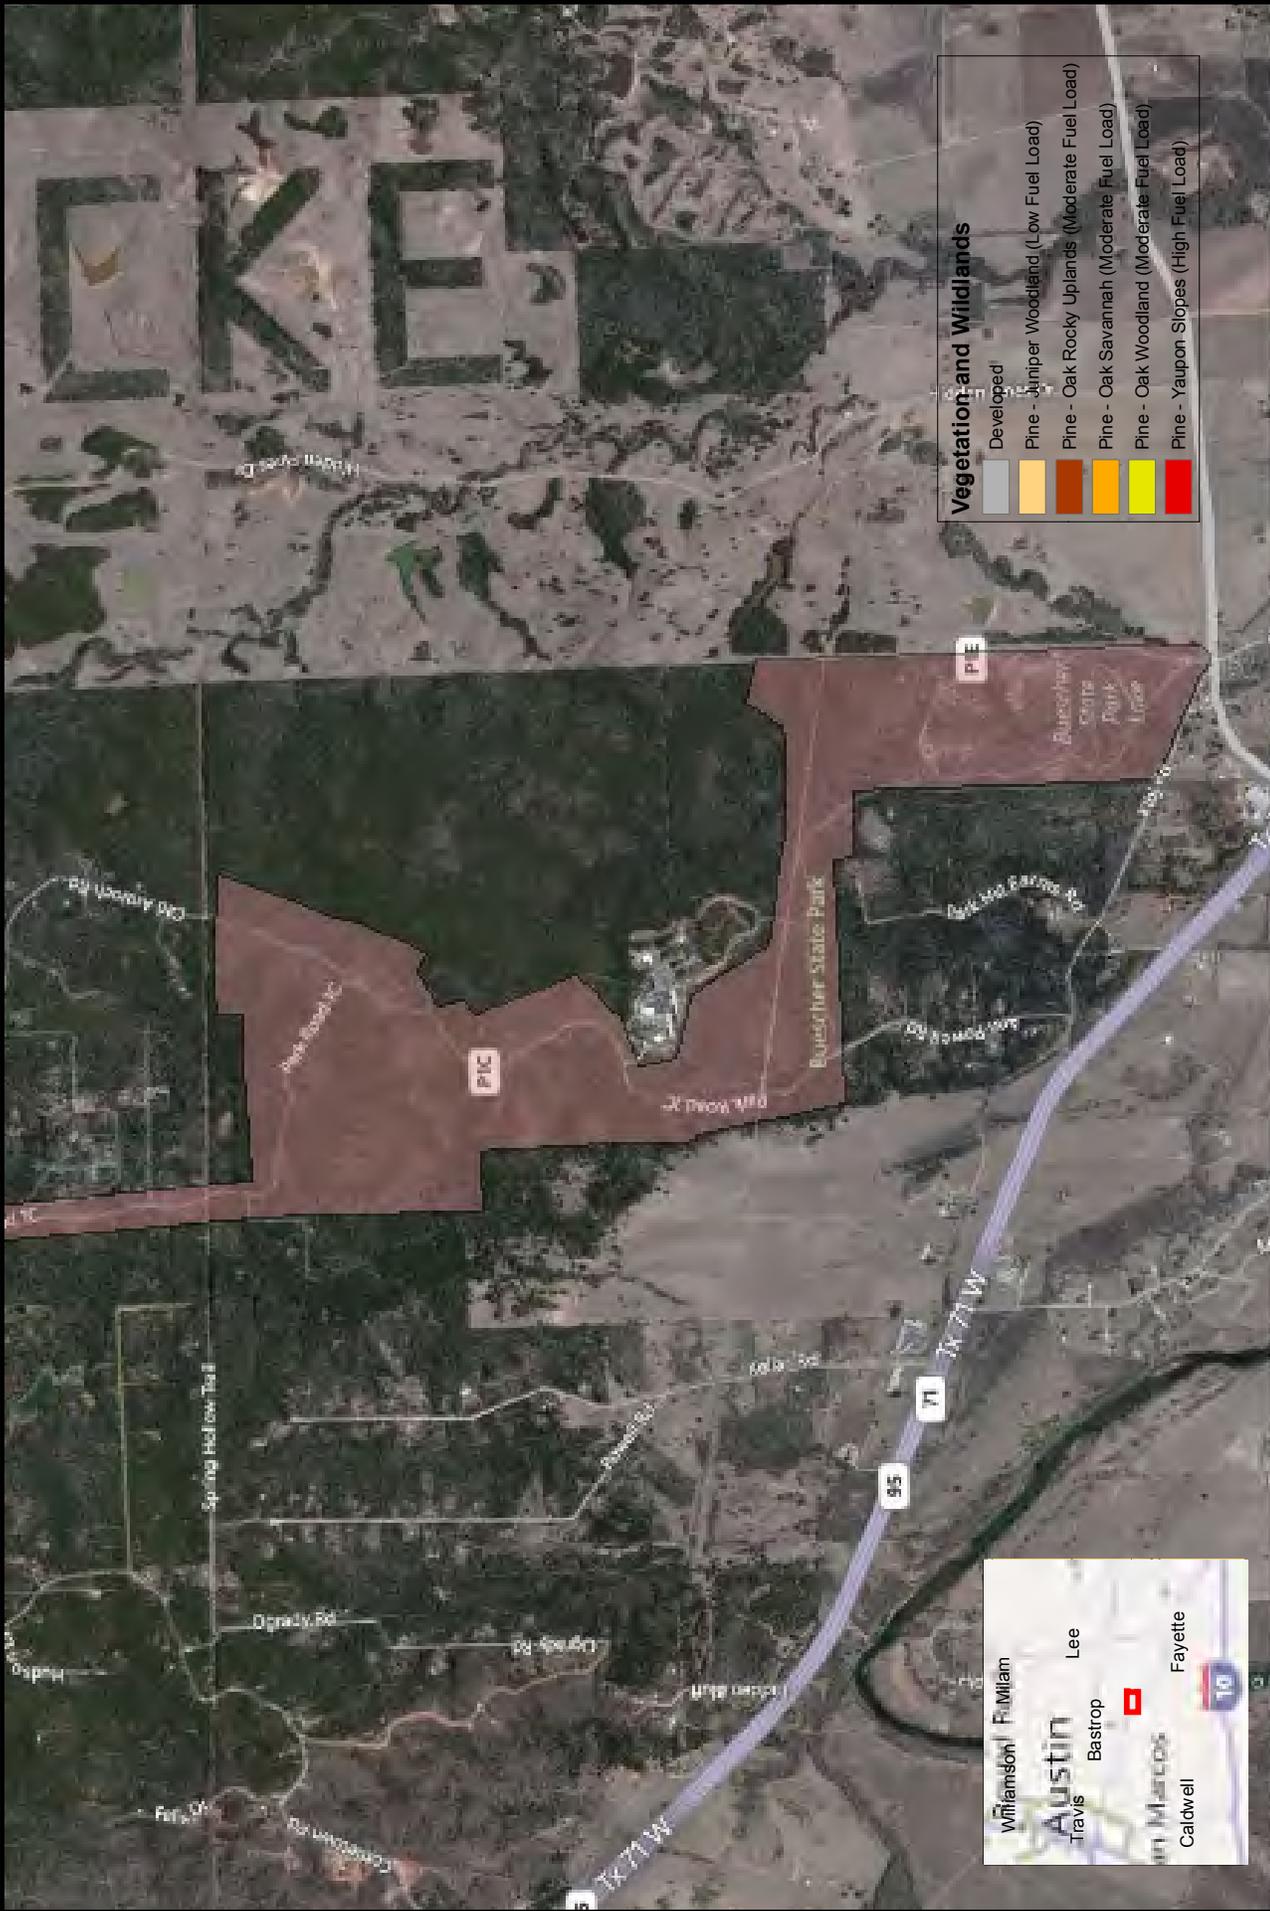
Drawn By: AM Date: 01-26-12 Project No.: 25014429 Figure: -1

Vegetation and Wildlands

- Developed
- Pine - Juniper Woodland (Low Fuel Load)
- Pine - Oak Rocky Uplands (Moderate Fuel Load)
- Pine - Oak Savannah (Moderate Fuel Load)
- Pine - Oak Woodland (Moderate Fuel Load)
- Pine - Yaupon Slopes (High Fuel Load)

Vegetation and Wildland Fuels Map

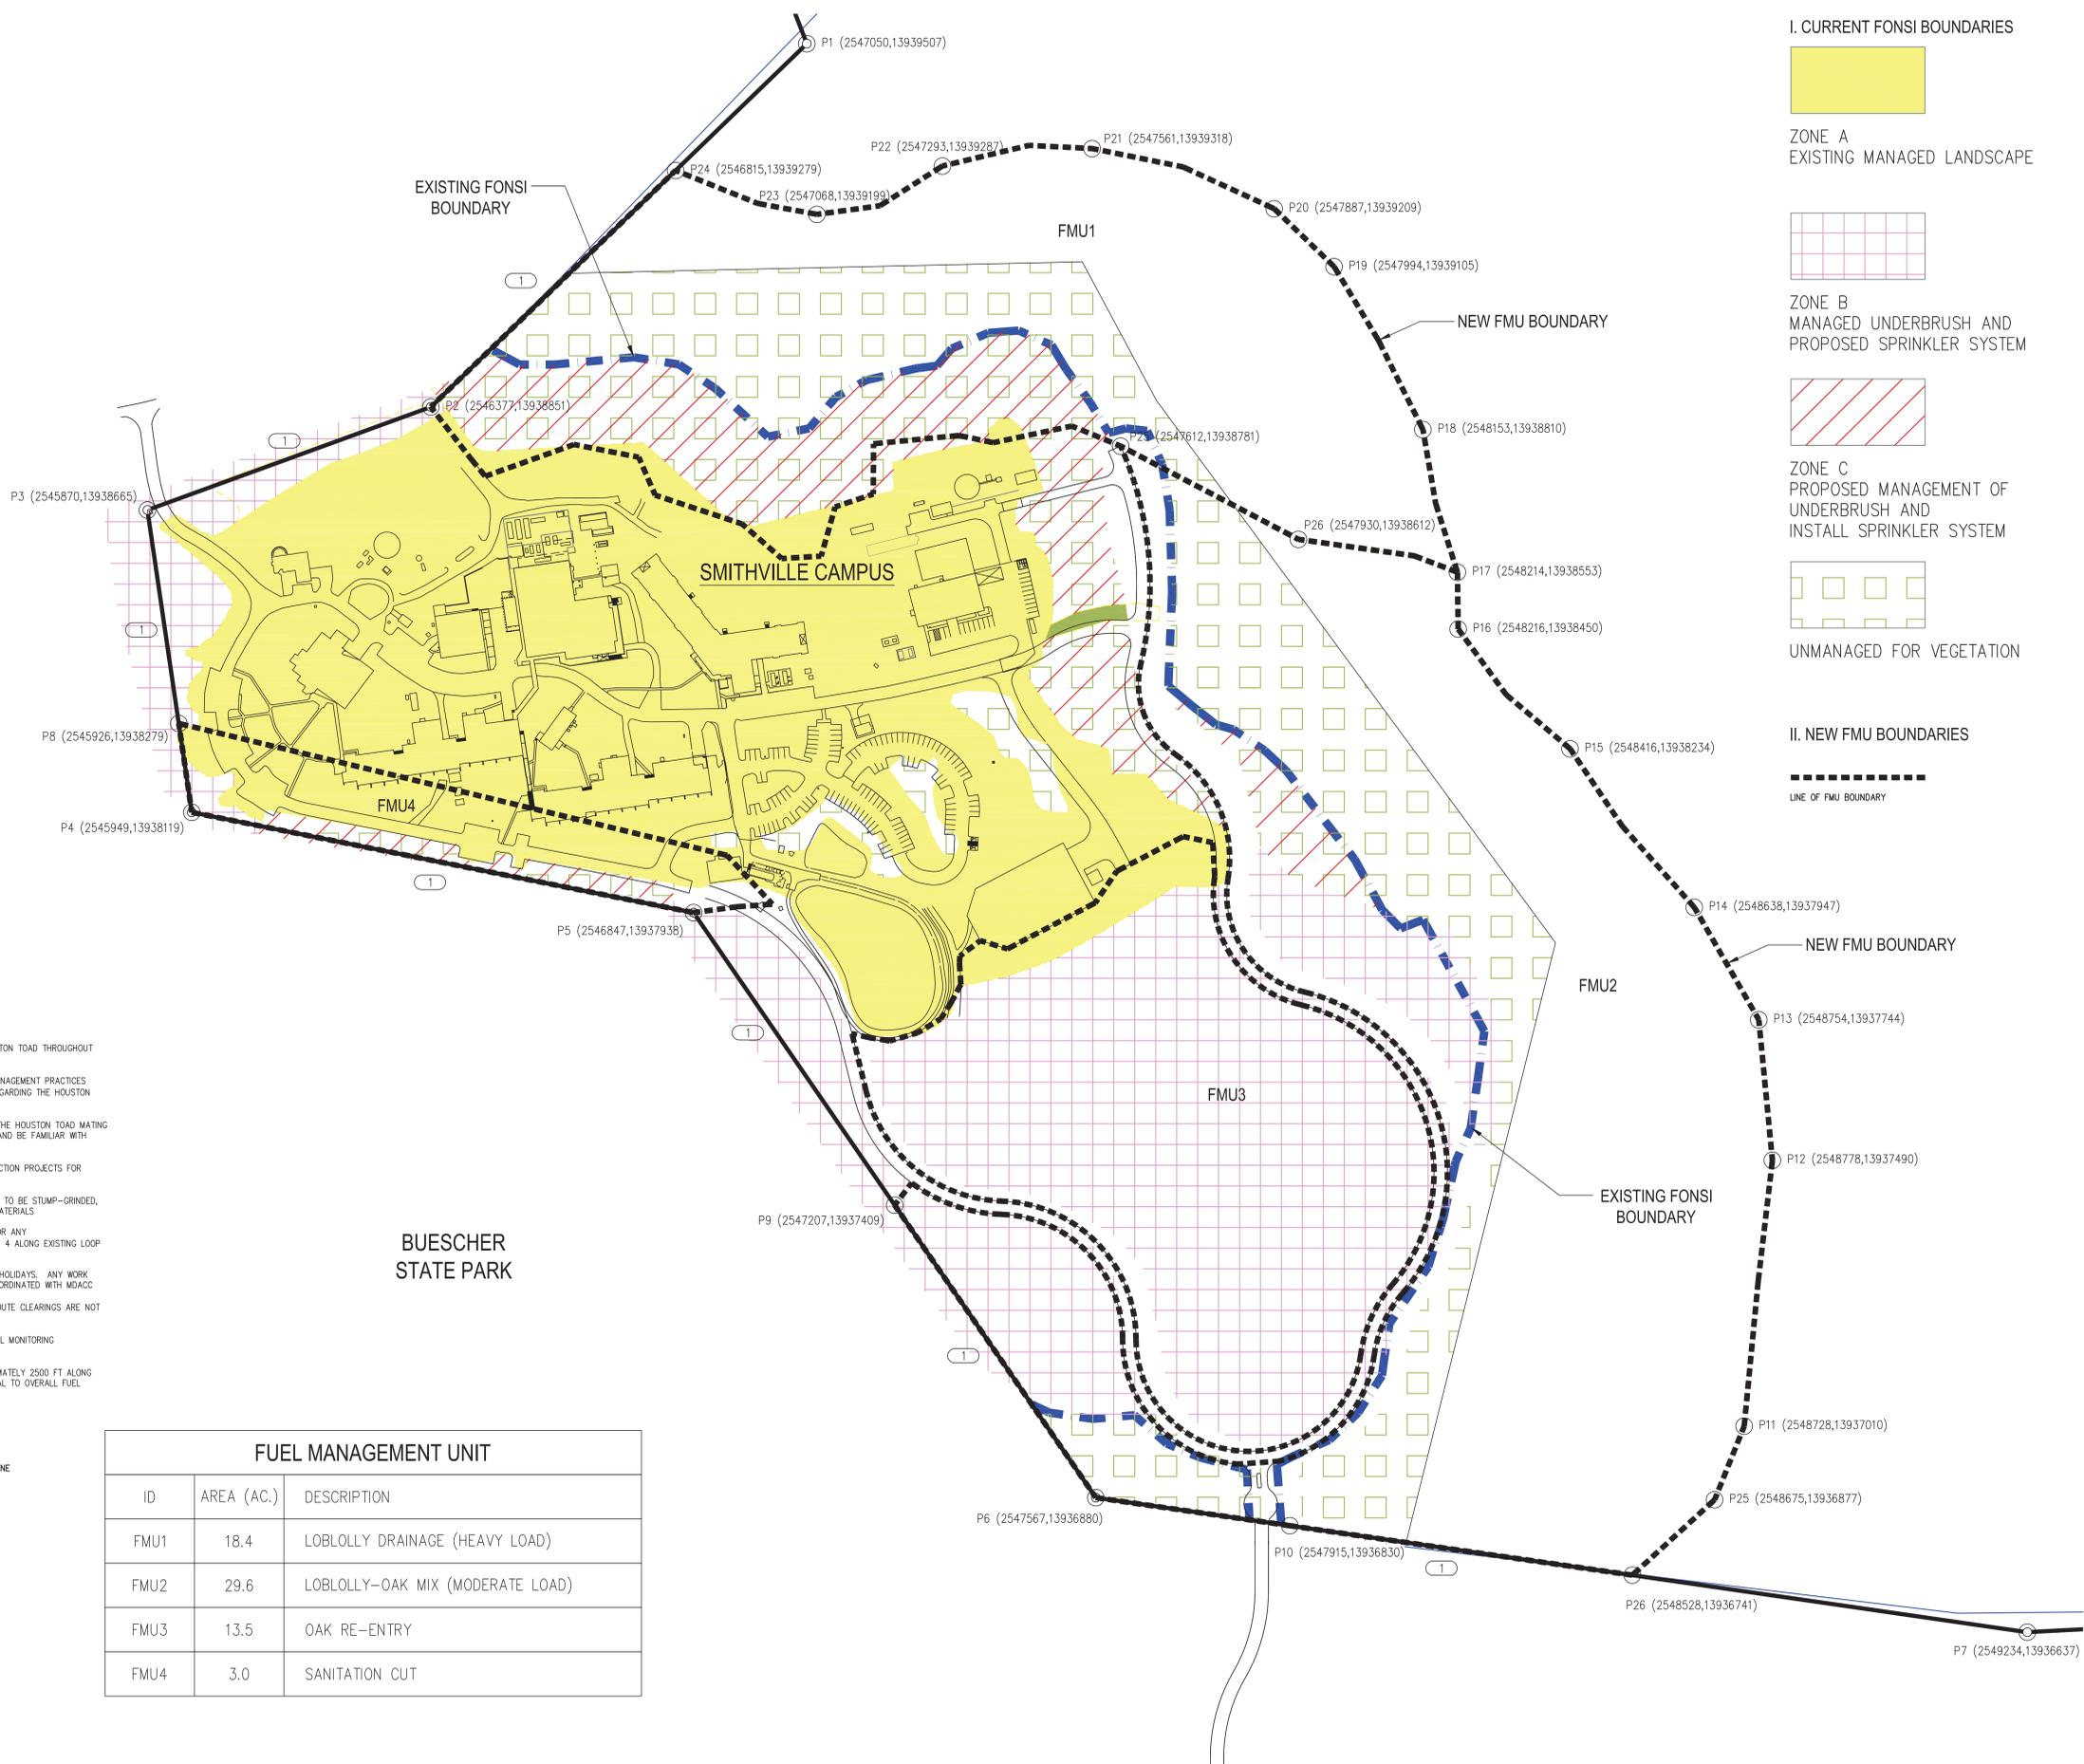
- I. CURRENT FONSI BOUNDARIES**
- ZONE A
EXISTING MANAGED LANDSCAPE
 - ZONE B
MANAGED UNDERBRUSH AND PROPOSED SPRINKLER SYSTEM
 - ZONE C
PROPOSED MANAGEMENT OF UNDERBRUSH AND INSTALL SPRINKLER SYSTEM
 - UNMANAGED FOR VEGETATION
- II. NEW FMU BOUNDARIES**
- LINE OF FMU BOUNDARY

FUEL MANAGEMENT UNIT		
ID	AREA (AC.)	DESCRIPTION
FMU1	18.4	LOBLOLLY DRAINAGE (HEAVY LOAD)
FMU2	29.6	LOBLOLLY-OAK MIX (MODERATE LOAD)
FMU3	13.5	OAK RE-ENTRY
FMU4	3.0	SANITATION CUT

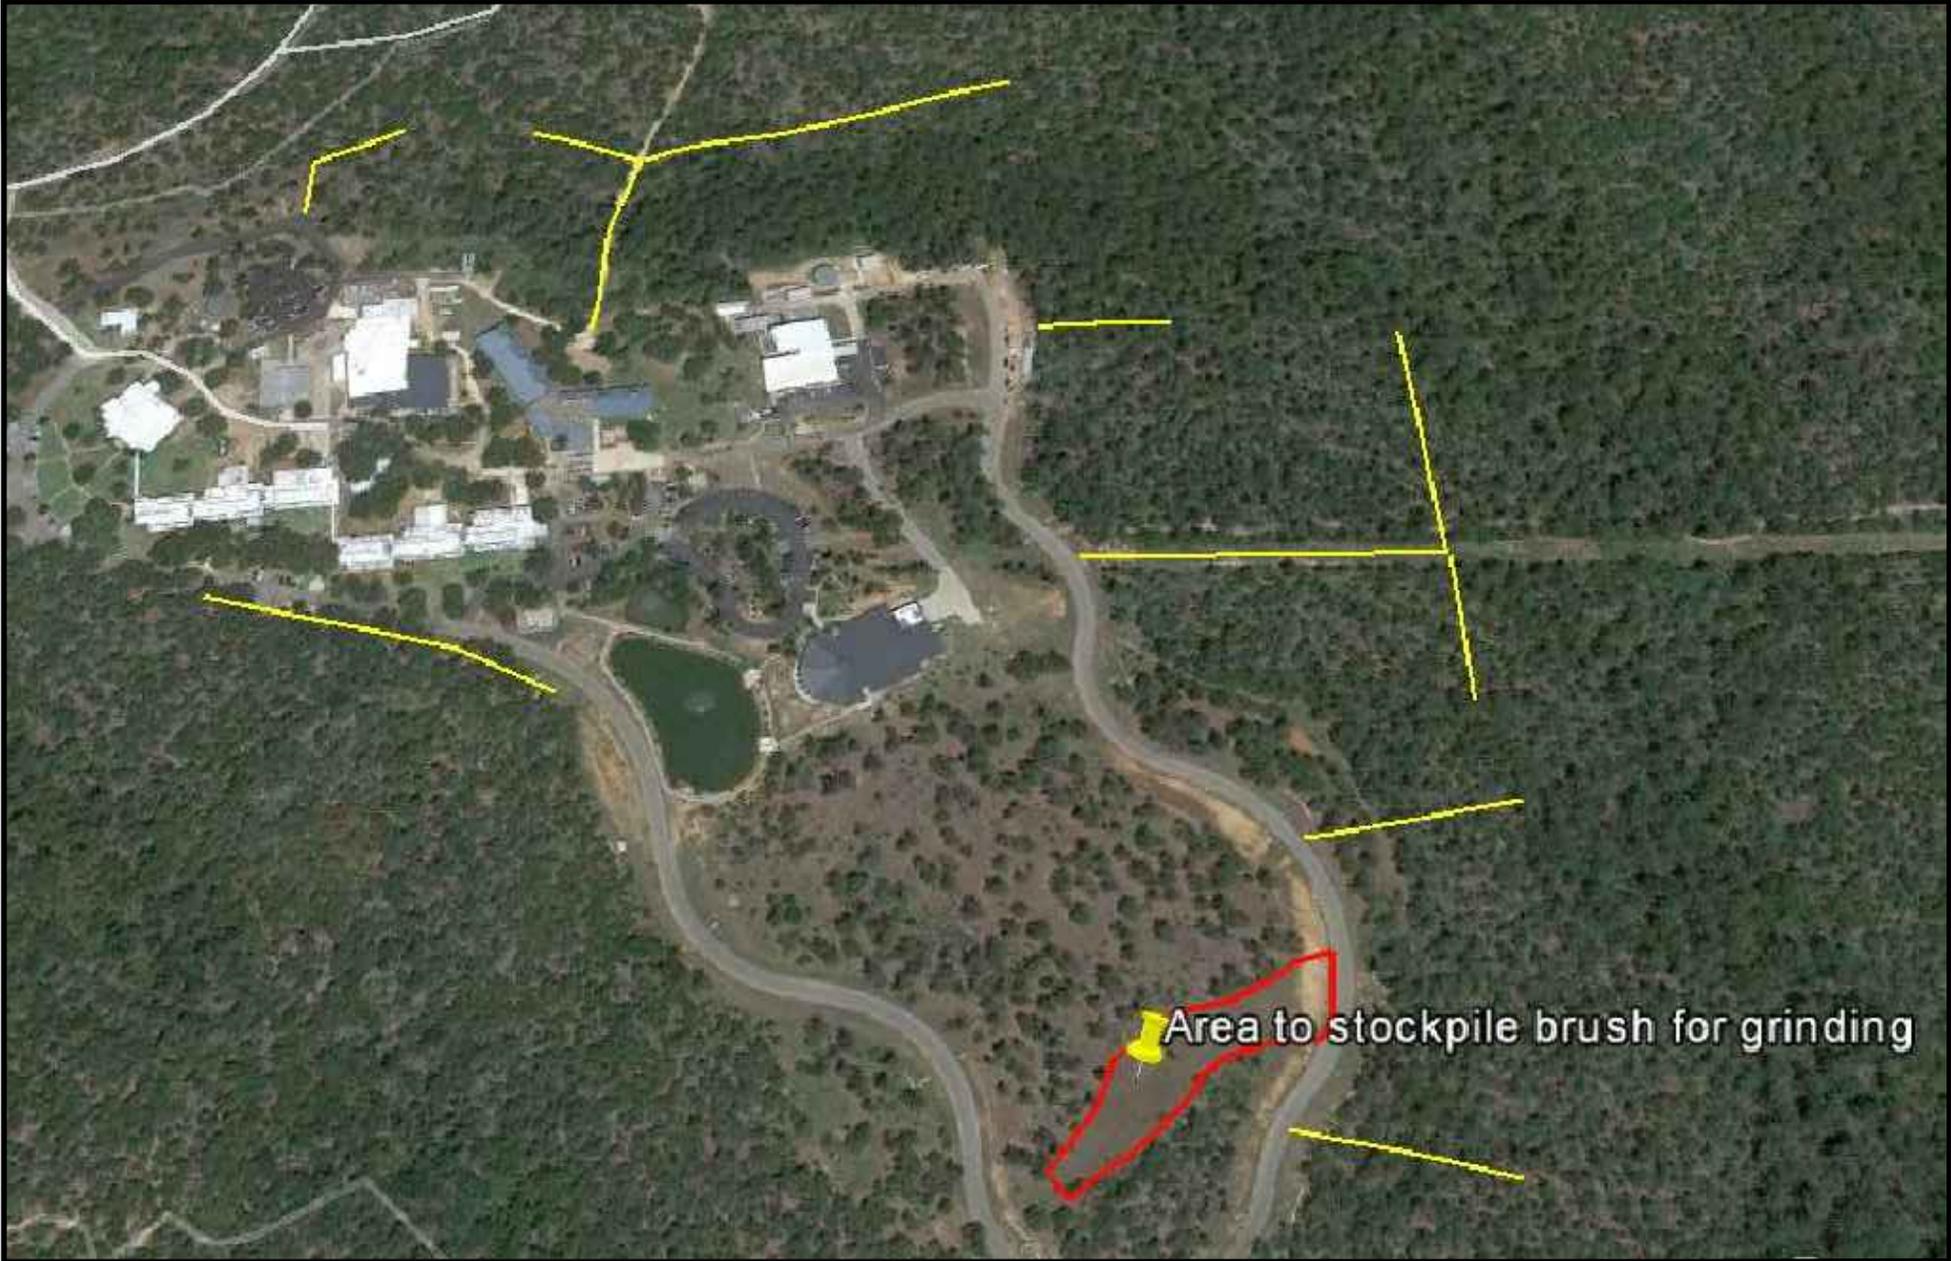
Drawn By:	Date:	Project No.:	Figure:
NAB	5/19/2015	25015345	3-3

Area to stockpile brush for grinding

- Brush Stocking Area
- Load Up / Haul Route

Map of MDACC Haul Routes and Temporary Staging/Grinding Site

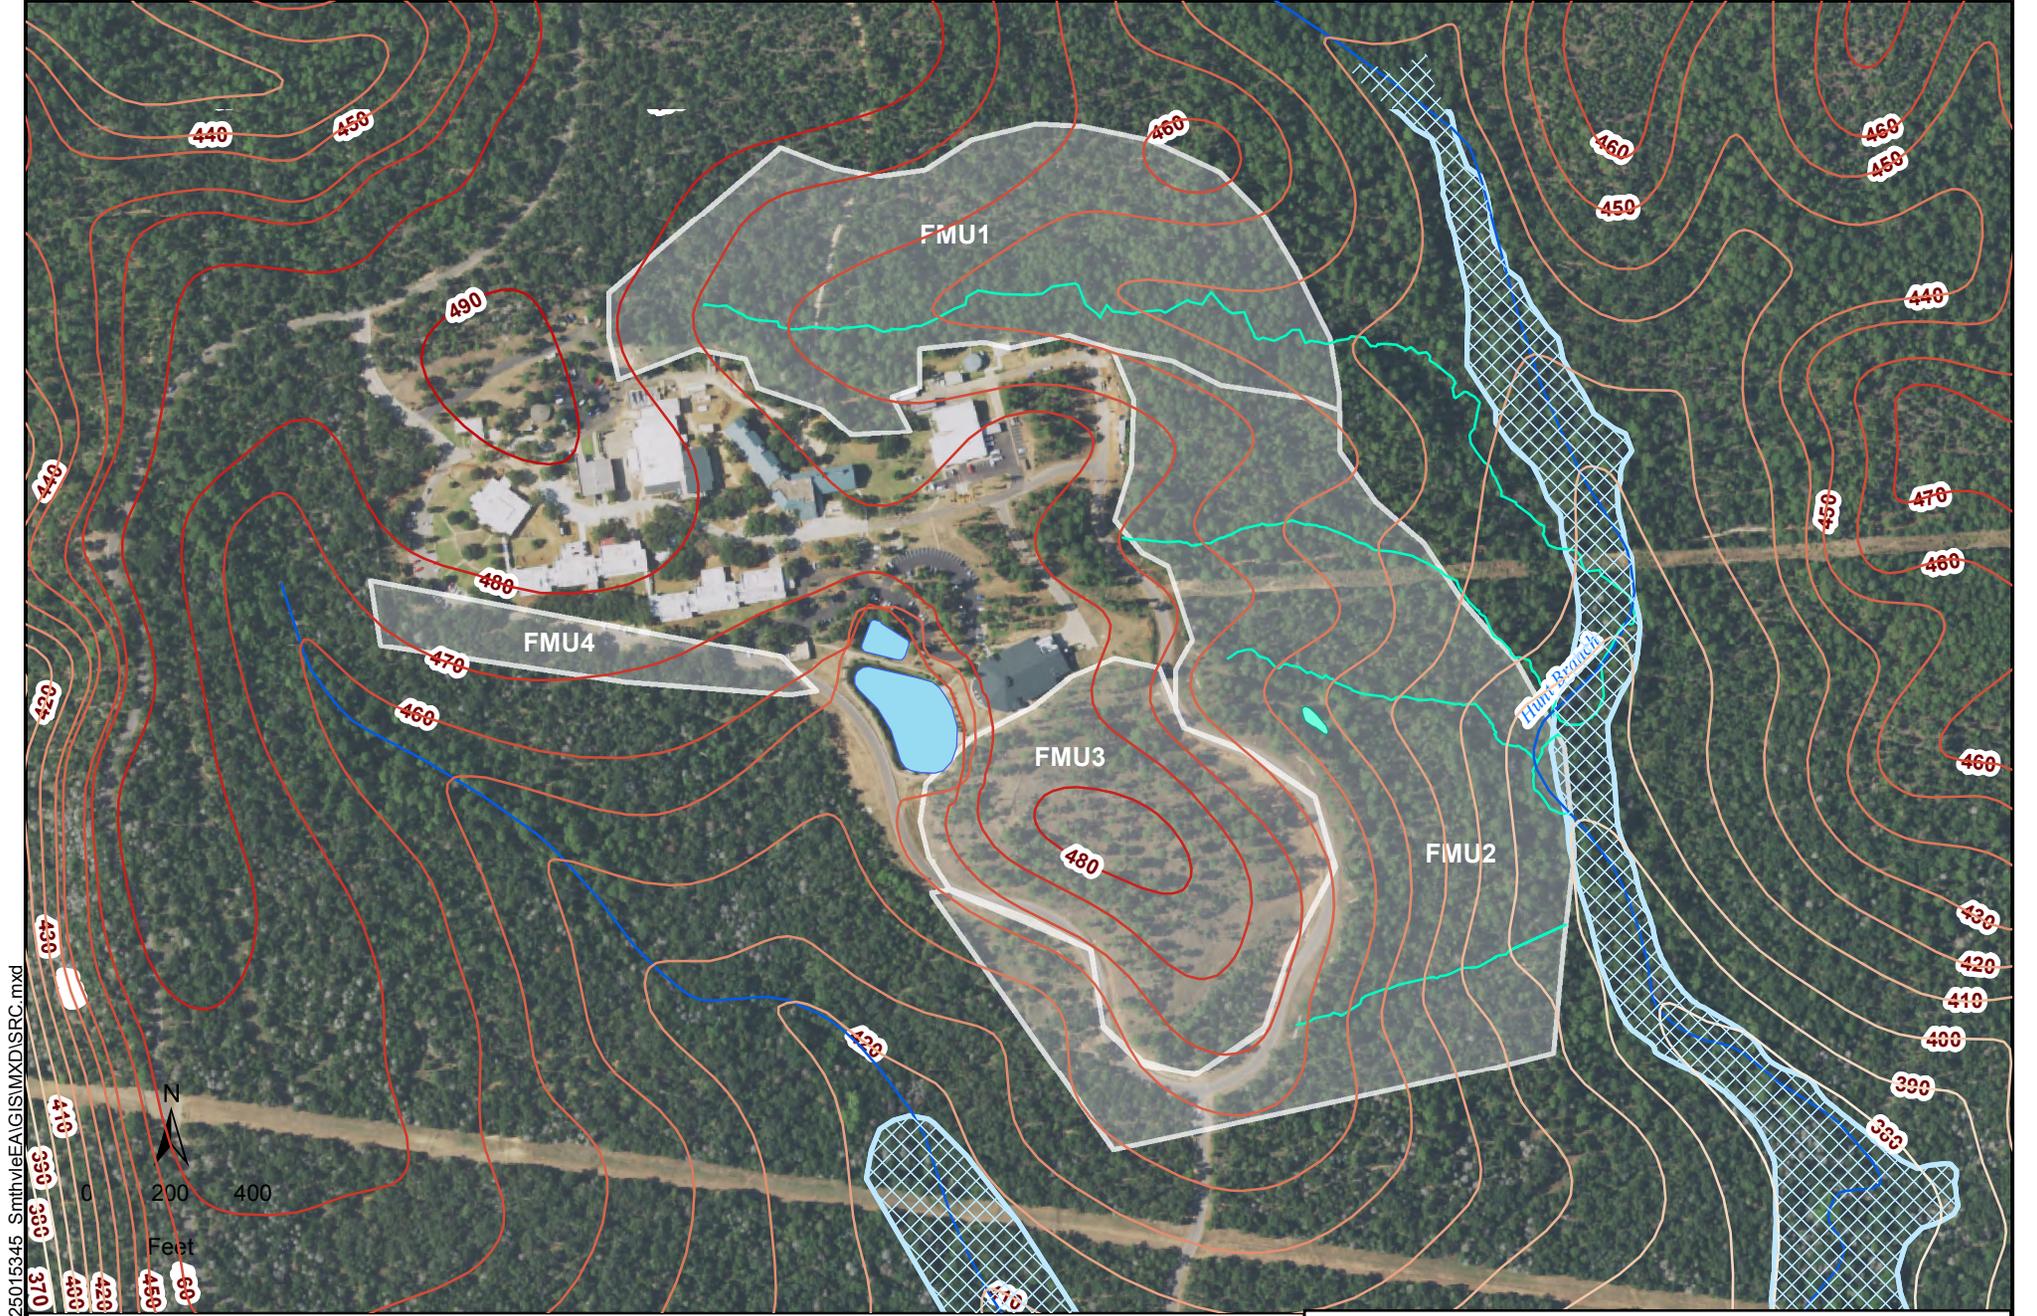
Drawn By: CW	Date: 3/4/2015	Project No.: 25014429	Figure 4_1
-----------------	-------------------	--------------------------	------------

Delineated Features
 Pond
 Drainages
Fire Management Units

Topography Map

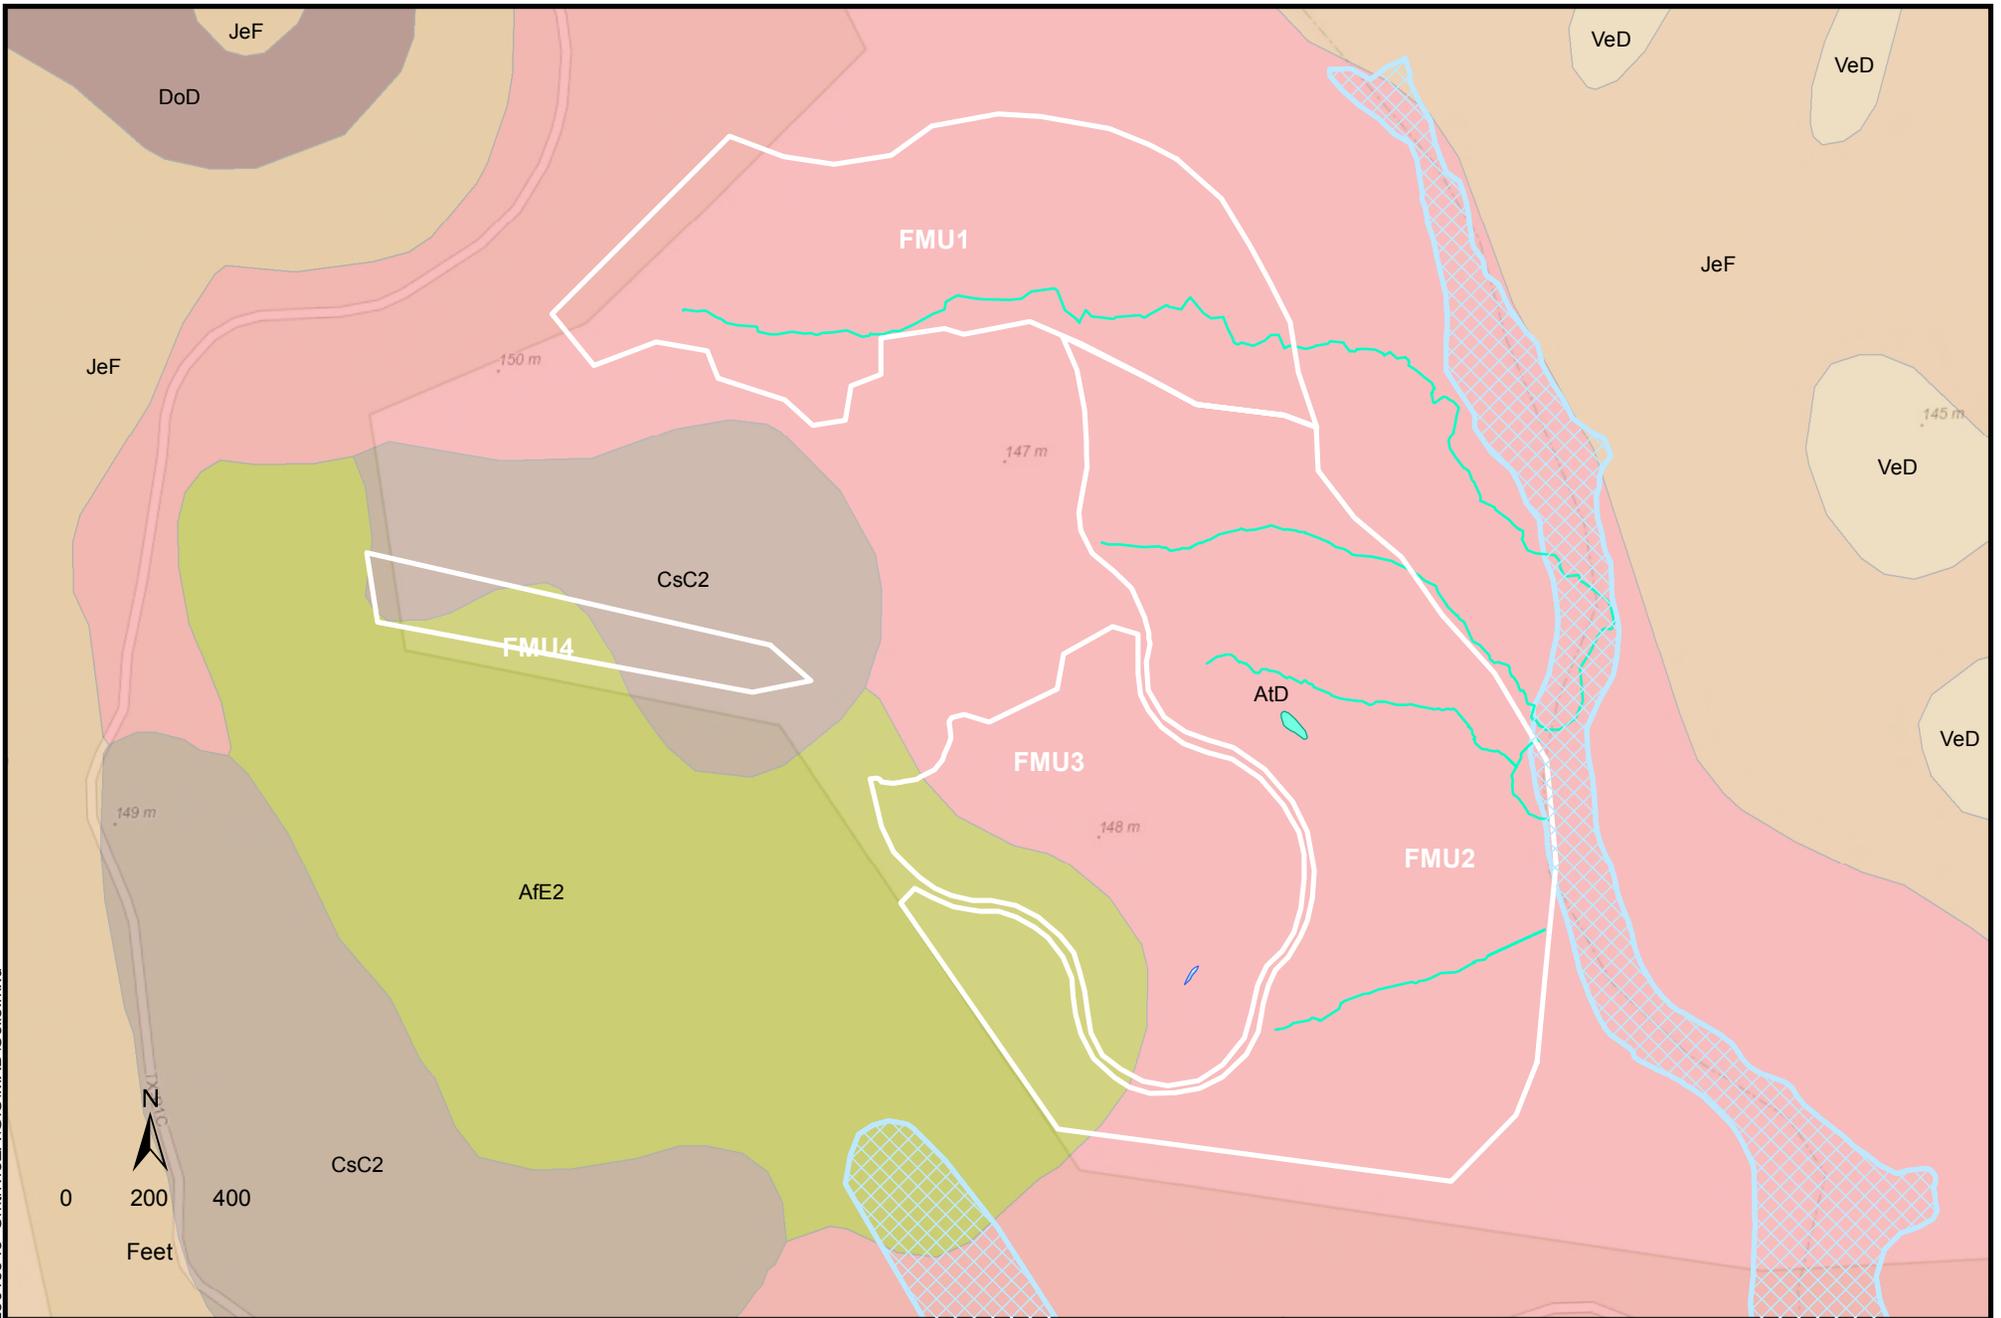
Drawn By: CW	Date: 4/6/2015	Project No.: 25014429	Figure 4_3
-----------------	-------------------	--------------------------	------------

- Afe2 - Edge fine sandy loam, 5 to 12 percent slopes, eroded
- AtD - Edge gravelly fine sandy loam, 3 to 8 percent slopes
- CsC2 - Crockett fine sandy loam, 2 to 5 percent slopes, eroded
- JeF - Jedd gravelly fine sandy loam, 5 to 20 percent slopes

Soils & Floodplain Map

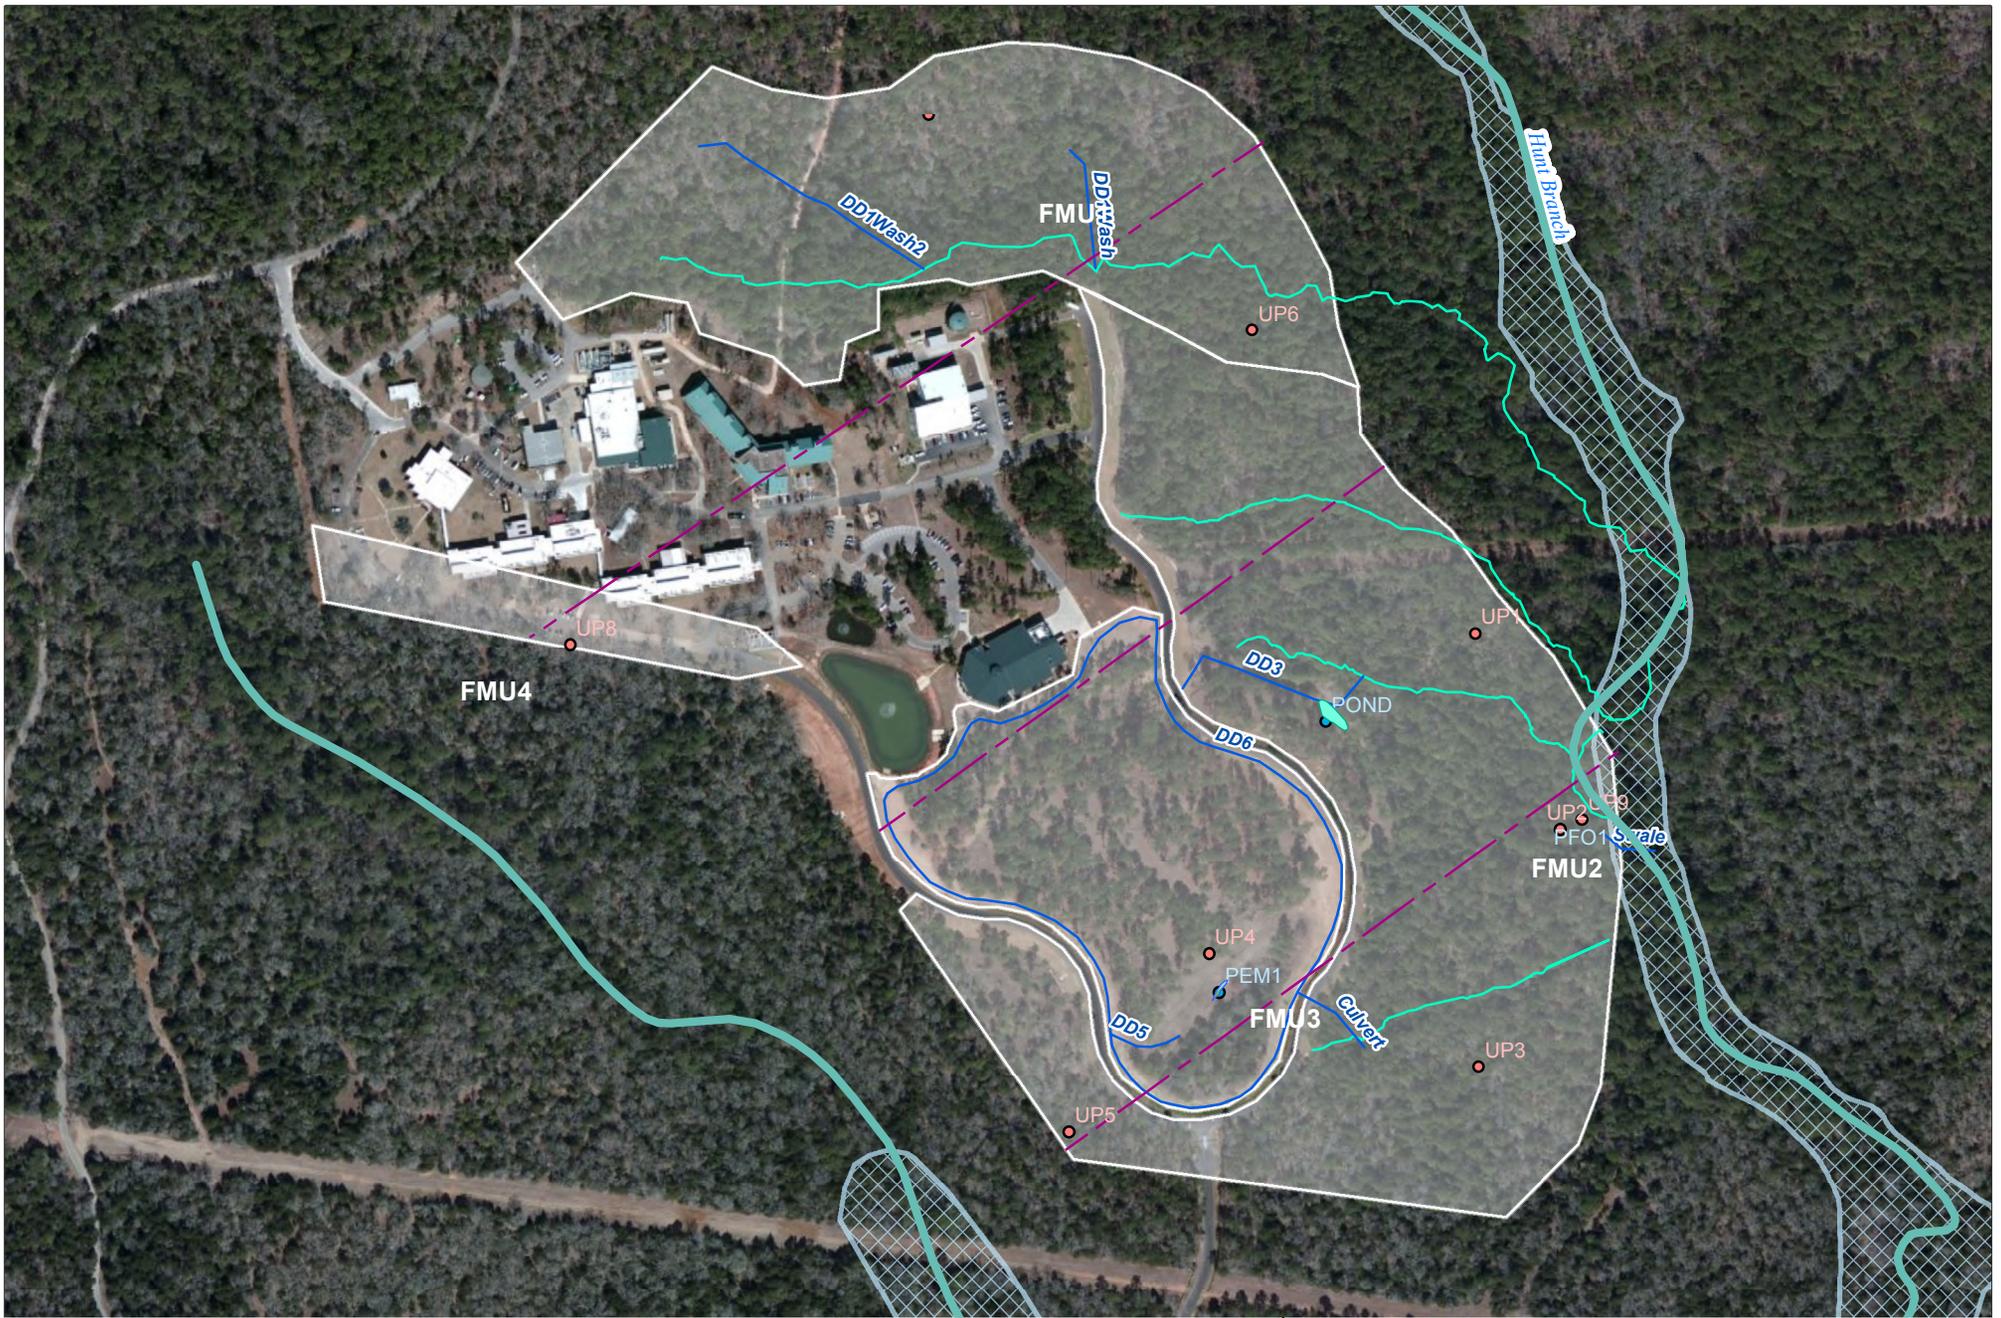
Drawn By:	Date:	Project No.:	
CW	4/6/2015	25014429	Figure 4-4

- Upland Soil Pit
- Wetland Soil Pit
- Transects
- Updated Drainages
- Drainages
- Stream/River
- Wetlands

Wetlands Map

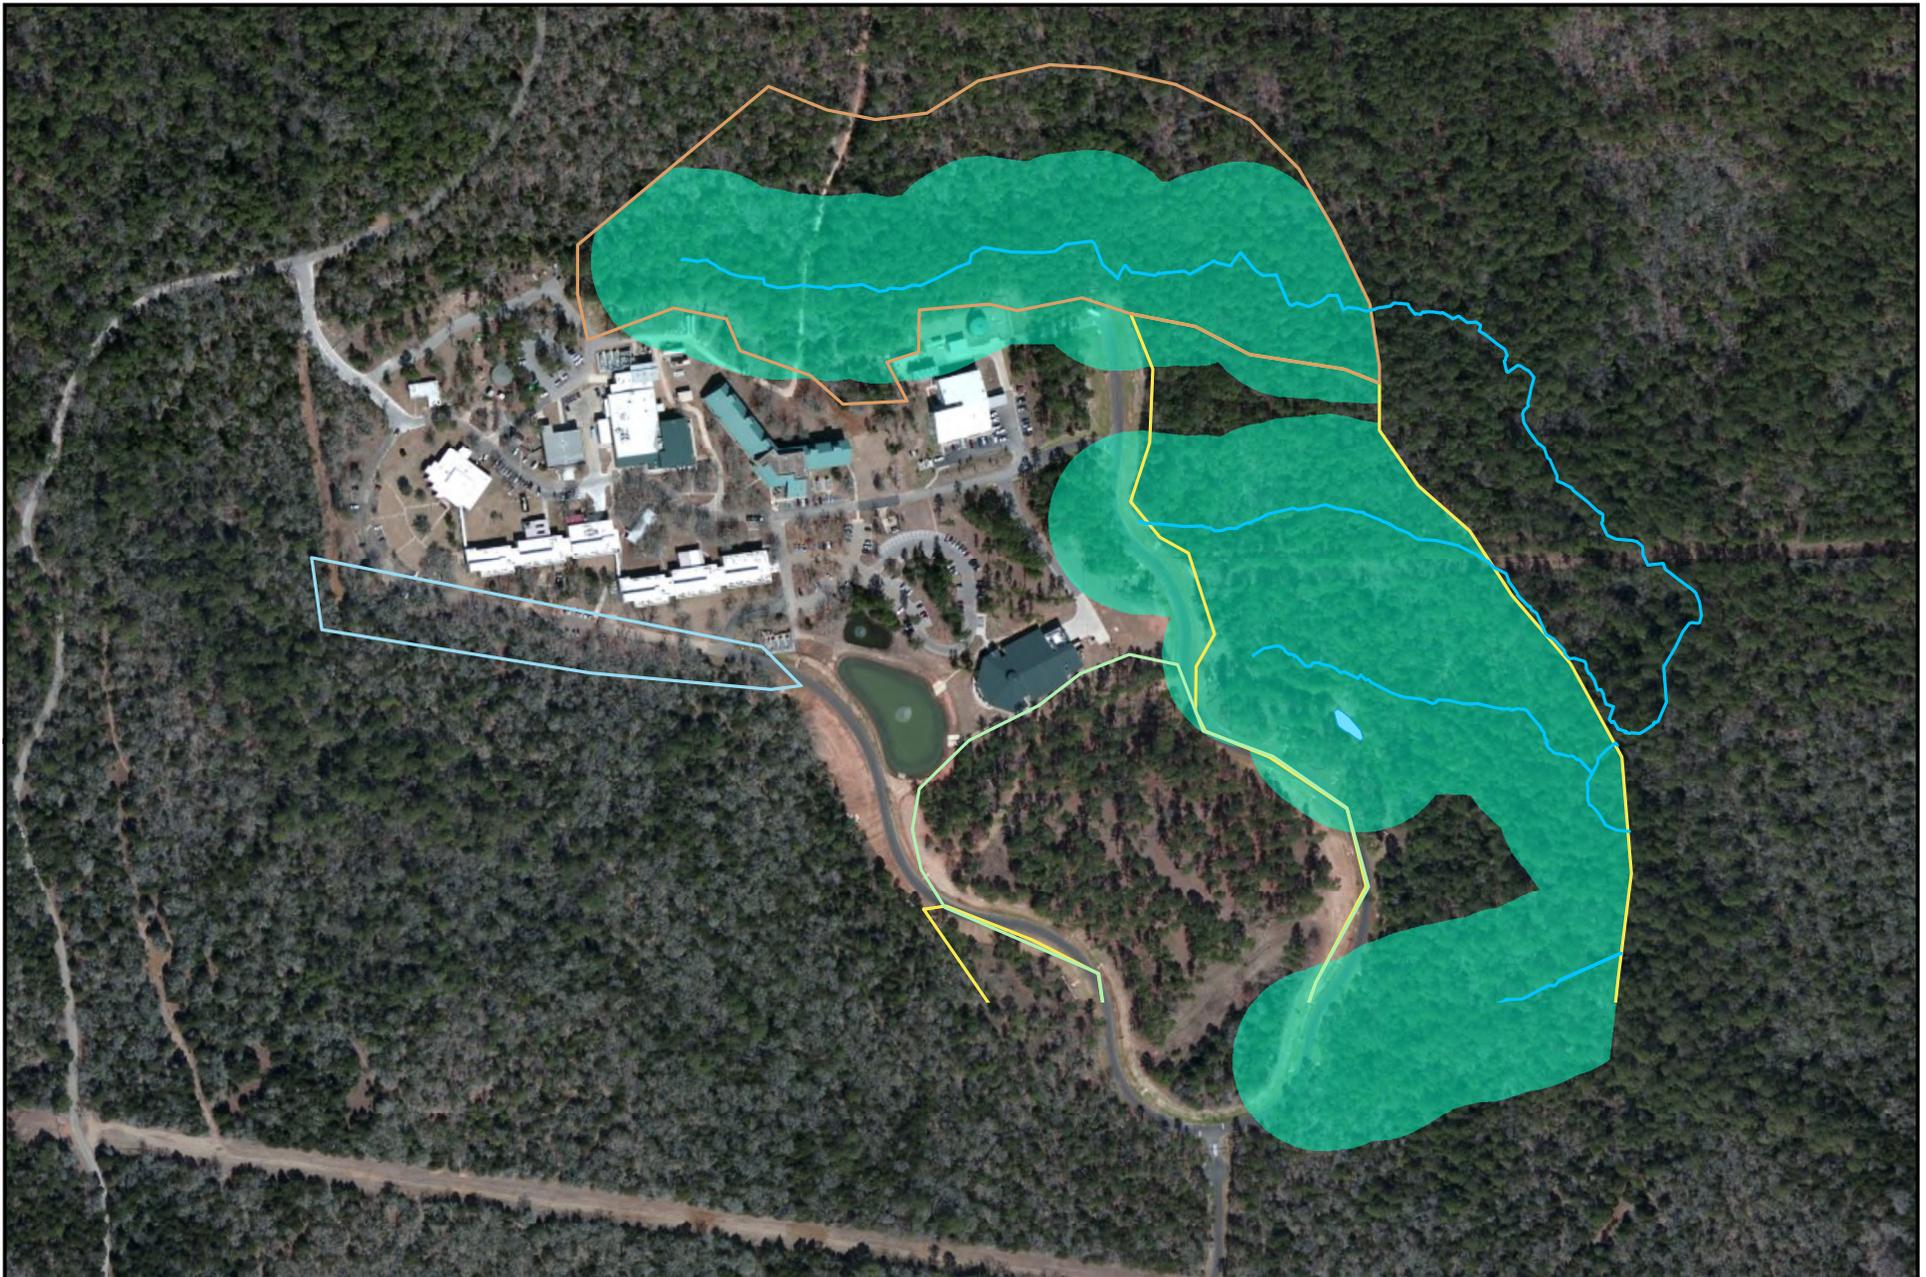
Drawn By: CW	Date: 2/10/2015	Project No.: 25014429	Figure 4-5
-----------------	--------------------	--------------------------	------------

200ft Habitat Buffer

Potential Houston Toad Habitat and Buffer Zone

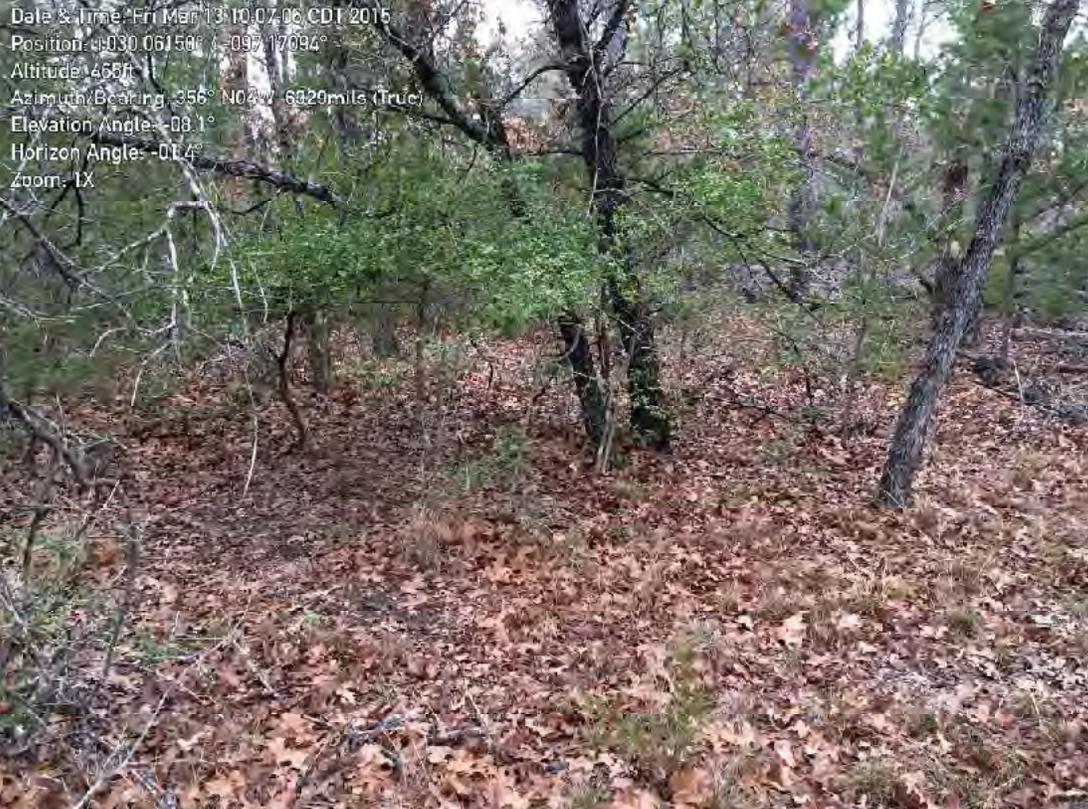
Description: Typical vegetation structure in FMU 1.

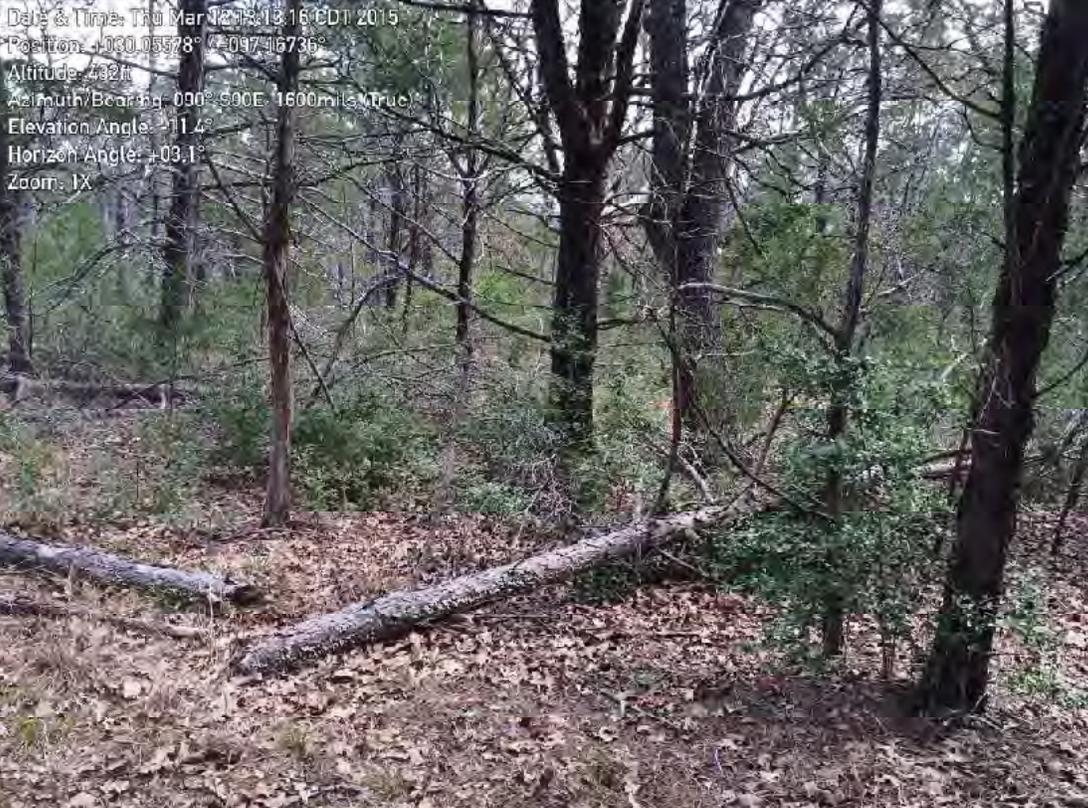
Description: Typical vegetation structure in FMU 2.

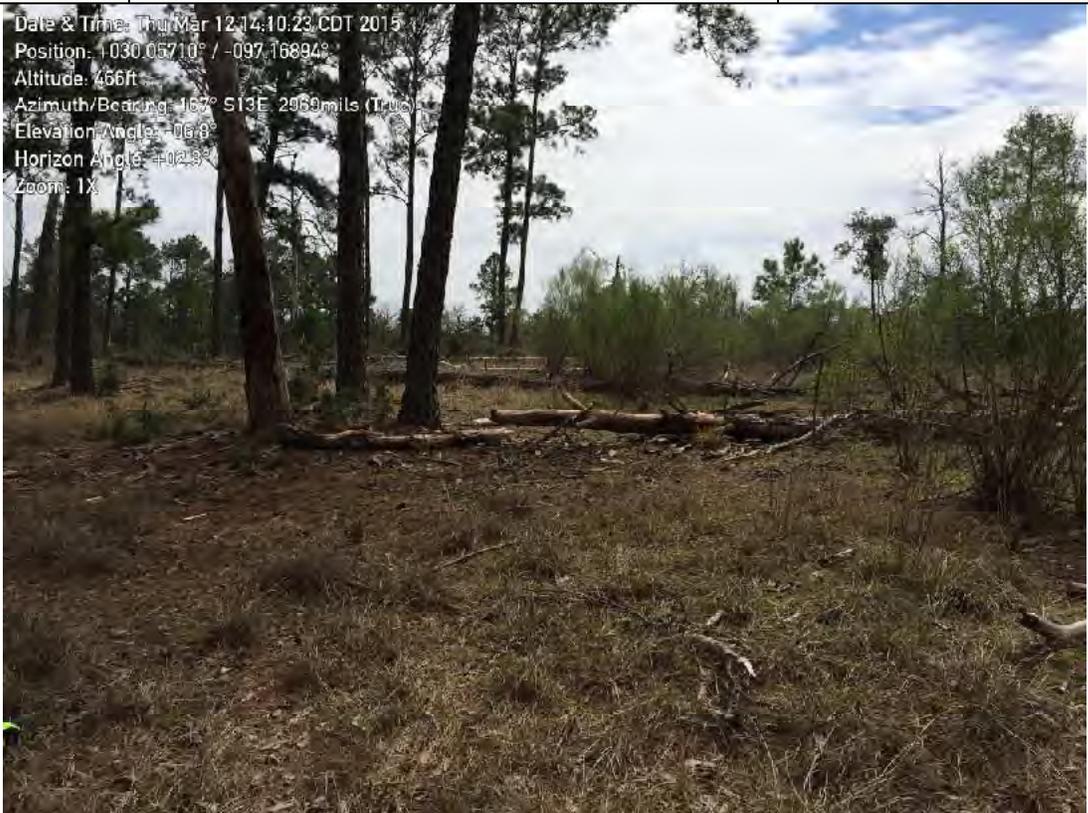
Description: Typical vegetation structure in center of FMU 3.

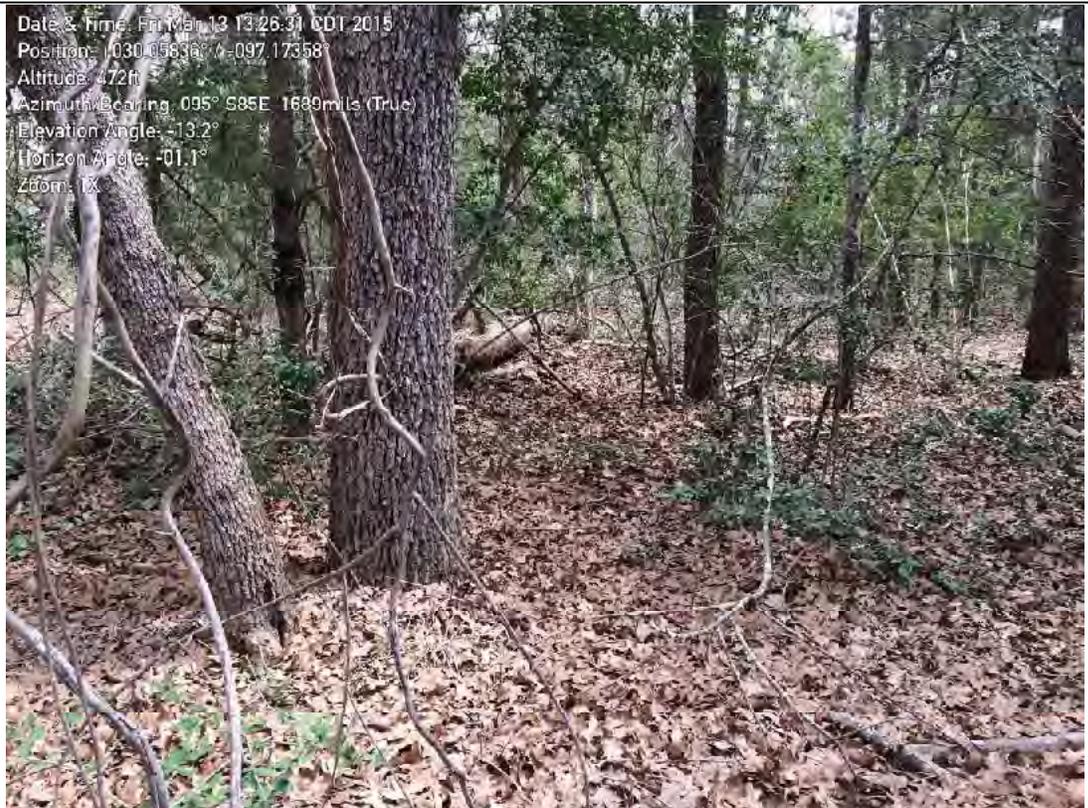
Description: Typical vegetation structure in FMU 4.
