**The University of Texas M. D. Anderson Cancer Center
Science Park - Research Division
Virginia Harris Cockrell Cancer Research Center
Smithville, Texas**

Figure 3-1 Proposed Fire Management Units Map

Appendix B

Photo Log

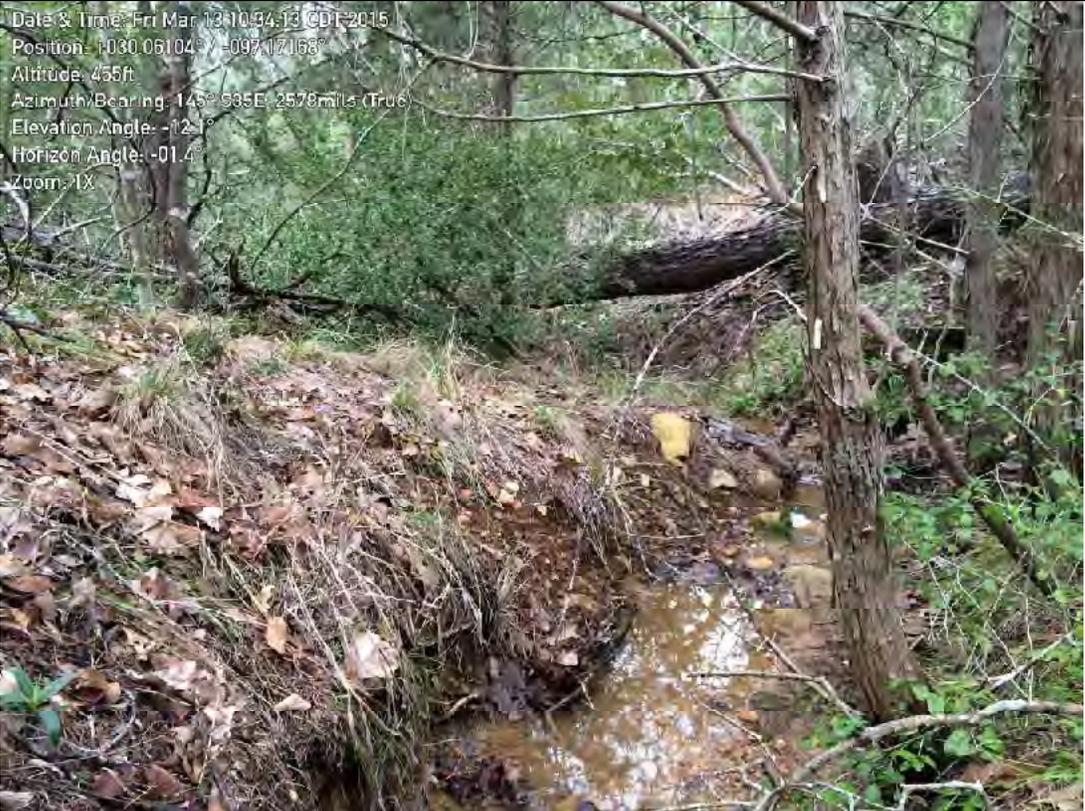
Description: This is one (DD1) of the four observed drainages that has potential Houston toad habitat.

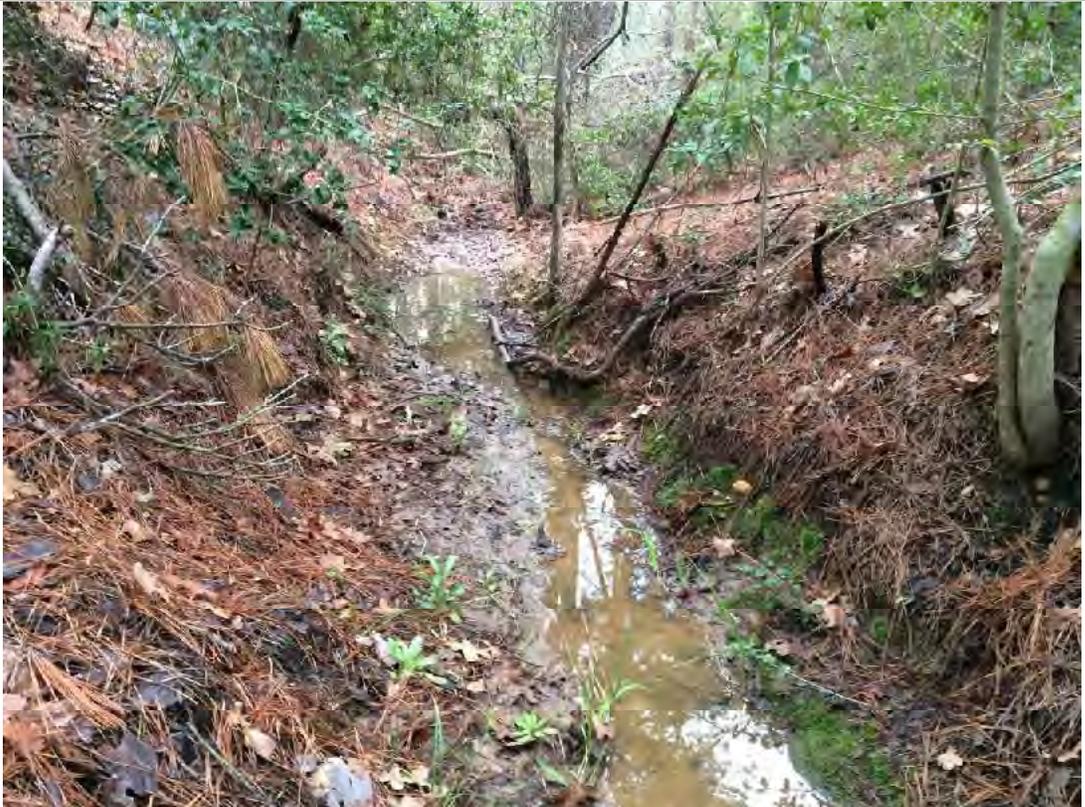
Date 3/12/2015	Photo No. 6

Direction Photo Taken: Southeast			
Description: This is one (DD2) of the four observed drainages that has potential Houston toad habitat.

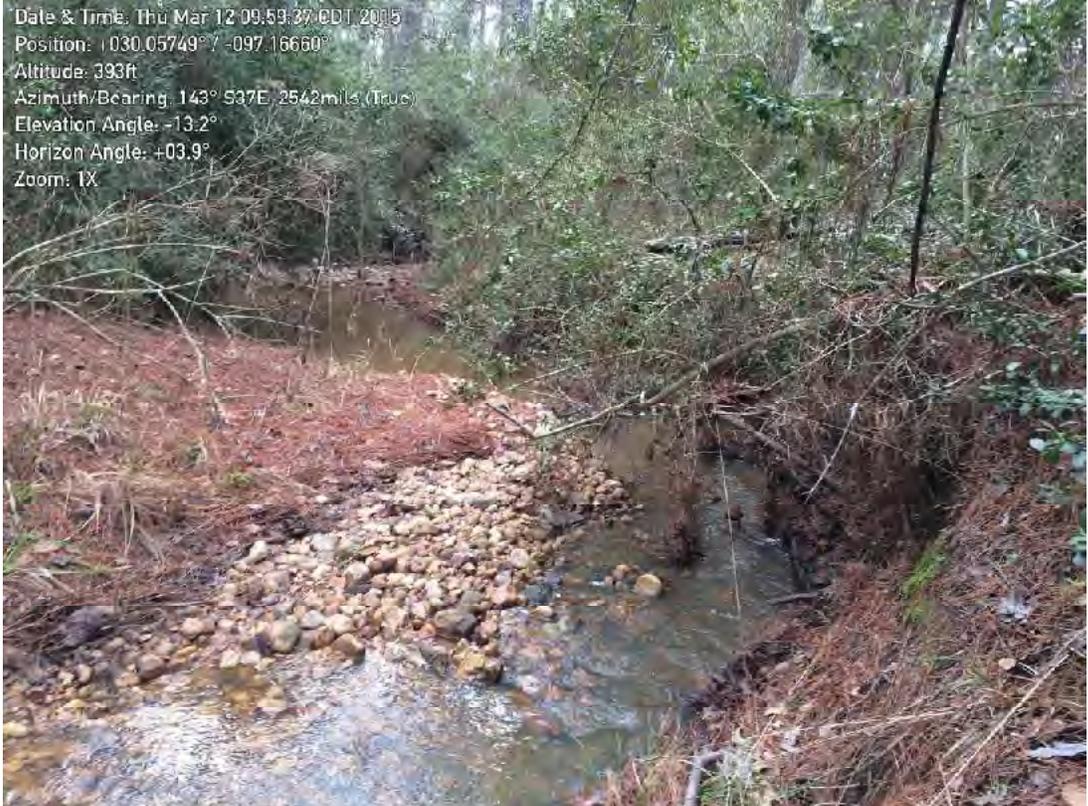
Description: This is one (DD3) of the four observed drainages that has potential Houston toad habitat.

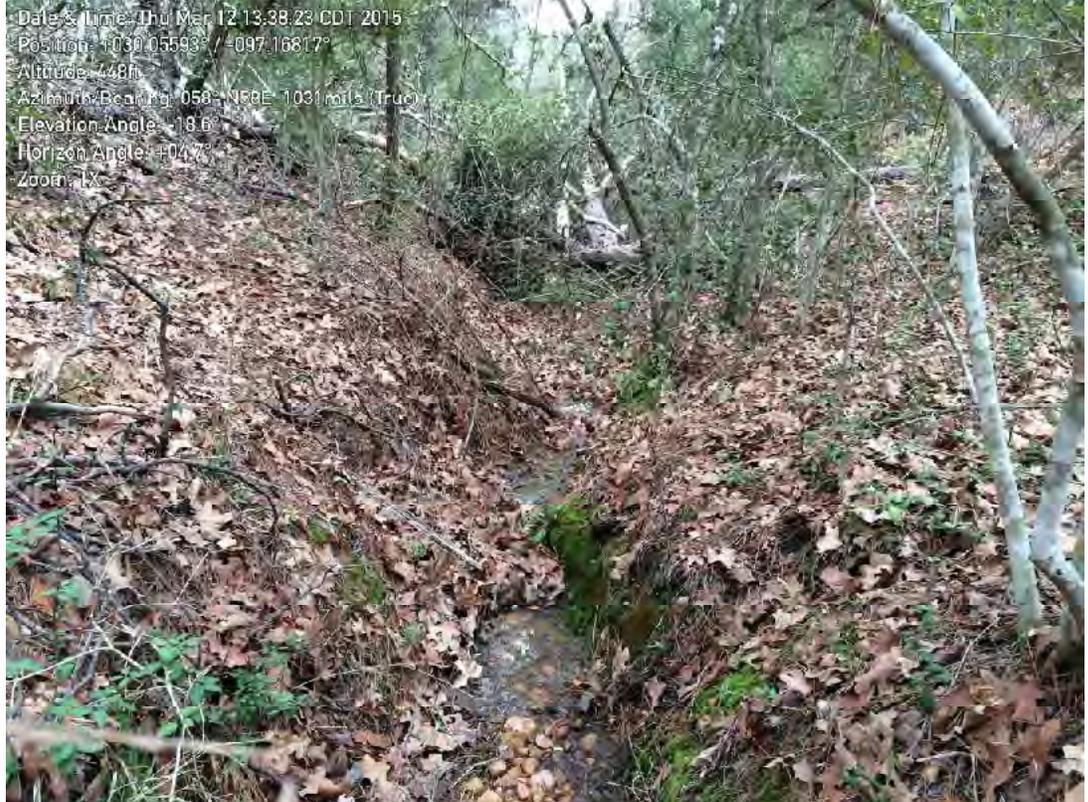
Description: This is one (DD4) of the four observed drainages that has potential Houston toad habitat.

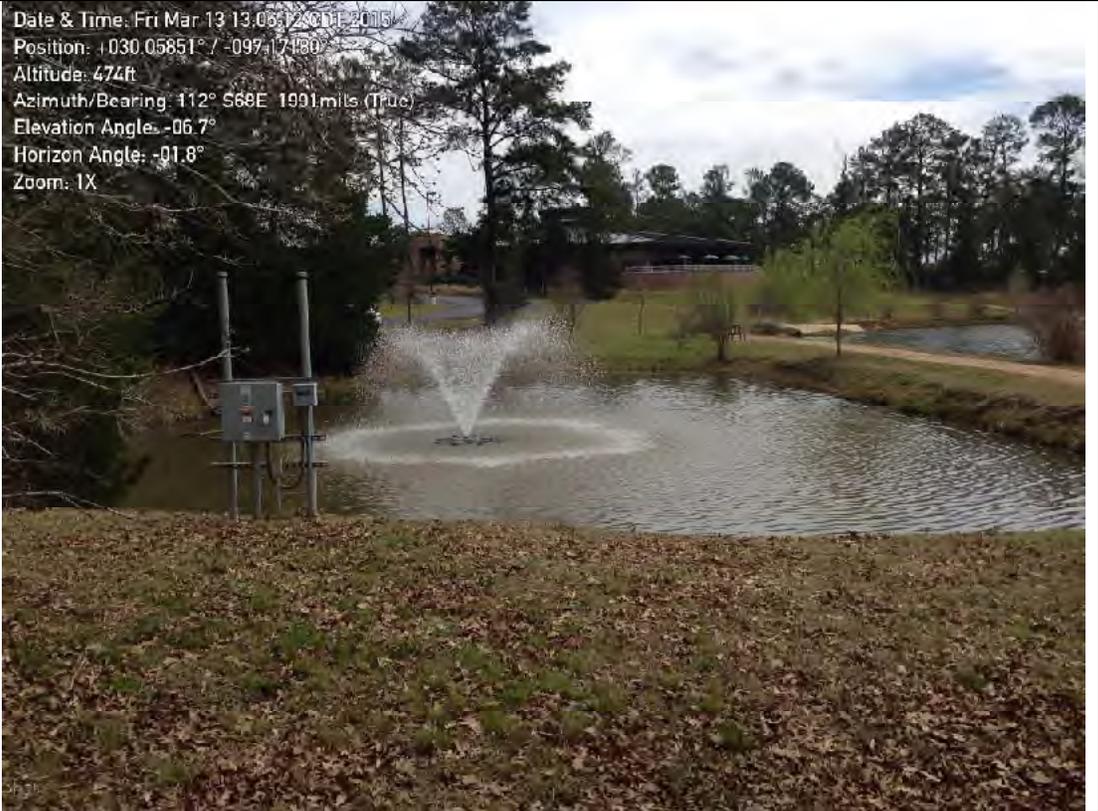
Description: Pond 1 is a small man-made detention pond north of Pond 2.

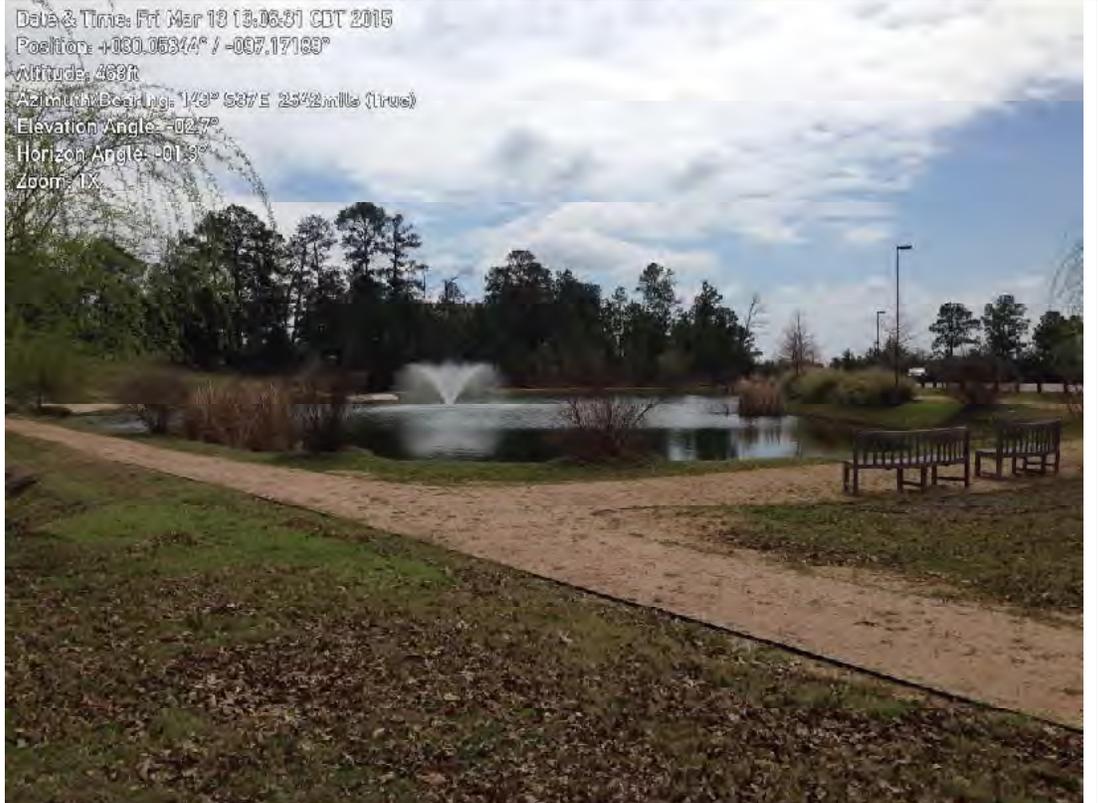
Description: Pond 2 is a man-made detention pond located southwest of Lab 4 and is adjacent to FMU 3.

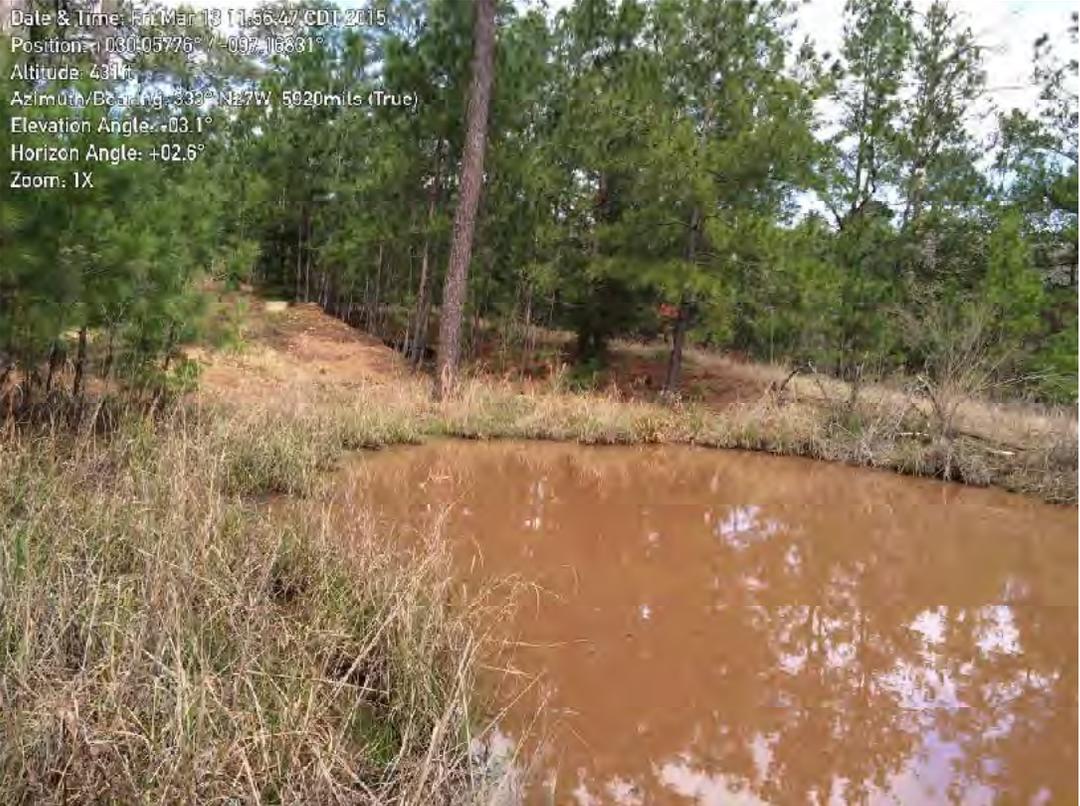
Description: Pond 3 is a detention pond that is located within FMU 2. Surface water runoff is designed to drain from FMU 3 through a culvert and down a drainage ditch into this pond. The detained water flows through an outfall pipe into DD3.

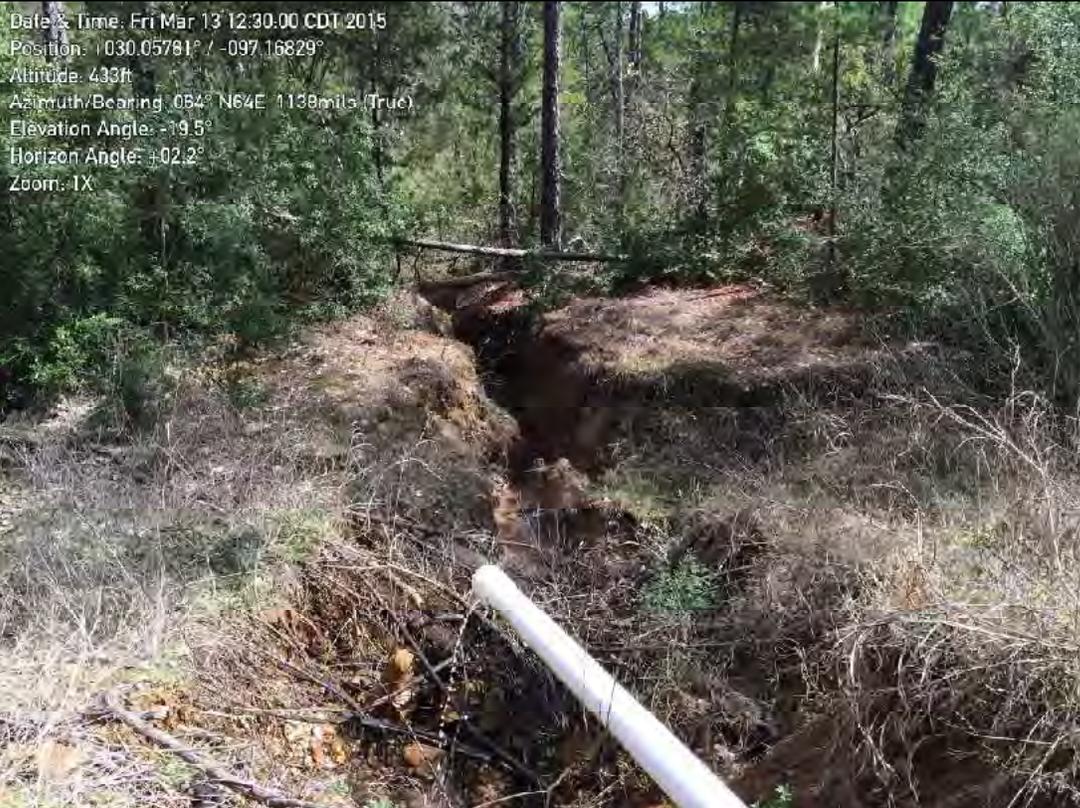
Description: Outfall draining Pond 3 into DD3.

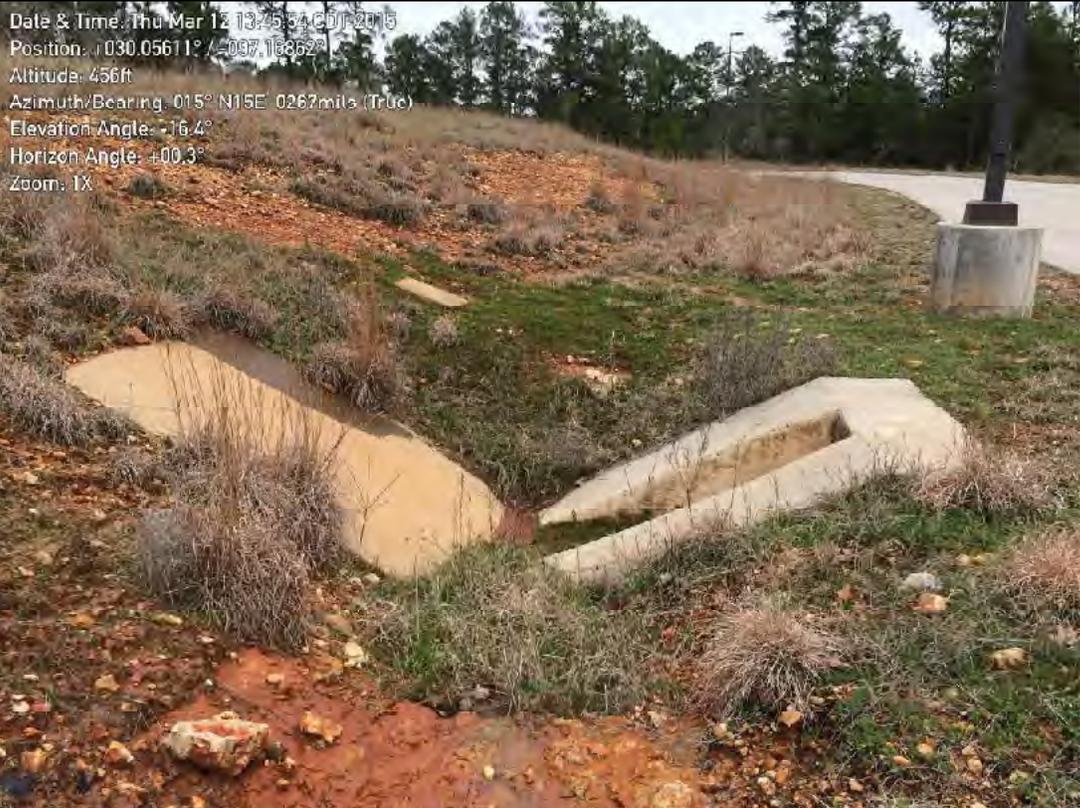
Description: A shallow drainage feature encircles FMU 3 and is directed through a concrete culvert under Circle Loop Road to Pond 3.

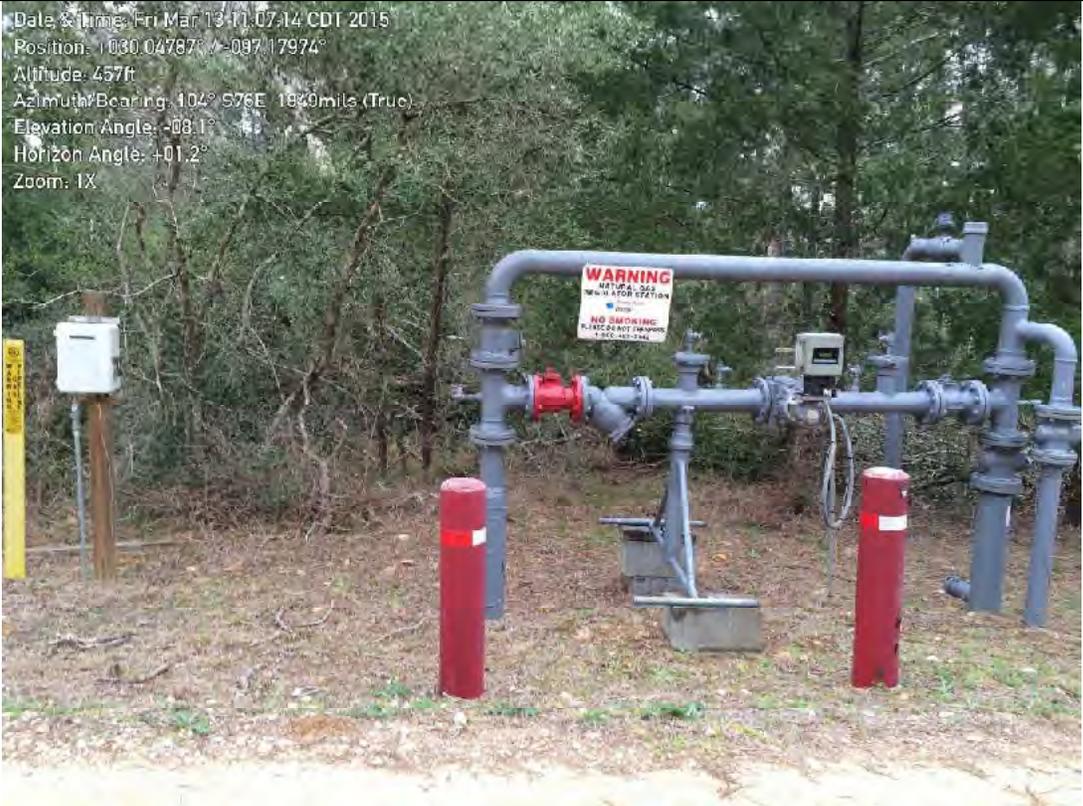
Client Name: MD Anderson Cancer Research Clinic		Site Location: Smithville, Texas	Project No. 25015345
Date 3/13/2015	Photo No. 25

A photograph of a gas metering station. The station consists of grey metal pipes and valves. A prominent red valve is visible. A white warning sign is attached to the pipes, reading "WARNING NATURAL GAS METERING STATION NO SMOKING PLEASE DO NOT DRINKING 1-800-368-5848". Two red cylindrical bollards are positioned in front of the station. The background shows a wooded area with trees and a utility box on a post to the left.	
Direction Photo Taken: Southeast			
Description: Gas Metering Station that provides utility to the MD Anderson Campus.
