APPENDIX B
AGENCY COORDINATION

Preliminary Jurisdictional Determination Report

Improvements to Lake Bella Vista Dam
Benton County, Arkansas

RE: Section 106 Review Consultation, FEMA DR-1975-AR
PW# 1562 Replace Lake Bella Vista Dam
Lake Bella Vista, Benton County, Arkansas
Coordinates: 36.43270, -94.23091

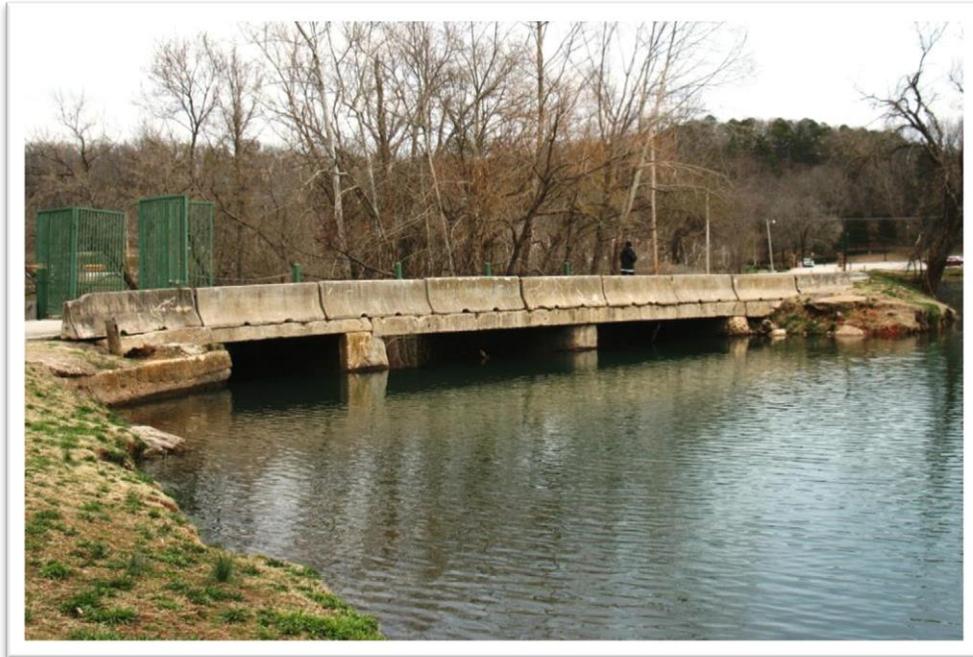
Photo 1: Lake Bella Vista Dam west side facing downstream.

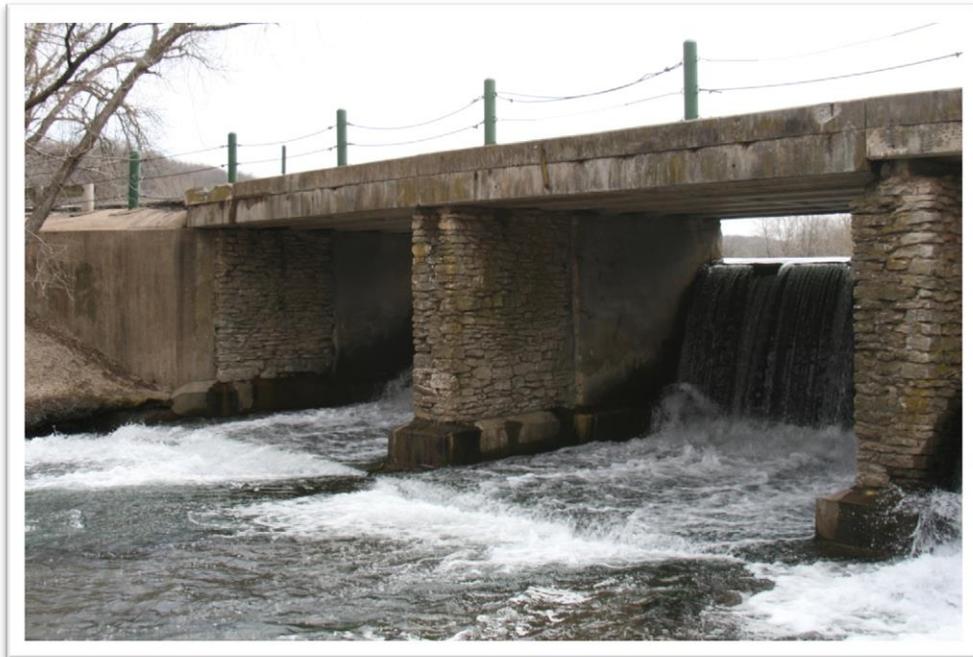
Photo 2: Lake Bella Vista Dam west side facing upstream.

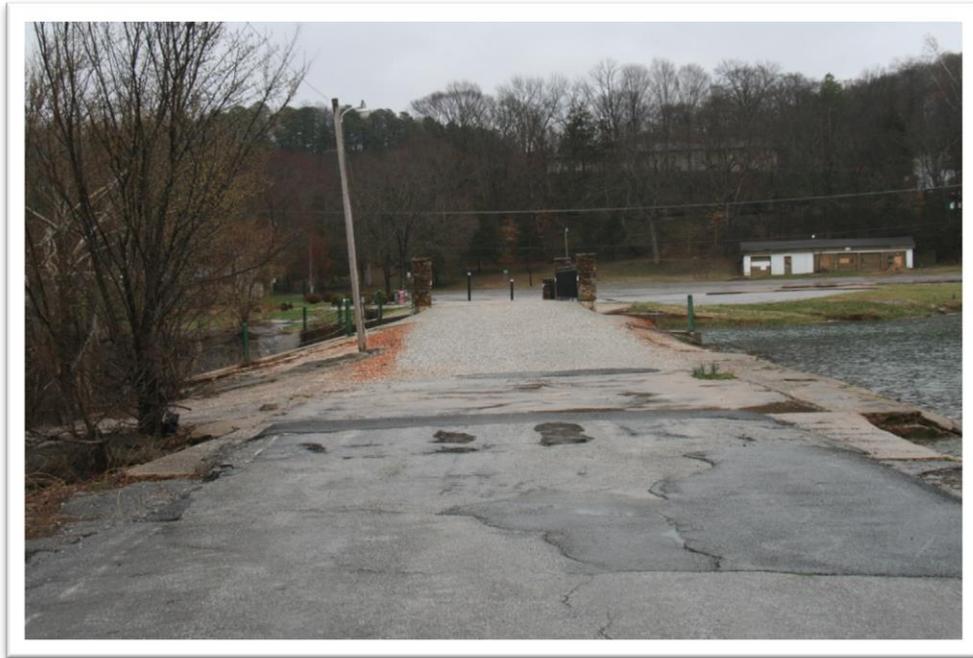
Photo 3: Road crossing Lake Bella Vista Dam, facing east.

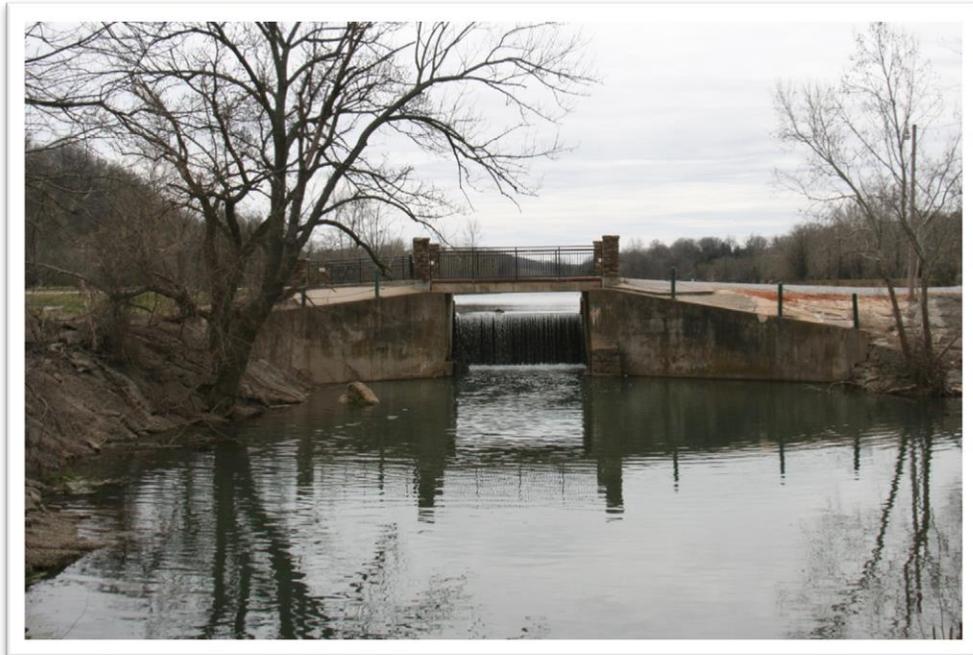
Photo 9: Lake Bella Vista Dam east side looking upstream

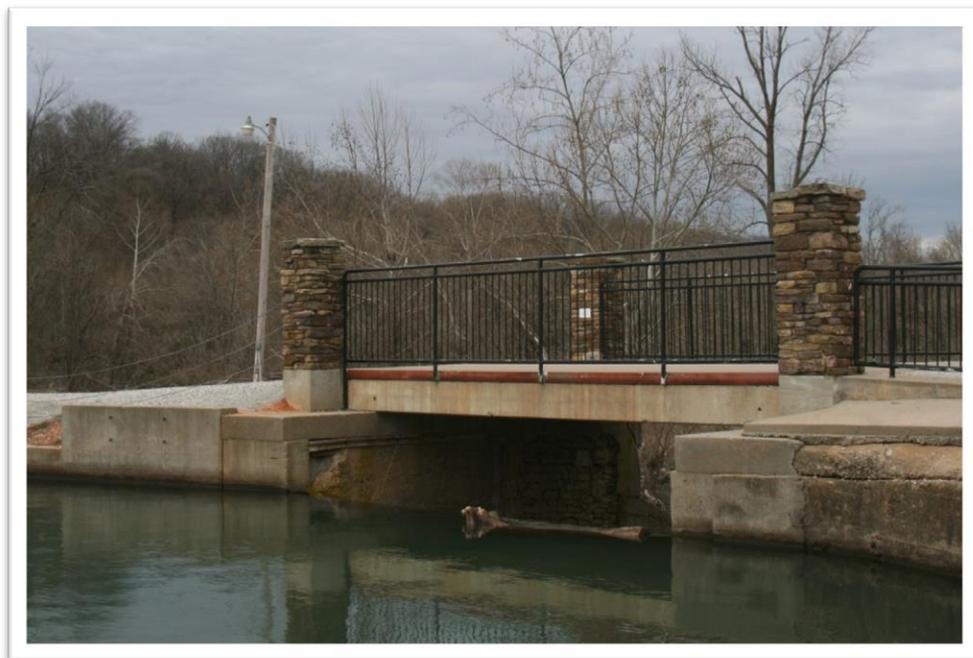
Photo 10: Lake Bella Vista Dam east side looking downstream

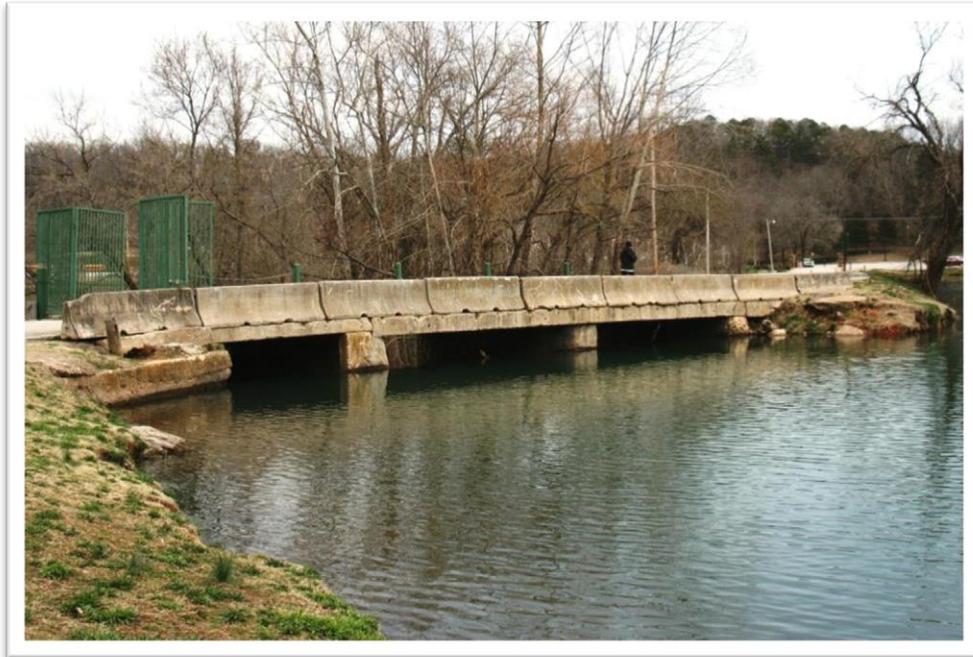
Photo 1: Lake Bella Vista Dam west side facing downstream.

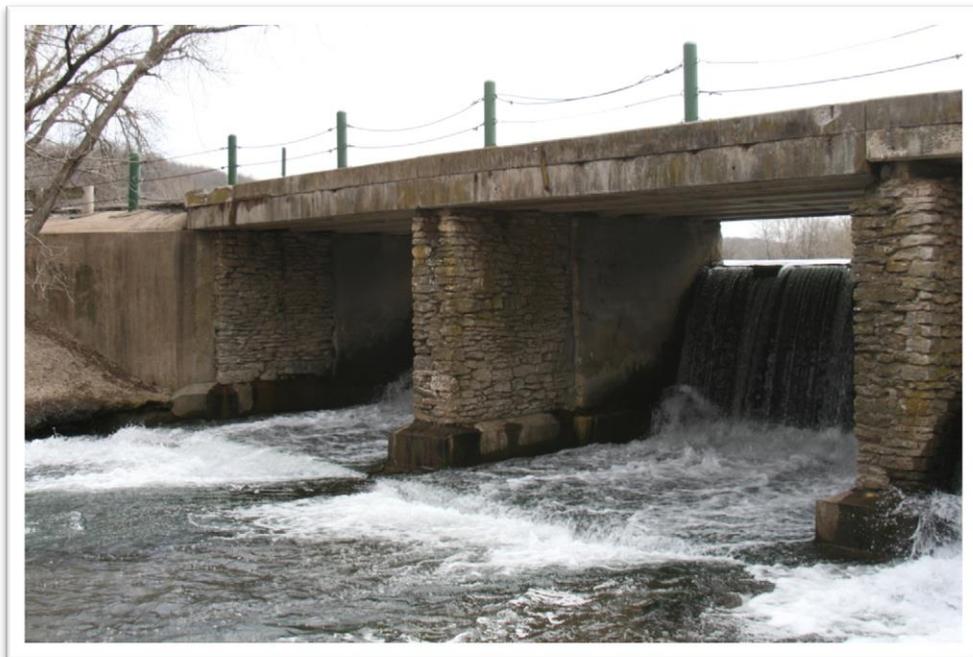
Photo 2: Lake Bella Vista Dam west side facing upstream.

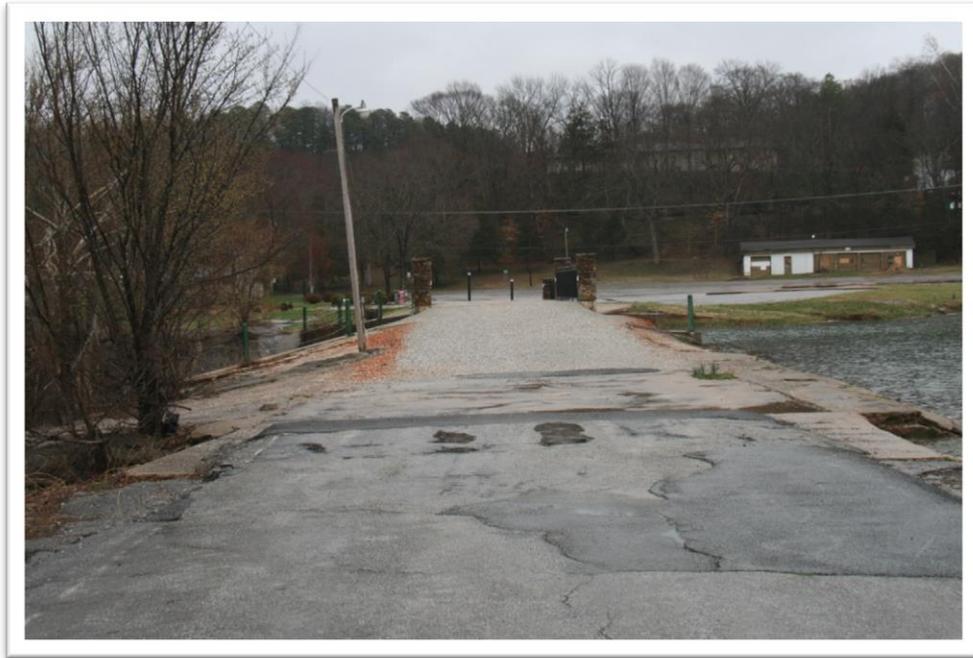
Photo 3: Road crossing Lake Bella Vista Dam, facing east.

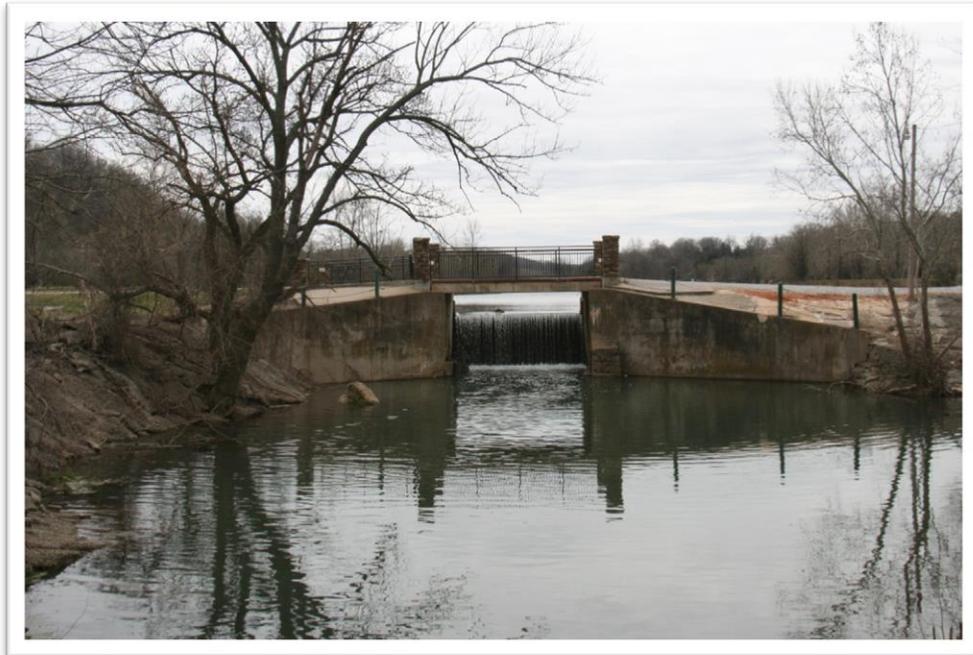
Photo 9: Lake Bella Vista Dam east side looking upstream

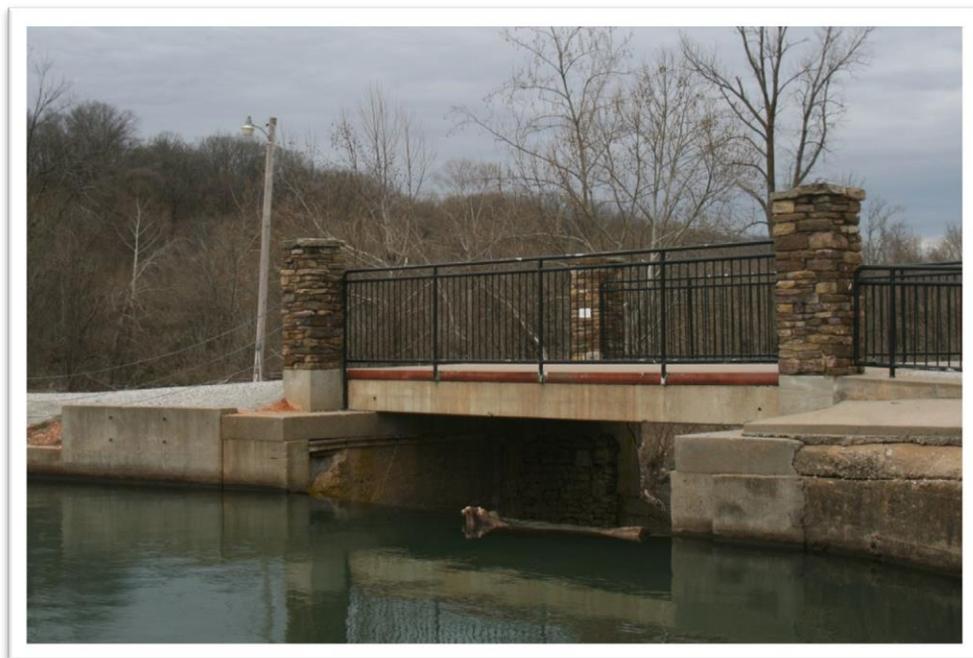
Photo 10: Lake Bella Vista Dam east side looking downstream

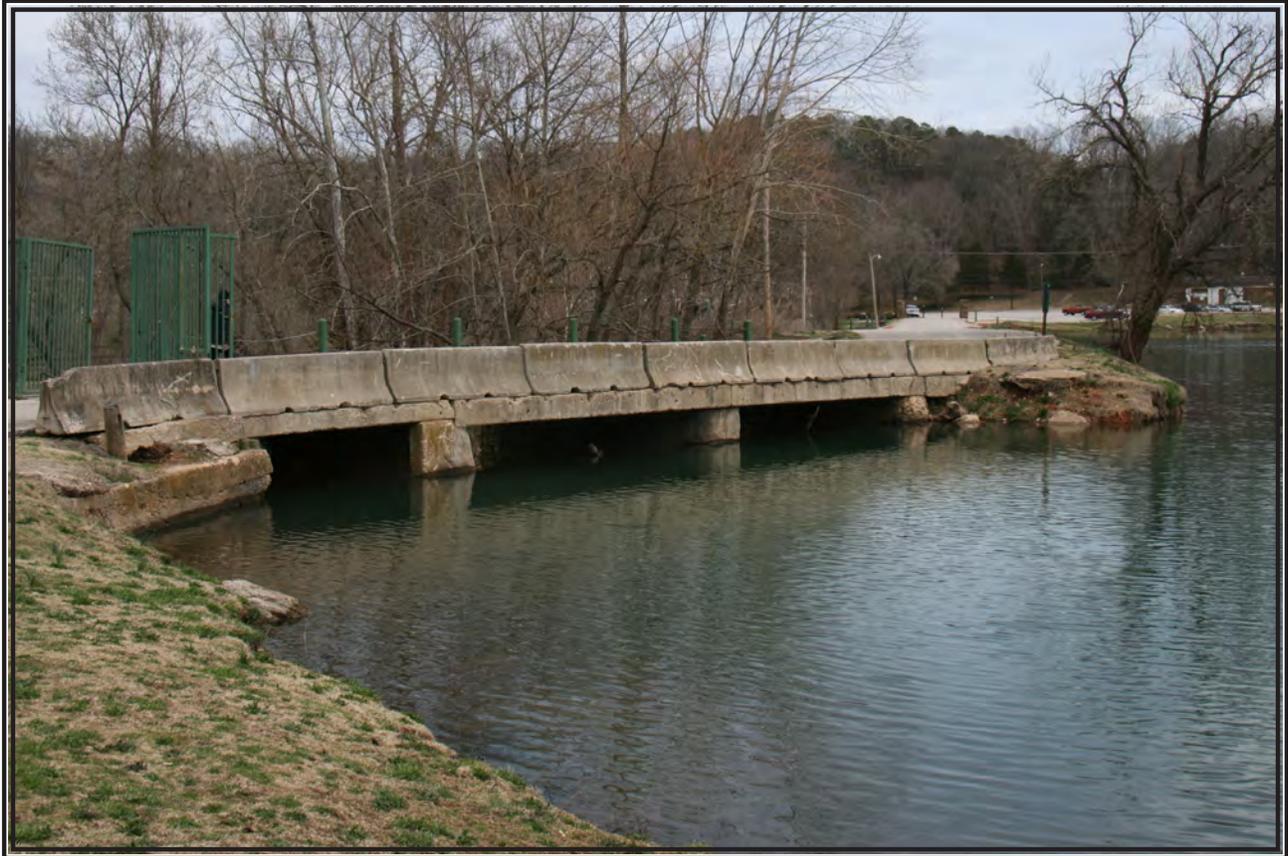
PHOTO 2: View of dam and west spillway facing northwest.

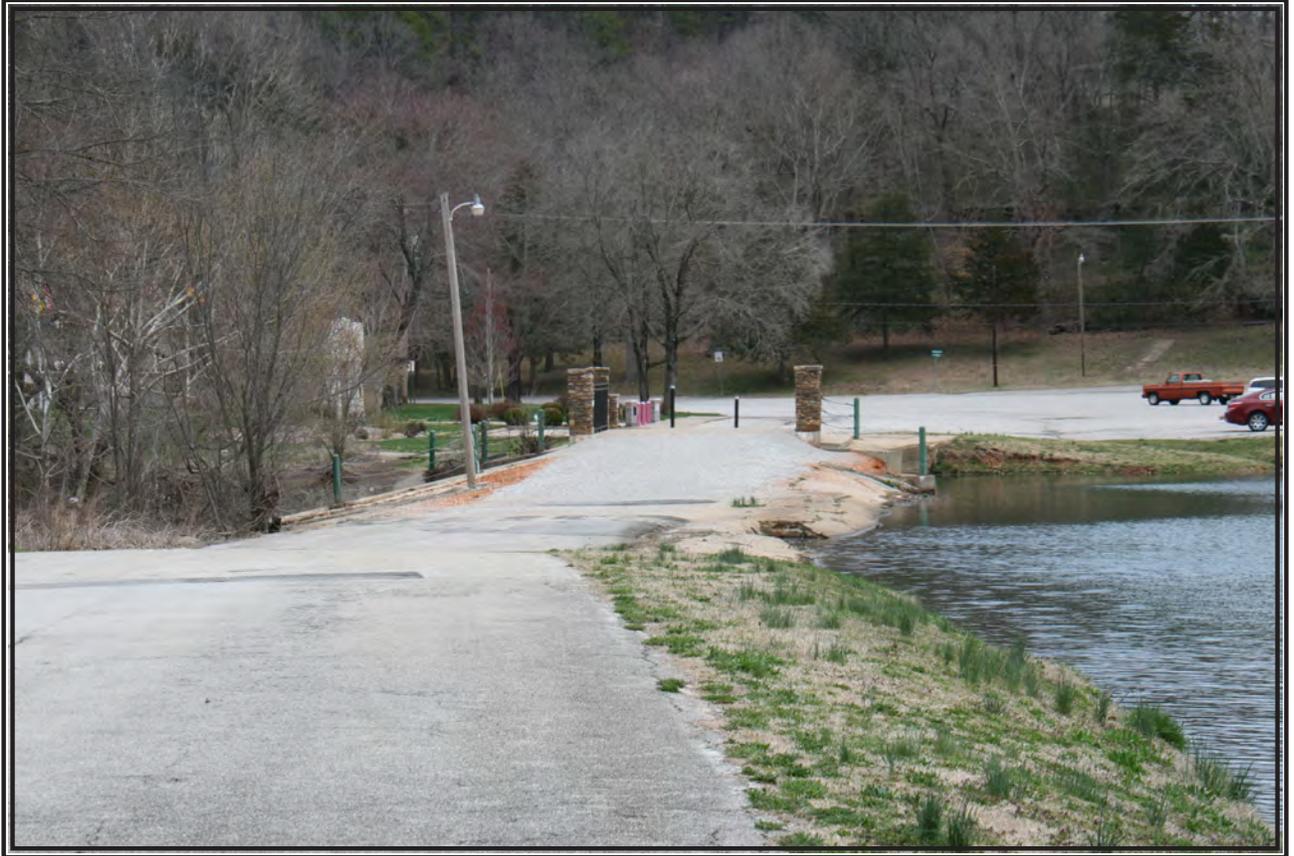
PHOTO 3: View of the top of the dam facing toward east spillway.

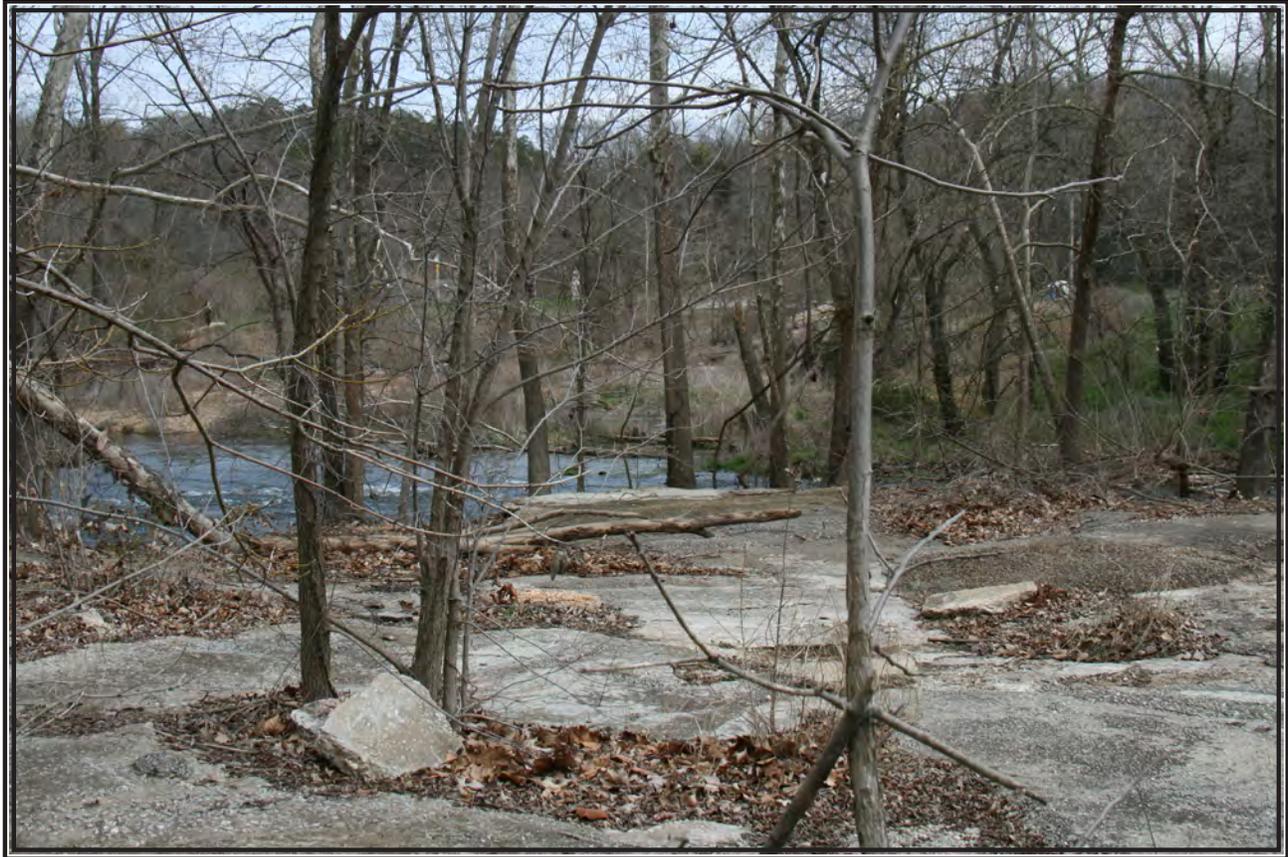
PHOTO 4: Downstream view towards Little Sugar Creek, facing northwest. Note concrete patching in attempts to stabilize embankment.

The dam is susceptible to frequent overtopping of the unprotected earthfill embankment, which is a recurring condition that will eventually lead to a complete (and possibly sudden) failure. The west spillway may have structural problems of unknown severity, with visible evidence of cracking and spalling of the concrete, and the gates are in poor and almost inoperable condition.

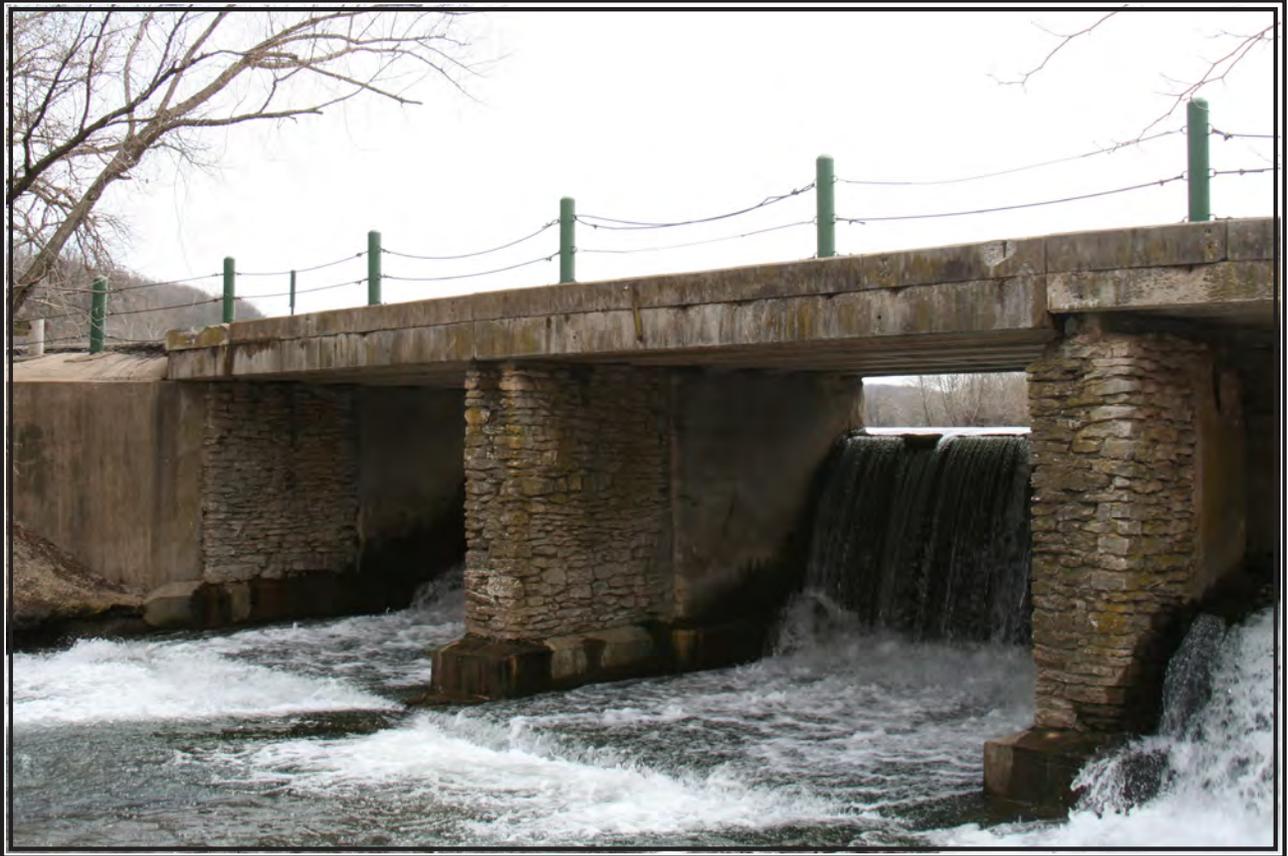
PHOTO 5: View of west spillway, facing northwest.

The piers of both spillways (east and west) are faced with rough-cut limestone. This detail was likely added to the spillways in the 1920s to match the rustic feel of some of the resort structures that once surrounded the lake. Both spillways were widened when the roadway was widened in the 1950s. The piers were expanded toward the downstream side, and a pre-cast webbed concrete deck replaced the original roadway over the dam.

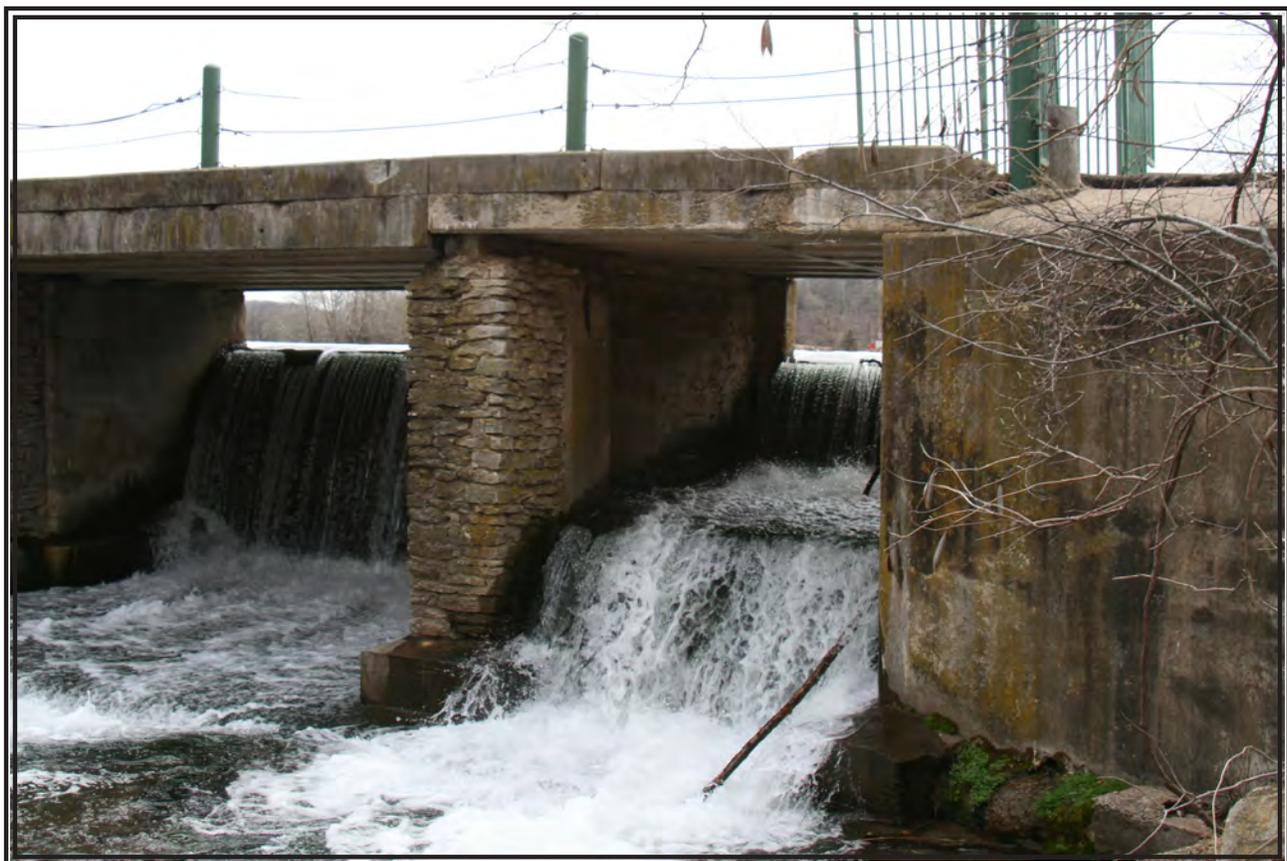
PHOTO 6: View of west spillway, facing northwest.

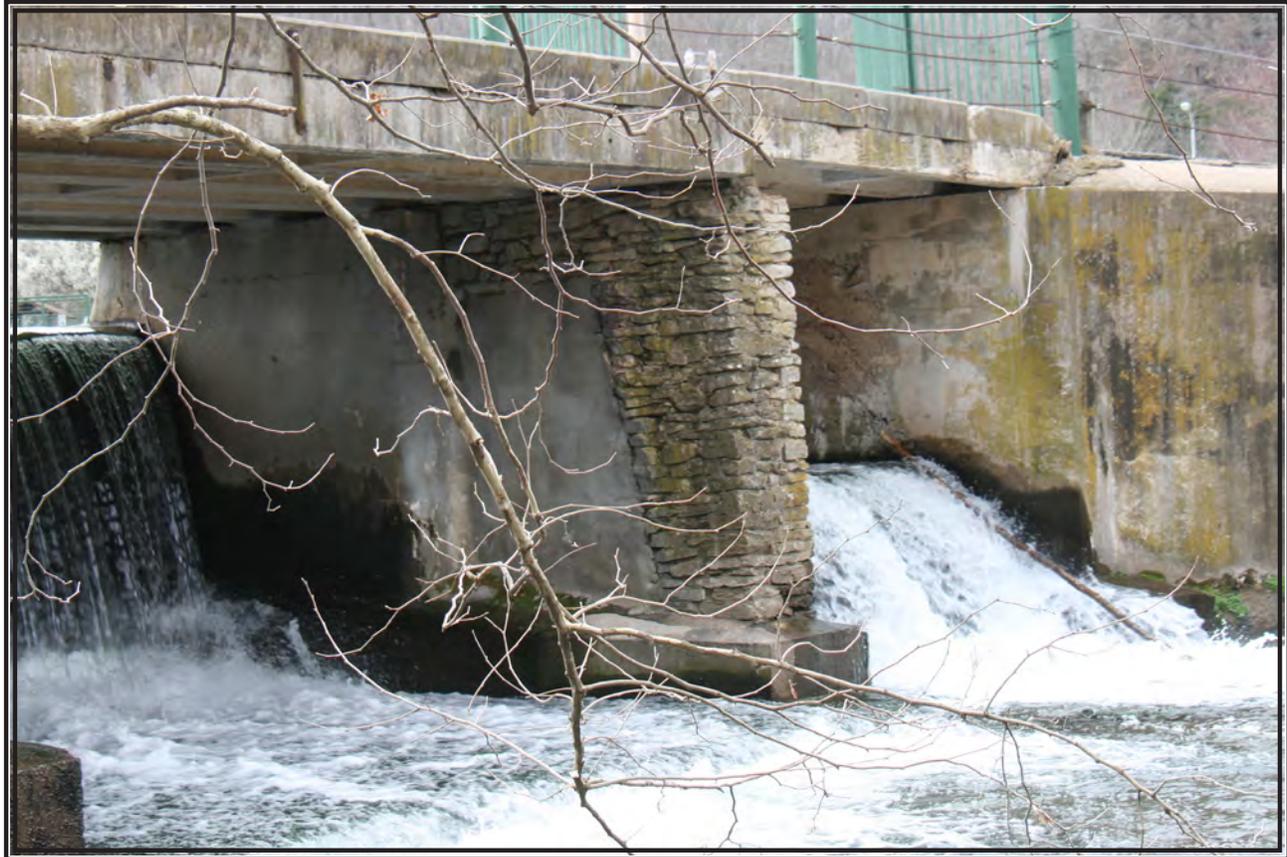
PHOTO 7: View of west spillway facing northeast towards western-most bay of the spillway and concrete stabilized embankment.

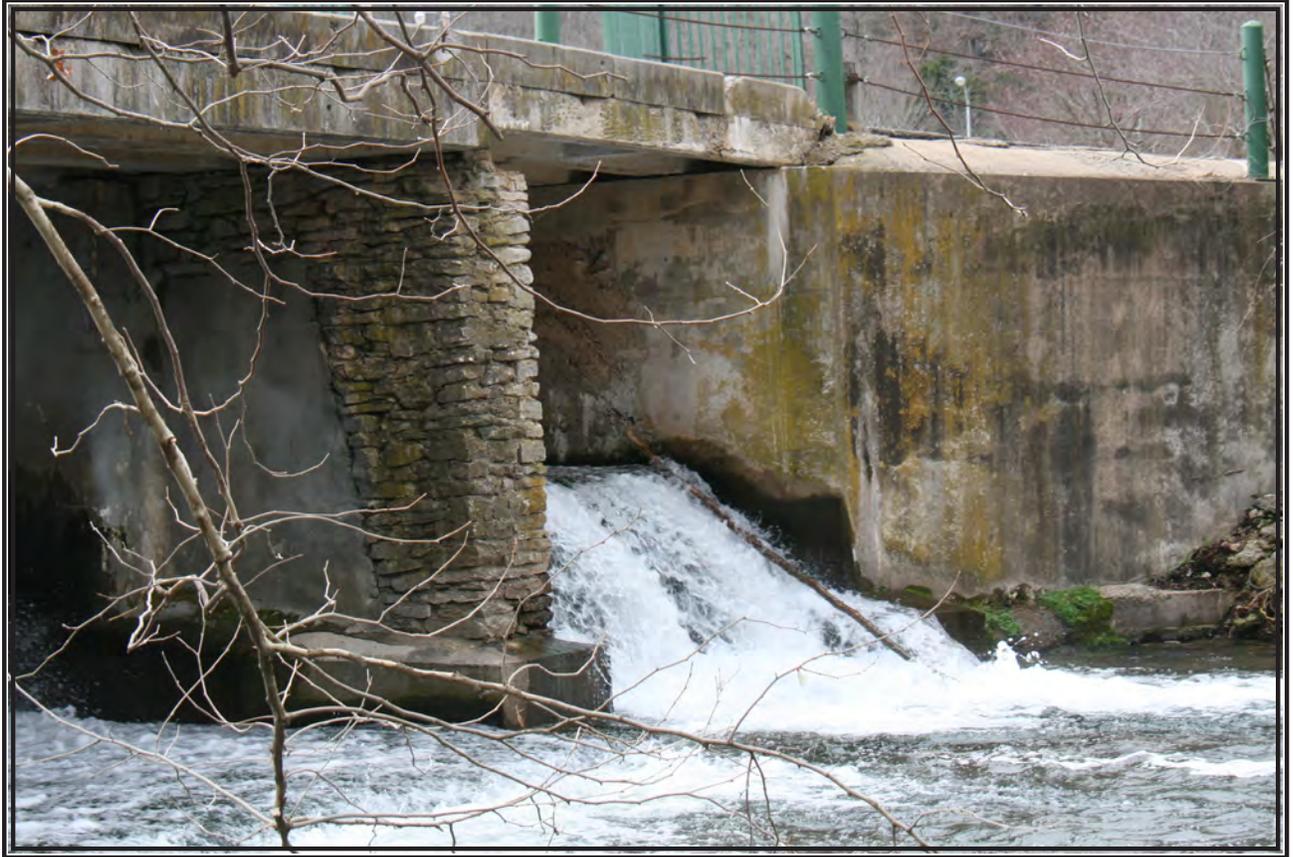
PHOTO 8: View of west spillway facing northeast.

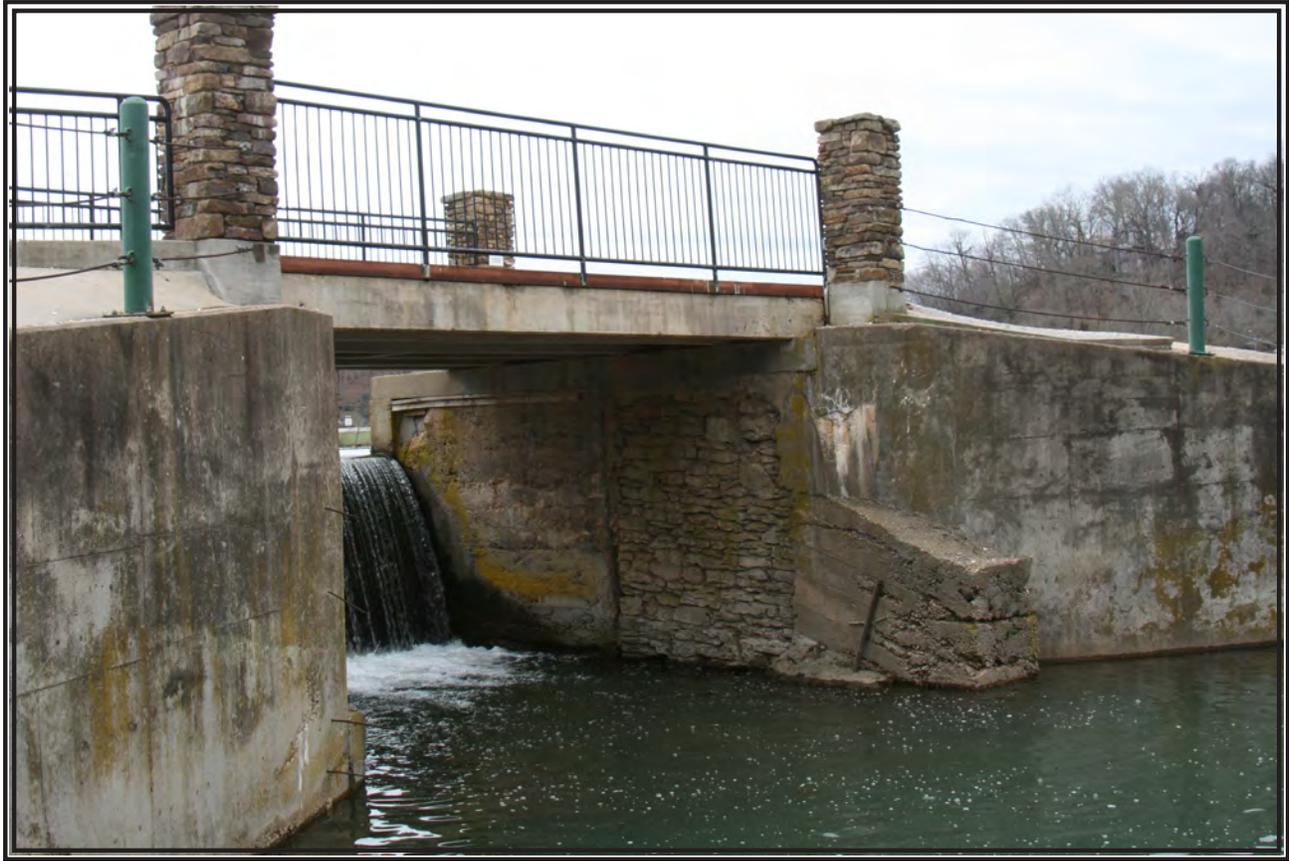
PHOTO 9: View of east spillway facing northeast.

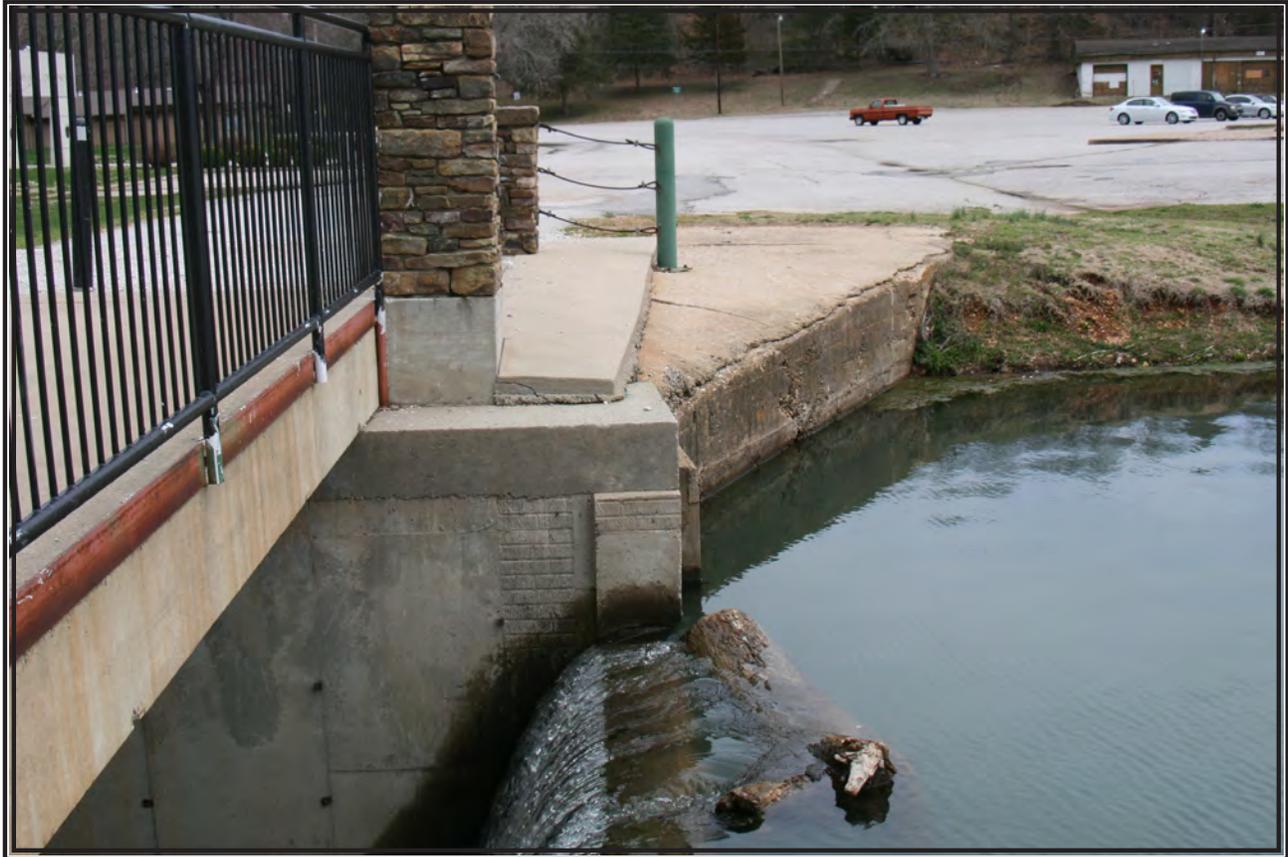
PHOTO 10: View of east spillway and retaining wall facing east. The proposed construction staging area is pictured in the background.

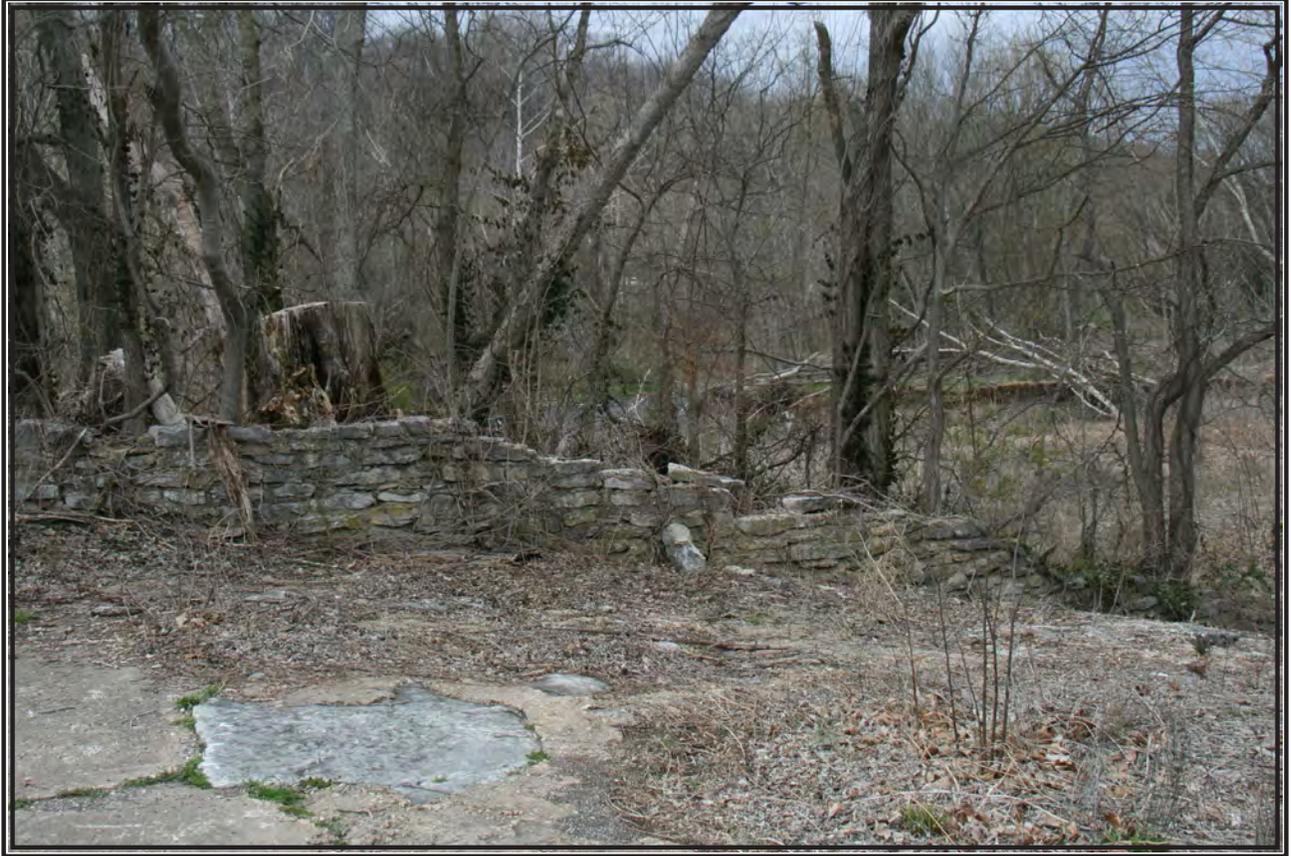
PHOTO 11: View of retaining walls downstream of the dam with poured concrete to stabilize embankments, facing west.
