Draft Environmental Assessment
Village of Ruidoso
Proposed Close Road Bridge Replacement
DR-1783-NM, Project Worksheet 94

Lincoln County, New Mexico
October 2015

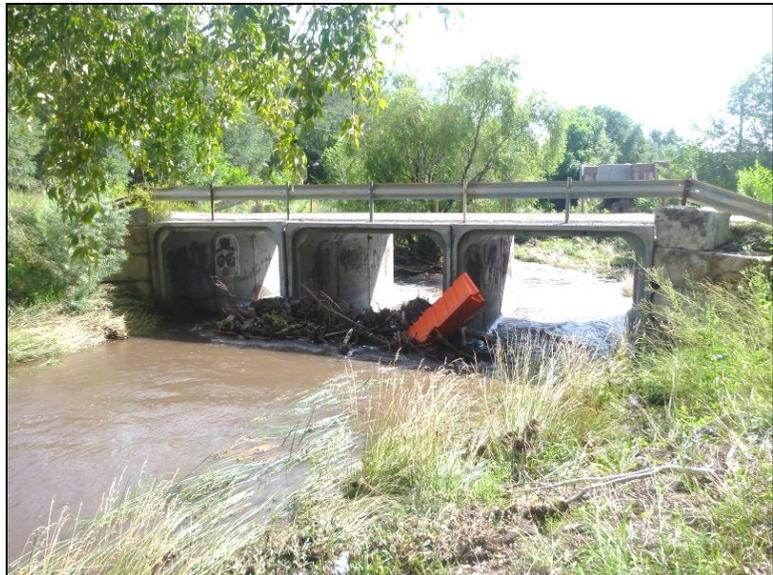
Figure 4: View of Close Road Temporary Bridge with Debris Build-up.

Under the No Action Alternative, the existing FEMA funded temporary box culvert bridge, which consists of three barrel box culverts with openings that are 10 feet (ft.) wide by 8 ft. high by 18 ft. deep (Figure 4), will remain as the crossing of the Rio Ruidoso. During flood events, debris flowing down the river will continue to collect at the walls of the culverts, creating an obstacle to aquatic migration. The existing culvert crossing and waterway would continue to have the potential during flood events to be overtopped or washed out, damage public transportation infrastructure, and accelerate soil embankment erosion. The collection of debris and sediment at the culverts can negatively influence the natural conditions of the river, such as temperature and pH, which could potentially impact the cold-water fishery designation of Rio Ruidoso.

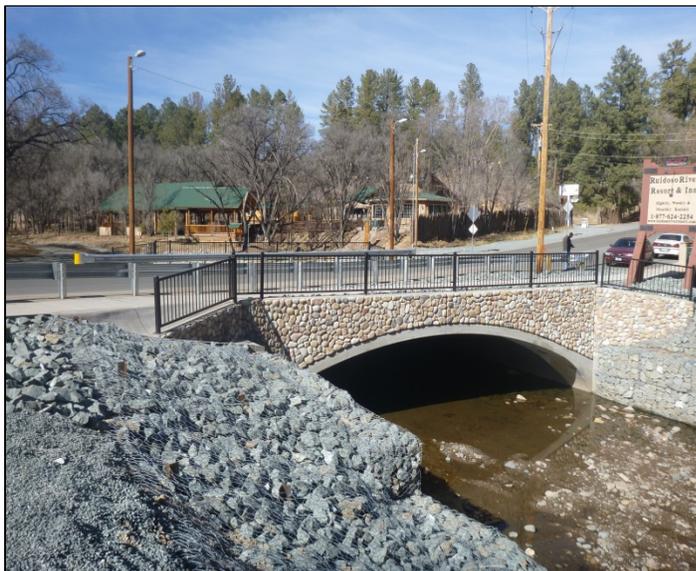
Figure 5: Example ConSpan Arch bridge at Eagle Drive in Ruidoso, NM

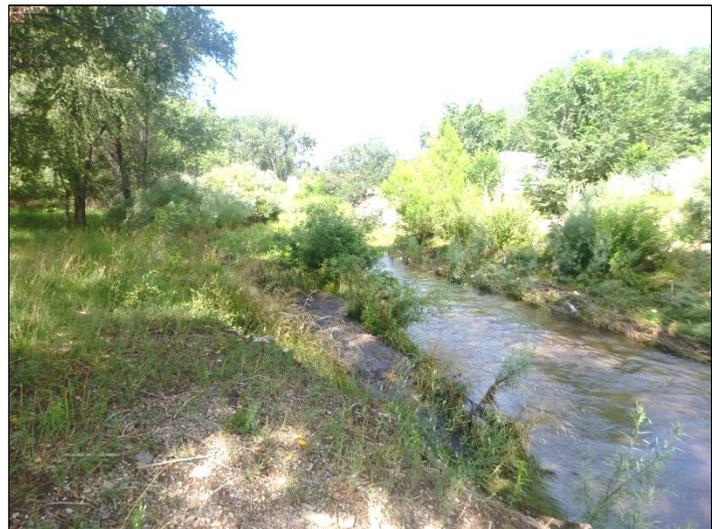
Figure 6: View of Rio Ruidoso west of Close Road Bridge.

The Village of Ruidoso's main surface water is the Rio Ruidoso (Figure 6). The Rio Ruidoso is a 30-mile river whose watershed is primarily within the Lincoln National Forest. The river starts within the Mescalero Apache Reservation and flows through the Sacramento Mountains to the Pecos River. Its headwaters are found near the top of Sierra Blanca Peak at an elevation of 12,300 ft. (3,749 meters [m]) amsl. Tributaries to the Rio Ruidoso within the Village of Ruidoso limits are Carrizo Creek and Cedar Creek. Various other streams feed into the Rio Ruidoso or fork from the Rio Ruidoso. The Rio Ruidoso is a tributary to the Pecos River, which is defined as a jurisdictional water by the US Army Corps of Engineers (USACE). Under the determinations of the USACE, those tributaries that feed into a jurisdictional water are also deemed a jurisdictional water. This means that the Rio Ruidoso is classified as a jurisdictional water. The Rio Ruidoso is also classified as a cold water fishery that supports substantial recreational use in the Village of Ruidoso and surrounding areas.

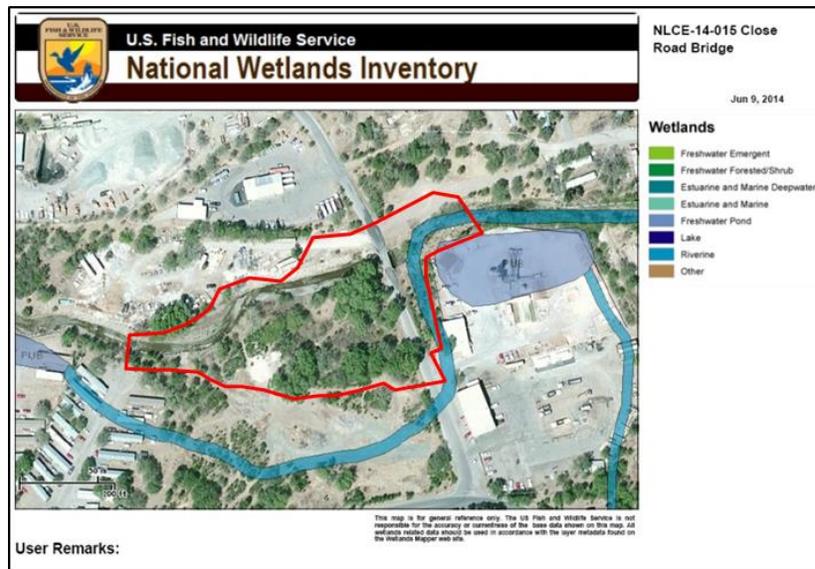
Figure 7: National Wetlands Inventory Map of the Proposed Project Area (USFWS 2014d).

On August 11, 2014, Zia Engineering & Environmental Consultants (Zia) conducted a Wetlands Determination and Delineation Survey (Zia 2014c, Appendix E) for the proposed bridge replacement along the Rio Ruidoso, in Ruidoso, New Mexico. The survey was completed in accordance with the *USACE Wetland Delineation Manual* (USACE 1987) and the *Regional Supplement to the Corps of Engineers Wetland Delineation Manual: Western Mountains, Valleys and Coast Region (Version 2.0)*. (USACE 2010) The area around Close Road Bridge was surveyed for wetlands. In total, eight sample pits were completed. Based on the USACE three-parameter method (hydrophytic plant community, hydric soils, and hydrology) the sample pits on the west side of Close Road identified a high water table, but the water table levels could not sustain water long enough for the soils to become hydric or maintain wetland vegetation. The sample pits located on the east side of Close Road were determined to still be uplands; and a ponding area was determined to be a wetland.

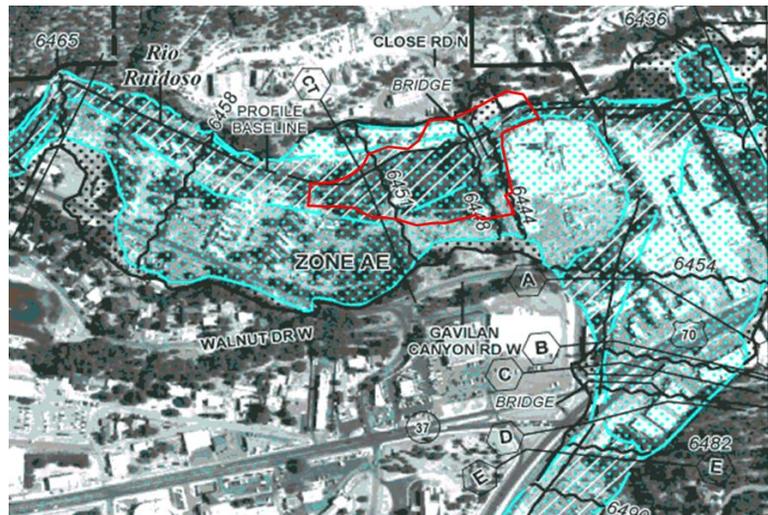
Figure 8: FEMA FIRM of the Proposed Project Area
(FEMA 2013b)

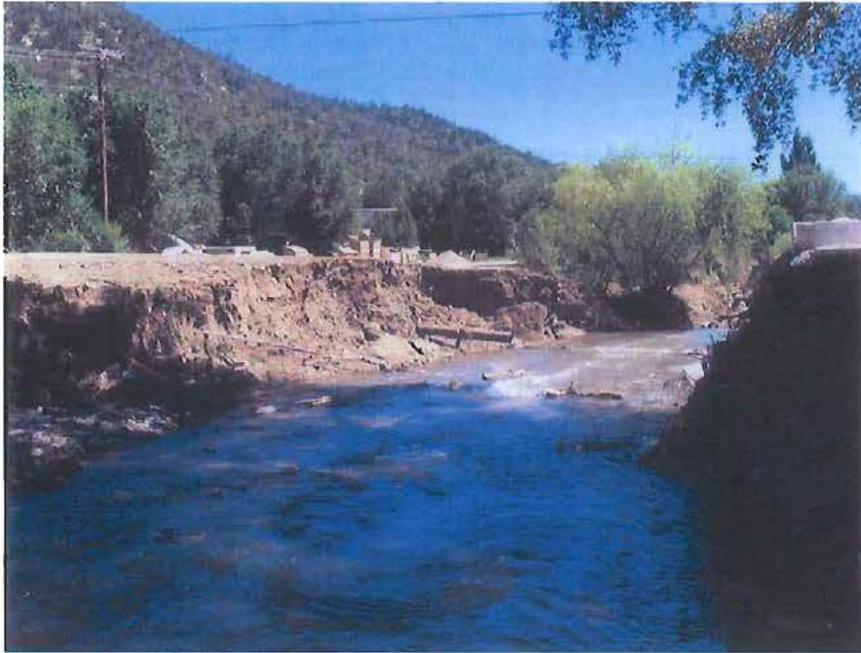
Photo 1: Looking downstream. Note brown pipe at left center of photo. The pipe is the center line of the destroyed structure.

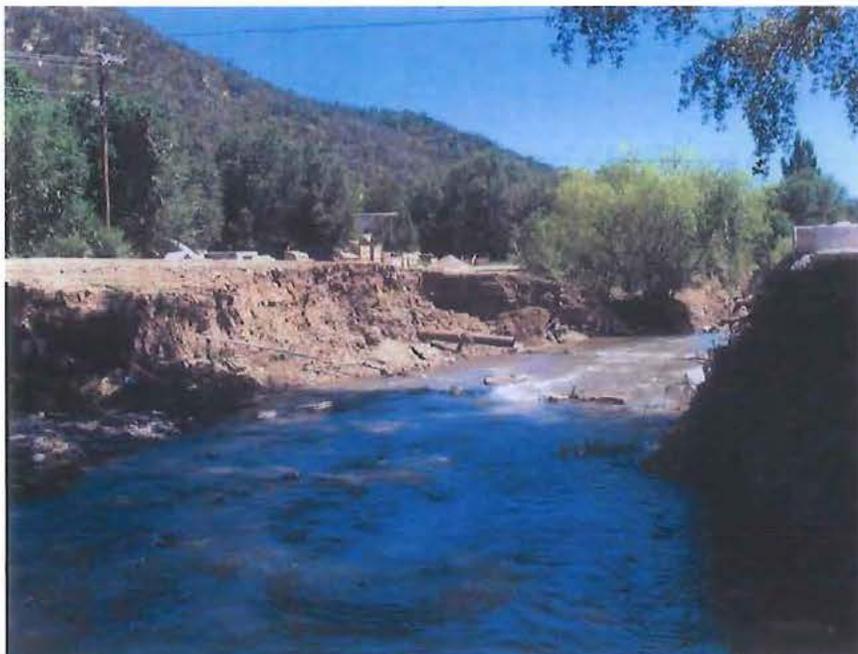
Photo 1: Looking downstream. Note brown pipe at left center of photo. The pipe is the center line of the destroyed structure.

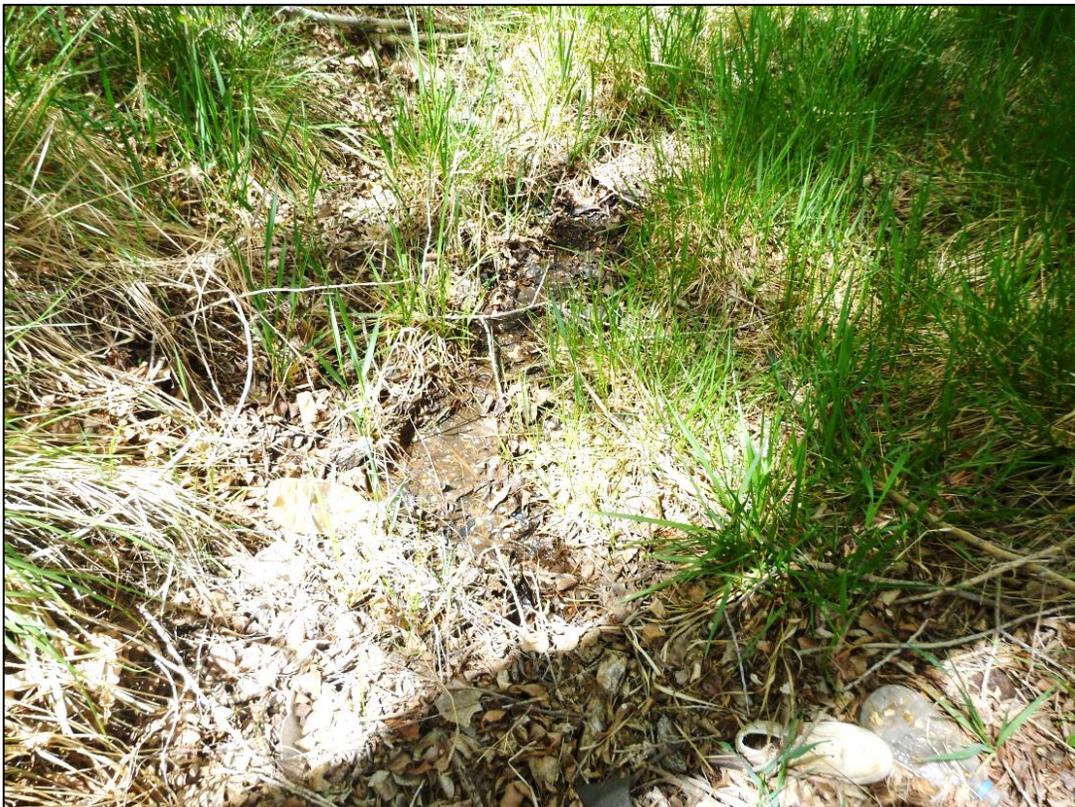
**Figure 14. Water seeping to the surface**

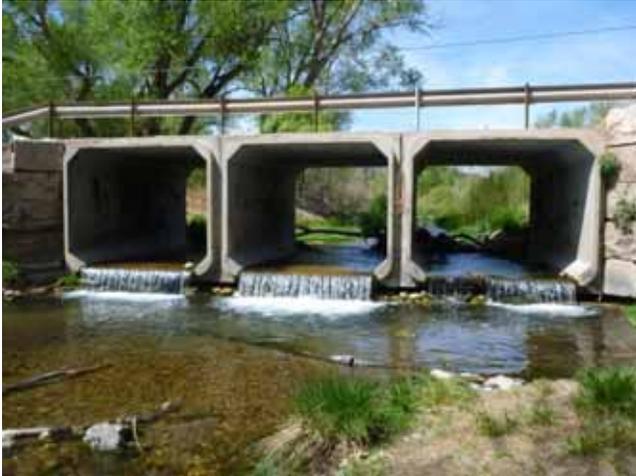
**Figure 6. View of water flow under Close Road bridge on 4-25-14**

On August 11, 2014, initial field observations were made, and it was very apparent that the project area had received immense amounts of rain recently (Figures 6 and 7). This was indicated by very damp soils and heavy vegetation growth. Additionally, there was a heavy amount of debris built up at the culvert bridge, and vegetation in the river was bent over or damaged indicating a heavy flow of water in the river.

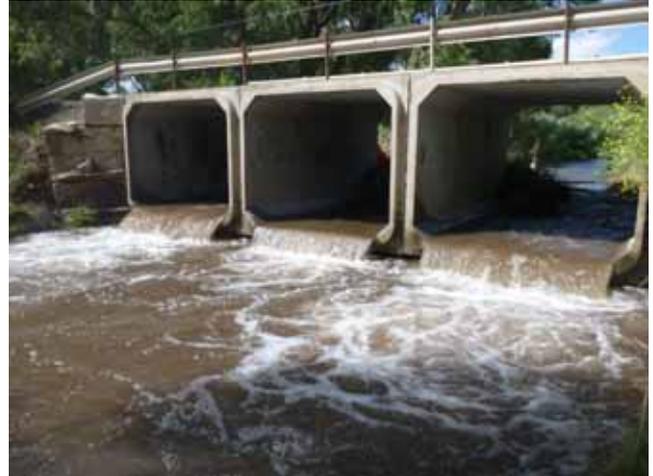
**Figure 7. View of water flow under Close Road bridge on 8-11-14**

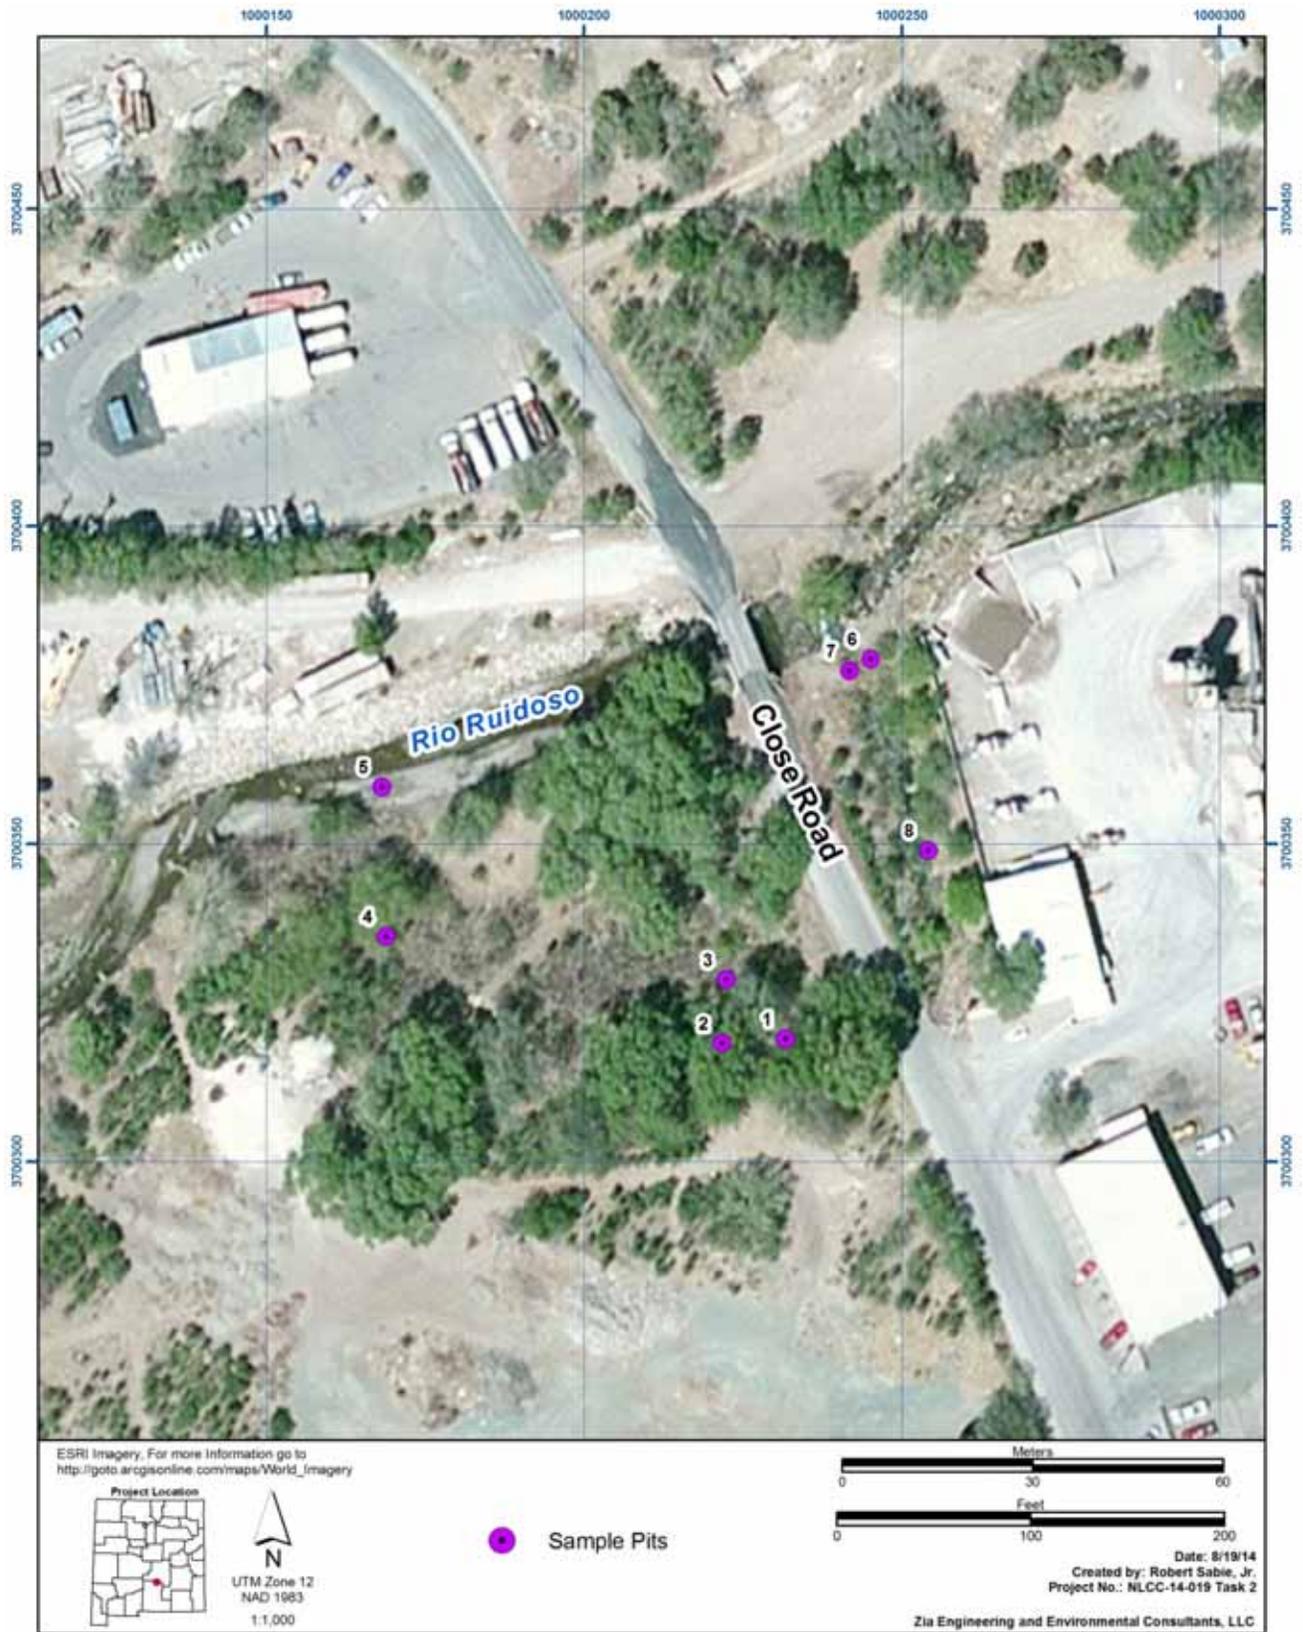
Figure 8. Sample Pit Locations

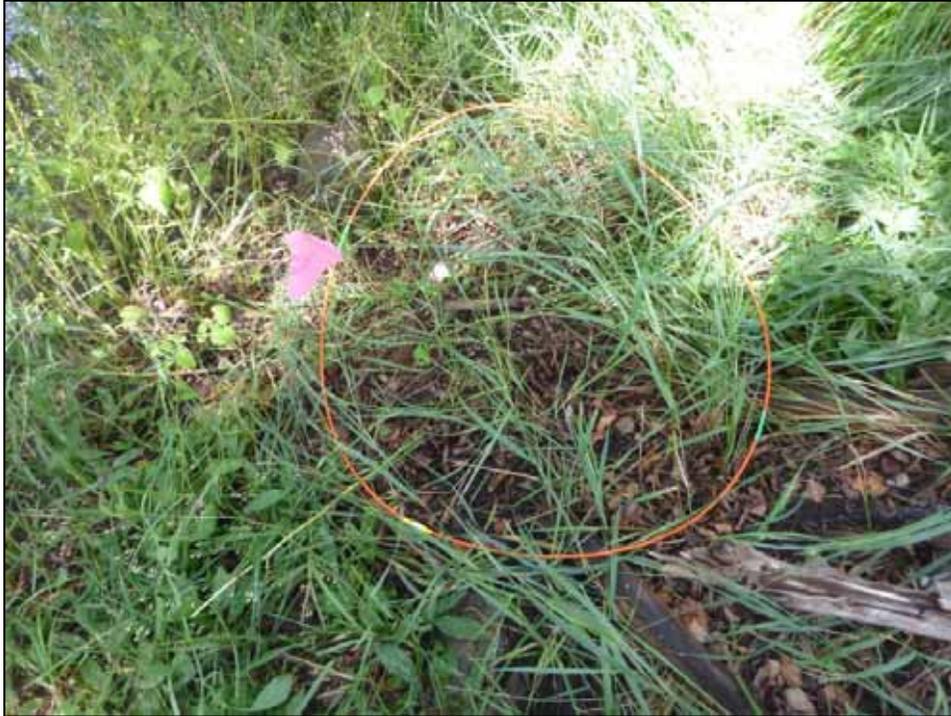
Figure 9. Soil Pit 1

Sample Pit Location 1 was chosen since it was located in a low lying area on the east side of Close Road near the culvert that ran under the roadway. At the time of the survey, water was observed at the surface in the vicinity. Of the three criteria for wetlands, only the hydrology was met within this area. The findings are described in the following sections. This area encompasses data sheet with sampling point designated SP 1. The data sheet describing the designated area is found in Appendix A.

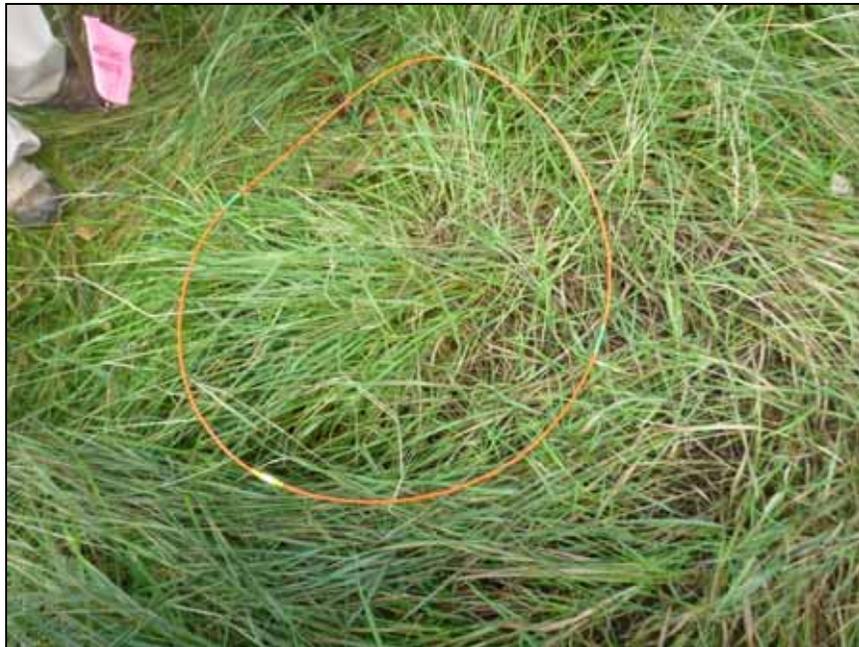
**Figure 12. Sample Pit 2**

Sample Pit Location 2 was chosen since it was located in a low lying area on the east side of Close Road located further east but surface water is seen nearby. Of the three criteria for wetlands, only the hydrology was met within this area. The area also contains fill material from the side banks. The findings are described in the following sections. This area encompasses data sheet with sampling point designated SP 2. The data sheet describing the designated area is found in Appendix A.

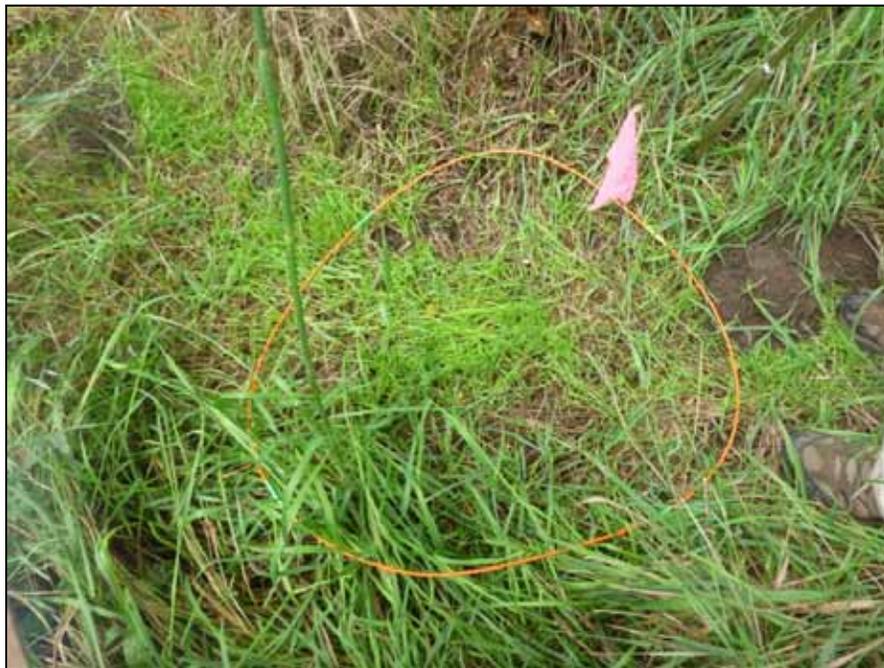
**Figure 14. Sample Pit 3**

Sample Pit Location 3 was chosen since it was located in what appeared to be previous waterway on the east side of Close Road located further east but surface water is seen nearby. Of the three criteria for wetlands, none were within this area. The findings are described in the following sections. This area encompasses data sheet with sampling point designated SP 3. The data sheet describing the designated area is found in Appendix A.

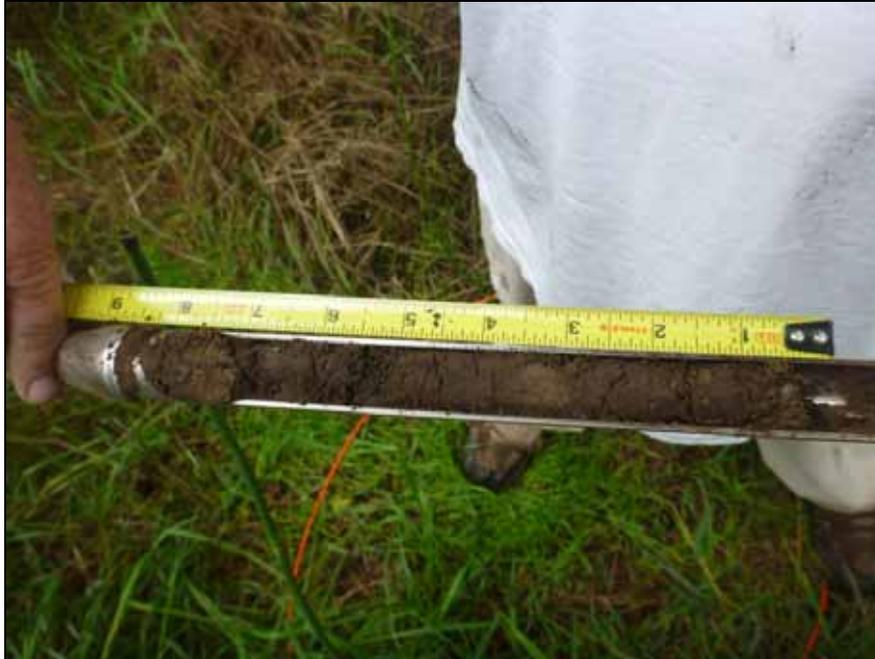
Affected Environment/ Resource Area	No Action Alternative	Proposed Action Alternative	Mitigation Measures
Physical Resources			
Geology and Soils	The existing culvert crossing and waterway would continue to have the potential during flood events to be overtopped or washed out, damage public transportation infrastructure, and accelerate soil embankment erosion.	Short-term adverse effects on soils/sediments from ground disturbances and soil exposure.	A SWPPP (Zia 2014e) will be enforced by the Village during construction. Construction will take during the lowest flow of water within the Rio Ruidoso. The contractor will be responsible for proper maintenance of construction equipment.

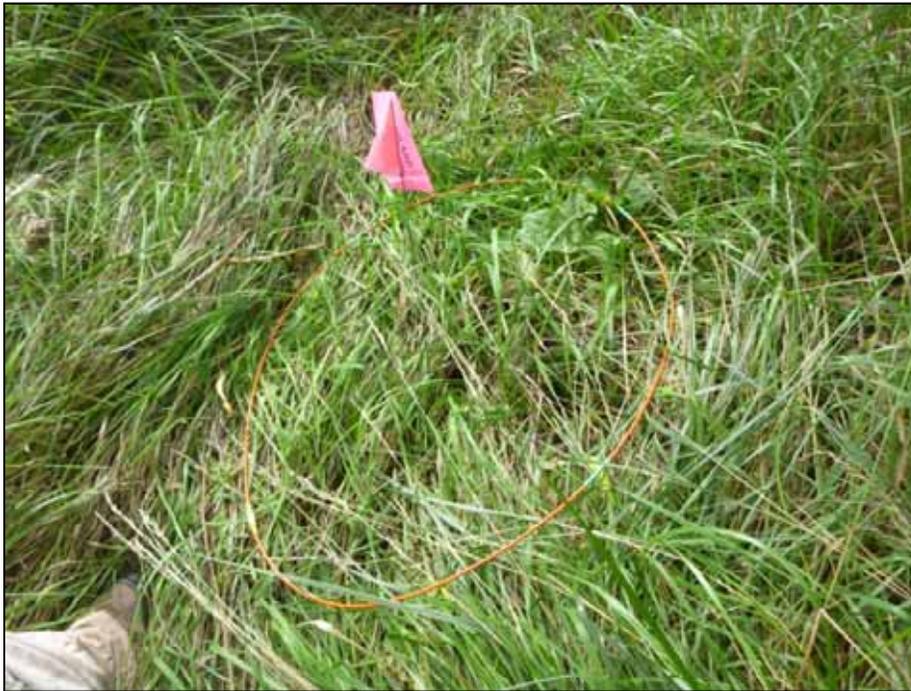
**Figure 16. Sample Pit 4**

Sample Pit Location 4 was chosen since it was located in what appeared to be a previous waterway on the east side of Close Road located further east but surface water is seen nearby. Of the three criteria for wetlands, none were met within this area. The findings are described in the following sections. This area encompasses data sheet with sampling point designated SP 4. The data sheet describing the designated area is found in Appendix A.

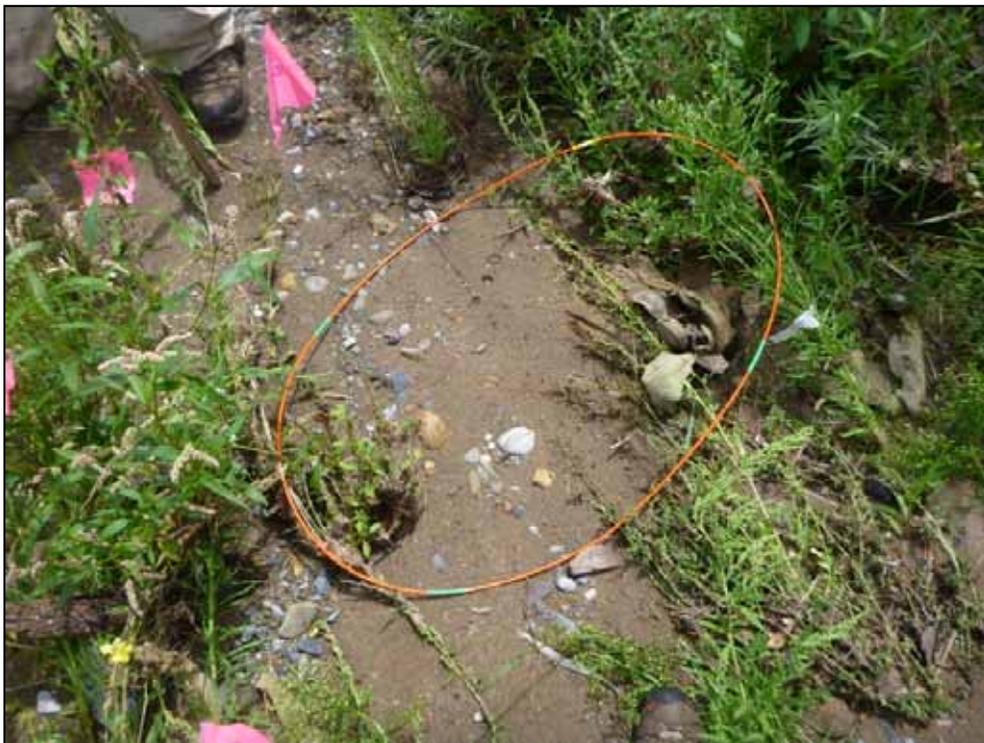
**Figure 18. Sample Pit 5**

Sample Pit Location 5 was chosen since it was alongside the Rio Ruidoso. Vegetation and water pathways alluded to the potential wetlands adjacent to the river. Of the three criteria for wetlands, none were met within this area. The findings are described in the following sections. This area encompasses data sheet with sampling point designated SP 5. The data sheet describing the designated area is found in Appendix A.

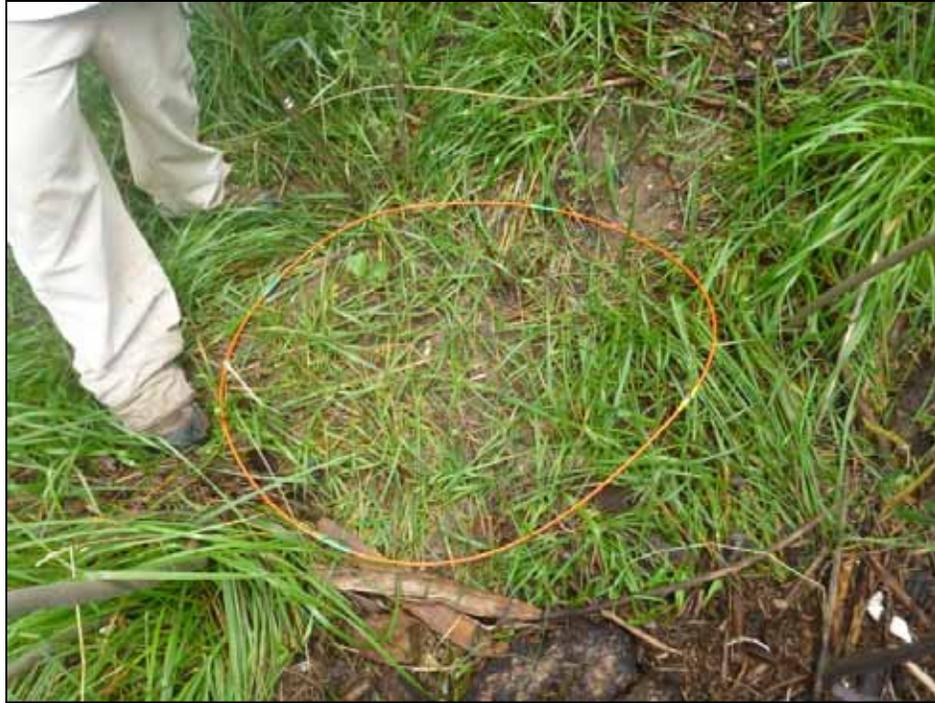
**Figure 19. Sample Pit 6**

Sample Pit Location 6 was chosen since it was located on the east side of Close Road next to a flowing waterway. Of the three criteria for wetlands, none were met within this area. The findings are described in the following sections. This area encompasses data sheet with sampling point designated SP 6. The data sheet describing the designated area is found in Appendix A.

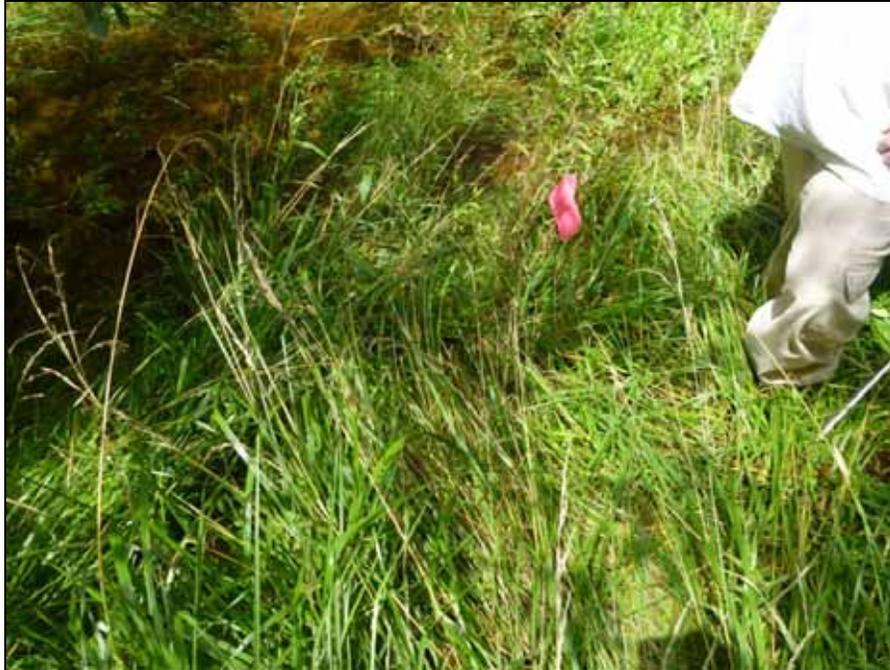
**Figure 23. Sample Pit 8**

Sample pit location 8 was chosen since it was located on the east side of Close Road next to a flowing waterway and a ponding area was observed. Of the three criteria for wetlands, only two criteria were met within this area; however this was used to confirm that the edge of the wetland area was achieved. The findings are described in the following sections. This area encompasses data sheet with sampling point designated SP 8. The data sheet describing the designated area is found in Appendix A.

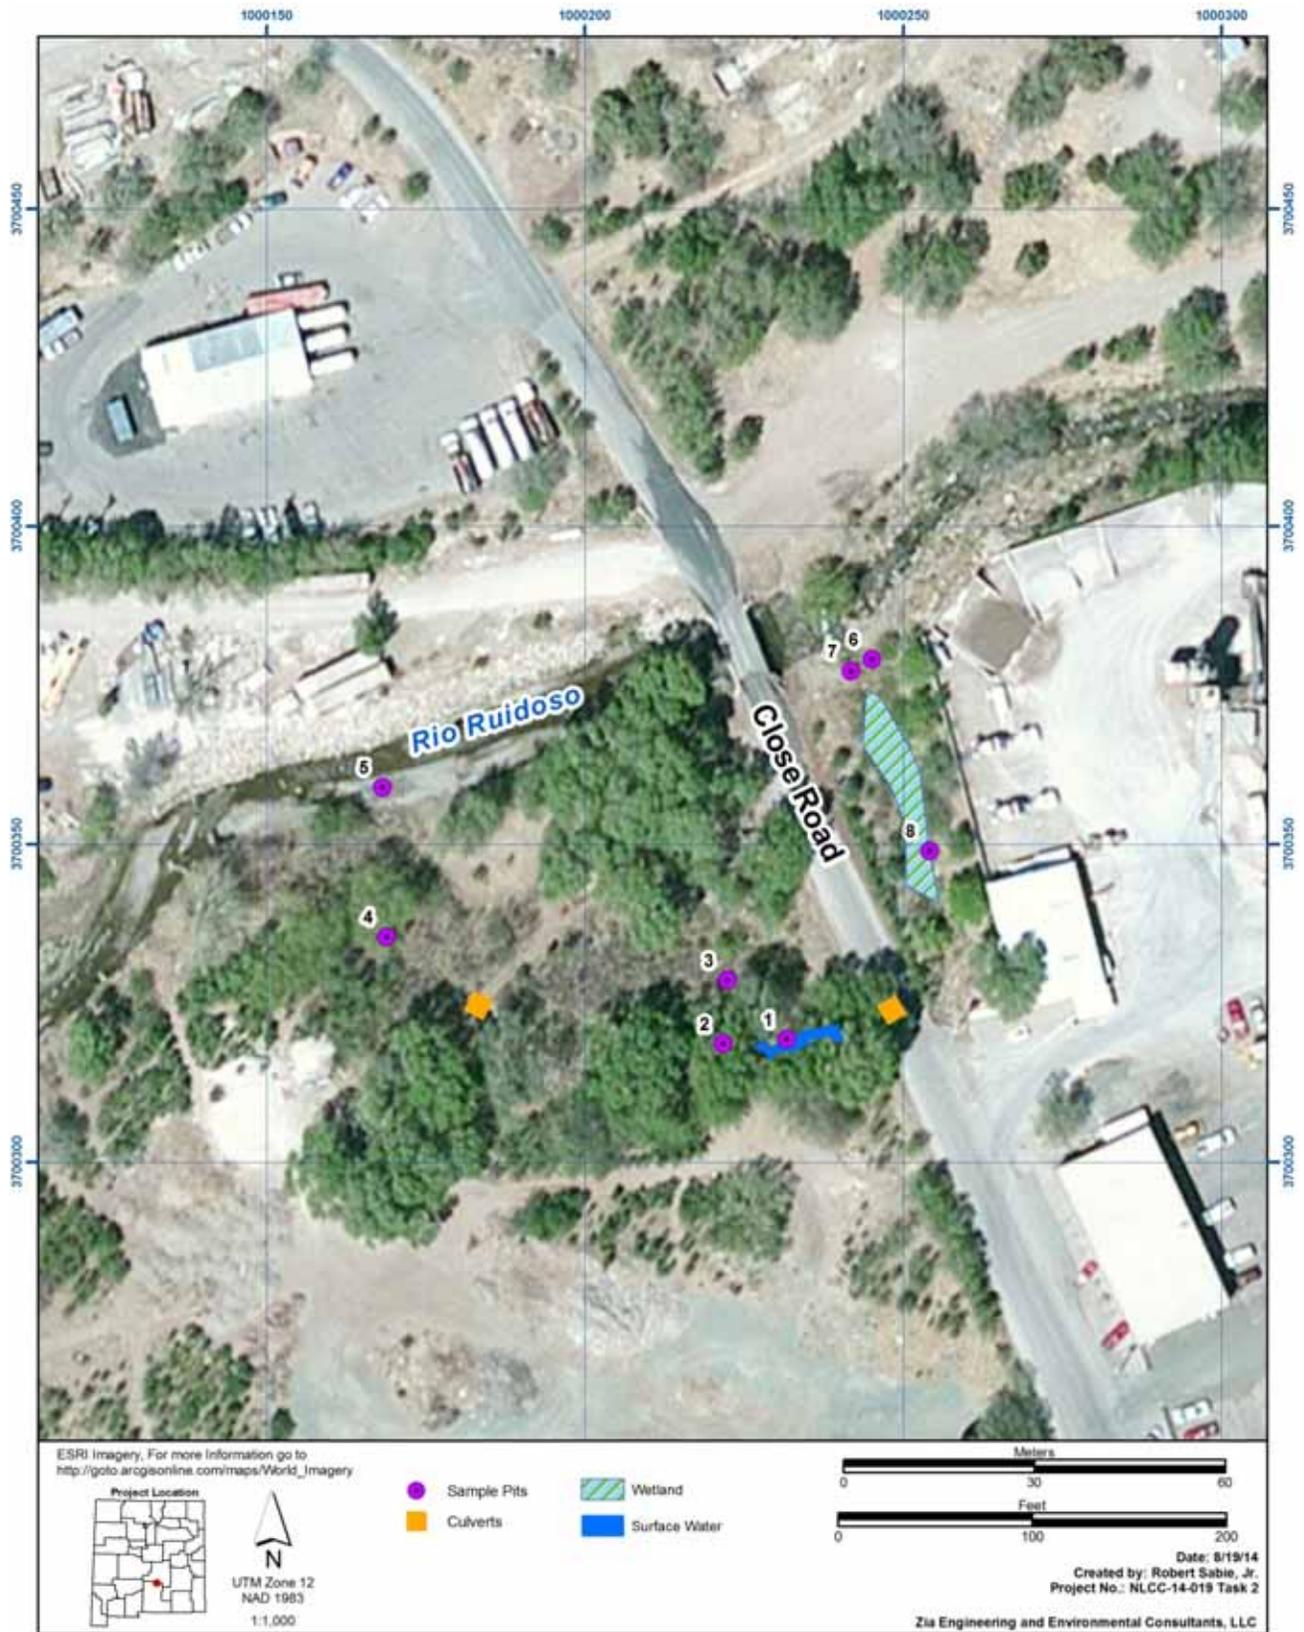
Figure 27. Mapped Wetland Area
