# APPENDIX B

## HYDROLOGIC AND HYDRAULIC STUDY

## **Post Road Channel Improvement**

The City of Carencro, Louisiana

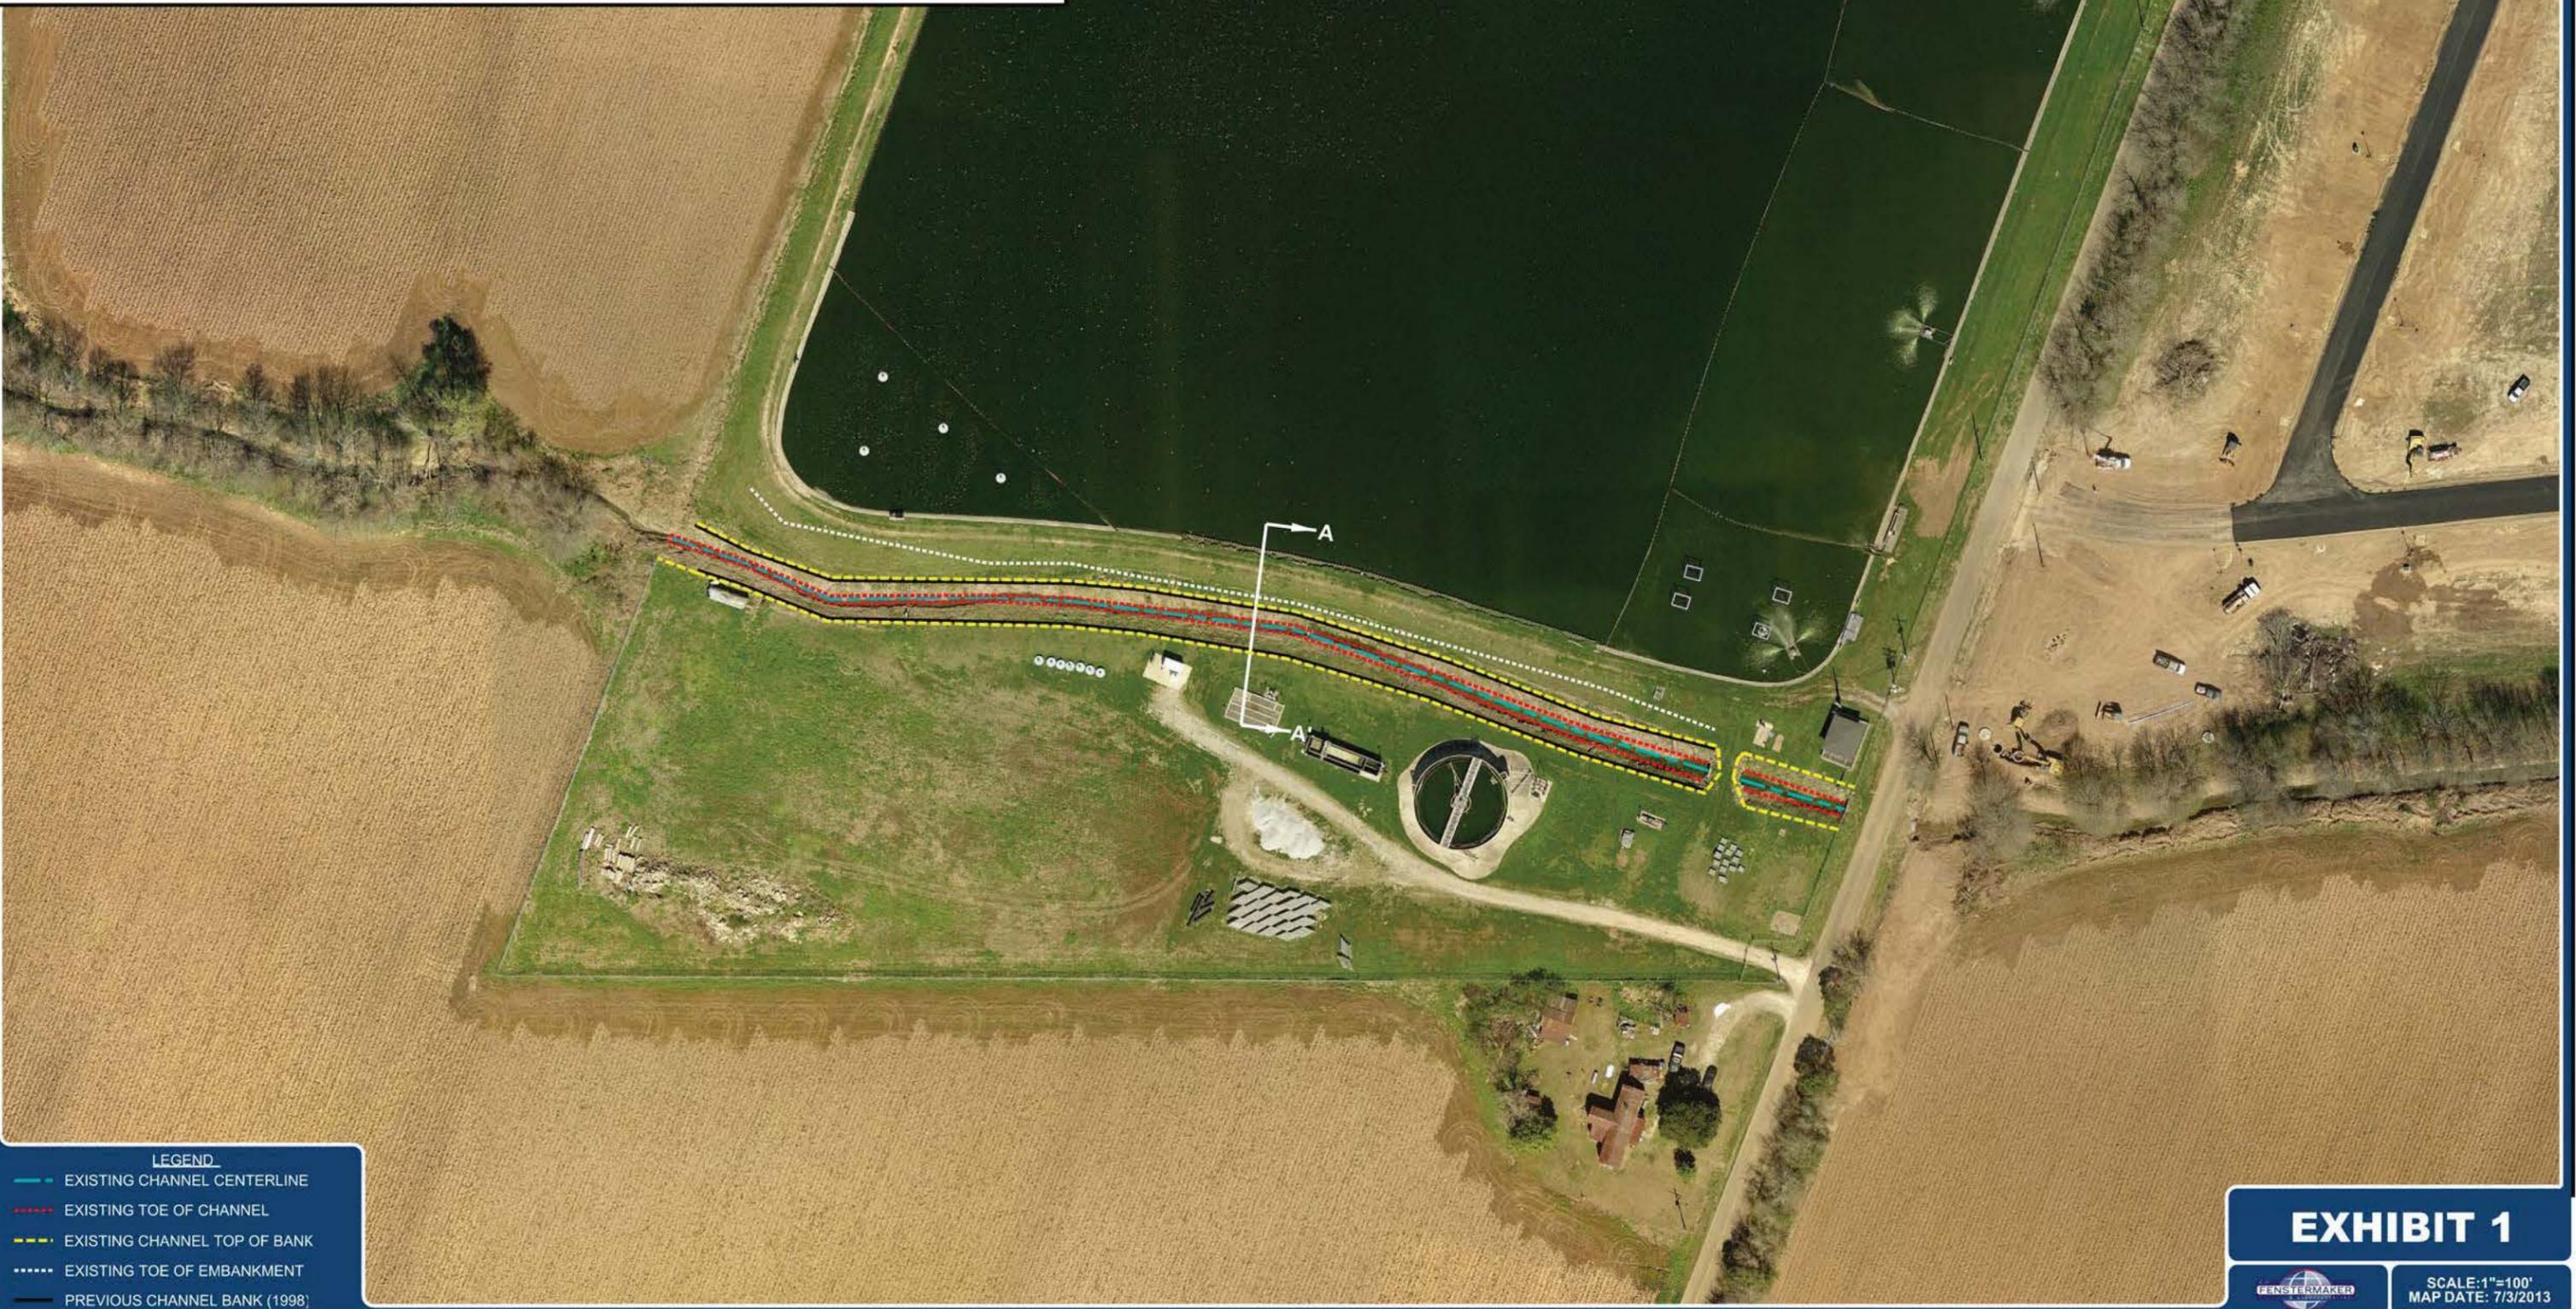
- LEGEND**
- EXISTING CHANNEL CENTERLINE
  - ... EXISTING TOE OF CHANNEL
  - - - EXISTING CHANNEL TOP OF BANK
  - ... EXISTING TOE OF EMBAKMENT
  - PREVIOUS CHANNEL BANK (1998)

The Post Road wastewater treatment facility lies upstream from the City of Carencro, Louisiana. The plant has been the primary wastewater facility of the City of Carencro for the past 30+ years. On the southern boundary of the pond exists an unnamed drainage channel which serves a western portion of Carencro as well as unincorporated areas of Lafayette Parish. The channel continues east and discharges into the Beau Bassin Coulee. The Beau Bassin Coulee traverses through the heart of the City of Carencro and eventually discharges into the Vermilion River just north of the City of Lafayette. C.H. Fenstermaker and Associates was tasked with analyzing the unnamed channel for the purpose of developing erosion protection measures in order to prevent an embankment failure which would potentially discharge 16 million gallons of untreated wastewater into the coulee which will flow through the City of Carencro, into the Vermilion River, and then eventually through the city of Lafayette. The project examined approximately 780 feet of the channel that flows along the Post Road Treatment Facility (see Exhibit 1 for project map).

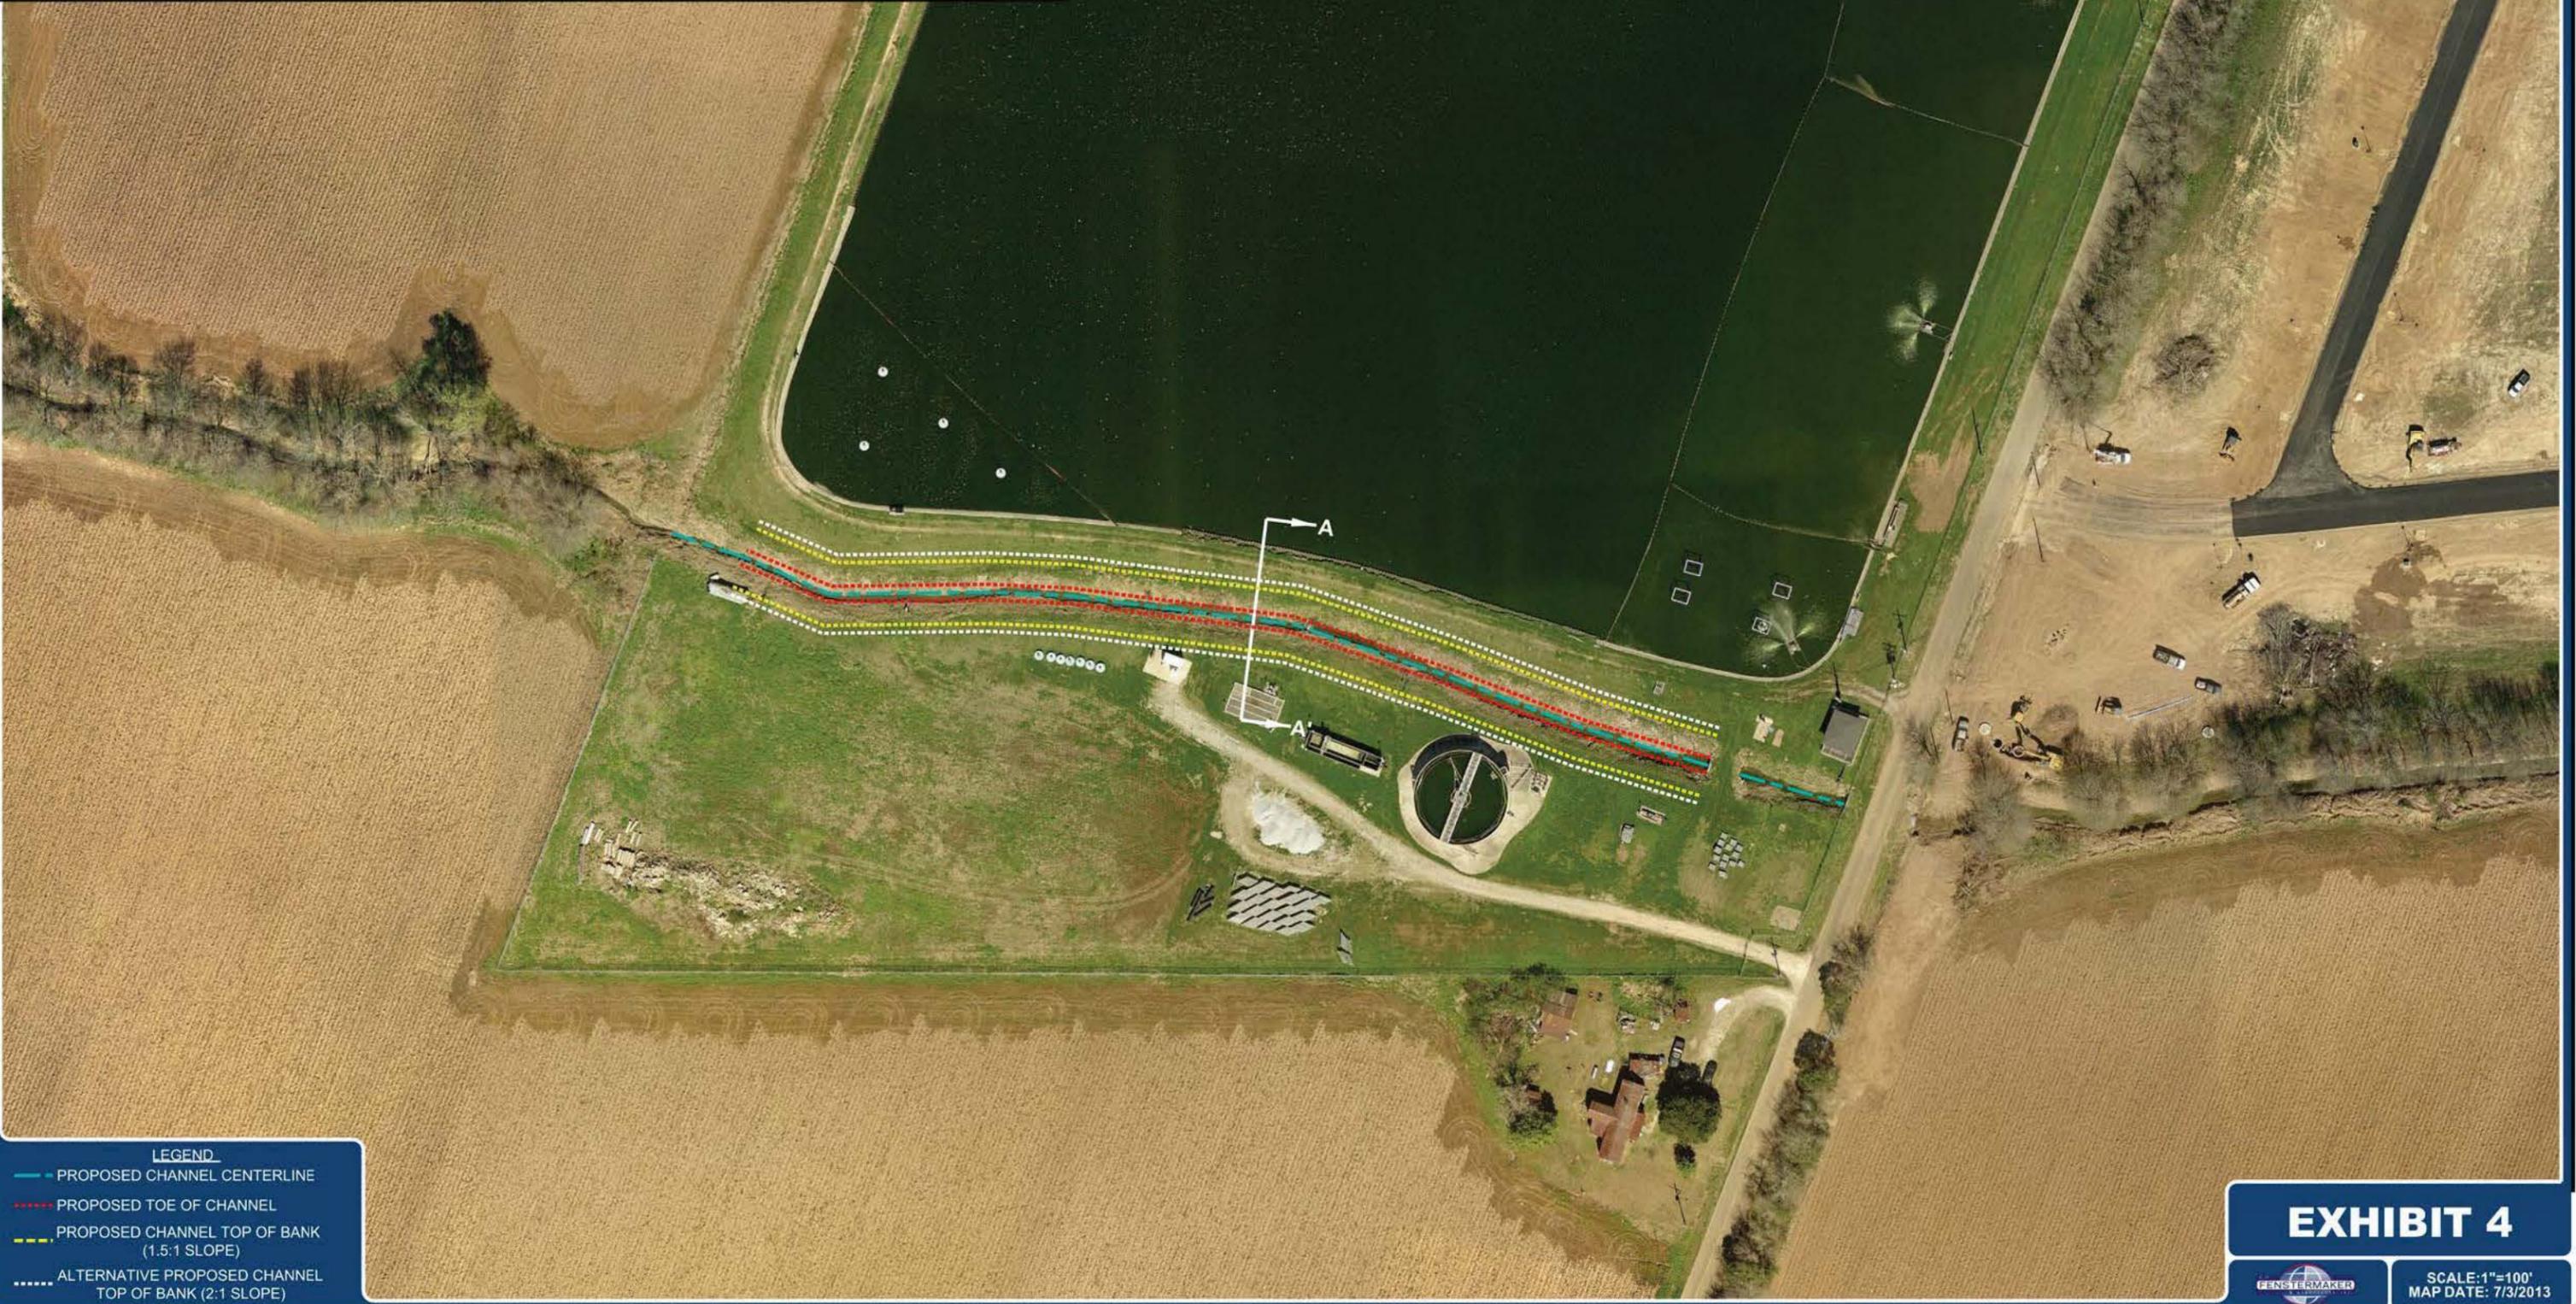
EXHIBIT 3

- STRUCTURAL CONCRETE LINED CHANNEL - 780 FT.
- EXISTING CHANNEL - 8,300 FT.

TOTAL CHANNEL LENGTH - 9,110 FT.

- LEGEND**
- PROPOSED CHANNEL CENTERLINE
  - PROPOSED TOE OF CHANNEL
  - PROPOSED CHANNEL TOP OF BANK (1.5:1 SLOPE)
  - ALTERNATIVE PROPOSED CHANNEL TOP OF BANK (2:1 SLOPE)

The proposed concrete channel was designed using a water discharge for a 10-year storm frequency.
