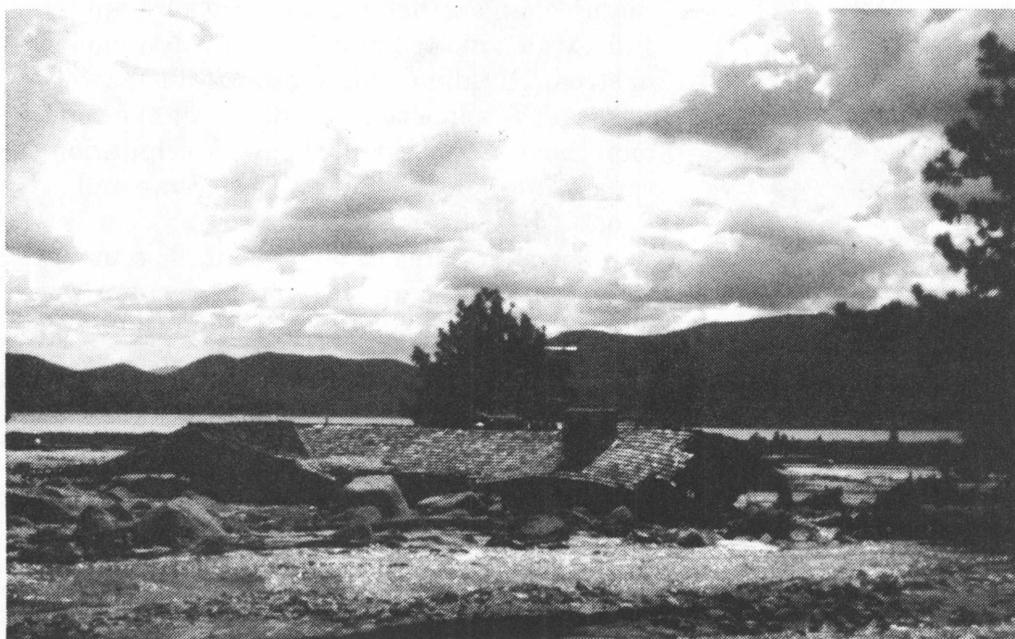
Figure 17.
House destroyed by
1983 Slide Mountain,
Nevada landslide
(photograph by
Robert J. Watters,
University of
Nevada, Reno).

In 1983 a large mass of rock detached from Slide Mountain in Nevada. The mass slid into Upper Price Lake, an irrigation reservoir, displacing most of the water which overtopped and breached the dam, flowing into Lower Price Lake. This lake's dam was also breached. The water flowed into Ophir Creek where it collected large amounts of debris and became a debris

flow. After traveling about four kilometers and dropping 600 meters in elevation, the debris flow emerged from the canyon onto the alluvial fan of Ophir Creek (total time—15 minutes). One person was killed, four injured, and numerous houses and vehicles were destroyed (Figure 17) (Watters, 1988).
