# Building Performance

## 3.1 Wind Hazard Observations

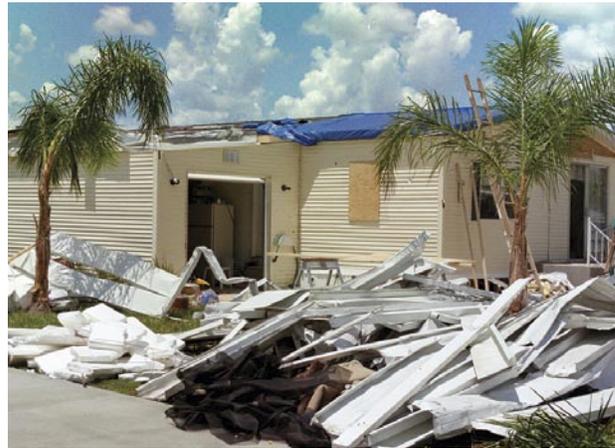
Manufactured housing that had structural damage resulting from accessory structure failure.

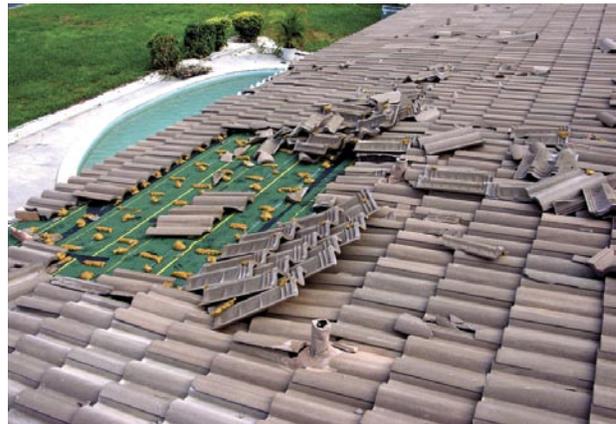
In addition to the damage shown in this photo, this one-story roof lost virtually all of the hip and ridge tiles during Hurricane Charley. (Punta Gorda Isles)

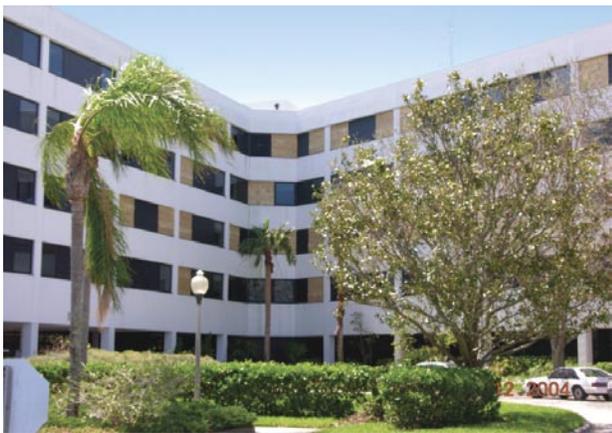
Aggregate from the Indian River Memorial Hospital's roof (Vero Beach) broke several of the patient room windows (which were covered with plywood after Hurricane Frances).

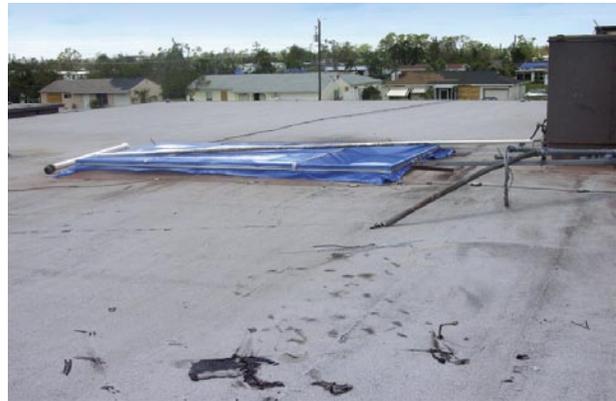
A large HVAC package unit was blown off this curb during Hurricane Charley. Note the loose LPS conductors this side of the curb. This school had significant damage from several pieces of rooftop equipment that blew off the building roof. (Port Charlotte Middle School)

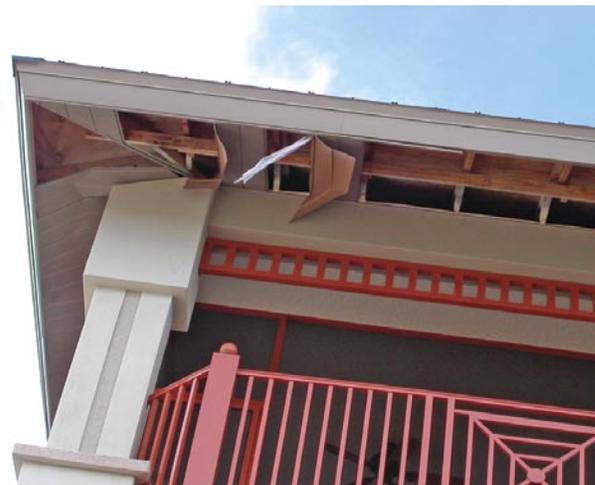
Soffit damage on the third story of a multi-family building. (Captiva Island)

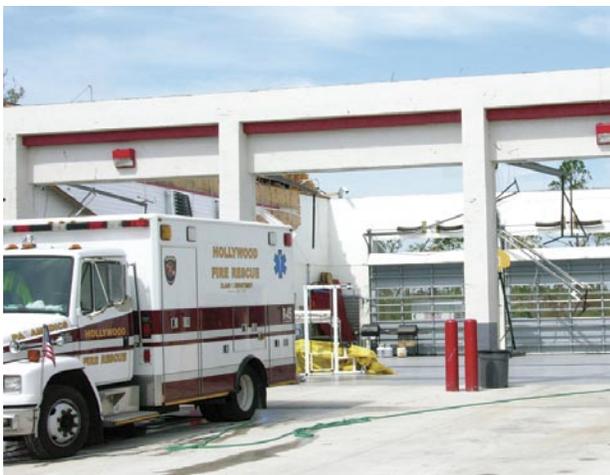
Failure of three of six new doors on a fire station in Charlotte County resulted in the loss of the entire roof structure over the apparatus bay during Hurricane Charley.

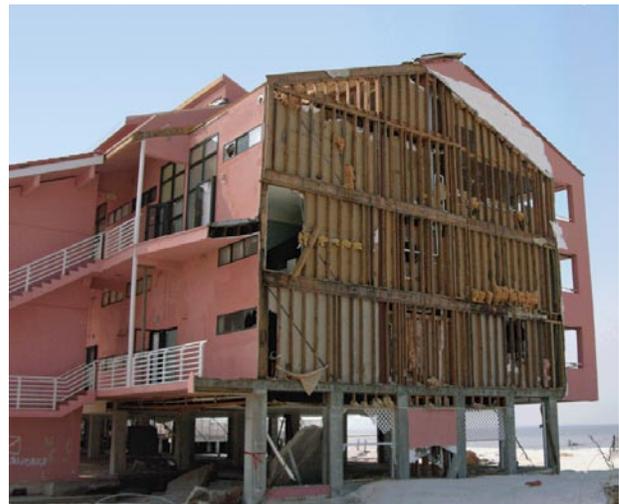
Example of wall cladding failure. The building had synthetic stucco installed over molded, expanded polystyrene insulation and gypsum board. The gypsum board blew off during Hurricane Ivan.

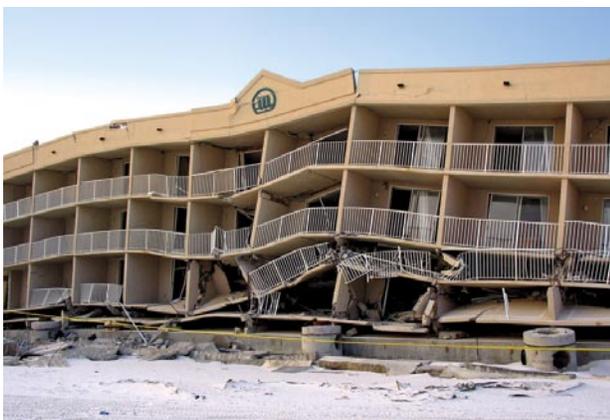
A multi-family condominium collapsed after Hurricane Ivan due to erosion of supporting soil under the shallow foundation.

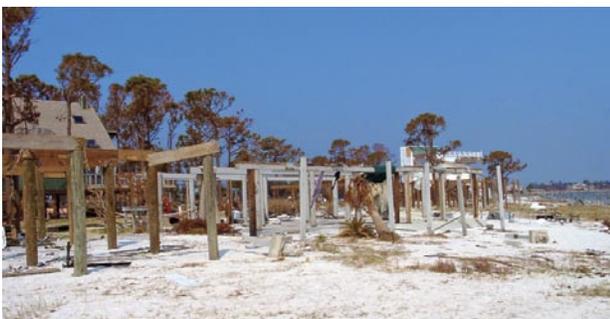
Several structures were completely torn off their pile foundations during Hurricane Ivan as a result of significant flood depths, waterborne debris impacts, and lack of connections.

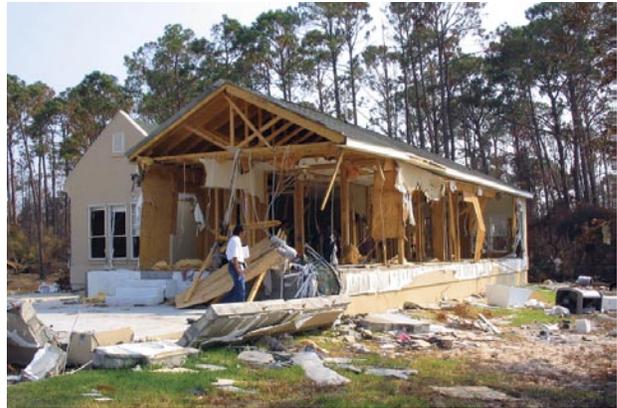
Flood water from Hurricane Ivan exceeded the required elevation of the top of the lowest floor supported by the stem wall foundation for this house leading to severe damage caused by waves and debris impact.

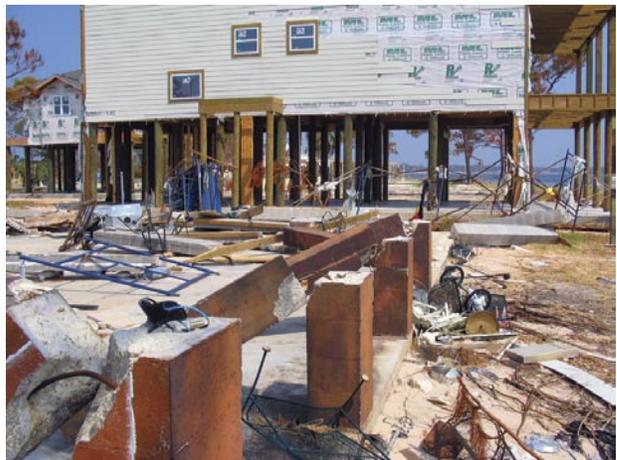
High flood levels during Hurricane Ivan and lack of structural capacity to withstand waves and debris loads caused this reinforced pier foundation to fail.

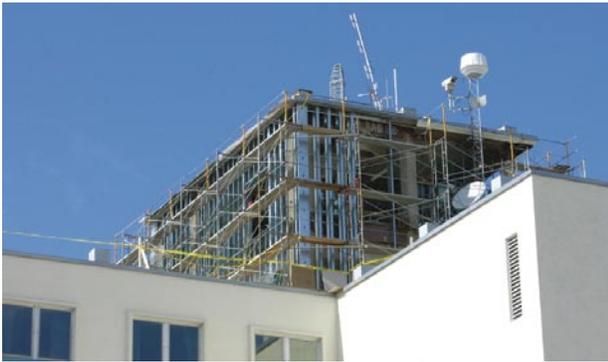
At the Martin Memorial Hospital (Stuart, Florida) wall panels blew off the elevator penthouse during Hurricane Frances. Rain water entered the elevator equipment room damaging much of the equipment. The falling panels punctured the main roof and at least one of the lower roofs. Because of rain water infiltration and lack of elevator service, floors 2 through 6, which contained 75% of the hospital's beds, were inoperative. Many patients were relocated to other hospitals until the penthouse walls were re-sheathed and new elevator equipment was installed.

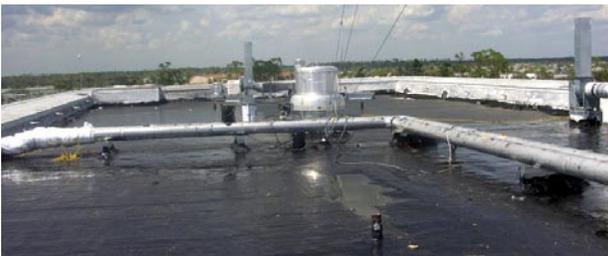
An emergency roof (shown) was installed after Hurricane Charley blew the mechanically attached PVC membrane roof covering off the concrete deck of the Fawcett Memorial Hospital.

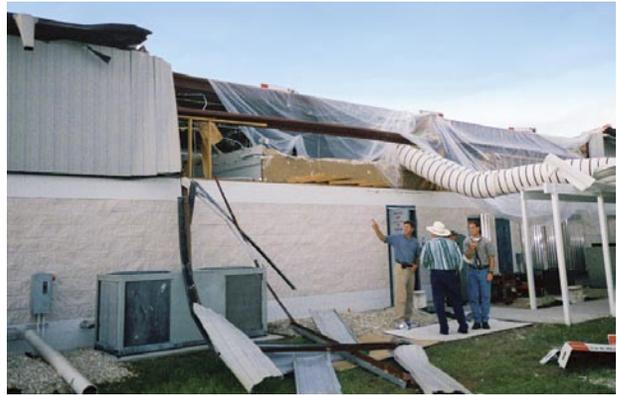
The Charlotte County Sheriff's Office/County EOC, located in a pre-engineered metal building, was significantly damaged and completely taken offline. Despite having openings protected with shutters, the building failed by loss of roof panels (failure of roof clips) and loss of metal wall panels. These failures allowed damaging amounts of rain and debris to enter the facility resulting in closure of the building. The county was aware of the weakness of this facility, and prior to Charley, had begun the design process for a new county EOC facility that would meet statewide Enhanced Hurricane Protection Areas (EHPA) requirements and guidelines not used in the design of the existing structure.

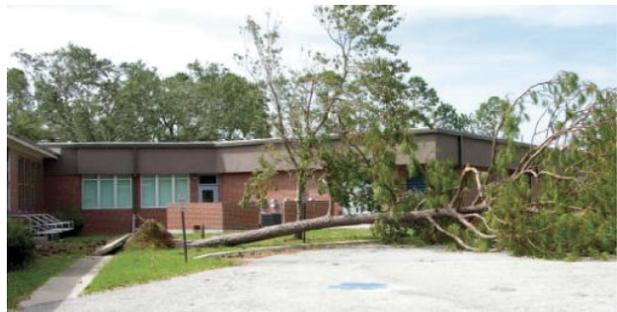
This school building experienced several building envelope problems, which allowed water intrusion, but it did not disrupt operations. Damage and disruptions may have been worse if design wind speed conditions had been experienced.
