# Introduction

## 1.1 Hurricane Ivan – the Event

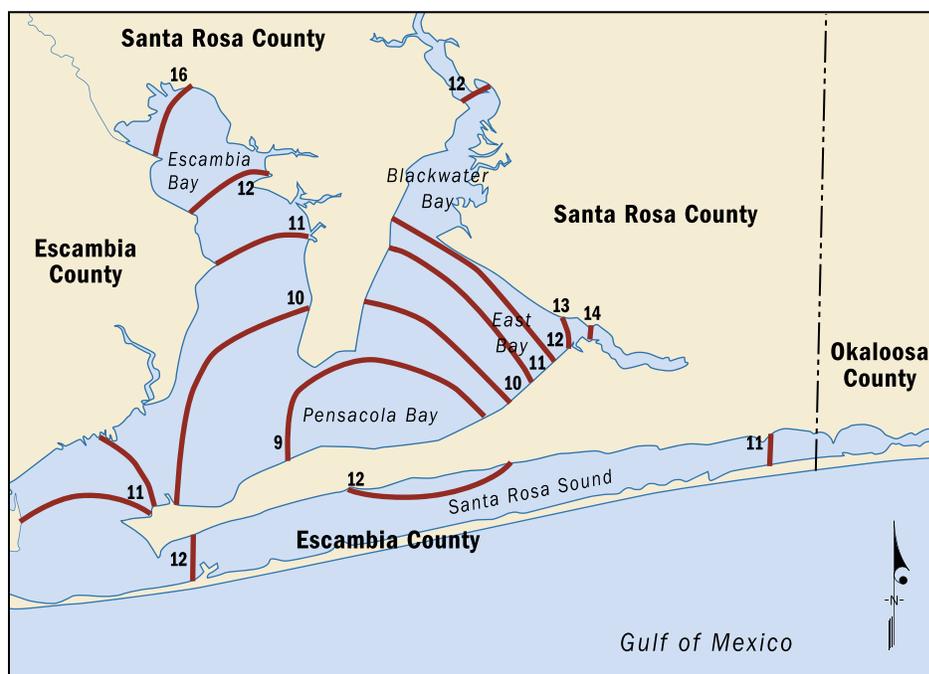
Figure 1-4.  
Surge elevation contours  
in Santa Rosa County,  
Florida

Figure 1-4 shows the surge elevation contours in Santa Rosa County. The HWM elevations in Santa Rosa County were generally found to be much higher than the effective BFEs in the inland bay areas. Along Pensacola Bay, the HWMs were generally 2-6 feet higher than the effective BFEs. However, there were also instances where the two elevations were equal, such as at Garcon Point along Pensacola Bay (both equal to 10 feet). Along Escambia Bay, the HWMs were found to be approximately 3-4 feet higher than the BFEs, and along East Bay, approximately 3-6 feet higher. Along the northern shoreline of Santa Rosa Sound, the HWM elevations differed from the BFEs by about +2 feet, while along Blackwater Bay, the HWMs were about 2-4 feet higher than the BFEs. As with the other impacted counties, several HWM elevations could not be compared to effective BFEs because the areas are currently mapped as Zone X, without established elevations.

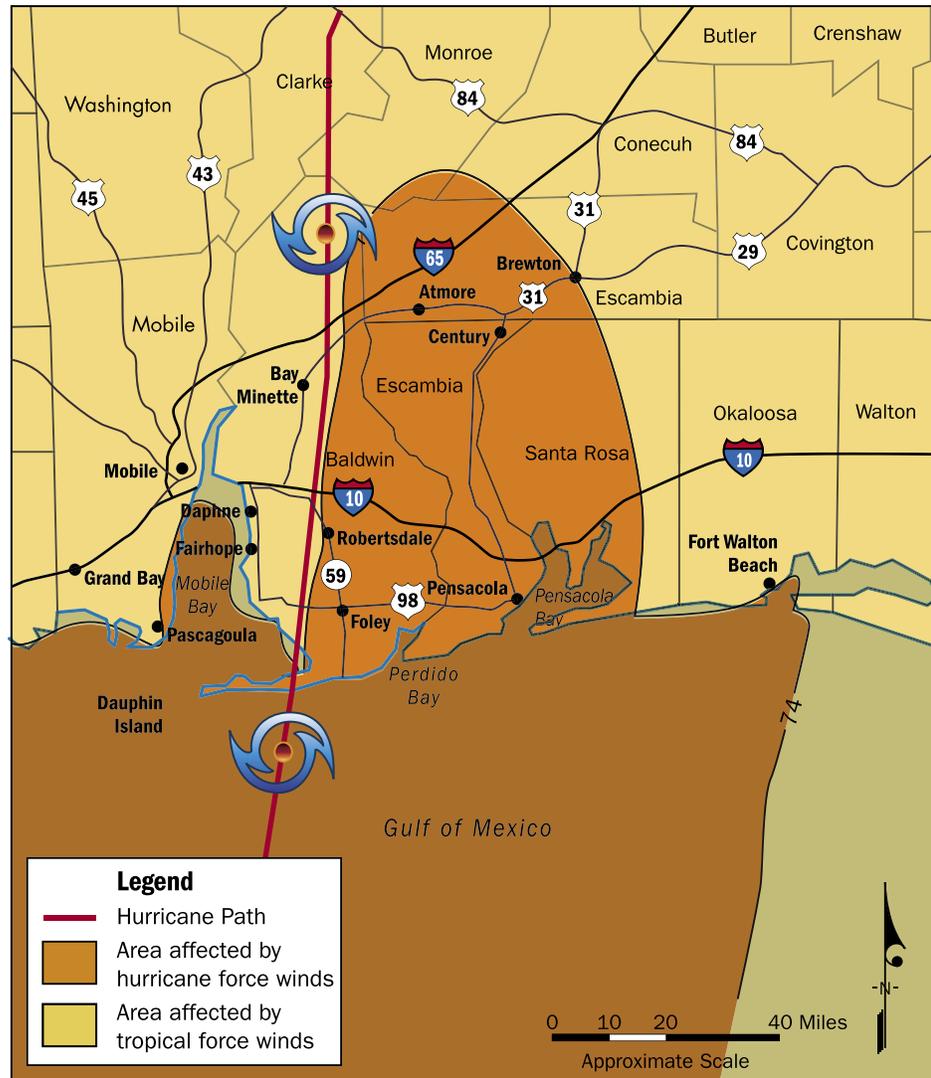
Figure 1-18.  
Extent of hurricane and  
tropical storm force  
winds for Hurricane Ivan

Figure 1-18 shows the approximate extent of tropical storm winds (39 to 73 mph, 1-minute sustained) and hurricane force winds (greater than 74 mph, 1-minute sustained) for Hurricane Ivan. These wind speed contours are based on a combination of actual wind readings and wind field models. The first wind field model is the H\*wind program (Weather and Forecasting, September 1996) produced by the Atlantic
