Performance of Critical and Essential Facilities

6.1 Emergency Operation Centers

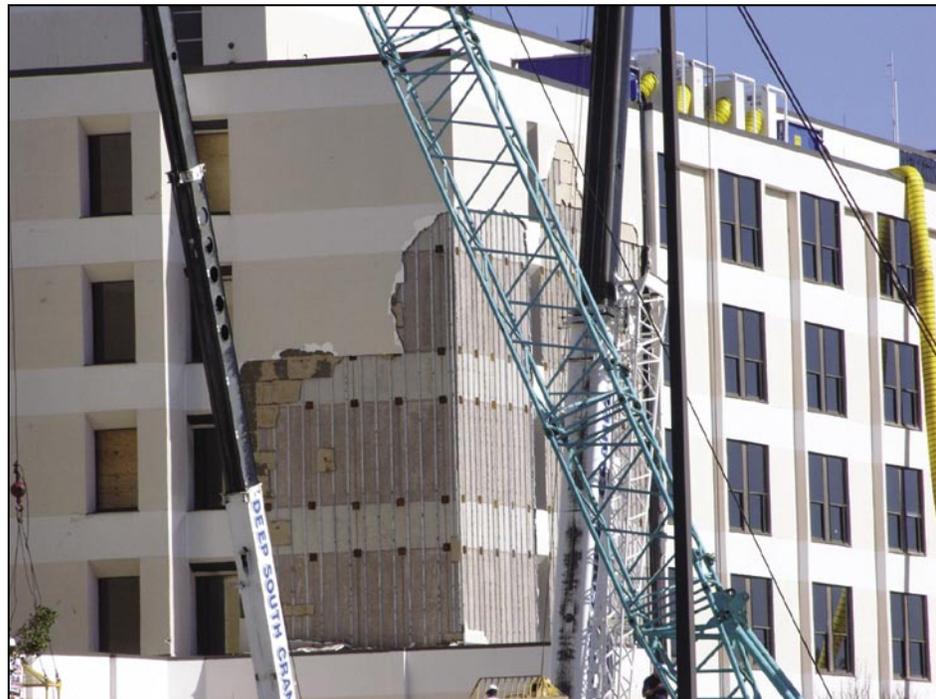
Buildings at four of the five hospital complexes experienced roof membrane damage – damage was significant at three of the facilities. Windows were broken at four of the complexes, with significant damage at one of them. EIFS blew off the walls at two complexes. At both complexes, the EIFS failures resulted in disruption of elevator service (see Figures 5-15 and 5-16). At one of the complexes, the EIFS failure resulted in significant glazing damage (see Figures 5-16 and 6-2). Rooftop equipment and LPSs were damaged at four of the complexes. Communications towers and antennas were damaged at two complexes. A loading dock canopy was blown away and several tall parking lot light fixtures collapsed at one complex. Sewage backed up in a cancer treatment facility because of power loss to a lift station. Tree-fall caused roof damage to a materials management building (an ancillary building at one complex).

Figure 6-2.
View of EIFS damage
at hospital building
(Pensacola)

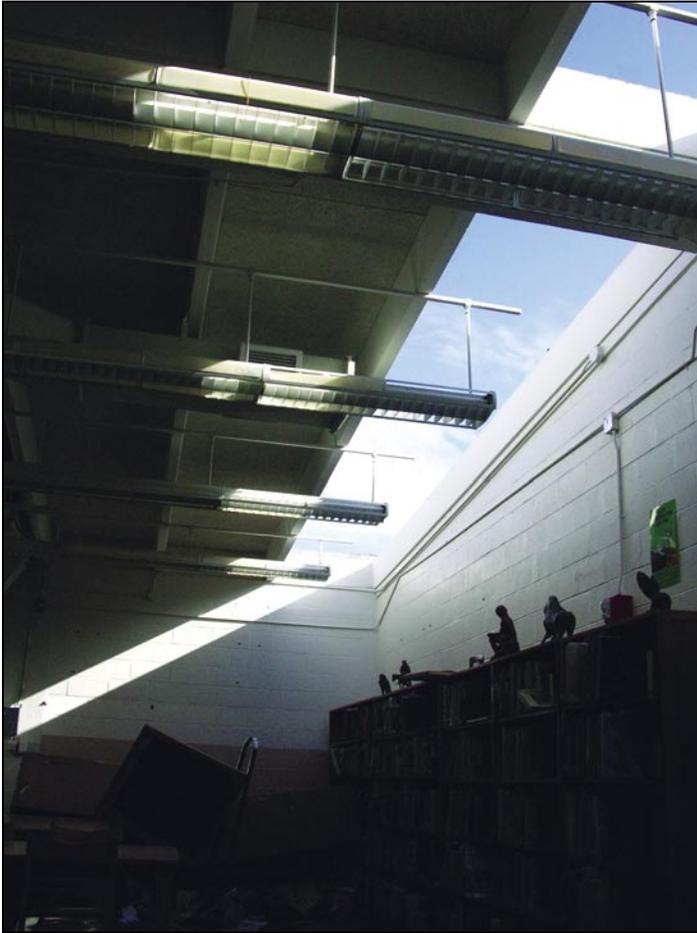
A limited amount of structural damage was observed. It consisted of collapsed walkway canopies at a few schools (Figures 4-98 and 6-5), loss of a portion of wood joists and roof decking at one school, loss of roof decking at one school (Figure 6-6), loss of an auto shop roof structure and portion of a CMU load-bearing wall (Figure 6-7), and loss of roof joists and collapse of CMU walls at an HVAC chiller enclosure. At three of the schools that experienced structural damage, portions of the schools were used as shelters. However, the structural damage did not occur where people were sheltered.

Figure 6-6.
Loss of cementitious wood-fiber roof deck panels at Workman Middle School (Pensacola)

The Workman Middle School sheltered approximately 25 people, including about 10 police officers who came in from patrol shortly before arrival of the high winds. Although a portion of the school complex experienced structural damage (Figure 6-6), no injuries were reported. Occupants took shelter in a newer building on campus that did not experience structural failure. As shown in Figure 3-26, a substantial amount of windborne debris (primarily roofing and canopy components from the school) was airborne in this area.
