Inventory of Lifelines in the Cajon Pass, California

Earthquake Hazard Reduction Series 60

Submitted to the Federal Emergency Management Agency
Washington, D.C.

INTECH Inc.
11316 Rouen Dr.
Potomac, MD 20854-3126

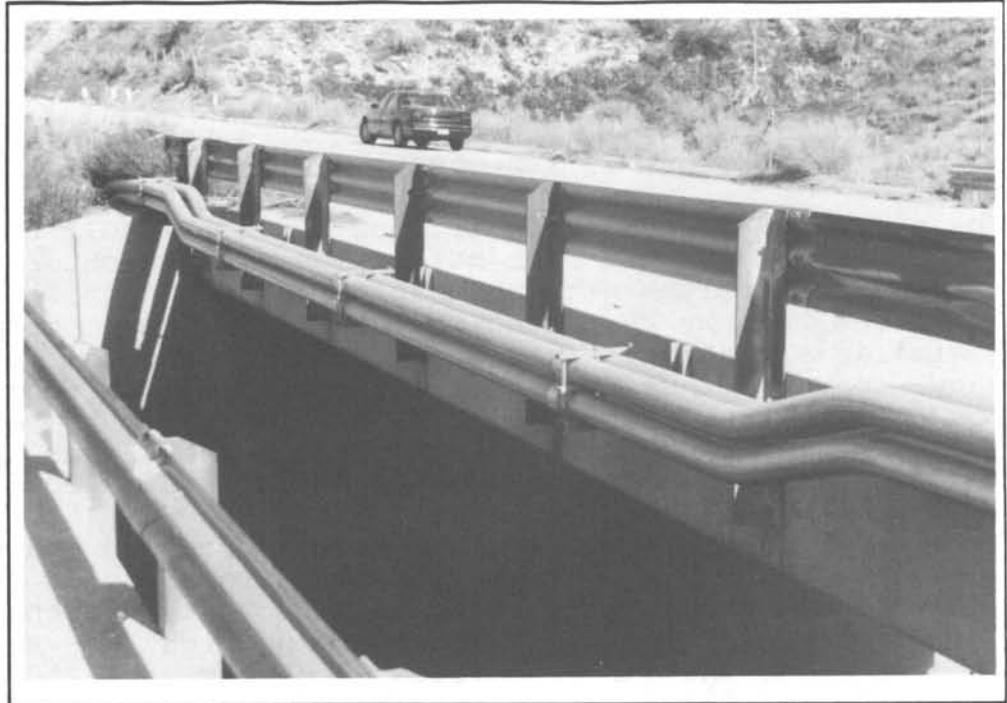
However, at bridge or culvert locations they are routed above ground along the bridge or above the culvert but still underground. Figure 3.2-3 is a typical example of the supports used to hang the cable conduits from the bridge. Earthquake criteria were not used in designing these supports. It is noted that this

Figure 3.2-3 Fiber Optic Conduits Crossing a Cajon Canyon Road Bridge

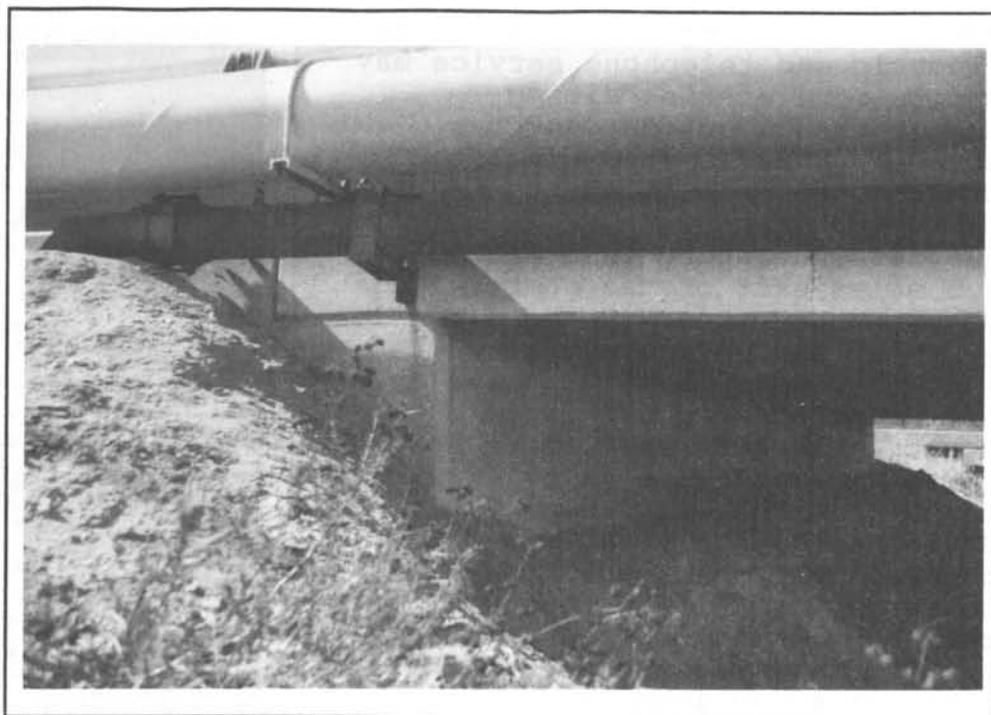
After about 2.25 miles the unimproved road (and AT&T and WTG West conduits) turn north by northeast. The conduits follow this winding road and approach the north bound section of I-15 about 0.5 miles south of the first I-15 intersection north of the Cajon Summit (the Caliente and Mariposa intersection) where they connect with and then follow the route of Mariposa Road. Mariposa Road runs parallel and east of the northbound lanes of I-15. As was done on the old Highway 66, whenever there is a bridge on the Mariposa Road the conduits are placed above ground on the bridge. Figure 3.2-8 shows a typical conduit routing at a bridge. The figure shows an additional pipe (believed to be an unidentified water distribution pipe) hung directly above the conduit.

Figure 3.2-8 A Fiber Optic Conduit Hung From a Bridge With a Water Distribution Pipe Directly Above It
