3.0 RECOMMENDATIONS

3.1 GENERAL RECOMMENDATIONS

3.2 SPECIFIC RECOMMENDATIONS

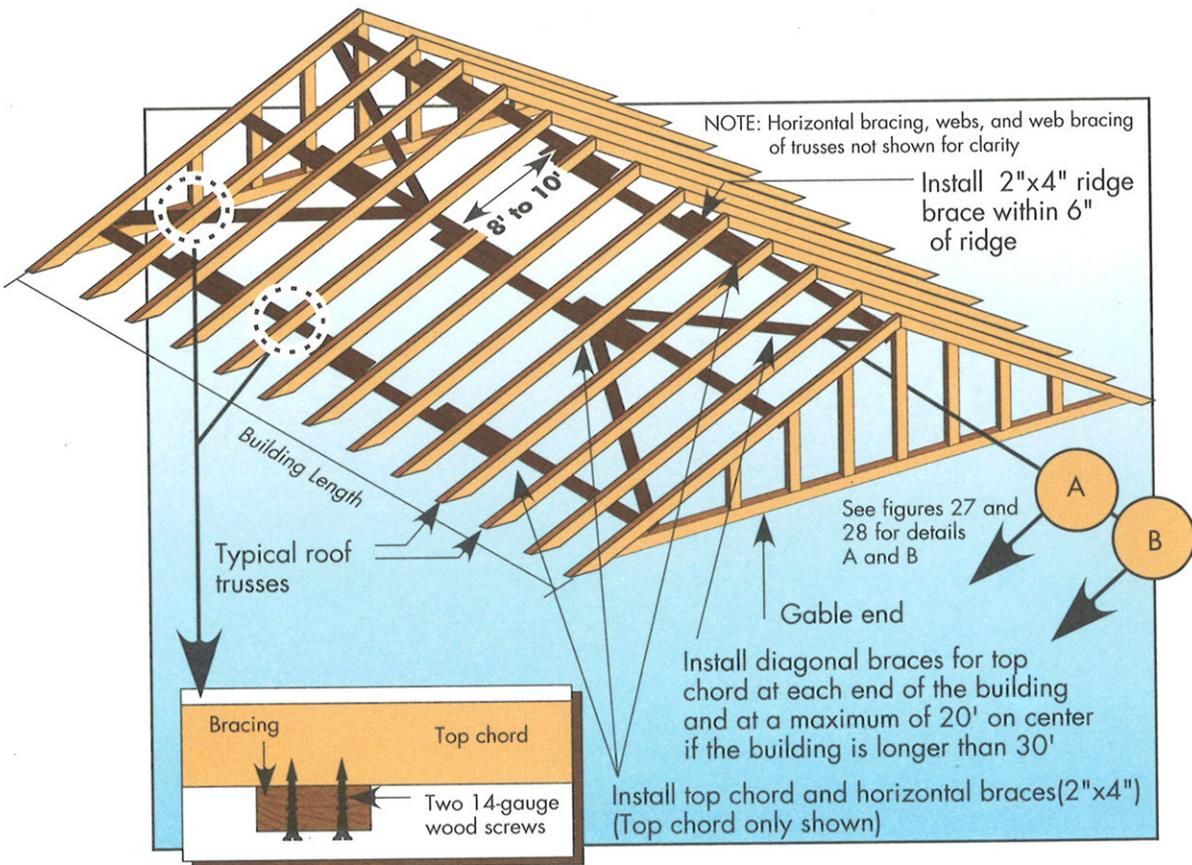
FIGURE 26. Typical roof truss top chord bracing.

1. In addition to the existing program of systematic framing inspections, a specific roof bracing and sheathing inspection should be required prior to installation of roof underlayment (SEE FIGURES 26-29). Note the extra bracing recommended for gable ends in particular.

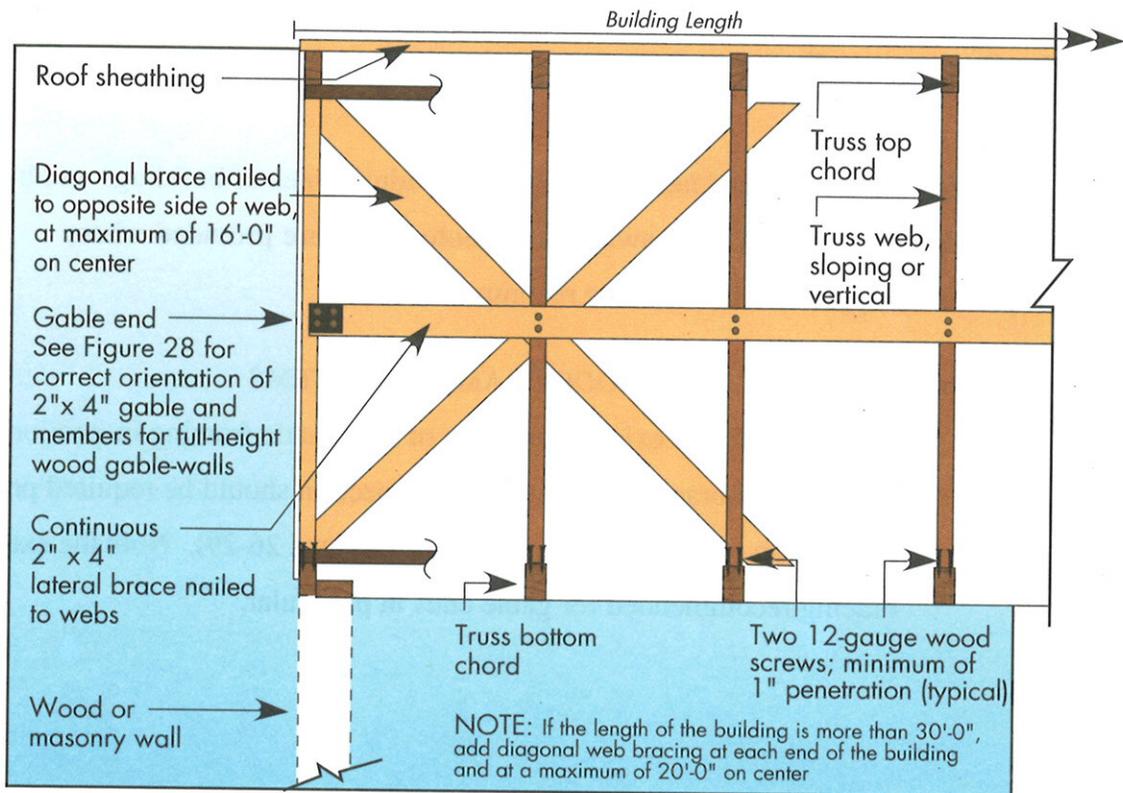
FIGURE 27. Detail A — Typical truss web bracing. Diagonal web bracing as shown, at each gable end of building.

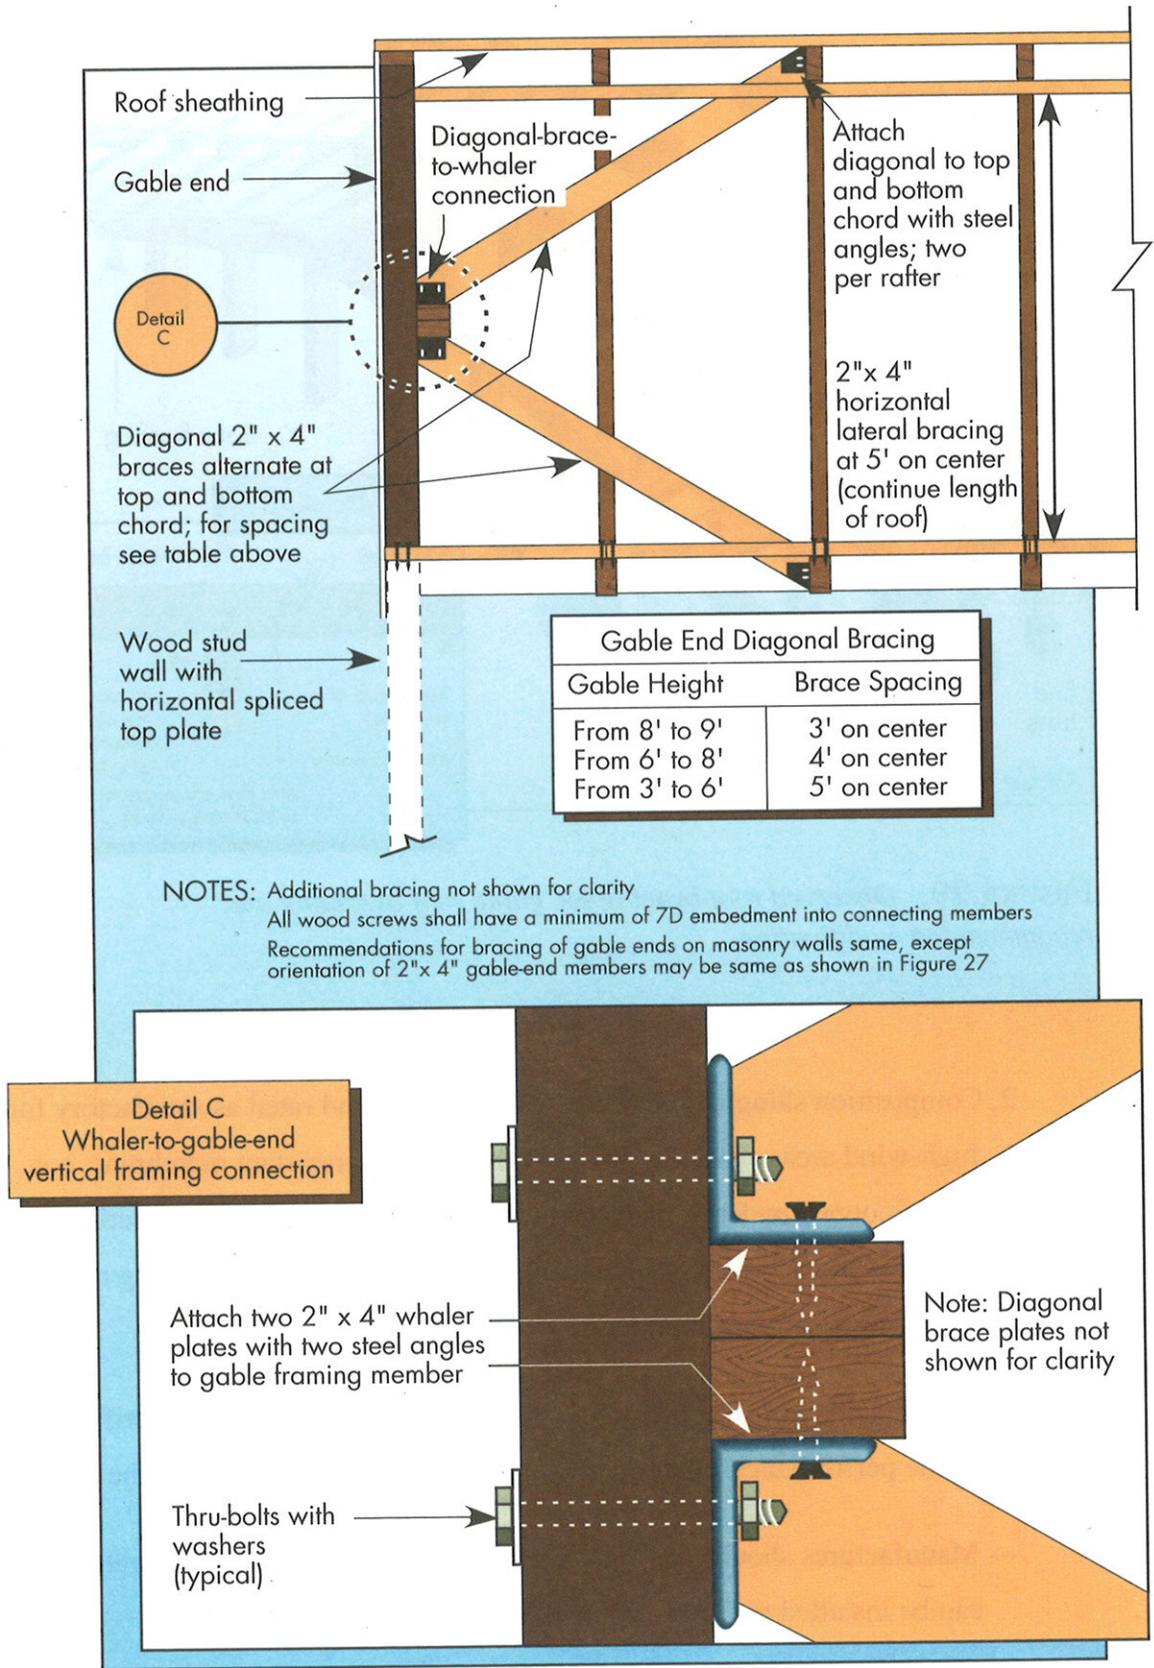
FIGURE 28. Detail B — Typical wood gable-wall bracing.

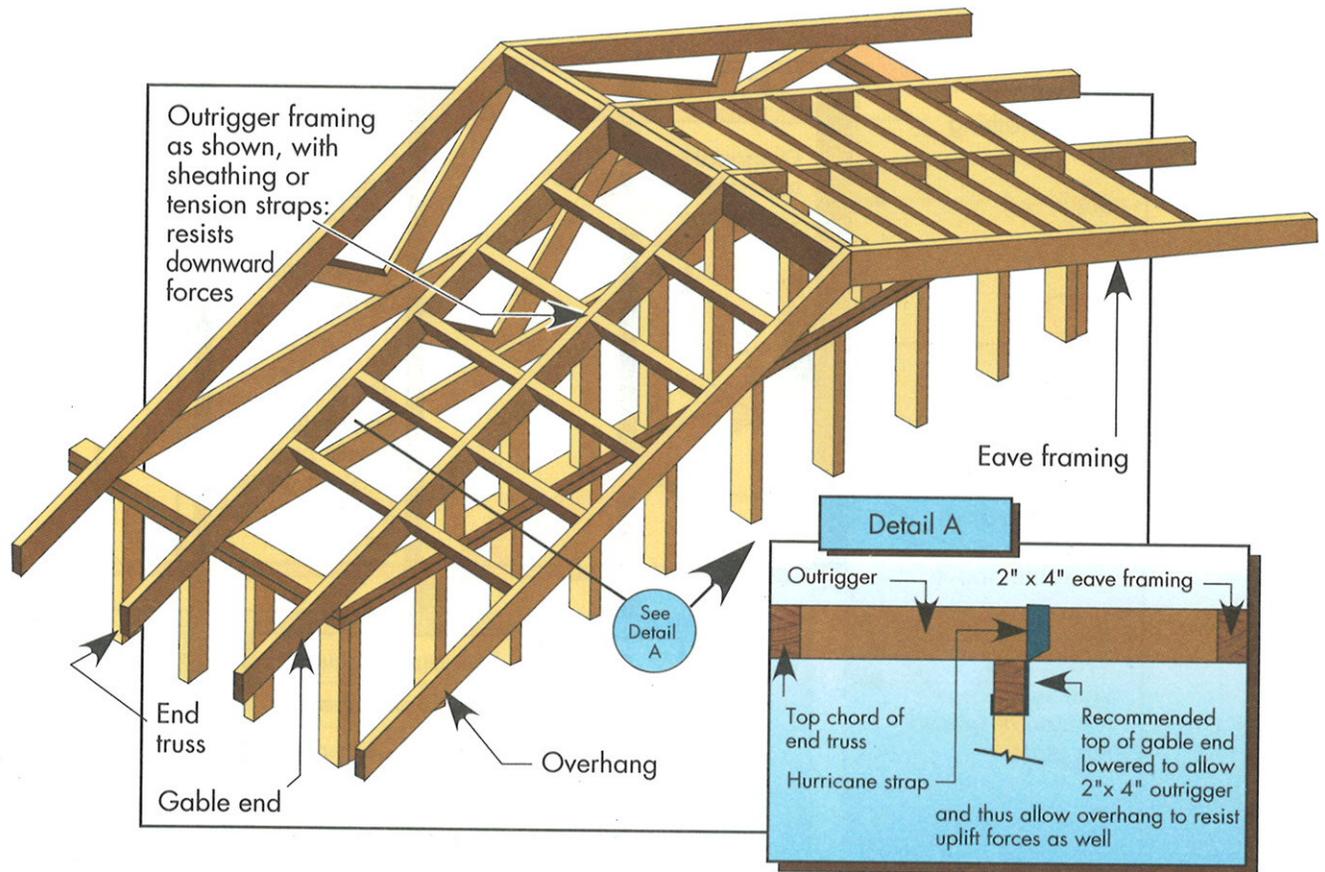
FIGURE 29. Observed roof bracing for gable roof overhang and recommended modification.

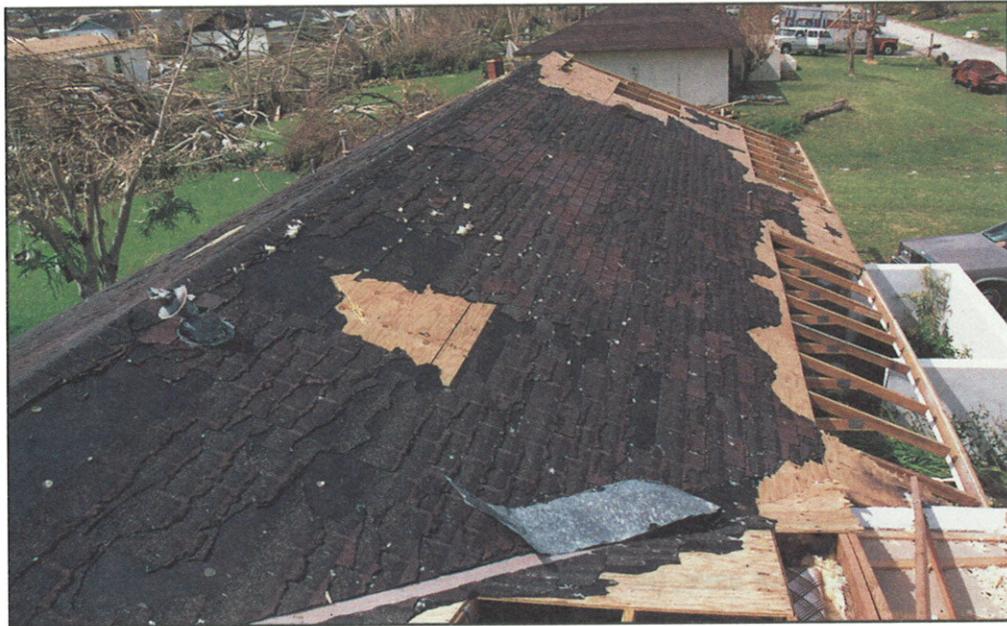
FIGURE 30. *Composition shingle and underlayment failure.*

2. Composition shingles should be manufactured and rated as satisfactory for high-wind areas. In the absence of this, a water-resistant membrane, e.g., a hot-mopped underlayment, should be installed to provide protection from the water infiltration that may result from the loss of roofing material during high-wind storms (SEE FIGURES 30 AND 31).
3. Manufacturers of roof tile products should provide testing and verification of tile performances under realistic conditions (as addressed by the Code).
 - Manufactures should verify that mortar used with extruded concrete tiles can be installed to Code requirements.

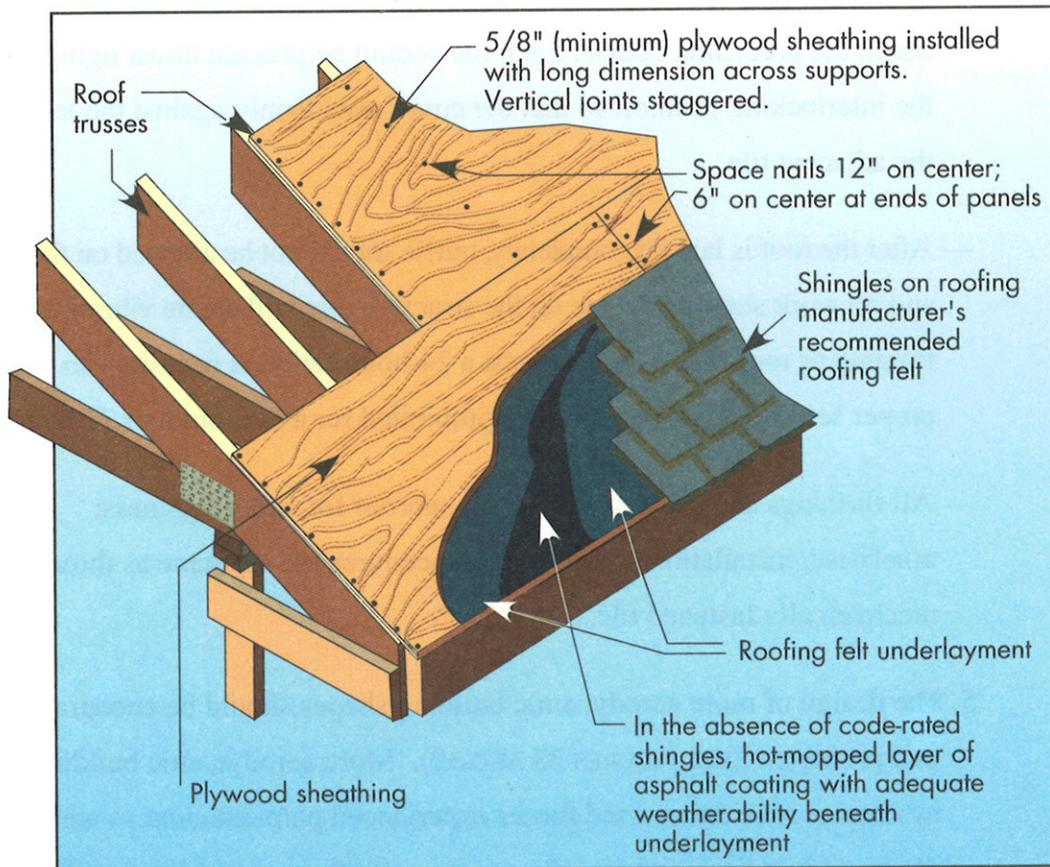
FIGURE 31. *Composition shingle roofing system showing sheathing and hot-mopped underlayment.*

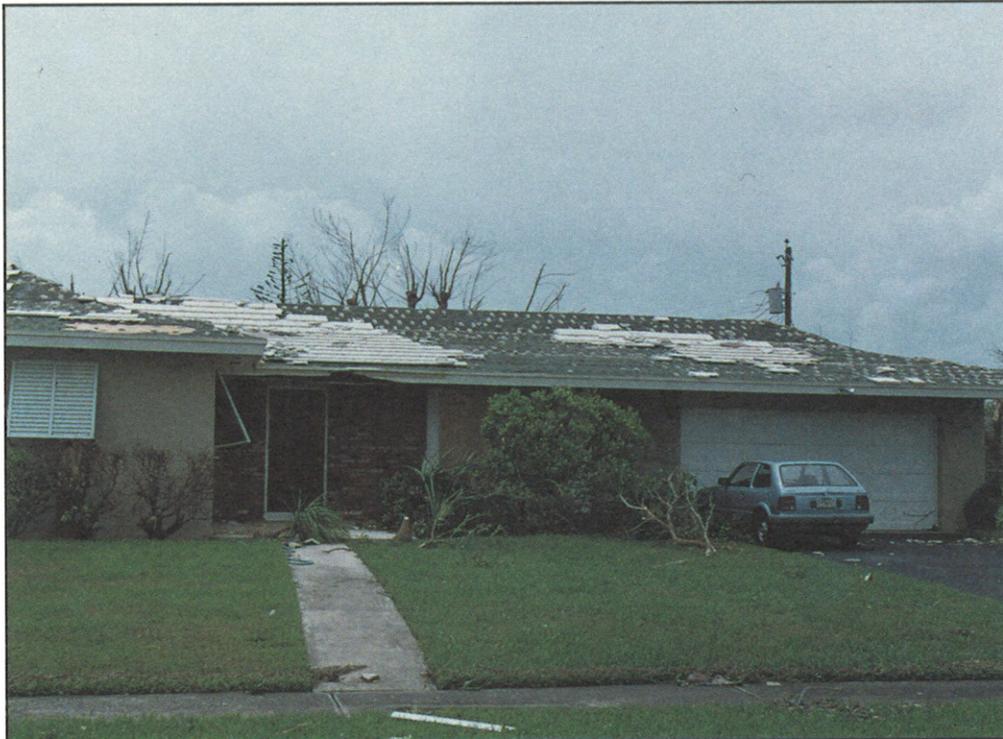
FIGURE 32. Failure of extruded concrete flat tile roofing. Bond failure between tile and mortar and between mortar and underlayment was observed.

4. Quality control of roof tile installation should be improved by ensuring both consistent mortar pad placements and installation in accordance with manufacturers' requirements, as specified by the Code. (SEE FIGURES 32-37). Though this would improve the survivability of roof tile systems, continued debris impact will result in damage occurring from future wind storms.

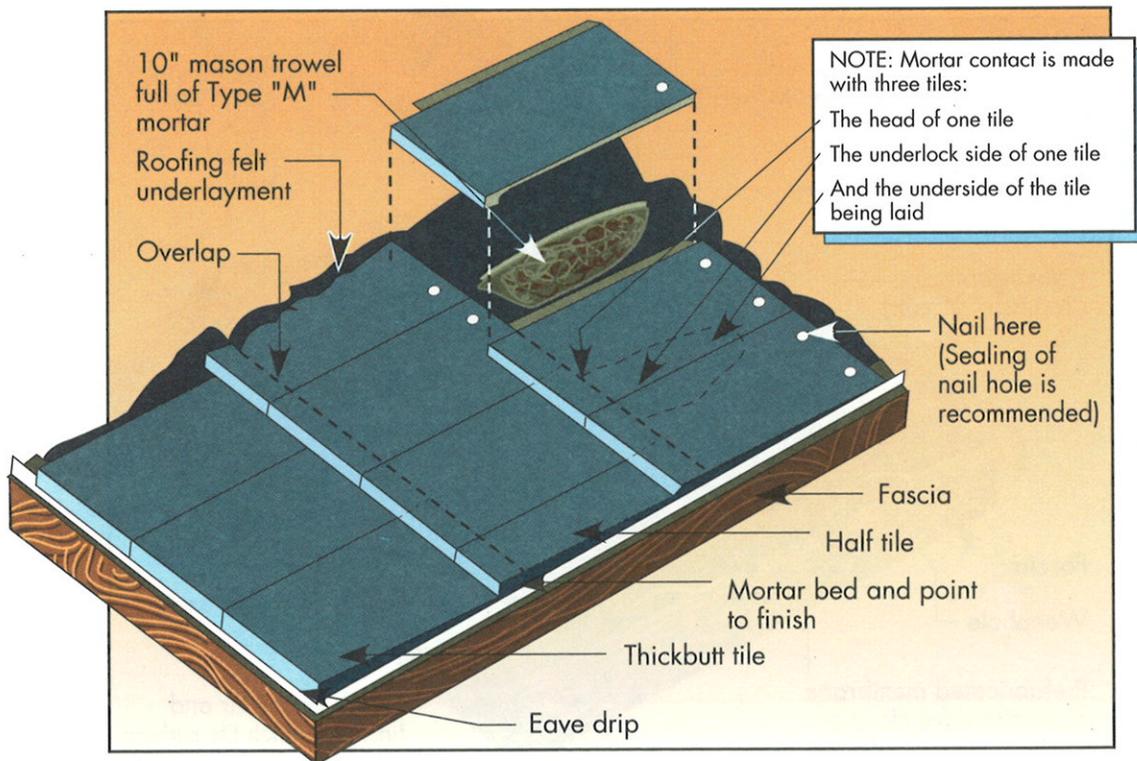
FIGURE 33. Recommended tile and mortar placement for extruded concrete flat tile roofing system.

- The roof should be marked off vertically and horizontally. Interlocking lugged or unlugged tile should be laid with minimum headlaps in accordance with manufacturers' recommendations (2 1/2 – 3 1/2 inches minimum).

- Prefabricated eave closure strips should be used to elevate the butt end of the first, or eave, tile to attain the proper slope.
 - A full 10-inch mason's trowel of mortar should be placed under each tile (under the pan section of "S" or barrel tiles), beginning at the head of the tile in the preceding course. Each tile should be pressed down tightly in the interlocking position so that the cover rests firmly against the lock of the adjacent tile.

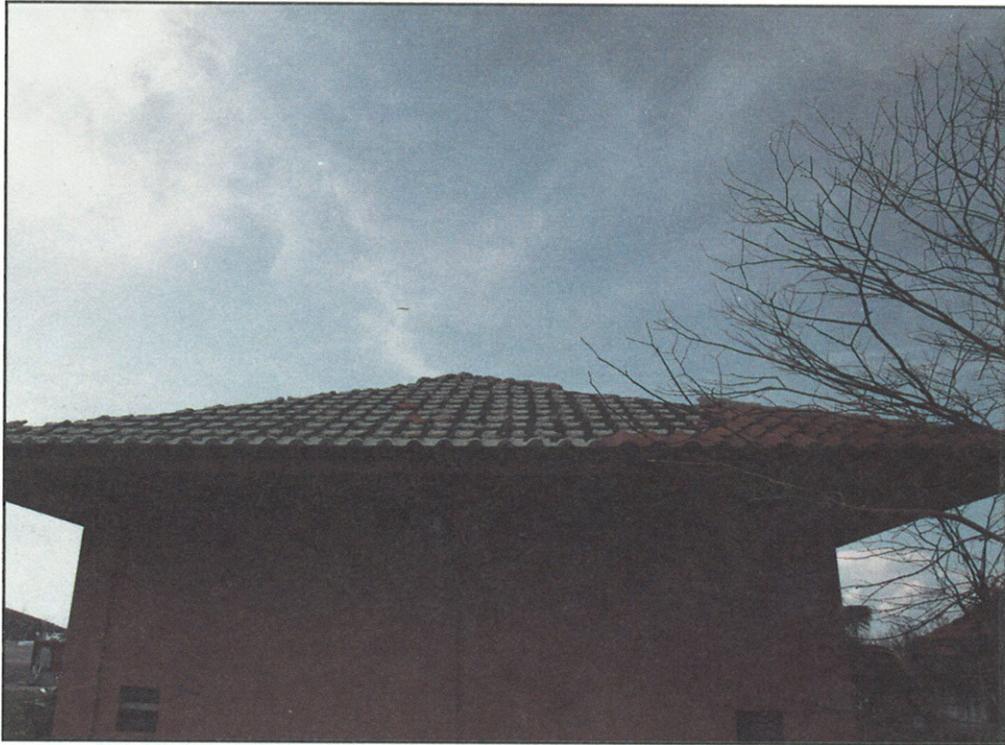
FIGURE 34. Failure of "S" tile roofing. Bond failure between mortar and tile was observed.

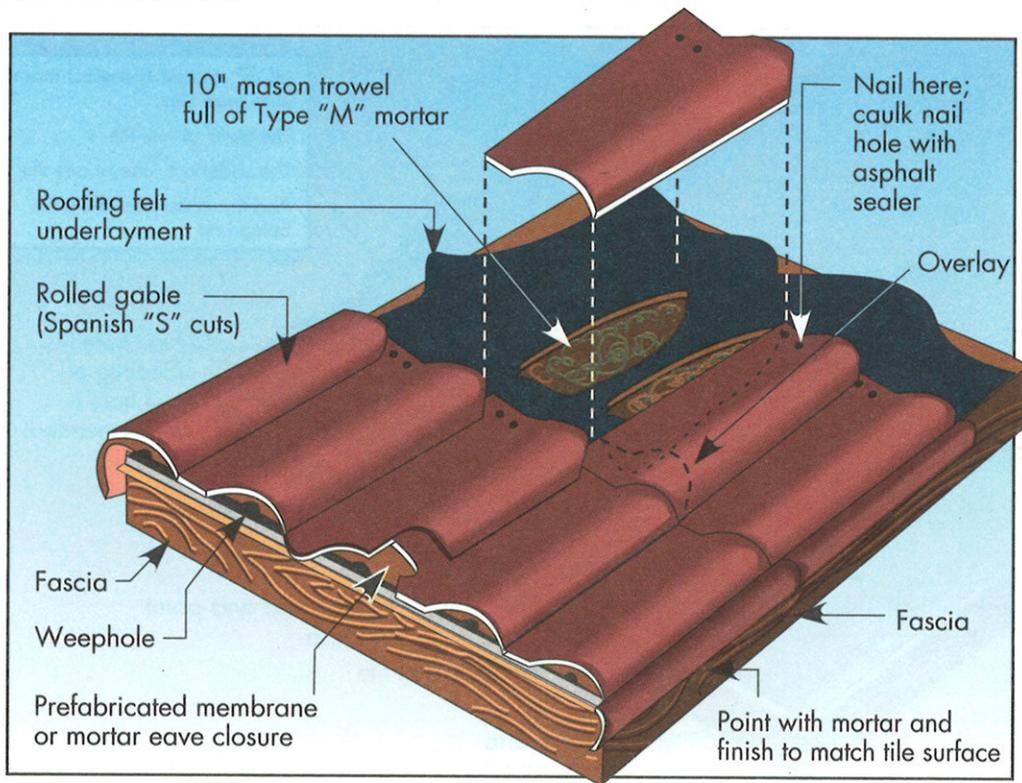
FIGURE 35. Recommended tile and mortar placement for "S" tile roofing system.

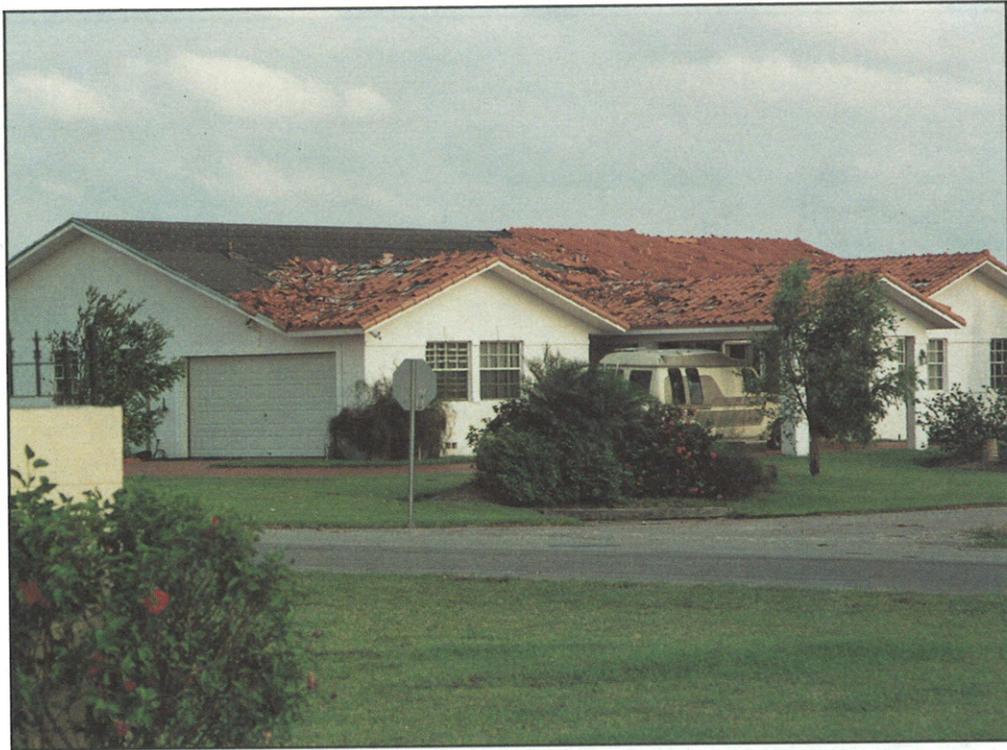
FIGURE 36. *Failure of barrel tile roofing. Bond failure between underlayment and mortar and between mortar and tile was observed.*

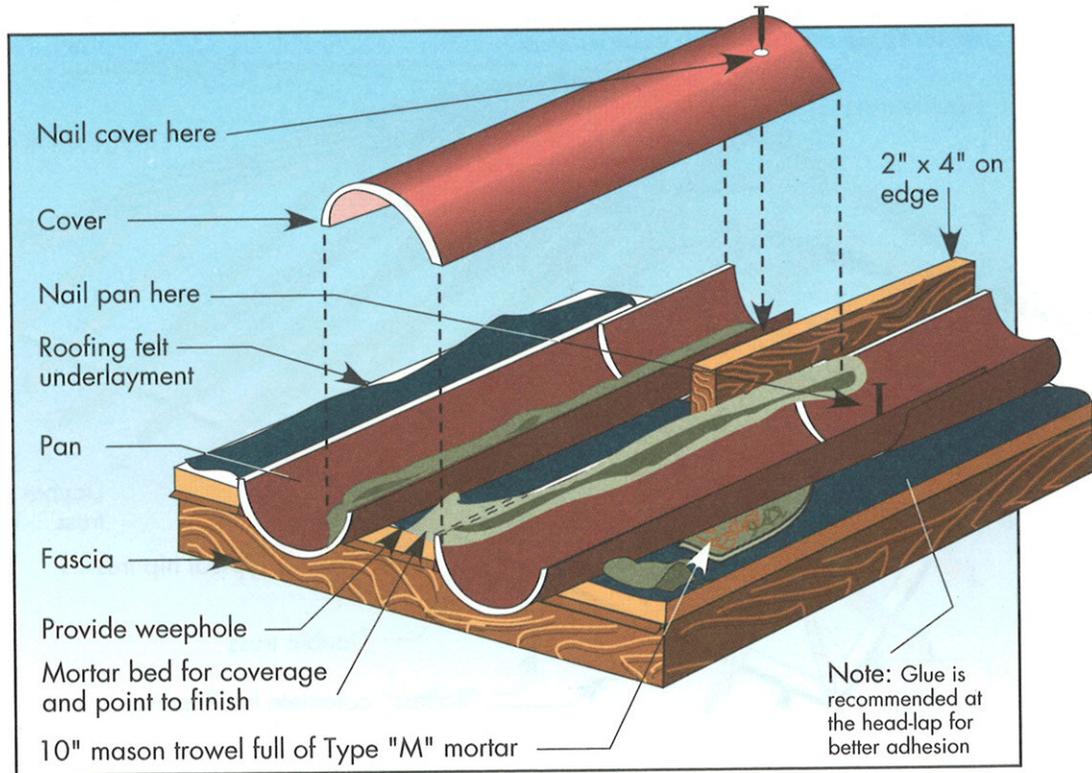
FIGURE 37. *Recommended tile and mortar placement for barrel tile roofing system.*

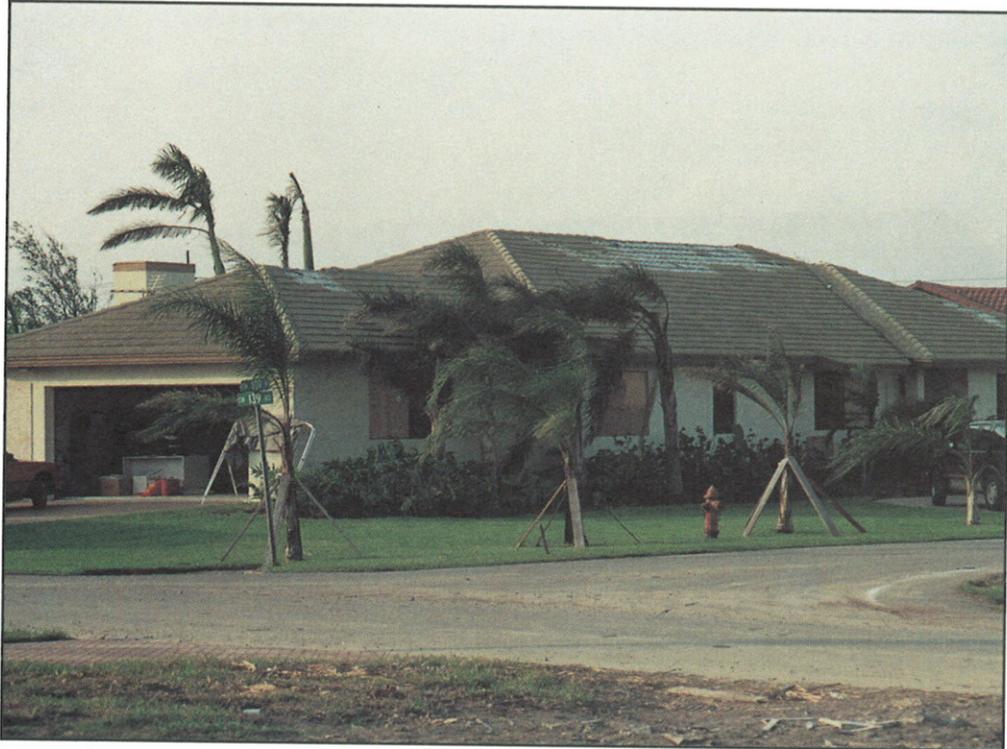
FIGURE 38. *Hip roof.*

5. The design of more aerodynamic building shapes should be encouraged and promoted (SEE FIGURES 38 AND 39). More aerodynamic building systems reduce direct wind forces experienced perpendicular to windward planes of buildings and also the consequent effect of whirling air flows, called vortices, that accumulate at the corners and edges of the planes. The

accumulation of both the direct and negative pressures resulting from these wind flows is particularly prevalent in the more abrupt or orthogonal planes of gabled roof systems.

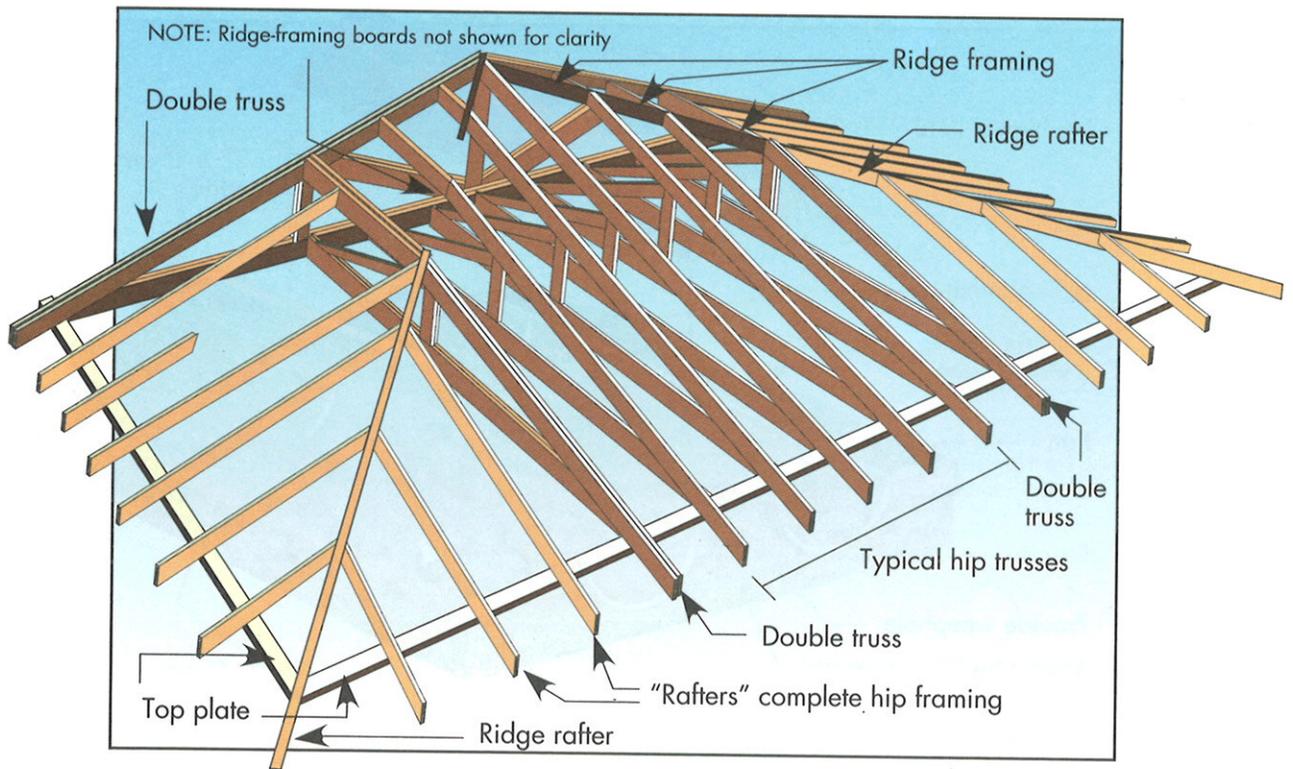
FIGURE 39. *Recommended hip roof framing.*

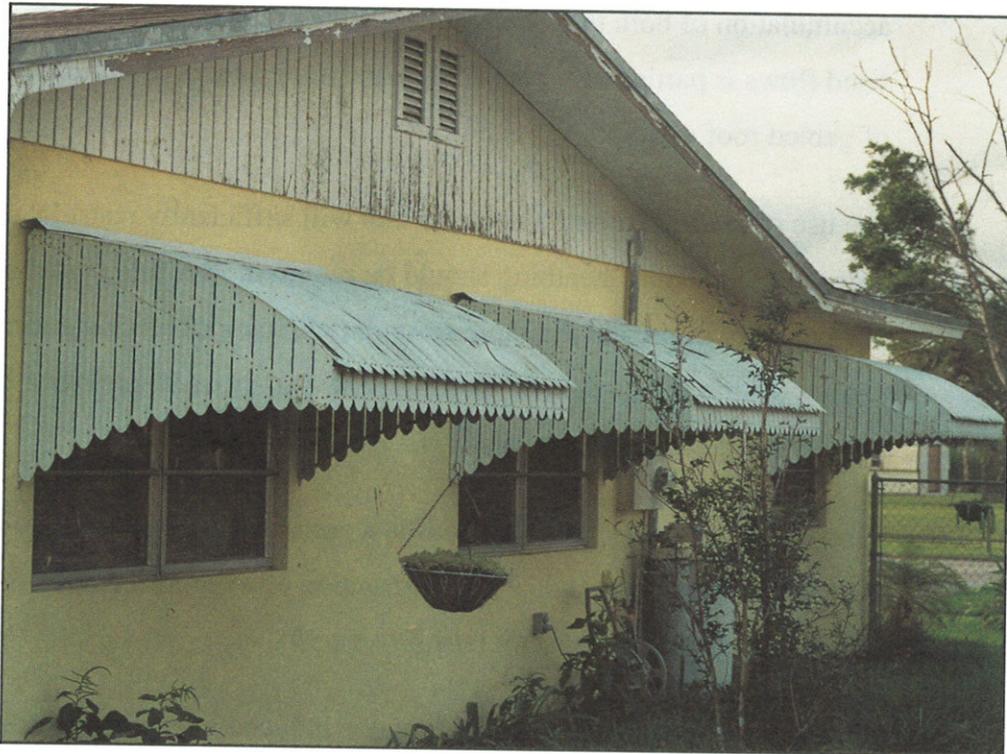
FIGURE 40. *Roof gable louvered venting and convertible awning/storm shutters.*

6. The use of braced truss roof systems that will sufficiently resist lateral forces independent of roof sheathing should be required. Roofing systems could be considerably improved if simple secondary bracing or blocking were to be applied within the truss network (thus relieving the roof's reliance on diaphragm sheathing action alone) (SEE FIGURES 26-29).
7. Substituting hip roofs for gable ends is a particularly advantageous solution and should be encouraged. The construction of a hip roof results in an inherently braced roof system (SEE FIGURE 39).
8. Venting with adequate openings to relieve induced internal pressures on roof structures is recommended (SEE FIGURE 40). However, venting must be installed in such a manner that the entry of uncontrolled air flow is not allowed. Such uncontrolled air flow could result in a buildup of induced internal air pressure.

4. Window design and protection standards should be developed that require a standard system of design and protection for windows in new buildings. These should include, but not be limited to, consideration of using shutters (SEE FIGURES 40 AND 49) and precut plywood (SEE FIGURES 50-53). The protection of windows in existing buildings should be encouraged. Providing cost incentives through the insurance rating process should be considered.

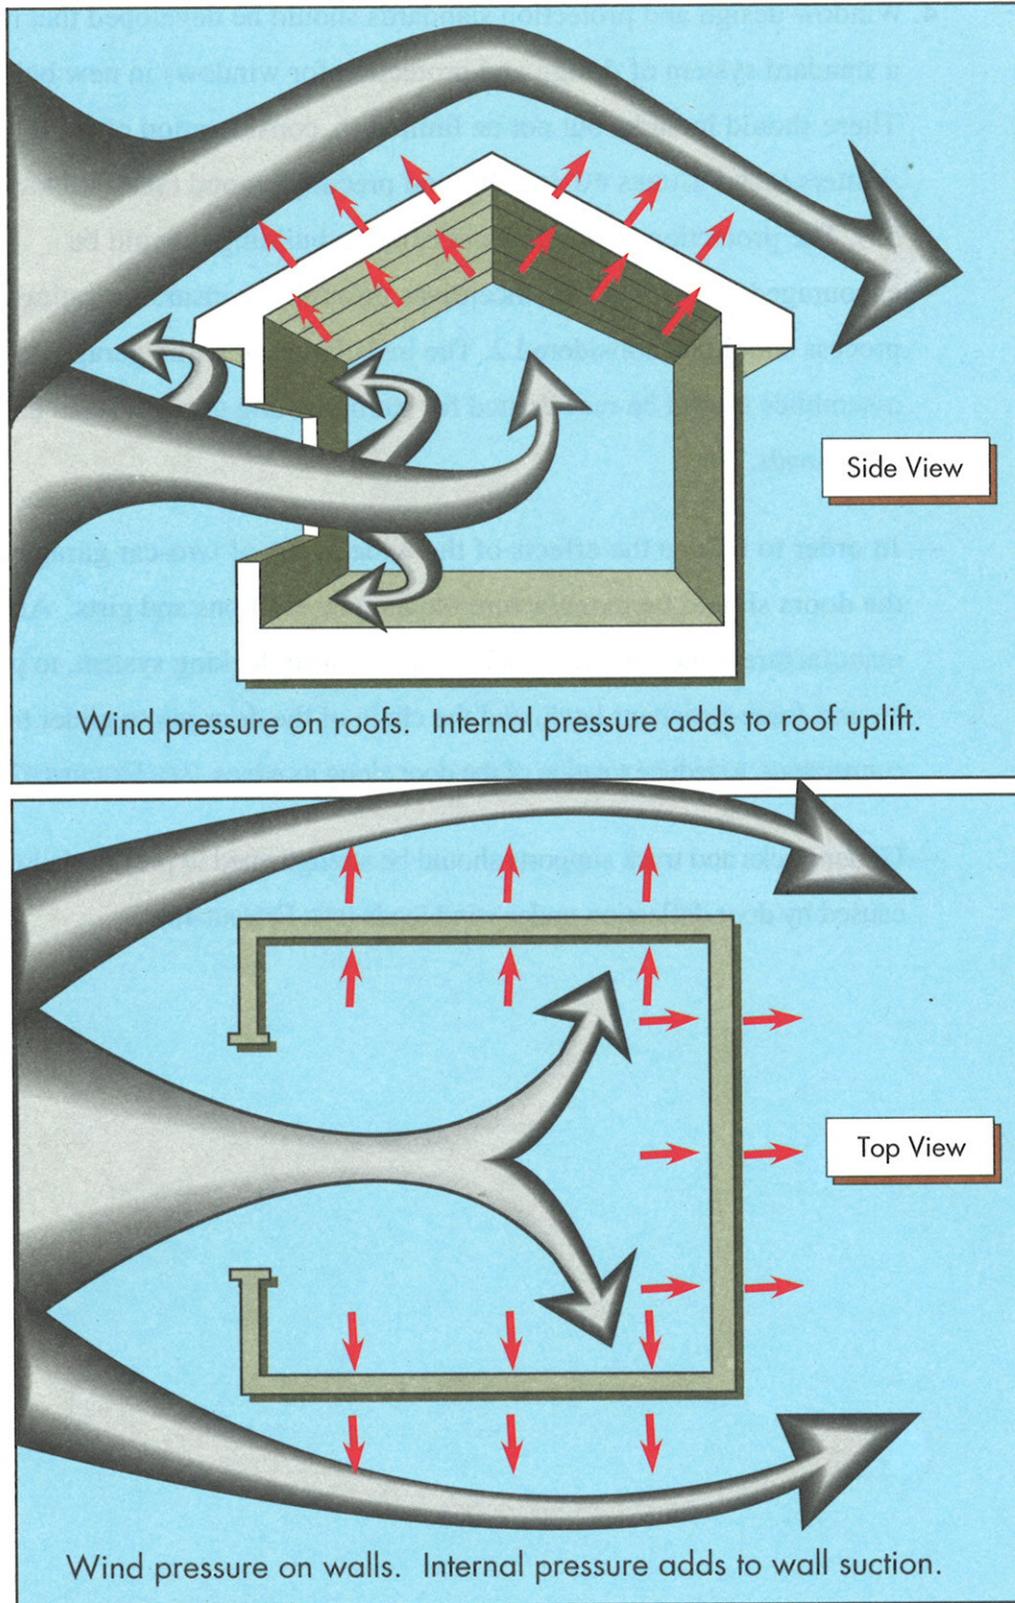
FIGURE 41. Results of building envelope breach due to failure of external doors and windows.

A breach of a building's envelope (i.e., the system by which the building resists wind penetration) is particularly hazardous during wind storms. Not only does penetration of wind and rain cause damage to the interior contents of buildings, but additional direct internal wind pressures combine with suction pressures on exterior faces, causing partial or complete blowouts of major structural systems such as walls and roofs (SEE FIGURE 41). Double-car garage doors and entry doors especially should be held secure during wind storms.

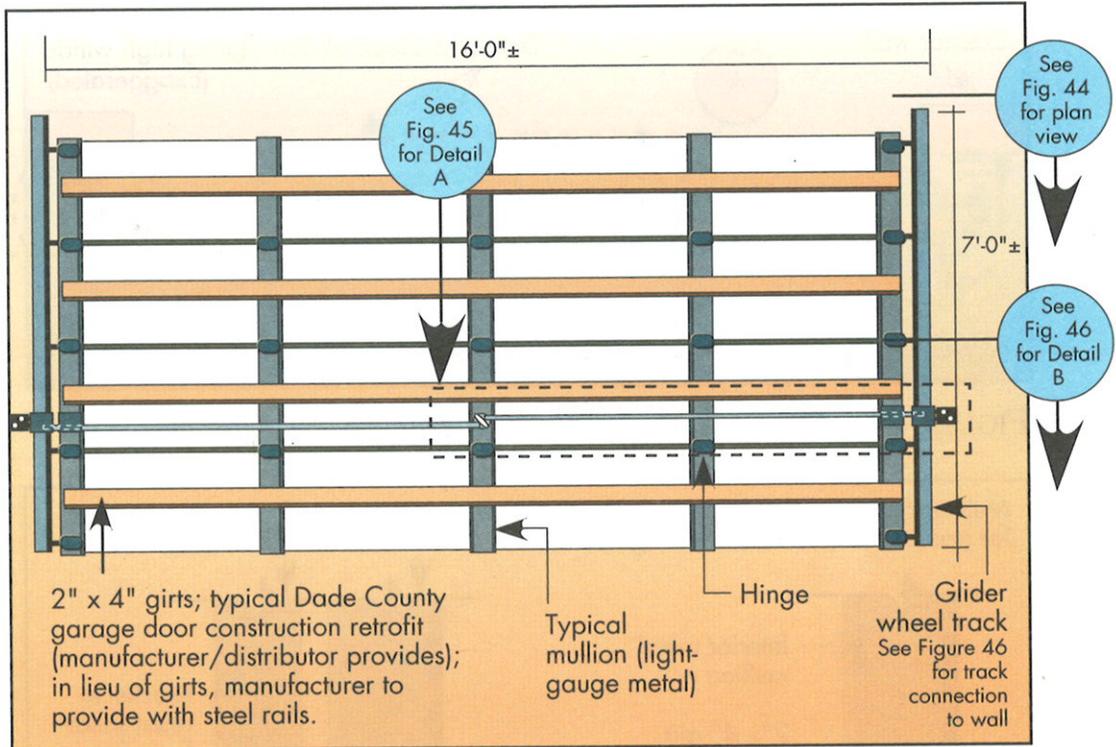
FIGURE 42. Typical garage door elevation.

2. The installation of entire garage door assemblies should be reevaluated for strengthening to resist wind and flood loads.
 - In order to reduce the effects of the wide spans of two-car garage doors, the doors should be manufactured to include mullions and girts. Also, manufacturers should reinforce both the security locking system, to provide a wind-force-resistant latch, and the chain of the door pin to glider track connections, to reduce rotation of the door along its edges. (SEE FIGURES 42-45).

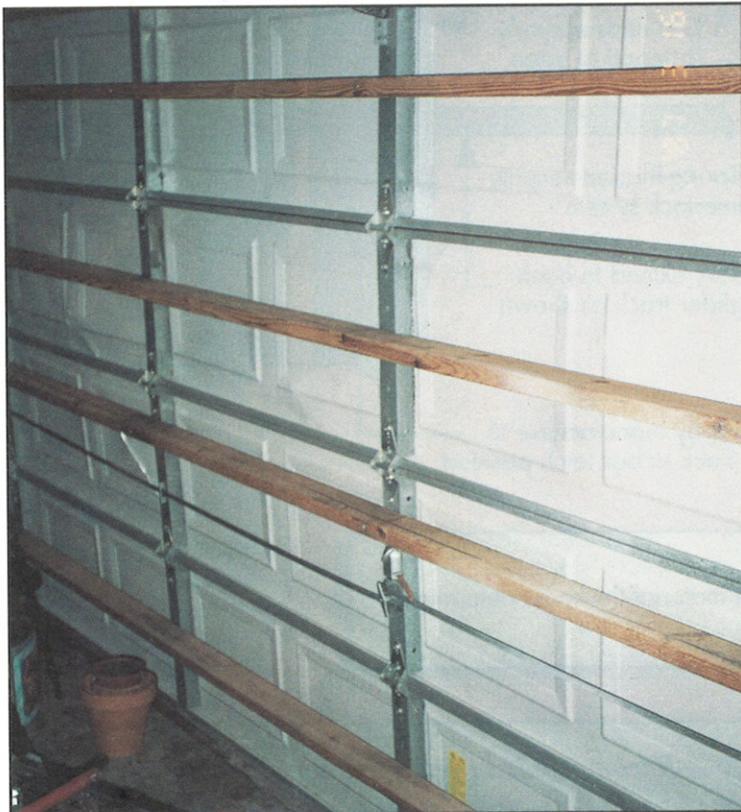
FIGURE 43. Example of garage door with 2" x 4" girts and metal mullions.

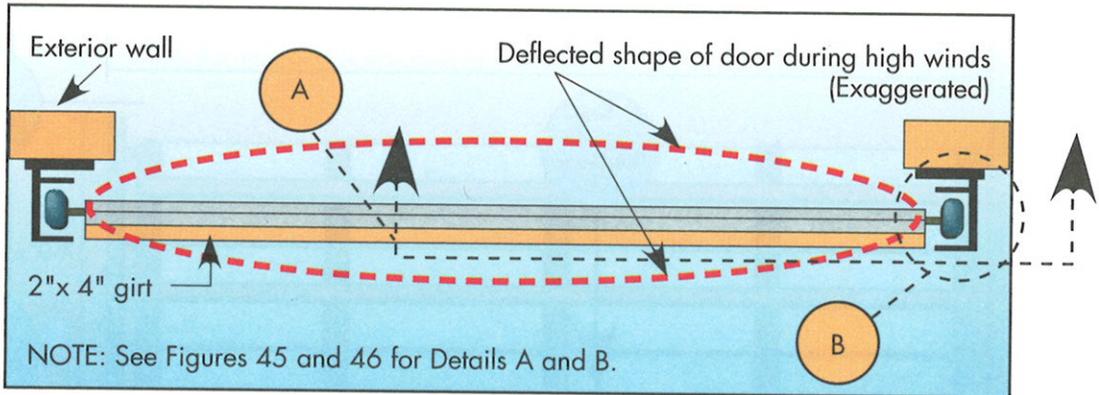
FIGURE 44. Plan view of typical garage door.

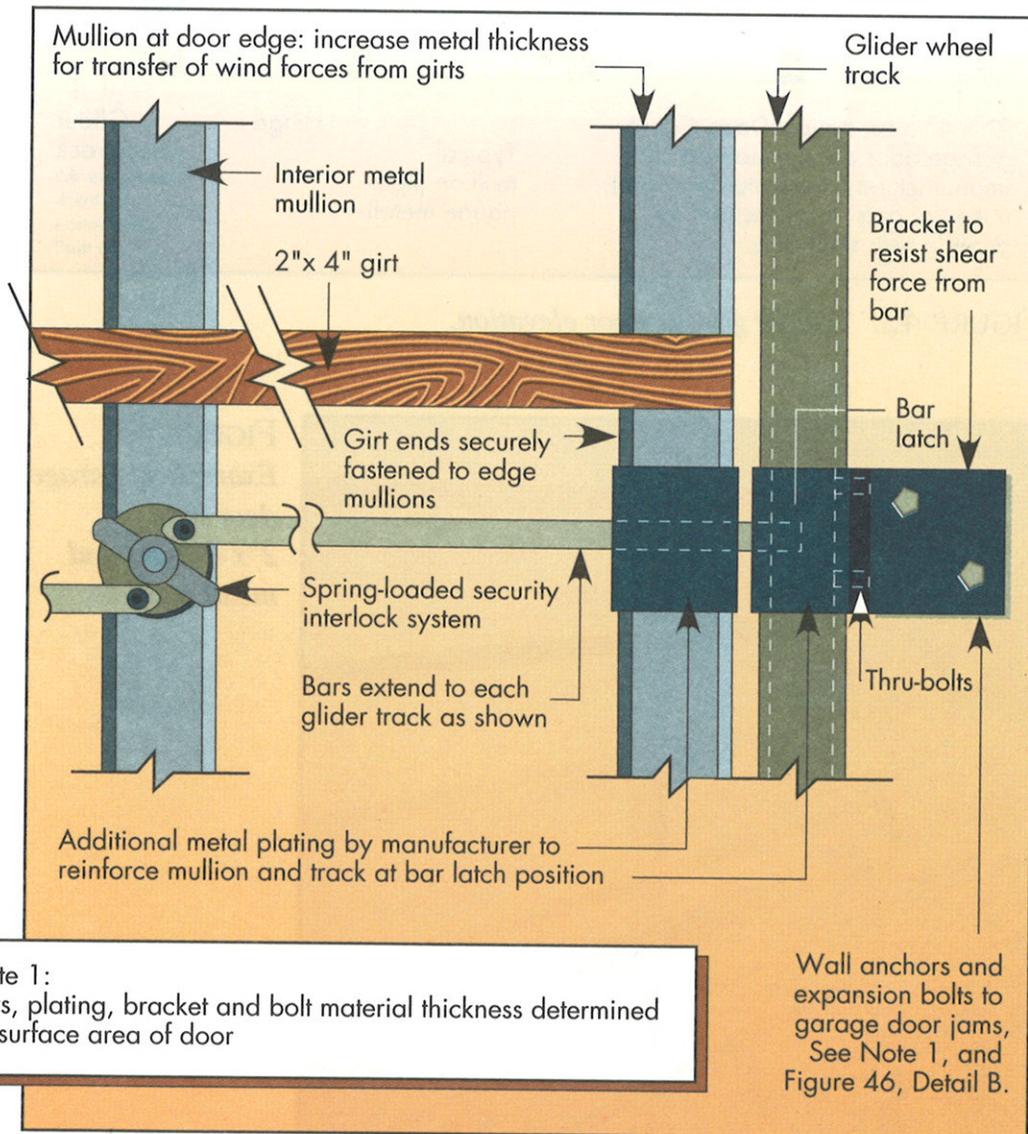
FIGURE 45. Detail A—Recommended reinforced horizontal latch system for garage door.

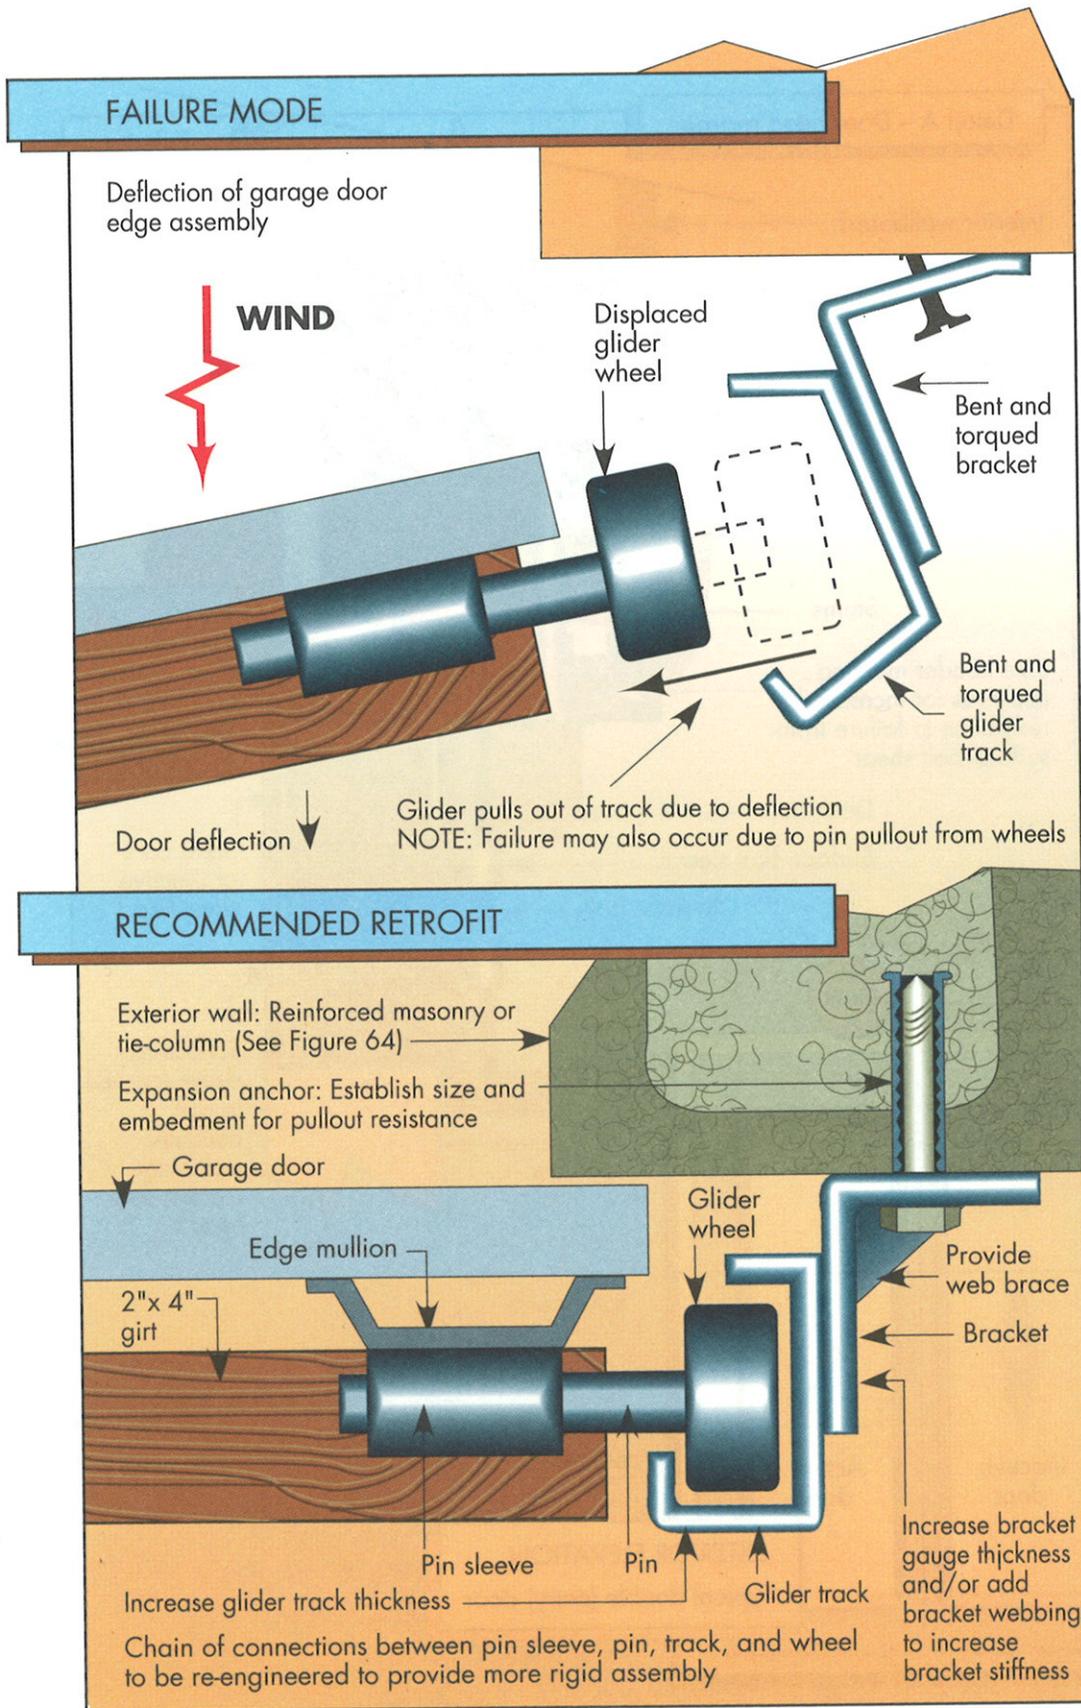
FIGURE 46. Detail B—Garage door failure at edge and recommended assembly improvements.

- Glider tracks and track supports should be strengthened to prevent failure caused by door deflection under wind loads (SEE FIGURE 46).
