3.0 RECOMMENDATIONS

3.1 GENERAL RECOMMENDATIONS

3.2 SPECIFIC RECOMMENDATIONS

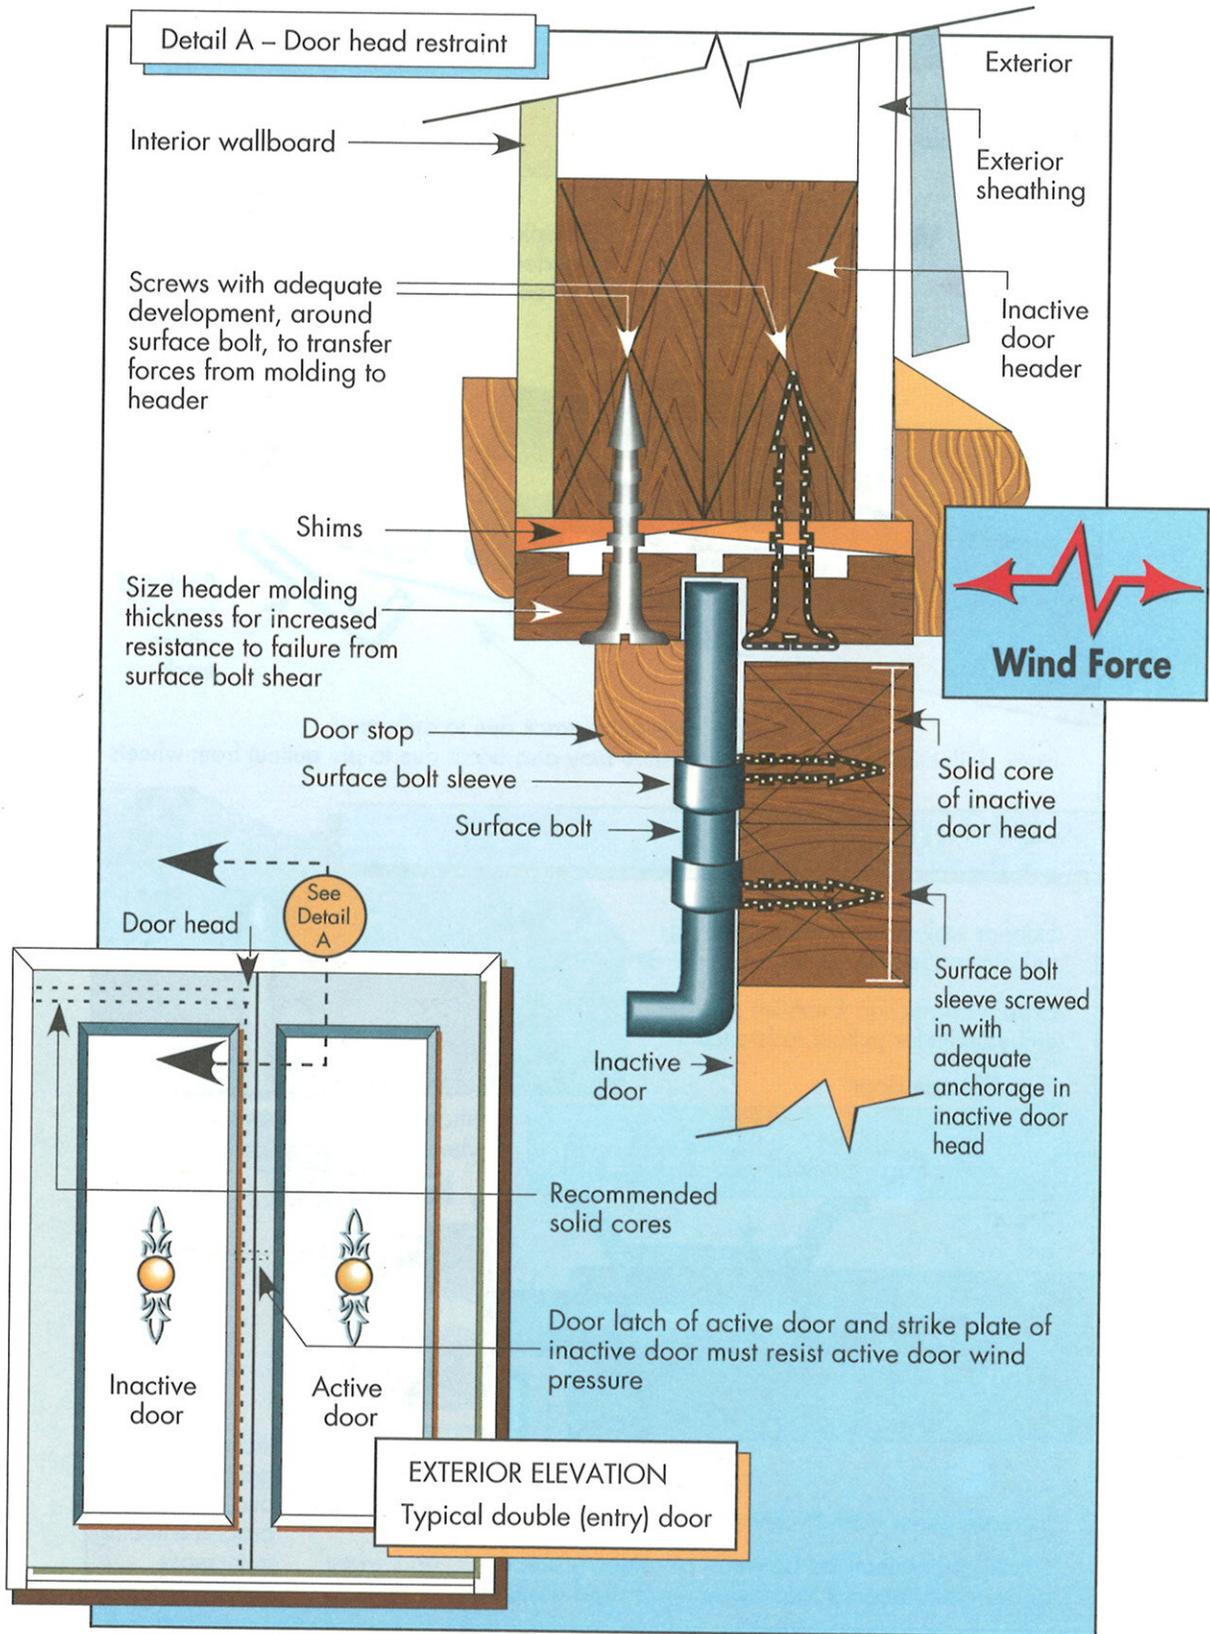
FIGURE 47. Double entry door header recommendations.

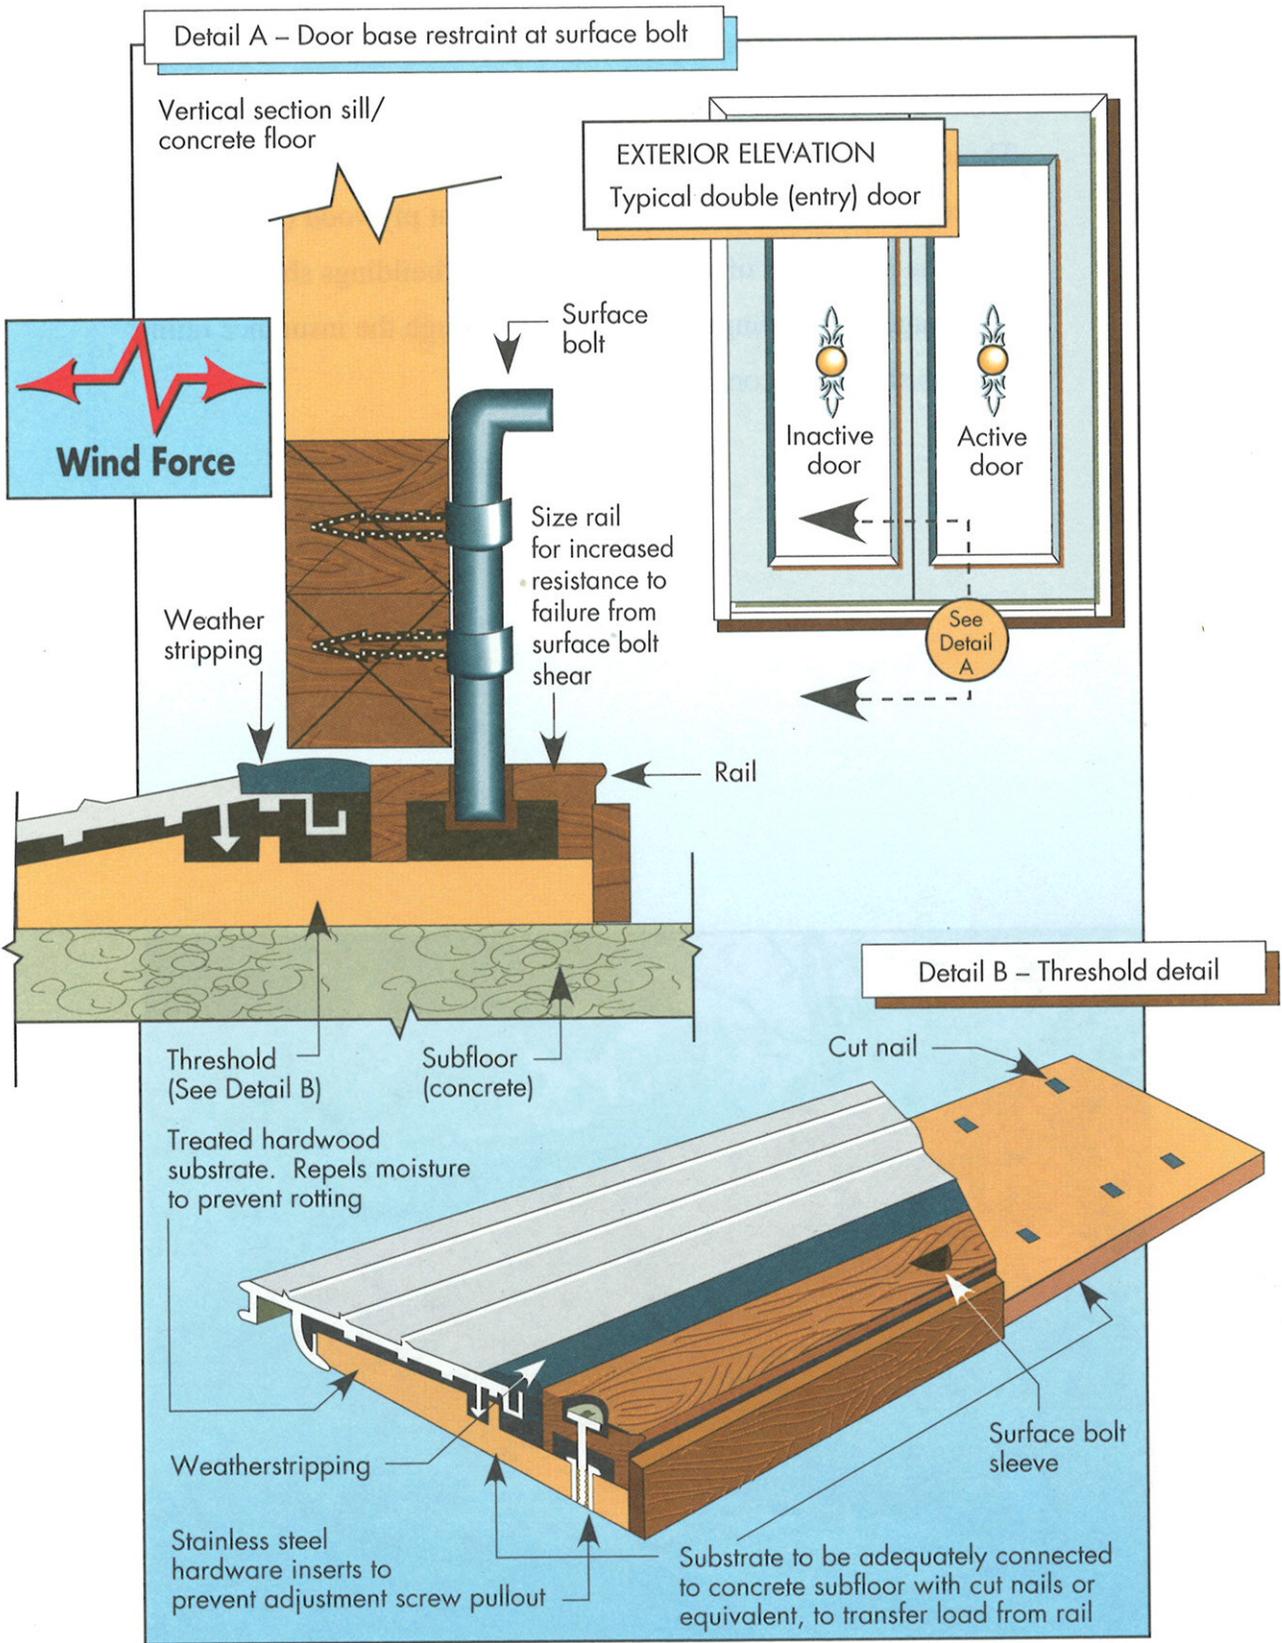
FIGURE 48. Double entry door threshold recommendations.

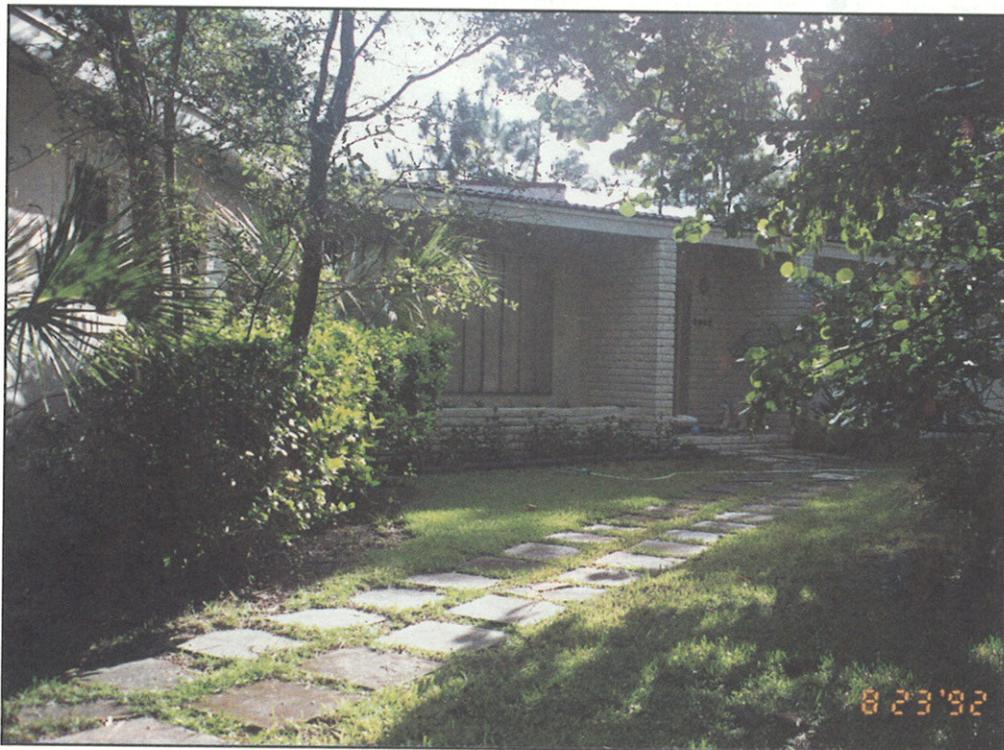
FIGURE 49. *Prefabricated storm shutters.*

4. Window design and protection standards should be developed that require a standard system of design and protection for windows in new buildings. These should include, but not be limited to, consideration of using shutters (SEE FIGURES 40 AND 49) and precut plywood (SEE FIGURES 50-53). The protection of windows in existing buildings should be encouraged. Providing cost incentives through the insurance rating process should be considered.

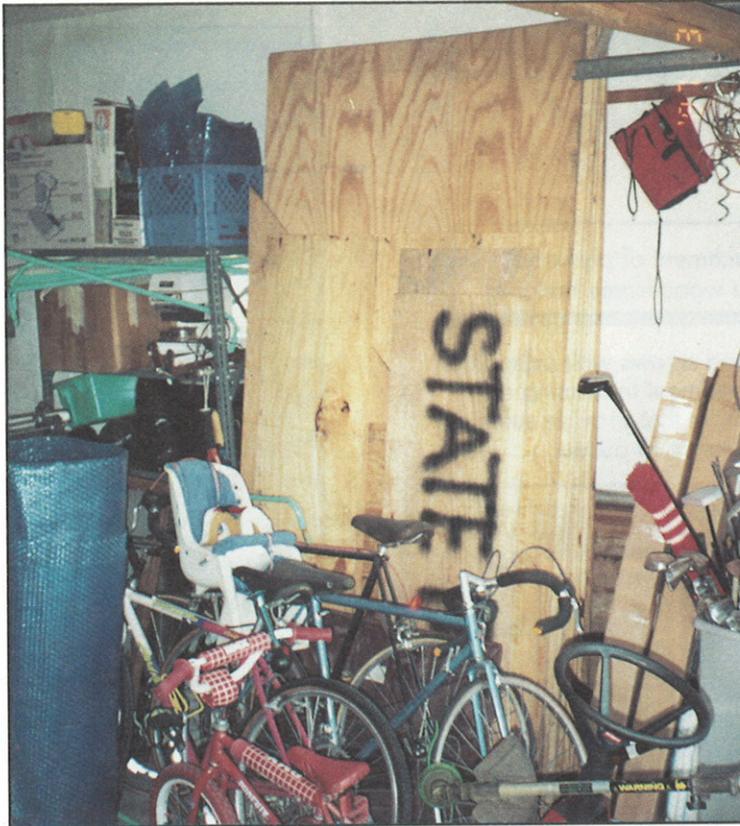
FIGURE 50.
*Previously purchased
plywood stored for
use as openings
protection during
storm conditions.*

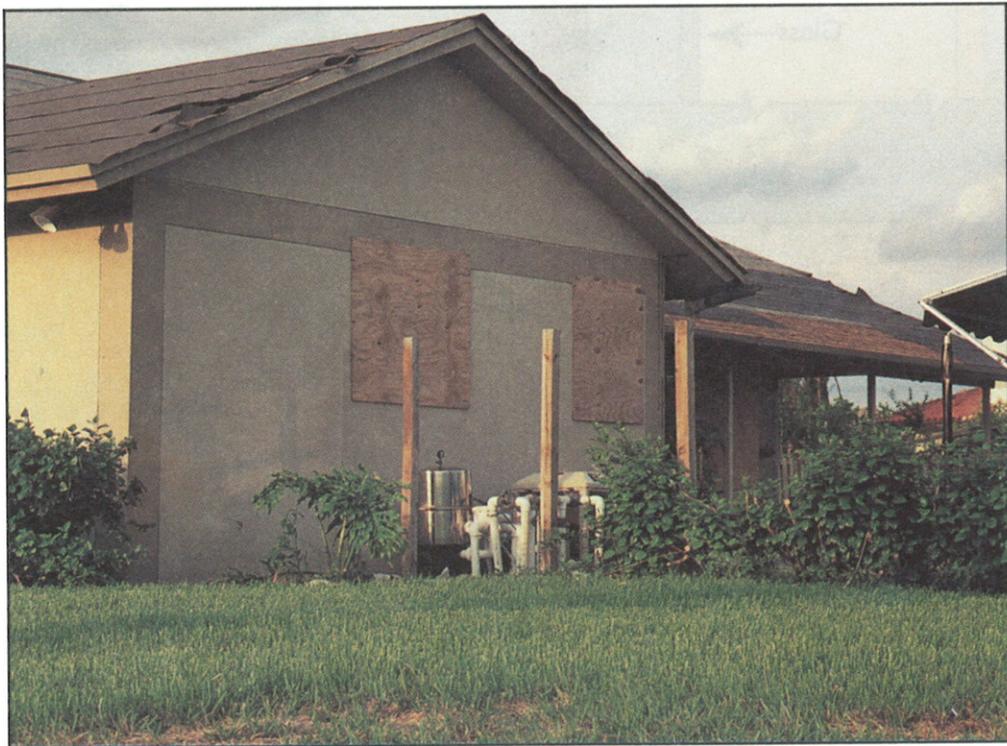
FIGURE 51. *Plywood used as openings protection installed. See Figures 52 and 53 for details.*

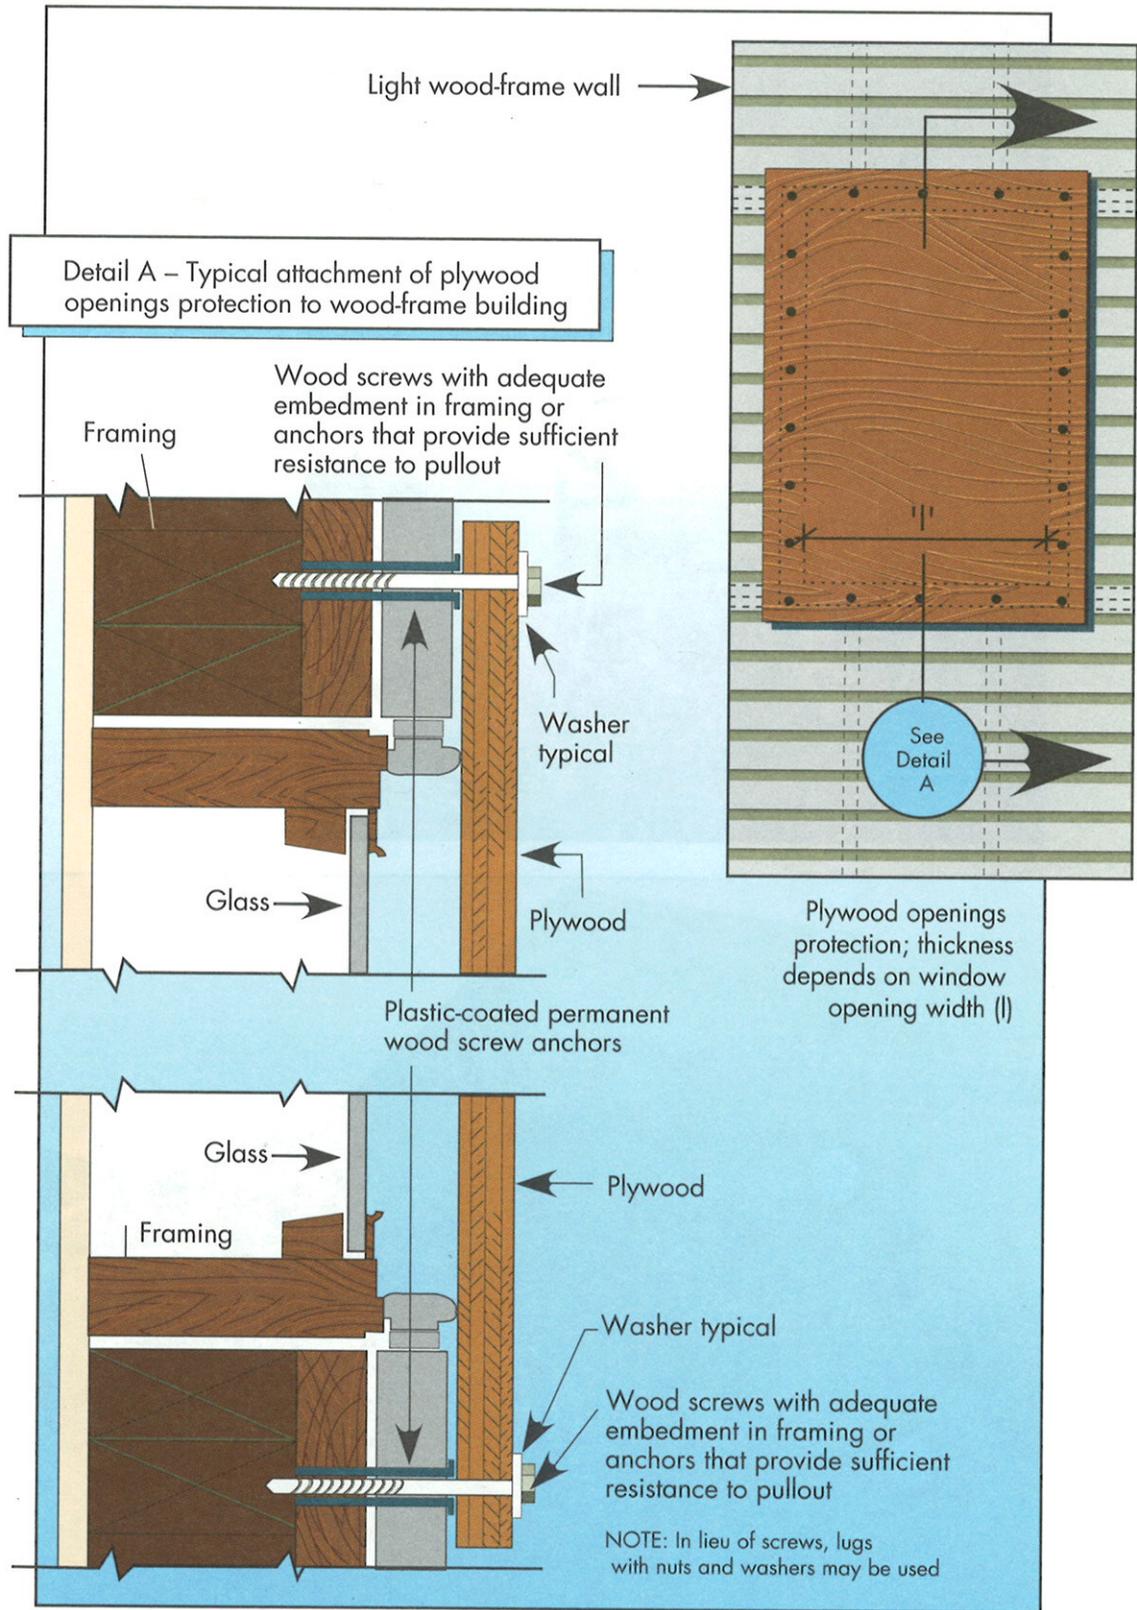
FIGURE 52. Typical installation of plywood openings protection for wood-frame building.

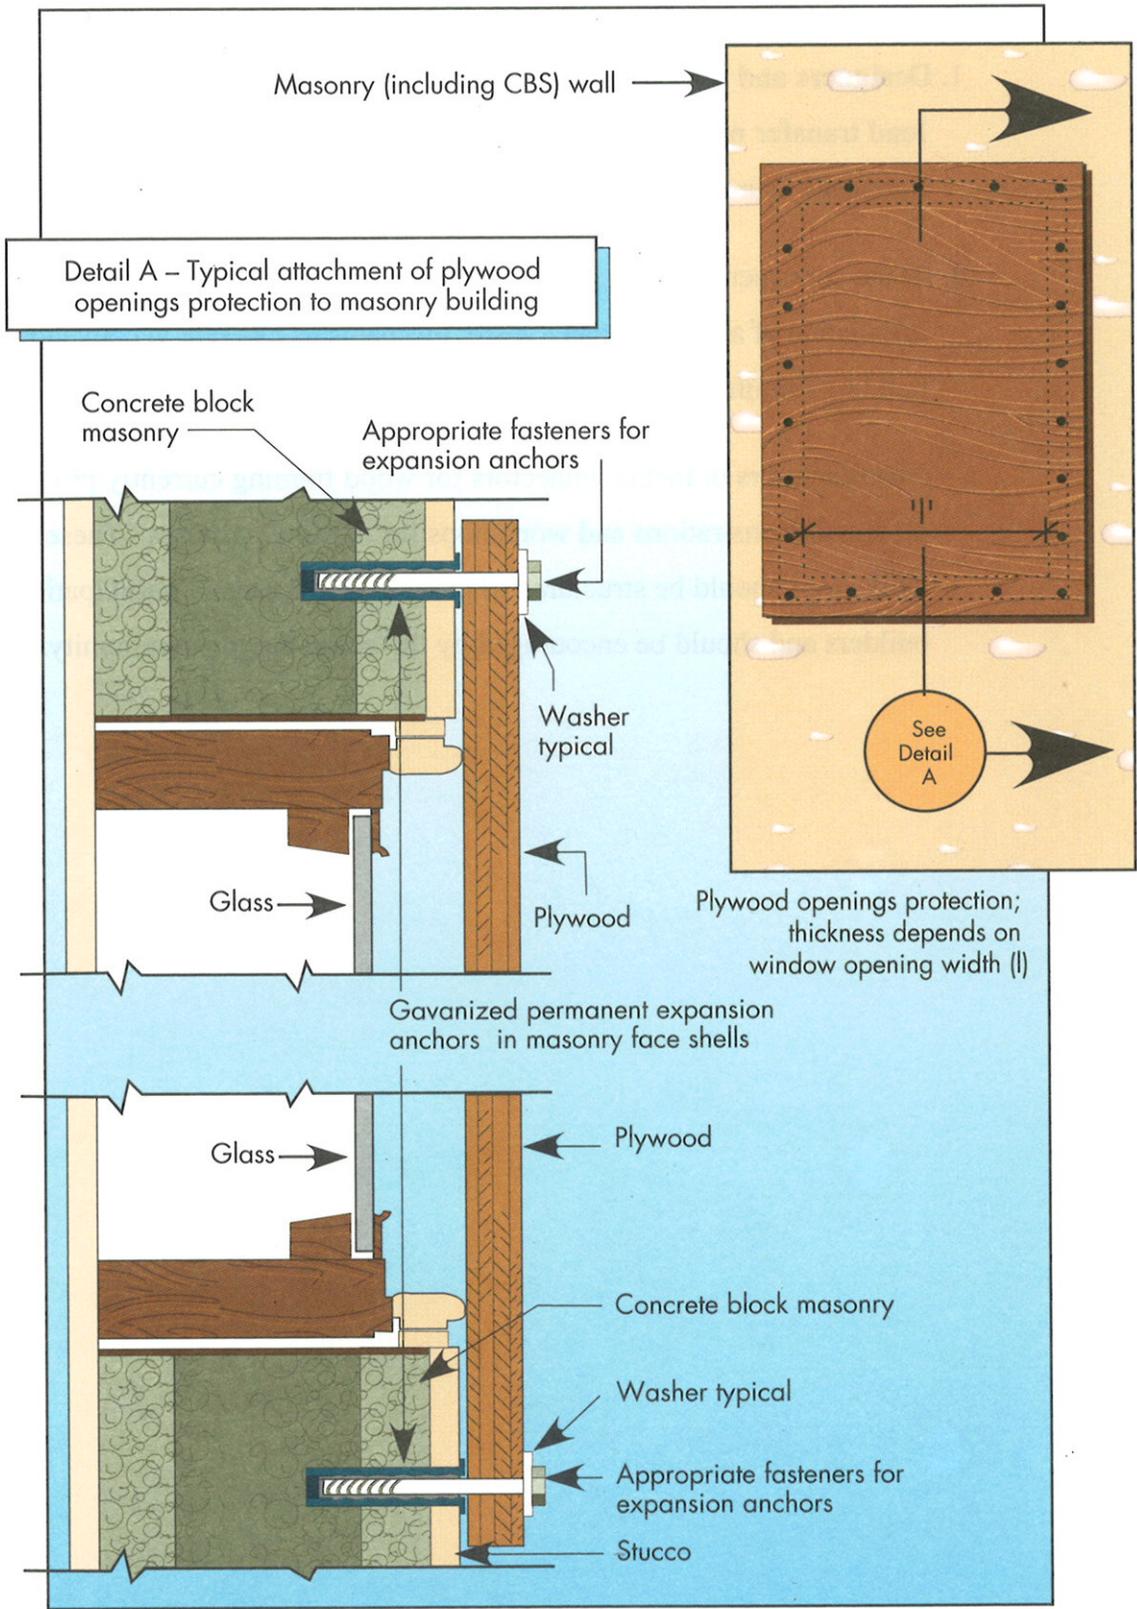
FIGURE 53. Typical installation of plywood openings protection for masonry (including CBS) building.

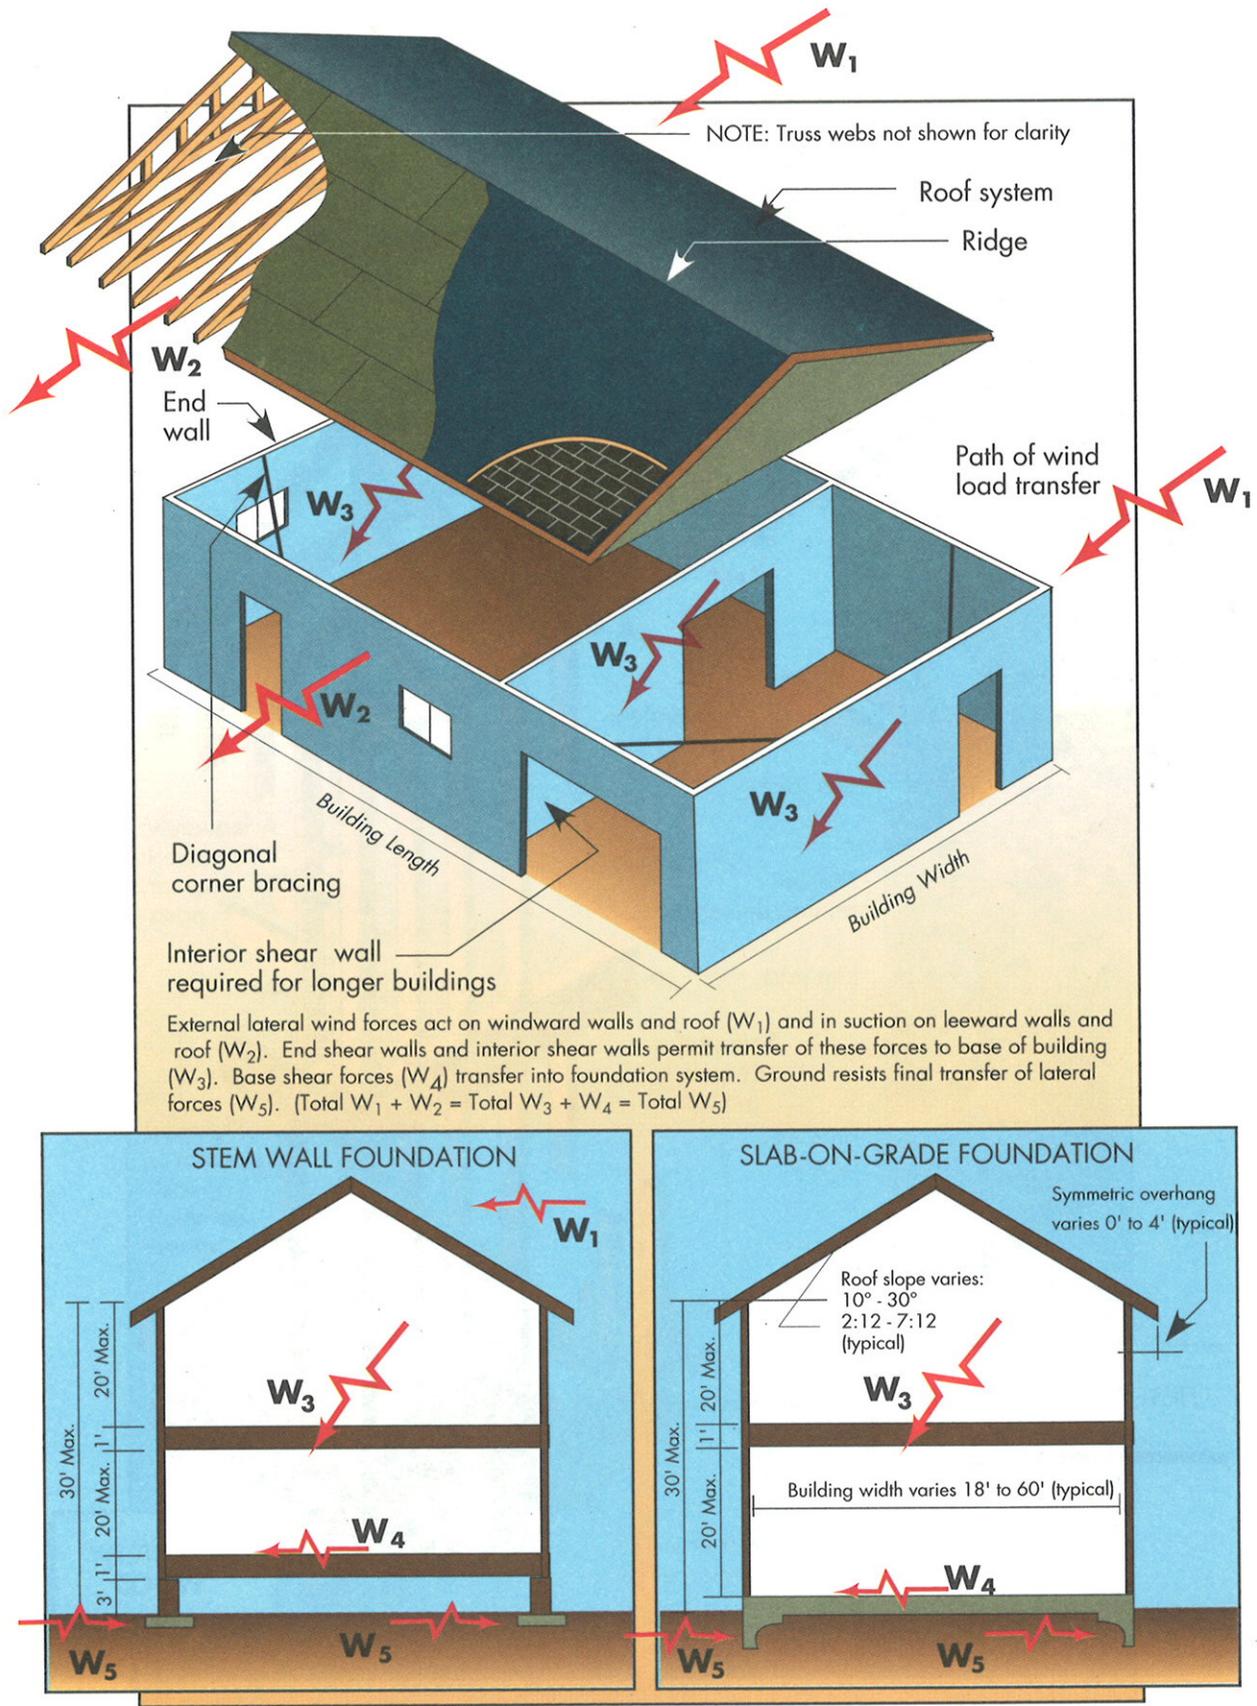
FIGURE 54. Typical lateral load transfer for one- and two-story buildings.

1. Designers and plan reviewers should pay greater attention to lateral load transfer mechanisms because of high lateral loads generated by hurricane winds (SEE FIGURES 9, 10, AND 54-58).
 2. At the construction stage, greater attention must be paid to the proper installation of all lateral load transfer mechanisms inherent in conventional building framing, especially hurricane straps and clips (SEE FIGURES 59-62).
- Manufacturers of metal connectors for wood framing currently provide on-site demonstrations and workshops for training purposes. These workshops should be structured to provide certificates of participation to builders and should be encouraged by the home-buying community.

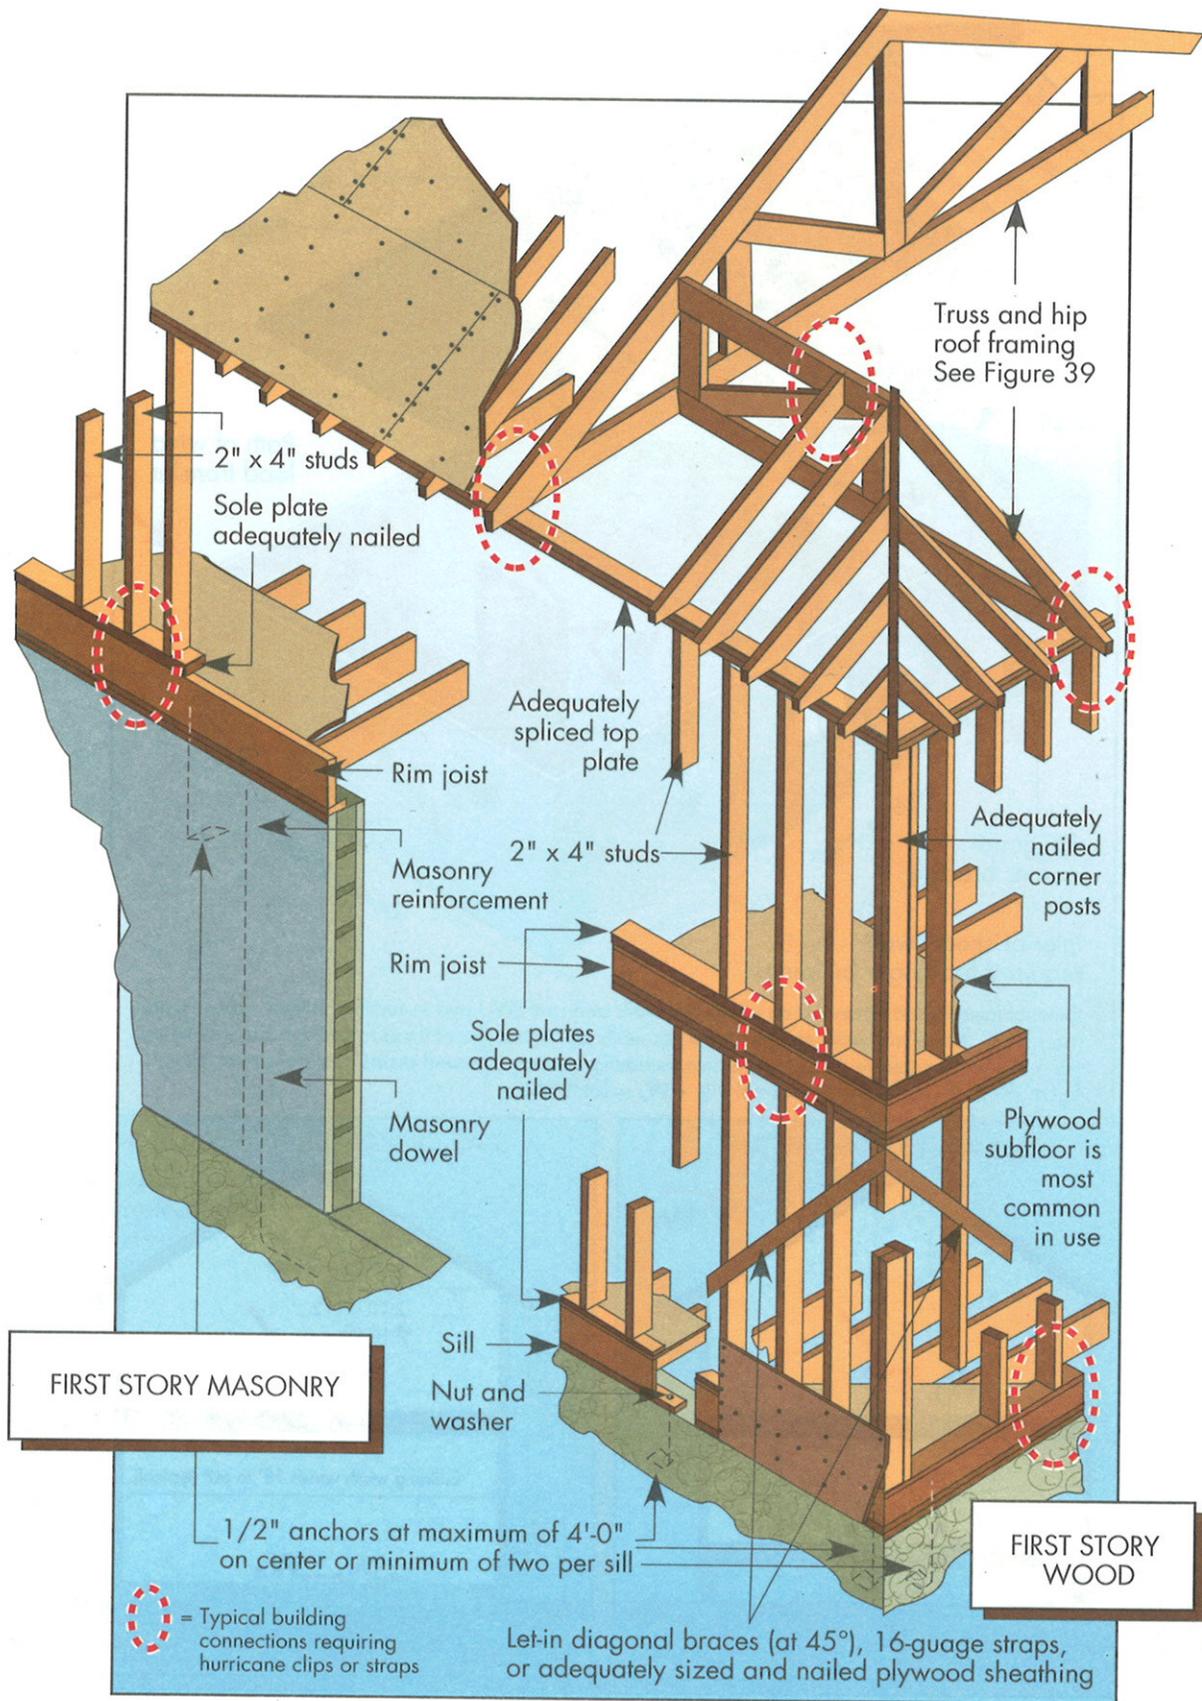
FIGURE 55. Primary wood framing systems: walls, roof diaphragm, and floor diaphragm.

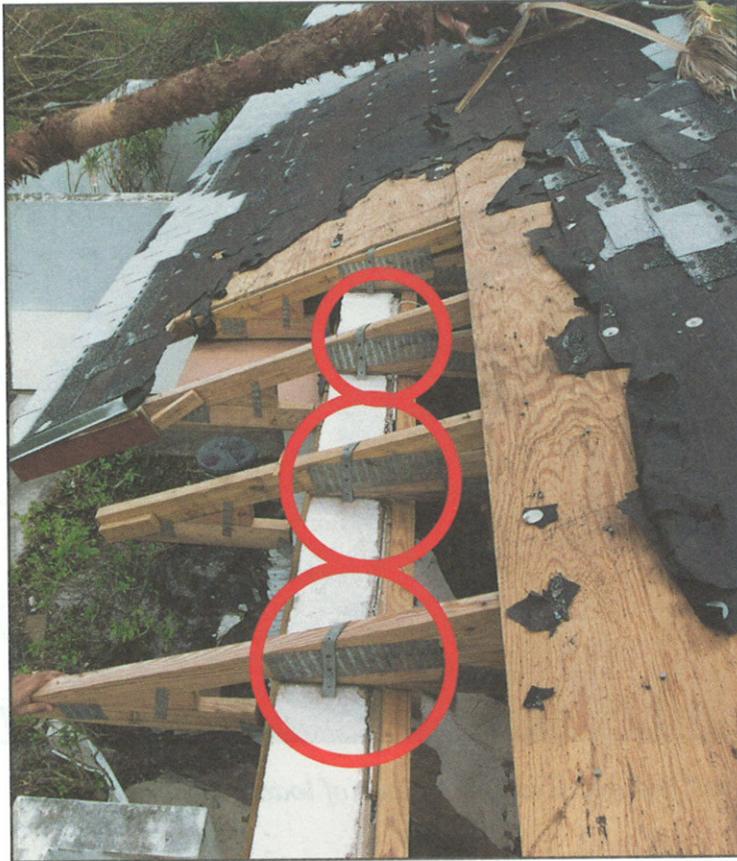
FIGURE 56.
*Properly placed
hurricane straps
from masonry
tie-beams to
roof trusses.*

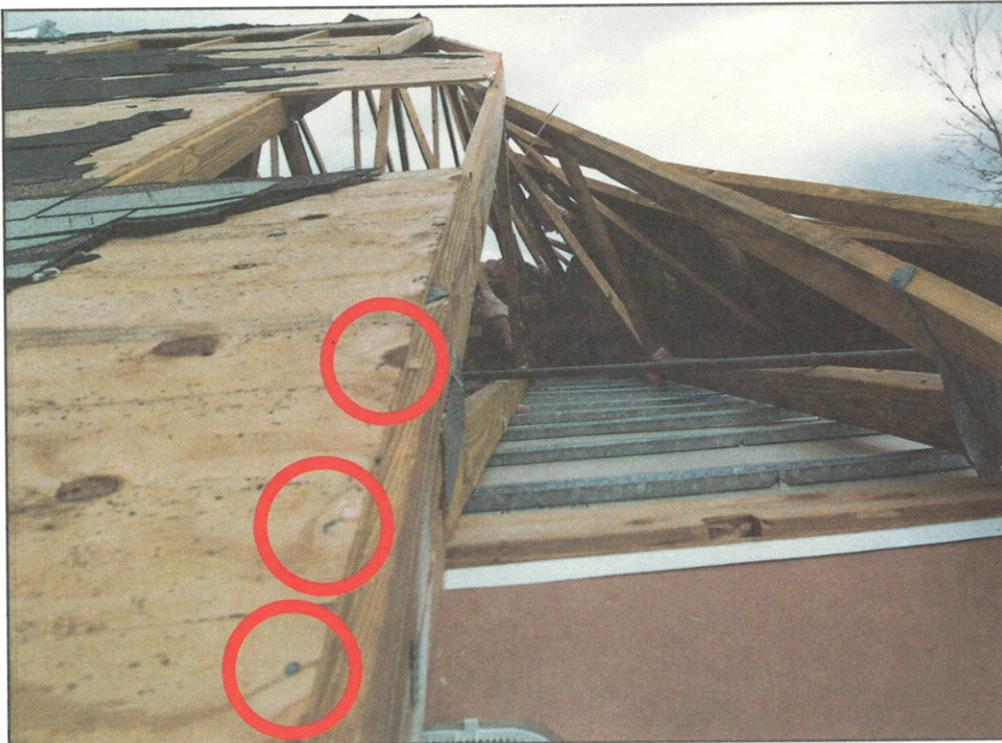
FIGURE 57. *Sheathing only tack-nailed.*

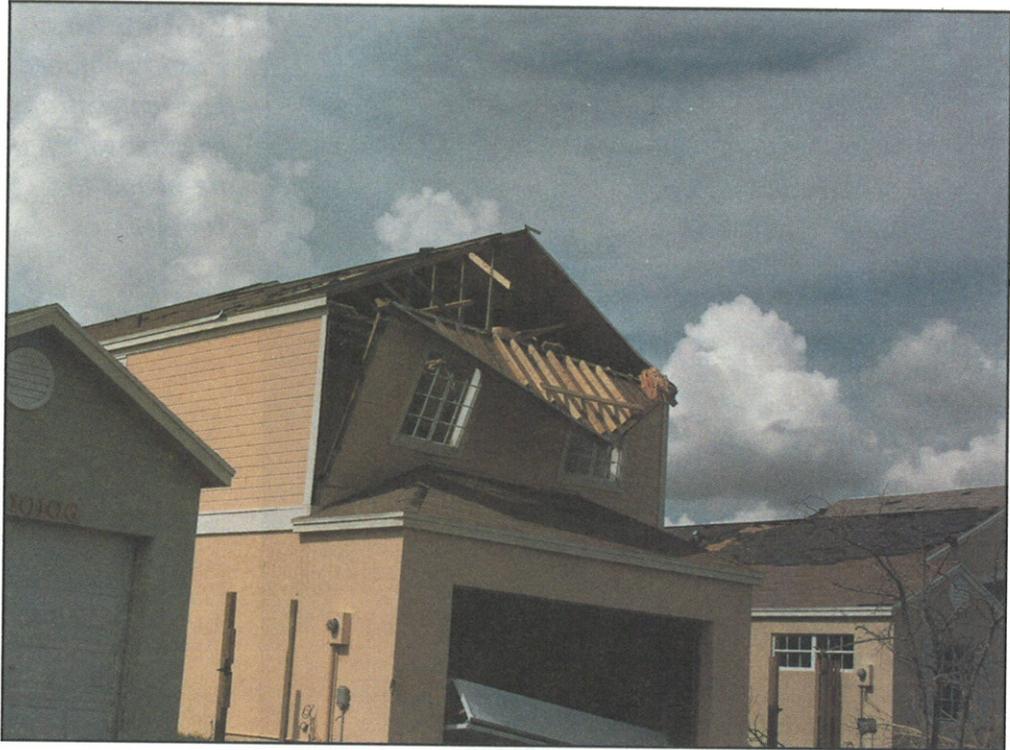
FIGURE 58. *End wall failure. Example of lack of load transfer capacity after separation.*

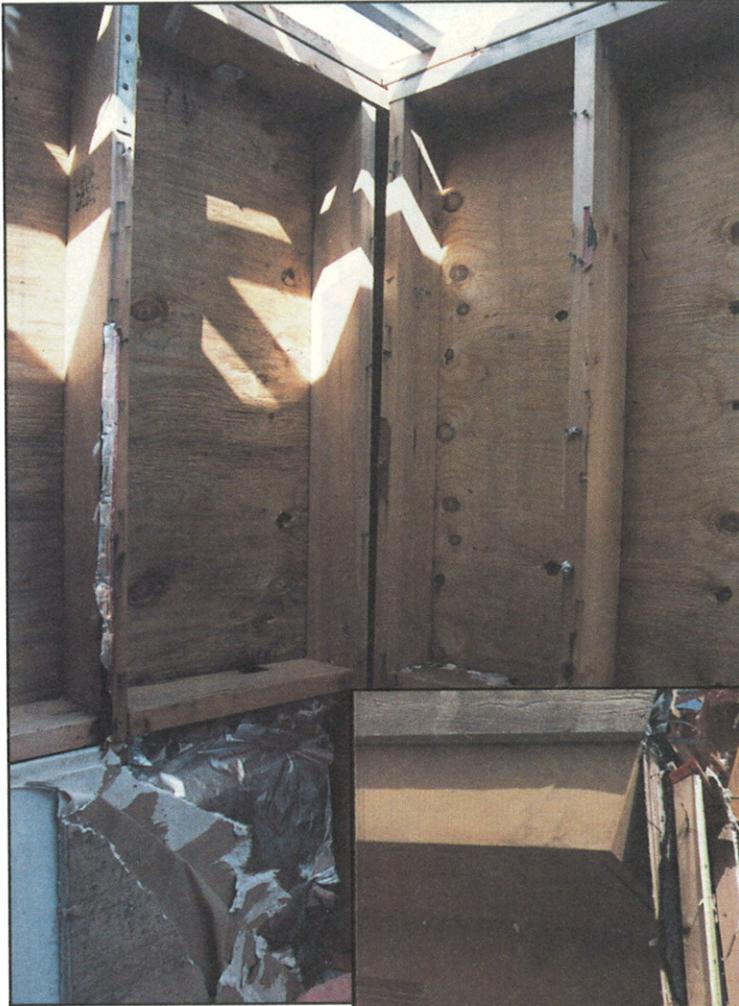
FIGURE 59.
*End column/corner post
missing from
wall.*

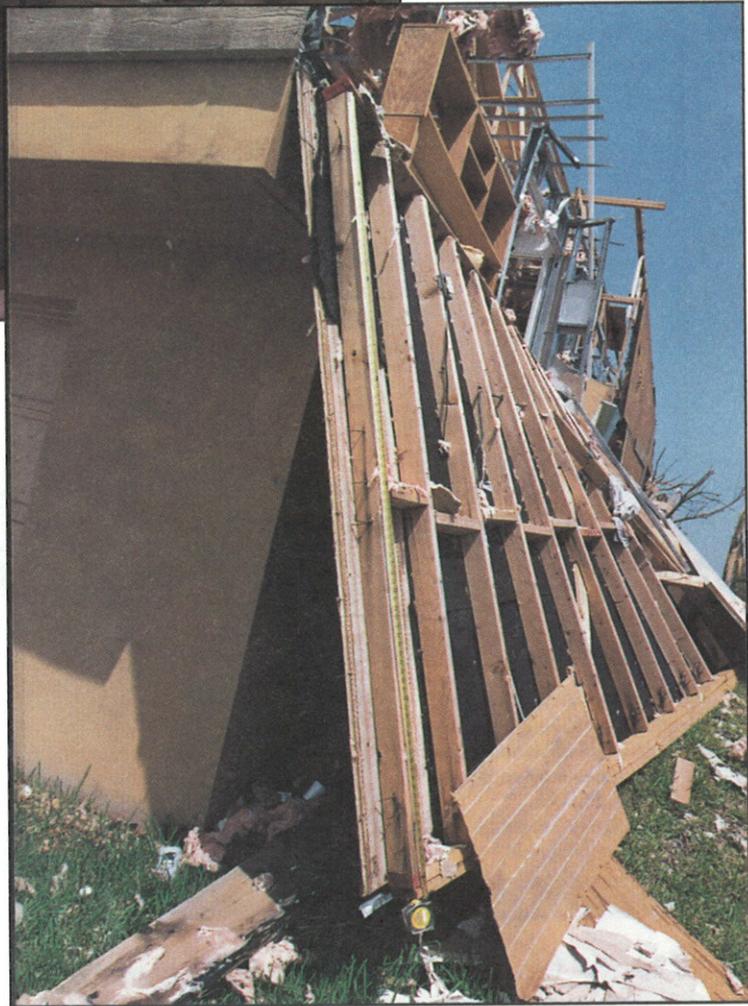
FIGURE 60.
*Side wall failure. Side
wall has no lateral load
transfer capacity due to
inadequately built-up
corner post.*

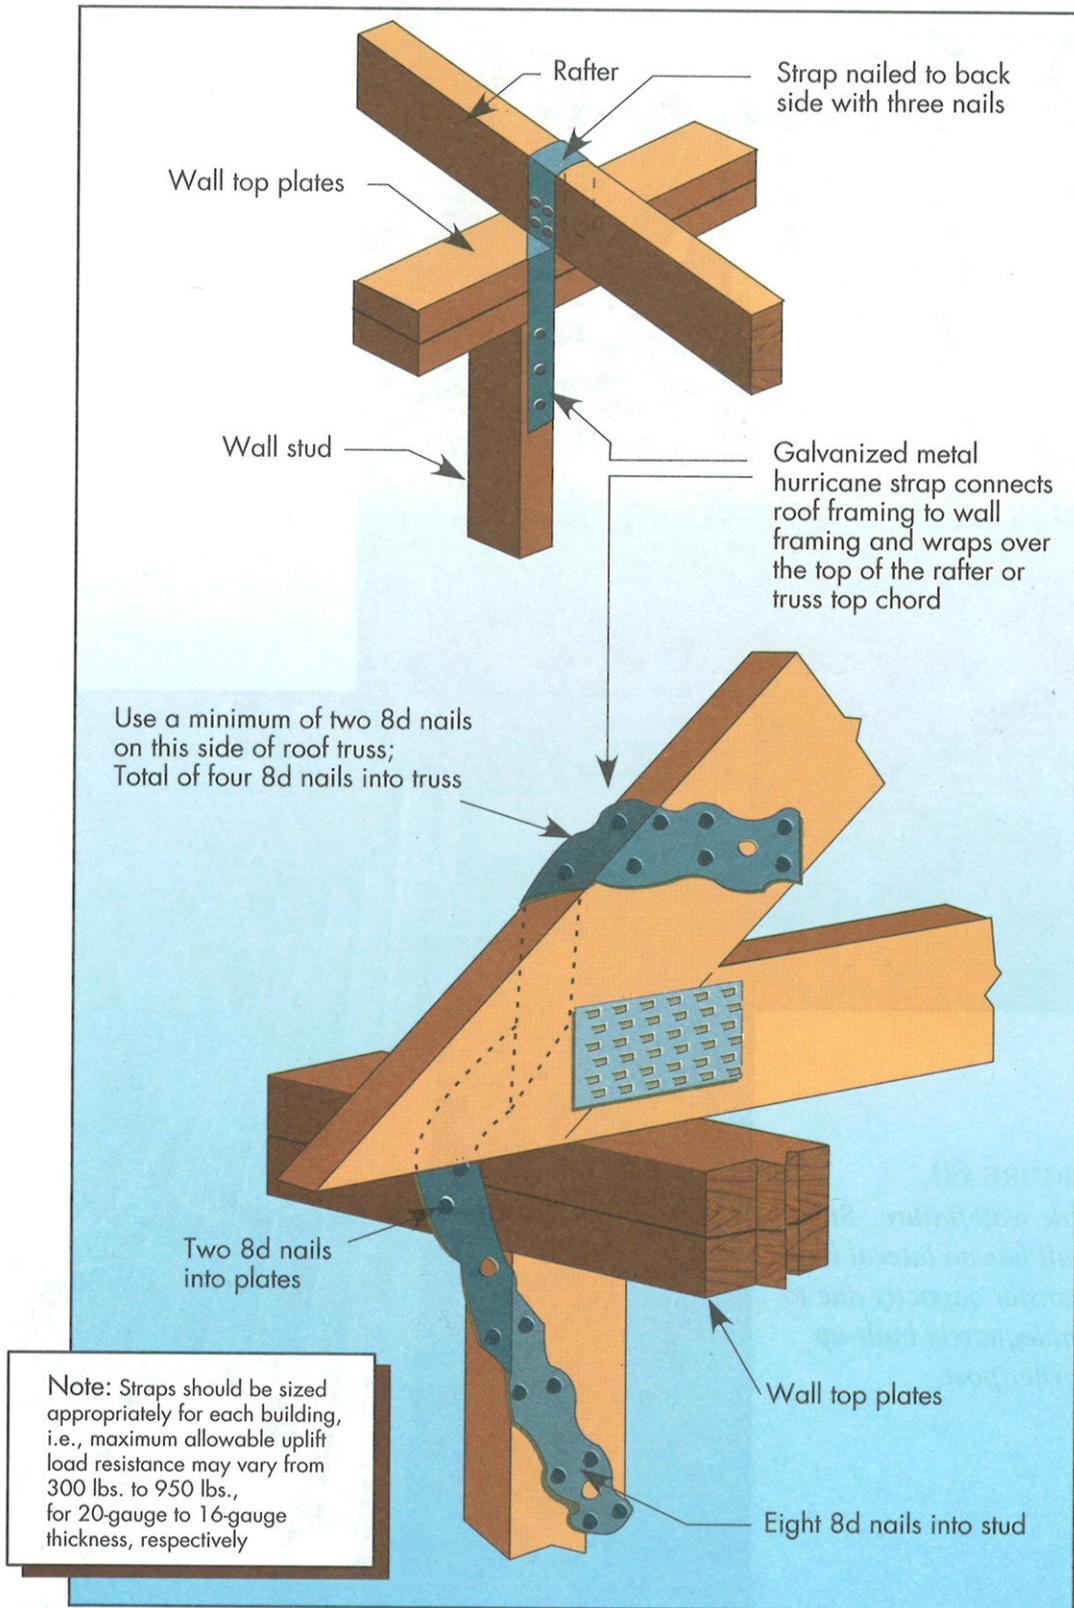
FIGURE 61. Typical hurricane strap to roof framing detail. Rafter or prefabricated roof truss.

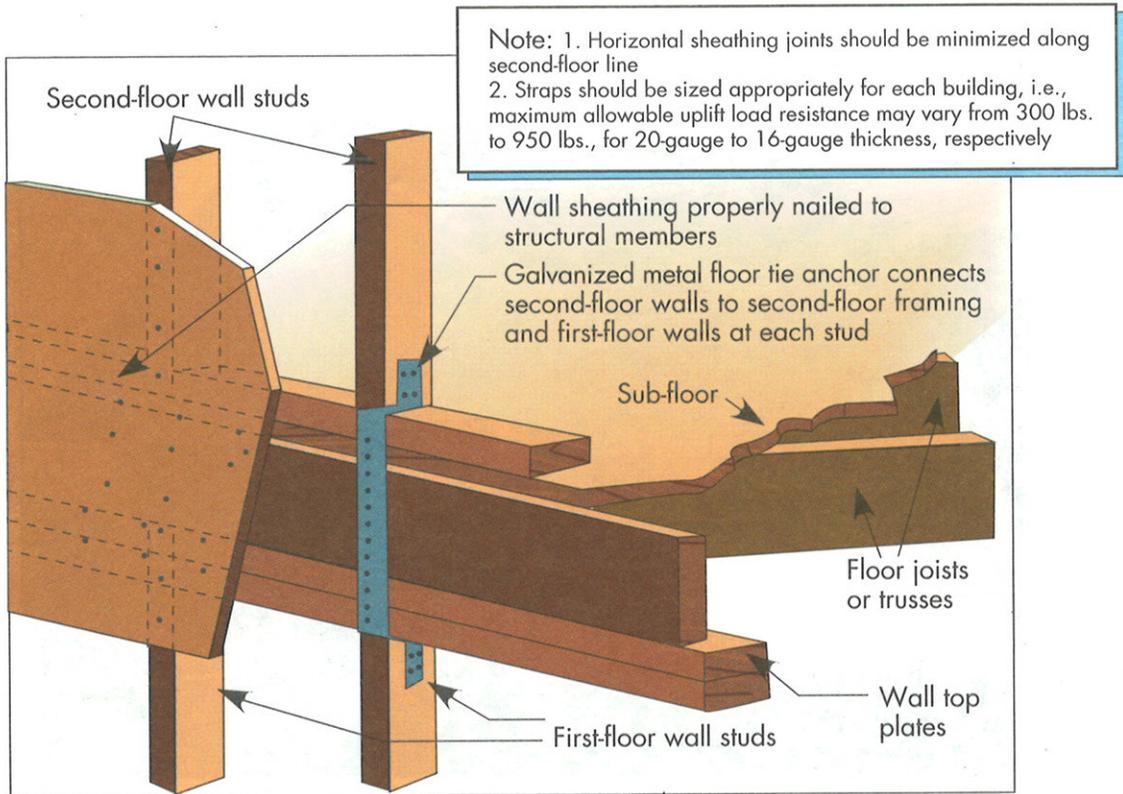
FIGURE 62. *Upper-floor tie to lower floor for two-story building. Floor tie anchor and nailed wall sheathing.*

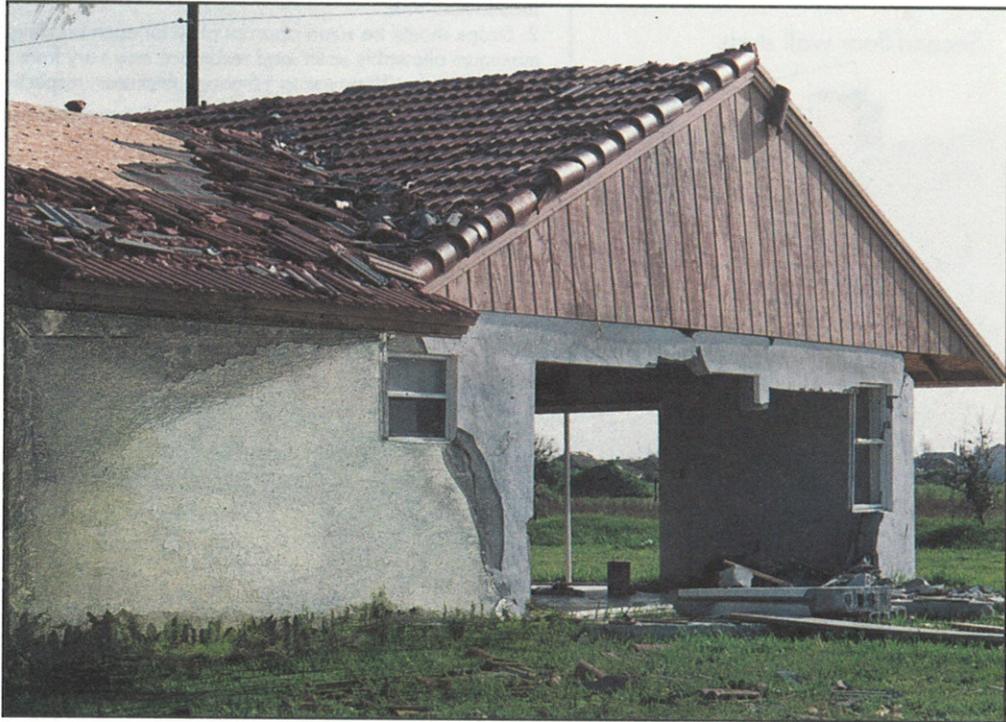
FIGURE 63. *Example of masonry construction. Wall separated from building envelope due to inadequate vertical wall reinforcing in connection to horizontal tie-beam.*

— The Code requirements for tie-beams/tie-columns, or alternative reinforced masonry construction, should be reviewed and enforced (SEE FIGURES 63 AND 64).

- A tie-beam of reinforced concrete should be placed in all walls of unit masonry, at each floor or roof level, and at such intermediate levels as may be required to limit the vertical heights of the masonry units to 16 feet.

- The use of concrete tie-columns at all corners, and at intervals not to exceed 20 feet on center of columns, should be reviewed as a Code improvement. The maximum area of wall panels of 8-inch-thick unit masonry as measured between concrete members which frame the panel, such as the tie-beams and tie-columns, should not exceed 256 square feet.

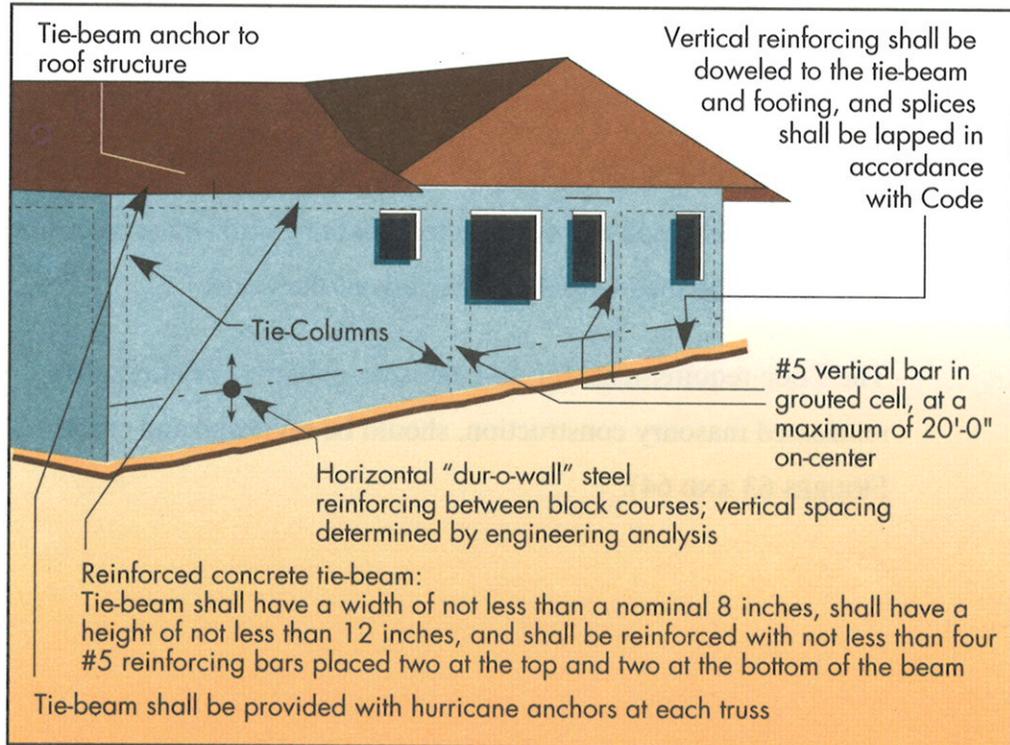
FIGURE 64. *Adequately designed and constructed tie-beam/tie-column masonry wall.*
