3.0 RECOMMENDATIONS

3.1 GENERAL RECOMMENDATIONS

3.2 SPECIFIC RECOMMENDATIONS

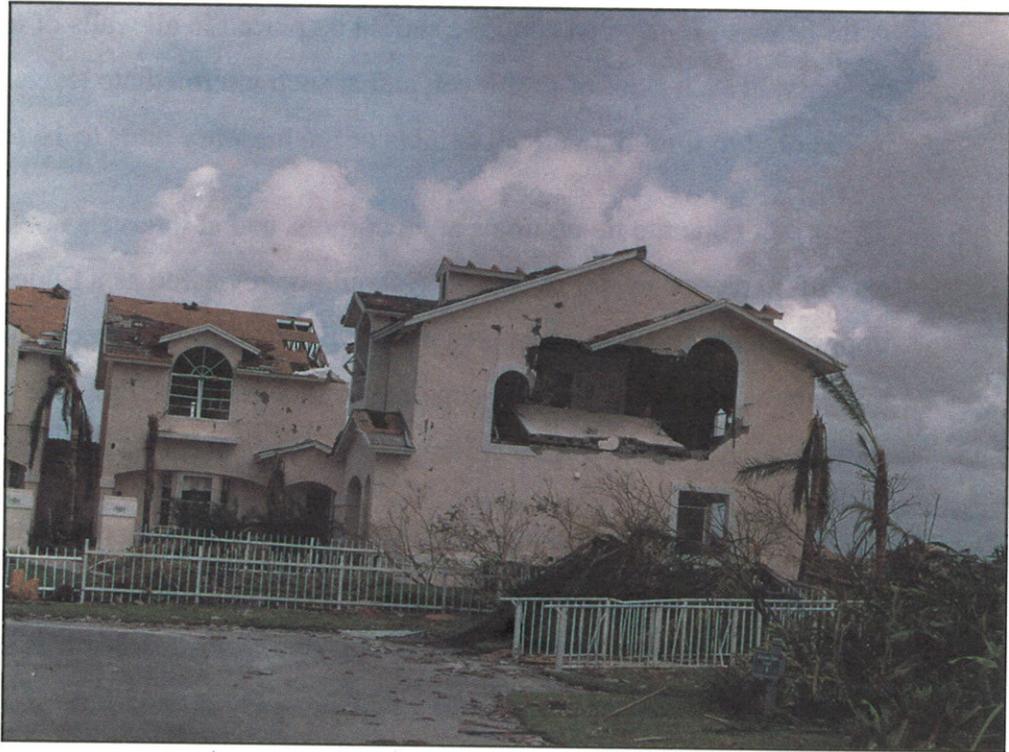
FIGURE 65. *End wall failure. Freestanding concrete masonry wall has discontinuous tie-beam.*

2. Masonry walls with continuous tie-beams should be engineered and constructed to support the specific architecture of the building. This includes consideration of freestanding cantilevered wall systems for elements such as firewalls that have discontinuous tie-beams. (SEE FIGURES 65-68).

- Bracing with struts or pilaster columns in walls perpendicular to the freestanding walls, or adequate reinforcing in the walls sufficiently anchored in the foundation or story below, must be engineered and installed.

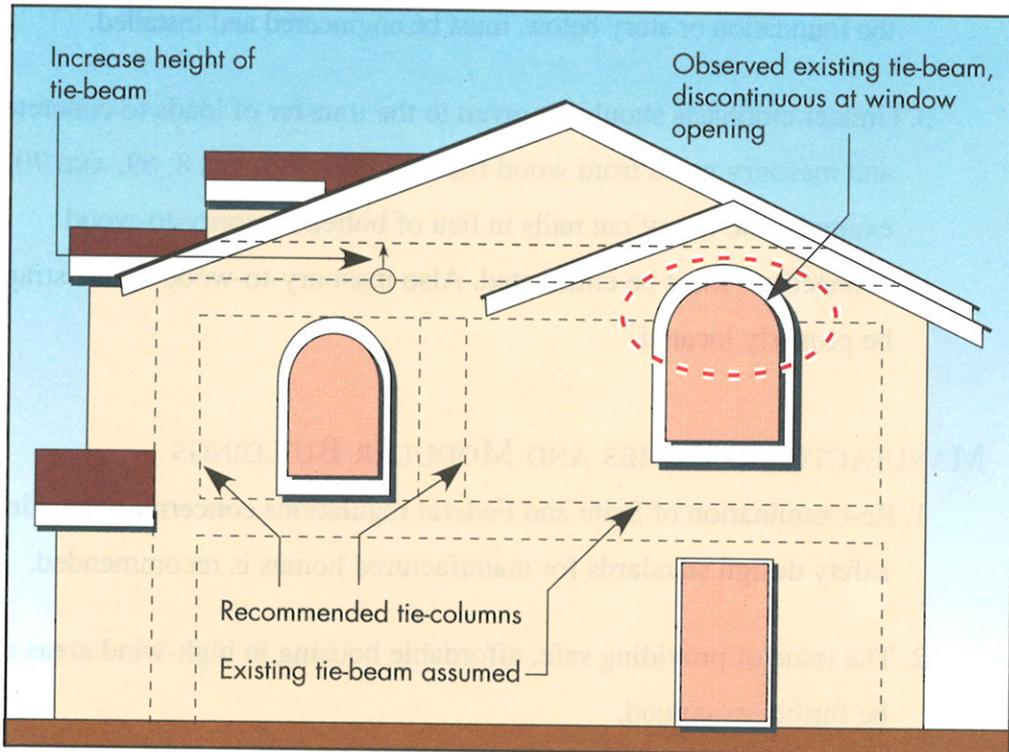
FIGURE 66. *Individualized architectural systems require designs for structural support.*

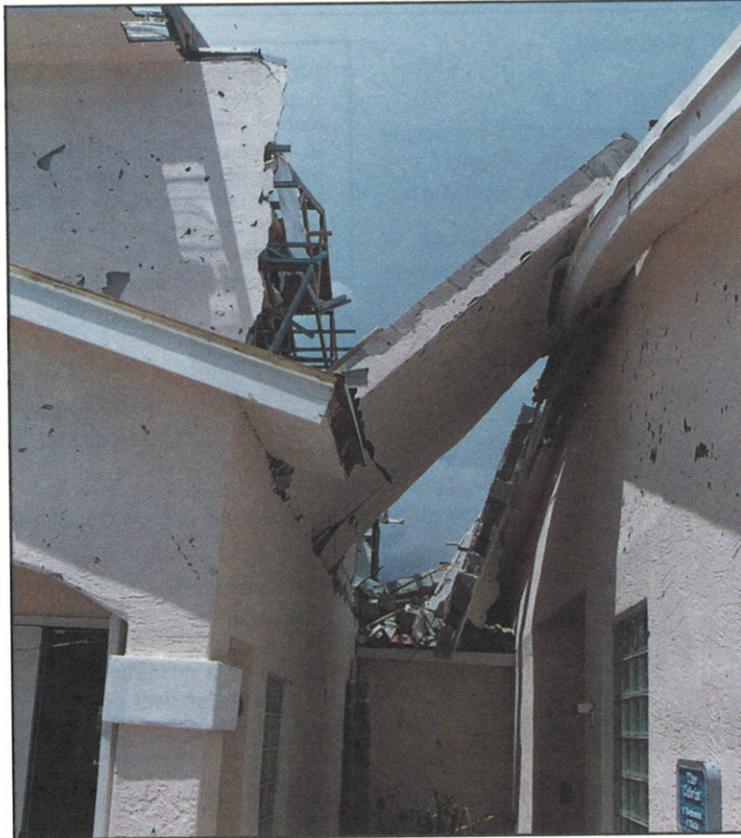
FIGURE 67.
*Firewall separation .
 Results from building
 corners being
 discontinuous with tie-
 beams. (See Figure 68
 for side view)*

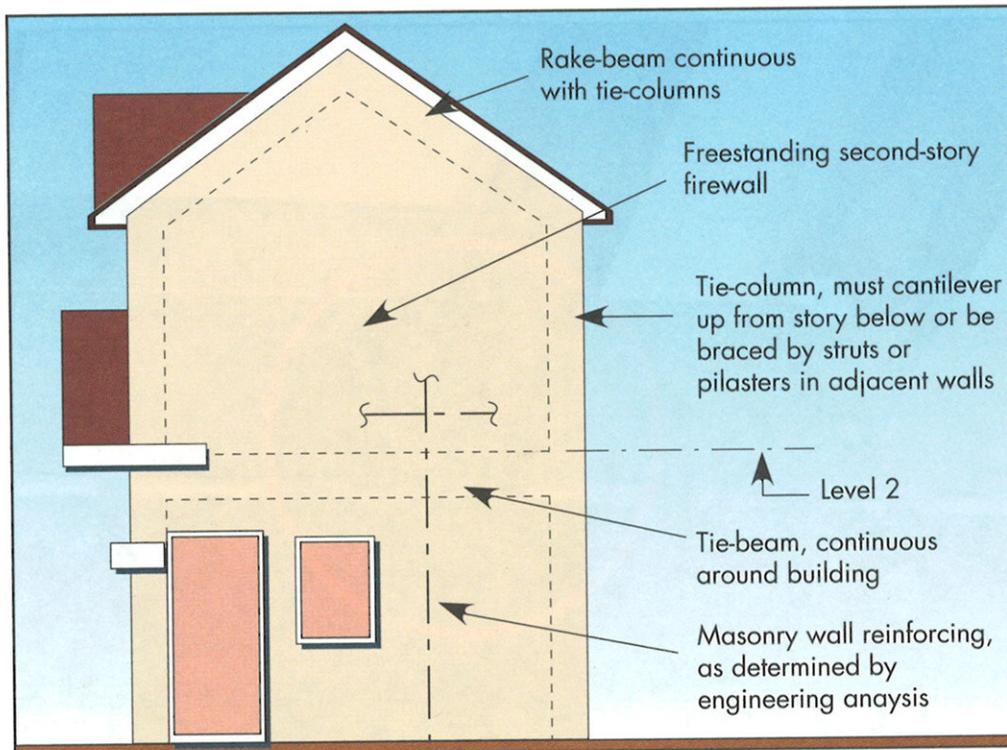
FIGURE 68. *Adequately designed and constructed freestanding cantilevered wall system.*

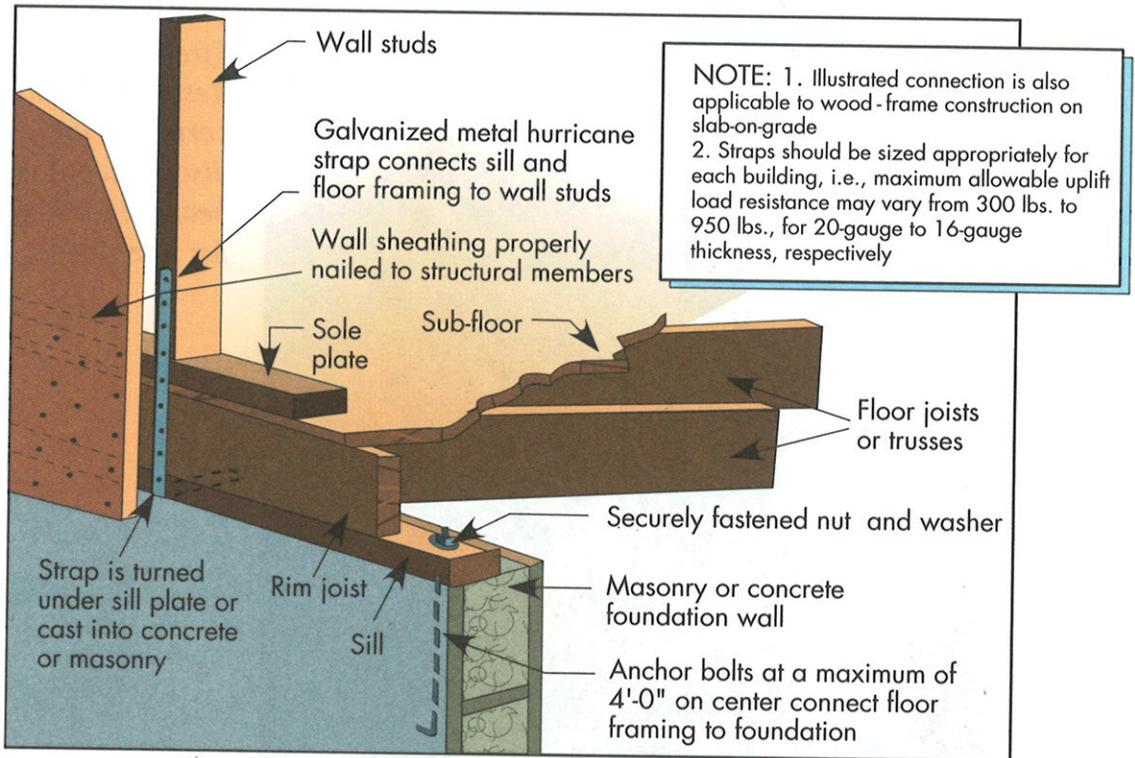
FIGURE 69. Lower-story wall anchorage to masonry (or concrete) base. Straps properly nailed at wall studs.

3. Greater emphasis should be given to the transfer of loads to concrete slabs and masonry walls from wood framing (SEE FIGURES 8, 69, AND 70). For example, the use of cut nails in lieu of bolted masonry-to-wood connections must be eliminated. Also masonry-to-wood-frame straps must be properly located.

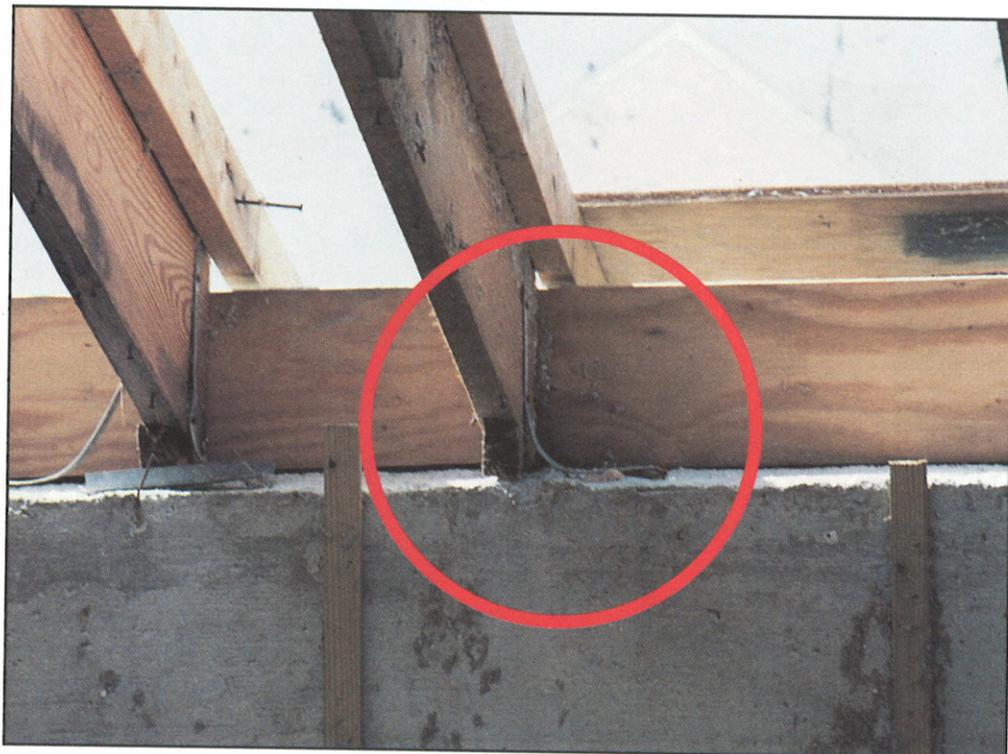
FIGURE 70. Improperly located masonry-wall-to-wood-frame straps.

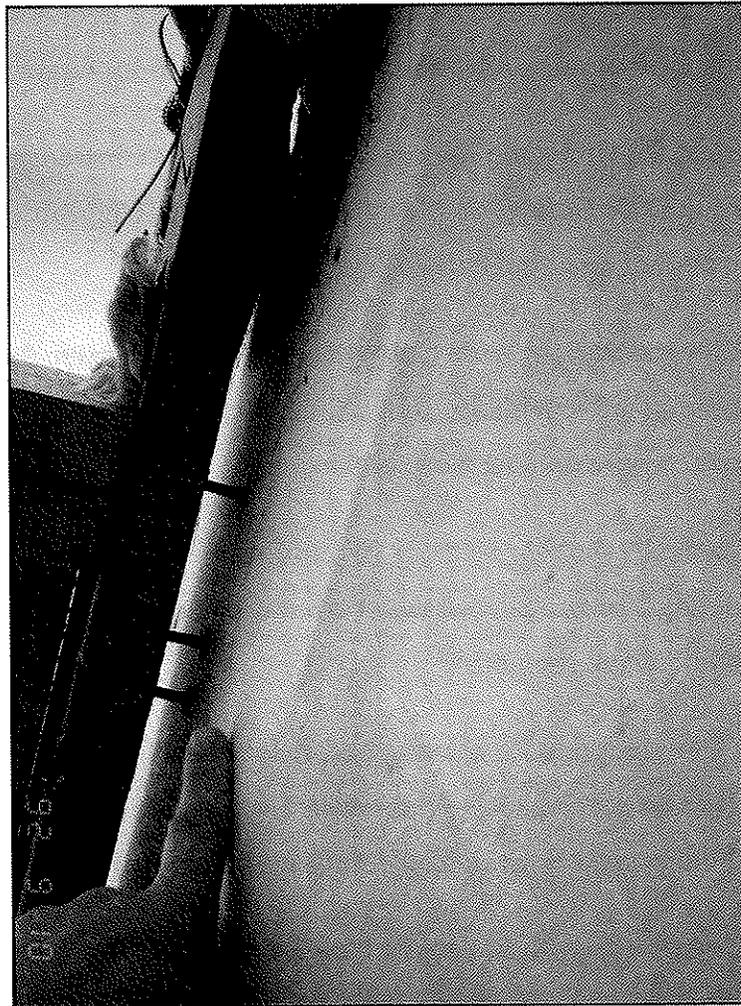
FIGURE 71. *Modular home. Partial separation of end panel (right) from roof structure (left). Evidence of failure due to nail withdrawal.*

3. Although the modular systems (SEE FIGURE 18) generally performed well, possible alternatives to the detailing and construction of weaker components of the systems should be reviewed. Most notably, the end-panel connections of end units, and roof sheathing should be reevaluated (SEE FIGURE 71).
