Environmental Assessment Monte Cristo Grade Road Bridge

Snohomish County, Washington
FEMA-1499-DR-WA (Public Assistance)
January 2009

**Prepared by Snohomish County Public Works
3000 Rockefeller Place
Everett, WA 98201**

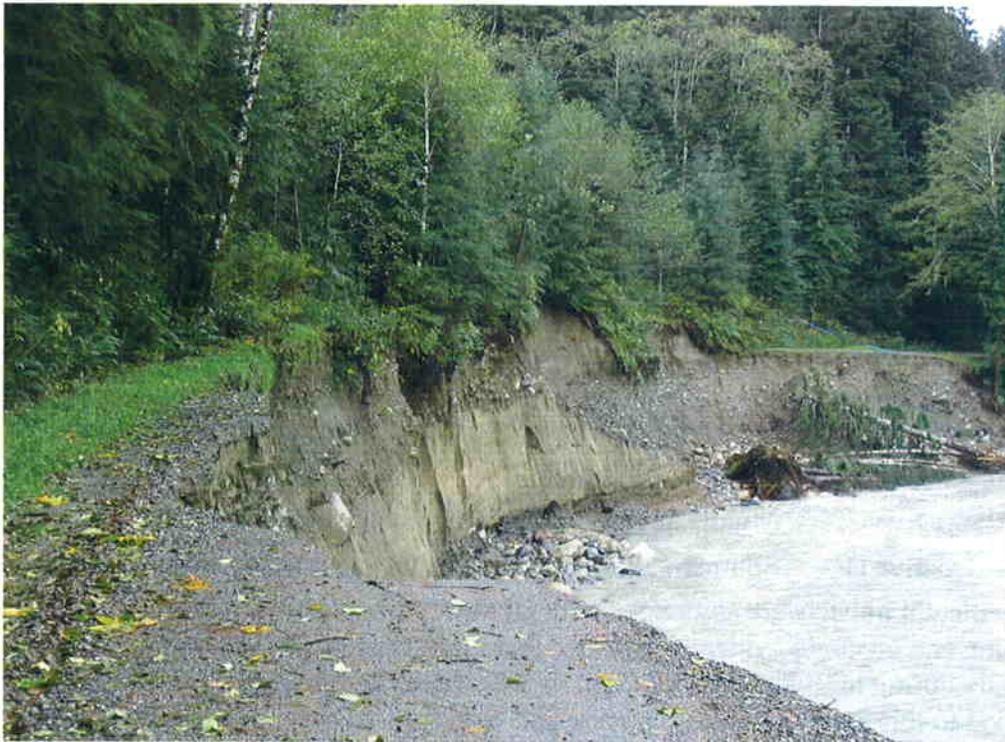
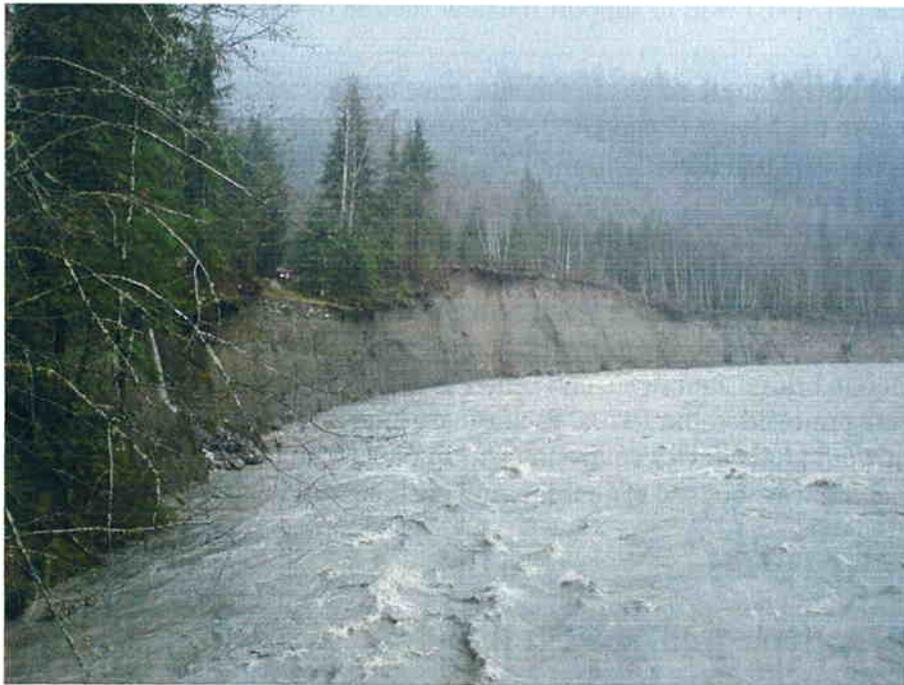
Figure 3: 2003 Washout Site

Site of Monte Cristo Grade Road washout, October 22, 2003 (looking downriver).

Washout site on December 3, 2007 during high flow (looking downriver from Blue Bridge).

Record rainfall occurred in Western Washington during October 19 - 21, 2003 causing extensive damage throughout the region. Flooding and erosion in the South Fork Stillaguamish River watershed caused about 650 feet of the Monte Cristo Grade Road, just outside of Verlot, Washington to washout. The Monte Cristo Grade Road is an unpaved gravel road accessing twenty four recreational properties and one residence. The river now occupies a section of the old road footprint. Additional erosion occurred during the 2006 and 2007 flood seasons. The road has been barricaded since 2003 and there is currently no vehicular access to the recreational properties and Forest Service land along the road. (See Figure 1: Project Location).

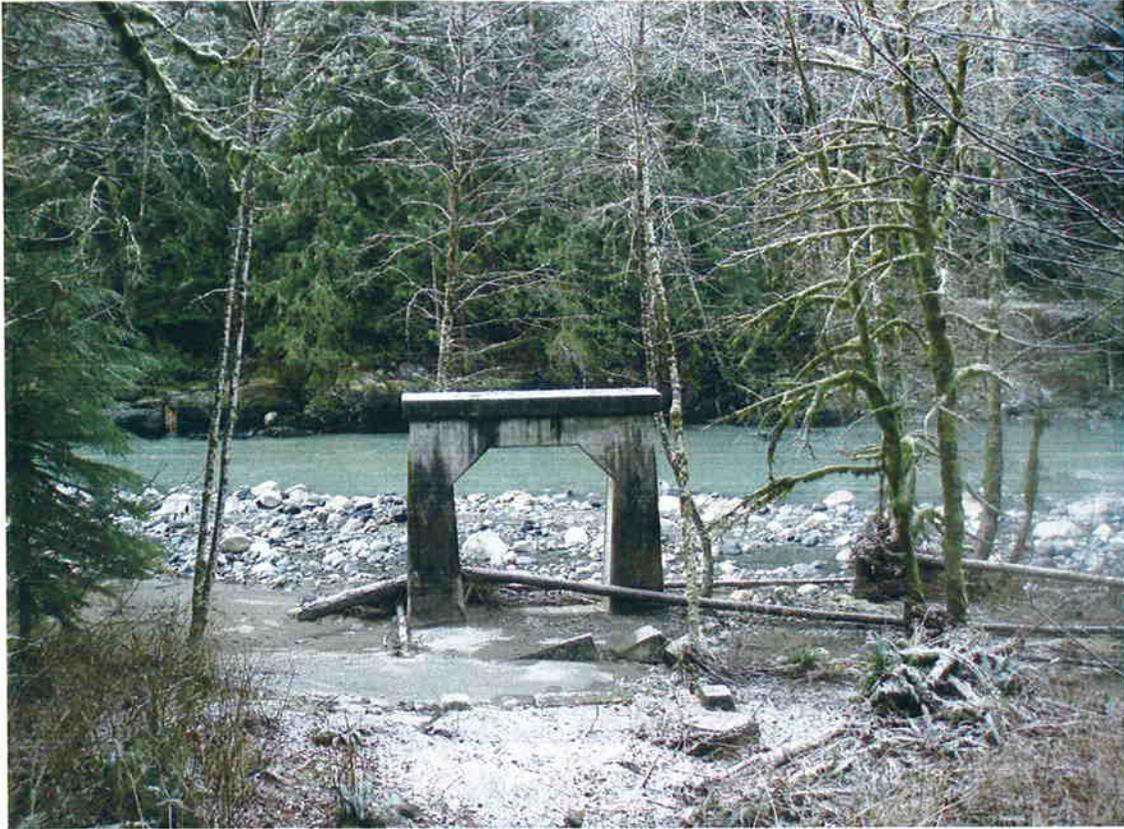
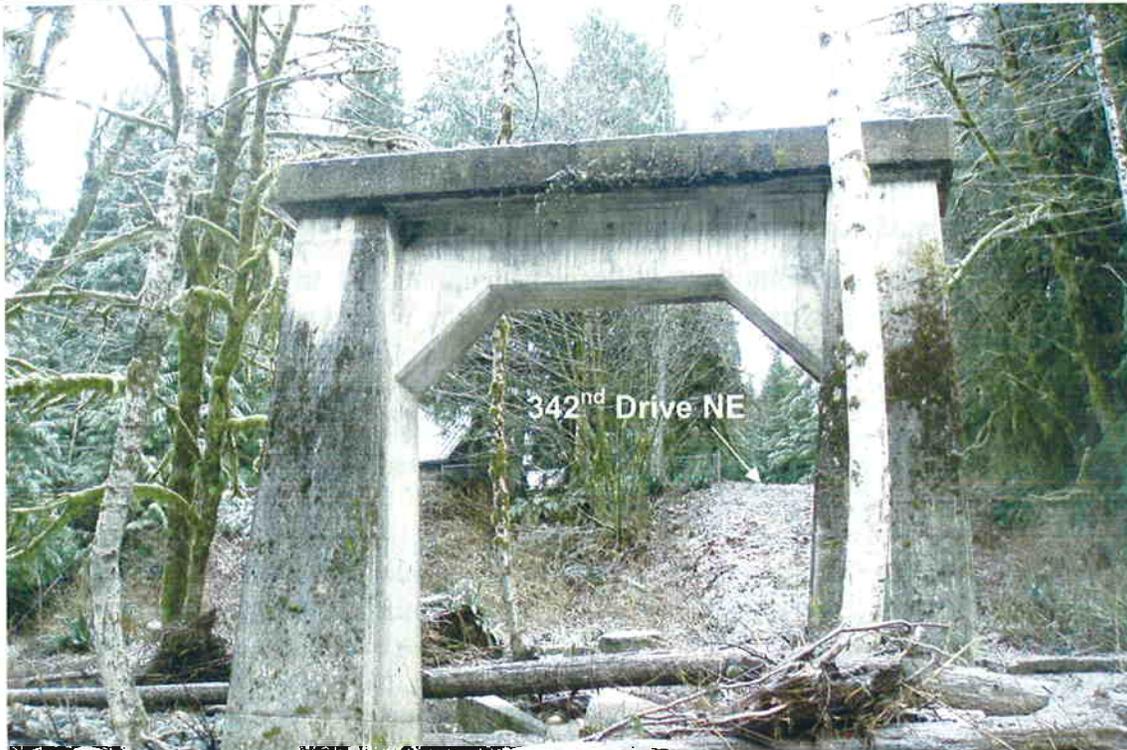
Figure 7: Existing Concrete Pier

Existing concrete pier to be removed: Top photo is looking south. Bottom photo is looking north.

A geotechnical evaluation of the remaining structures was conducted in 2006. According to this study, the existing center pier would need to be removed and replaced due to inadequate scour resistance and vertical load capacity. It is anticipated that the concrete abutment on the south side of the river would be left in place and modified to accommodate the new superstructure. If after more detailed analysis it is determined to be deficient, the abutment would be removed and replaced in the same location. A new abutment would also be constructed at the north end of the bridge at the end of 342nd Drive NE.

Construction would occur during the dry season. Ground impacts on the north side of the river include excavation for removal of the center pier and construction of a new pier. The proposed center pier would be at approximately the same location as the existing pier. The old pier is a cast-in-place structure with two columns supporting a concrete cap. (See Figure 7: Existing Concrete Pier). Impacts would also include excavation and removal of the existing north abutment where 342nd Drive NE dead ends. The abutment would be replaced with piles.

The new center pier will be supported by seven 24-inch diameter pipe piles driven to refusal. The north abutment would be supported by five 18-inch piles driven to refusal. Open-ended pipe piles are recommended due to their drivability in the granular soils encountered at the site. The depth of excavation for the center pier and north abutment piles is not determined at this time. Additional investigation is planned to determine the site design scour depth, the elevation and shape of the pile cap and pile depth.

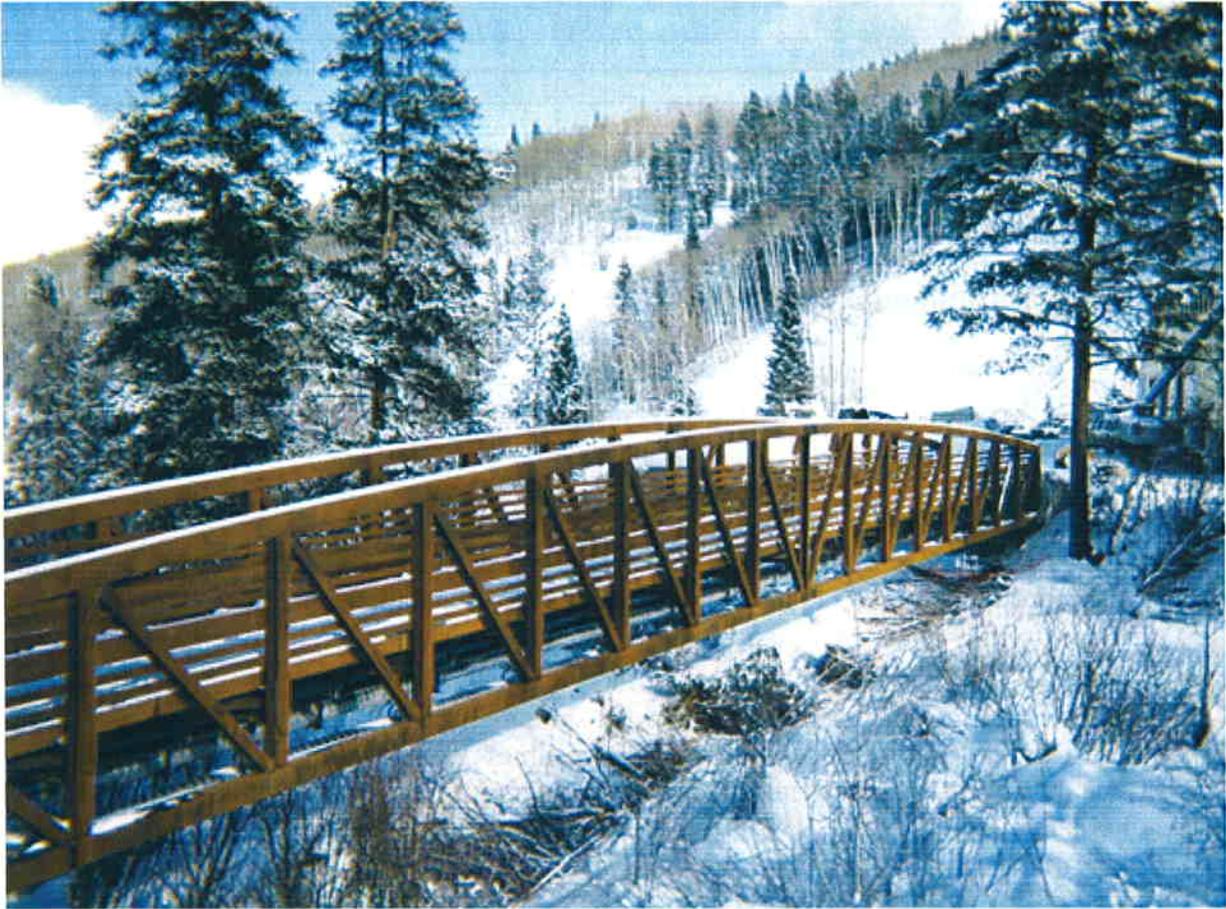
Figure 9: Bridge Design

This bridge shown above is similar in design to the one proposed for the Monte Cristo Grade Road Bridge. The photo shows a prefabricated steel truss bridge.

Under the Bridge Option the existing concrete center pier would be removed and replaced with a similar structure. The new bridge is planned to be a prefabricated steel truss similar to the one pictured in Figure 9: Bridge Design. The bridge would be visible from the end of 342nd Drive NE. The bridge would also be visible from the river and the adjacent beach around the bridge site. The bridge may be visible from some of the cabins and homes off of 102nd Street NE just west of the bridge site. Due to the heavy vegetation and distance it is not likely the bridge would be visible from the Mountain Loop Highway.

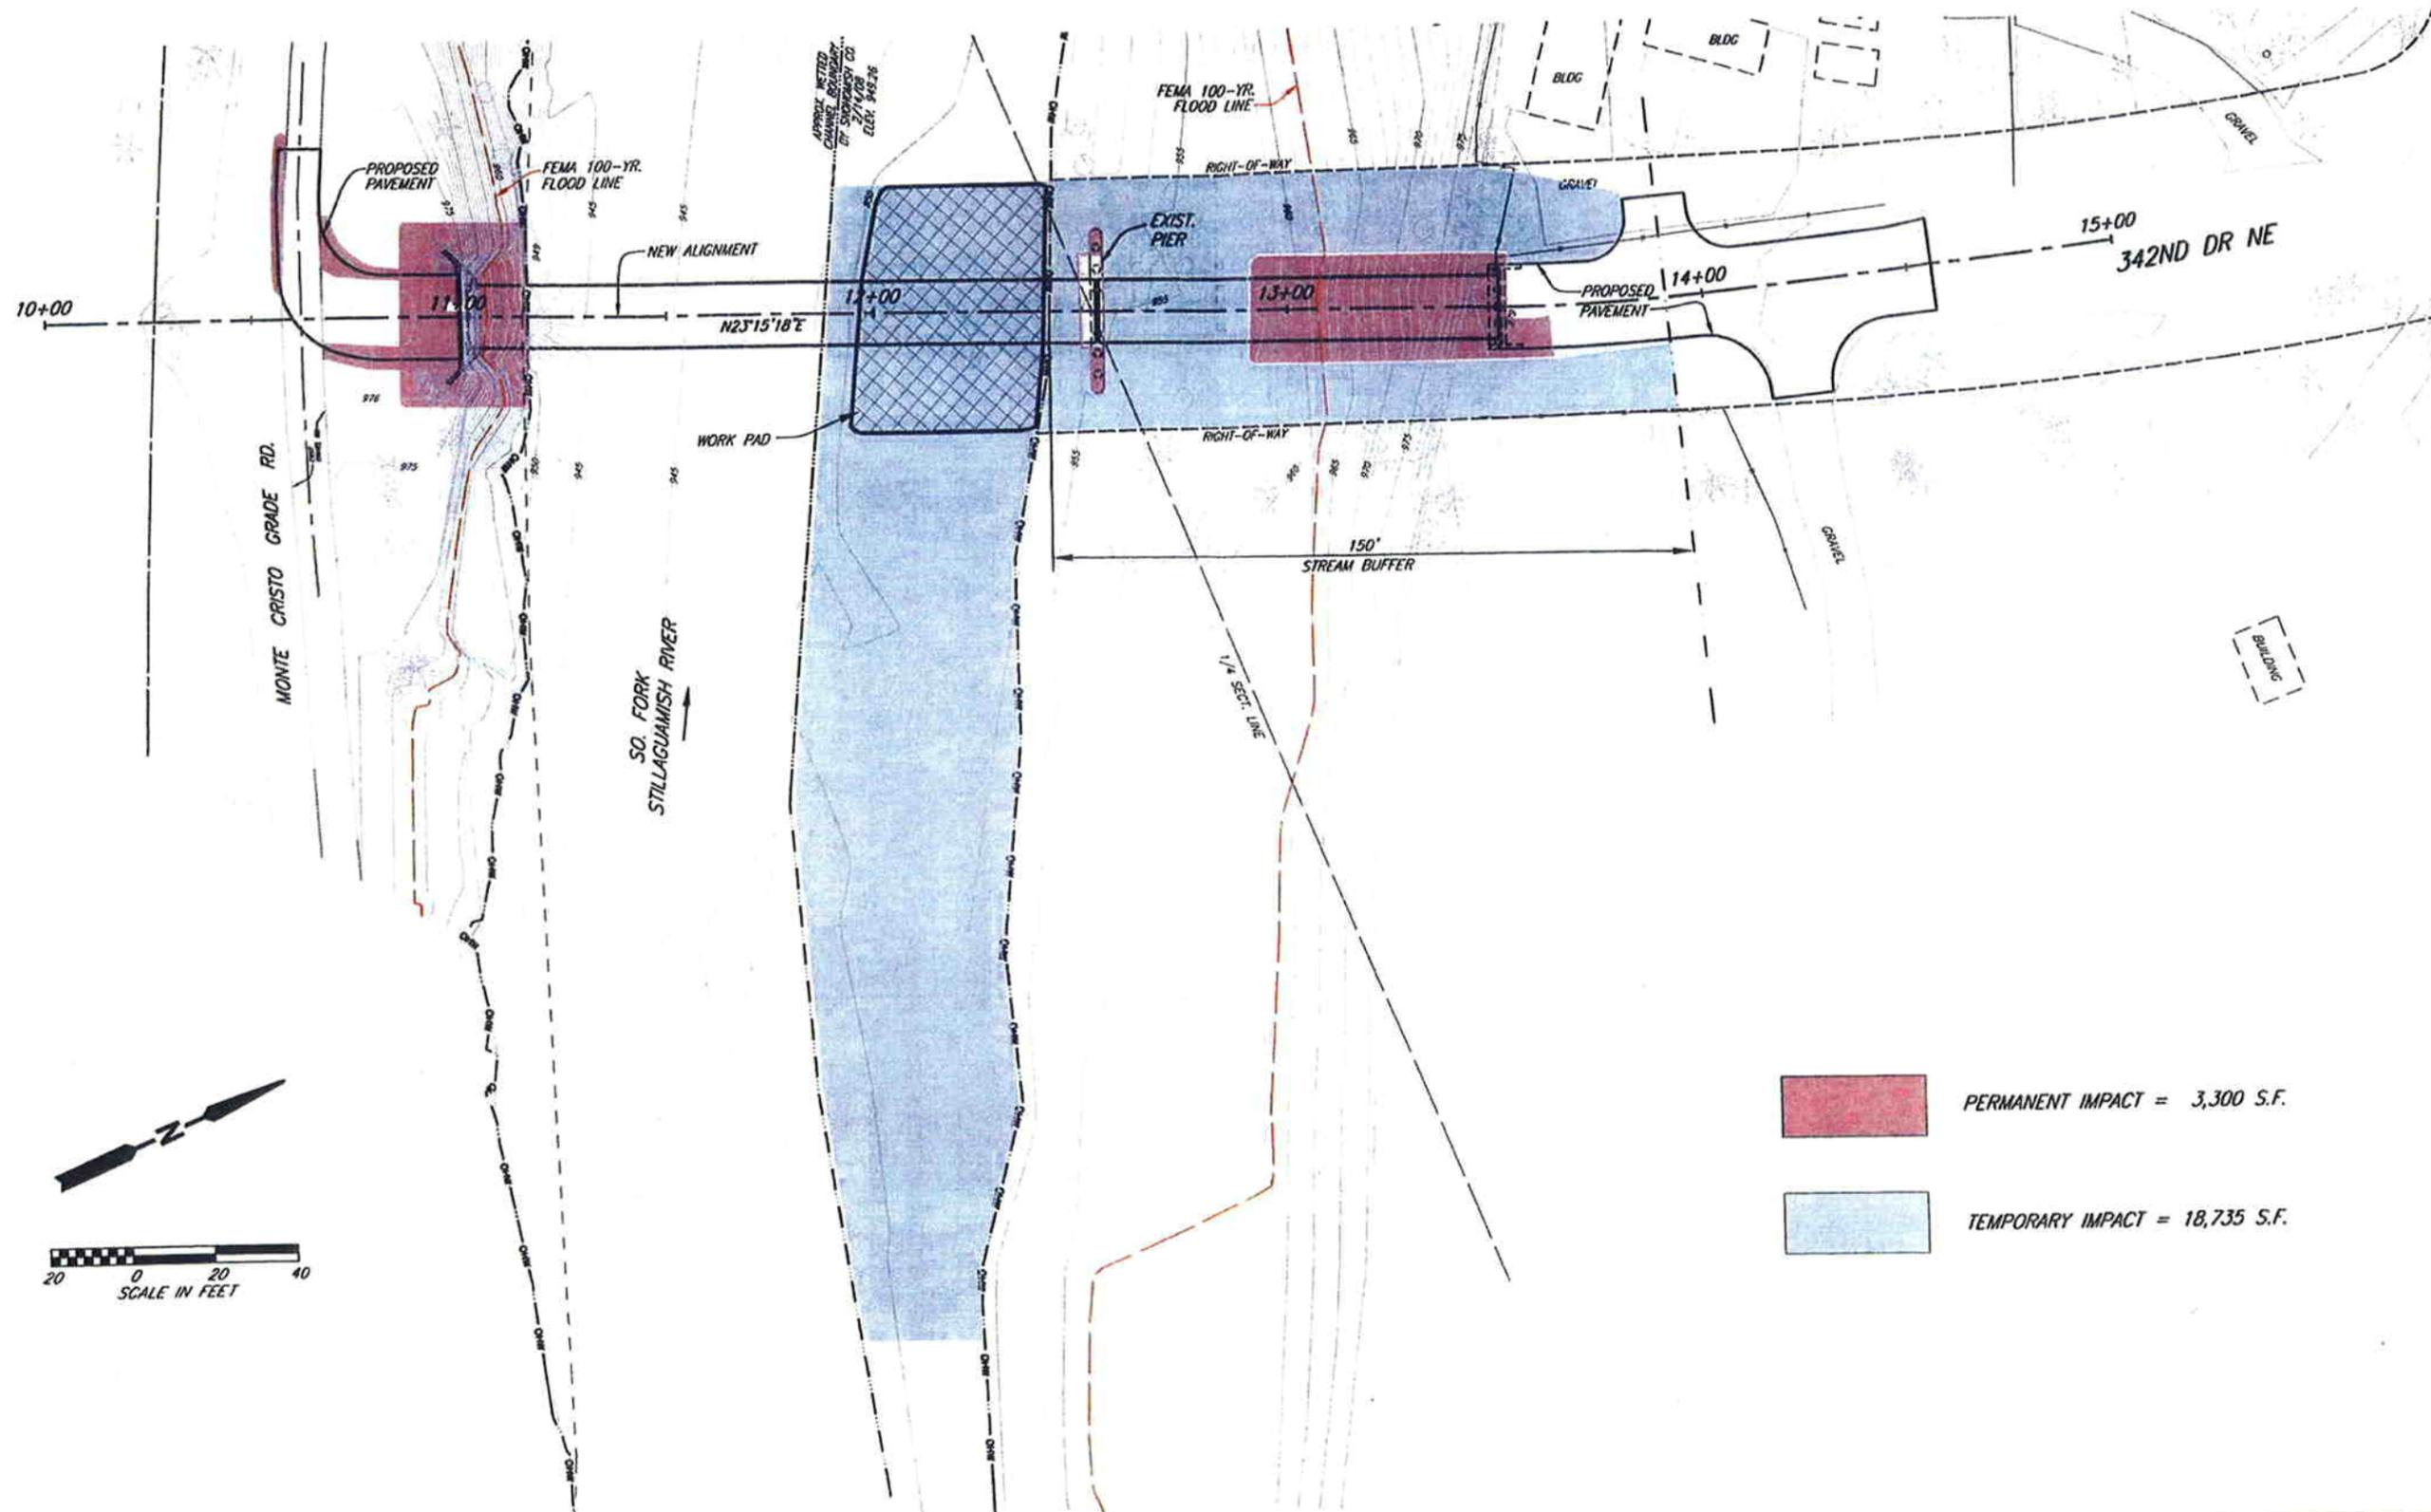
PERMANENT IMPACT = 3,300 S.F.

TEMPORARY IMPACT = 18,735 S.F.

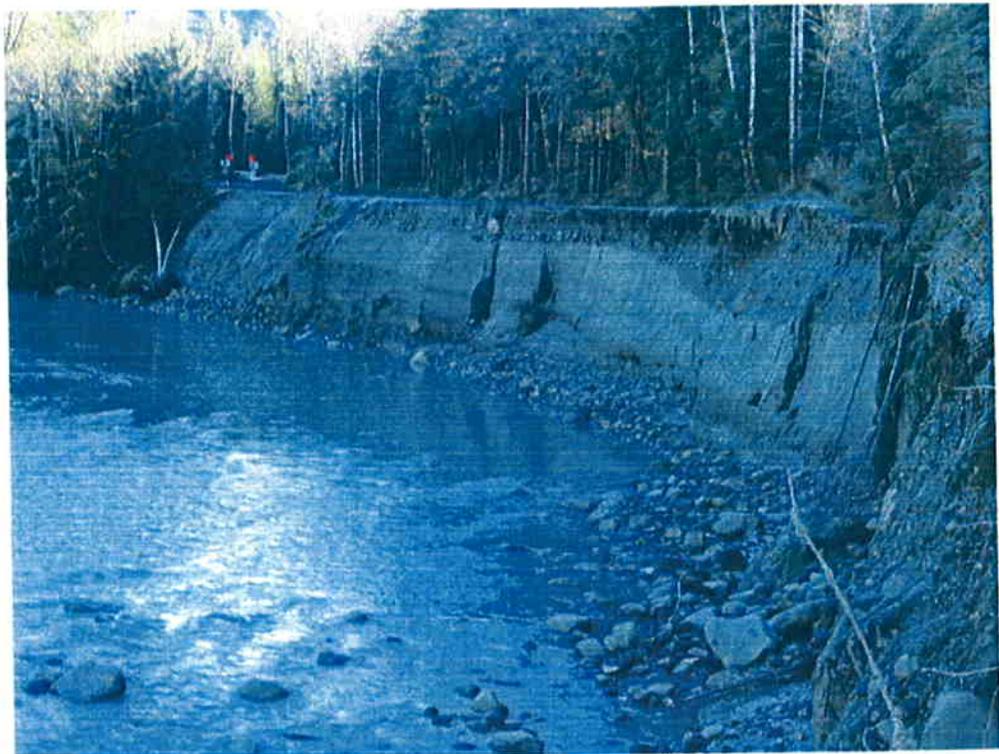
Looking upstream –road is washed out until the orange flags

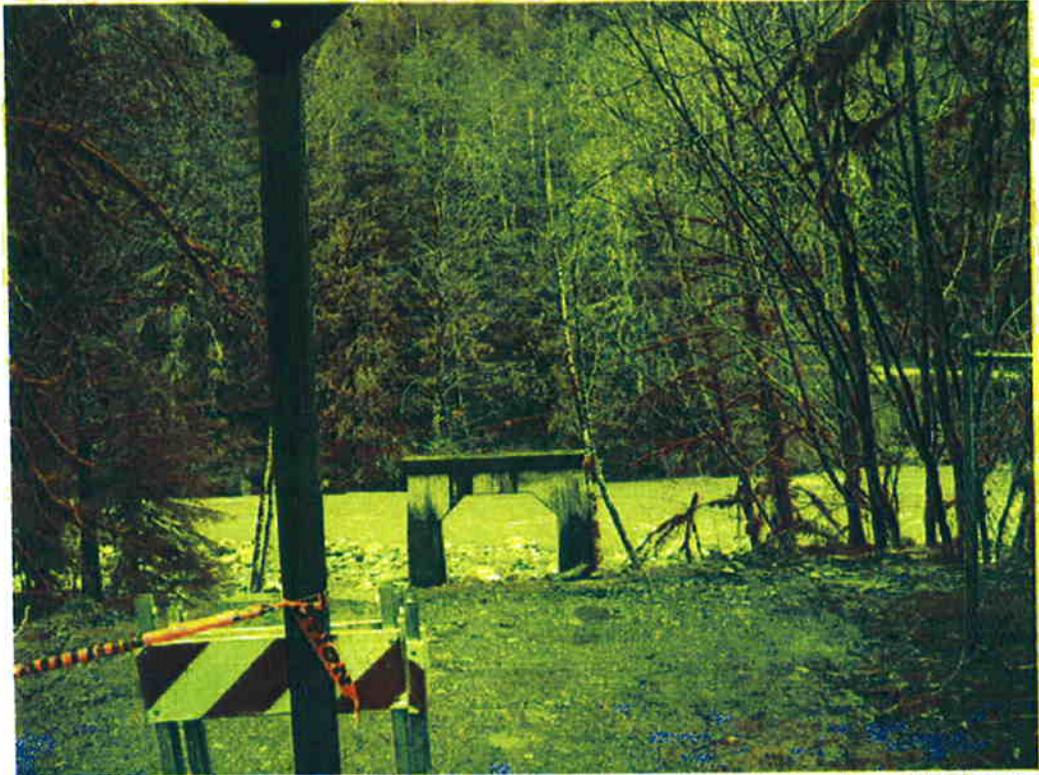
From the north abutment looking south at the center pier and south abutment

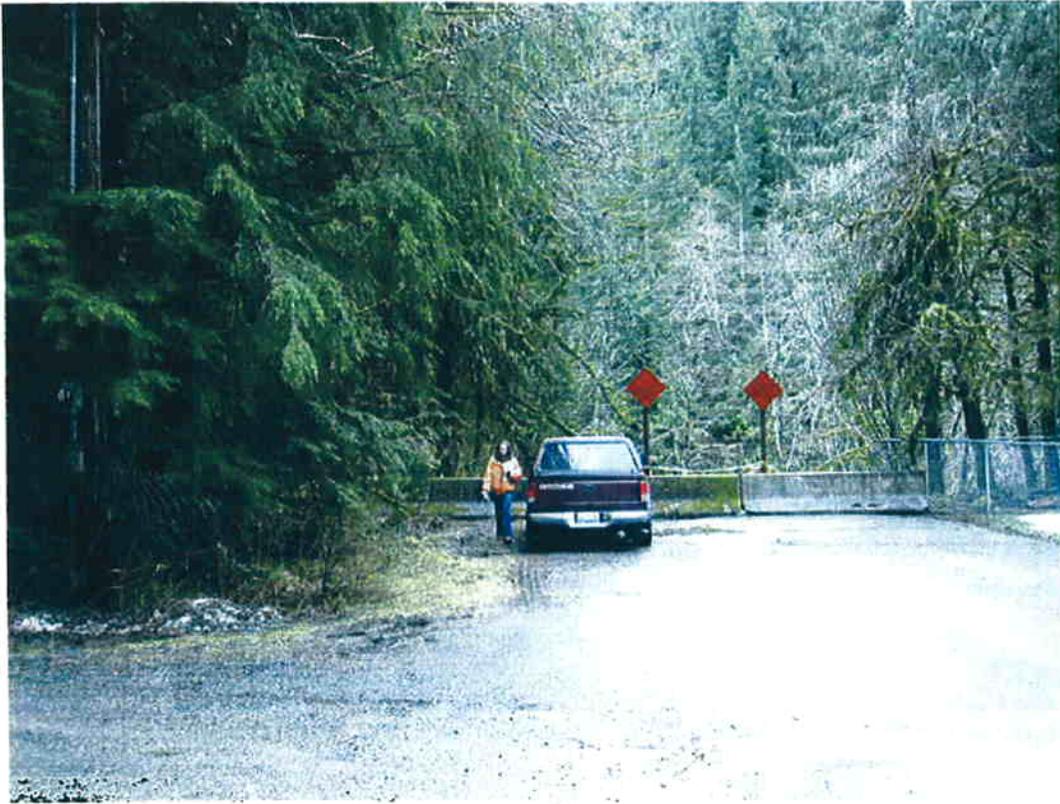
North abutment will be near the concrete barriers

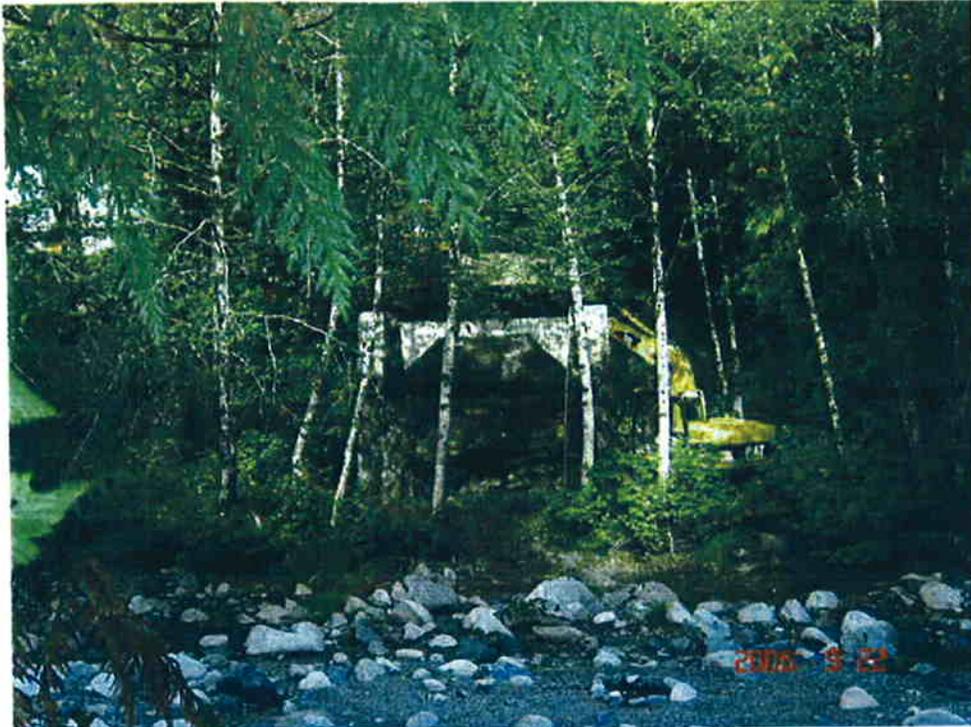
Existing center pier prior to 2006 flood

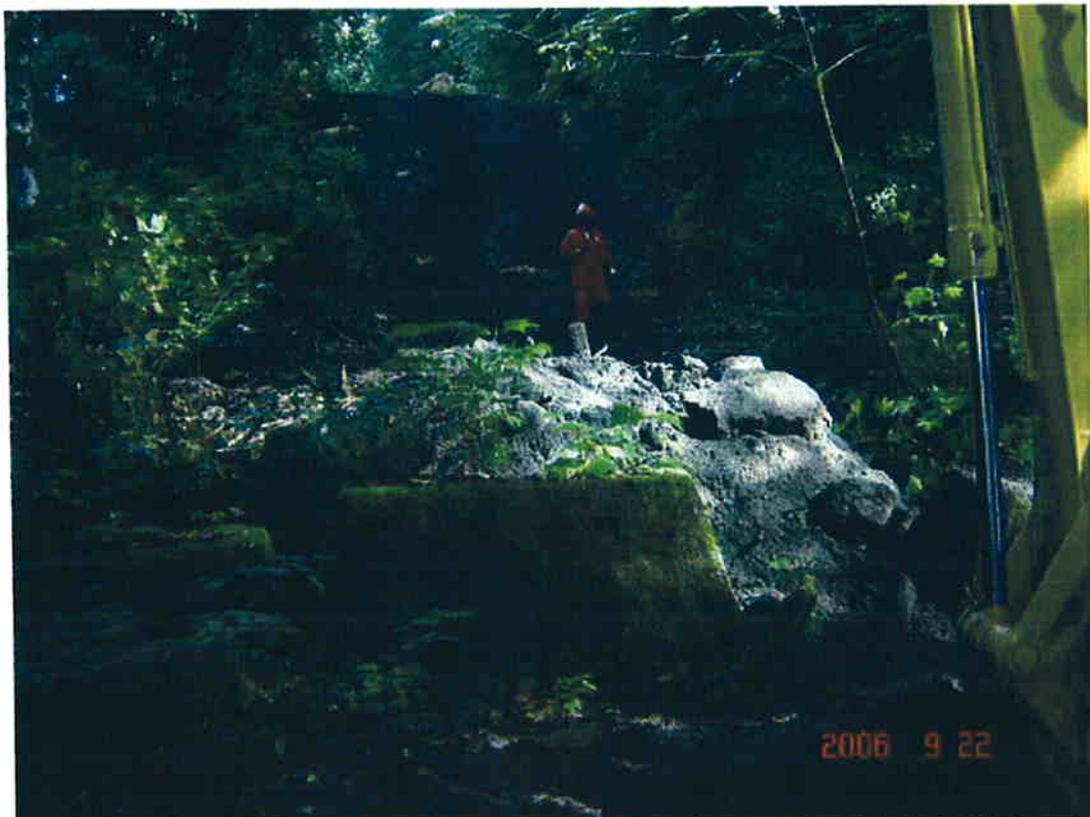
Exploratory digging at pier. Photo shows steep bank from the end of 342nd DR NE

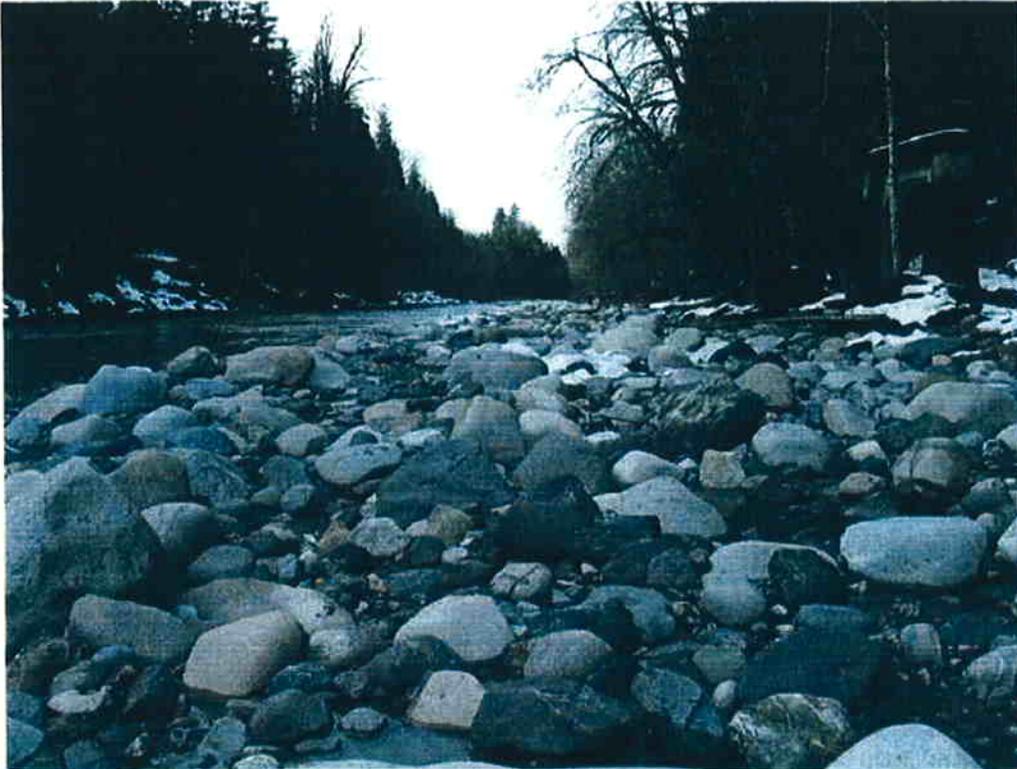
Gravel bar-location of crane pad and truss assembly area.

At the river level, approximately 310 cubic yards of temporary fill would be needed for the crane pads and construction access. The beach area is sandy, relatively flat with cobbles and boulders. The pad areas would be cleared and geo-textile laid down and covered with compacted gravels and quarry spalls to provide a base for the crane pads and construction access. Existing cobbles and boulders from the crane pad locations would be stockpiled. This material would be

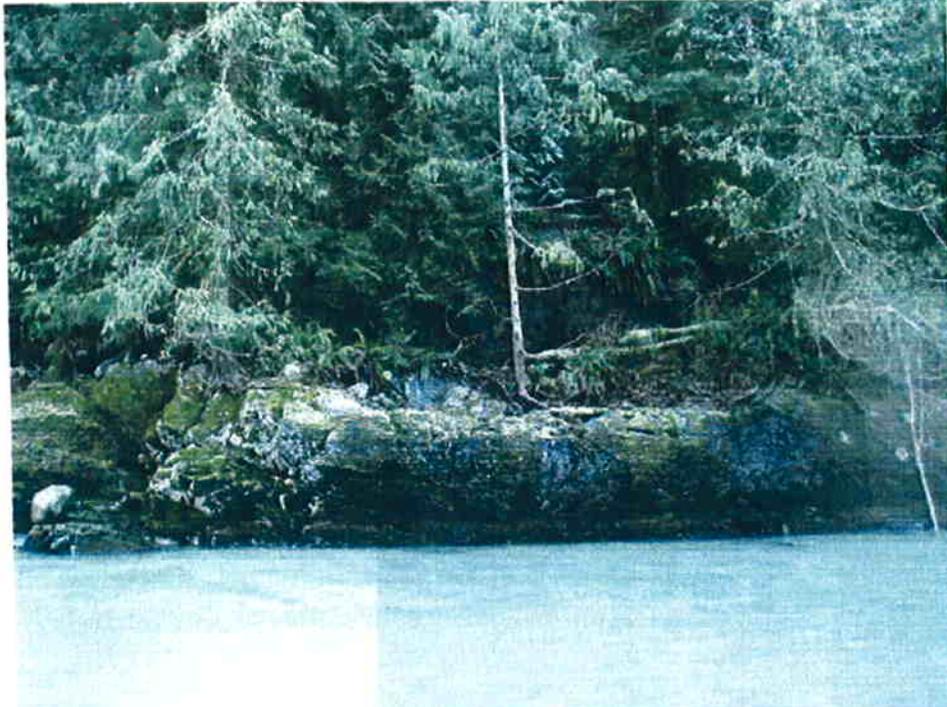
South abutment on top of bedrock

The south abutment area consists of a cast in place concrete structure that appears to be founded on bedrock. Bedrock exposed several tens of feet upstream of the abutment consisted of fresh foliated, medium dark gray to dark gray, fine grained granulose, very strong phyllite. Bedding or foliation dips to the north-northeast at around 70 degrees.

This old abutment is assumed to be a cast-in-place structure founded on exposed bedrock. The top of the abutment is nearly flush with the surrounding ground. The structure is approximately 14 feet in height from the road surface to the base. The abutment would be cleaned and reused. The abutment would be modified with additional concrete to support the bridge, if necessary.

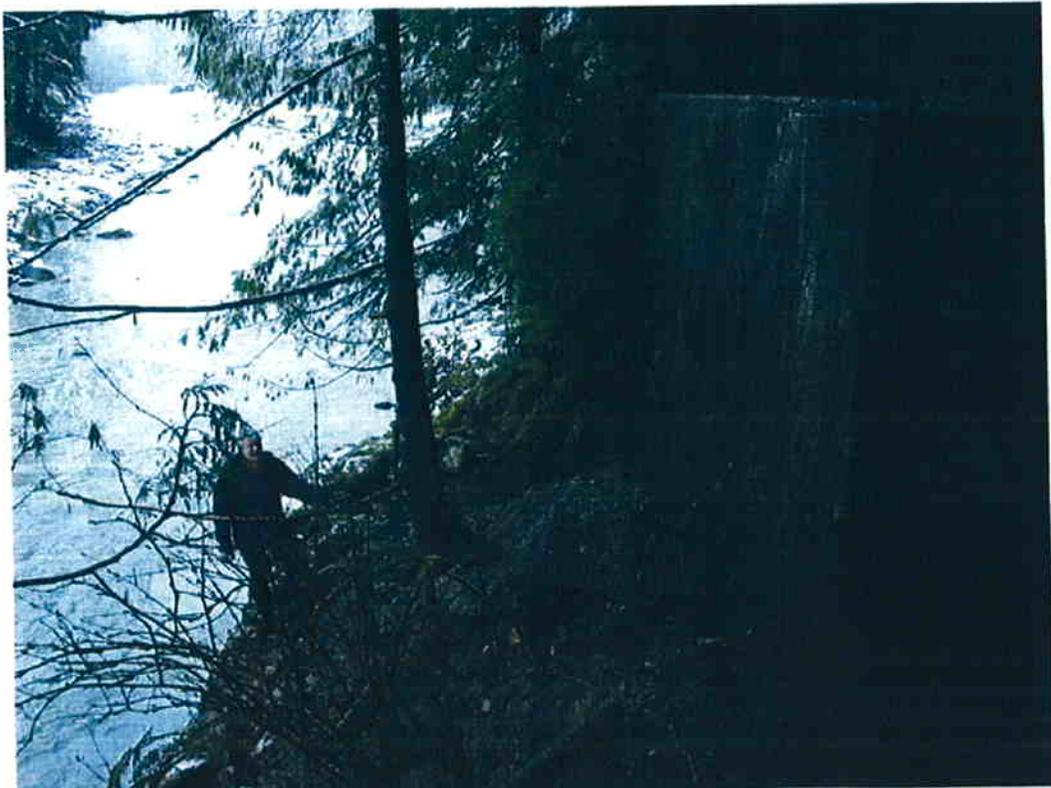
South abutment –to be used for the proposed bridge

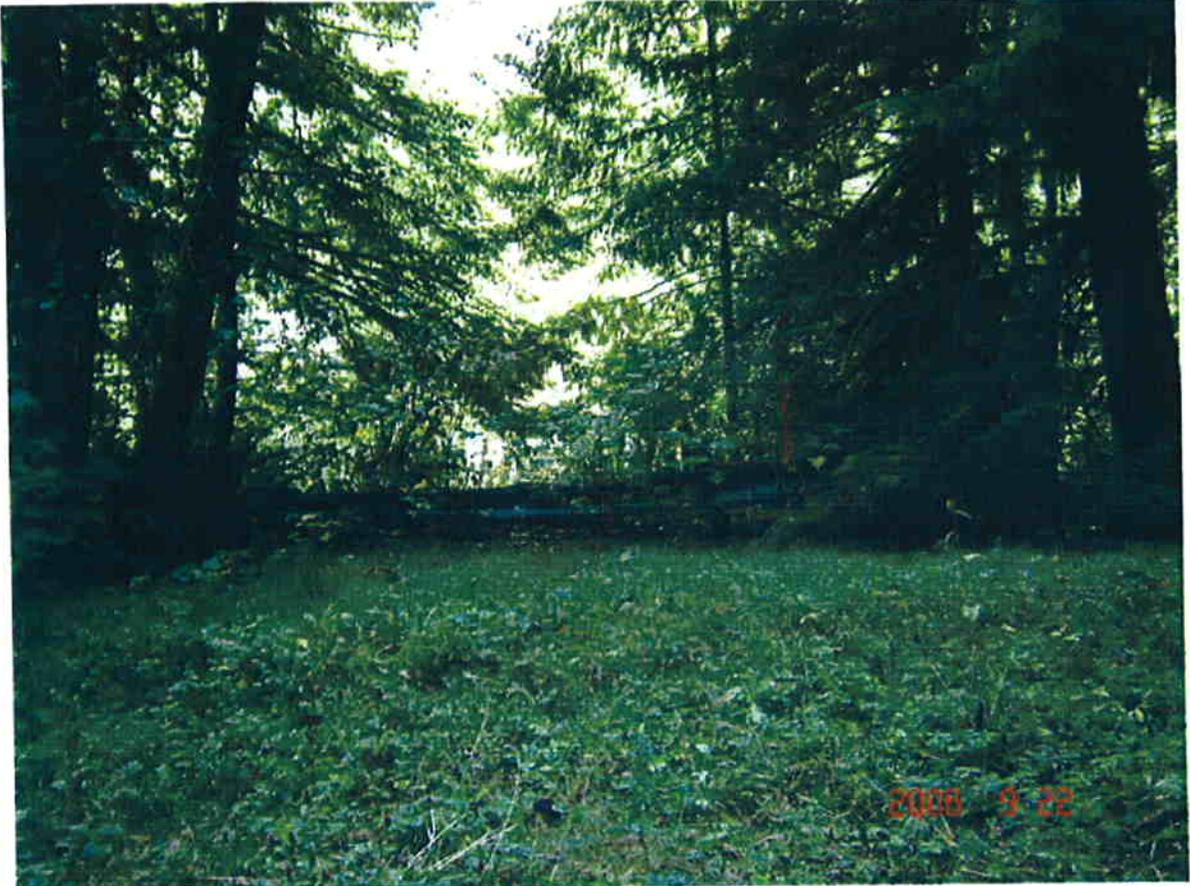
Existing approach to the south abutment (abutment is directly behind the guardrail).
