# MIDWEST FLOODS *of* **2008** & IN IOWA & WISCONSIN

# 1 Introduction

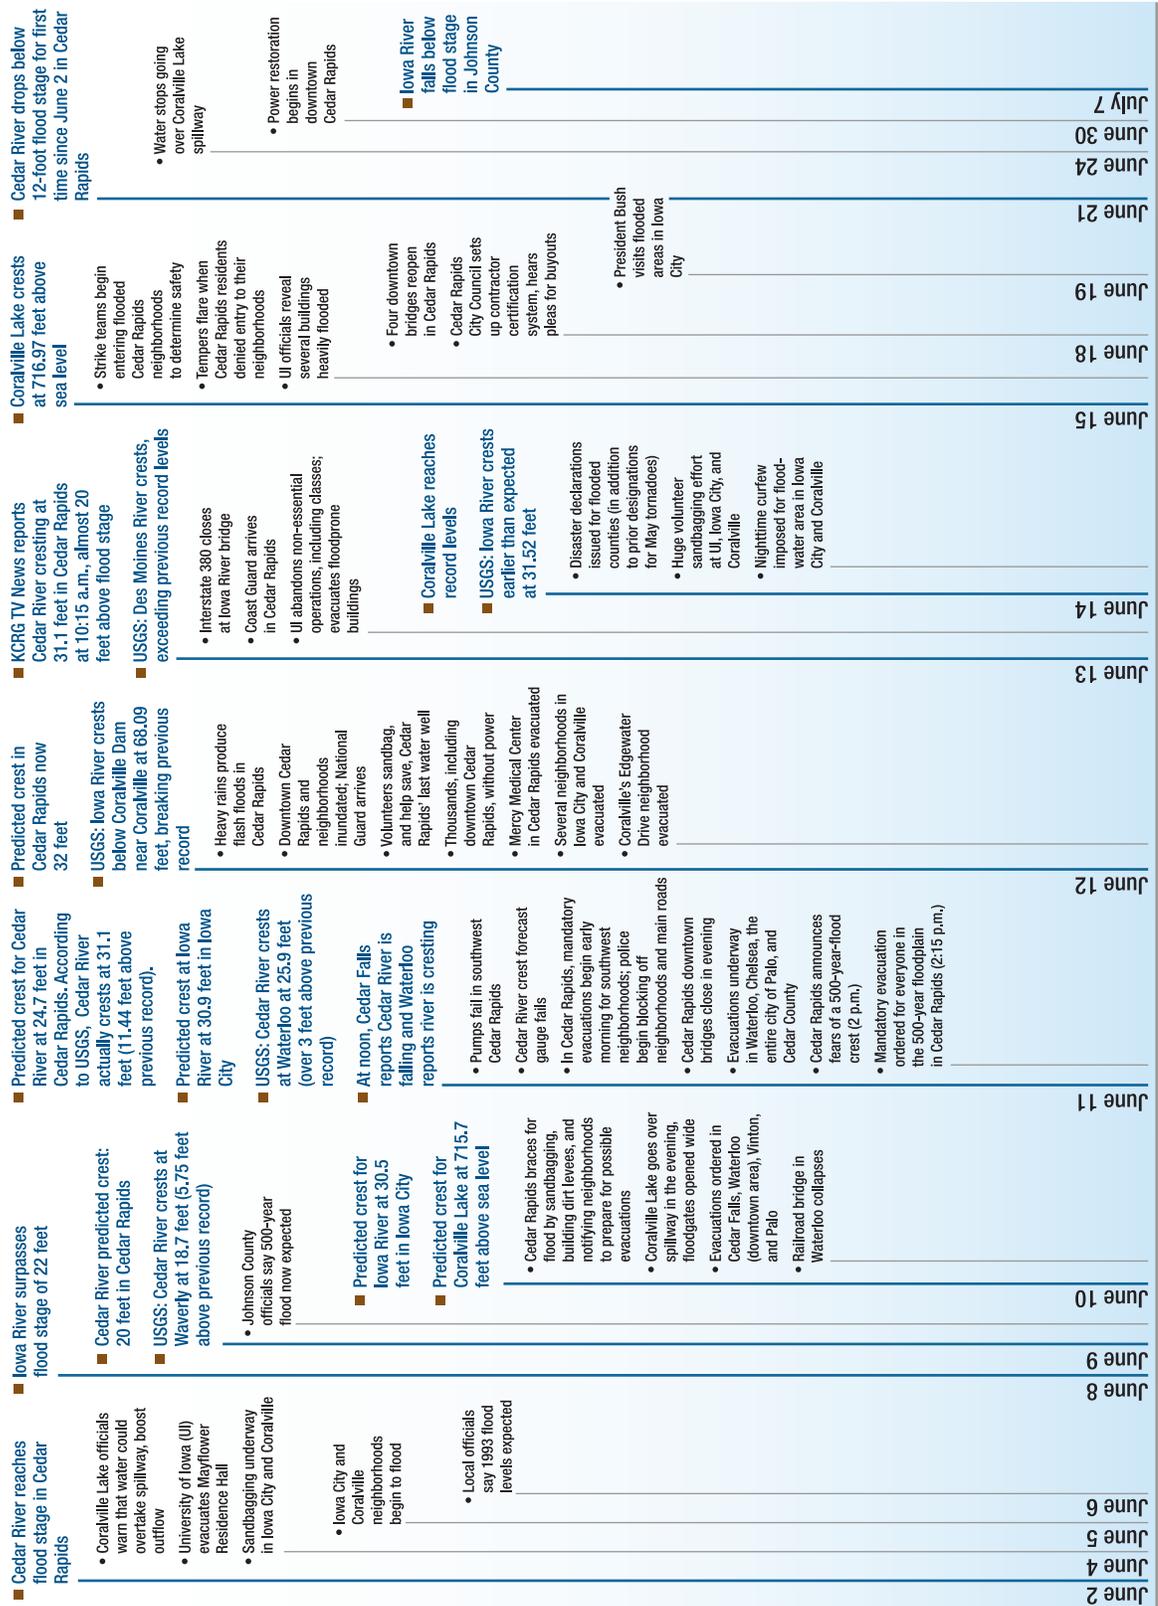
Figure 1-5. Iowa flood timeline  
 SOURCES: KCRG TV NEWS, USGS

A timeline of the Iowa flood is presented in Figure 1-5.

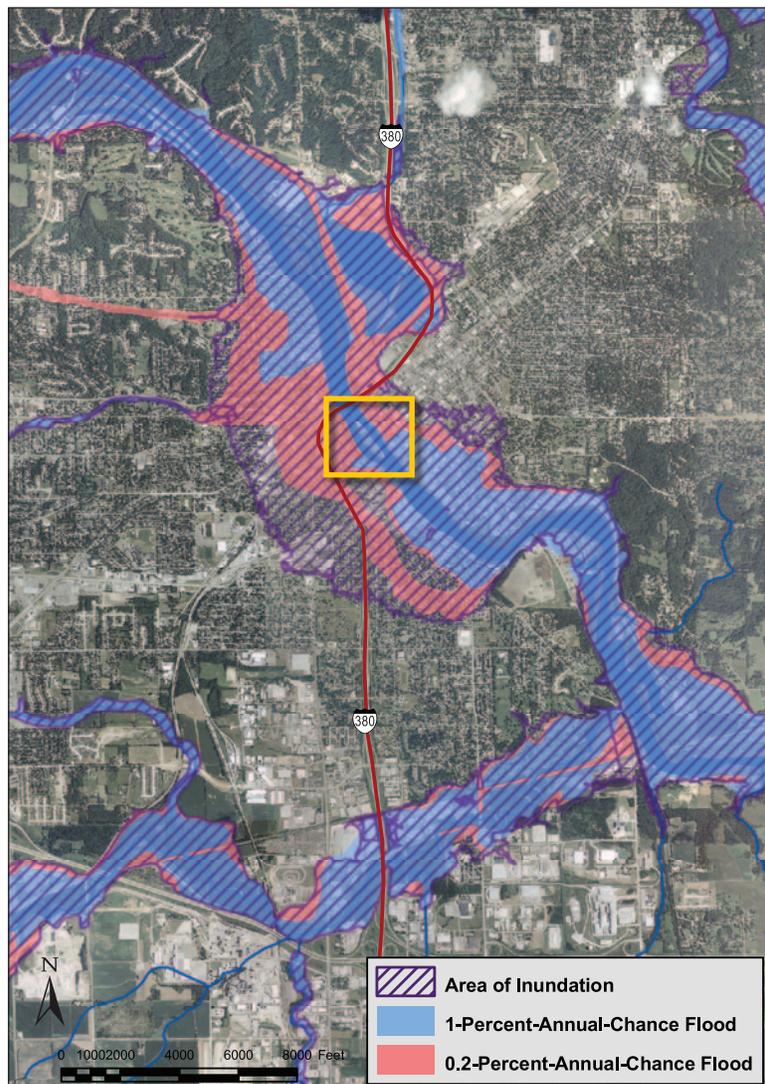
**Figure 1-6.**  
Cedar Rapids, Iowa, areas of flood inundation. The downtown area, including Mays Island, is highlighted by the yellow box.

In Cedar Rapids, a flood crest more than 12 feet above the previous record of 19.66 feet set in 1961 flooded areas well outside of the designated floodplain (Figure 1-6). A portion of the downtown area with several government facilities including City Hall is located on Mays Island in the Cedar River, which flooded (Figure 1-7). Levees were overtopped, flooding neighborhoods that were thought to be adequately protected. Three food manufacturing plants in Cedar Rapids (Quaker, Swiss Valley Farms, and Penford Products) were closed because of flood inundation to facilities as well as access roads. By June 23, floodwater was moving swiftly across overtopped banks and levees along the Cedar River. The City of Cedar Rapids reported over \$5.4 billion in flood losses with inundation affecting 9.2 square miles, 1,300 city blocks, 3,894 single family residences, and 818 commercial properties and government buildings in this jurisdiction alone.<sup>9</sup> Structures such as the Linn County Sheriff’s Office and Mercy Medical Center were subject to riverine flooding even though they were located outside of the 0.2-percent-annual-chance floodplain (also known as the 500-year floodplain) on the FIRM.

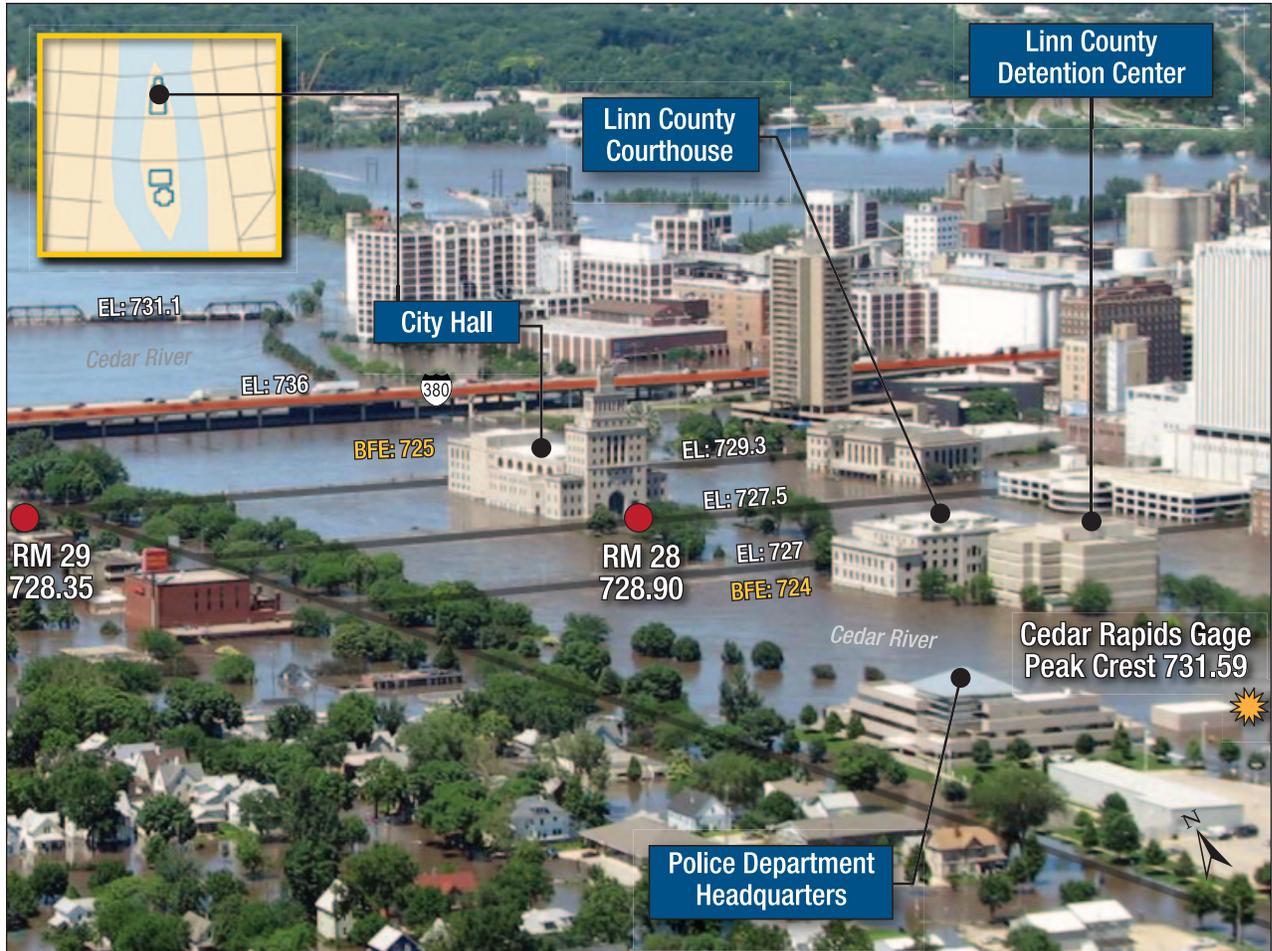
Figure 1-7. Inundation in Cedar Rapids, Iowa, exceeded 1- and 0.2-percent-annual-chance flood elevations.

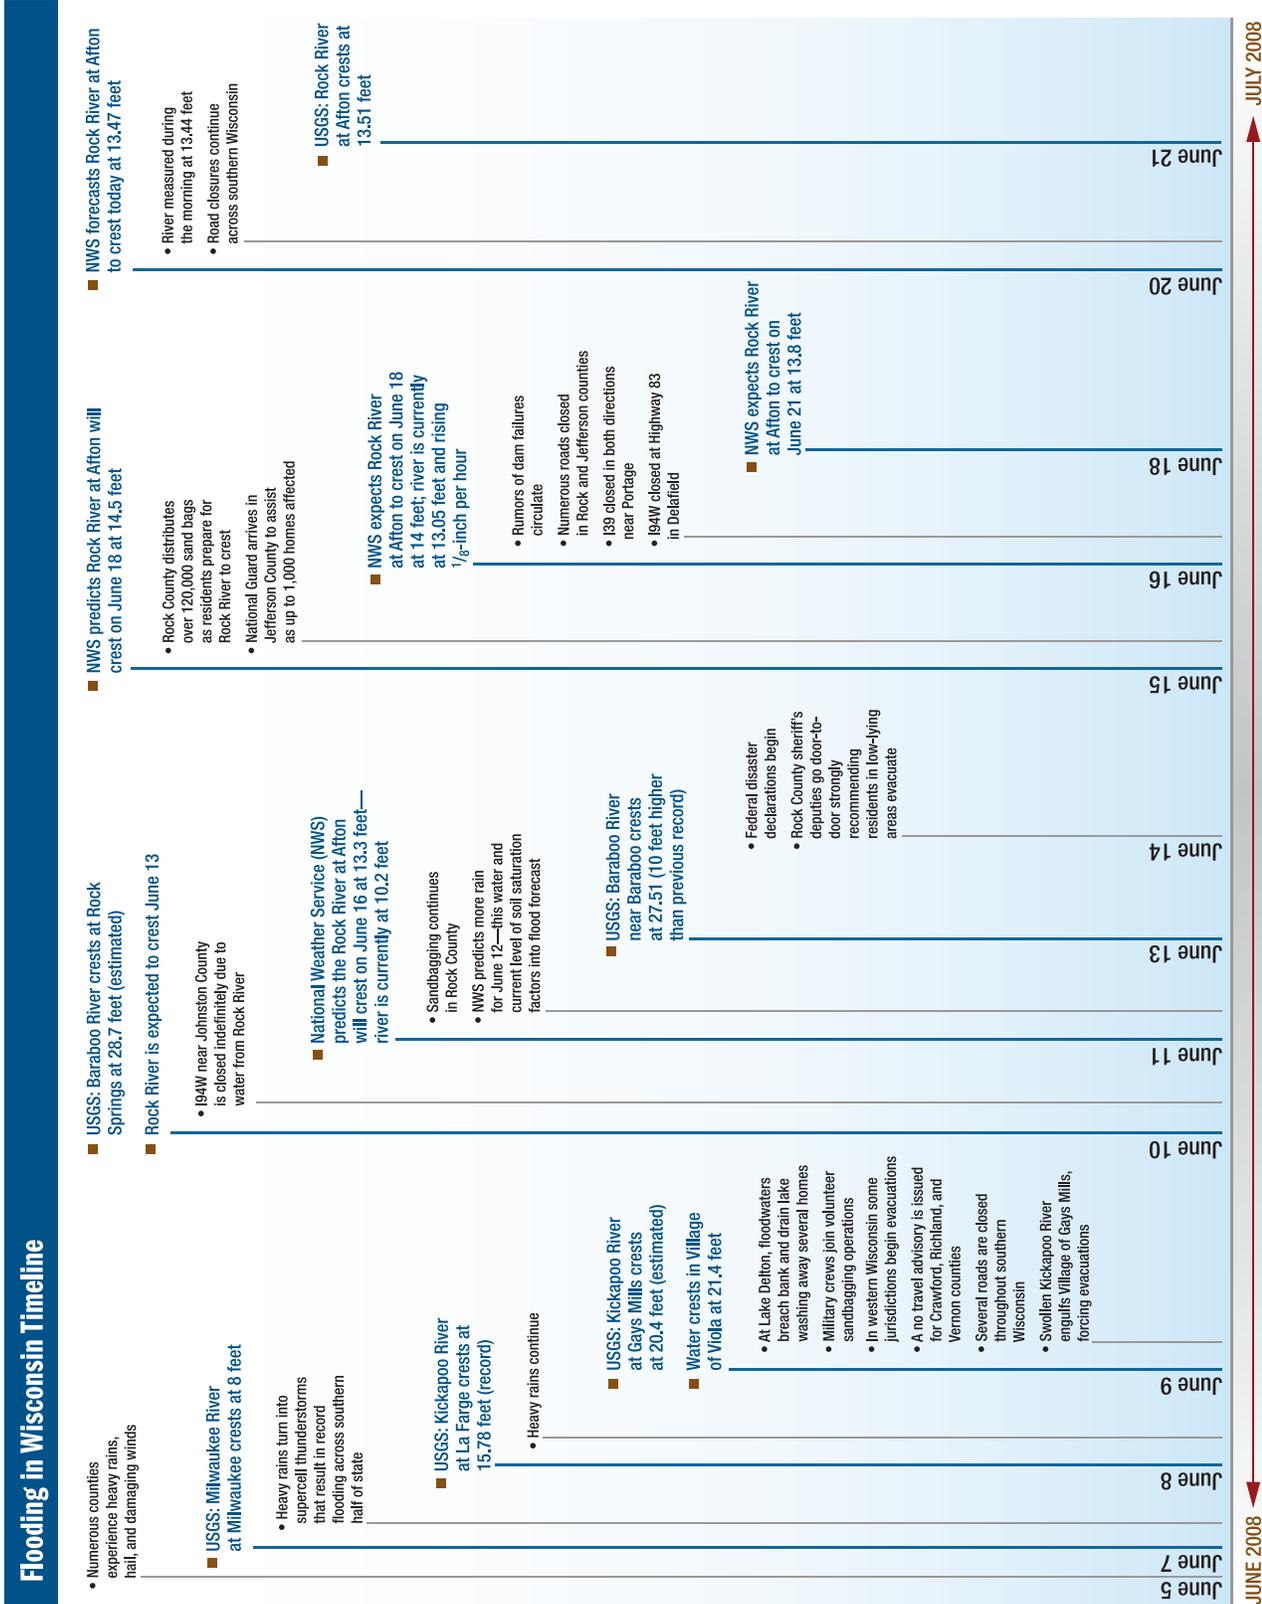
Figure 1-8. Wisconsin flood timeline

As a result of flooding across southern Wisconsin, hundreds of people were forced from their homes as several highways were closed and homes became inundated. The Rock, Kickapoo, and Baraboo Rivers were greatly impacted by the rainfall and experienced significant flooding, with floodwaters reaching 0.2-percent-annual-chance levels and breaking flood records in some locations (refer to Section 1.2 and Table 1-1 for flood crest observation information). Low-lying farm fields were inundated, and millions of dollars in crops were lost. Several manufacturing facilities impacted by the flood, including Tyson and Avalanche Organics, laid off workers. A timeline of the flooding in Wisconsin is presented in Figure 1-8.

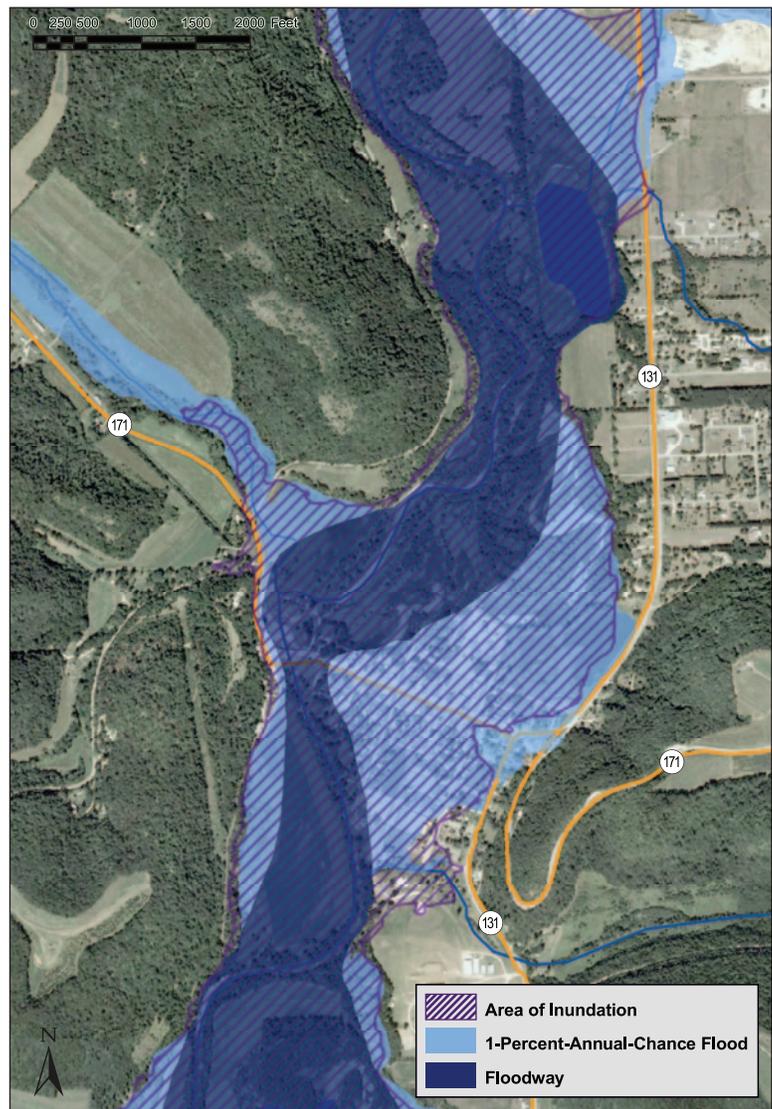
**Figure 1-9.**  
Gays Mills, Wisconsin, areas of flood inundation

Most of the downtown area of Gays Mills was flooded in June 2008.<sup>10</sup> In August 2007, just 10 months before the June 2008 flood, the Kickapoo River had inundated the western portion of Gays Mills with record flooding. Several homes were awaiting pending buyouts and some businesses had not yet reopened when the new flooding occurred. Rock Springs was inundated by 7 feet of water throughout the downtown area. Figures 1-9 and 1-10 illustrate the scale of inundation across Gays Mills and Rock Springs in June 2008.

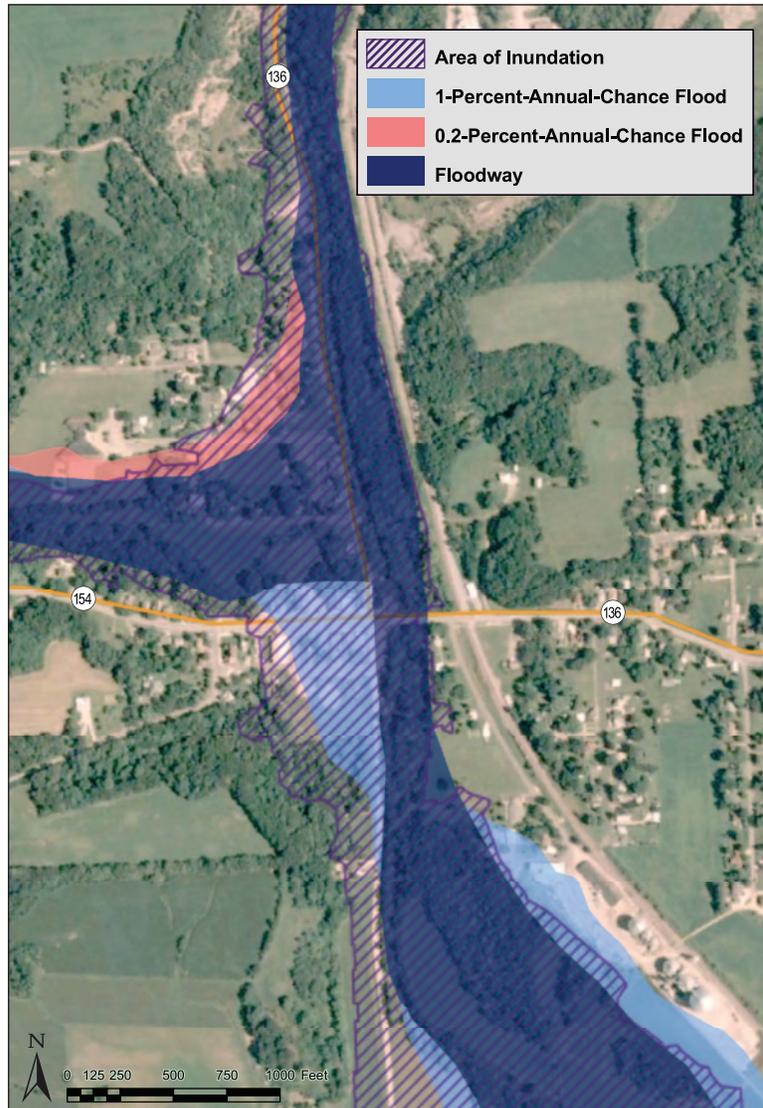
Figure 1-10.  
Rock Springs, Wisconsin, areas of flood inundation

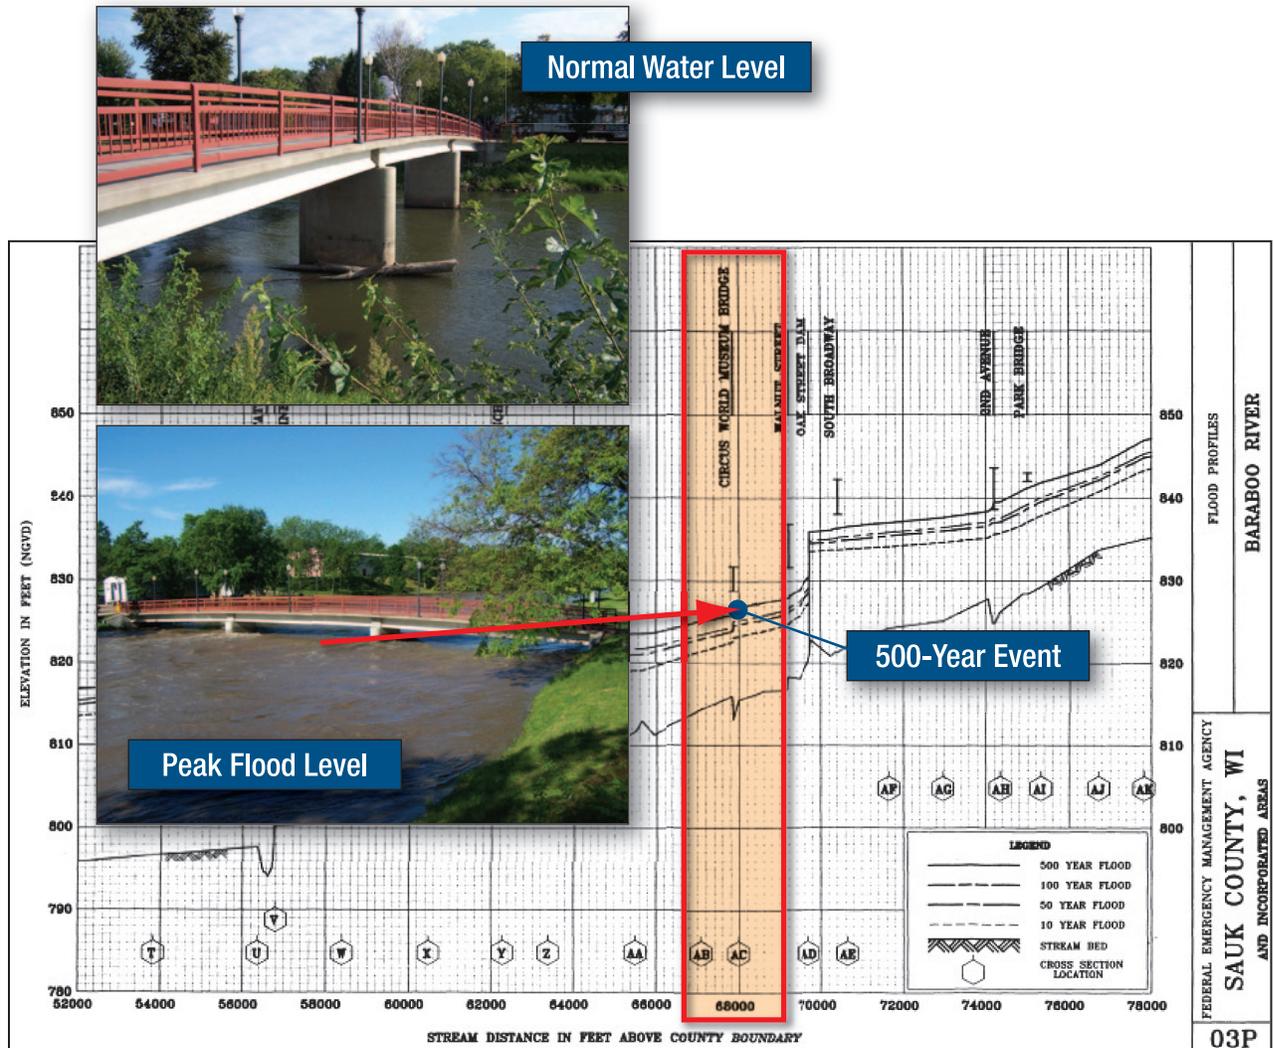
Figure 1-11. Observed flood levels at the Circus World Museum Bridge along the Baraboo River, which were just below the estimated 0.2-percent-annual-chance flood elevation, validate the estimated recurrence intervals (Baraboo, Wisconsin).

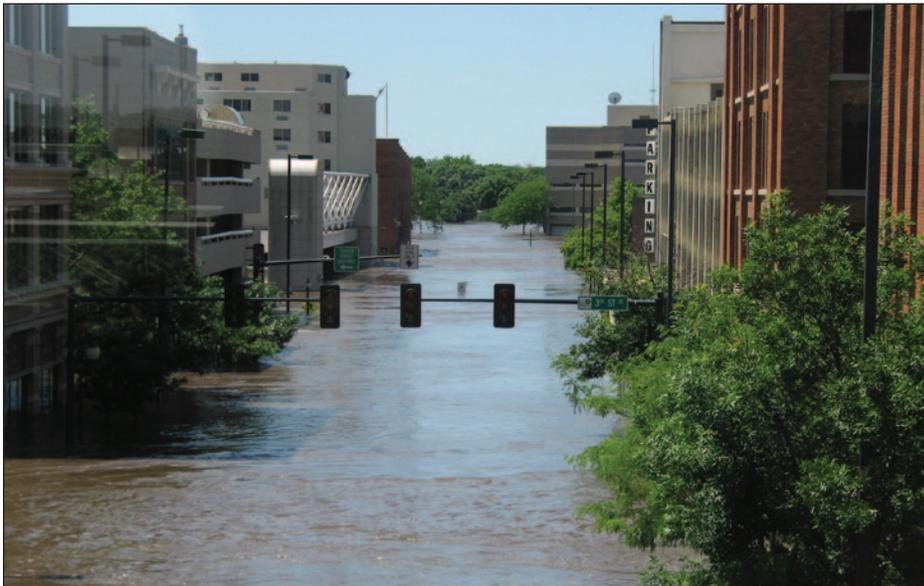
Figure 1-12. Downtown Cedar Rapids, Iowa was inundated by several feet of water in June 2008, causing significant business interruption losses and recovery time (Cedar Rapids, Iowa).
