**SITE LOCATION MAP
NEW HIGHWAY GARAGE PROJECT**

TOWN OF HANCOCK, NEW YORK

**Phase 1A Cultural Resources Report
Geomorphological Examination**

**Phase IA Literature Review and
Sensitivity Assessment,
New Town Highway Garage,
Town of Hancock,
Delaware County
New York**

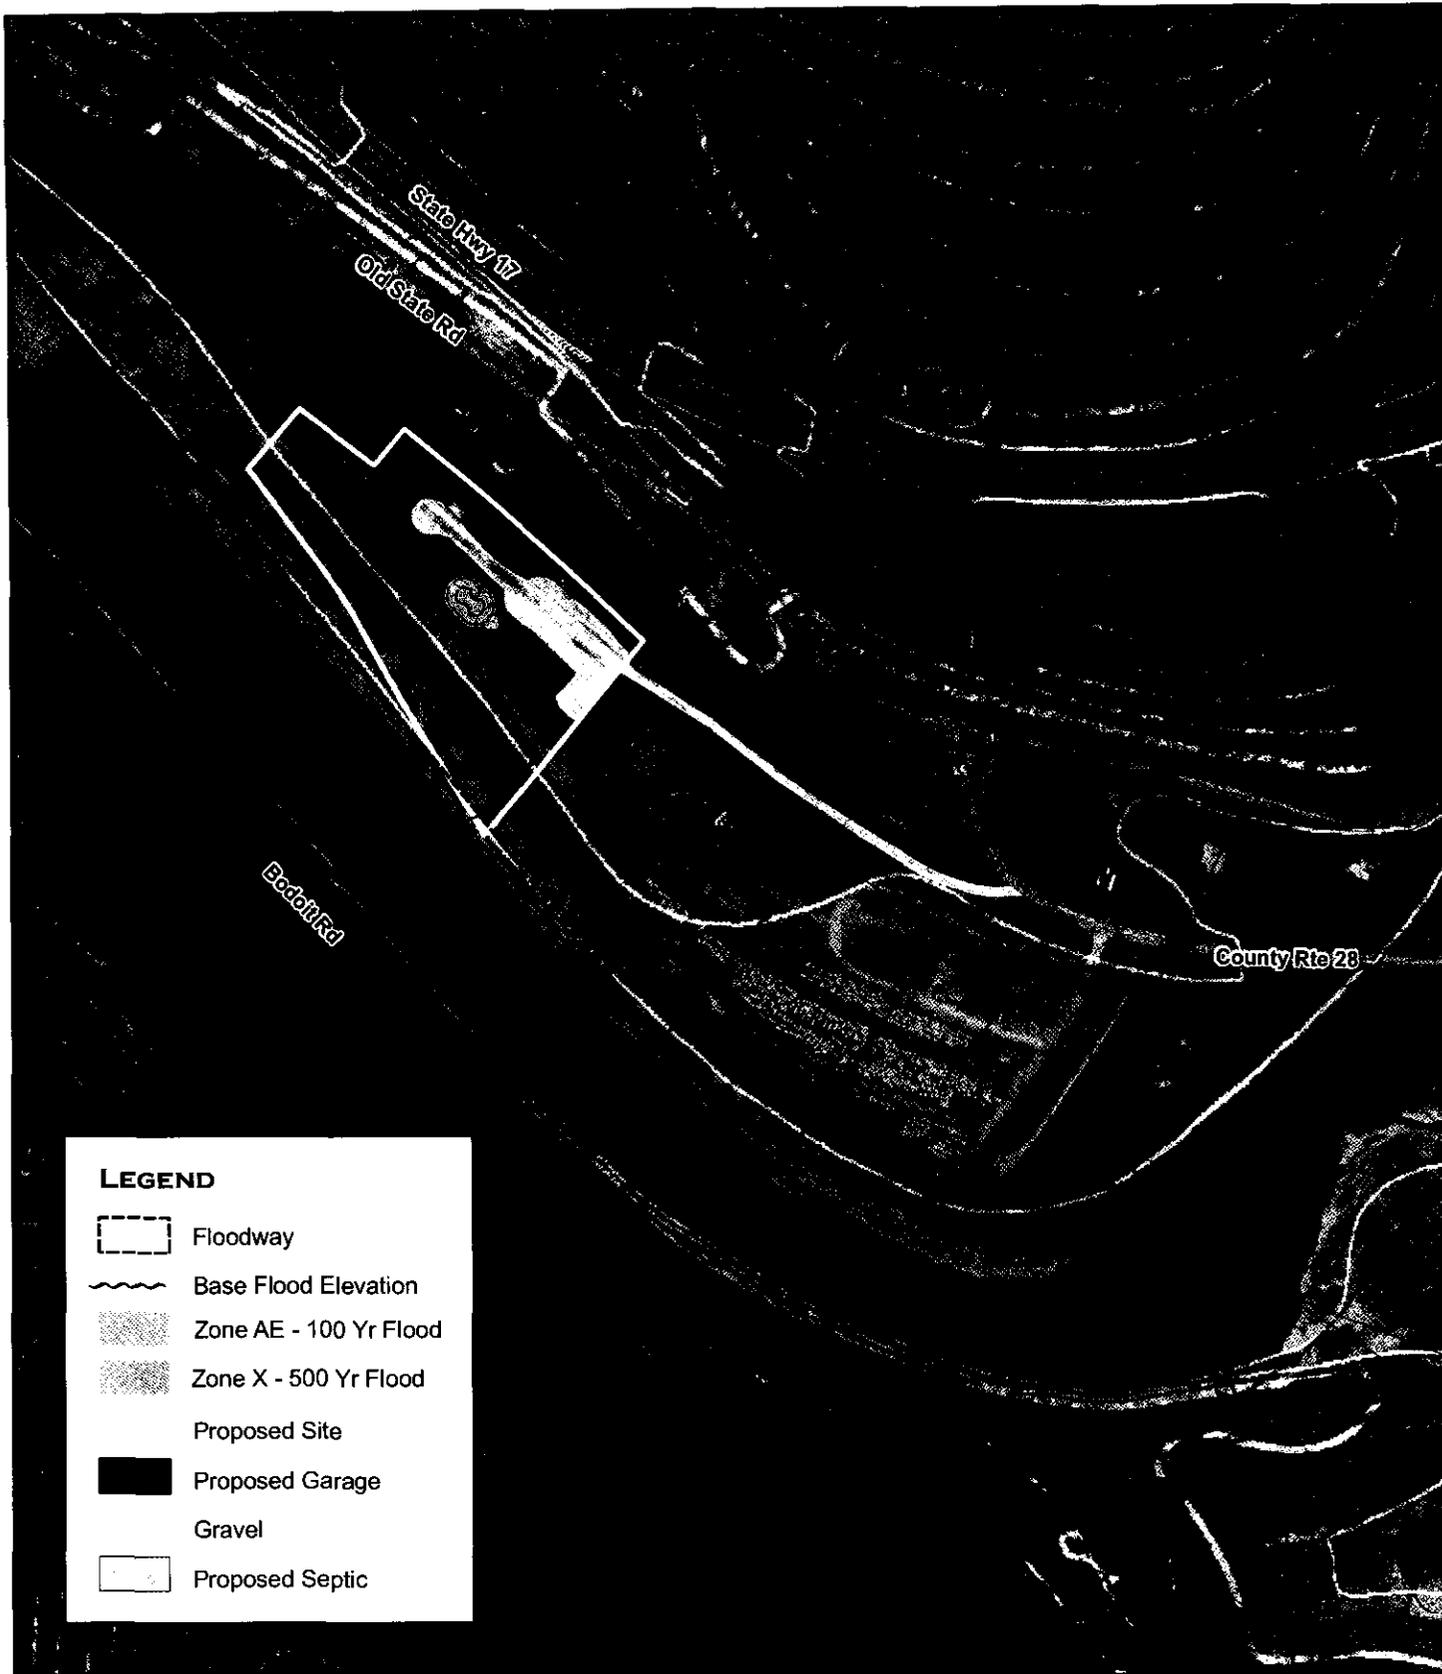
FIGURE 5
FLOOD ZONES MAP
NEW HIGHWAY GARAGE PROJECT
 TOWN OF HANCOCK, NEW YORK

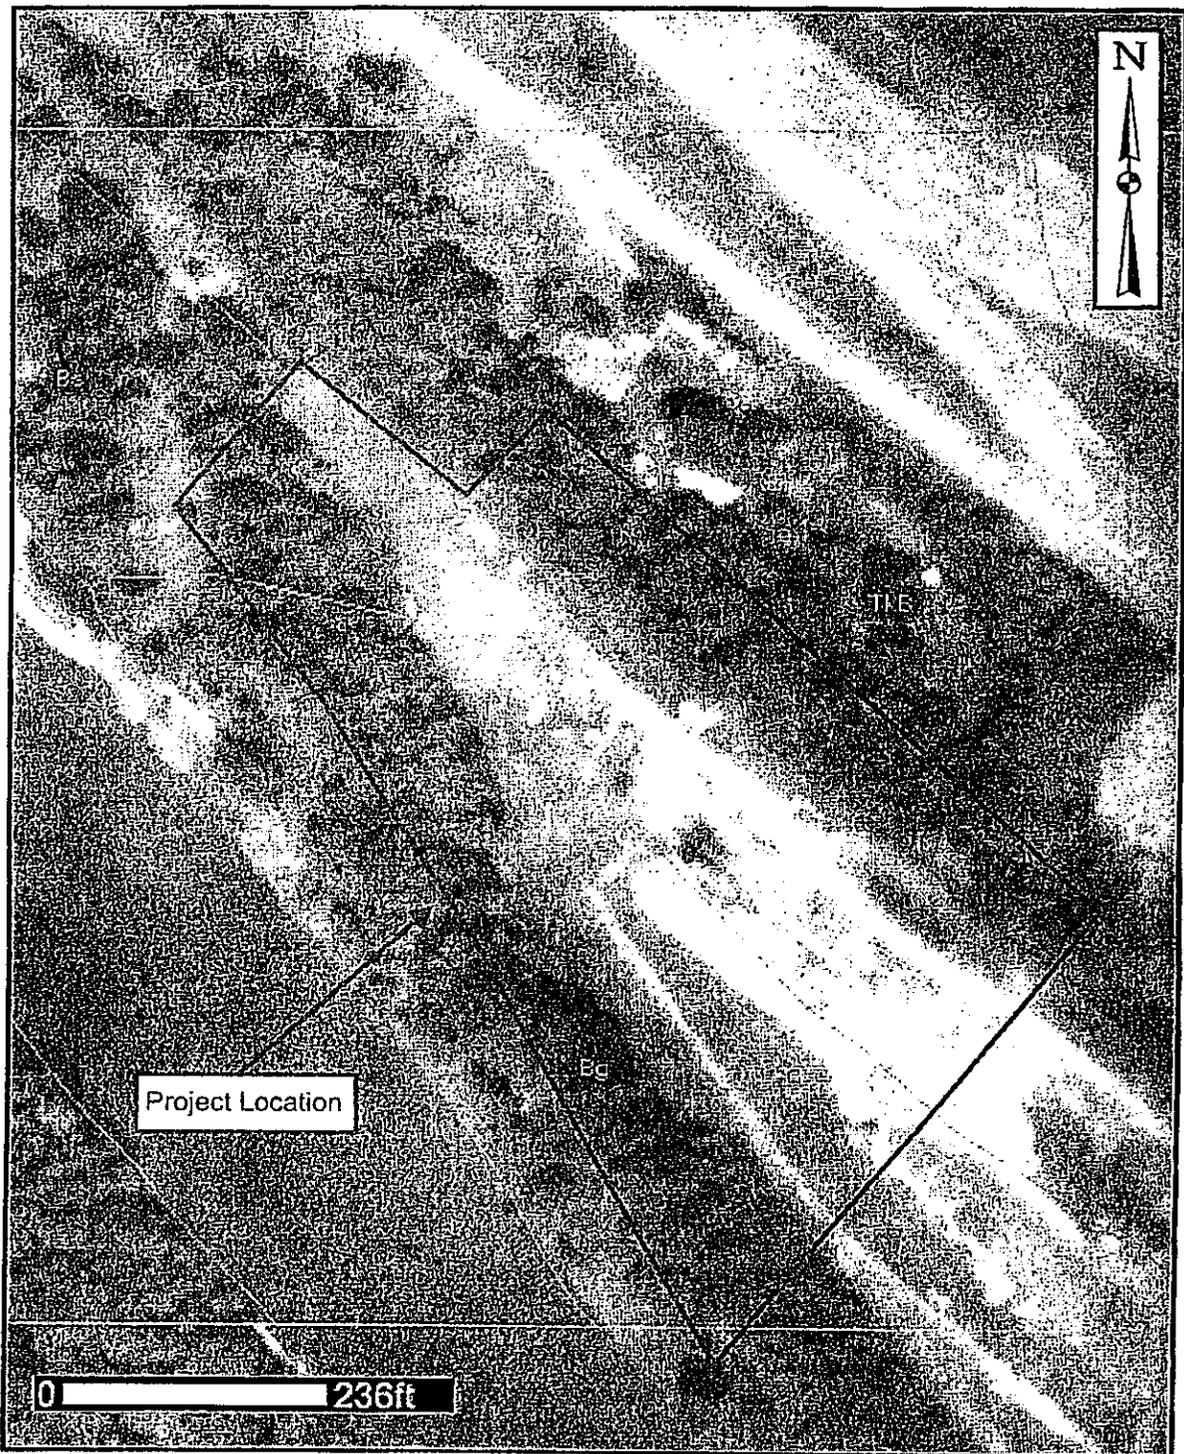
Figure 3. Map showing the location of the project area on NRCS soil map.

The NRCS web soil survey (WSS) shows three soil types as occurring within the boundaries of the current project: Barbour-Trestle complex (map unit Bg), Basher silt loam (map unit Bs), and Tunkhannock gravelly loam (map unit TkB). The Barbour-Trestle complex is a mixture of Barbour loam and Trestle silt loam where the two soils cannot be differentiated from one another. This soil type is found running along most of the southwestern half of the project area. The Barbour series consists of very deep well drained soils formed in recent alluvial deposits derived from areas of acid, reddish sandstone, siltstone, and shale. They are nearly level or gently sloping soils on flood plains. Mean annual temperature is 50 degrees F, and mean annual precipitation is 40 inches. A typical soil profile of Barbour loam is listed below in Table 1.

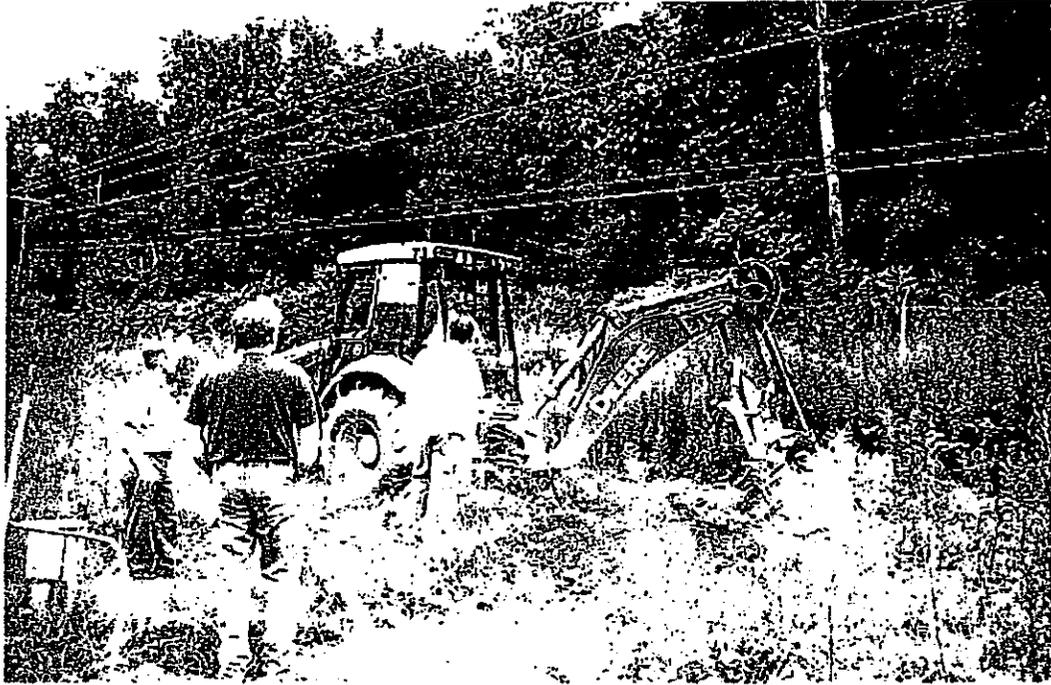
Photo 5. View of the excavation of backhoe trench (BHT) No. 3, facing northeast.

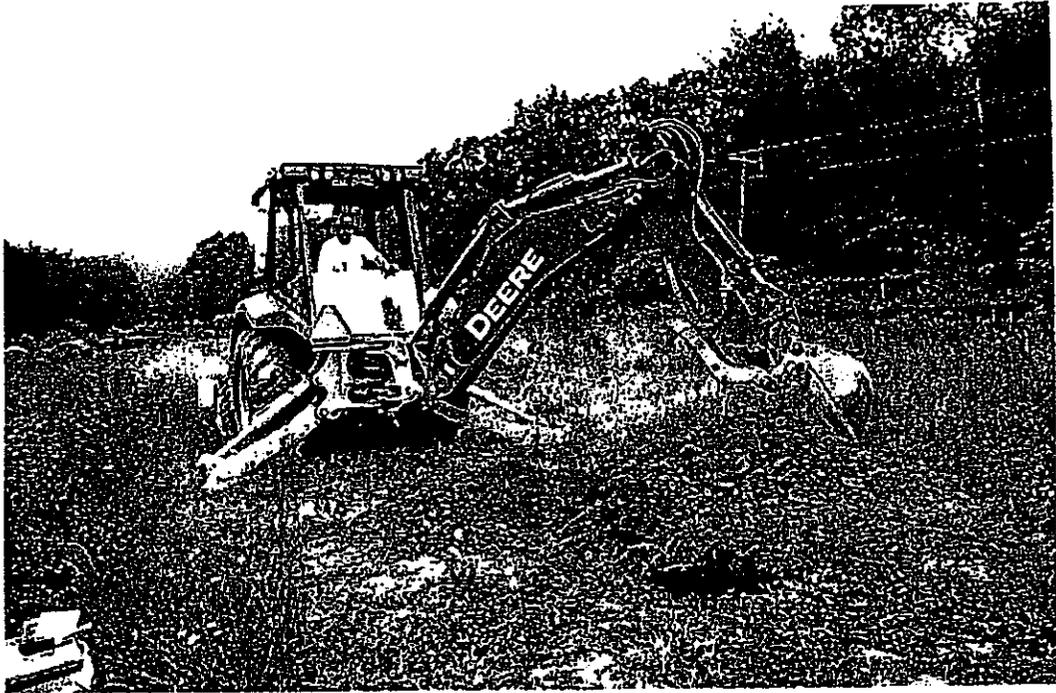
Photo 3. View of the excavation of backhoe trench (BHT) No. 2, facing north.

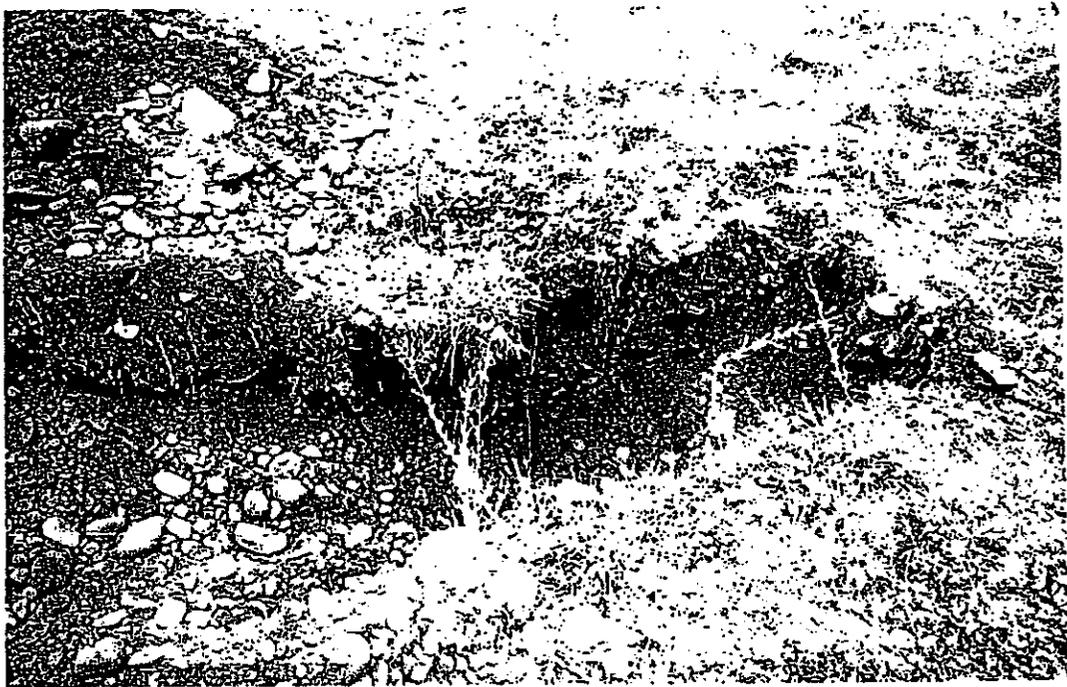
Photo 4. View of BHT 2 showing soils, facing northeast.

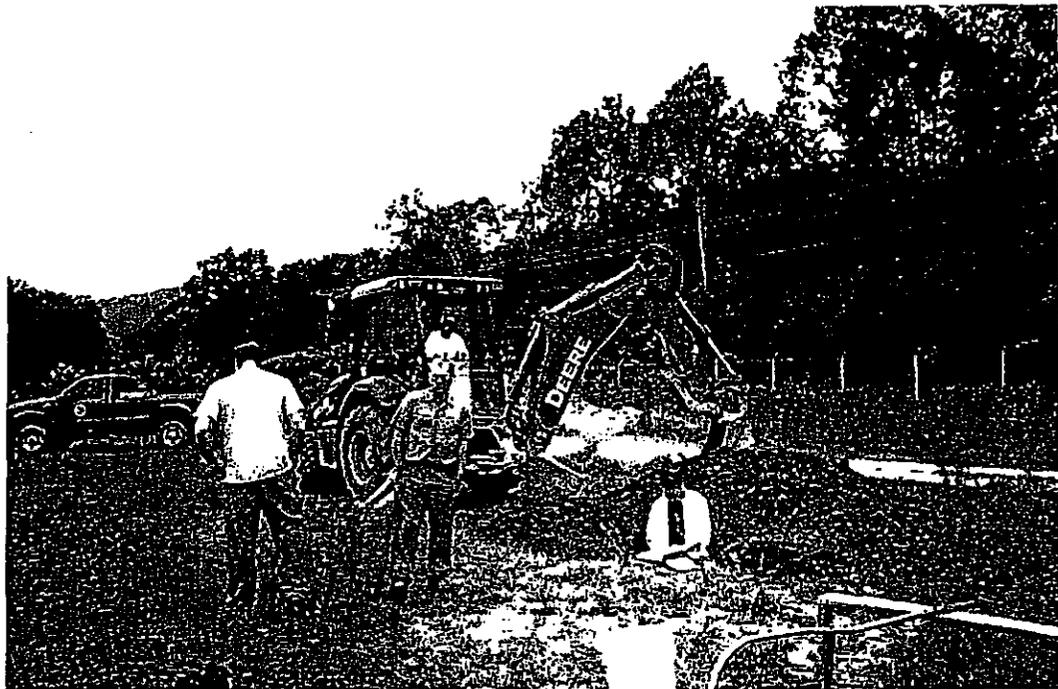
Photo 1. View of the excavation of backhoe trench (BHT) No. 1, facing north.

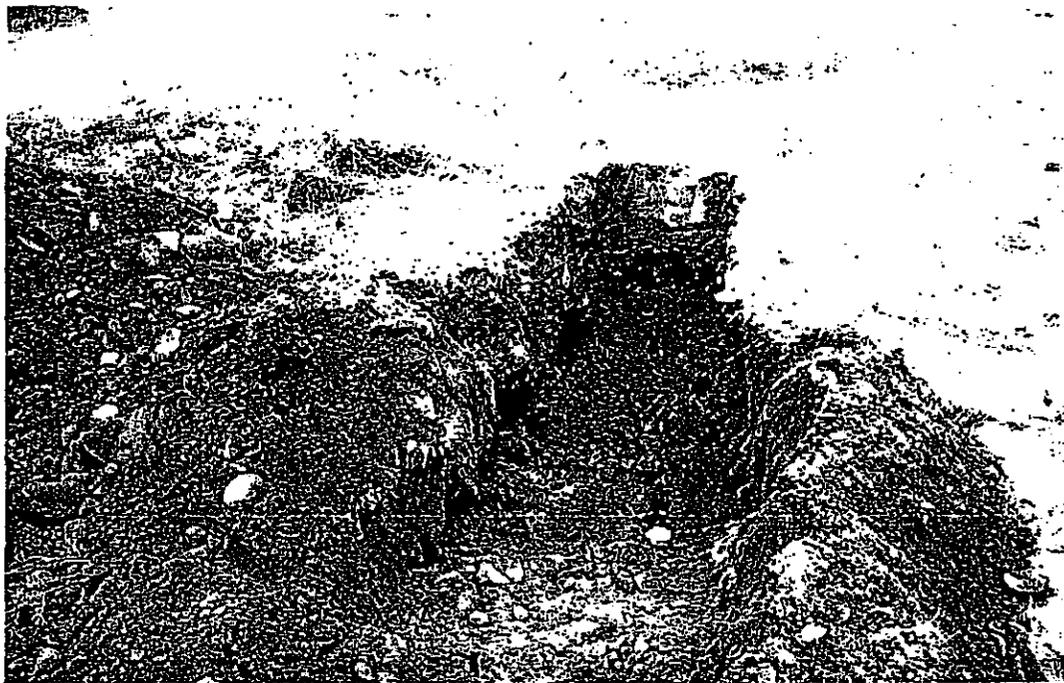
Photo 2. View of BHT 1 showing soils, facing southeast.
