## Draft Environmental Assessment

Sedro-Woolley Fire Station

Grant Request EMW 2009 FC 01076R

City of Sedro-Woolley

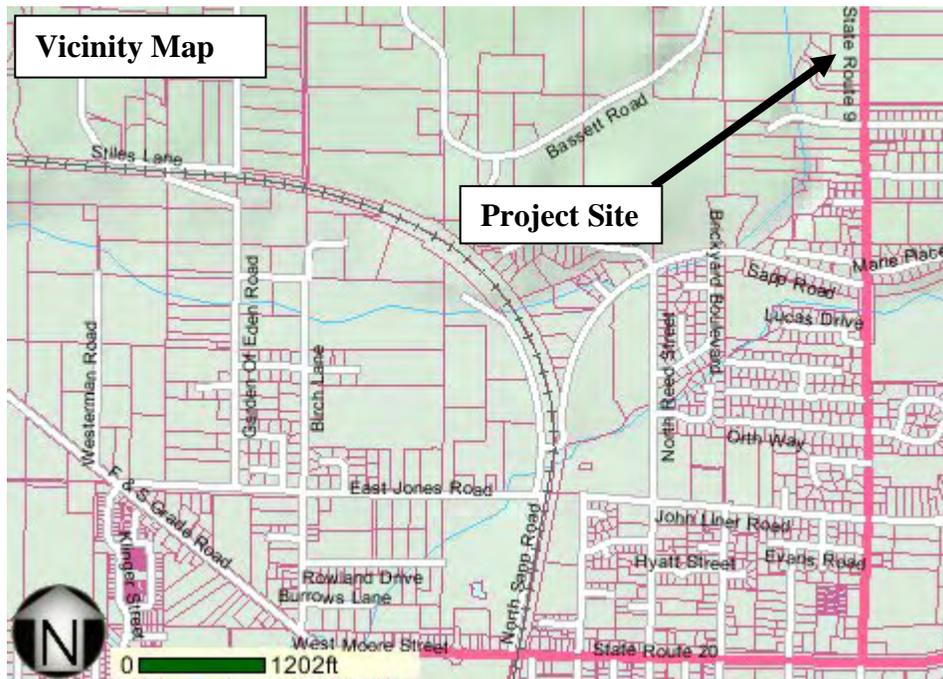
The overall site layout allows stormwater runoff to sheet flow off of the proposed parking, and enter the rain garden system. Roof runoff will be connected directly to the detention pond.

The proposed project will construct a new fire station building including paved access and parking on an existing 2.32 acre lot. This will include the construction of a rain garden system to treat the stormwater, and a detention pond to provide flow control. This system treats and detains the stormwater from the site and discharges through a control structure to the existing ditch along the north property line. The site location is shown in the vicinity map below.
