DHS/FEMA Environmental and Historical Preservation (EHP)
Compliance Review Template

Washington State Environmental and Historical Preservation Compliance Review Template

Project Information	
Name of Project	Thurston County EOC
Purpose and Scope of Project	Construction of a new Emergency Operations Center (EOC) to serve Thurston County
Estimated Cost of Project Phase	\$4,000,000
Estimated Cost of All Project Phases	\$16,000,000 (from Master Plan budget)
Provide precise location of the project using latitude and longitude coordinates, and if available, a complete street address	The latitude and longitude of the project site is: 46.949621, -122.908739. The project site consists of two parcels of land (2.0 and 2.4 acres) located just north of the existing Thurston County Maintenance Facility which is located at 9605 Tilley Road S, Olympia, WA 98512. The two parcels are located at 9521 and 9439 Tilley Road S.
Provide the dimensions in 3D in acreage, square footage, and heights of structure and/or land affected; include height and structural support information for all communication towers; specify all temporary and permanent improvements; provide site plan	The project site is 4.8 acre

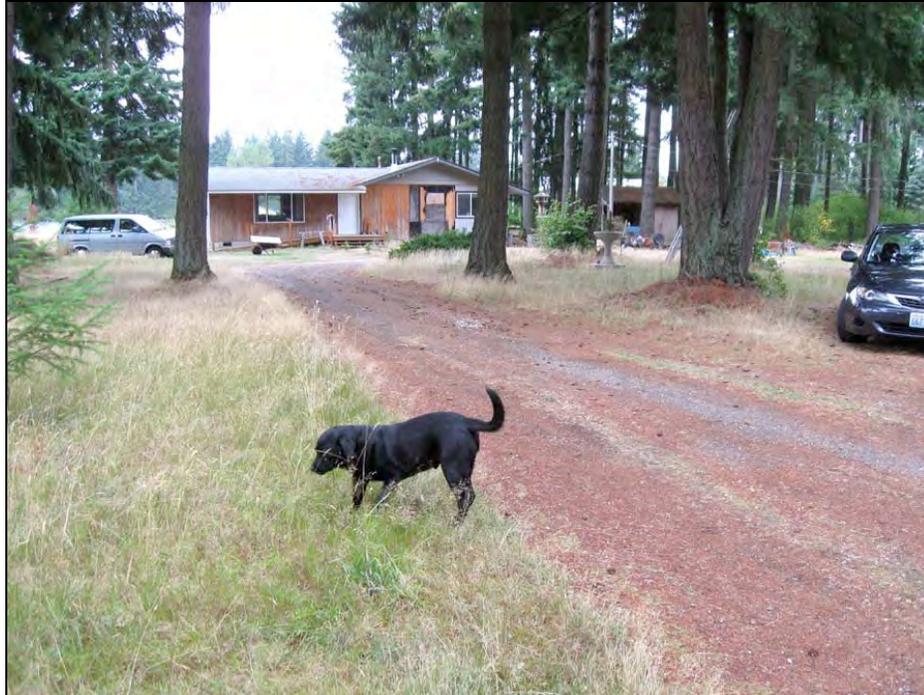
Figure 2. Representative view of the eastern portion of the project area (parcel no. 12722110300).

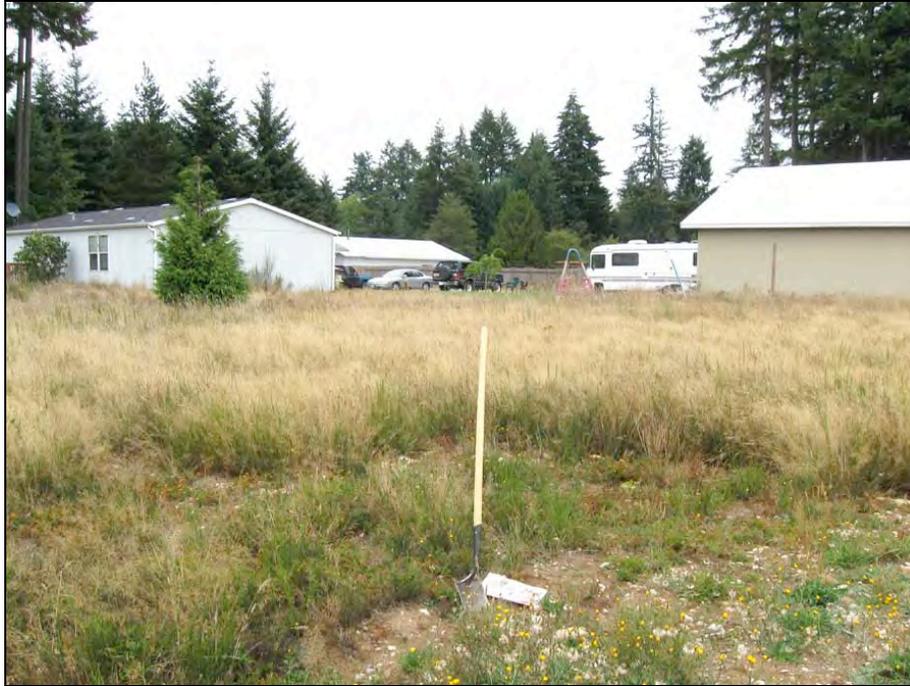
Figure 3. Representative view of the eastern portion of the project area (parcel no. 12722110301).

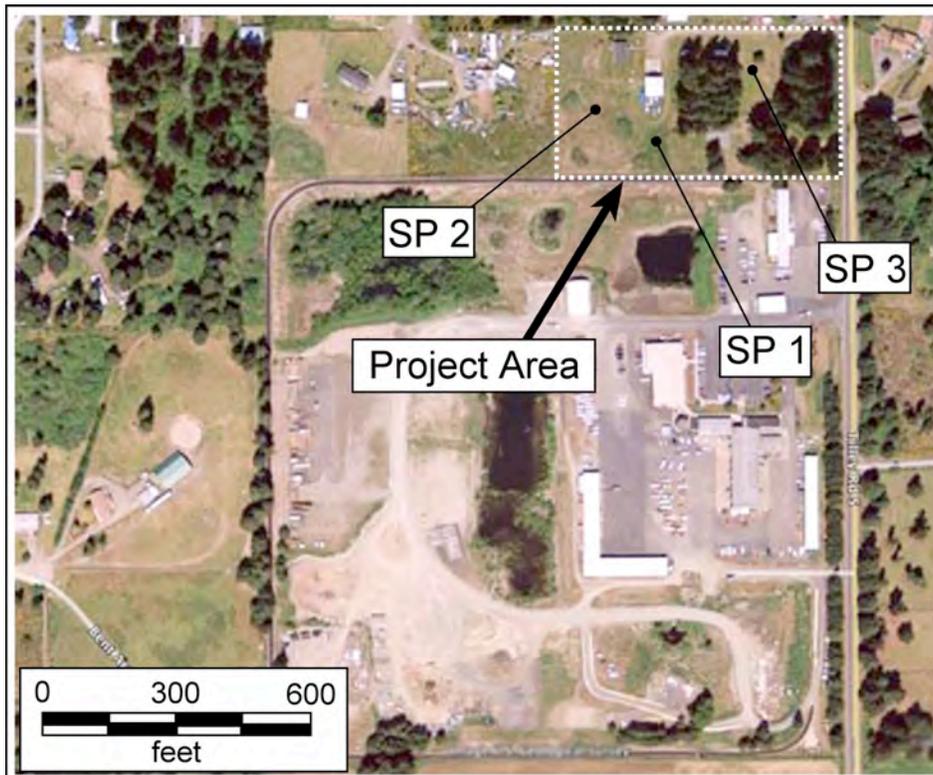
Figure 4. Aerial photo of the project area annotated with shovel probes (SP).

Three shovel probes (SPs) were dug in the flatter terrain in the east portion of the project area (Figure 4). Sediments were examined and screened through 0.25-inch mesh and probes refilled (Table 1). The subsurface layer was characterized by homogeneous very gravelly sandy loam several inches thick over gravelly sandy loam and glacial till, consistent with mapped soils for the project area. No cultural material was identified.

SP	Description (depths in centimeters)	Archaeology Identified
1	00-05: brown sandy loam, pebbles 05-40: light brown sandy loam, gravels	No
2	00-05: brown sandy loam, pebbles 05-40: light brown sandy loam, gravels	No
3	00-05: brown sandy loam, pebbles 05-40: light brown sandy loam, gravels	No

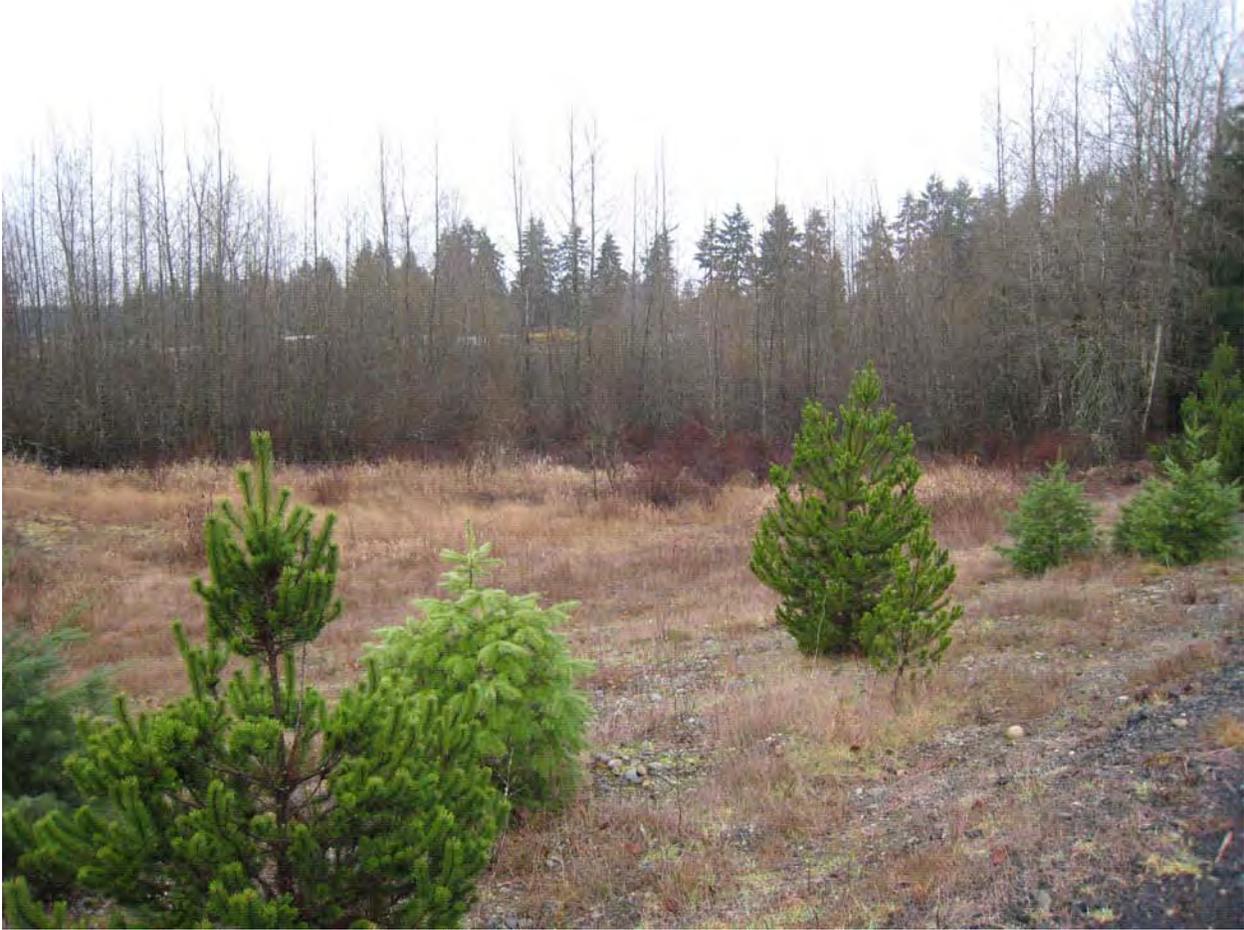
Southwest view from Northeast corner of wetland

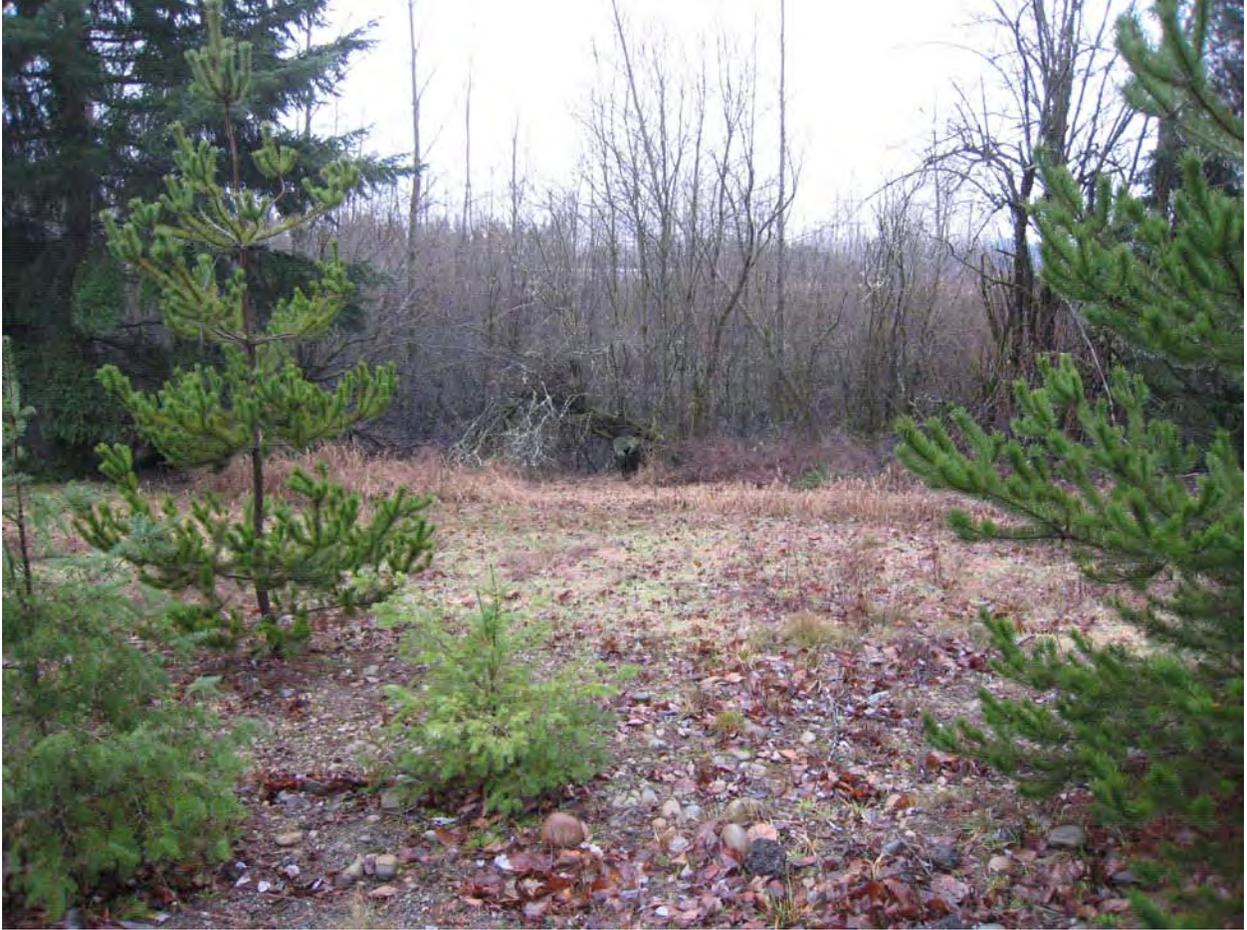
East view from west side of wetland

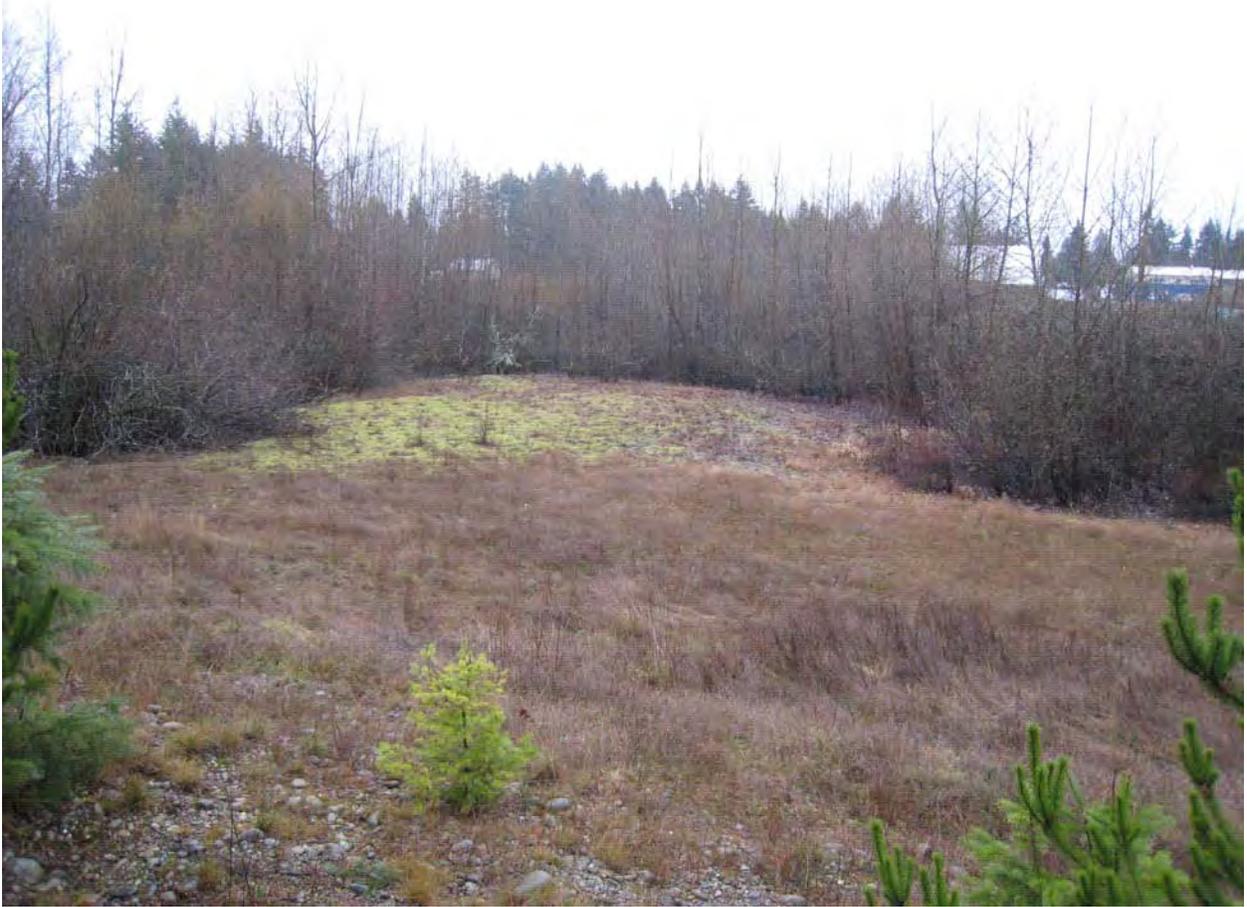
Northeast view from Southwest Corner near wetland

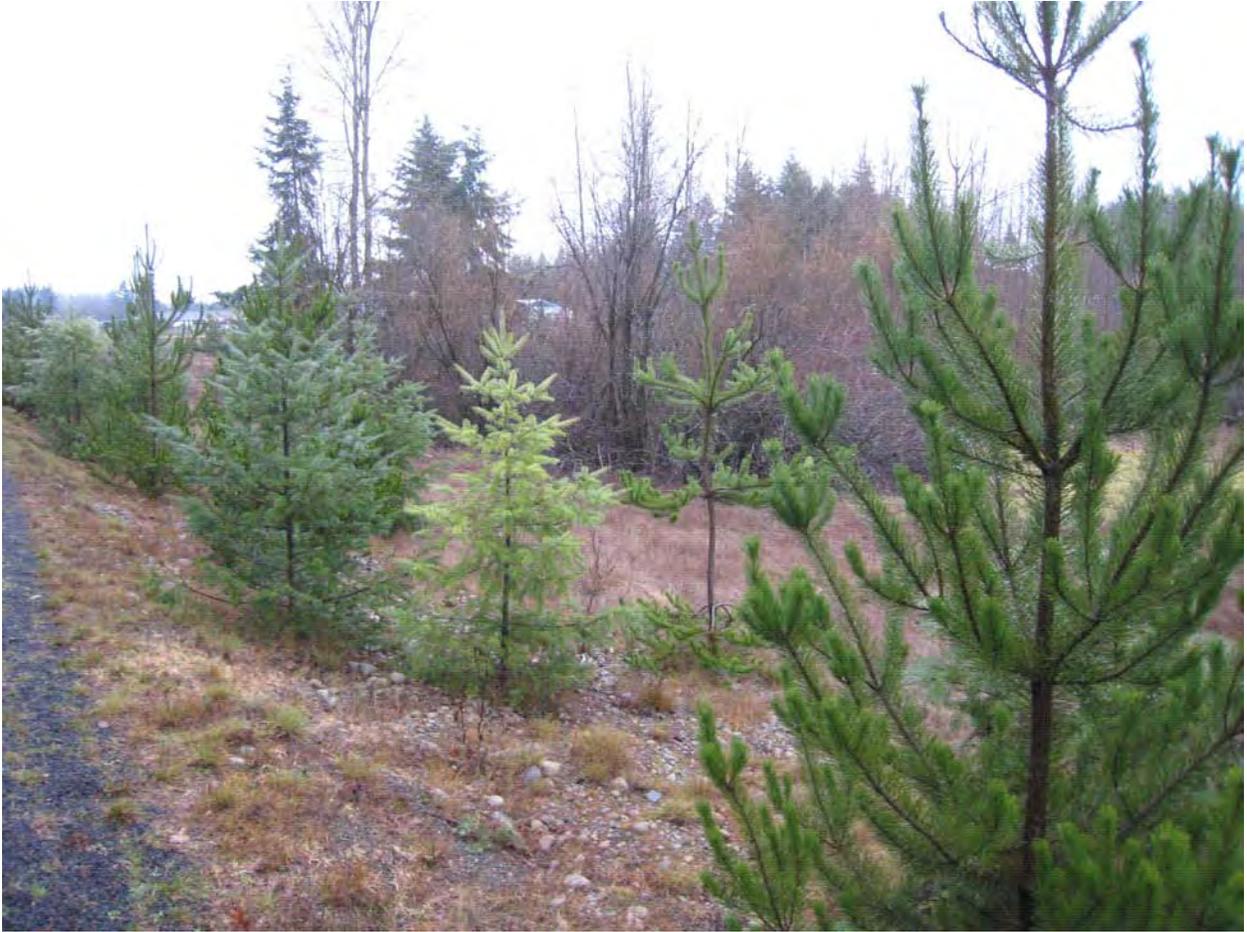
Northeast view from Westside of wetland

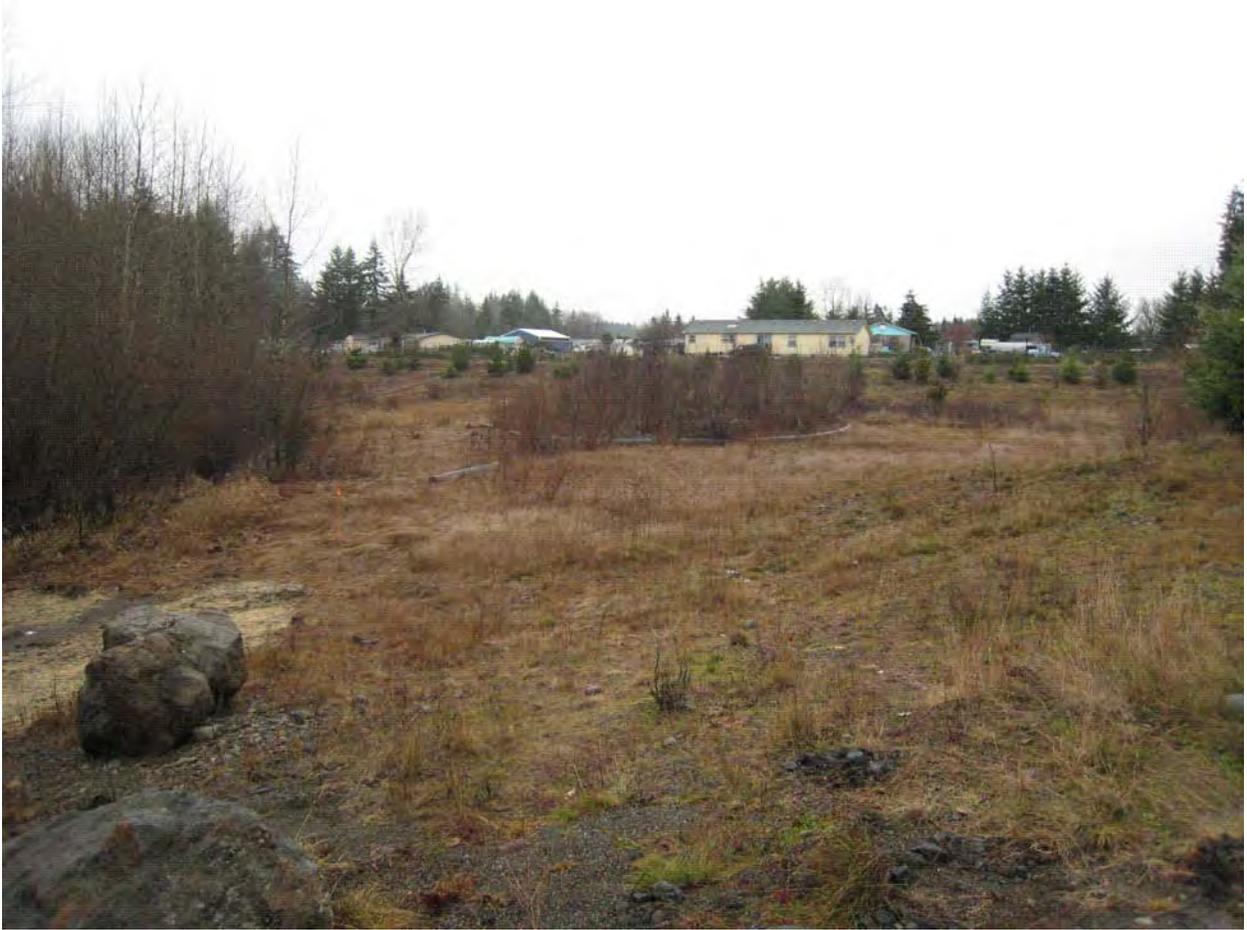
North view of eastern edge of wetland from South side of wetland

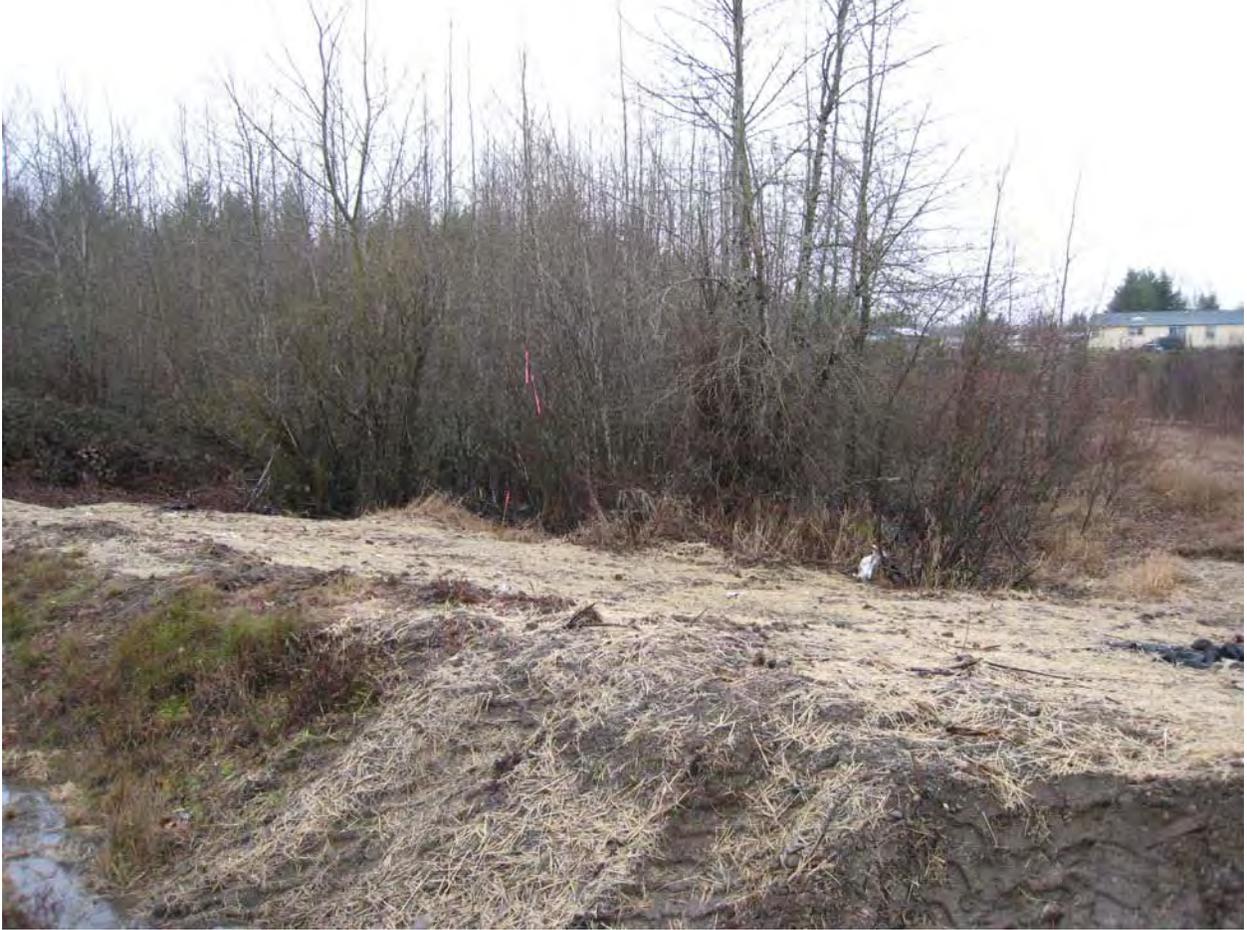
Northwest view of Southeastern wetland edge
