HAZUS User Group
Success Story

Eagle, Alaska Uses HAZUS

to Map Safe Rebuilding Zones Following Ice Jam Devastation

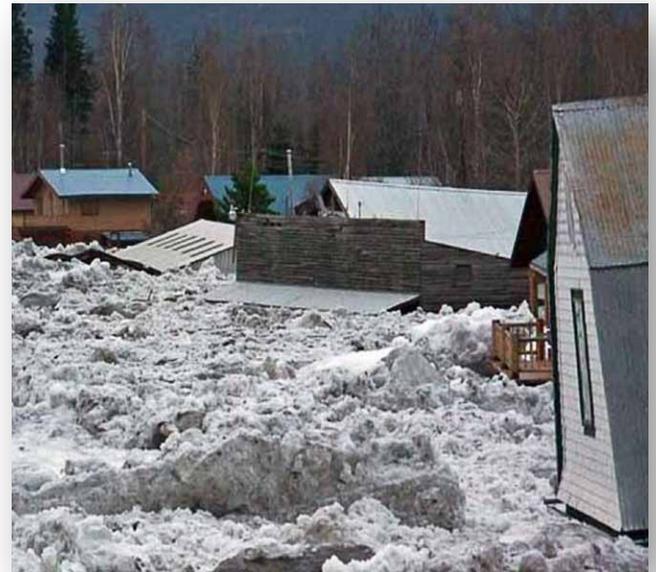
Ice and debris flowing through Eagle, Alaska.

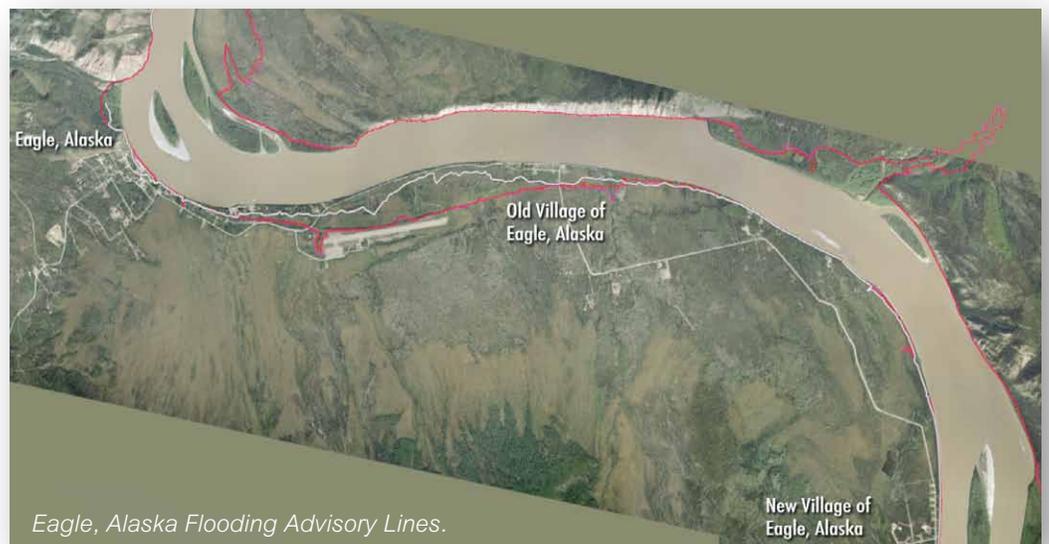
Eagle, Alaska Flooding Advisory Lines.

The GIU team created several maps to illustrate to business and home owners the safe zones for rebuilding. The bright white line on the photograph above represents the extent of ice movement on the Yukon River in Eagle, Alaska in early May 2009. The last "great ice jam" recorded occurred in 1937. Actual data on the severity and extent of the flooding were sparse. Anecdotal reports indicated they were comparable to that in 2009. Therefore, it can be concluded that any structures built within the area of ice movement during the 2009 disaster are subject to damage or destruction in future flooding caused by ice jams.

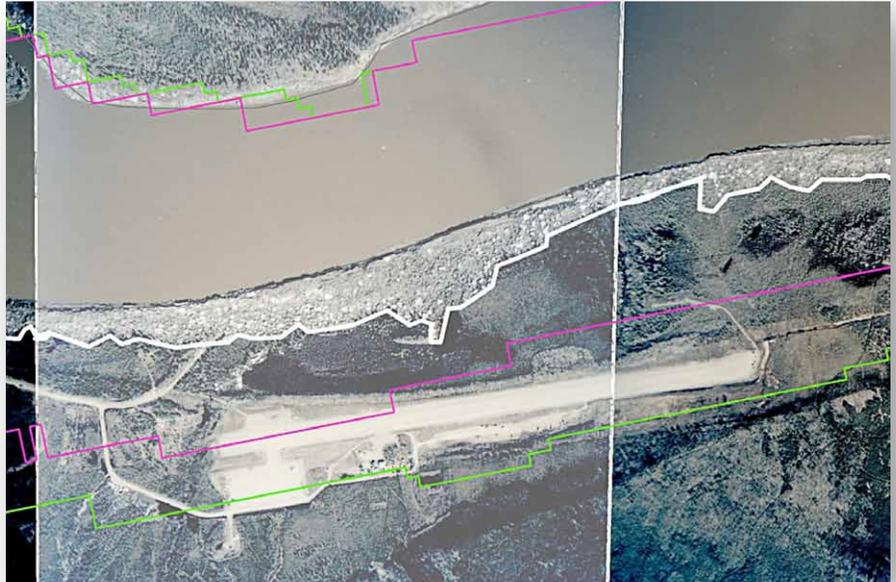
The pink line in the photograph is the extent of a 100-year flood modeled by the GIU using the HAZUS flood model and

Acceptable levels of risk from ice-jam flooding.

an assumed river discharge of 575,000 cubic feet-per-second (cfs). The green line is the result of a HAZUS simulation that assumed a discharge twice as large, approximately 1.2 million cfs.

The use of HAZUS made it possible to illustrate that rebuilding in the 100- and 500-year zones put property at risk for flooding. Since HAZUS also generates a base flood elevation (bfe), residents who rebuilt in these zones also knew how high to elevate their structures to avoid flooding. To minimize, or at least to reduce the risk of future losses and damages, rebuilding needed to occur in safe zones, areas above the indicated (or expected) flood level.
