8.0 Log Structure Evaluation

9.0 **Resource B881 National Register Eligibility Determination**

DOLLYWOOD INTERCHANGE PROJECT
Sevier County Historic Resource 882--House
Pigeon Forge, Sevier County, Tennessee

DOLLYWOOD INTERCHANGE PROJECT
Sevier County Historic Resource B881—Log Crib
Pigeon Forge, Sevier County, Tennessee

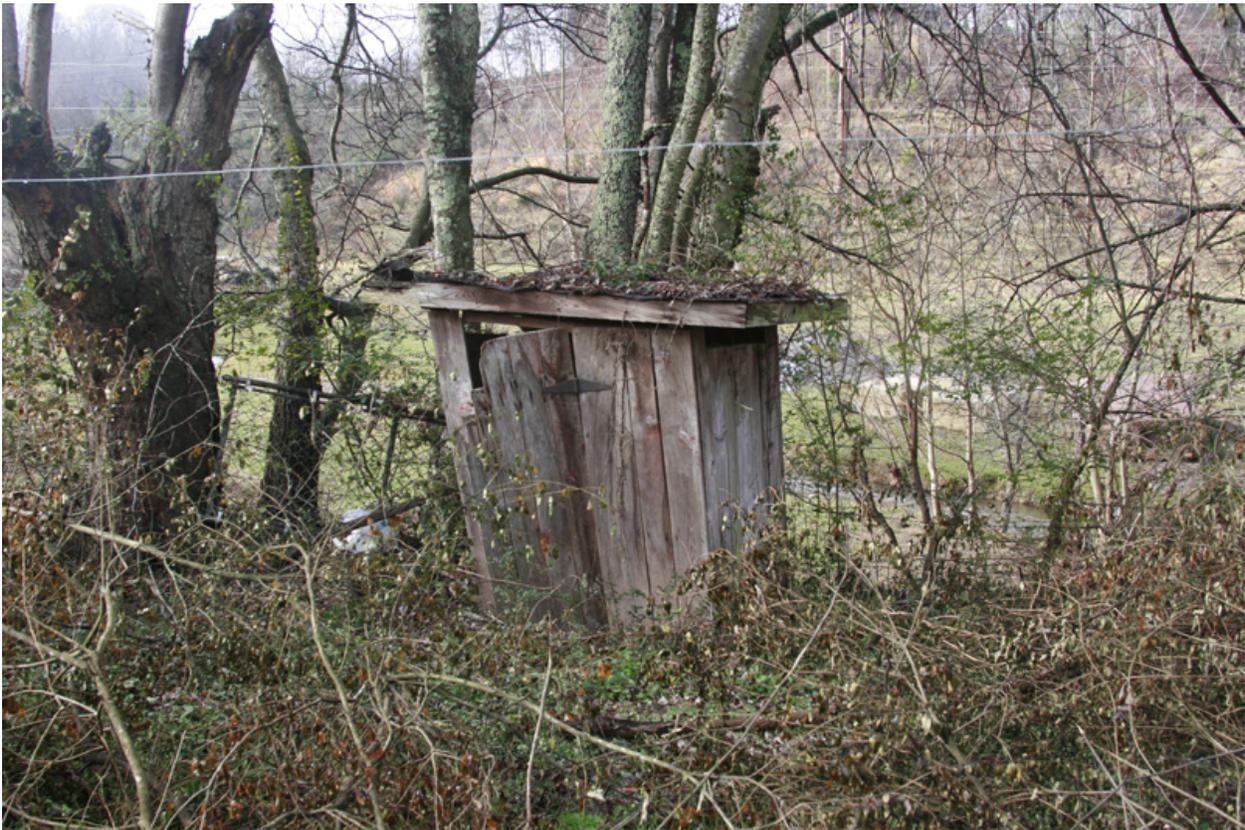
A small privy (outhouse) is located directly behind the west axis of the house, and along the bank of Middle Creek. It is approximately 4'x4'x6' in size, and is of shed type construction with batten board finish. The privy is a “single hole” design, with a excrement trough leading directly into Middle Creek. It is surfaced with several layers of mineral coated 90# asphaltic roofing material. While it is not possible to date this building to the construction of the house—it is obvious that it predates the rear addition to the house and its addition of internal sanitary plumbing. Although in fair condition, it is rapidly deteriorating and soon will no longer be a part of the fabric of the landscape.

Figure 7—Privy, with Middle Creek visible in background

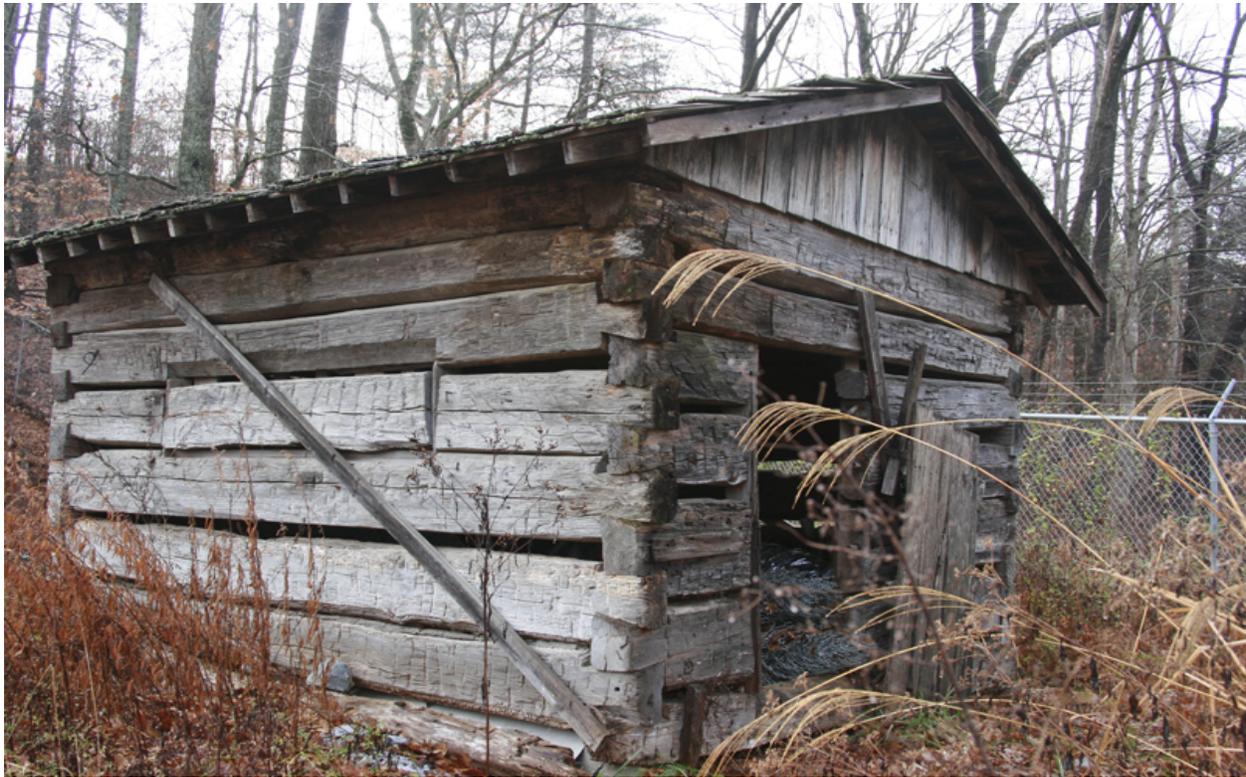
Figure 8—Front diagonal view of shed

As it currently presents, the shed is a 12'W x 14'D x 7'H (from sill to plate) log pen. The logs themselves are of Eastern White Pine, and have been squared on two sides with an adze. There is a 7/8 course of logs forming the walls. The cornering (joinery) is of the half-dovetail type, a fairly common pattern which followed settlers down the Shenandoah and into Tennessee during the early 1800s.

The structure is resting on a series of concrete blocks, and is covered with a relatively recent (~20-30 years) open tail rafter system, finished in hand split wood shakes. The eaves are finished with batten board. There are two openings in the walls—a 3'x5' offset entry, and a single log “choked” opening on the left side. On the right, several scallops between the logs were observed that would have carried some sort of side appurtenance. The batten door in the front is not original to the construction, as evidenced by remaining wooden pegs which retained a casement system for a fitted door, now both missing.

There is marked deterioration of the log fabric—particularly in the sills, upper corners, and top sill. This is due to the action of rot and fungal growth. As a self standing structure, this building presents several problems for interpretation and classification.

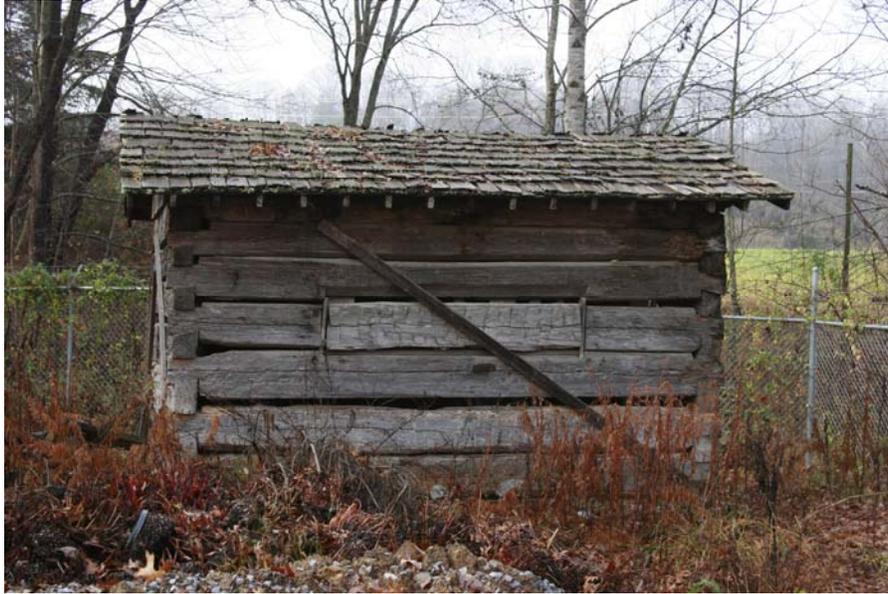
Left side, showing “chocked” opening
