# PHASE 1 ARCHEOLOGICAL AND ABOVE-GROUND RESOURCE SURVEY SUMMARY REPORT

*Proposed Willowood Addition Channel Improvements of  
Spring Creek Tributary 1  
City of Edmond, Oklahoma County, Oklahoma*

May 3, 2010

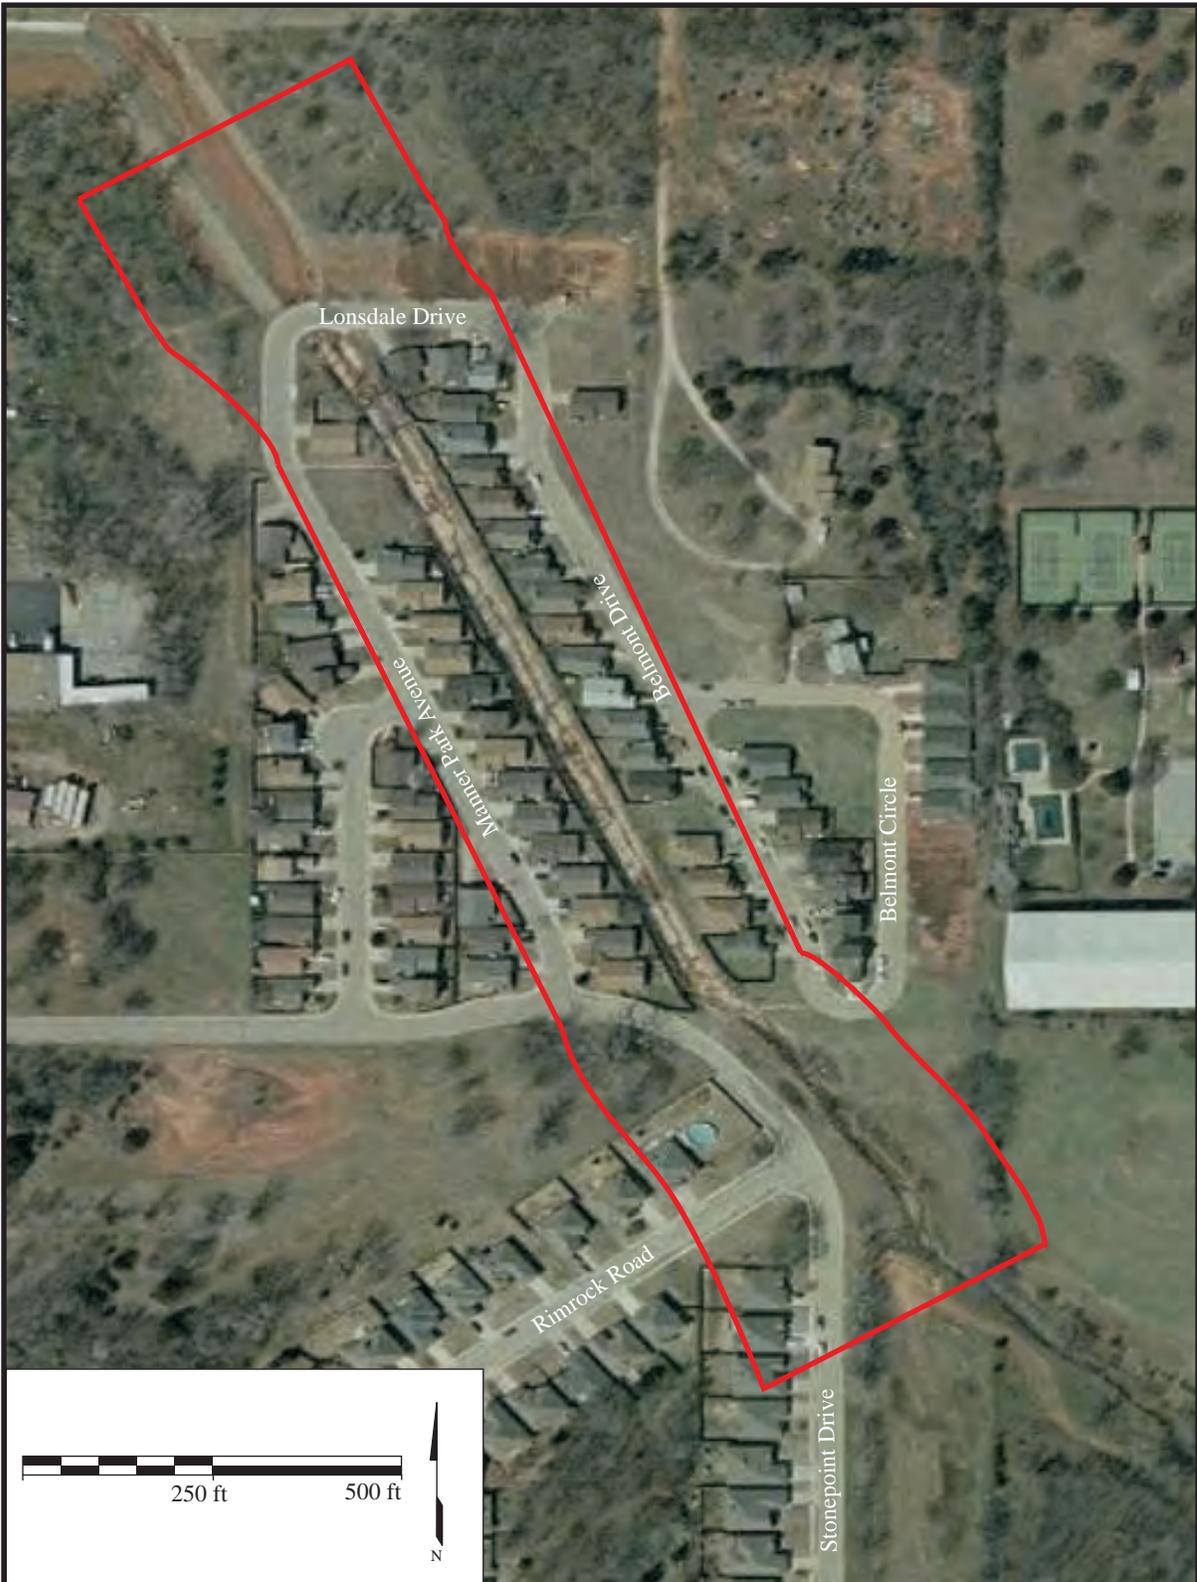
**Attachment 1.** The location of the project Area of Potential Effect (APE), Oklahoma County. The project area is located in the northwest quarter of Section 32, Township 14 North, Range 2 West, Indian Meridian.

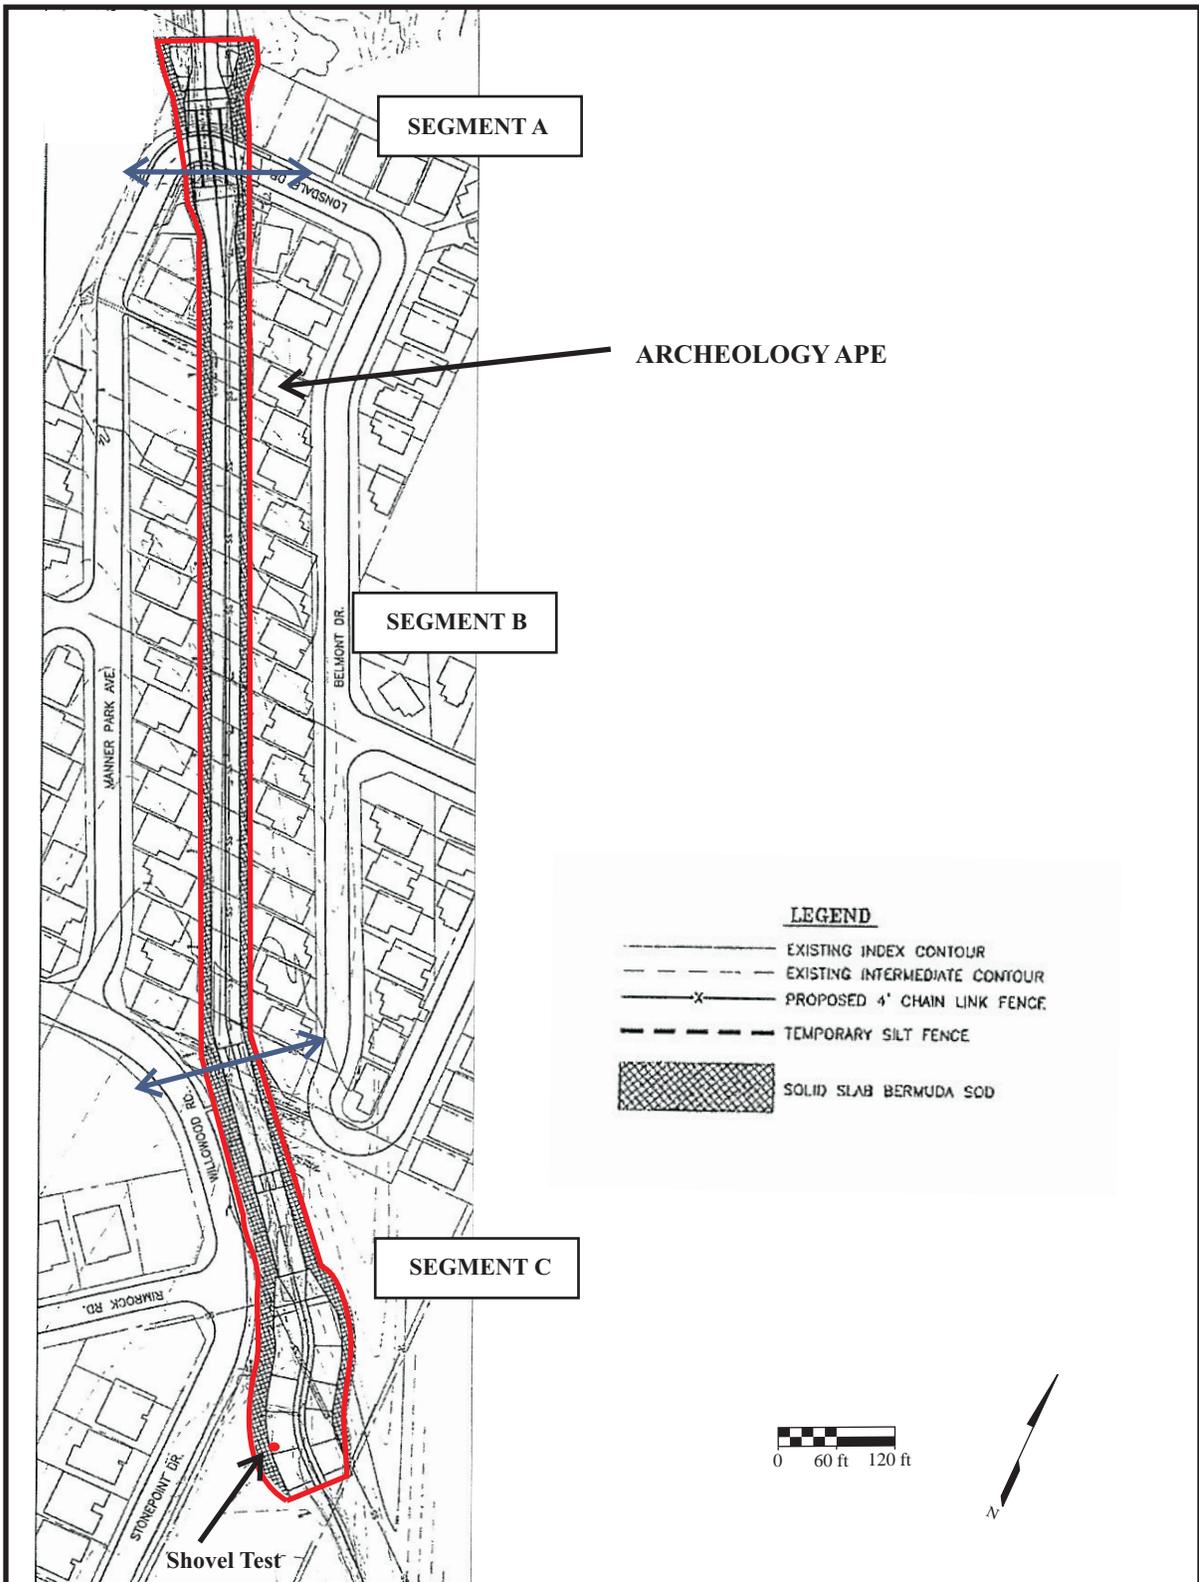
Attachment 3. The archeological APE shown on engineering plans.

- Expanding the Lonsdale Drive culvert system from a double 10-foot or 3-meters (m) wide by 5-foot (1.5-m) high concrete box structure to a quadruple 10-foot (3-m) wide by 10-foot (3-m) high concrete box structure (Segment A: Attachment 3).

- Channelizing an additional 230 linear feet (70.1 m) of Spring Creek Tributary 1 south of Willowood with a 12-foot (3.7-m) wide concrete-bottom trapezoidal channel with 7:1 riprap side slopes (Segment C: Attachment 3).

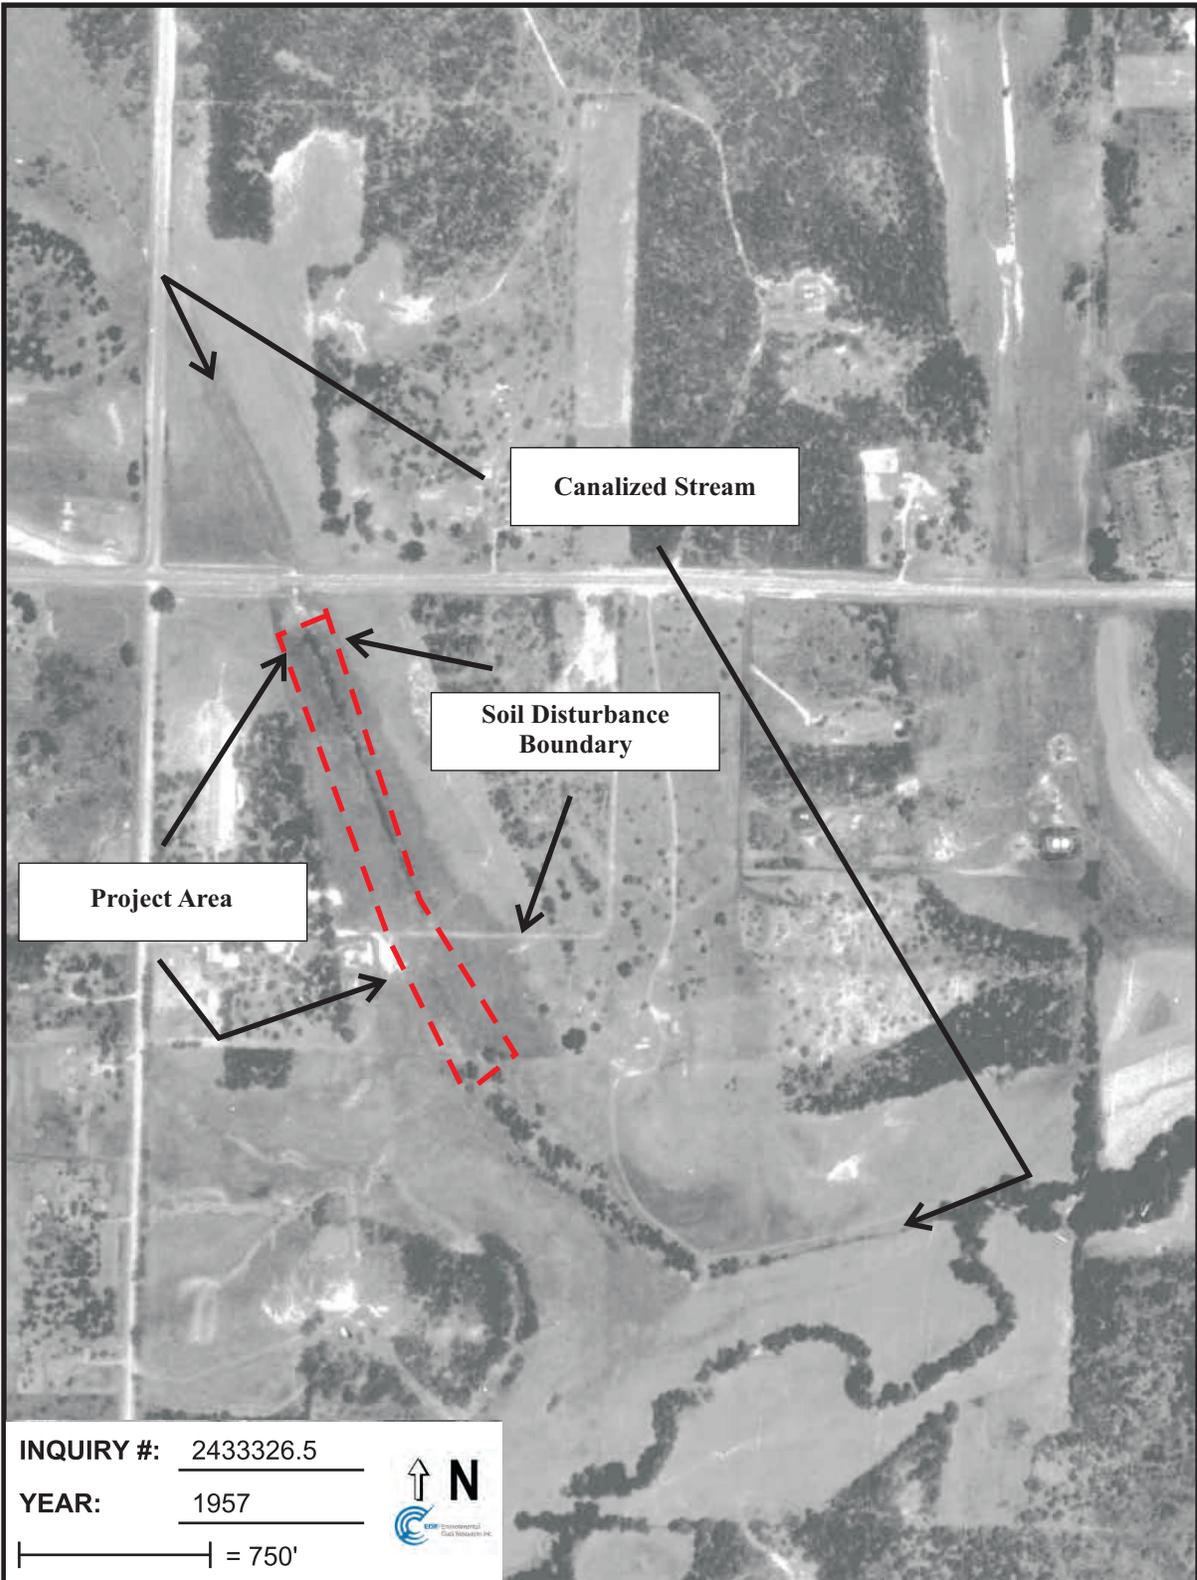
**Attachment 4.** 1957 aerial photograph of the project area showing the canalized segment of Spring Creek Tributary 1.

The Aerial Photo Decade Package obtained from EDR in 2009 included aerial photographs for 1957, 1963, 1970, 1984, 1995, and 2005. The 1957 aerial photograph depicts the early canalization of Spring Creek Tributary 1, extending well to the north and south of the APE (see Attachment 4). The construction and development of Willowood after 1980 included a series of prepared building sites on the south end of the APE (Segment C). These lots have remained empty and provide communal greenspace.

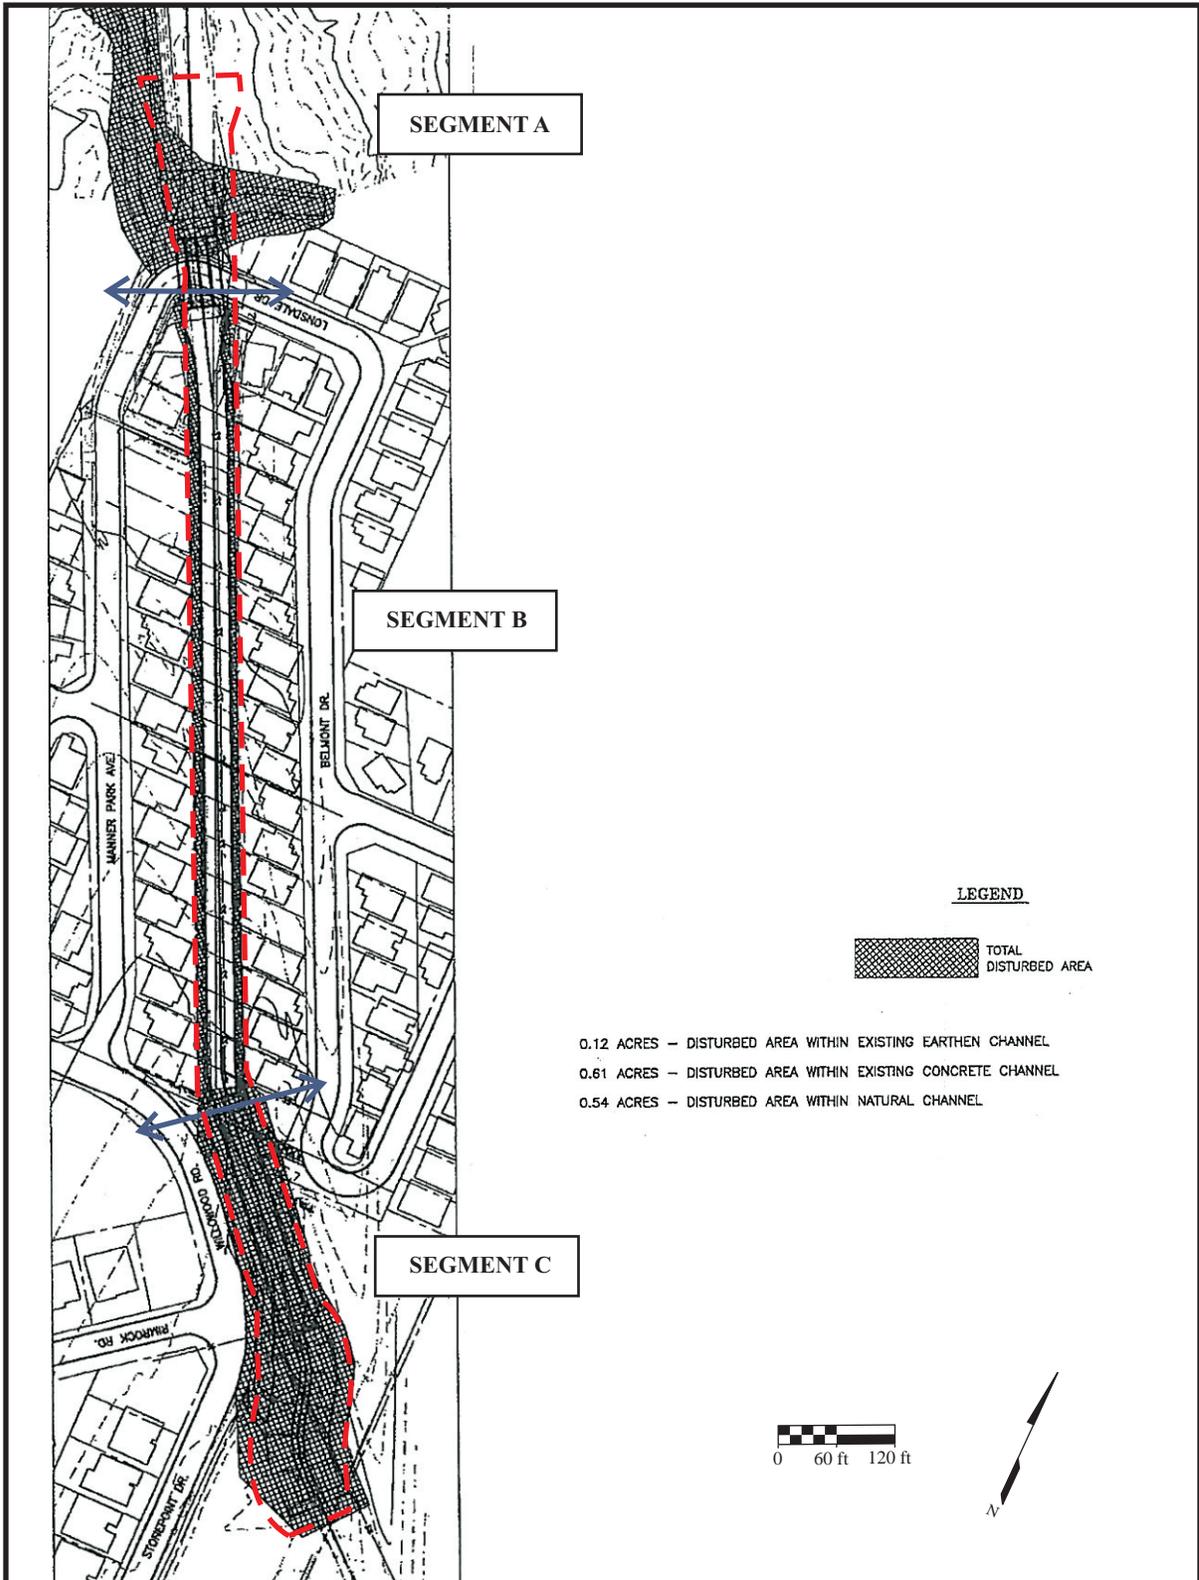
**Attachment 5.** Meshek-defined disturbance based on 2009 engineering survey with archeological APE defined in red.

The archeological field methods developed for the assessment of the APE took into account engineering data collected by Meshek (2009). Meshek identified the portions of the APE that had been subject to previous disturbance, most notably the north and south ends of the APE, where widening beyond the current ROW is proposed (Attachment 5).

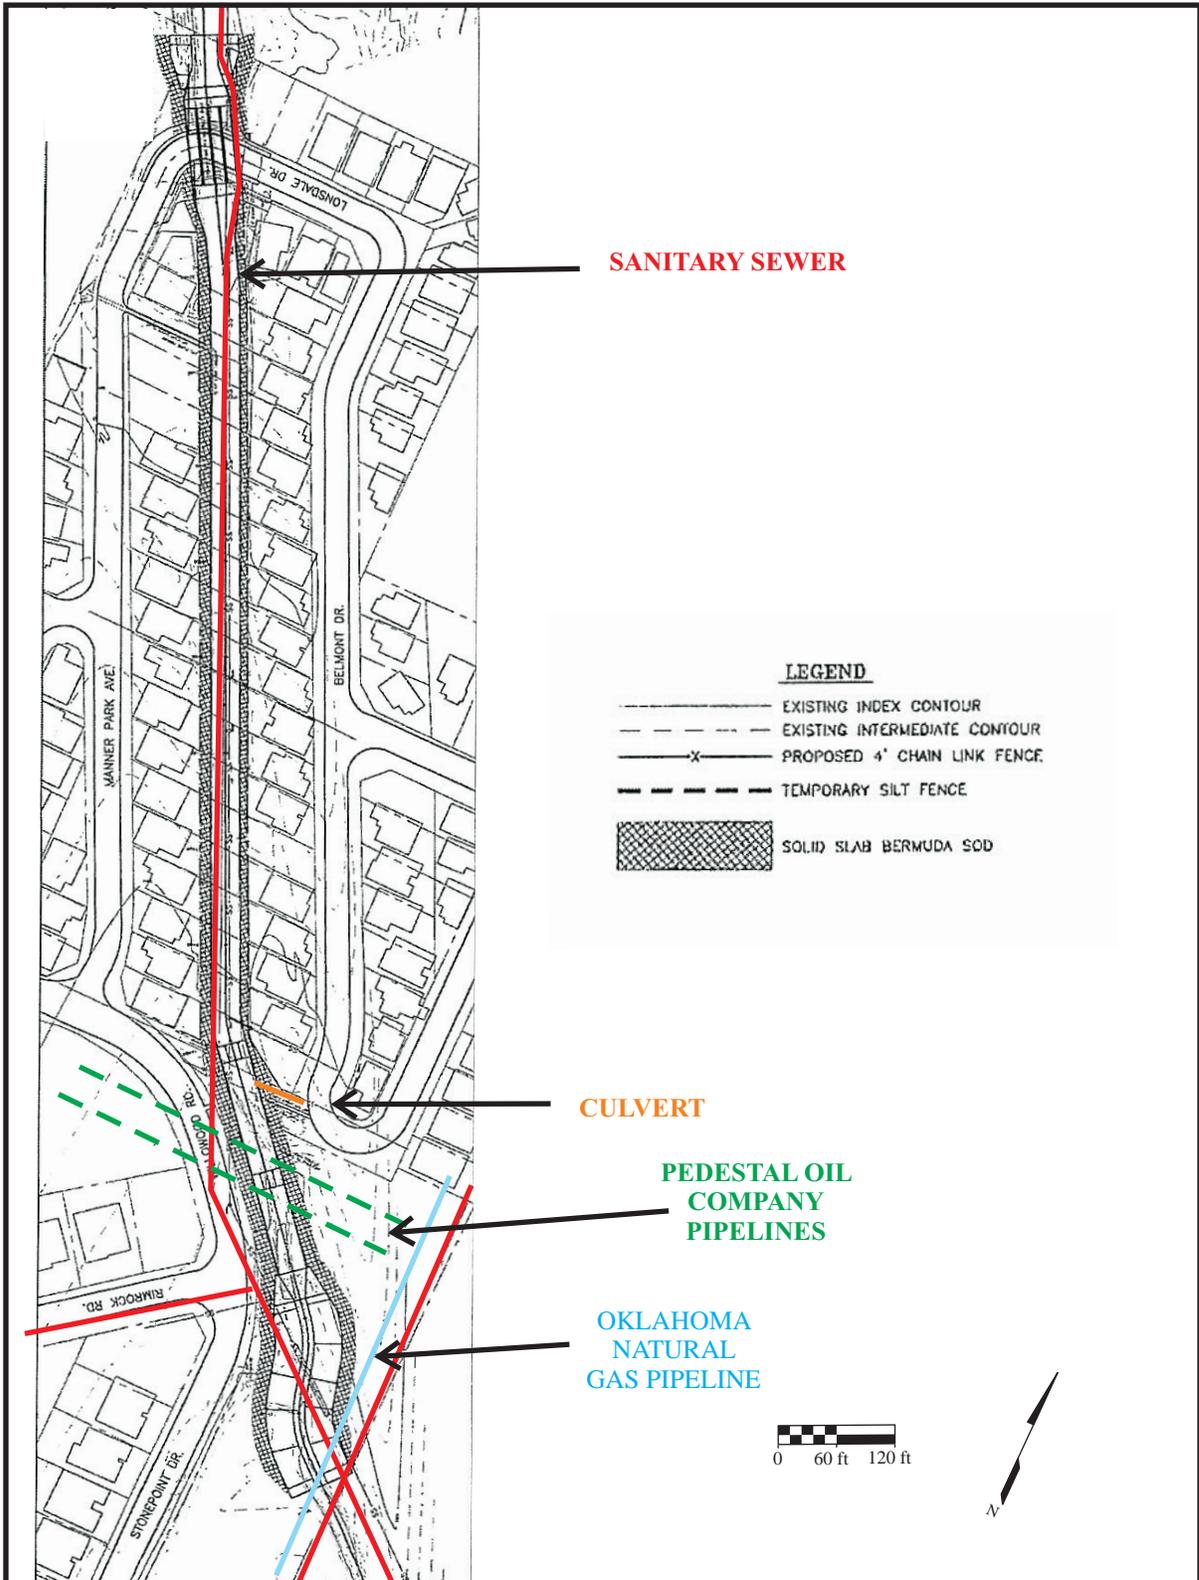
**Attachment 6.** Locations of buried utilities confirming project area disturbances.

The archeological and above-ground surveys confirmed that the APE was disturbed and/or an altered landscape. No historic properties were evident within the APE. Attachment 6 shows the location of utility trenches identified through the field reconnaissance. Representative photographs of the project area are included as Attachments 7 through 10.

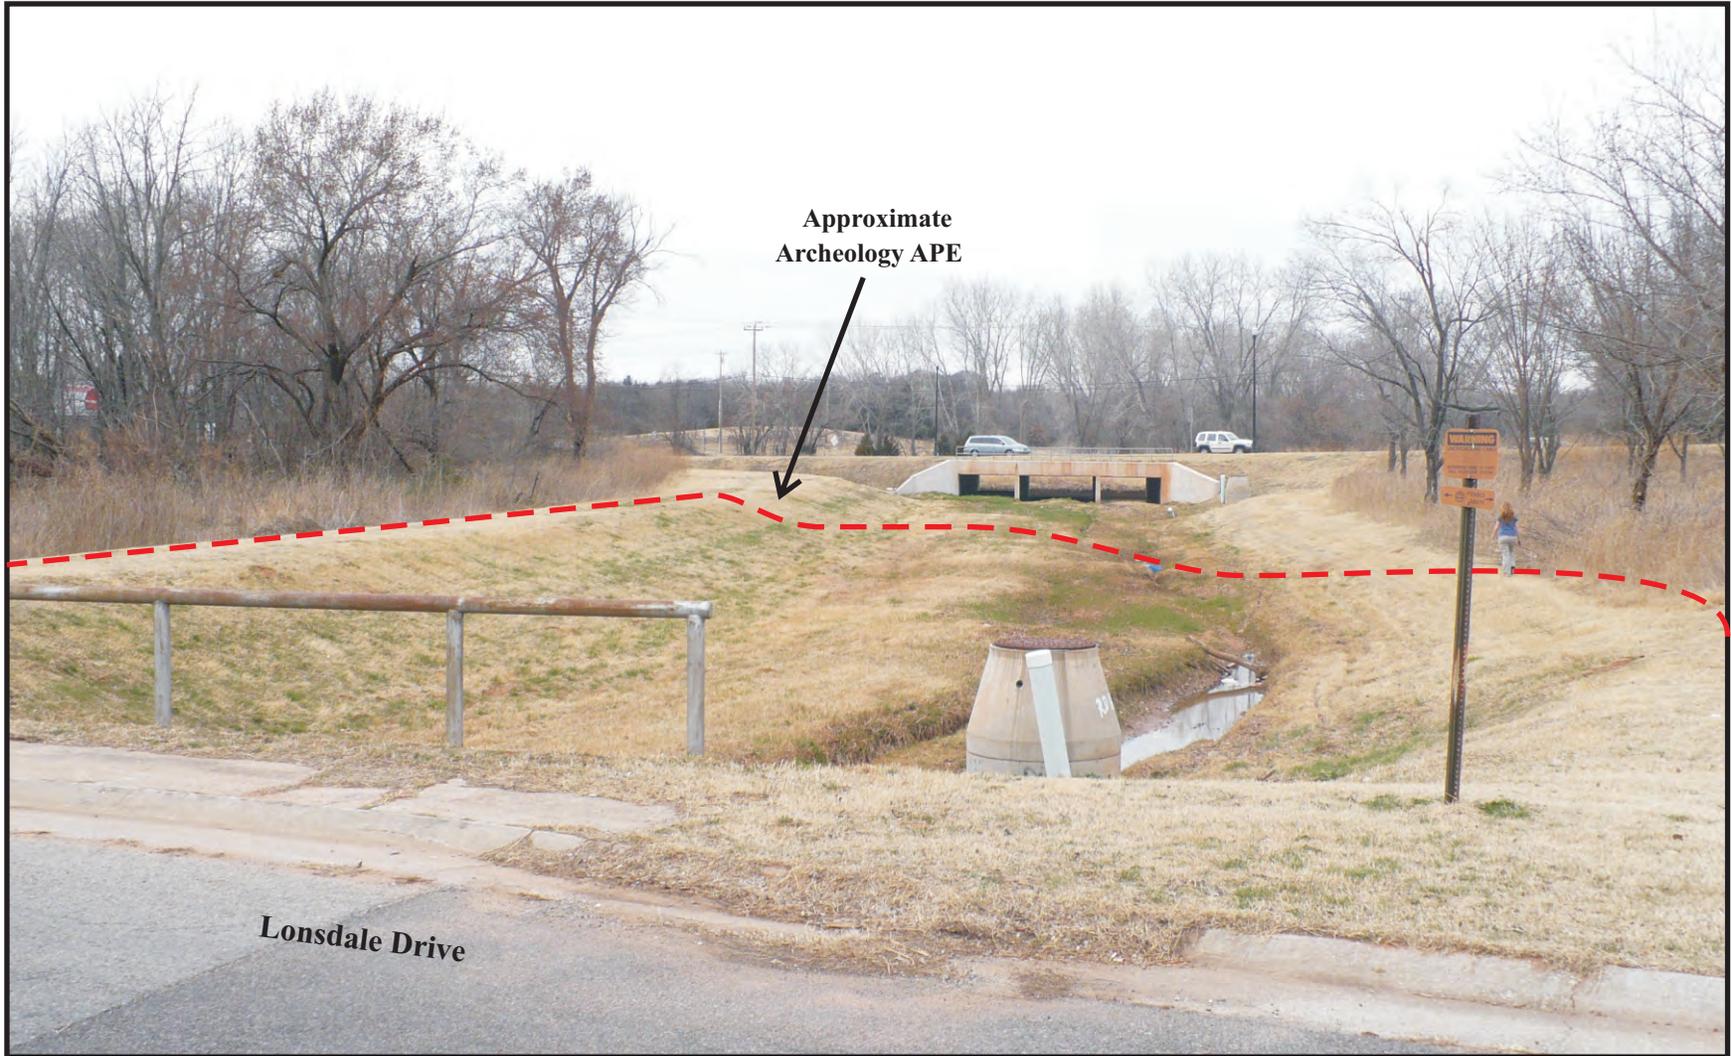
Attachment 7. Segment A, view to west showing canalized stream, levee, and sanitary sewer riser.

Segment A comprises the northern section of the APE. It represents a wide, flat, earthen section of the canalized stream (see Attachments 3, 5 and 7). A flood control levee is located at the western margin of the stream segment, and a manhole riser attests to a sanitary sewer line buried within the channel.

Segment A was determined to be completely disturbed or altered by the construction of levees (1950s), subdivision site preparation and trenching for sanitary sewer lines (approximately 1980), and stabilization and replacement of riprap and sod following recent flood episodes (1990s to present). No subsurface investigations were warranted for Segment A of the APE.

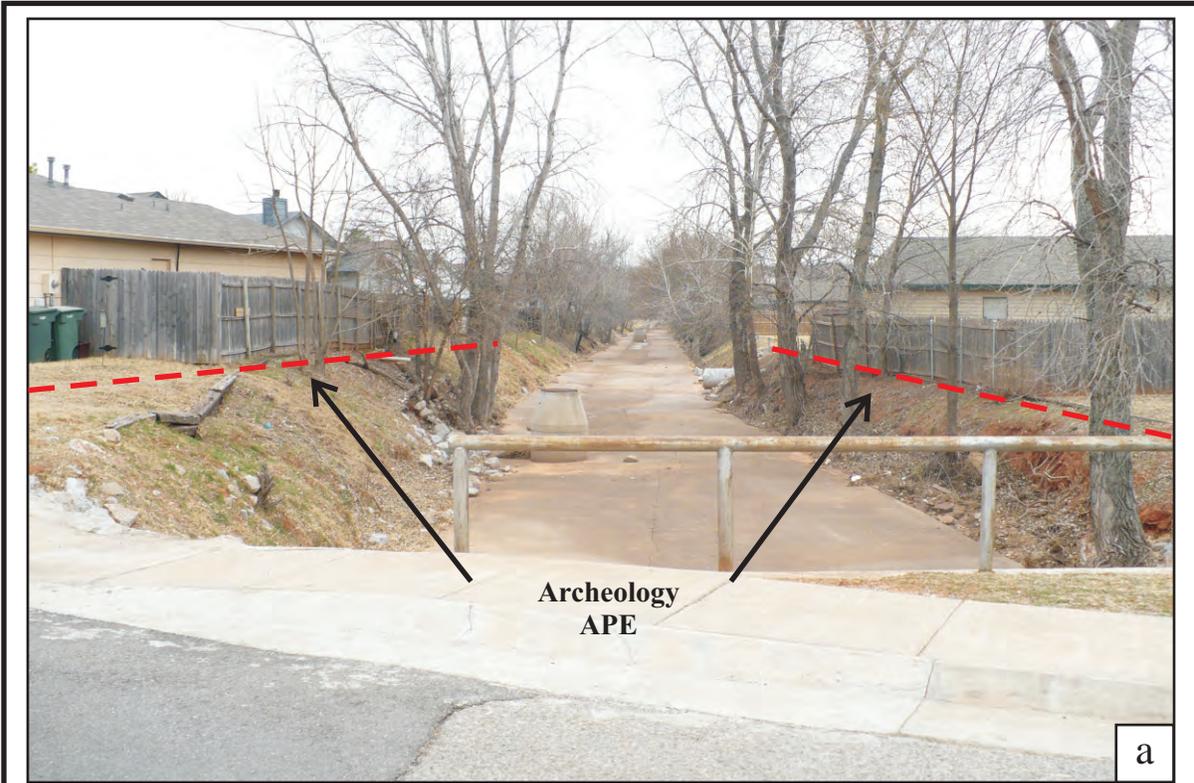
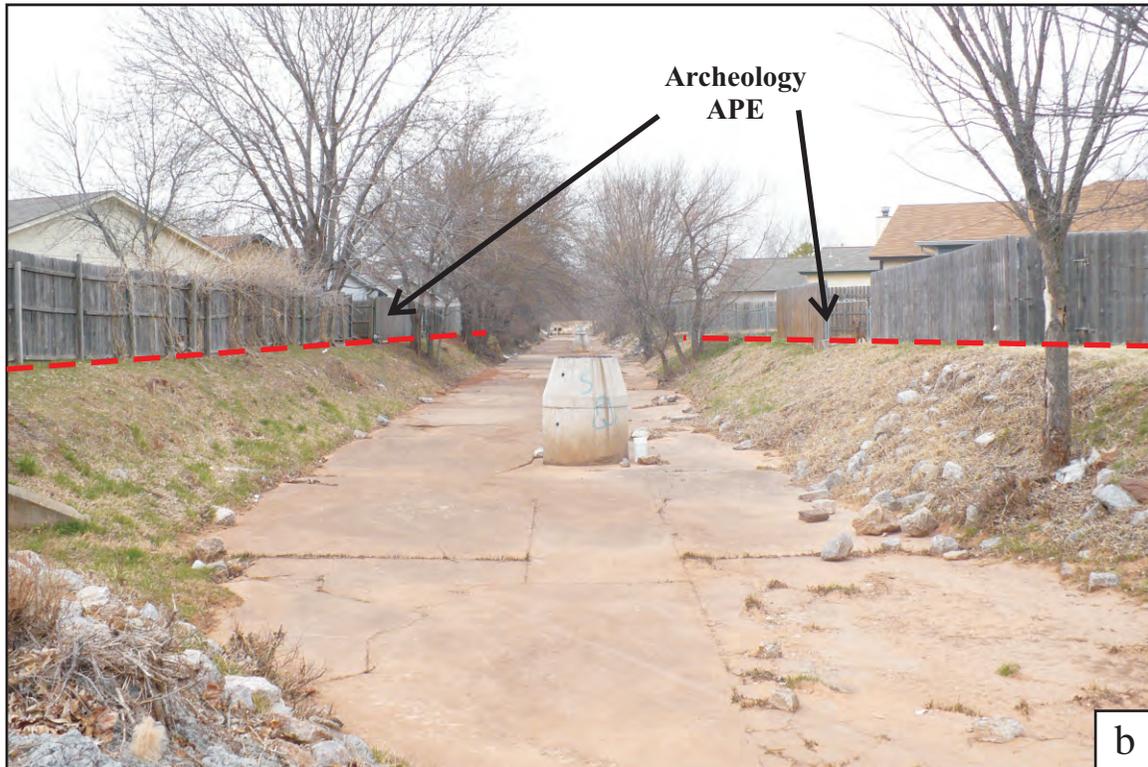
**Attachment 8.** Segment B showing channeled stream with concrete-lined bottom, view southeast from Lonsdale Drive (a), and from Willowood Road, view northwest (b).

Segment B comprises the central portion of the APE and is represented by a canalized section of the stream with a concrete-lined bottom and earthen and riprap sidewalls beveled to a 45-degree slope. These abut residential lots (see Attachments 3 and 5). As with Segment A, manhole risers attest to a buried sewer line under the channel. The east and west boundaries of Segment B are bounded by private fencing (Attachment 8).

Segment B was completely disturbed by the canalization of the stream segment (1950s), subdivision site preparation and trenching for sanitary sewer lines and the placement of concrete along the stream bottom (1980). Additionally, visual inspection of the channel walls identified the use of riprap and possible fill material for stabilization. No subsurface investigation was warranted for Segment B.

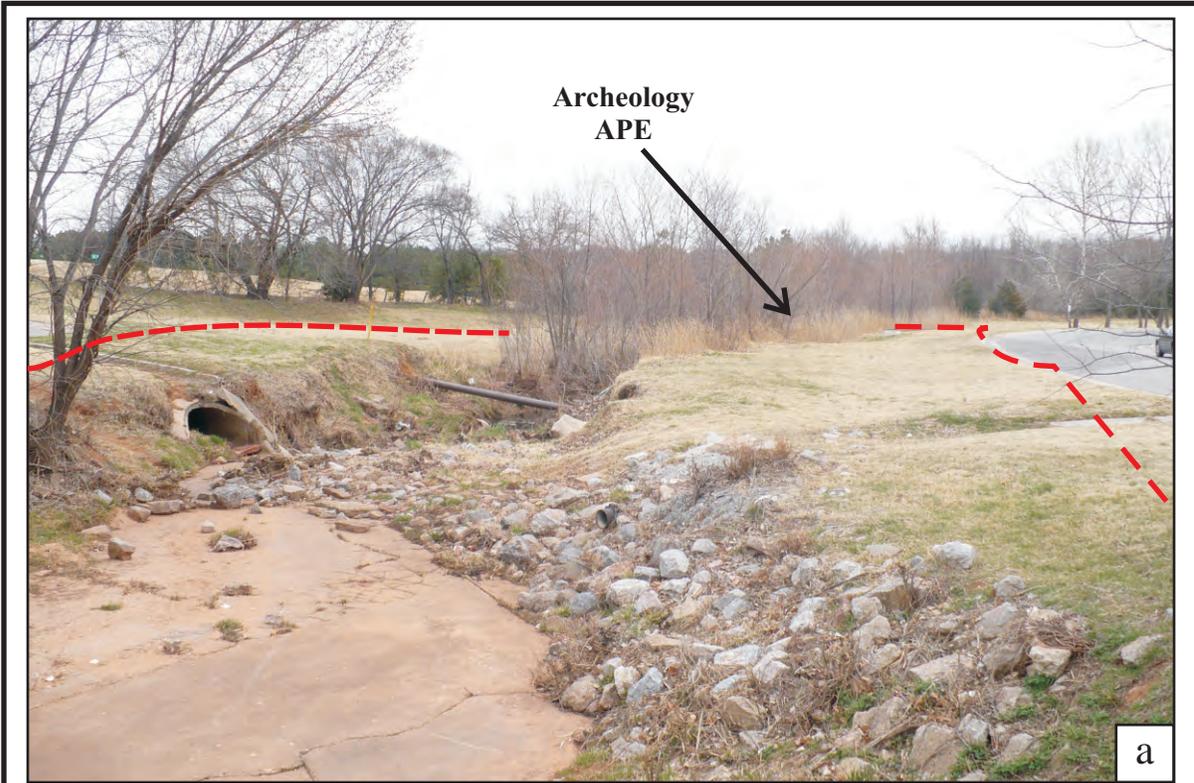
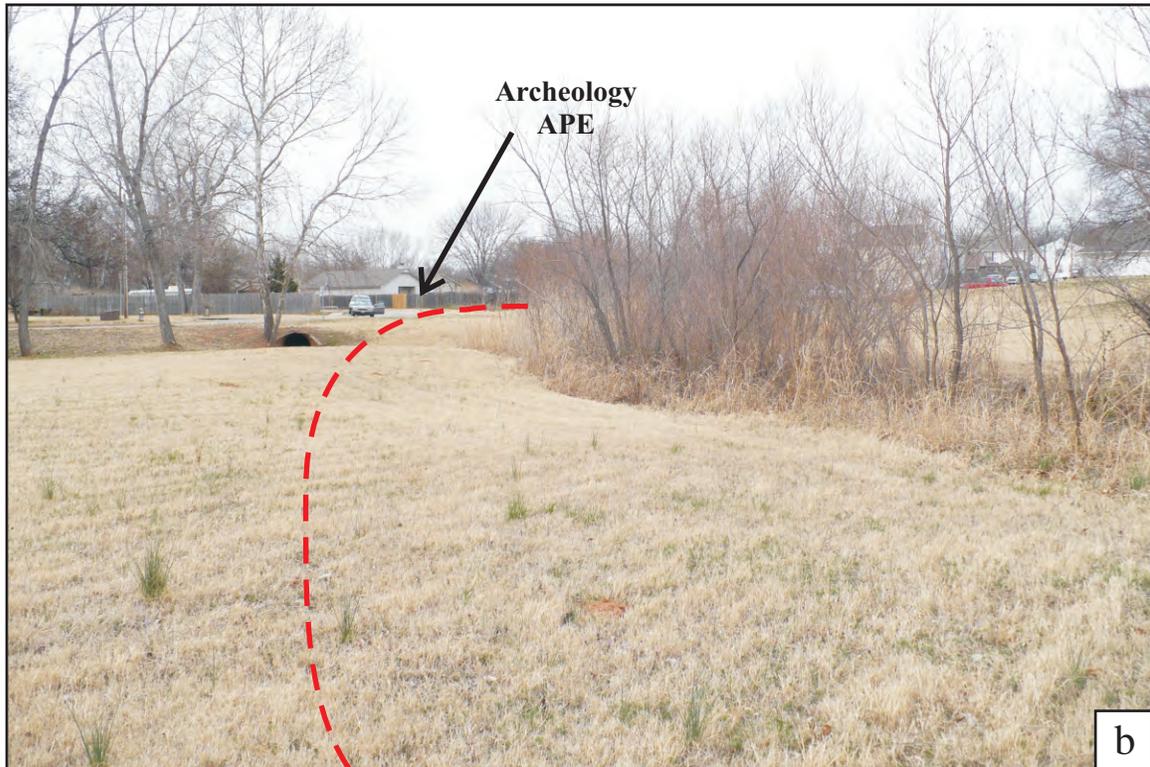
**Attachment 9.** Segment C showing reduction of stream to canalized weedy ditch and riprap fill, view southeast (a), and view north (b).

Segment C is the portion of the APE south of Willowood. It begins as a wide and flat earthen section of the stream, and quickly constricts into a canalized weedy ditch for the remainder of the APE (see Attachments 3, 5 and 9). Portions of channel sidewalls in Segment C are covered with concrete and asphalt rubble. Extensive pipeline trench disturbance was noted throughout the segment (Attachment 5, 6 and 10). The buried sanitary sewer line continues through Segment C on the western side of the stream channel. An Oklahoma Natural Gas (ONG) pipeline extends along the eastern side of the stream channel, and two Pedestal Oil Company gas pipelines extend across the channel in an east-west direction (Attachment 5, 6 and 10). In addition, a buried concrete culvert extends from a grated drop-box at Belmont Circle. The culvert opens at the southern edge of Willowood and drains into the stream channel within Segment C.

Segment C of the APE also appeared to be completely disturbed and/or altered by canalization of the stream segment (1950s). Additional disturbances and alteration of the APE occurred during the 1980s. Development in the project area includes the placement of fill and riprap along the stream margins; trench excavation for the placement of the sanitary sewer lines, two Pedestal Oil Company gas pipelines, and an ONG gas pipeline; and construction of a concrete stormwater culvert.

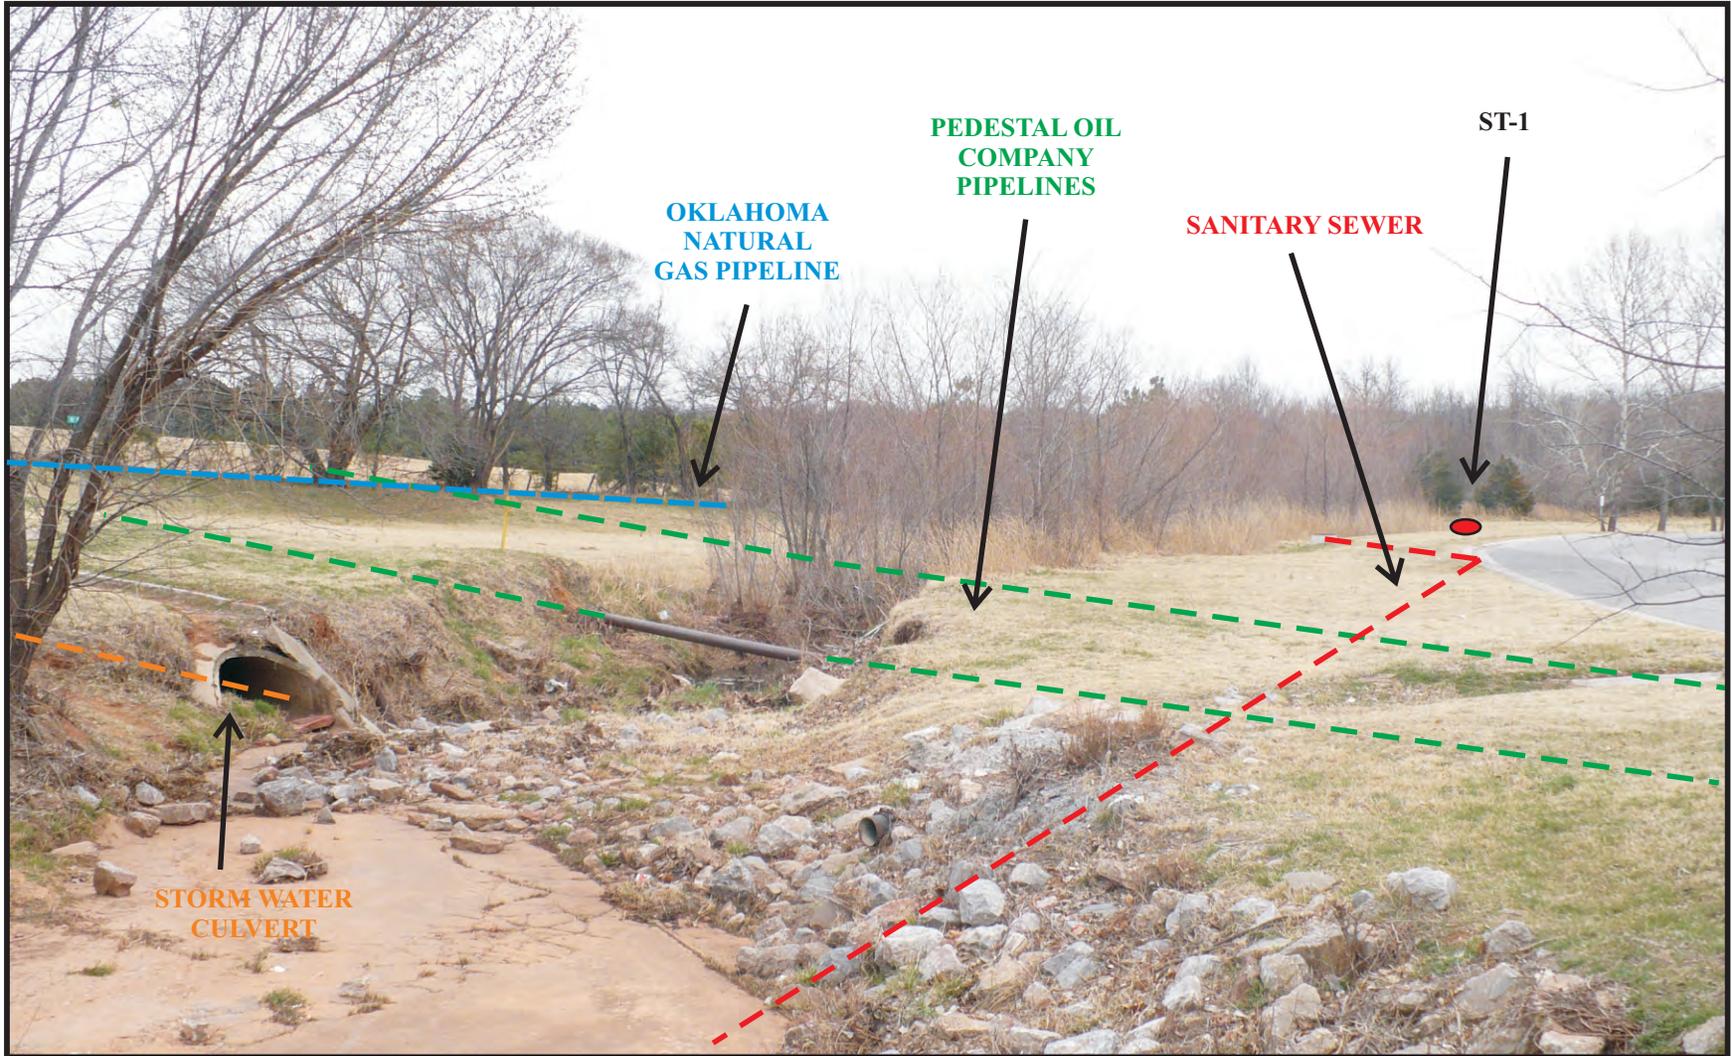
**Attachment 10.** Overview of Segment C showing extensive utility trench disturbances and the location of shovel test ST-1.

One shovel test (ST-1) was excavated at the southern end of Segment C. The location and profile are shown in Attachments 3, 10, and 11. The test yielded only modern debris and soil types indicative of modern fill. The shovel test revealed two soil zones. The 30-by-30 cm shovel test (11.8-in<sup>2</sup>) was excavated to 90 centimeters below surface (cmbs) (35.4 in) to reveal 60 cm (23.6 in) of modern fill soil over 30 cm (11.8 in) of sterile fill sand.

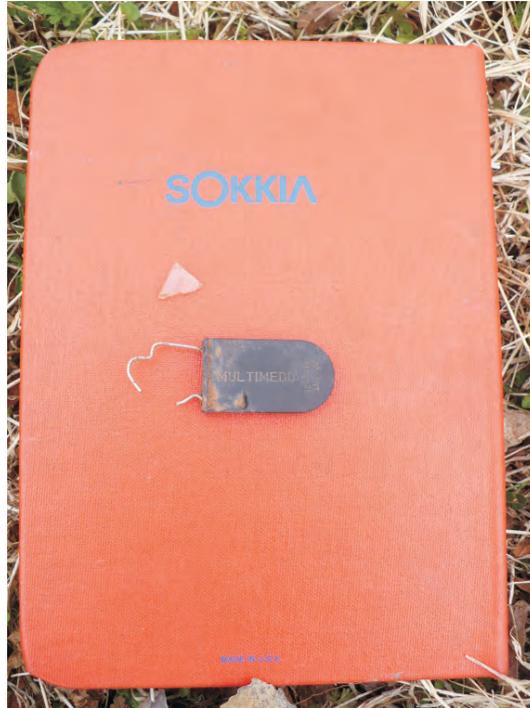
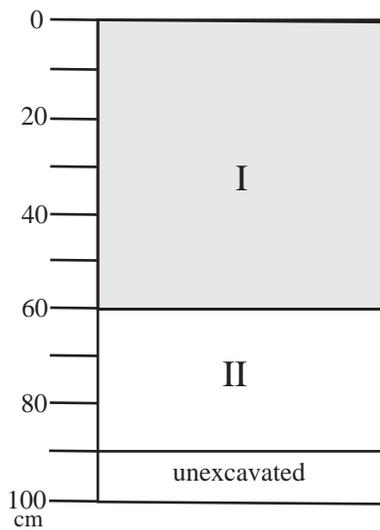
Zone I: 0-60 cm  
mottled  
2.5 YR 4/4 to 2.5 YR 5/8  
silty sand with modern debris

Zone II: 60-90 cm  
5 YR 5/6  
sterile coarse sand

**Attachment 11.** Modern debris recovered from Zone 1 fill and ST-1 soil profile.

Zone 1 consists of mottled fill layers ranging from reddish brown (2.5YR 4/4) to red (2.5YR 5/8) silty sand. The zone contained modern debris, indicating a disturbed fill soil zone. Items recovered included a black plastic security tag with wire-tie (Attachment 11). This item (impressed with the word MULTIMEDIA) is typically used as a tamper-resistant seal on residential electric meters. Additional items recovered included modern-era colorless bottle glass and concrete fragments. It would appear that Zone 1 fill had been added to raise the landform and decrease flooding.

Zone 2, a yellowish red (5YR 5/6) sterile coarse sand, was identified at 60 cmbs (23.6 in) and excavated to a depth of 90 cmbs (35.4 in). No cultural material or natural inclusions were recovered from Zone 2. The coarse sand appeared to be clean fill material. The soils documented in the shovel test indicate the landform likely represents the active stream channel overlain by more than 90 cm (35.4 in) of modern fill.
