Final Environmental Assessment

Tiger Mountain Trail Re-Route and Footbridge Relocation

King County, Washington

FEMA-1817-DR-WA (Public Assistance)

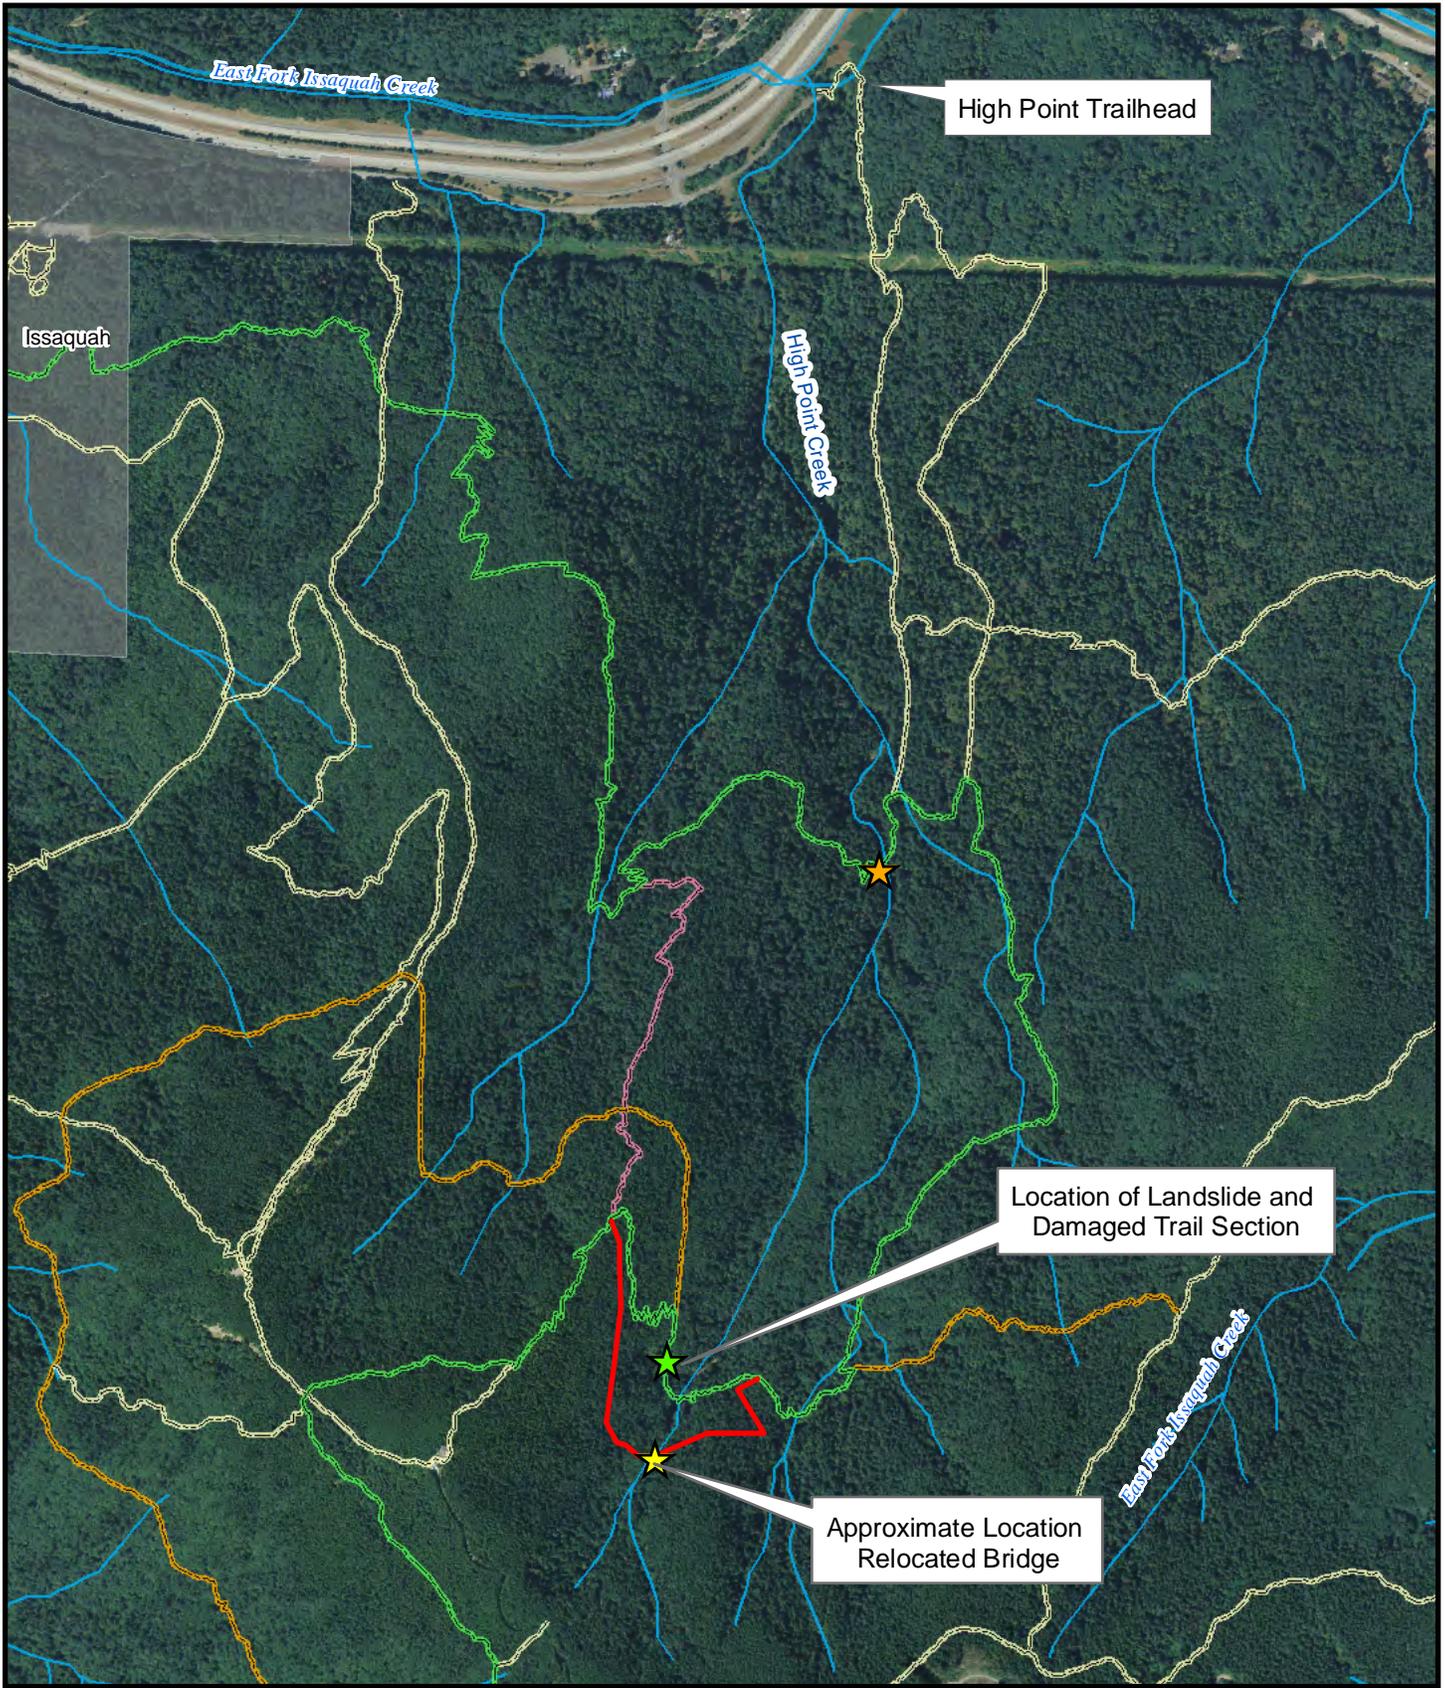
- ★ Damage Site
- ★ Relocated Bridge Site
- ✂ Generalized Trail Re-Route
- ★ Tiger Mountain Trail Footbridge Project Location
- ~ Streams
- ~ Trails
- ~ Tiger Mountain Trail
- ~ West Tiger RR Grade
- ~ K-3 Trail

FEMA has prepared a separate EA (FEMA 2010b) for another DNR project to replace a Tiger Mountain Trail footbridge over High Point Creek (*Tiger Mountain Trail Footbridge Project*) located approximately 0.8 mile downstream in the same watershed; that project is similar in nature and scale to the proposed project in this EA (Figure 1.2-3, *Project Site*).

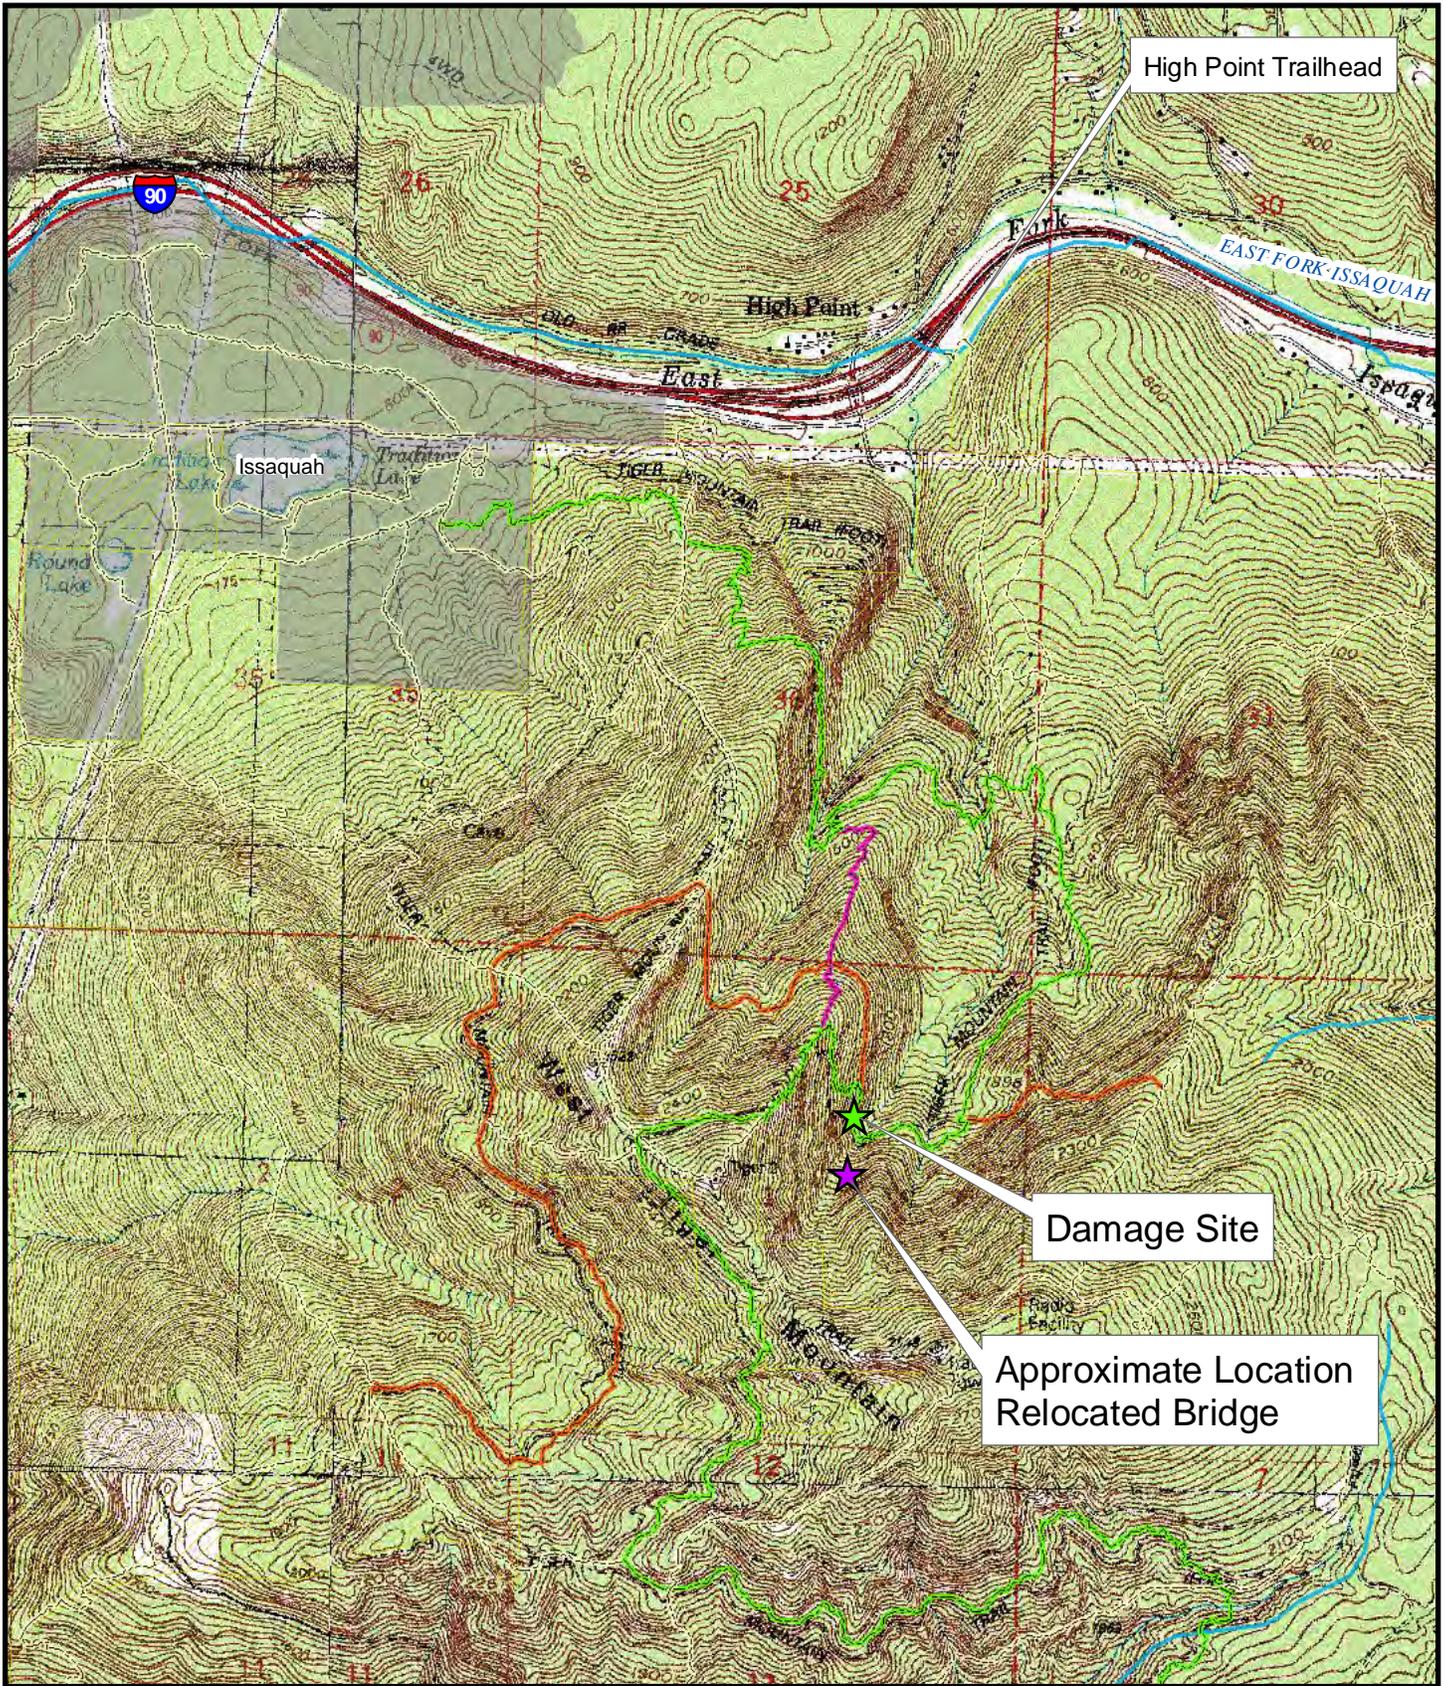
- ★ Damage Site
- ★ Relocated Bridge Site
- Trails
- Tiger Mountain Trail
- West Tiger RR Grade
- K-3 Trail

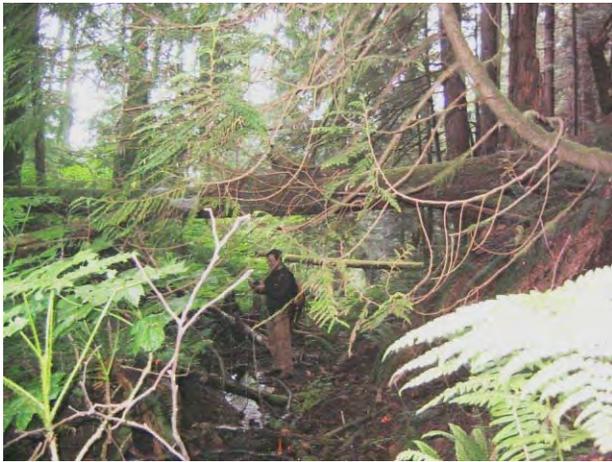
Upper High Point Creek and Proposed Bridge Location

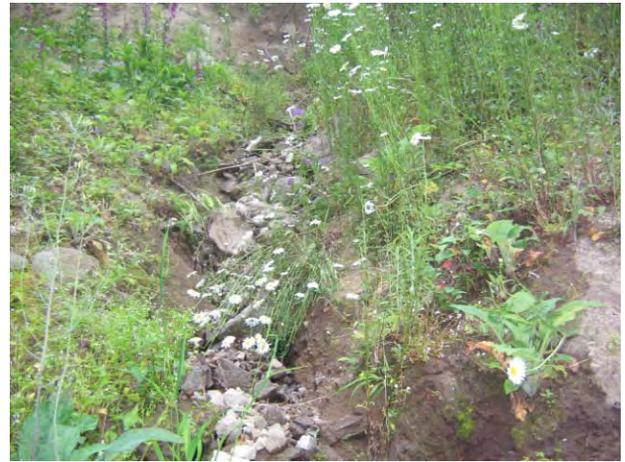
The damaged TMT trail crosses one of several unnamed tributaries to Upper High Point Creek. The unnamed tributary is a steep, single channel creek with sparsely vegetated banks. The bankfull width is 12 to 18 inches. Hydrology concentrates in this tributary, but also appears to sheetflow across the entire landslide area (Figure 3.2-1, *Photos of Streams and Vegetation*). The area was stripped of ground vegetation, including trees, and is vulnerable to additional mass movement from recurring rain storms (FEMA 2009). The temporary bypass trail crosses over the lower portions of the landslide and in the same unnamed tributary. This unnamed tributary is seasonally intermittent, and mapped by DNR as Type ‘N’, a non-fish bearing stream (DNR 2011).

Unnamed Tributary to Upper High Point Creek

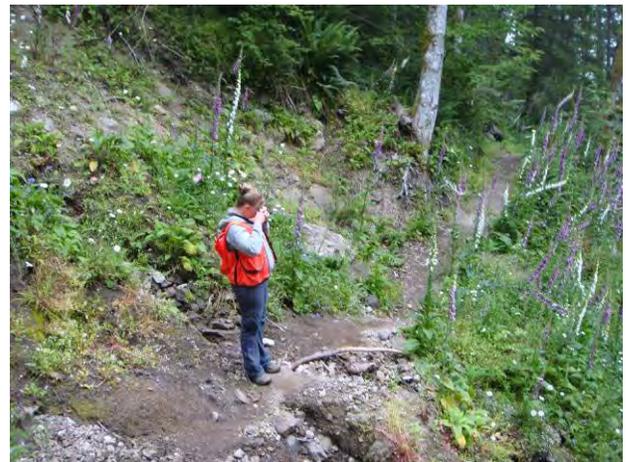
Disturbed Uplands and Bypass Trail

Disturbed uplands are limited to the landslide area in the damaged portion of the TMT and constructed bypass trail (Figure 3.2-1, *Photos of Streams and Vegetation*). This area has 50% bare ground with patches of herbaceous species that are dominated by foxglove (*Digitalis purpurea*), oxeye daisy (*Leucanthemum vulgare*), and bedstraw (*Galium aparine*).
