**WETLAND INVESTIGATION REPORT
FOR
PHASE 1 ENVIRONMENTAL STUDY
SANITARY SEWER COLLECTION SYSTEM
CITY OF STORM LAKE, IOWA
GRIGGS ENVIRONMENTAL STRATEGIES LLC
PROJECT NO. 10-255**

June 28, 2011

**GES PROJECT No. 10-255
JUNE 28, 2011**

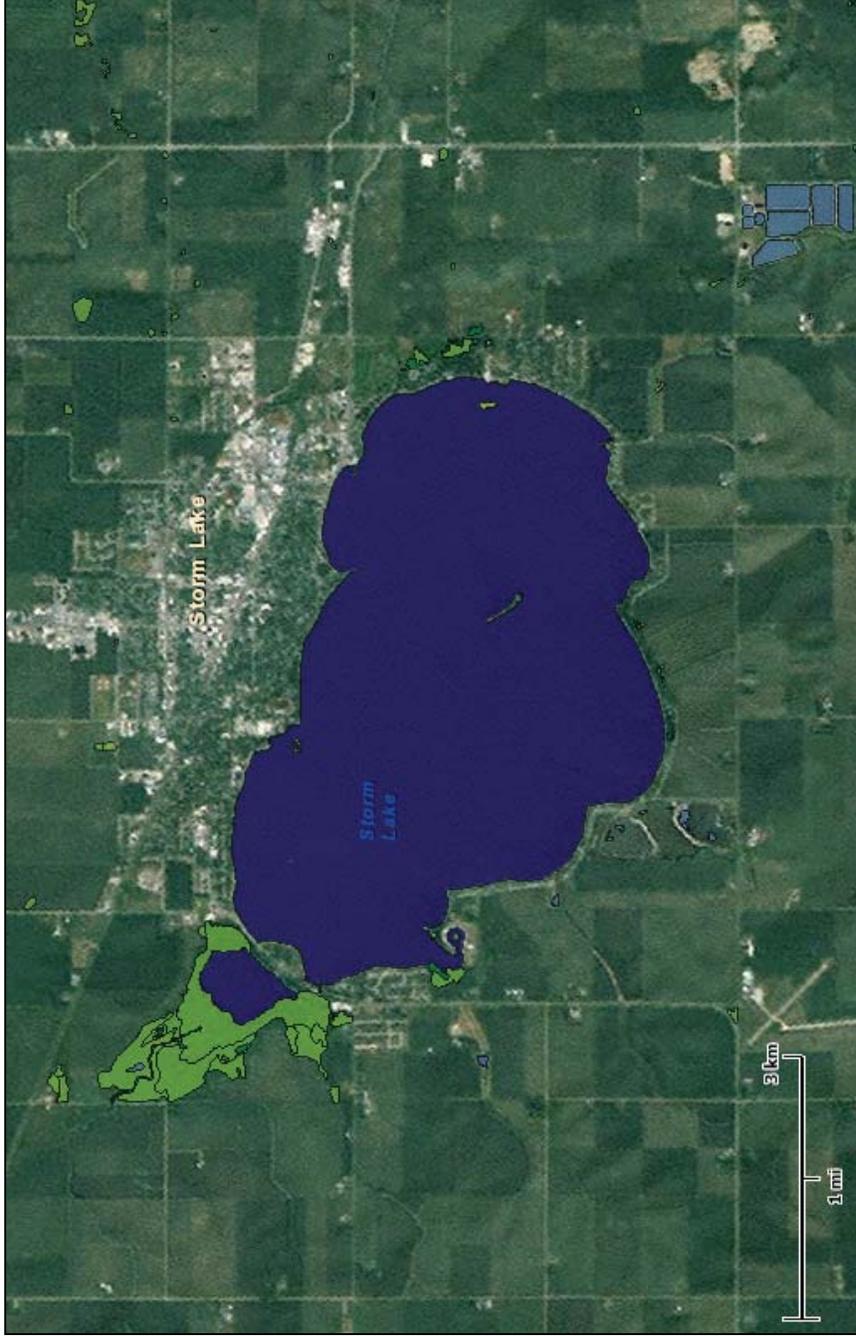
FIGURE 4 – NATIONAL WETLAND INVENTORY MAP

The National Wetland Inventory map of the project area indicates several areas of mapped wetlands within the vicinity, mainly associated with Storm Lake and Little Storm Lake (Figure 4).

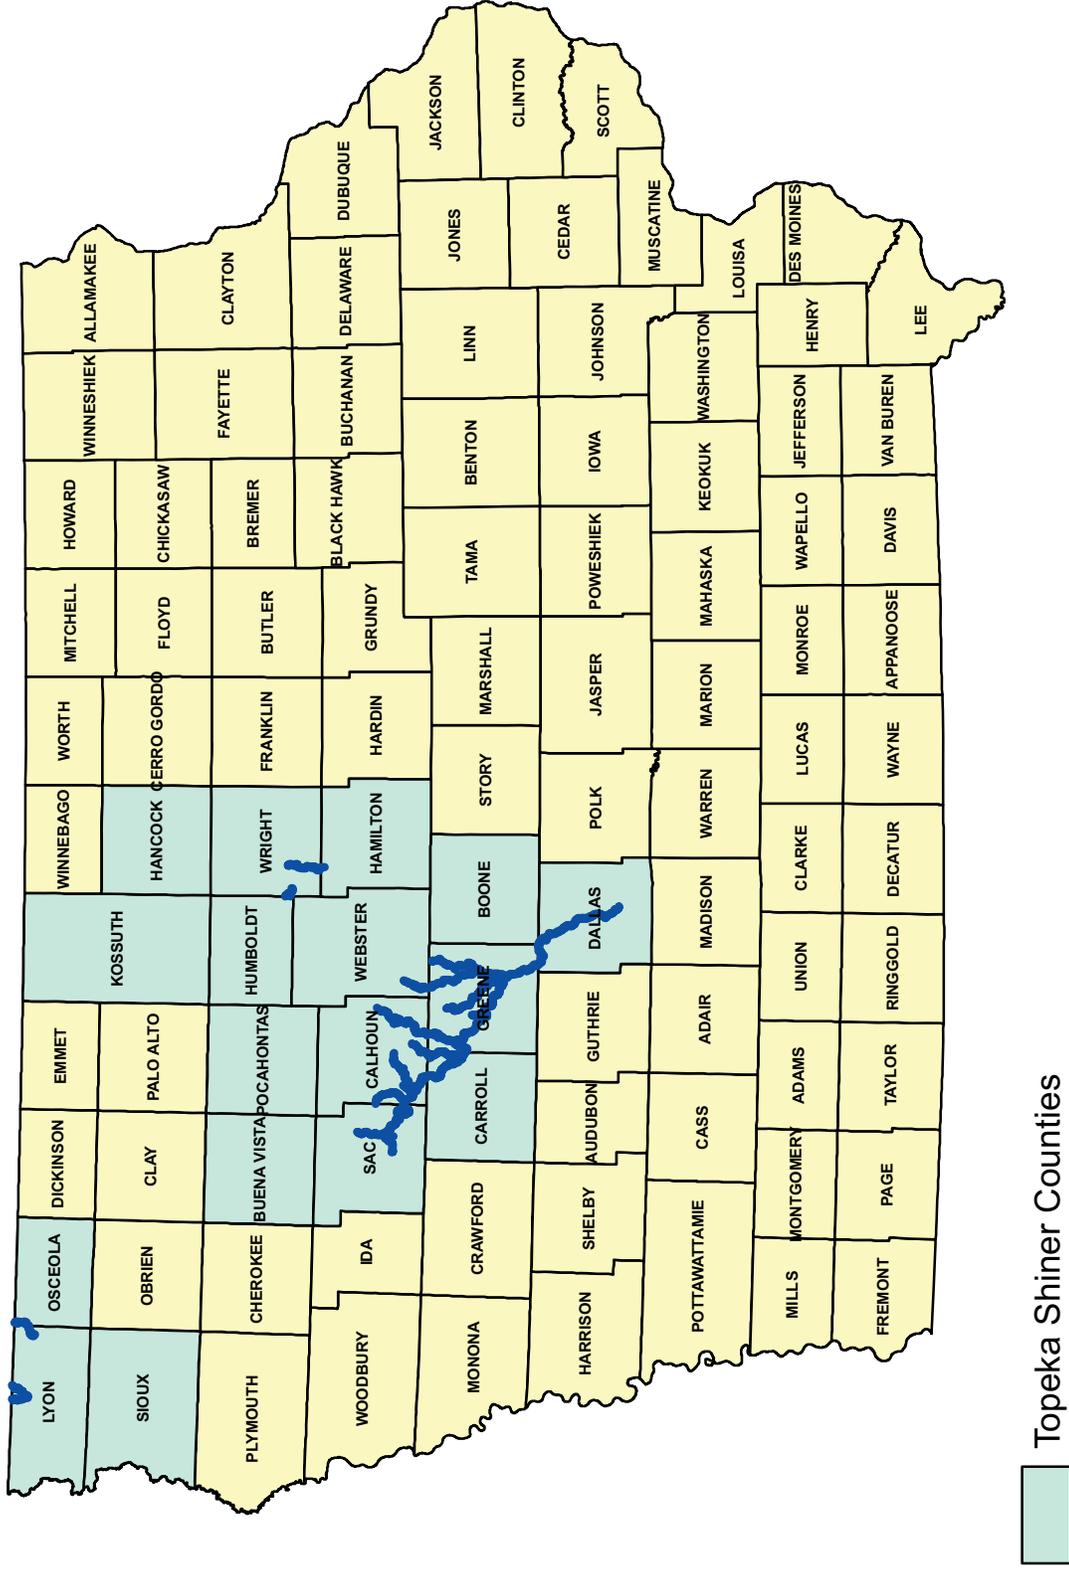
FIGURE 5 – TOPEKA SHINER RANGE MAP

The project is located within the designated Critical Habitat area for Topeka shiners (Figure 5). Because the project alignment crosses Outlet Creek and several other unnamed perennial streams, design and construction of the project must consider potential impacts to this protected species. Suitable mitigation may include avoiding direct disturbance of the streams by direction boring or other construction techniques.

Topeka Shiner Range and Designated Critical Habitat in Iowa

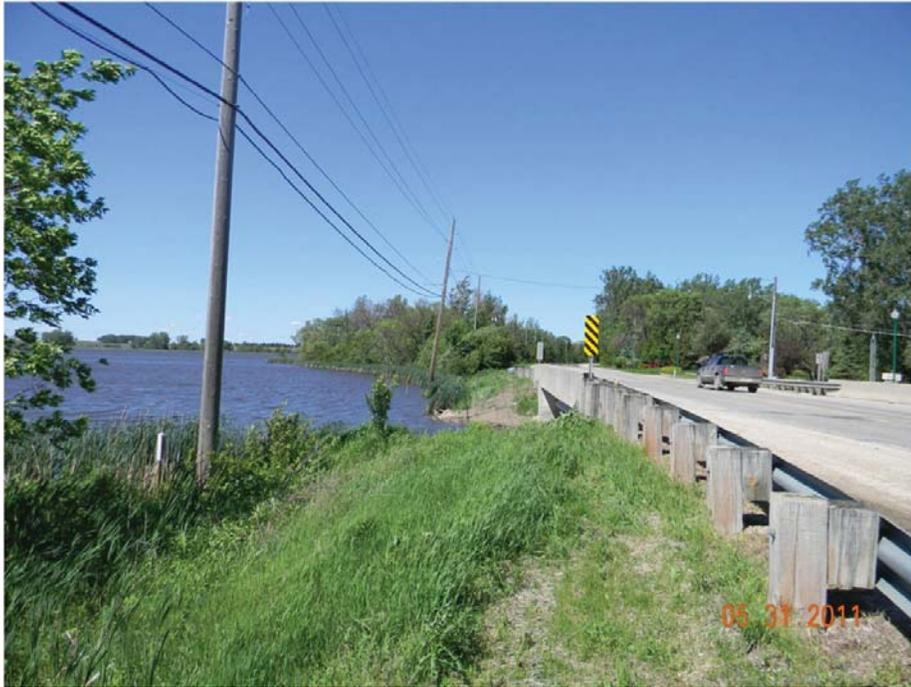
Hydrophytic Vegetation Present? Yes <input checked="" type="checkbox"/> No _____ Hydric Soil Present? Yes _____ No <input checked="" type="checkbox"/> Wetland Hydrology Present? Yes _____ No <input checked="" type="checkbox"/>	Is the Sampled Area within a Wetland? Yes _____ No <input checked="" type="checkbox"/>
Remarks: Inlet crossing is a water of the U.S.

PHOTO 1 – VIEW OF INLET CROSSING (WUS) FACING NORTHEAST.

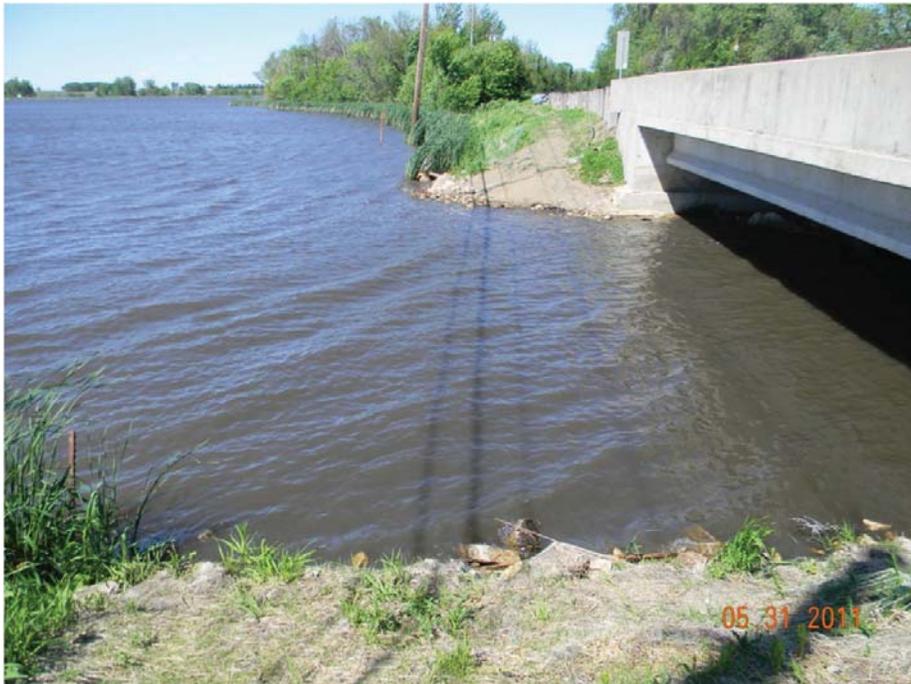
PHOTO 2 – VIEW OF INLET CROSSING (WUS) FACING NORTHEAST.

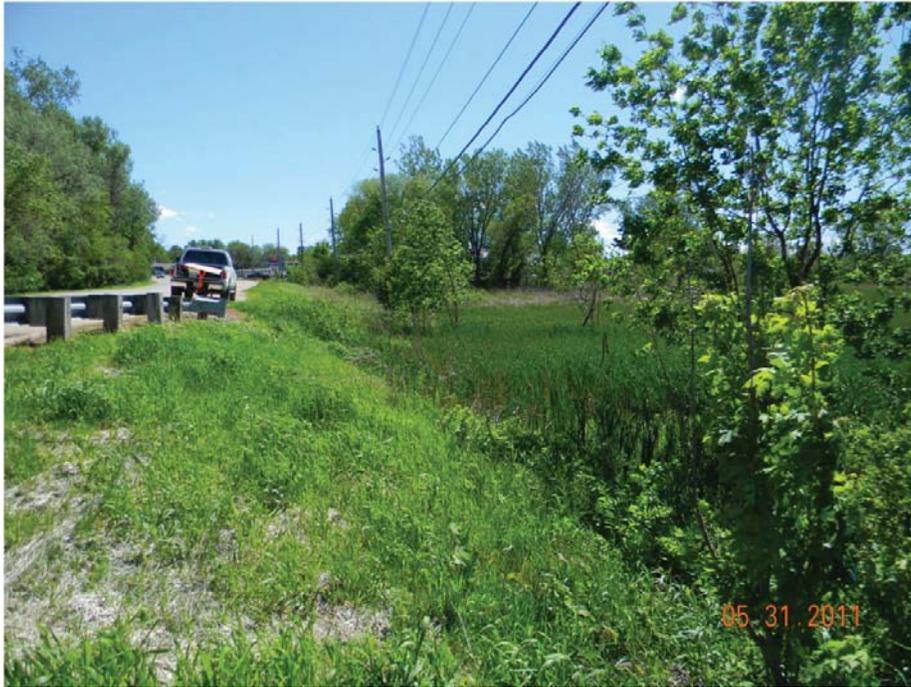
Wetland SL1 is approximately 0.45 acres in size and considered Palustrine Emergent (PEM) and Palustrine Forested (PFO) wetland. The wetland boundaries are identified by changes in vegetation, soils and hydrology. The wetland extends well beyond the study corridor to the west and north.

PHOTO 3 – VIEW WETLAND SL1 FACING SOUTHWEST.

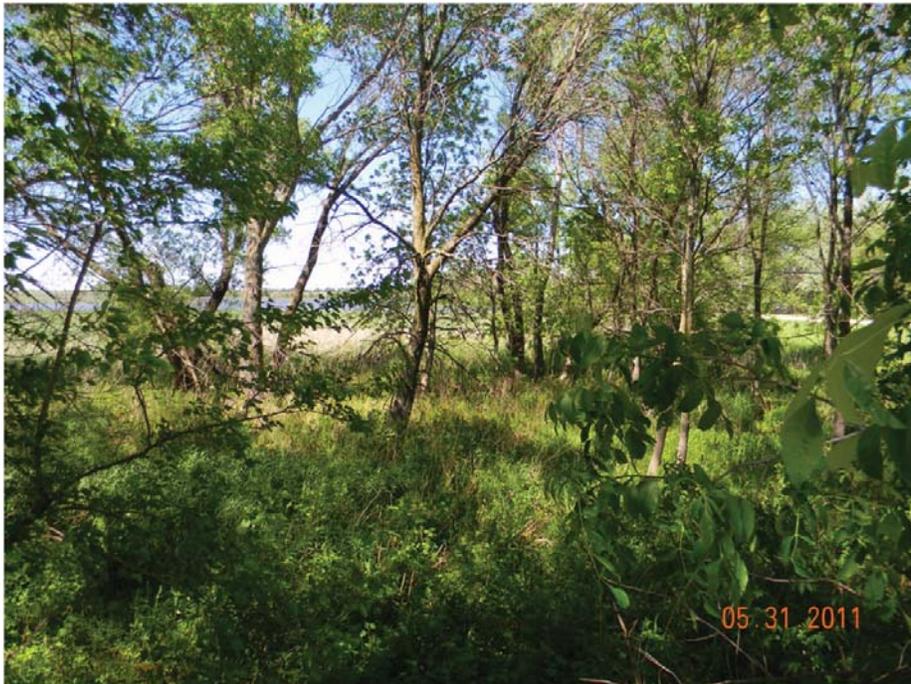
PHOTO 4 – VIEW OF WETLAND SL1 FACING NORTHEAST.

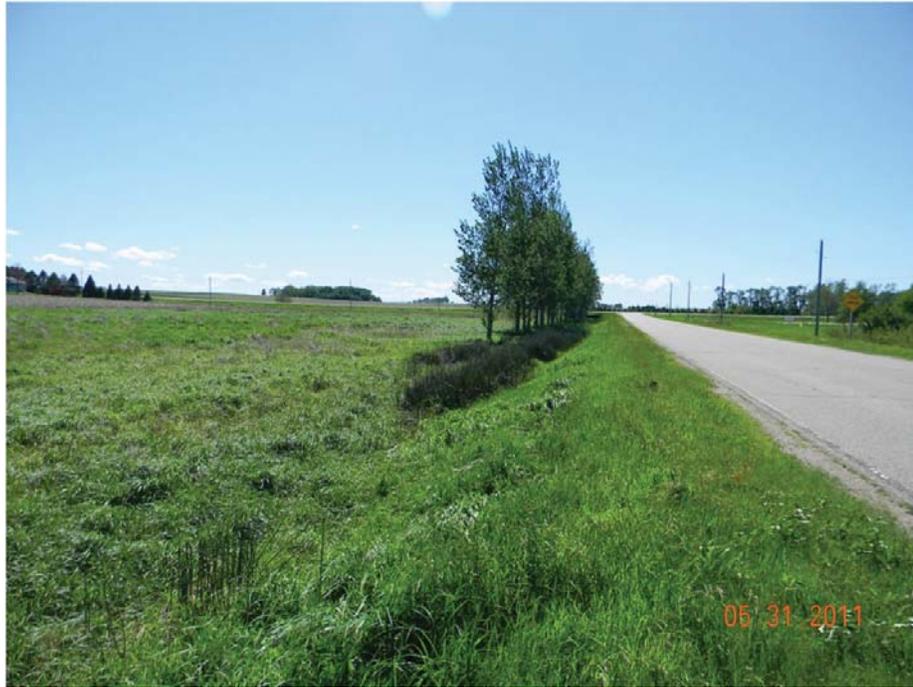
Wetland SL2 is approximately 1.56 acres in size and considered a PEM wetland (sedge meadow). The wetland extends beyond the study corridor limits to the south and is part of a USDA wetland restoration project.

PHOTO 5 – VIEW WETLAND SL2 FACING WEST.

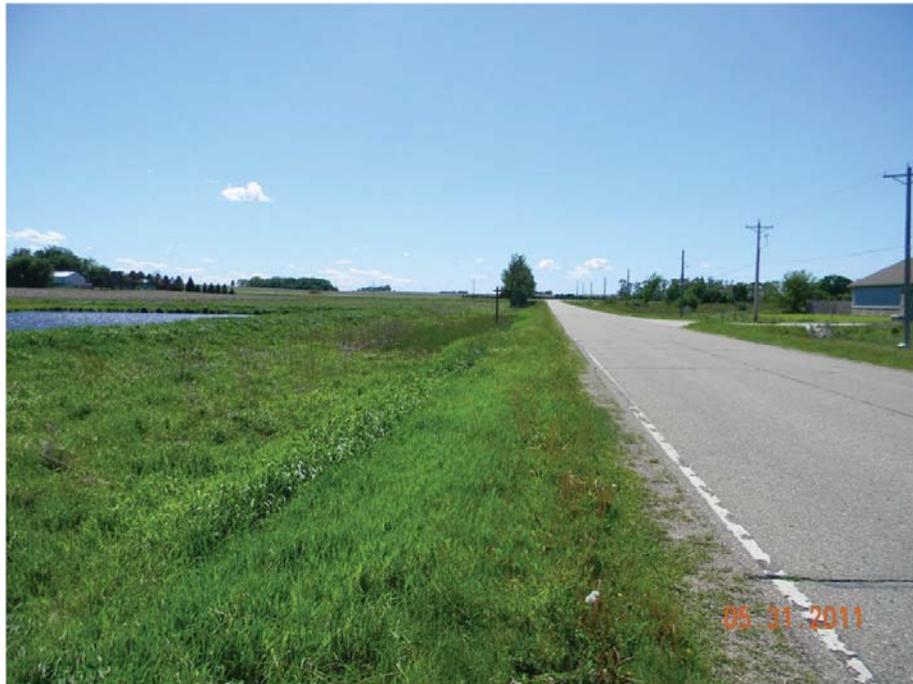
PHOTO 6 – VIEW OF WETLAND SL2 FACING WEST.

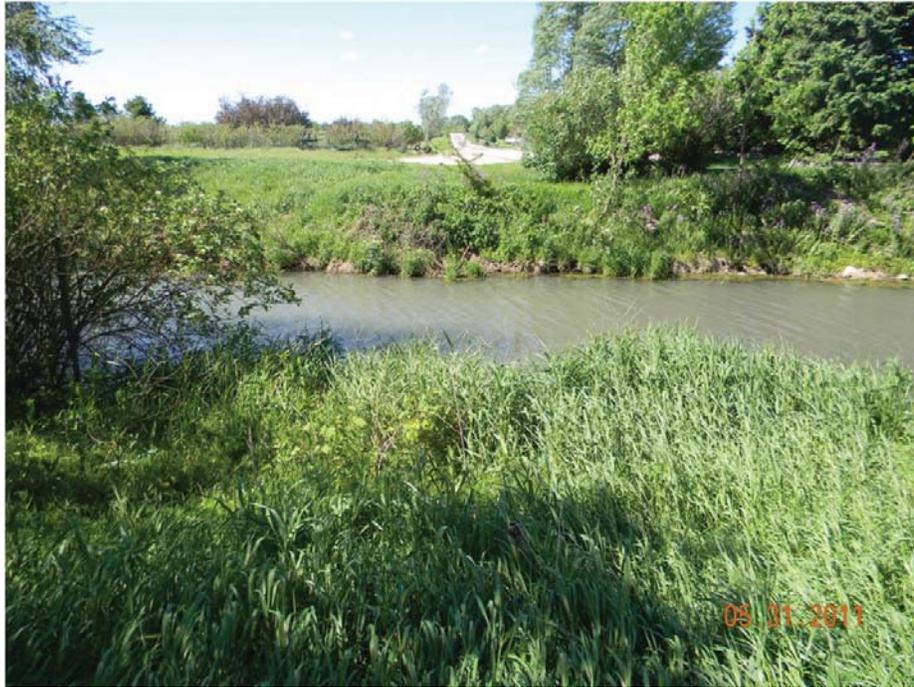
Hydrophytic Vegetation Present? Yes <input checked="" type="checkbox"/> No _____ Hydric Soil Present? Yes _____ No <input checked="" type="checkbox"/> Wetland Hydrology Present? Yes _____ No <input checked="" type="checkbox"/>	Is the Sampled Area within a Wetland? Yes _____ No <input checked="" type="checkbox"/>
Remarks: Stream crossing is a water of the U.S.

PHOTO 7 – VIEW OF UNNAMED STREAM CROSSING (WUS) FACING NORTH.

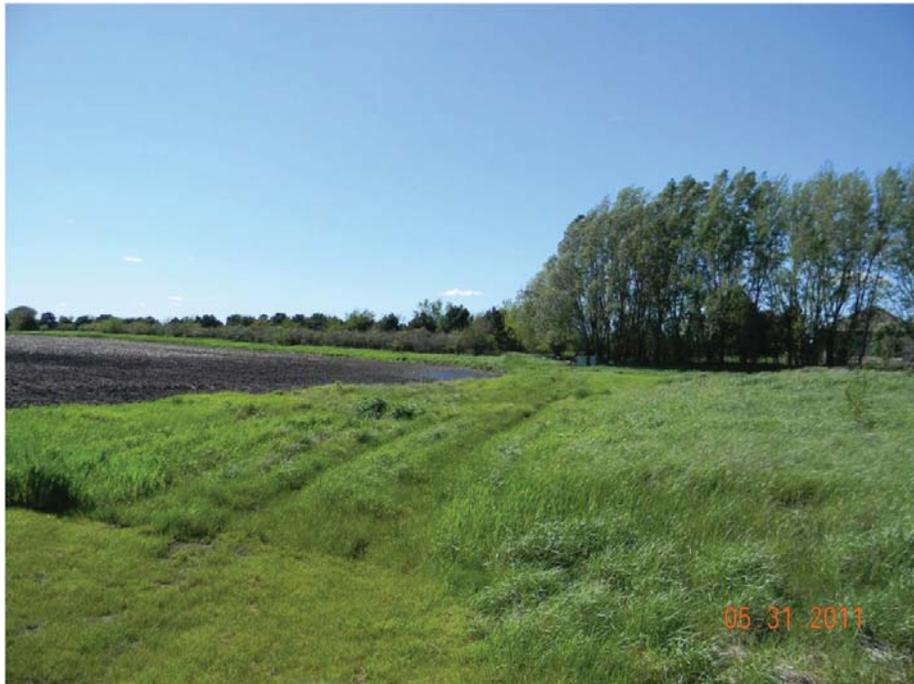
Wetland SL3 is approximately 0.09 acres in size and considered a PEM wetland (sedge meadow). The wetland is a closed depression adjacent to the lake.

PHOTO 8 – VIEW OF WETLAND SL3 FACING NORTHWEST.

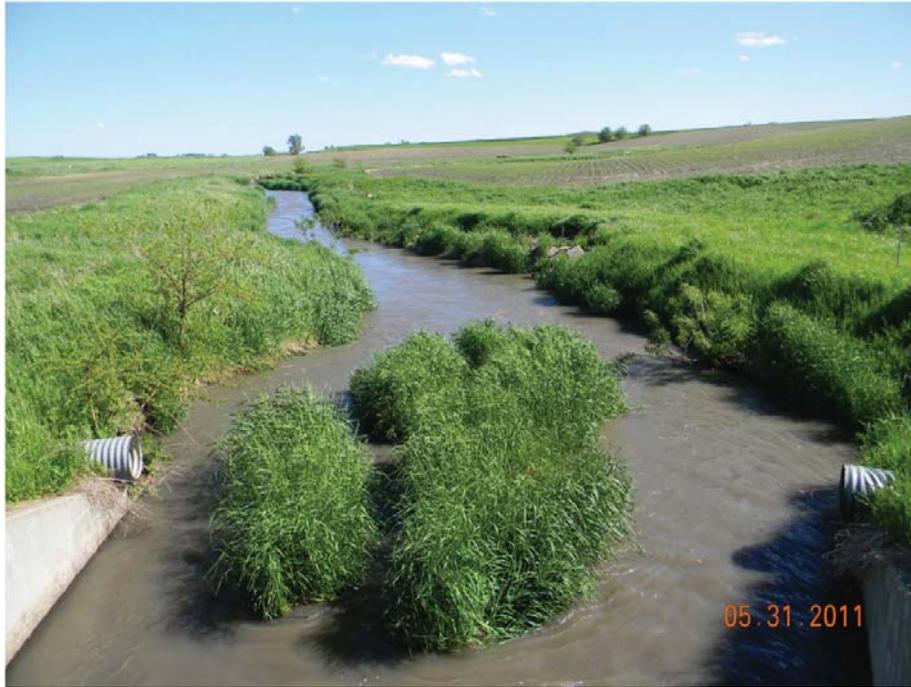
In addition to the identified wetland impacts, the project alignment crosses jurisdictional waters of the U.S. (open water and stream crossings) at three locations: the lake inlet, an unnamed stream adjacent to wetland SL3, and Outlet Creek. No other potentially jurisdictional waters are located within the project area.

PHOTO 9 – VIEW OF OUTLET CREEK CROSSING (WUS) FACING SOUTH.

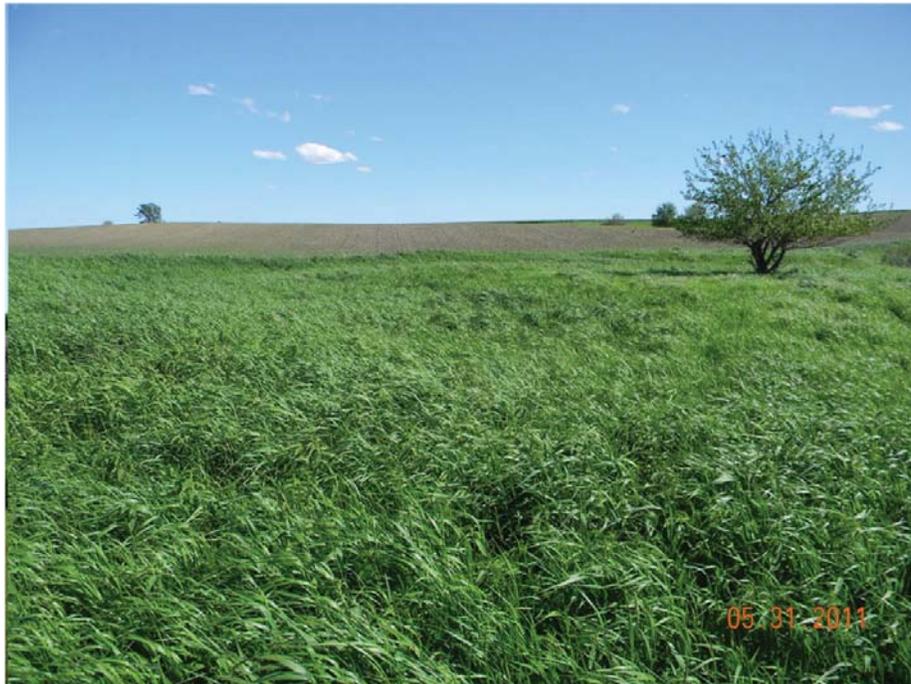
Wetland SL4 is approximately 0.13 acres on size and considered a PEM wetland. The wetland is a remnant oxbow adjacent to Outlet Creek.

PHOTO 10 – VIEW OF WETLAND SL4 FACING SOUTH.
