Project/Site: Clarksville WWTP Expansion and Effluent Line Replacement Project City/County: Clark Sampling Date: 12/13/2011
 Applicant/Owner: Town of Clarksville State: Indiana Sampling Point: DP-6
 Investigator(s): B. Deetsch, L. Darnell Section, Township, Range: _____
 Landform (hillslope, terrace, etc.): Large depression (Wetland 2) Local relief (concave, convex, none): Concave
 Slope (%): 1-2% Lat: N 38.2936° Long: W 85.7760° Datum: _____
 Soil Map Unit Name/Uaa - Udorthents, cut and filled NWI classification: _____
 Are climatic/hydrologic conditions on the site typical for this time of year? Yes X No _____ (If no, explain in Remarks.)
 Are Vegetation _____, Soil _____ or Hydrology _____ significantly disturbed? Are "Normal Circumstances" present?
 Are Vegetation _____, Soil _____ or Hydrology _____ naturally problematic? Yes X No _____
 (If needed, explain any answers in Remarks.)

HAZARDOUS MATERIALS ASSESSMENT REPORT

***RE: Hazardous Materials Environmental Assessment
Expansion and Effluent Line Replacement Project
Clarksville Waste Water Treatment Plant
1 Leuthart Drive
Clarksville, Clark County, Indiana
Linebach Funkhouser, Inc. Project No. 186-12***

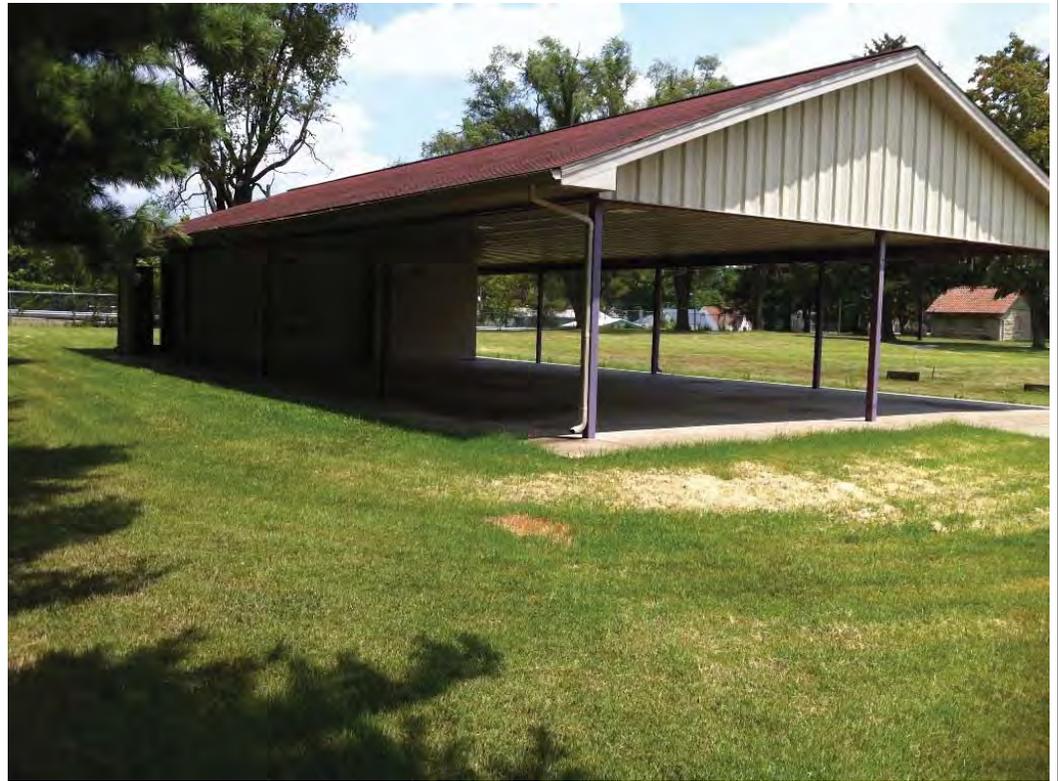
Structures at the Midway Park property include a pavilion and garage, associated with historic use of the site as a residence and later a public park.

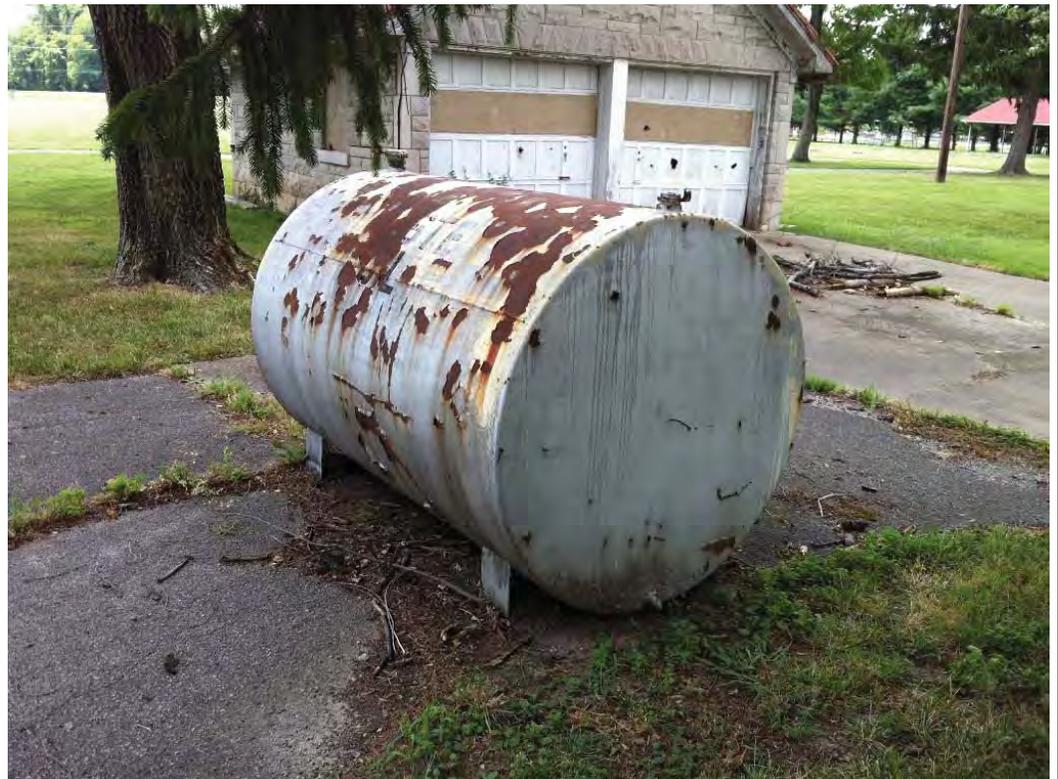
2

An above-ground storage tank (AST) was noted adjacent to the garage structure. The AST was labeled to contain waste oil, but appeared to contain minimal fluid. Rusting was noted on the exterior of the AST; however, no apparent release was noted.

An above-ground storage tank (AST) was noted adjacent to the garage structure. The approximately 500-gallon AST was labeled as 'Waste Oil'. A damaged port cap was noted at the top of the AST, exposing the interior of the AST to the atmosphere and allowing the infiltration of rainwater. A small quantity of liquid was noted in the bottom of the AST.

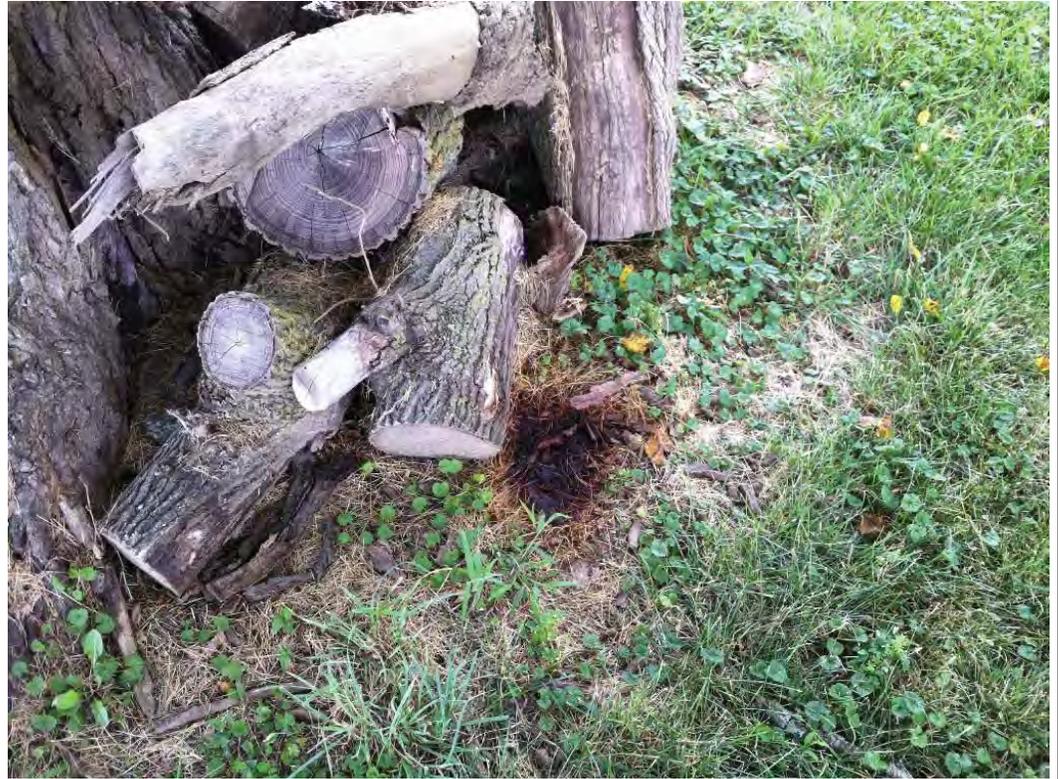
An insignificant amount of soil staining was noted adjacent to a tree in the northeast portion of the park property.

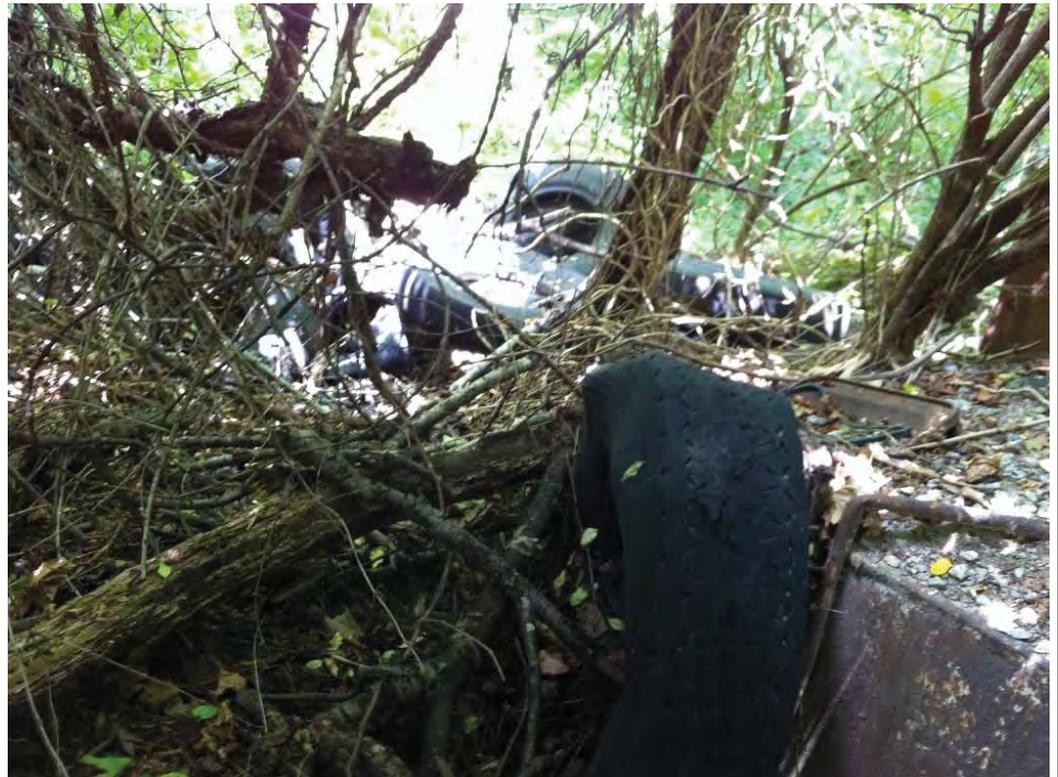
4

Abundant solid waste was encountered on the Lucas Brothers property. This area is west of the flood wall, and north of the former railroad track. Waste from this former dump reportedly affected public water wells to the southeast.

The site reconnaissance of the Lucas Brothers Paving property, however, revealed abundant solid waste materials at the ground surface, likely with a former landfill located at this property (as discussed in following sections). The solid waste included scrap metal, waste tires, automotive parts (oil filters, gas tanks, etc.), rusted 55-gallon drums, bottles and cans, and asphalt and concrete construction debris. A trail, apparently used by off-road vehicles, appeared to be associated with limited dumping of more recent solid waste debris.

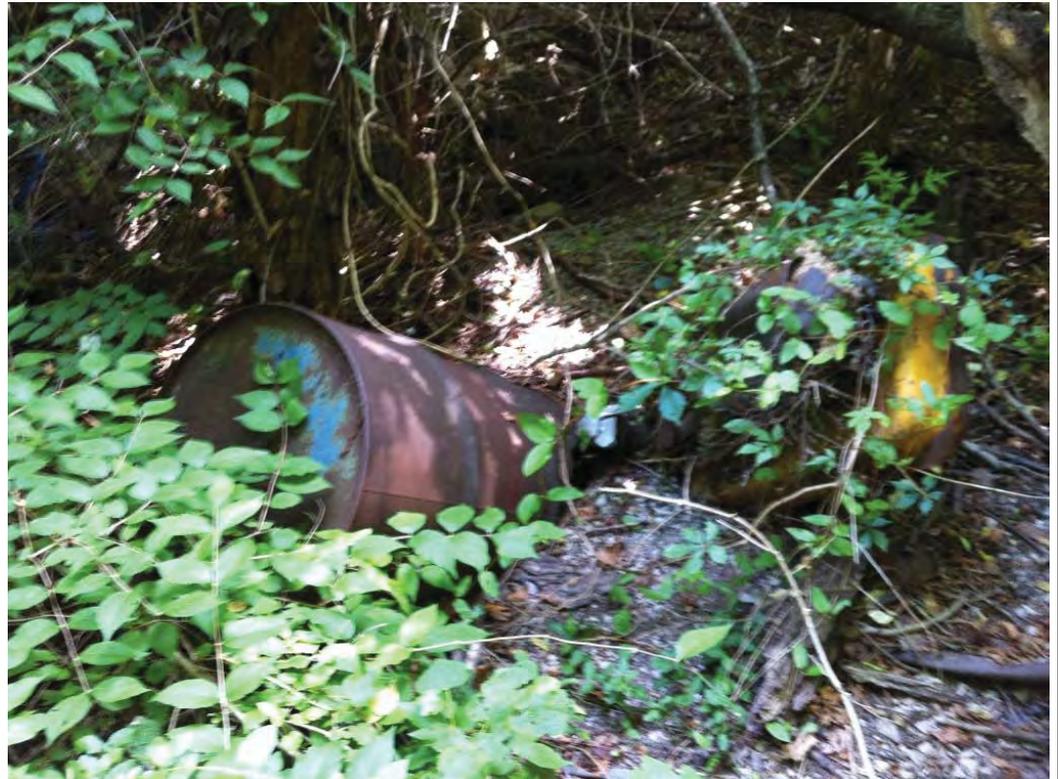
Additional solid waste on the Lucas Brothers property included unlabeled and rusted drums and automotive parts, such as the gas tank depicted.

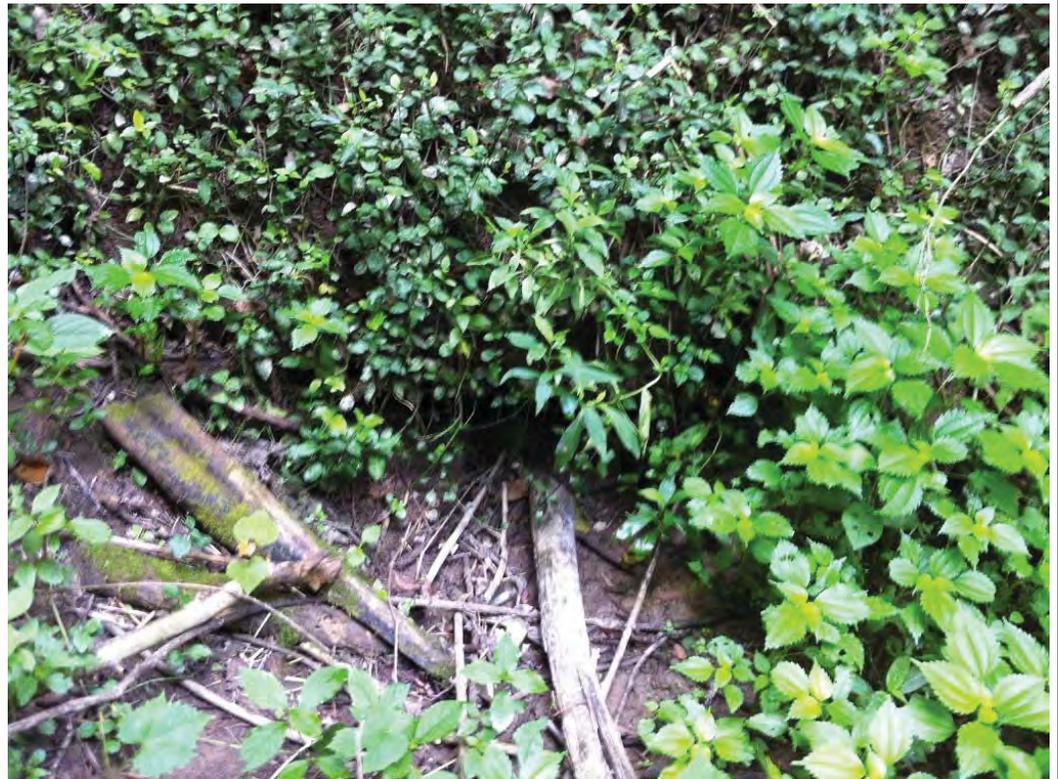
6

A wet weather spring or sink appeared to be present, based on observations of likely wet weather flow patterns. Typical karst/cave features are not expected in the area; however, some subsurface flow may be present.

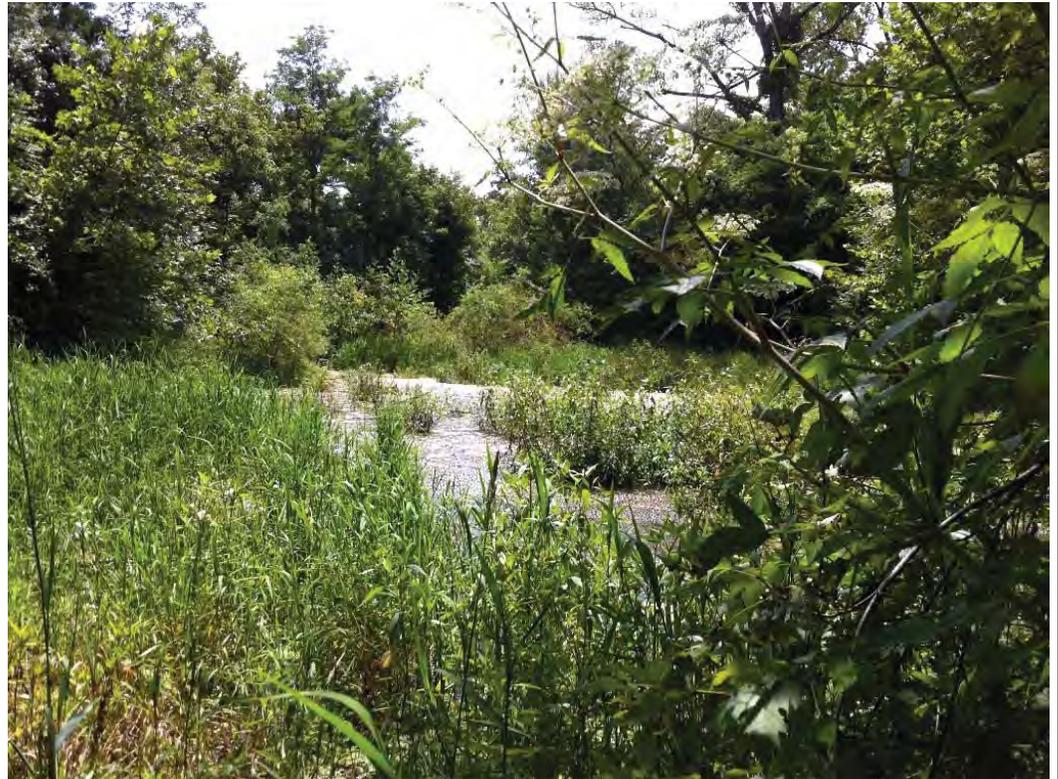
A pond was noted on the IDNR property west of the flood wall and south of the former railroad track. Access to the pond was limited by thick vegetation.

The site reconnaissance of the IDNR property also revealed small amounts of solid waste debris at various locations. A small pond, present along the western boundary of the property, appeared to discharge to a surface water feature flowing to the south. The water feature appeared to deposit an orange (iron) precipitate, with additional precipitate noted in the bank of the water feature. While no obvious sheen or odor was associated with the water feature, the general appearance of the water suggested possible leachate impact from the former landfill at the upgradient Lucas Brothers Paving property. The surface water feature was noted to flow south, discharging directly to Mill Creek. Thick plant and algae growth were noted at the confluence with Mill Creek but not within the water feature itself.

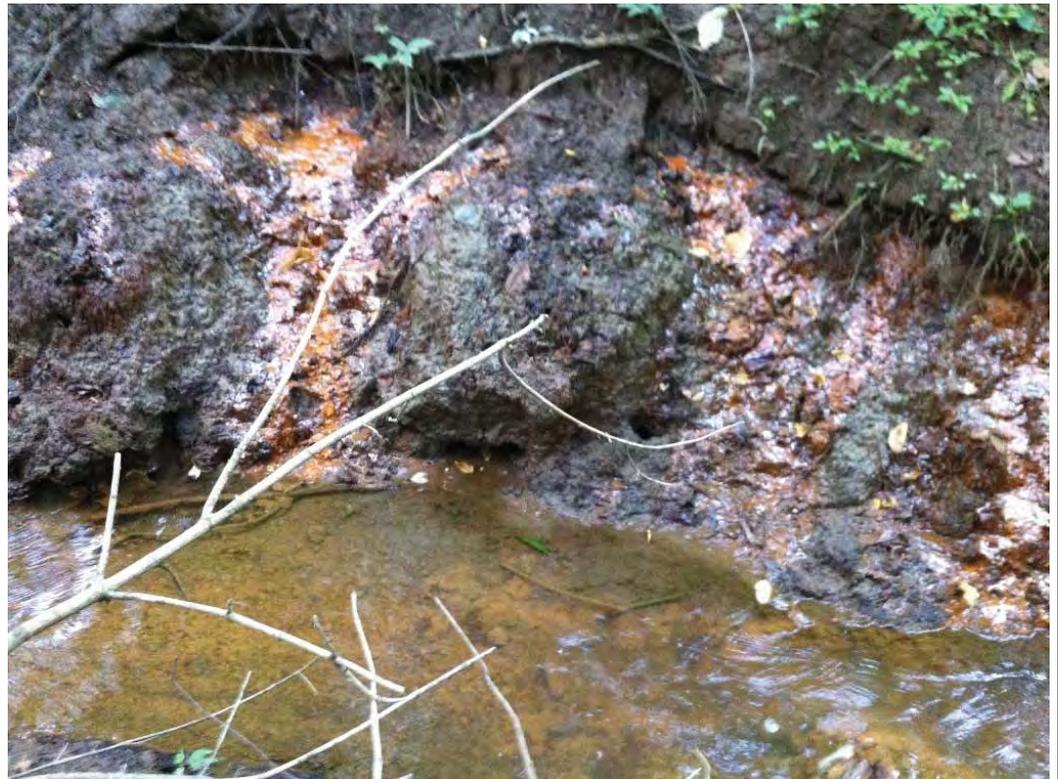
8

Water discharge from the pond appeared to precipitate iron, possibly associated with leachate from the former dump to the north. Additional areas of apparent leachate were noted in the banks of the surface water feature.

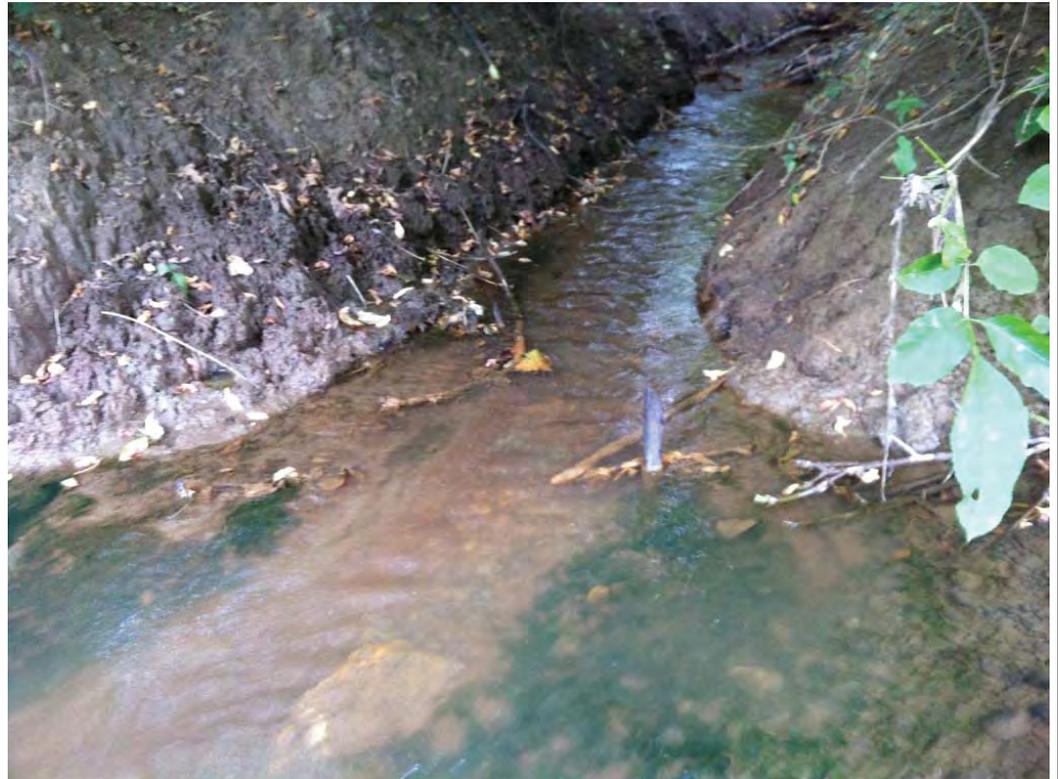
Algae growth was noted at the confluence of the suspect leachate water feature and Mill Creek. No stressed vegetation was observed directly, but is suspected based on a general lack of vegetation or plant growth within the main channel of the suspect leachate surface water feature..

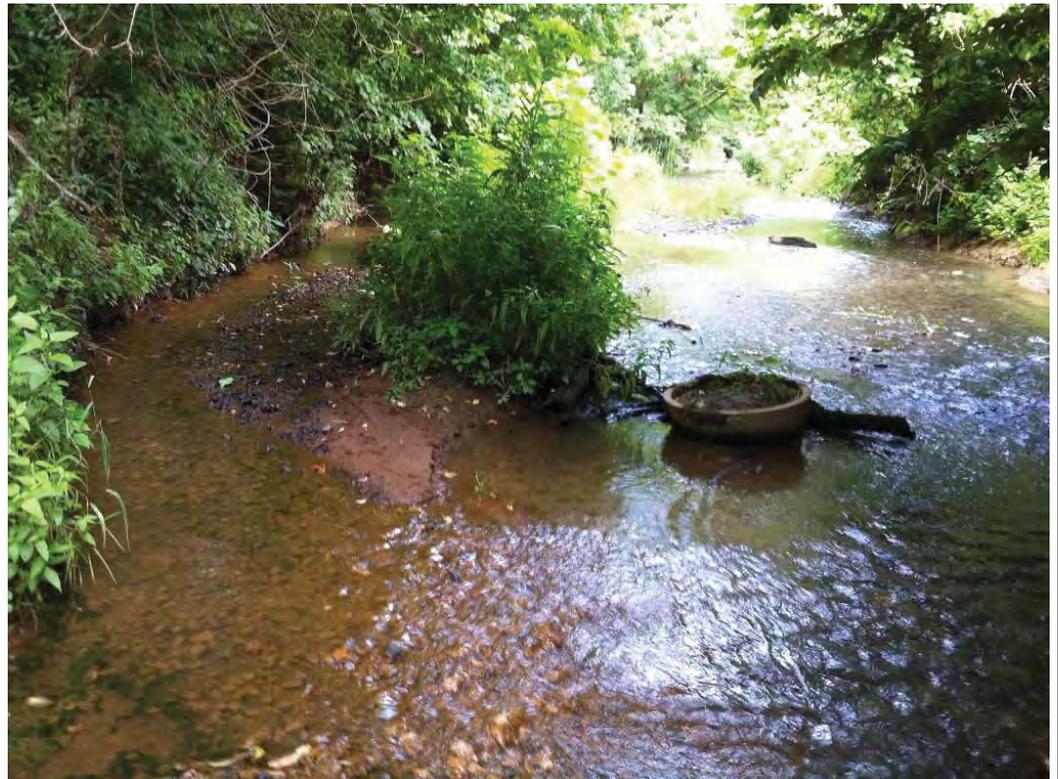
10

A second view of the confluence, downstream of the water feature discharge point.

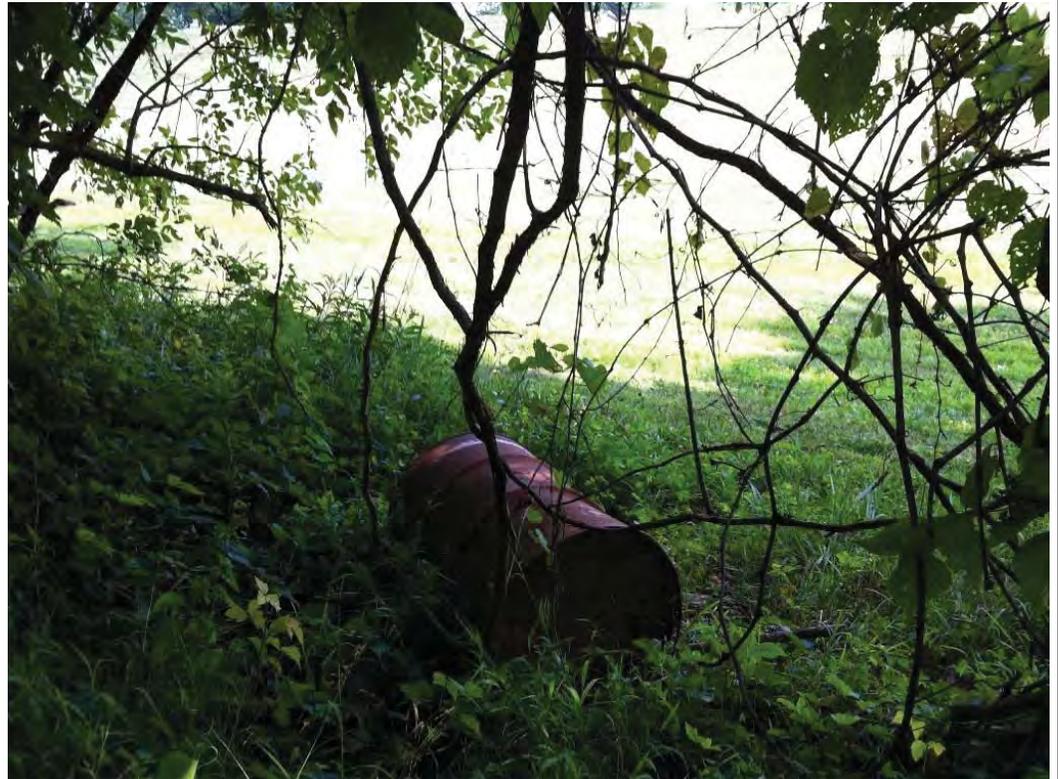
Solid waste debris was noted throughout the Lucas Brothers and IDNR properties, and noted with a drum identified near the southeast corner of the effluent line study area.

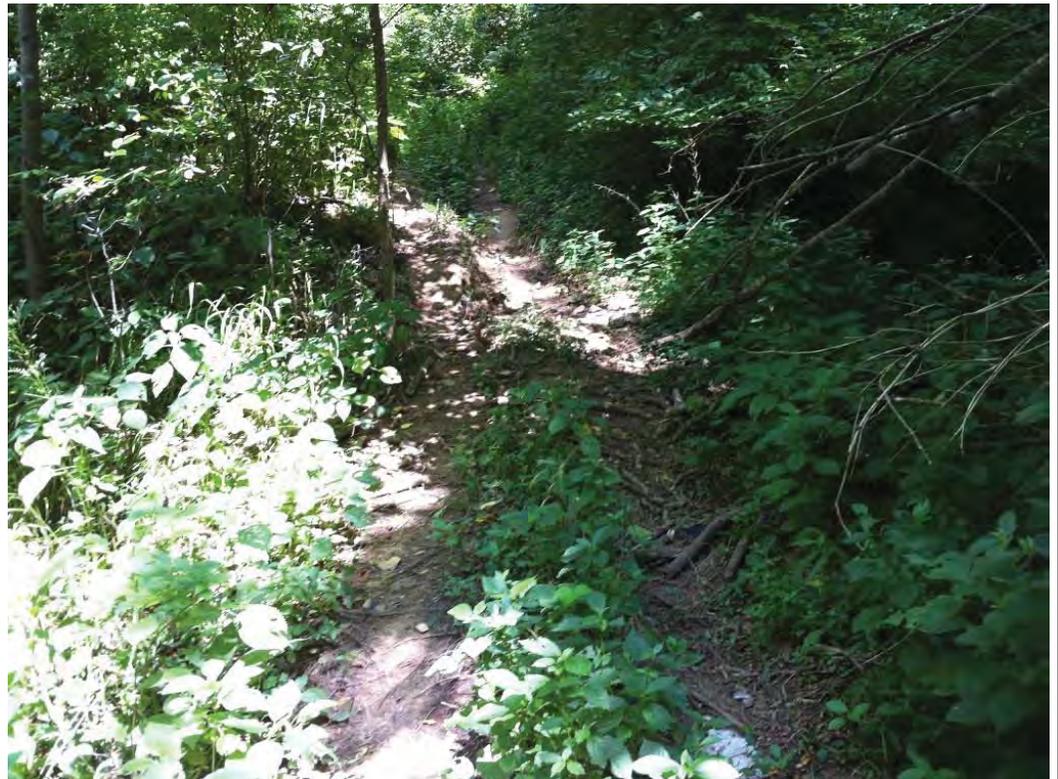
12

Minor amounts of solid waste dumping was noted on the IDNR property, along an ATV trail that runs through the property.
